**RZ05-1636 Part-B**

**Cattle Vat - 1**

**North Property Line  
6501 N 78th Street**

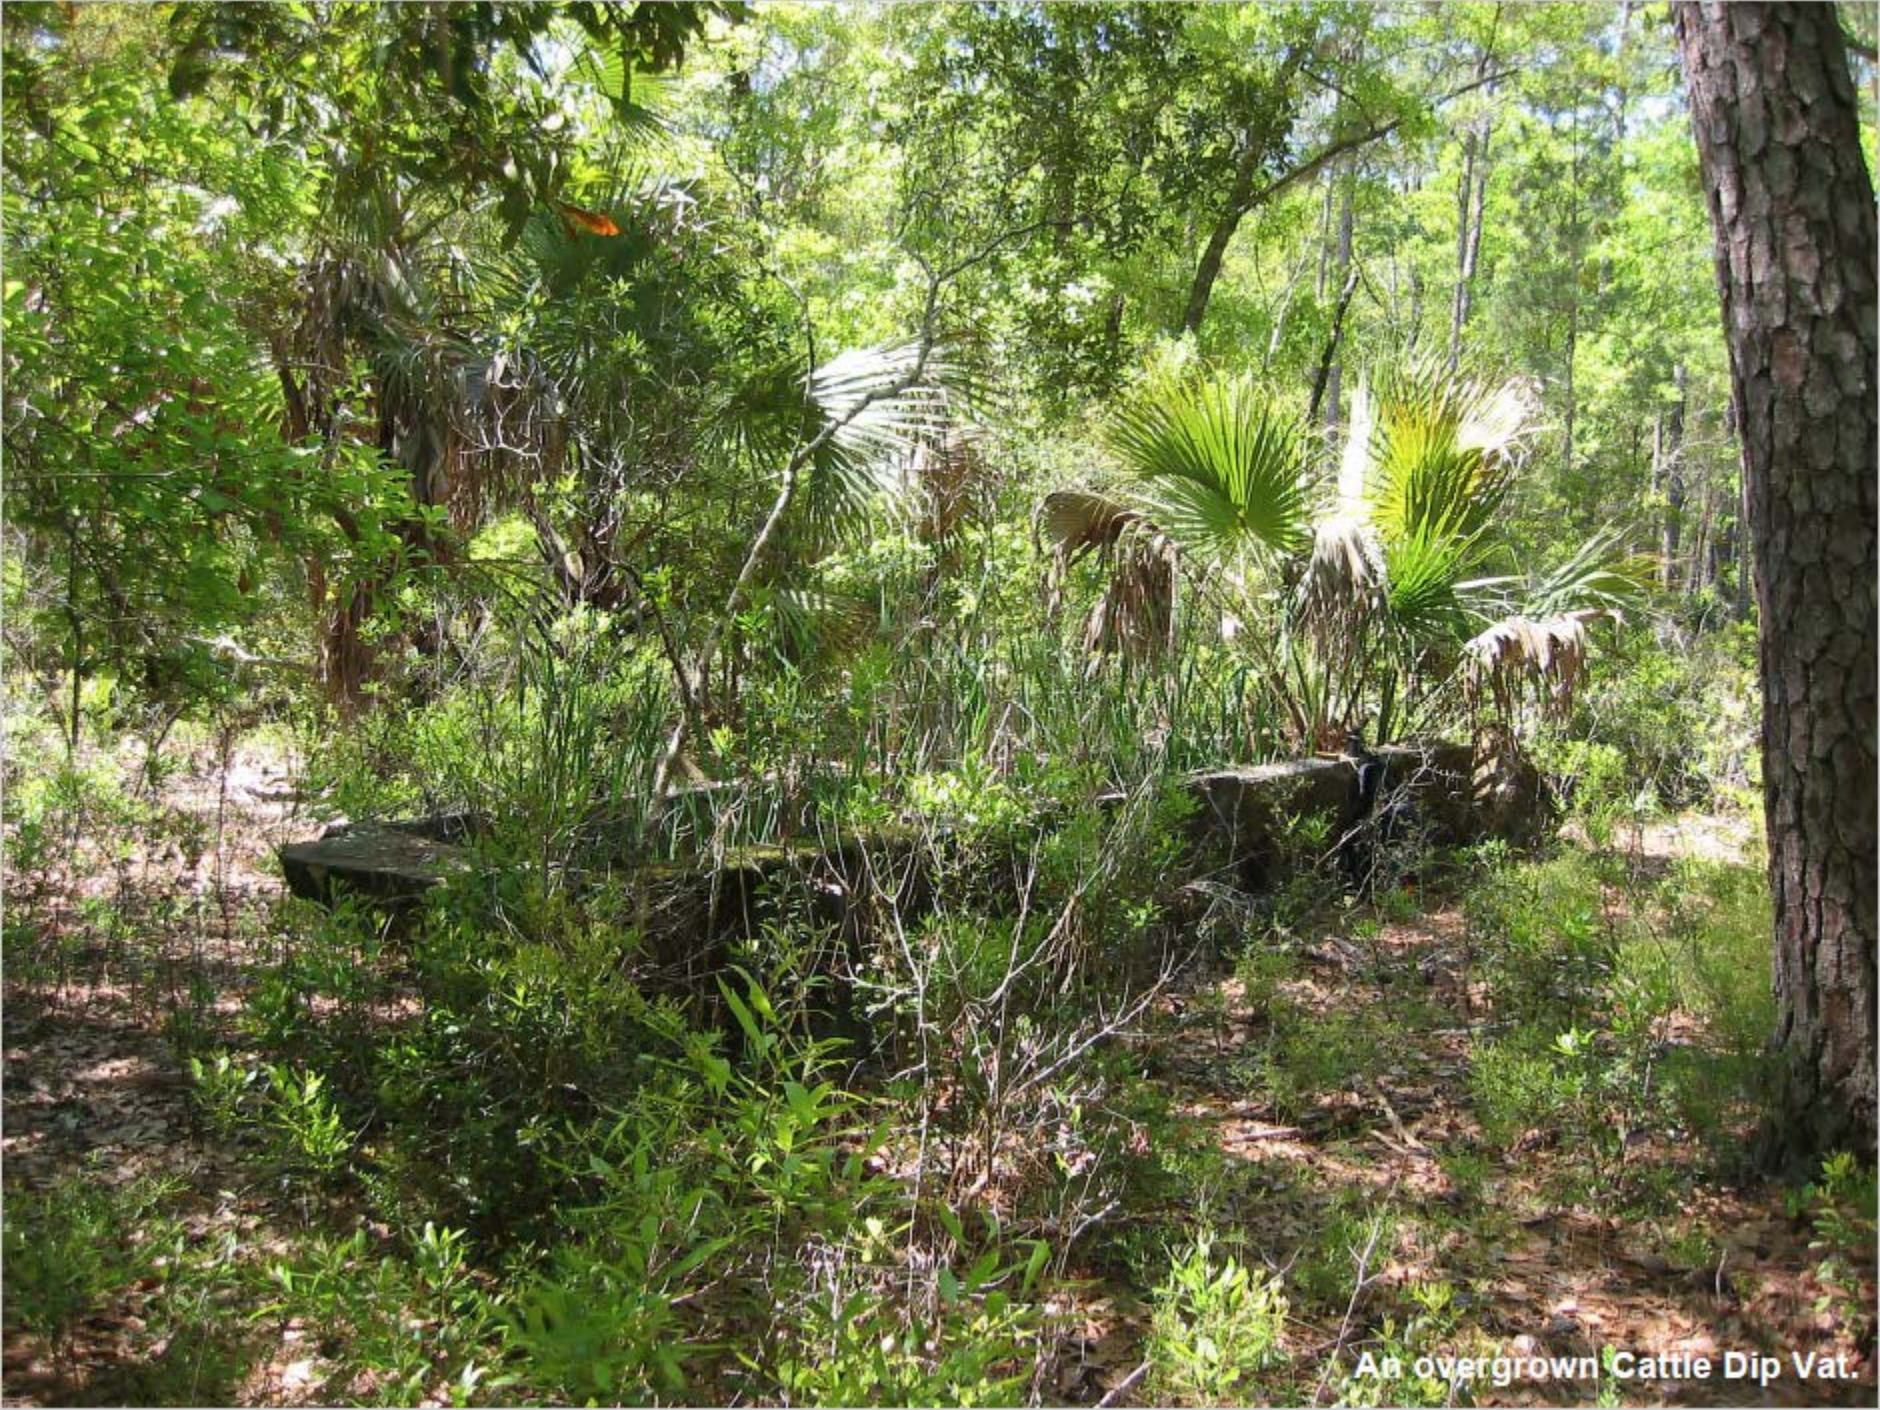
An overgrown Cattle Dip Vat.

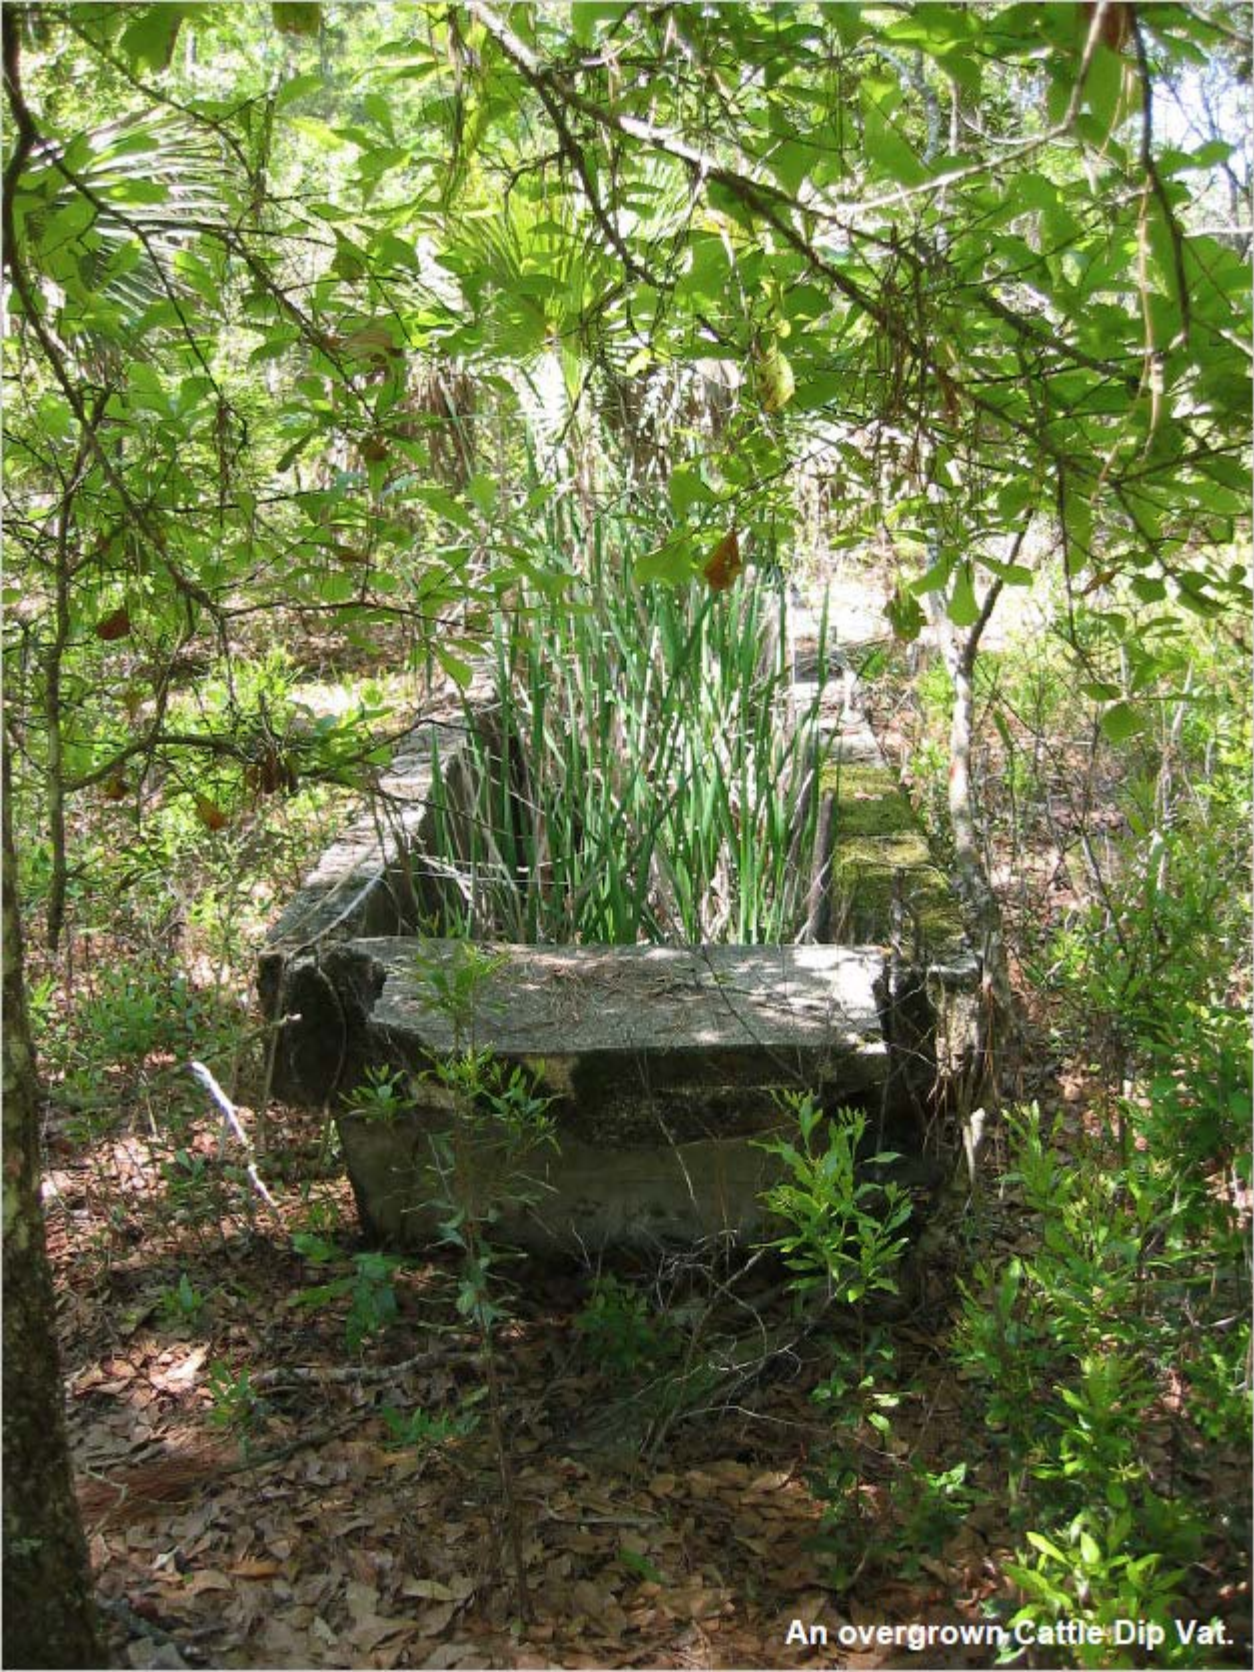
An overgrown Cattle Dip Vat.

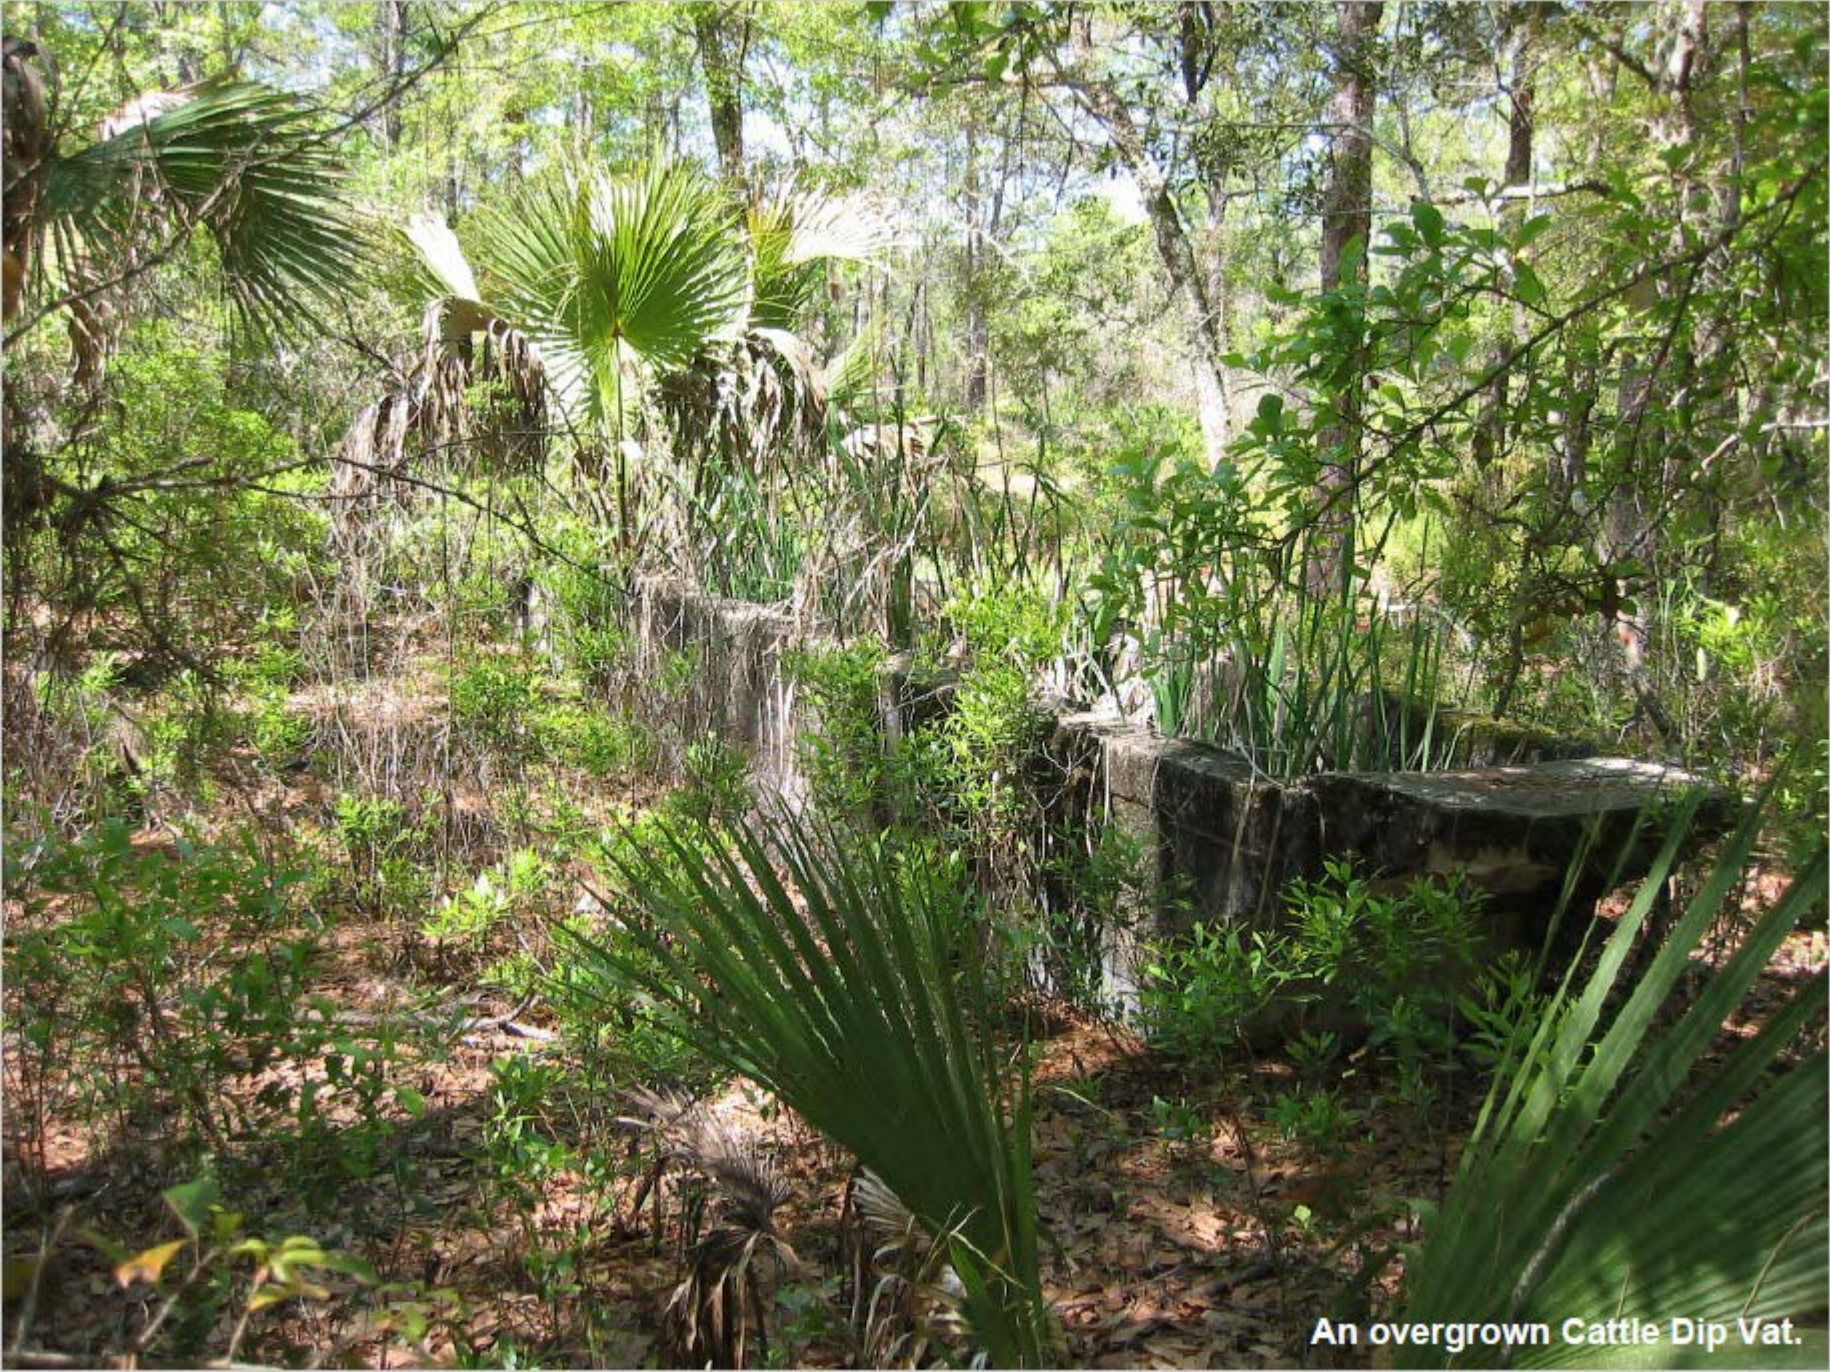
An overgrown Cattle Dip Vat.

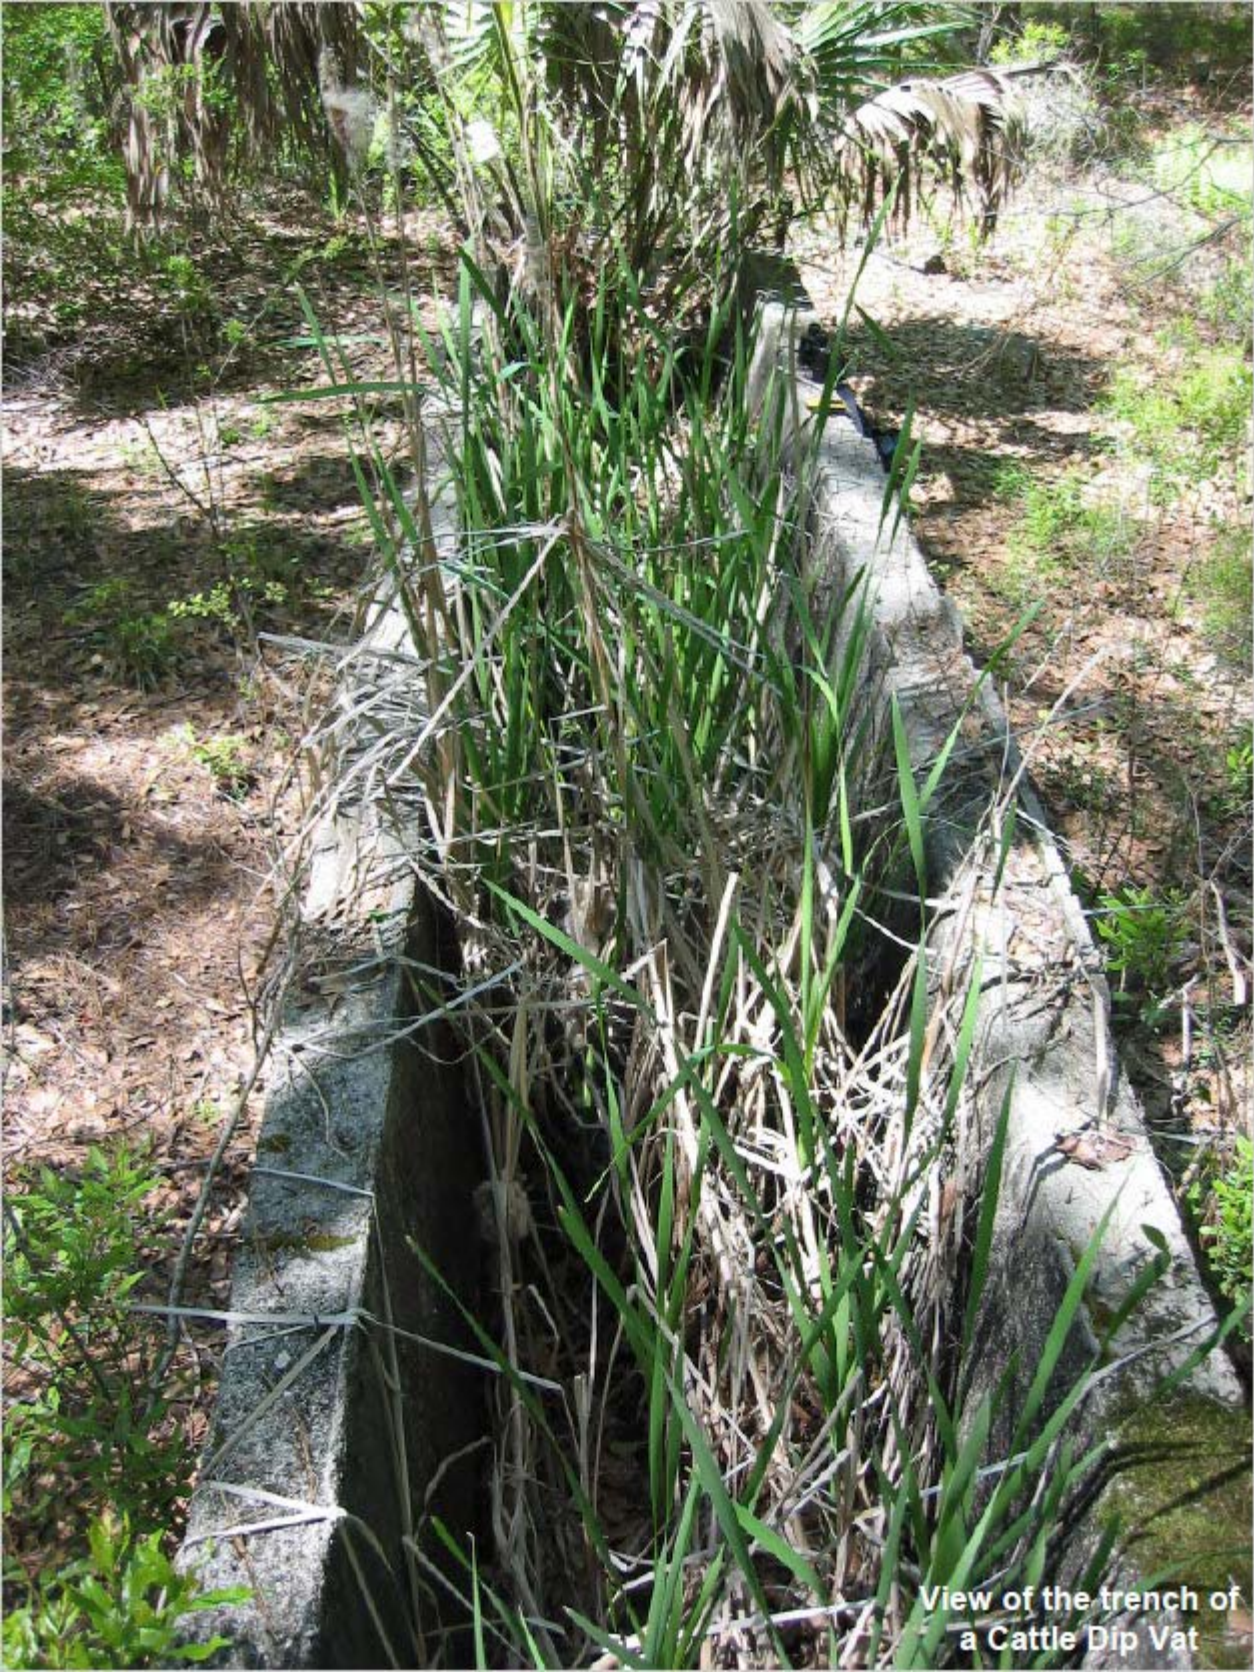
View of the trench of  
a Cattle Dip Vat

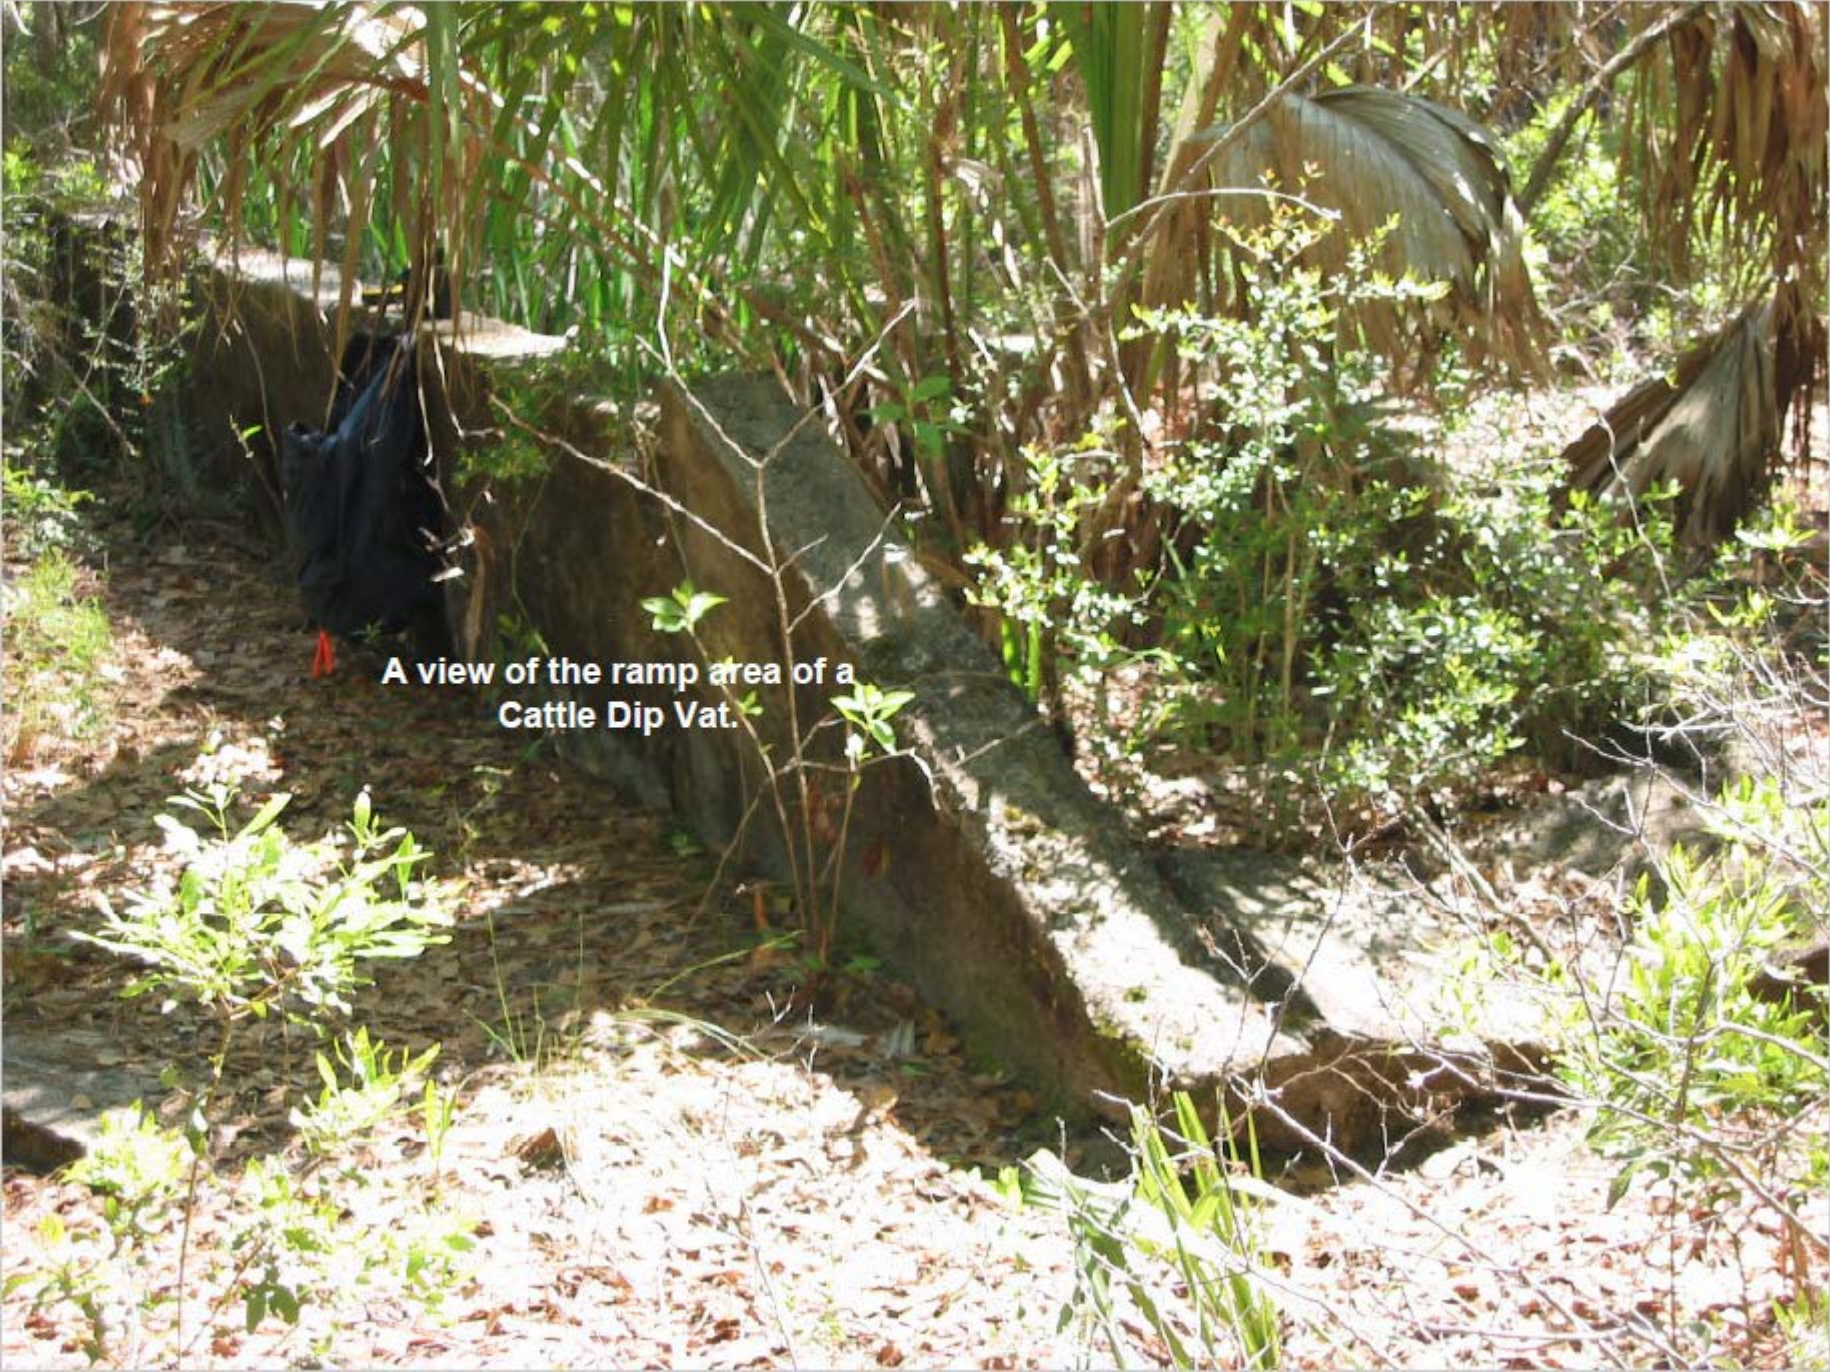
**A view of the ramp area of a  
Cattle Dip Vat.**

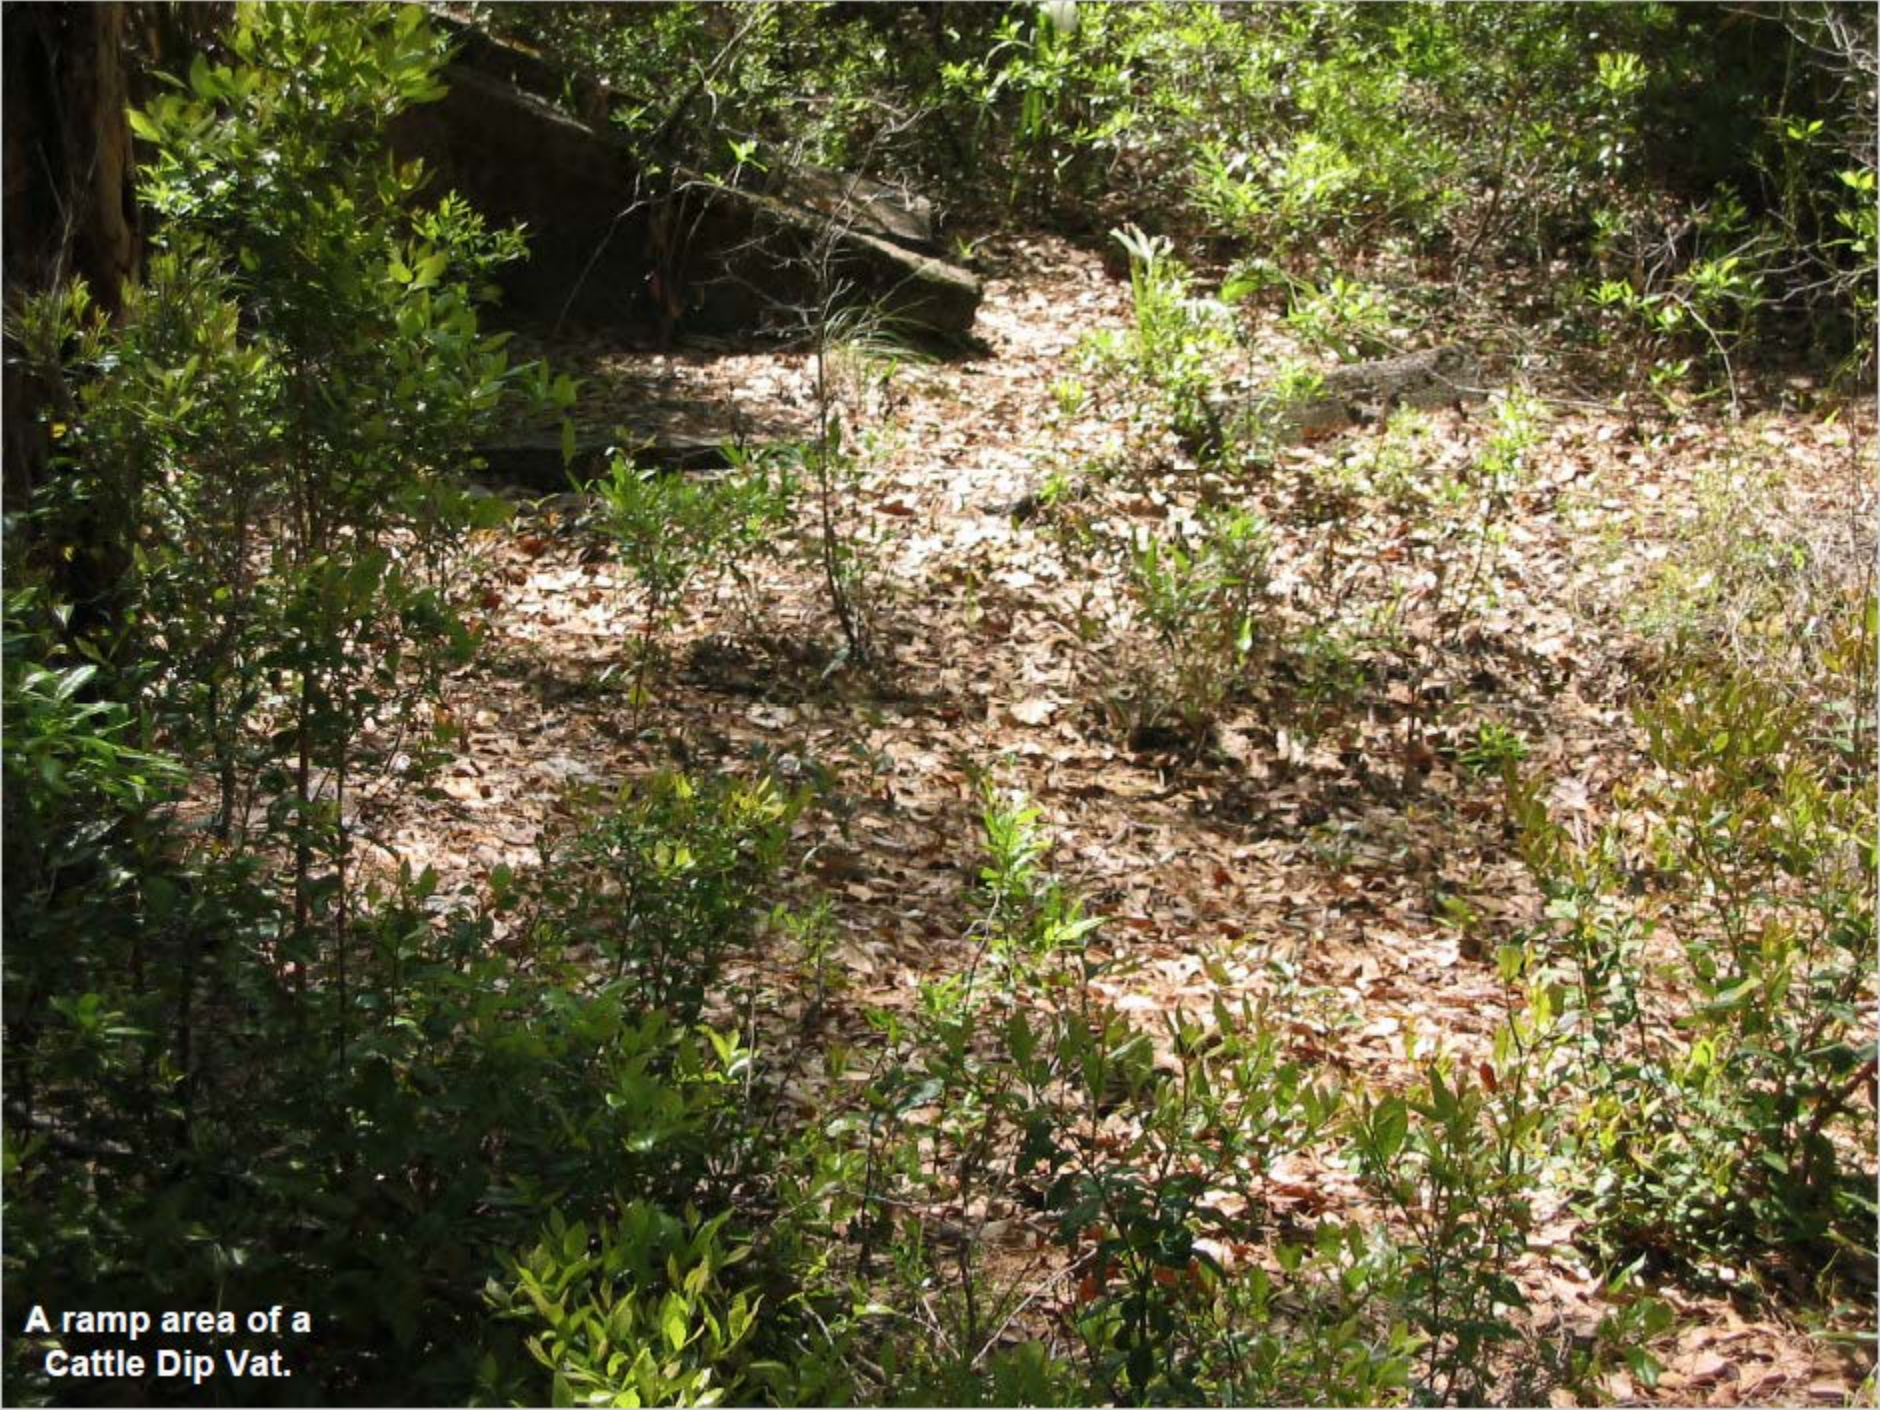
**A ramp area of a  
Cattle Dip Vat.**

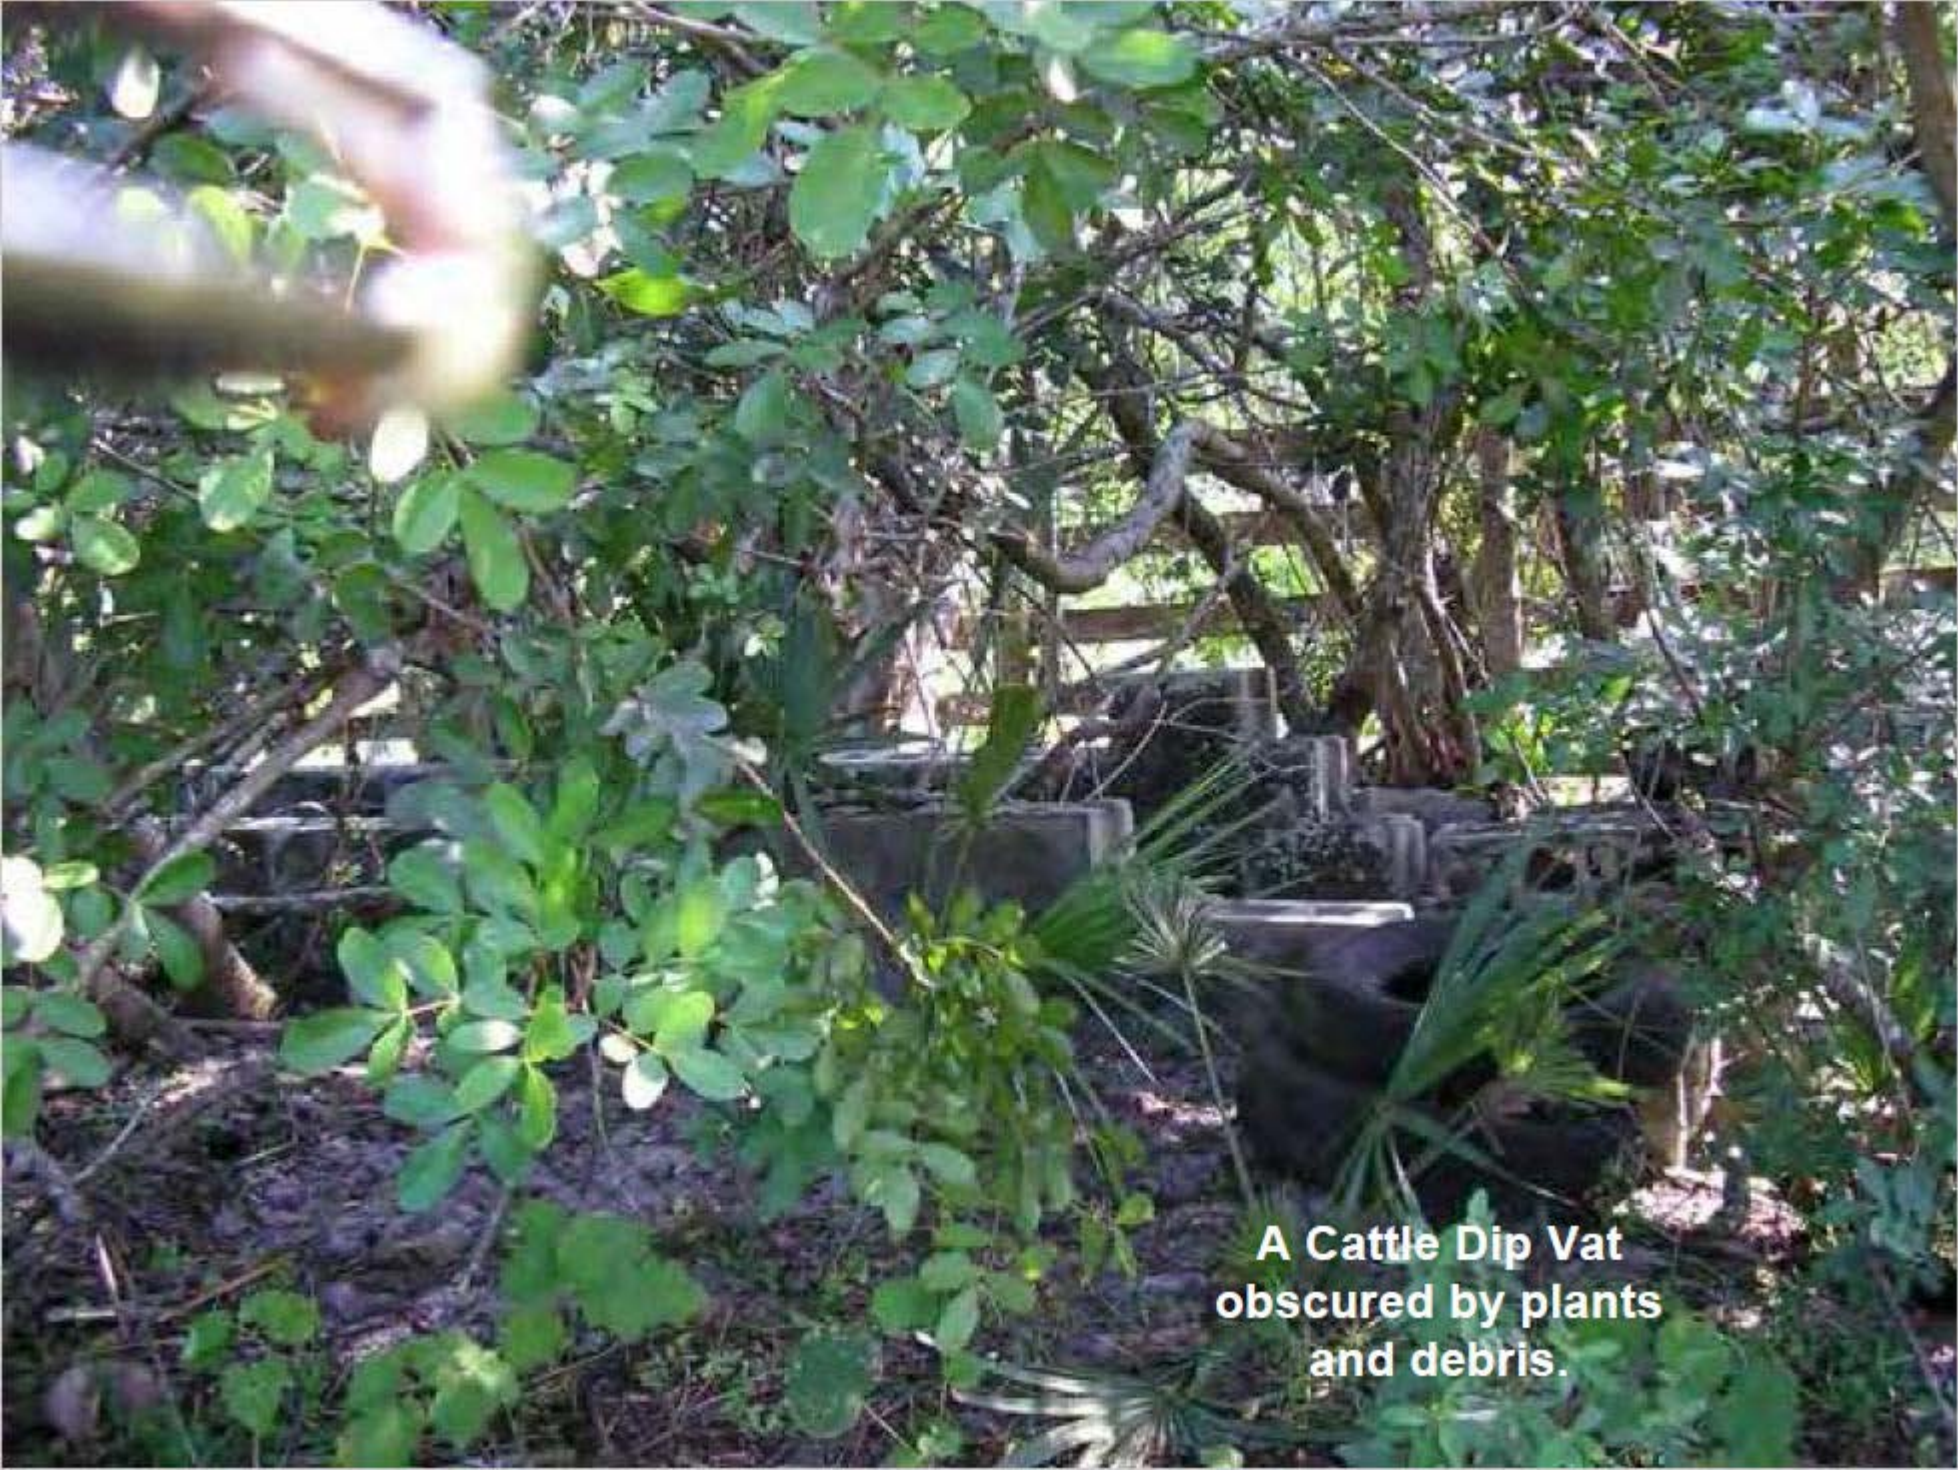
**A Cattle Dip Vat  
obscured by plants  
and debris.**

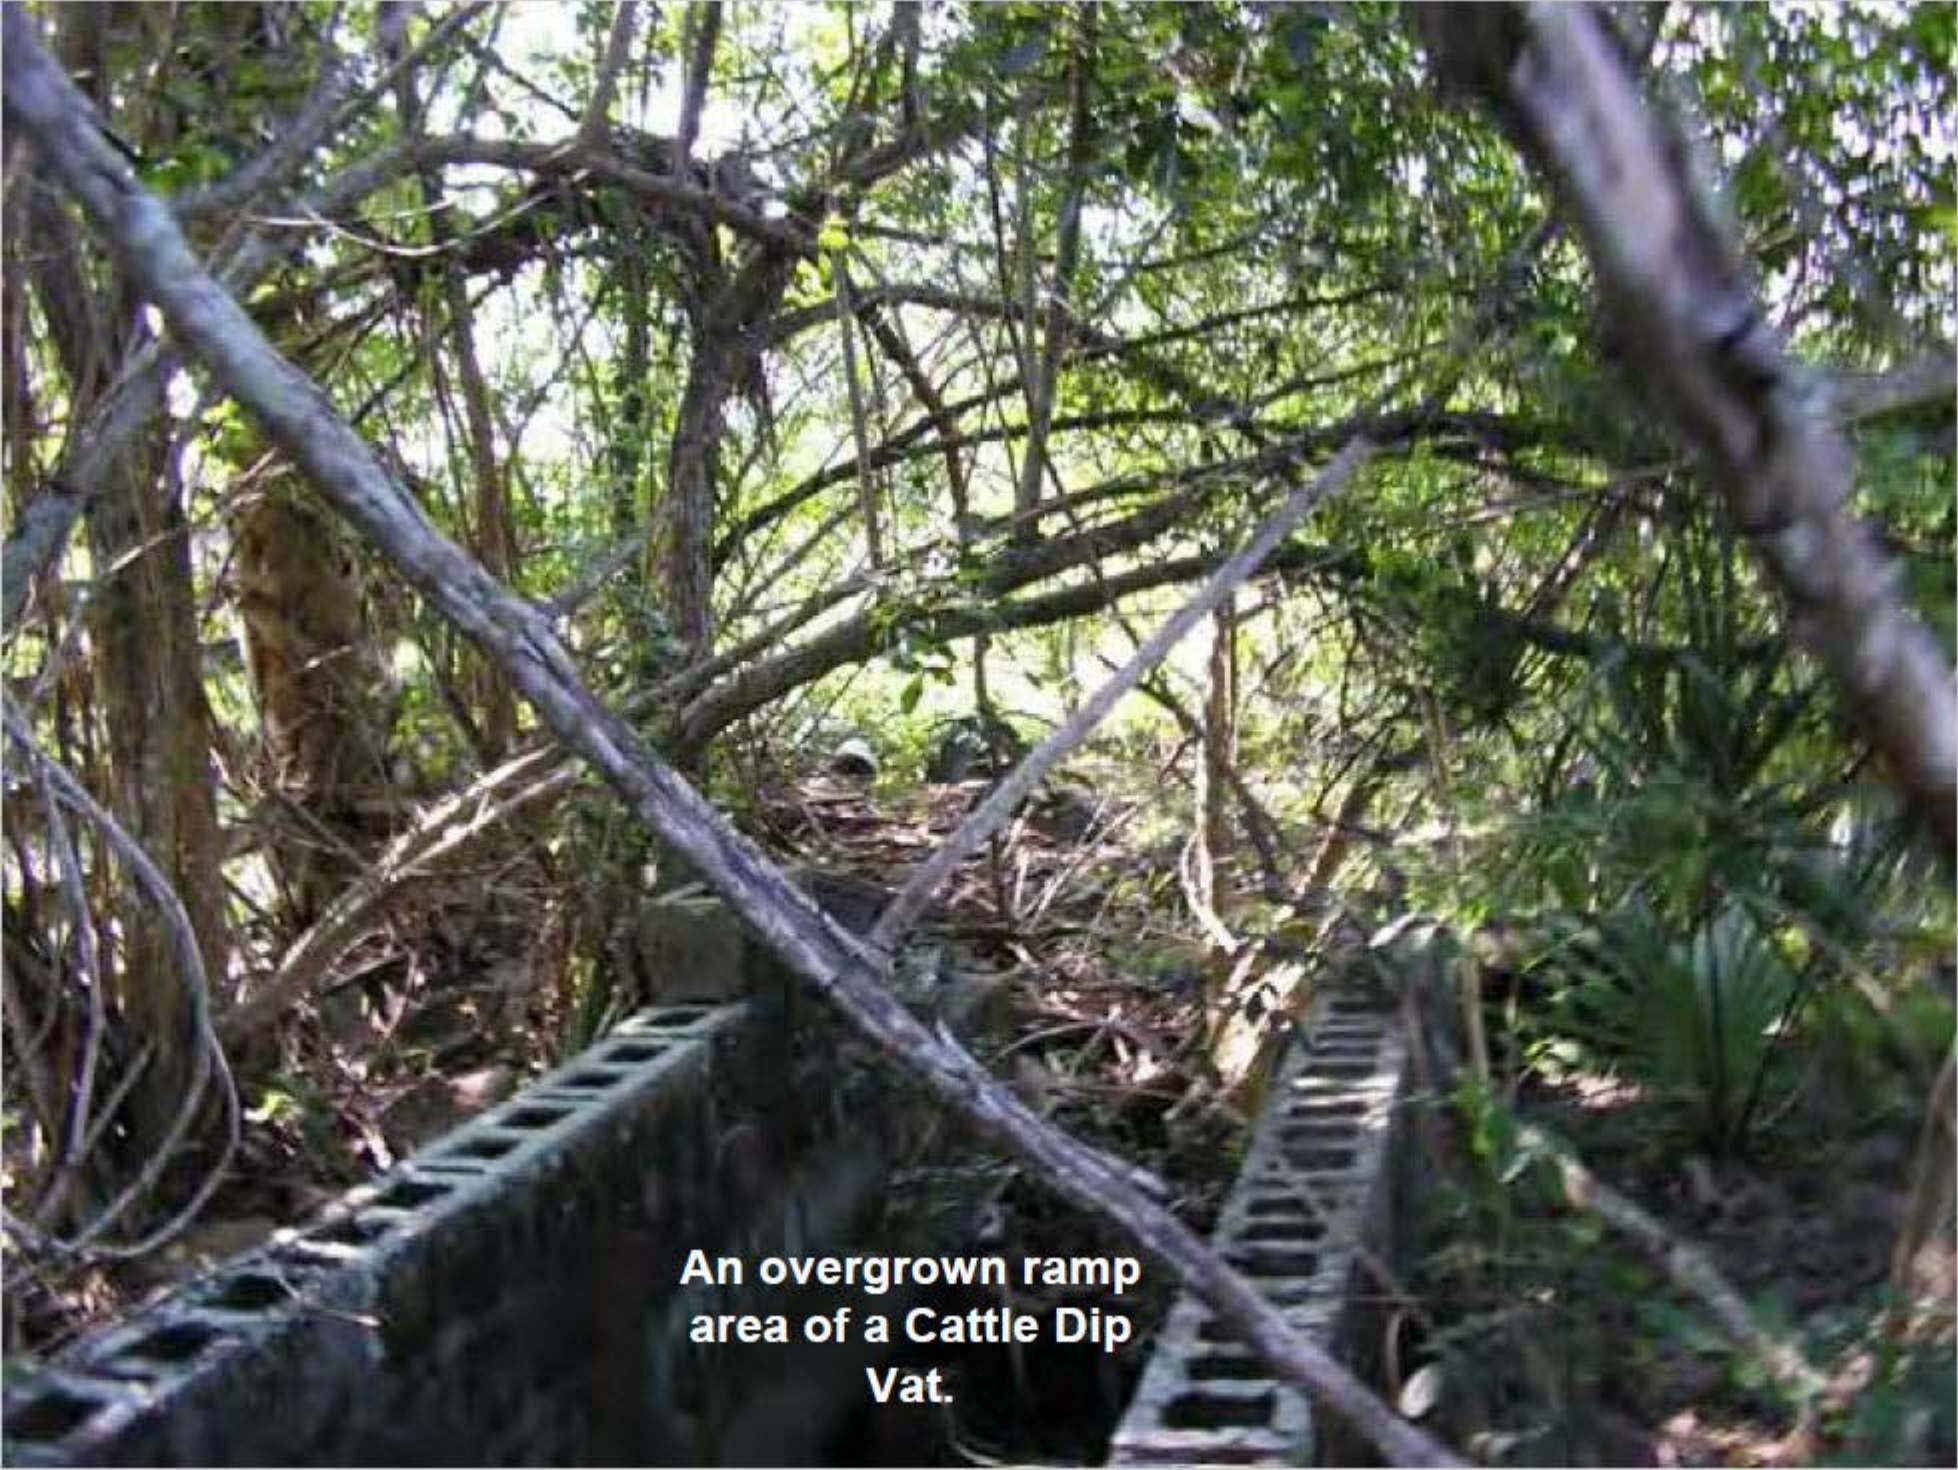
**An overgrown ramp  
area of a Cattle Dip  
Vat.**

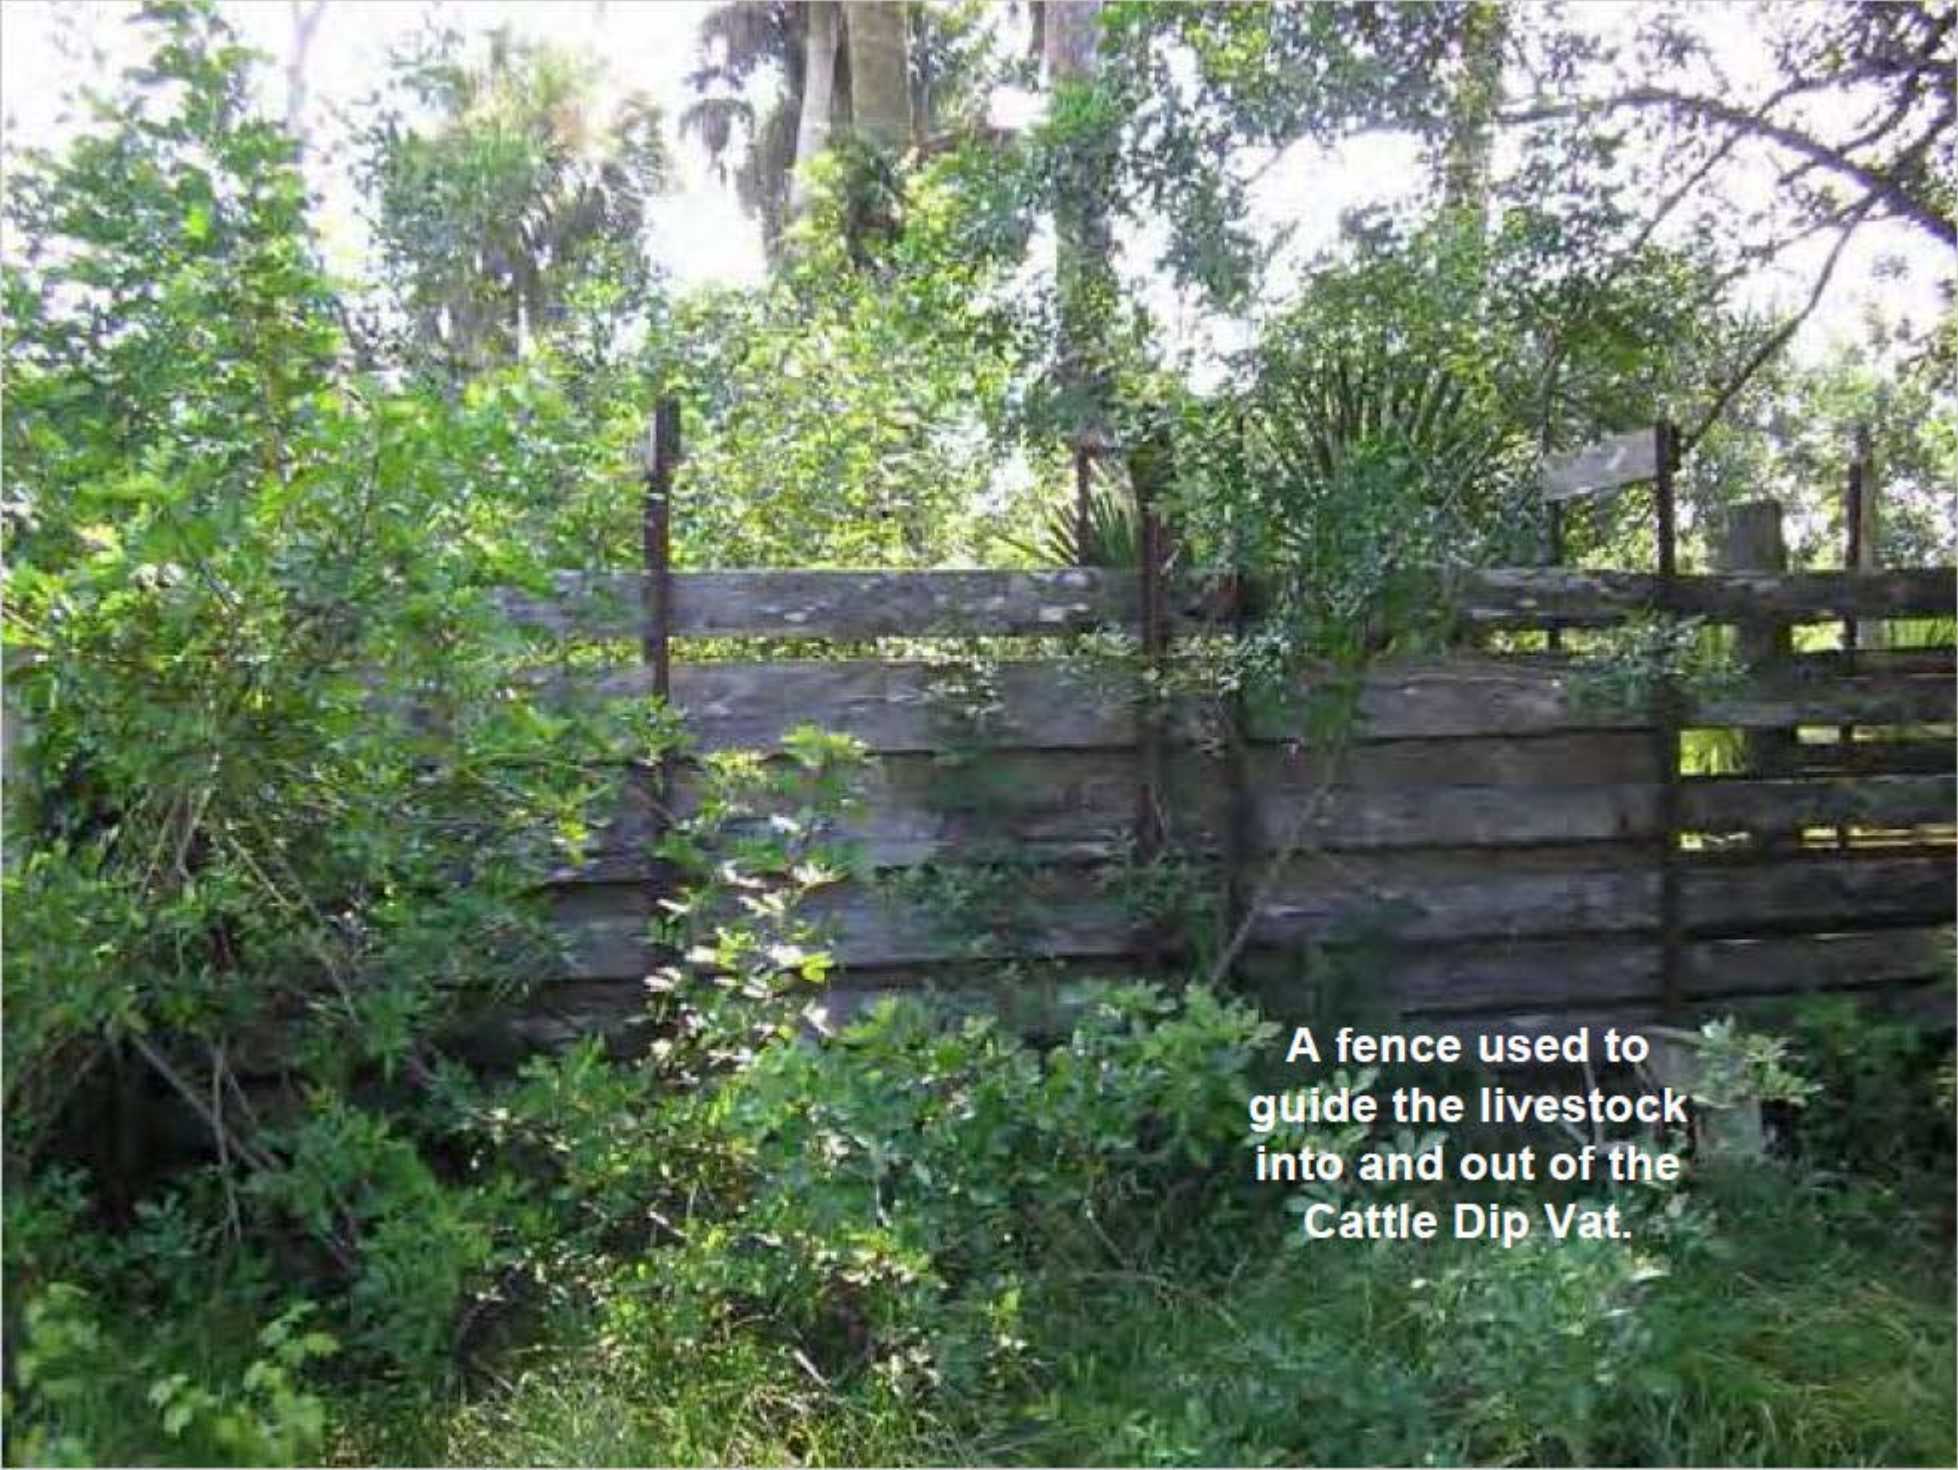
**A fence used to  
guide the livestock  
into and out of the  
Cattle Dip Vat.**
