**RZ05-1636 Part-B**

**Cattle Vat - 1**

**North Property Line  
6501 N 78th Street**

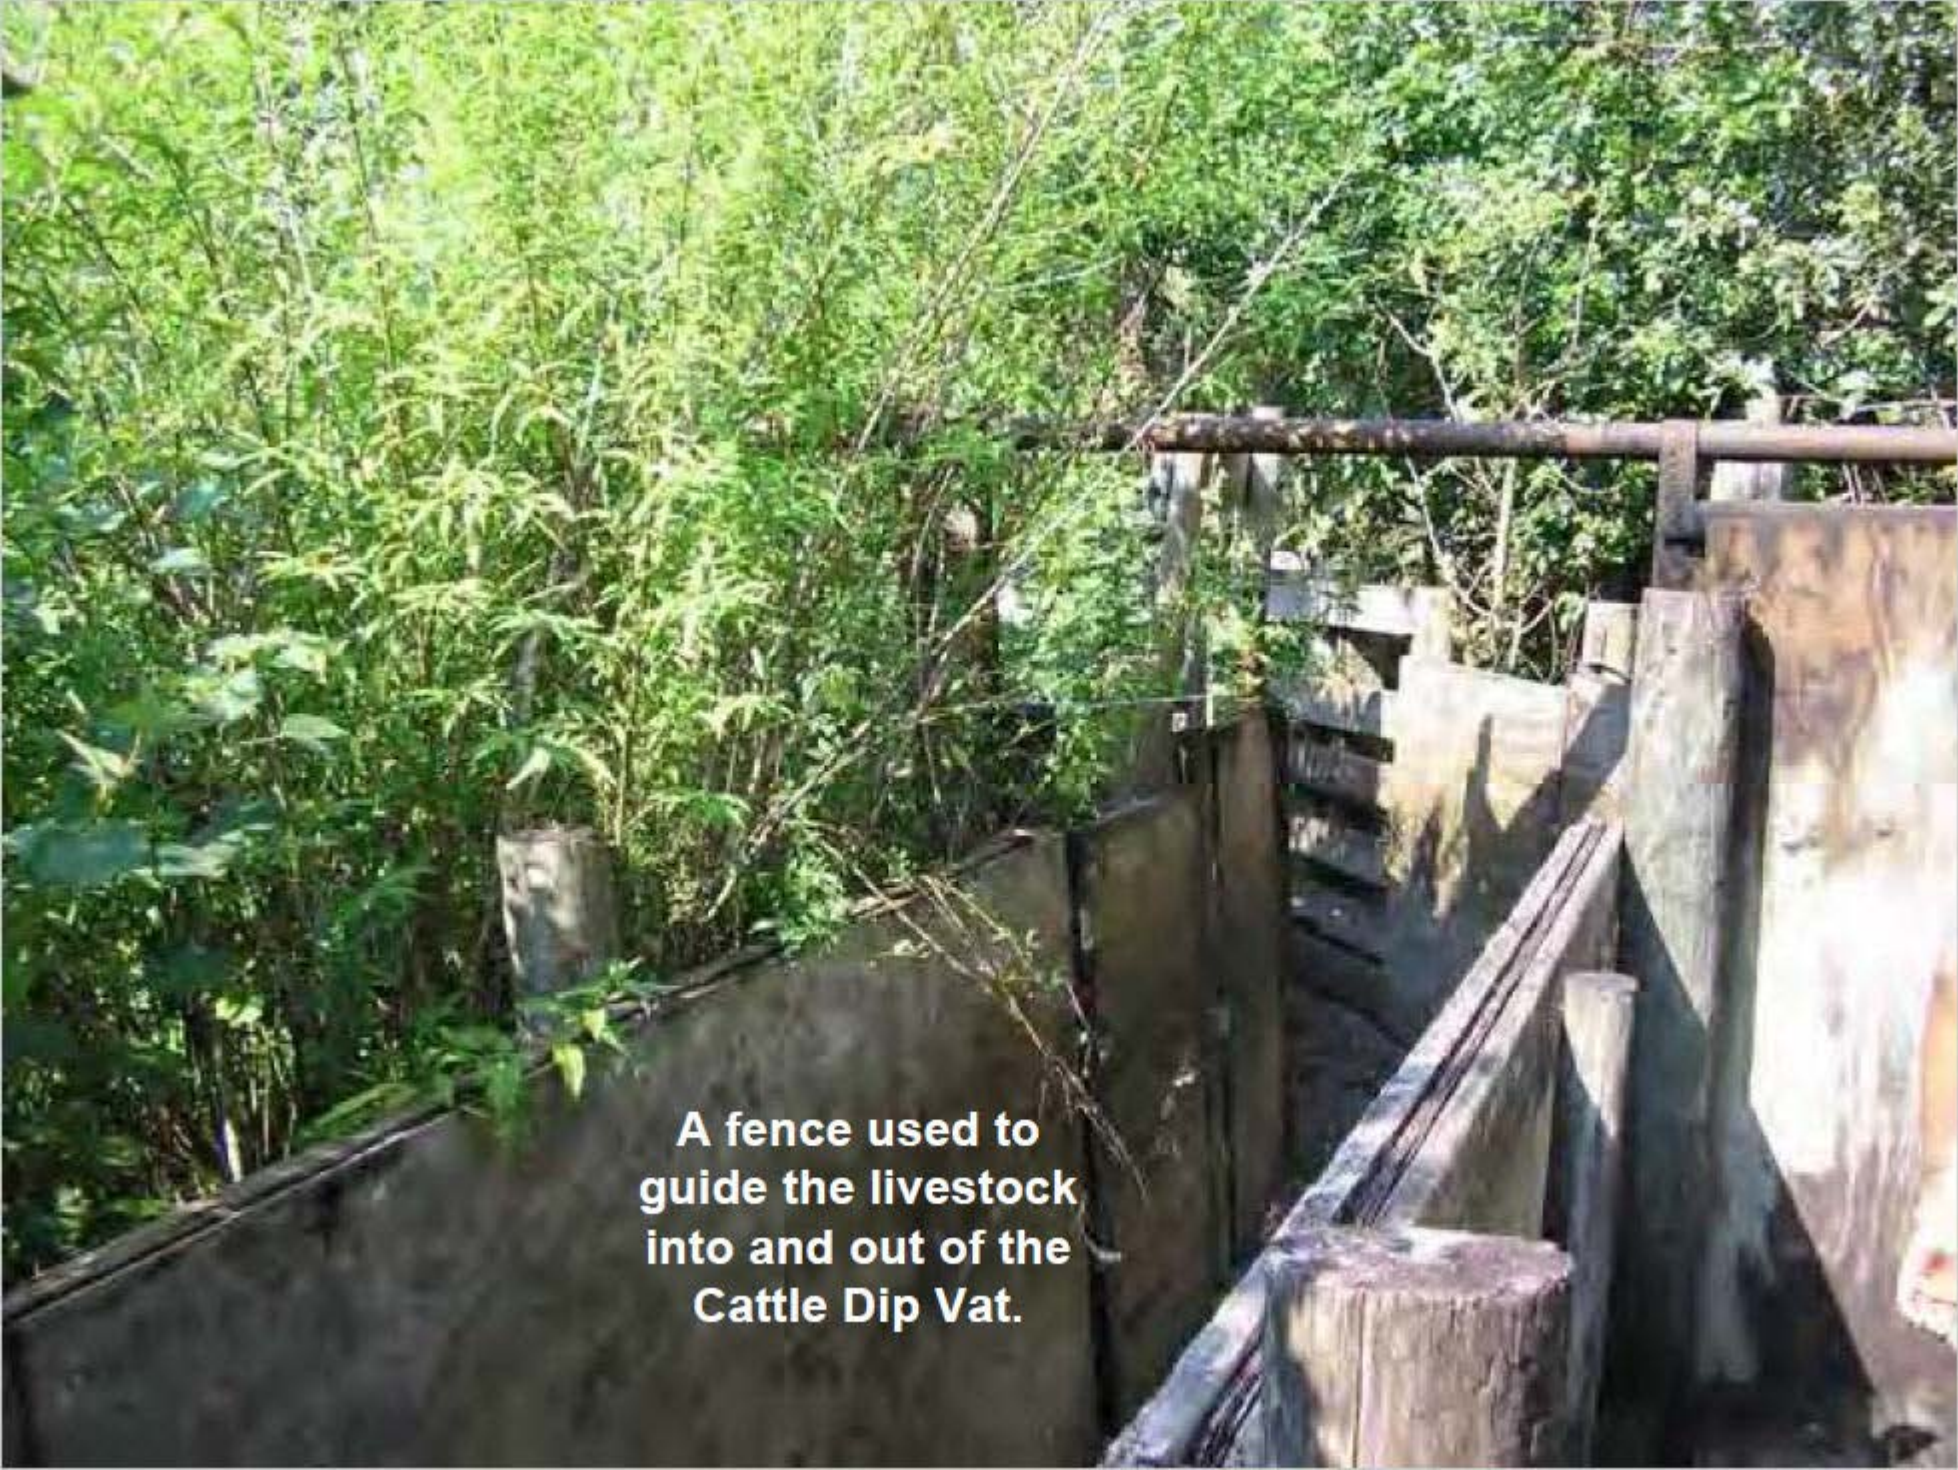
**A fence used to  
guide the livestock  
into and out of the  
Cattle Dip Vat.**

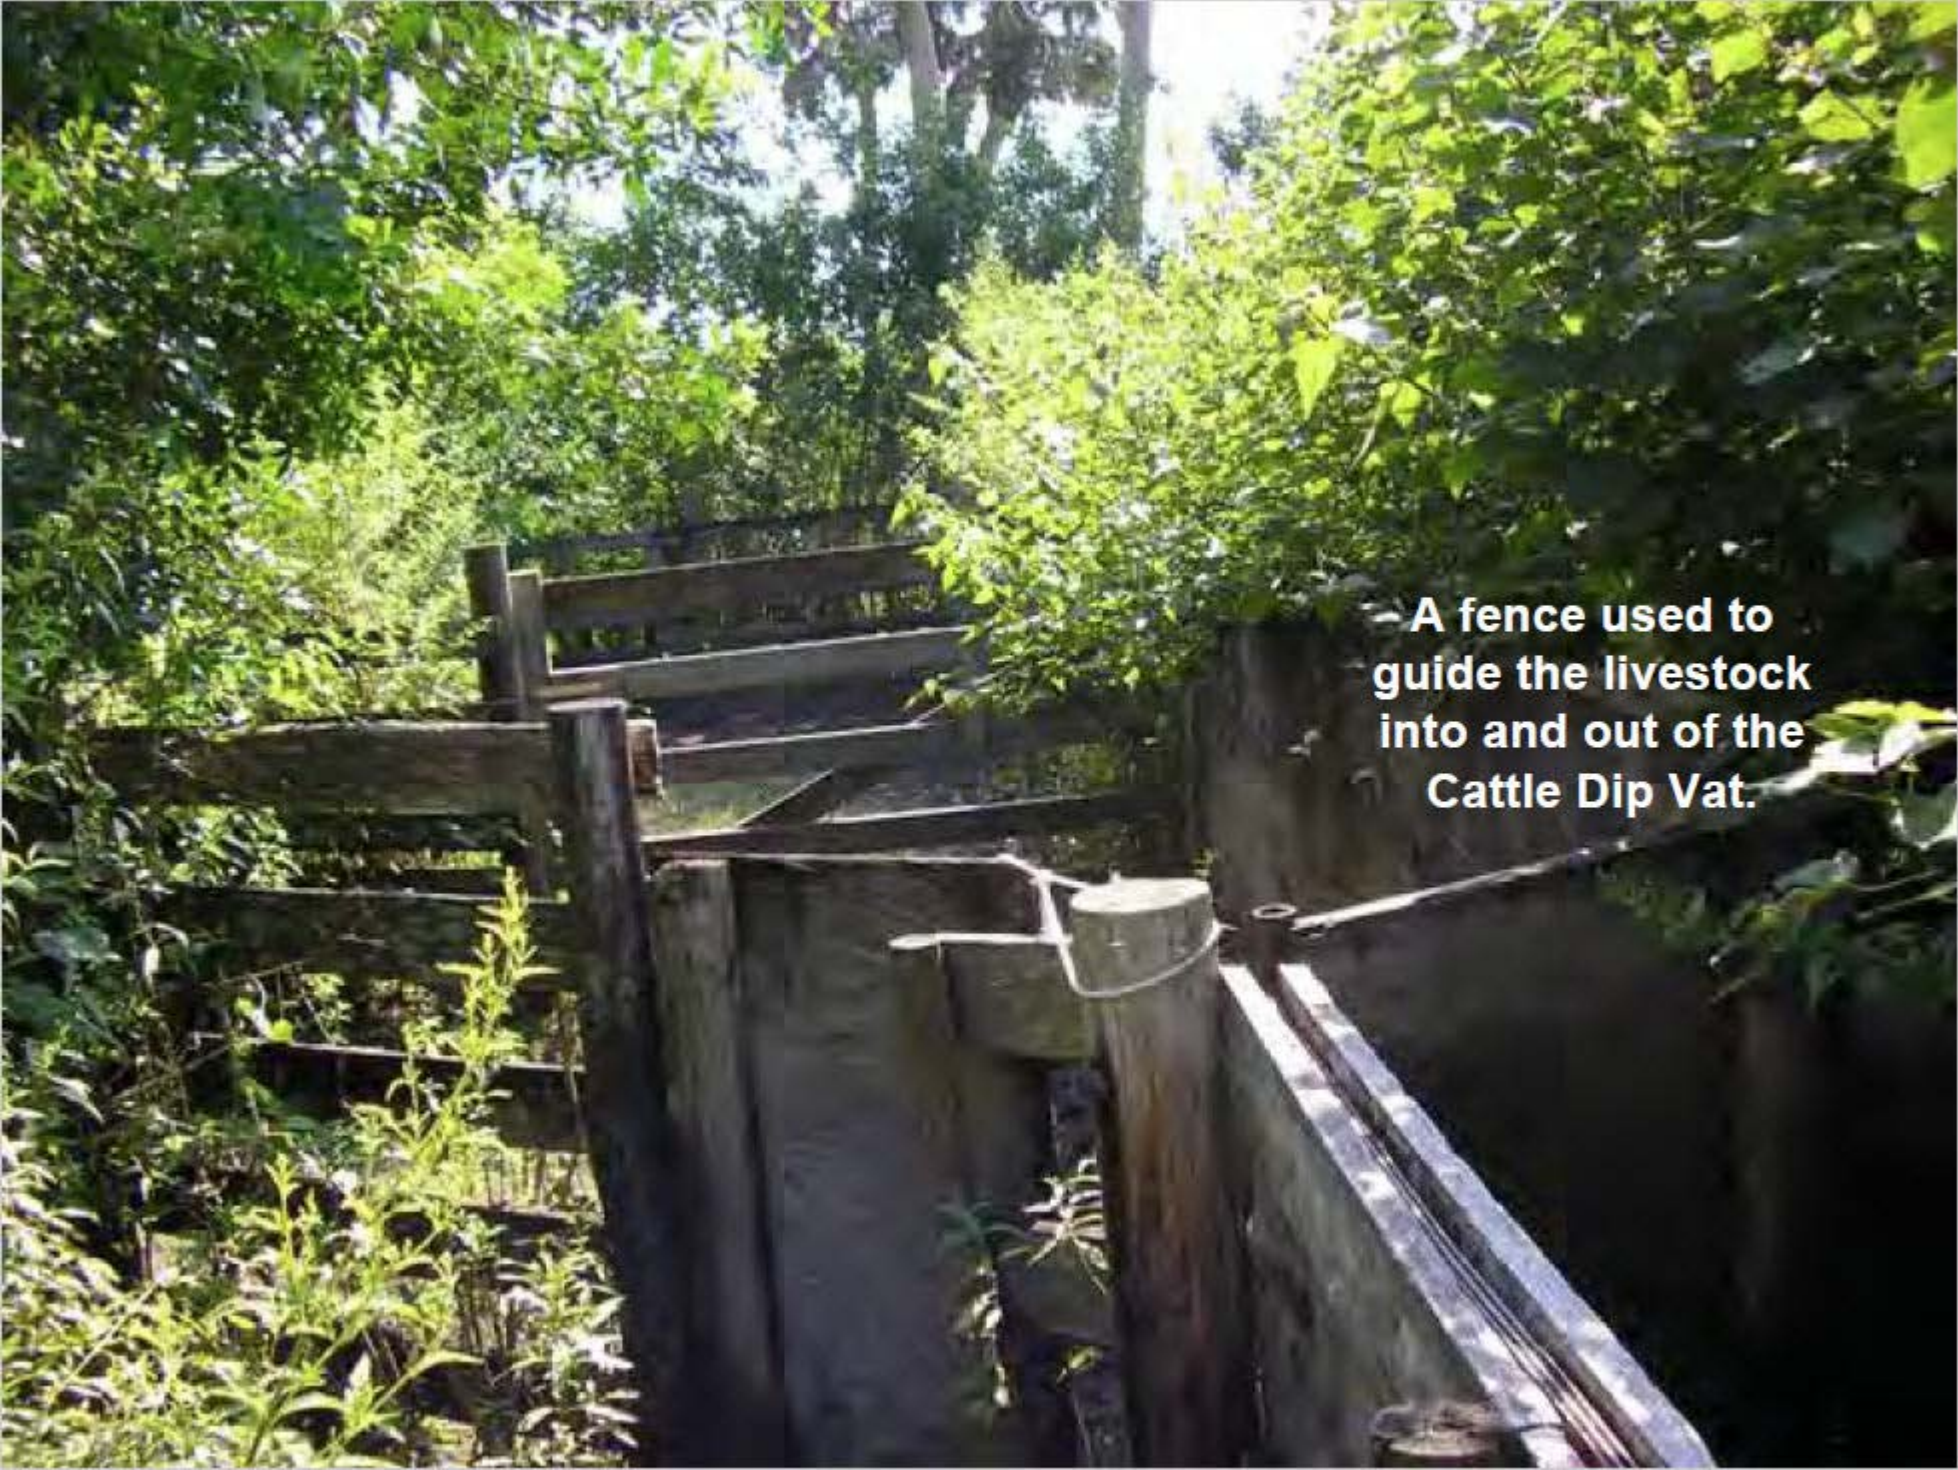
**A fence used to guide the livestock into and out of the Cattle Dip Vat.**
