Hurricane Irma
Post-Storm Beach Conditions and
Coastal Impact in Florida

Division of Water Resource Management
Florida Department of Environmental Protection

April 2018

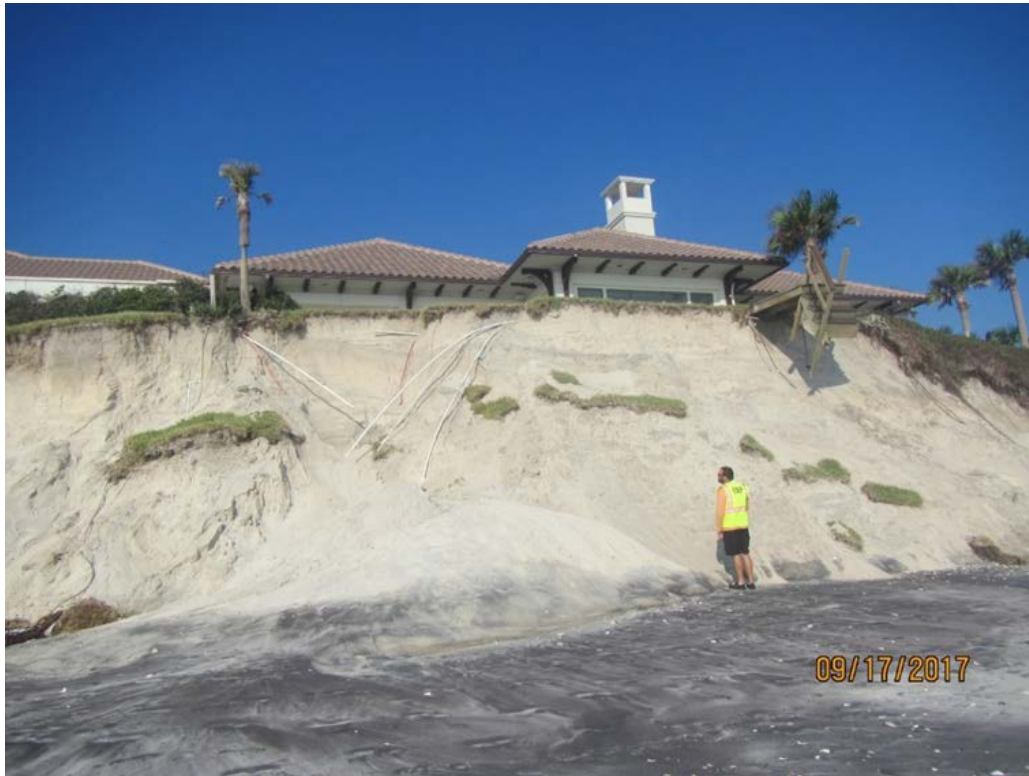
Figure 9. Major dune erosion threatening structure at R30, Ponte Vedra.

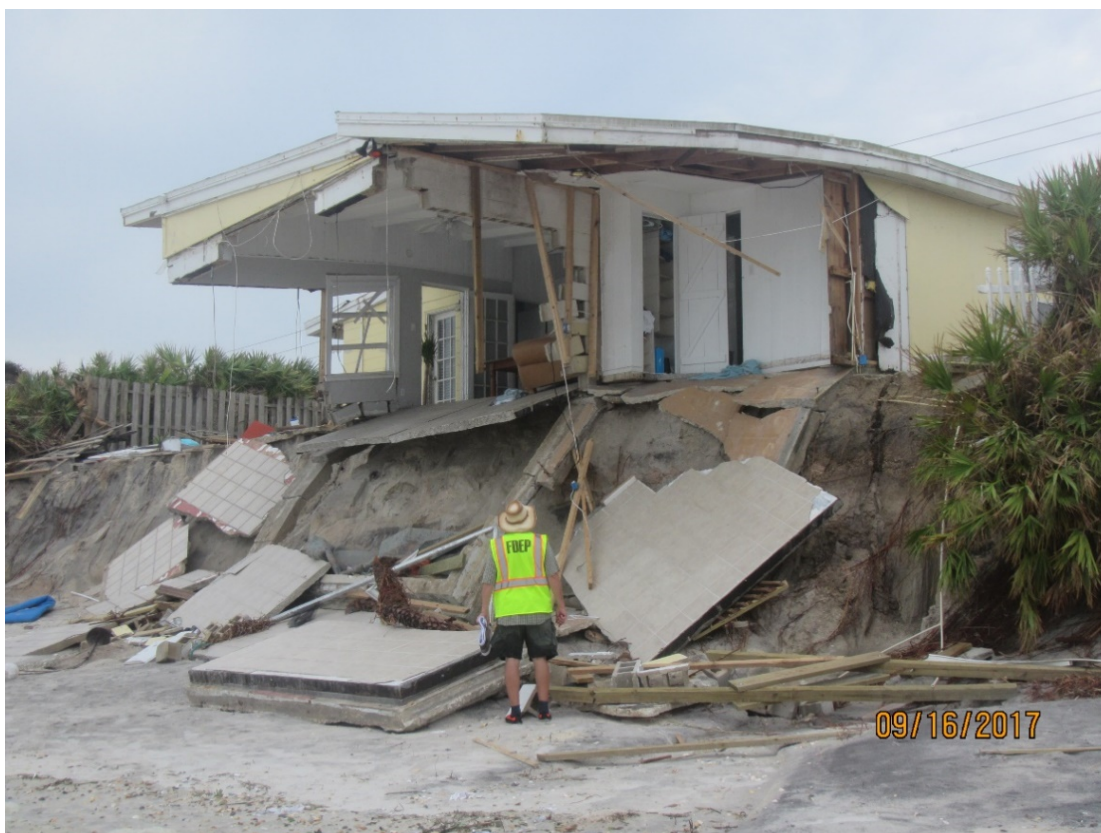
Figure 16. Single-family dwelling destroyed near R94, South Ponte Vedra.

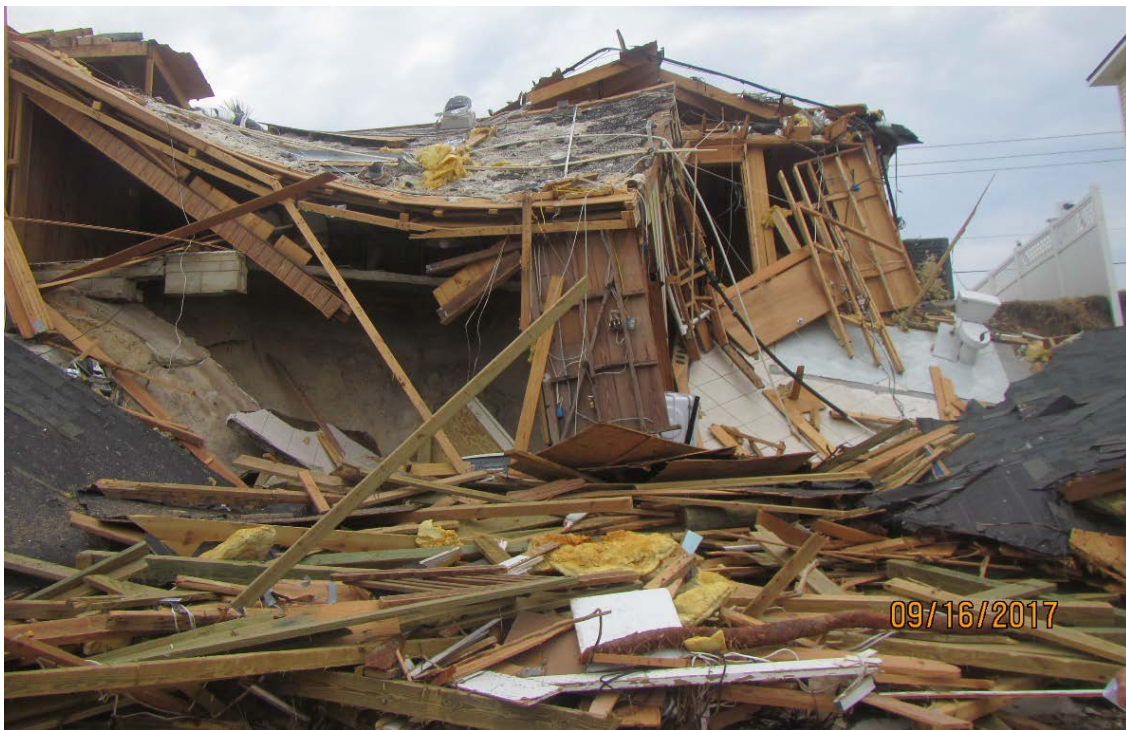
Figure 17. Seawall failure and single-family dwelling destroyed at R89.4, South Ponte Vedra.

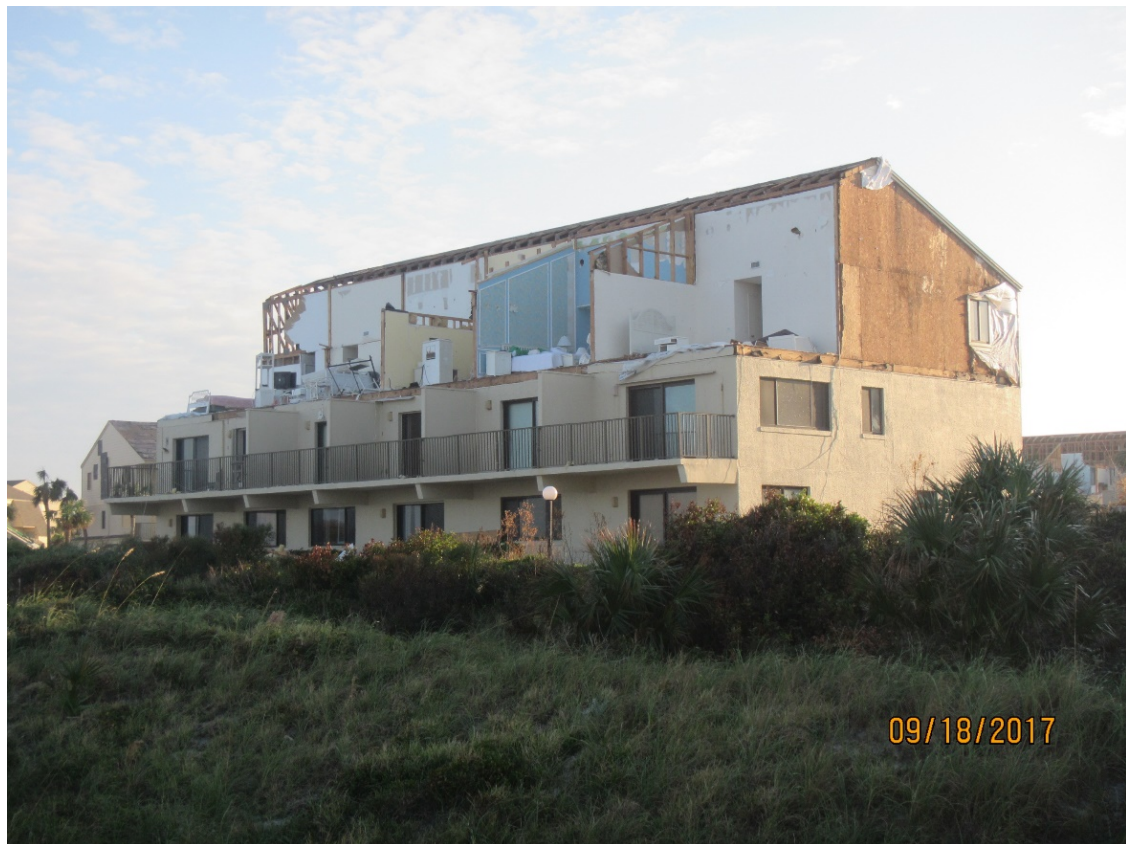
four condominium buildings being destroyed and five condominium buildings, eight single-family dwellings and a storage building sustaining major damage (Figure 18).

Figure 18. One of four condominiums destroyed by rain band tornado, Matanzas Shores, R192.4.

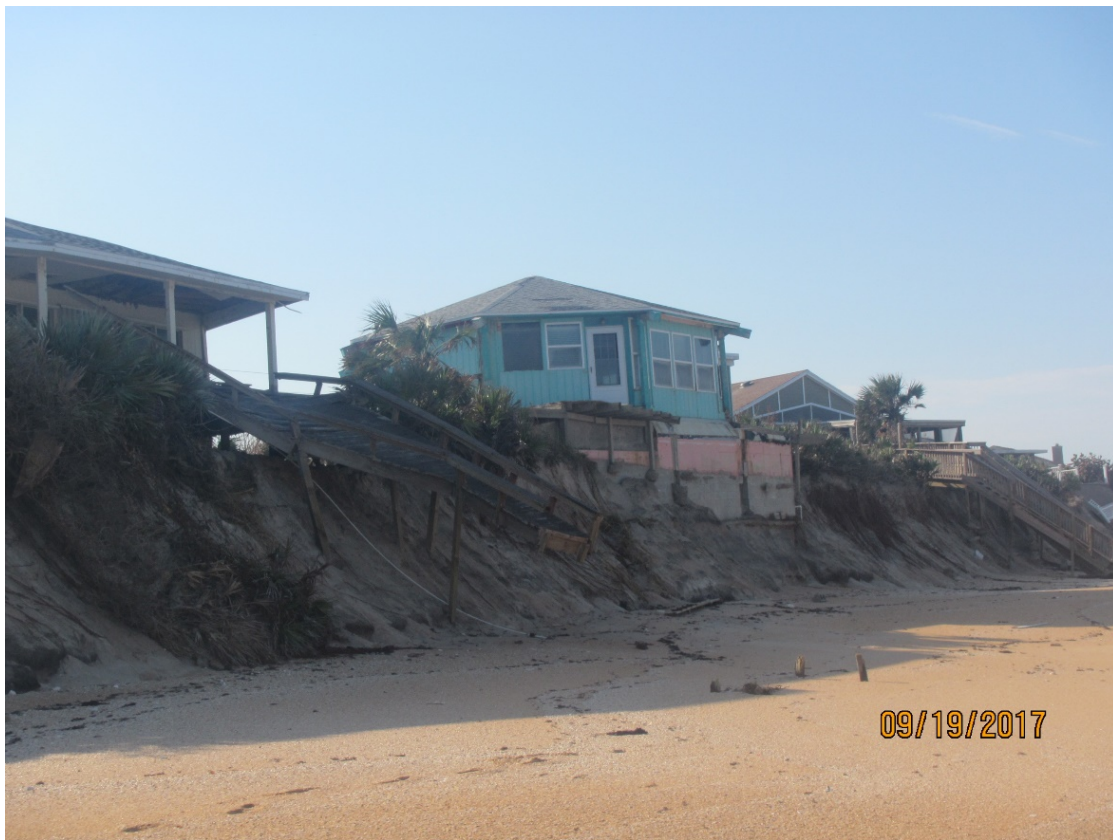
Figure 20. Single-family dwellings threatened along Painters Hill near R55.

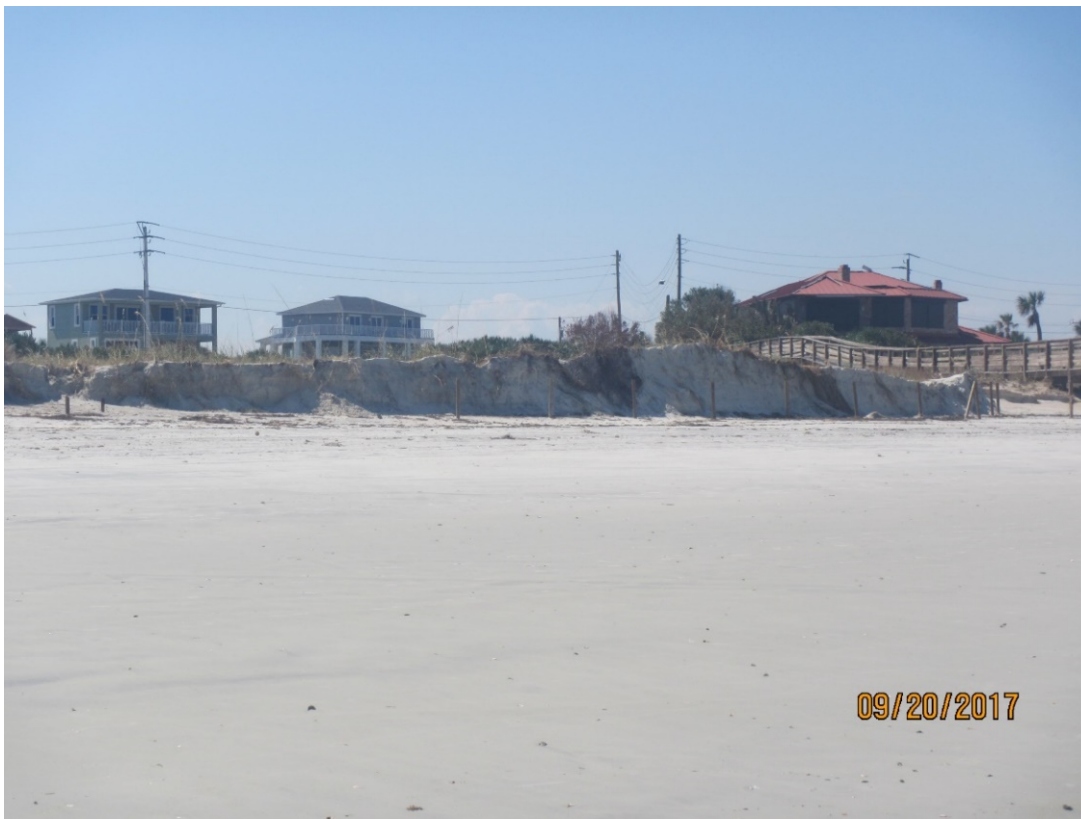
Figure 25. Major beach and dune erosion near R143, Town of Ponce Inlet.

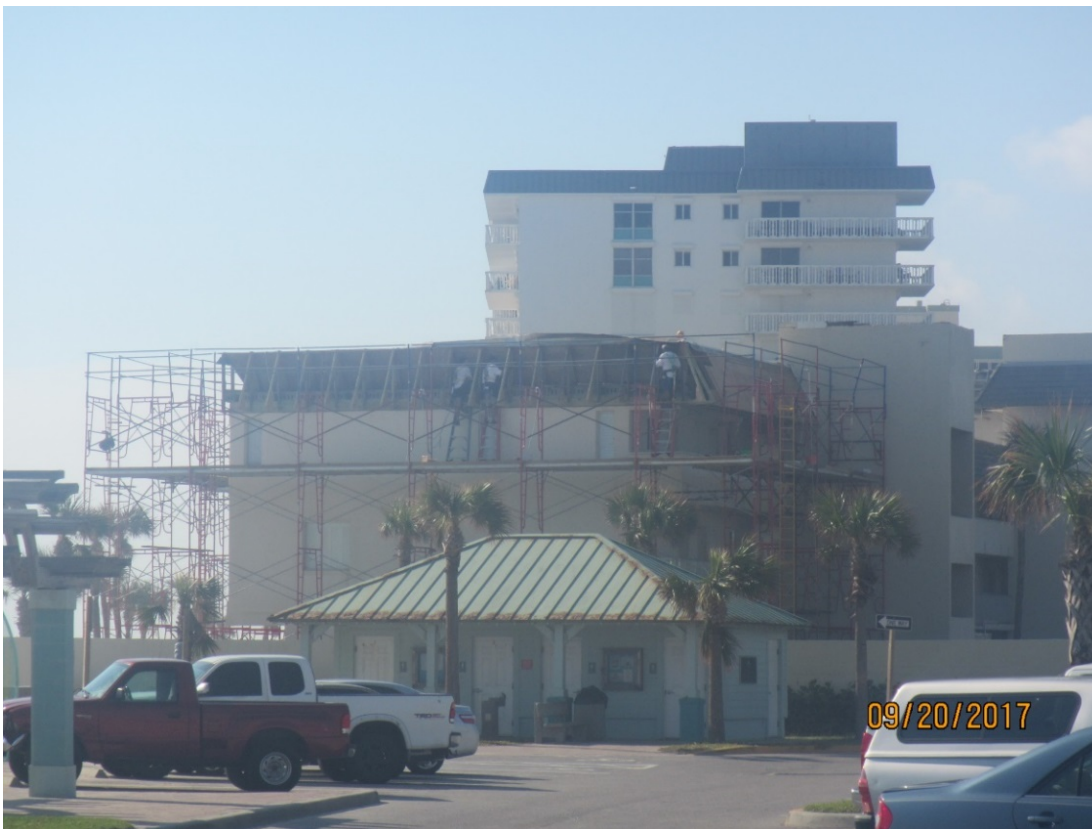
Figure 27. Wind damage to condominium at R40, Ormond Beach.

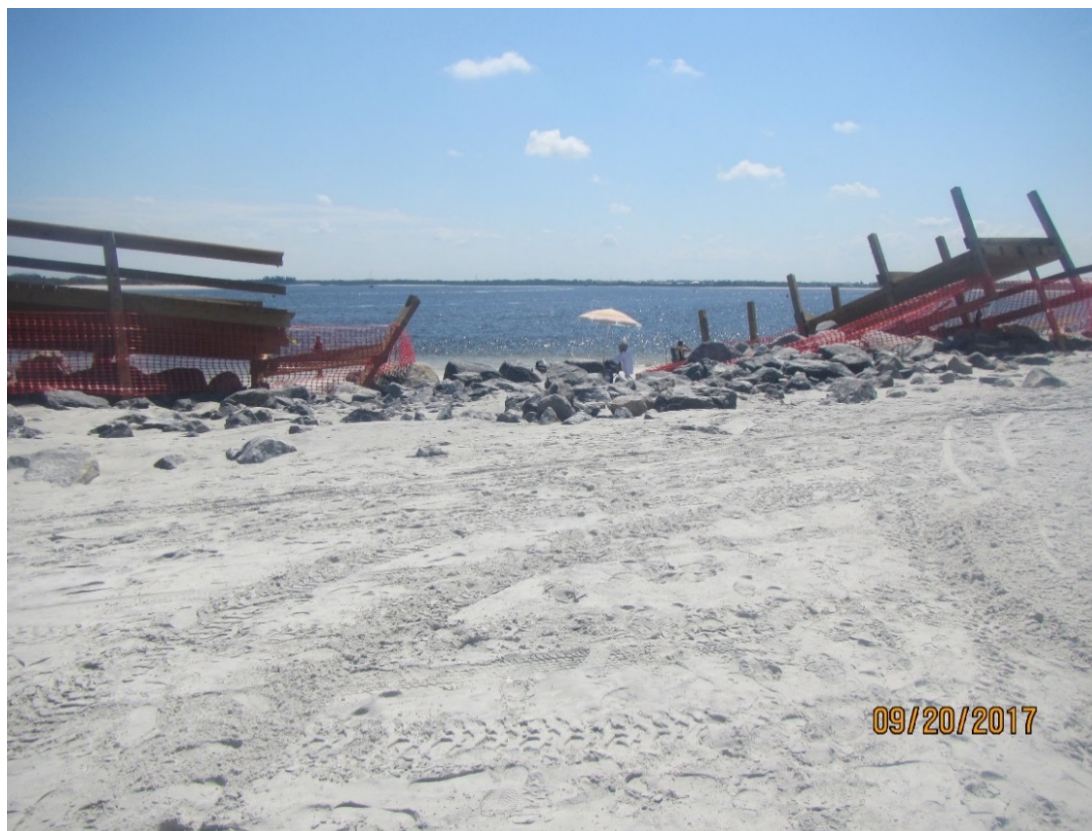
Figure 28. Major damage to north jetty and boardwalk at Ponce de Leon Inlet, R148.

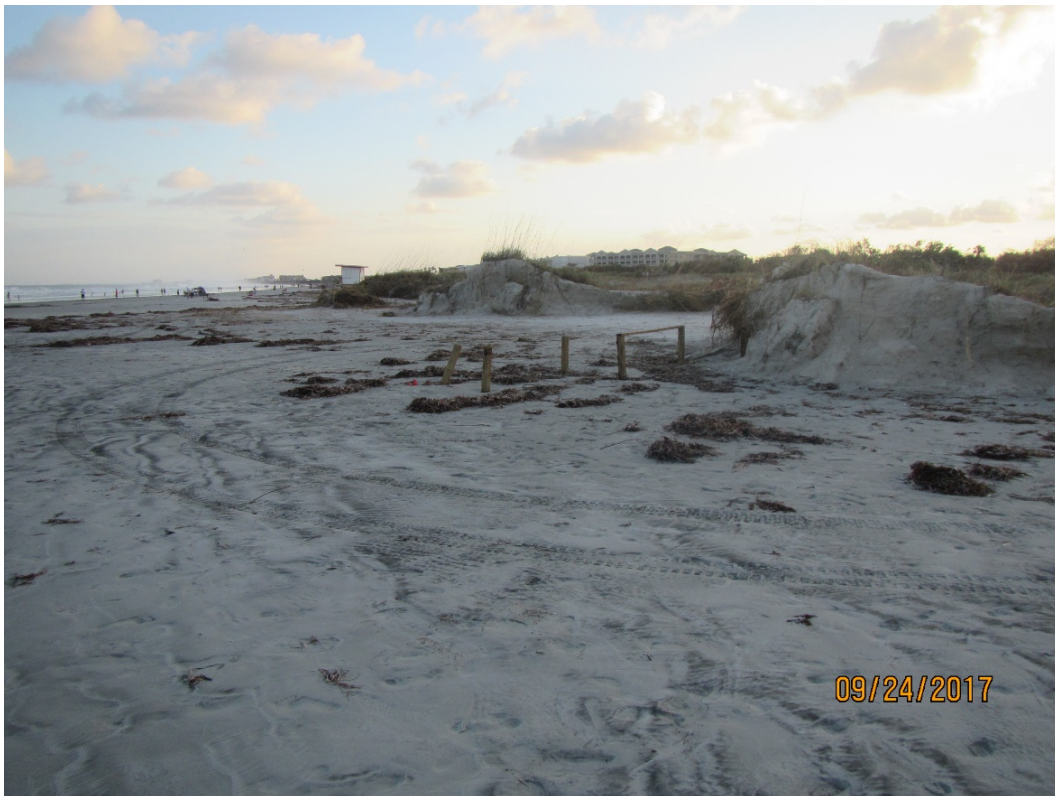
Figure 30. Major dune erosion at Jetty Park near R1, Port Canaveral.

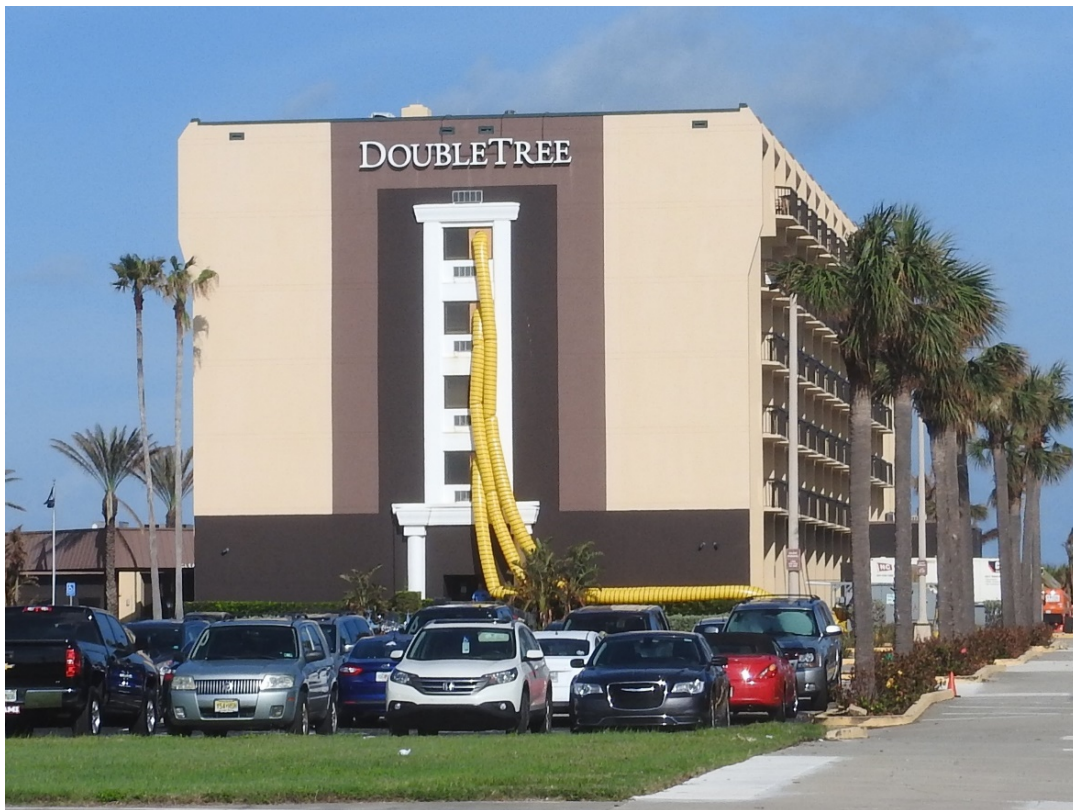
Figure 34. Hotel severely damaged by an apparent tornado at R26, Cocoa Beach.

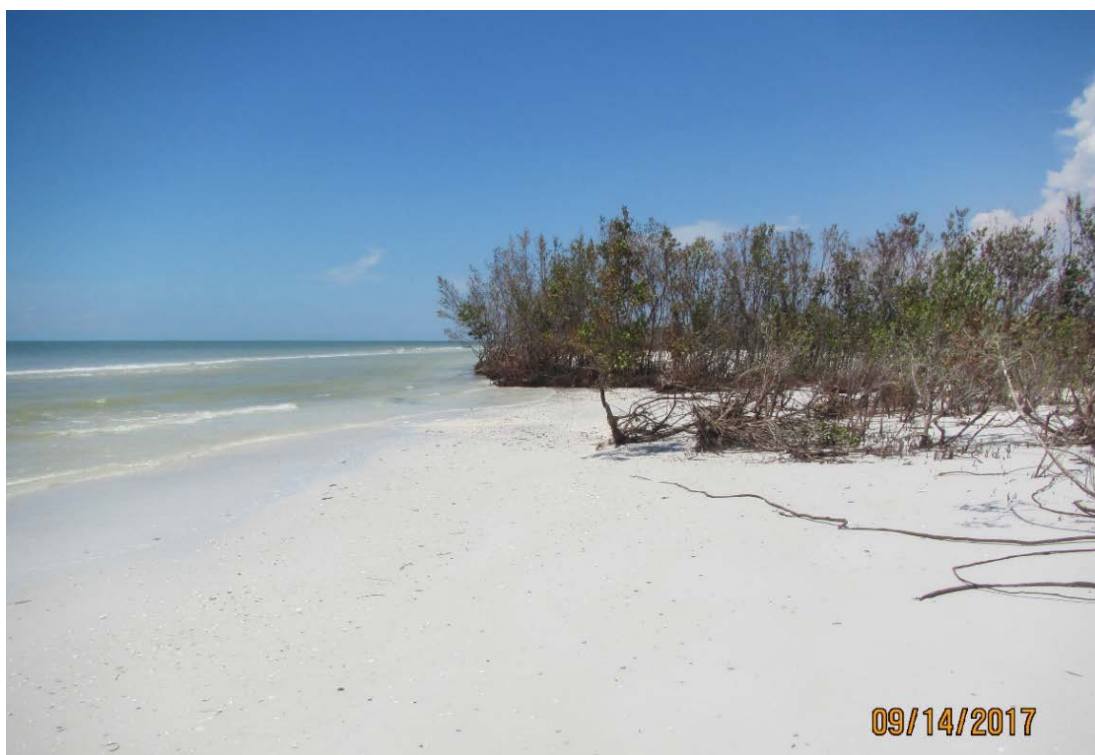
Figure 37. North Marco Island erosion near R132.

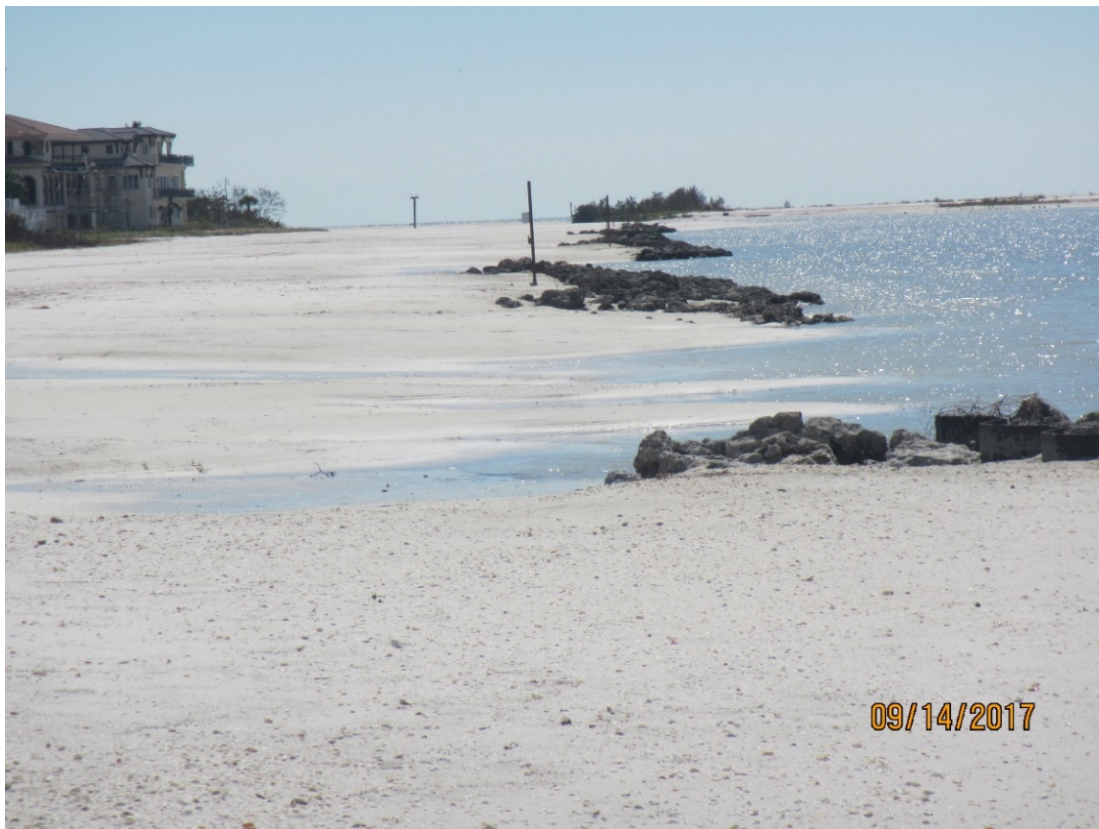
displaced boulders. At the north end of Marco Island along Hideaway Beach, five of the boulder mound T-groins sustained minor damage consisting of displaced boulders. To the east of Hideaway Beach at the Ville de Marco West complex, 250 feet of concrete seawall was destroyed (level IV damage) and a condominium building was undermined (Figure 42). Another condominium building on the Isle of Capri across Big Marco Pass from Marco Island sustained major roof damage. Along the 7 miles of shoreline on Keewaydin Island north of Marco Island, three single-family dwellings sustained major roof damage. Most of the damage along the coast of the City of Naples was due to the storm surge and waves, with a little wind damage. One single-family dwelling, one parking garage and one multi-family dwelling sustained major wind damage. The multi-family dwelling also sustained understructure damage to three units from the storm surge. Three ocean outfall pipes and the Naples Fishing Pier also sustained major damage due to the storm waves. In southern Naples, four timber groins also sustained major damage due to the storm waves, and a 125-foot-long vertical concrete seawall sustained minor damage (level II damage).

Figure 38. T-groin field along Hideaway Beach near V313.

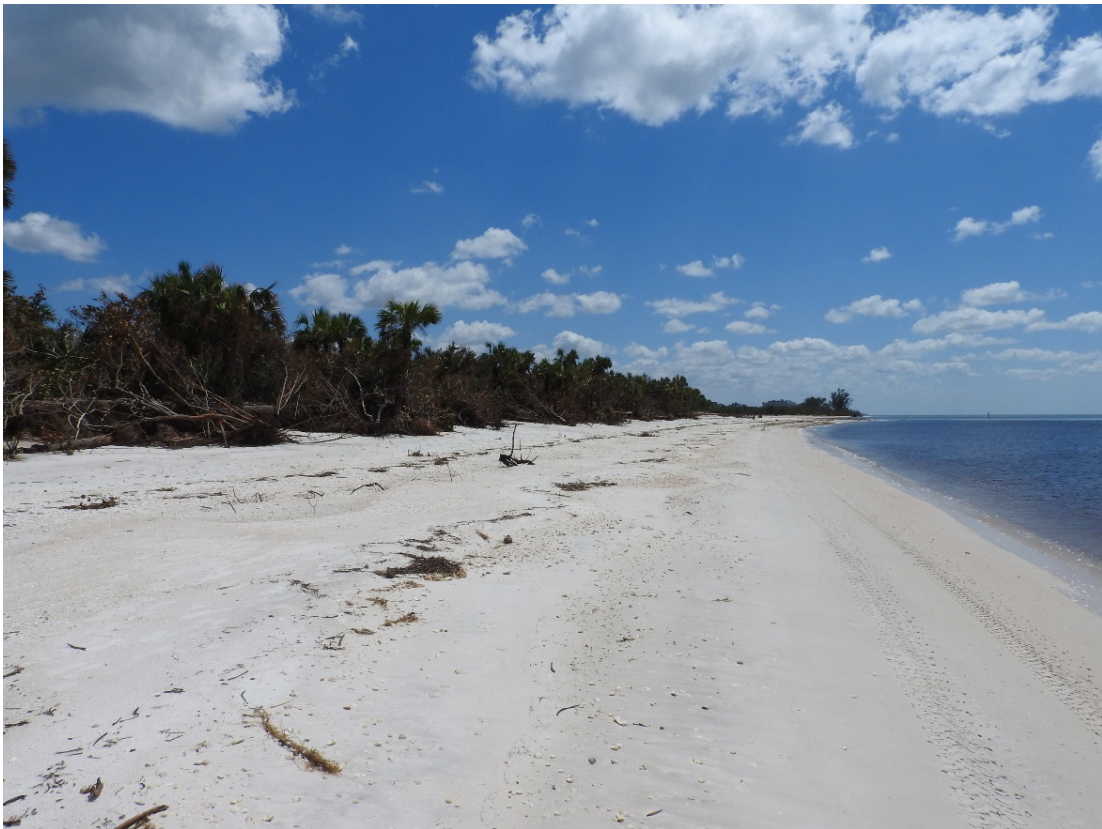
Figure 40. Major beach and dune erosion near R15 north of Wiggins Pass looking south.

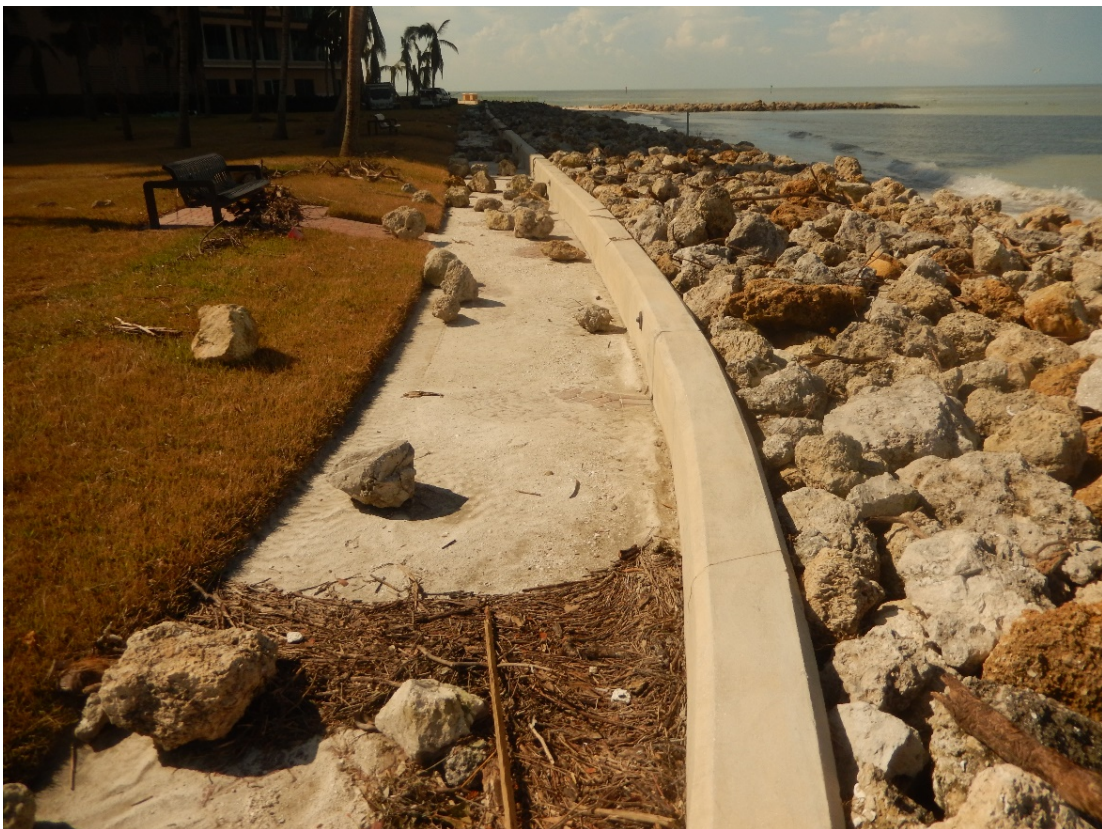
Figure 41. South Marco Island revetment damage near R148.

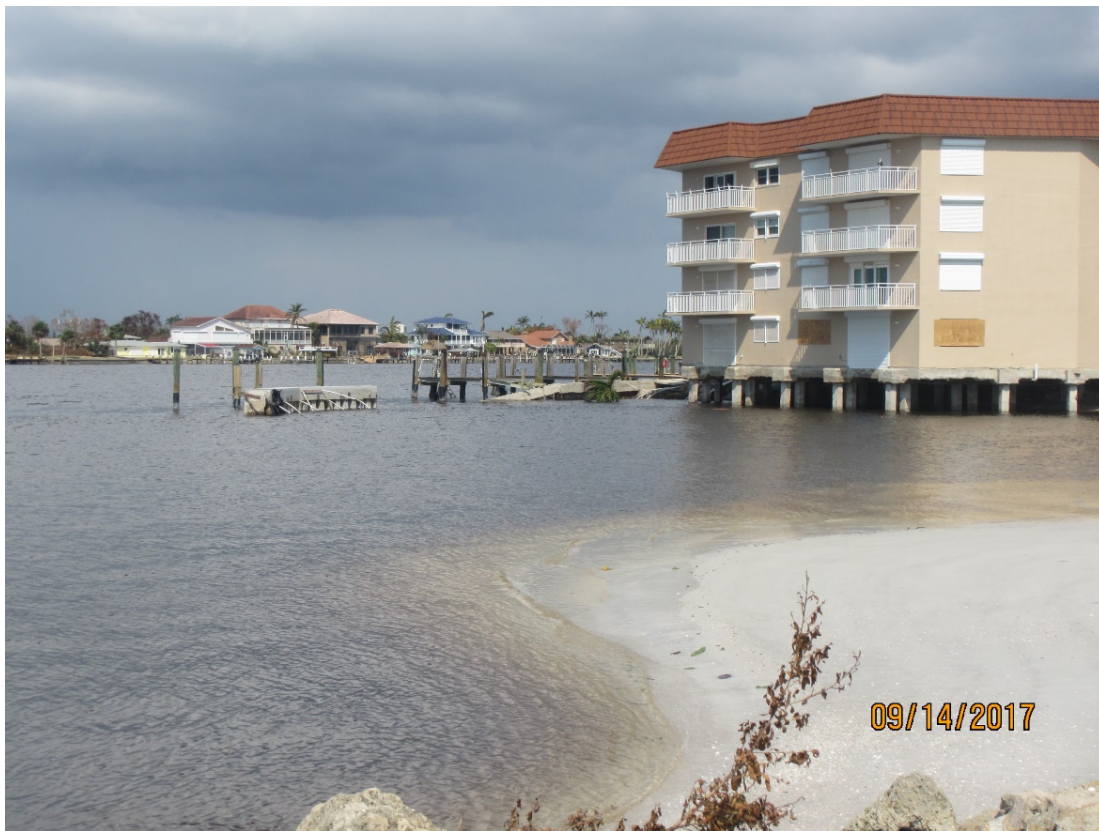
Figure 42. Seawall destroyed and condominium undermined in Big Marco Pass near V310.

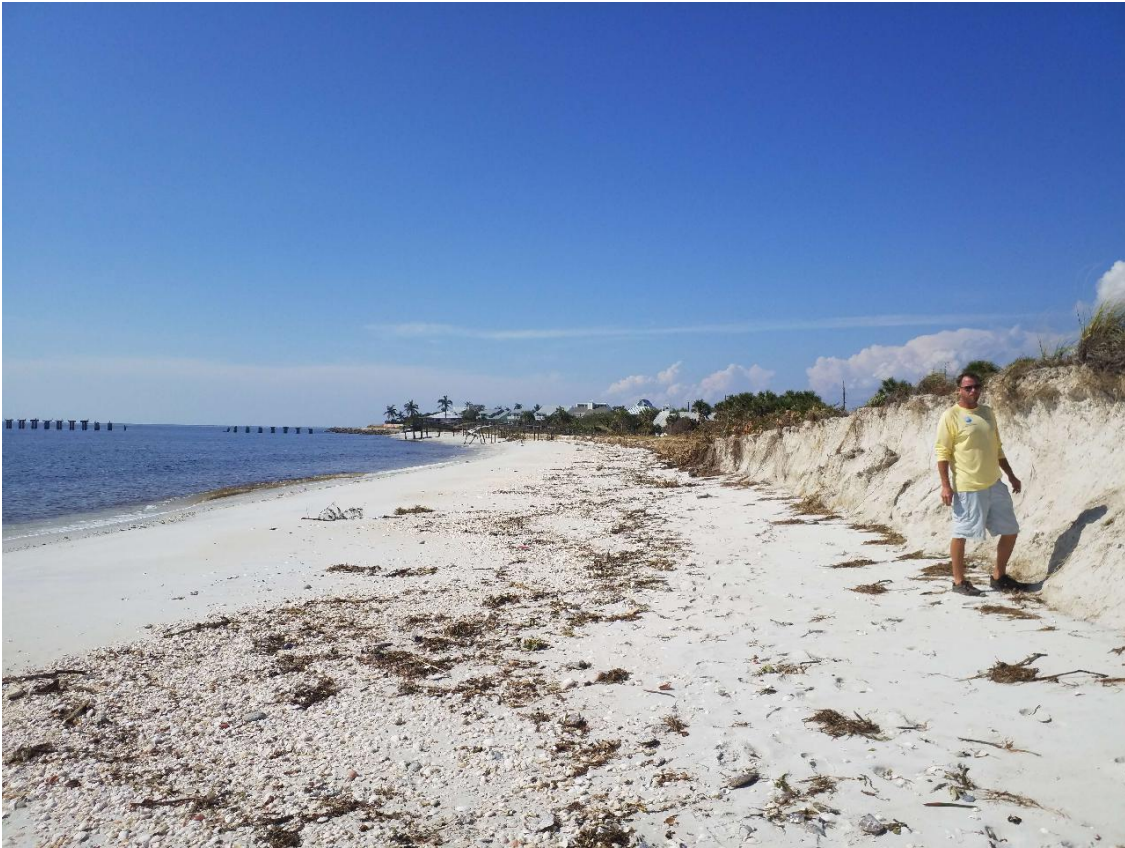
Figure 44. *Erosion and damage to dune walkovers at the southern end of Gasparilla Island State Park, R26.*

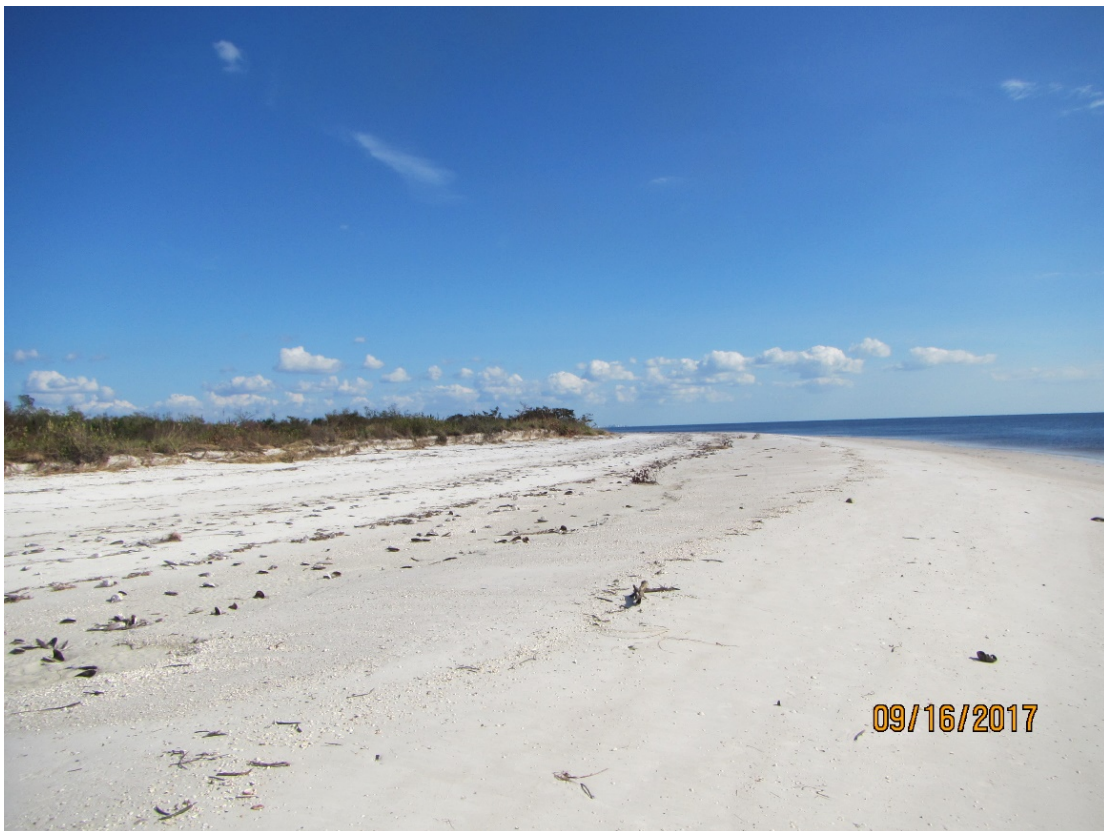
Figure 49. Minor erosion at the northern end of Lovers Key near R213.

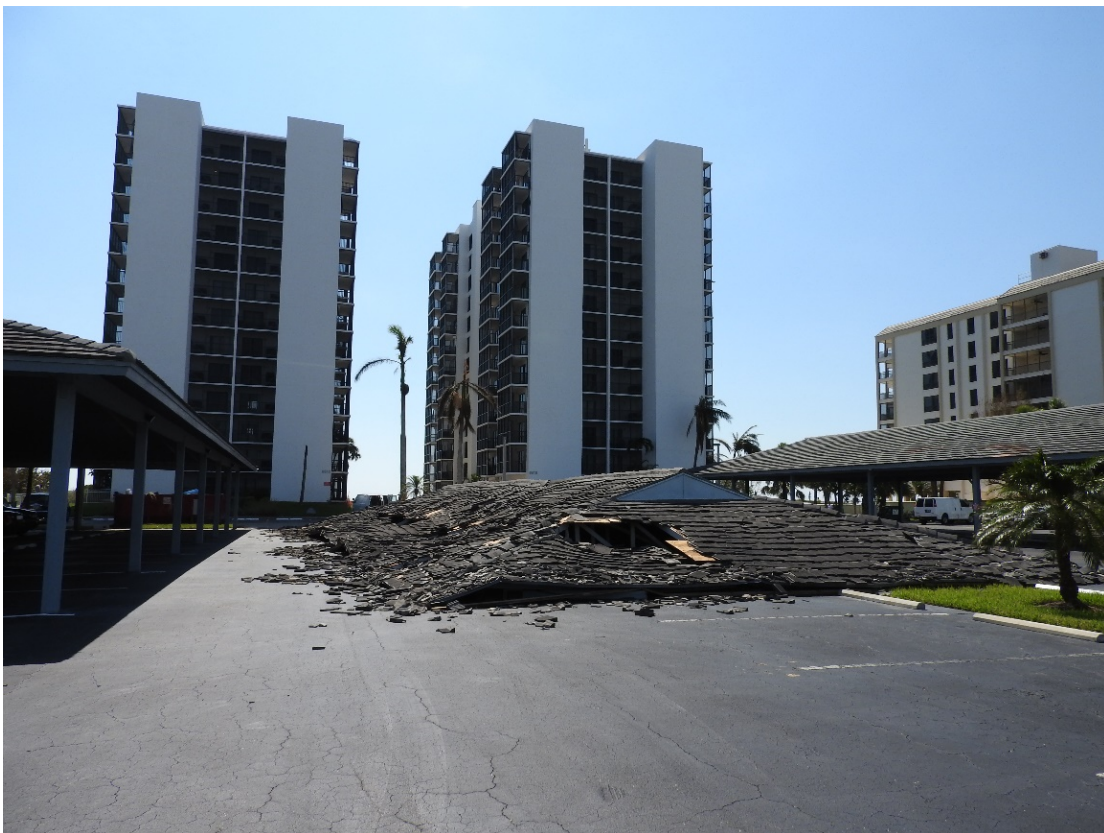
Figure 50. Collapsed parking garage structure at Fort Myers Beach near R201.

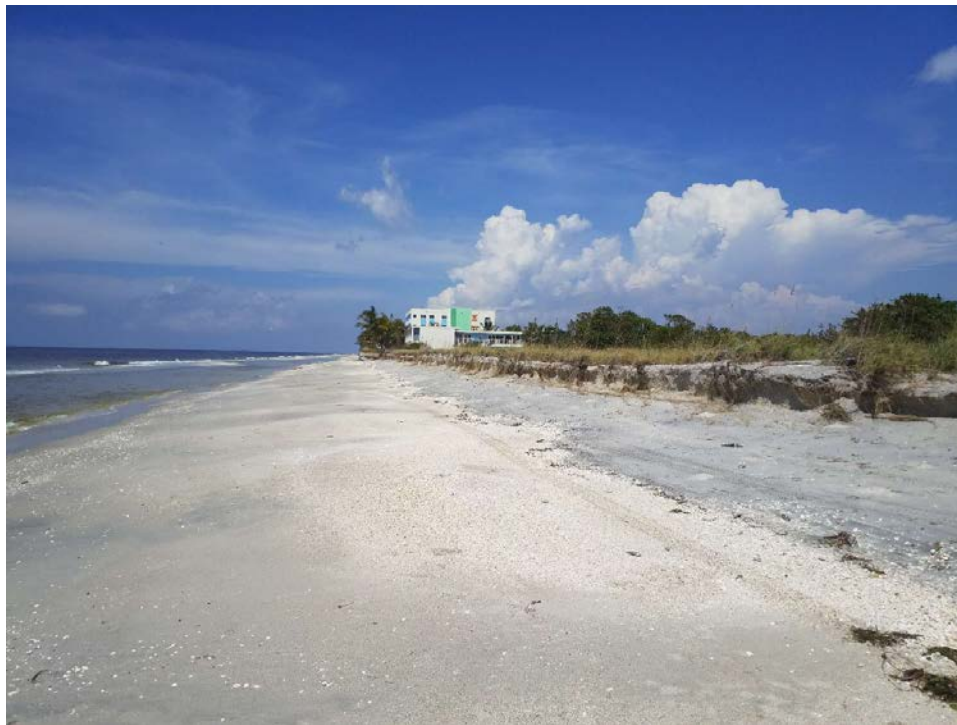
Figure 52. Beach and dune erosion at Stump Pass State Park near R16.

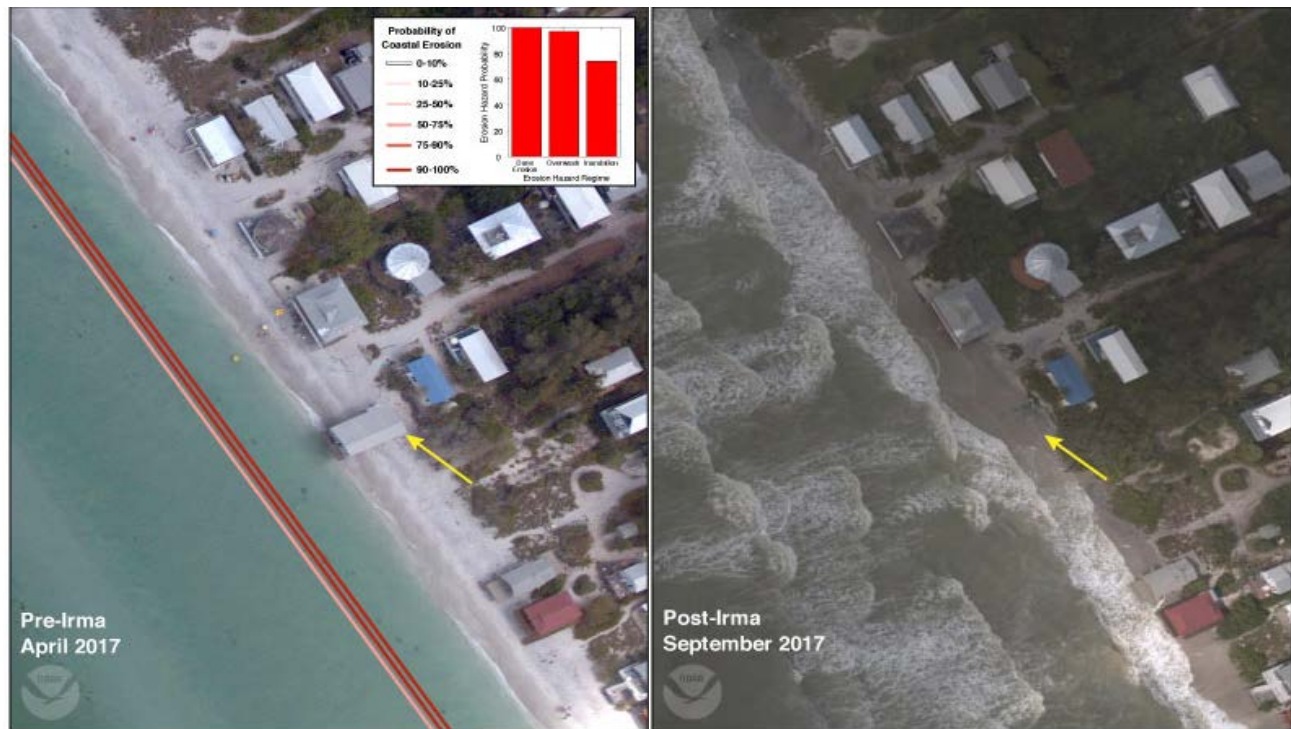
On Little Gasparilla Island, an older pile-supported single-family dwelling near R49 that was located on the active beach and into the foreshore seaward of mean high water was destroyed (Figure 53).

Figure 53. Comparative NOAA aerial photos showing the dwelling on Little Gasparilla Island destroyed near R49 (Source: National Assessment of Coastal Change Hazards, St. Petersburg Coastal and Marine Science Center, USGS).

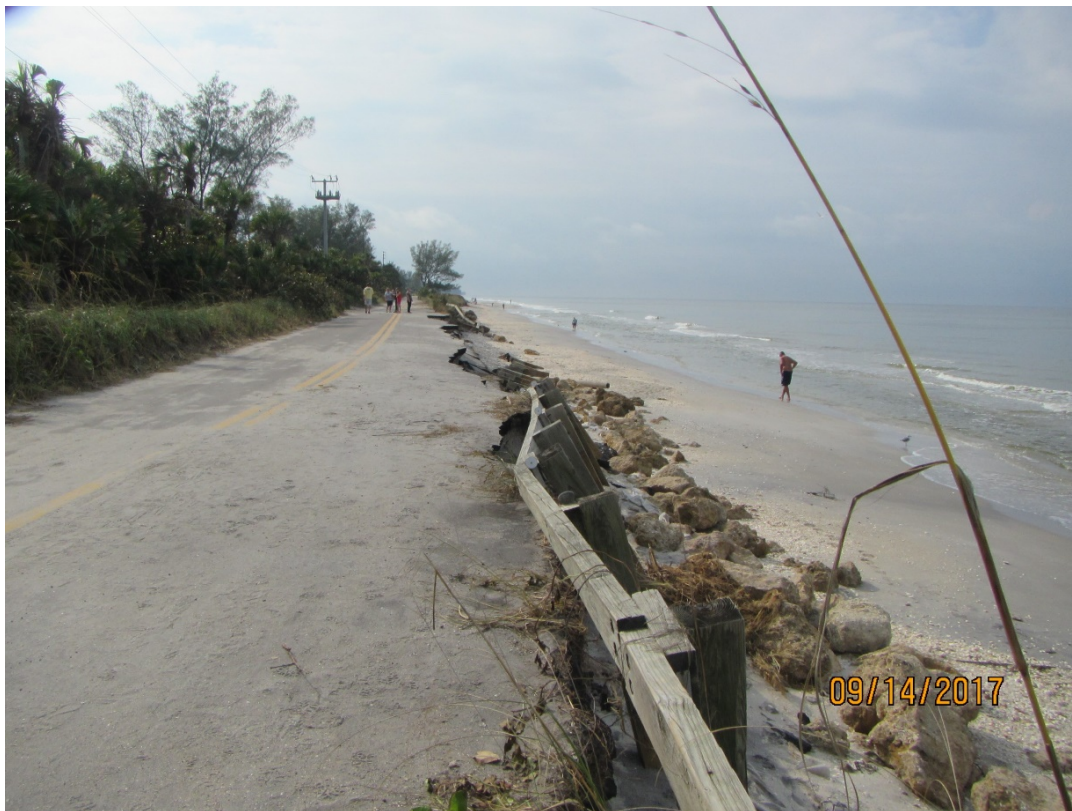
A small segment of beach erosion was observed near the south end of Manasota Key (R175-R176) where more than 100 feet of the Manasota Key Road sustained major damage (Figure 55). Another small segment of erosion was observed further south at R182, where a single-family dwelling is threatened (Figure 56).

Figure 55. Dune erosion that damaged Manasota Key Road near R175.

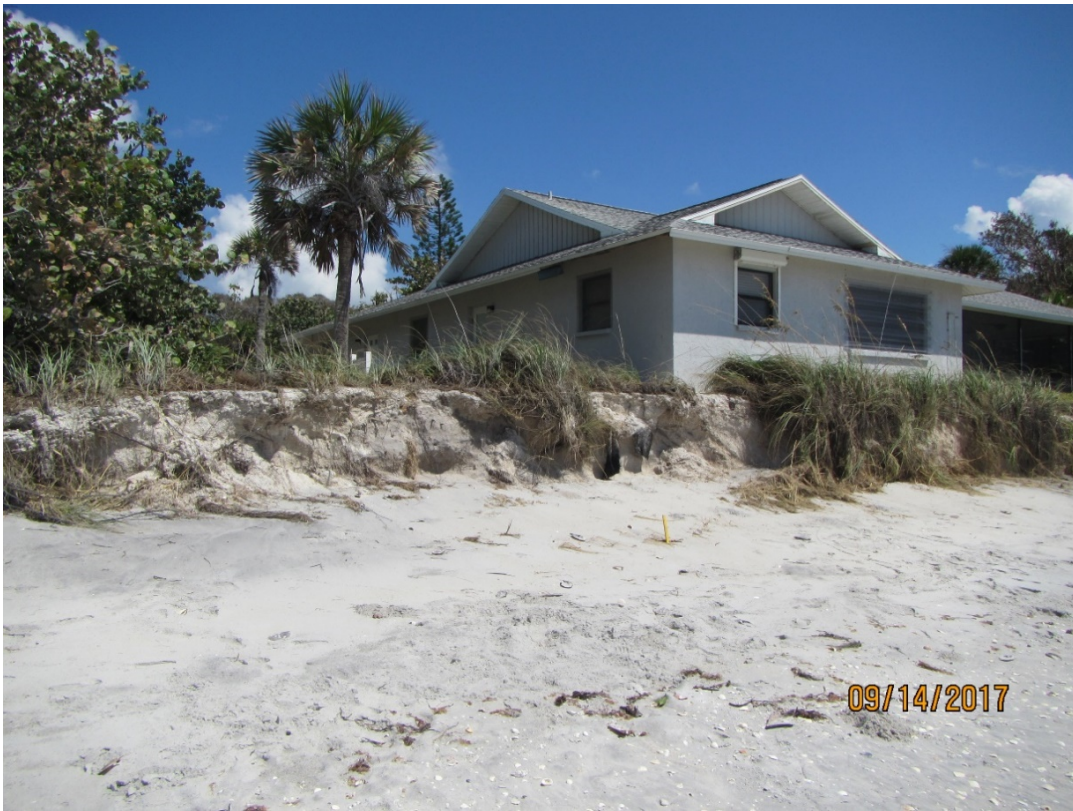
Figure 56. Dune erosion that threatened a residence near R182.

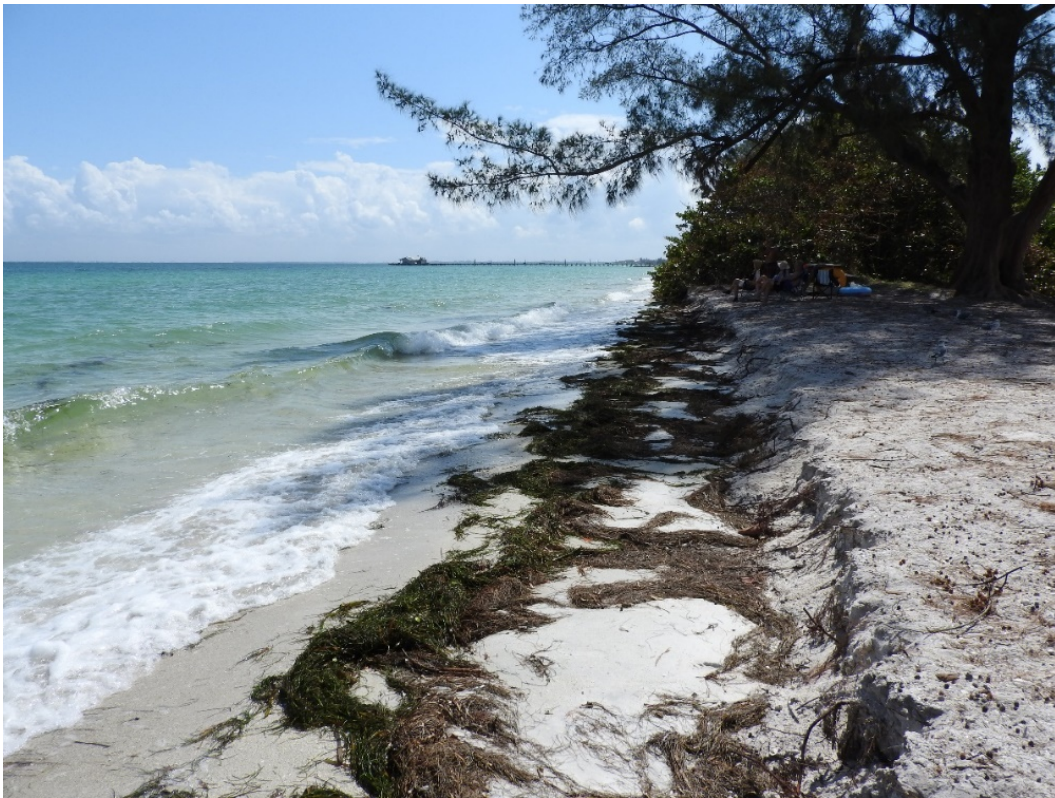
Figure 58. Beach erosion at the northern end of Anna Maria Island between R2 and City Pier.

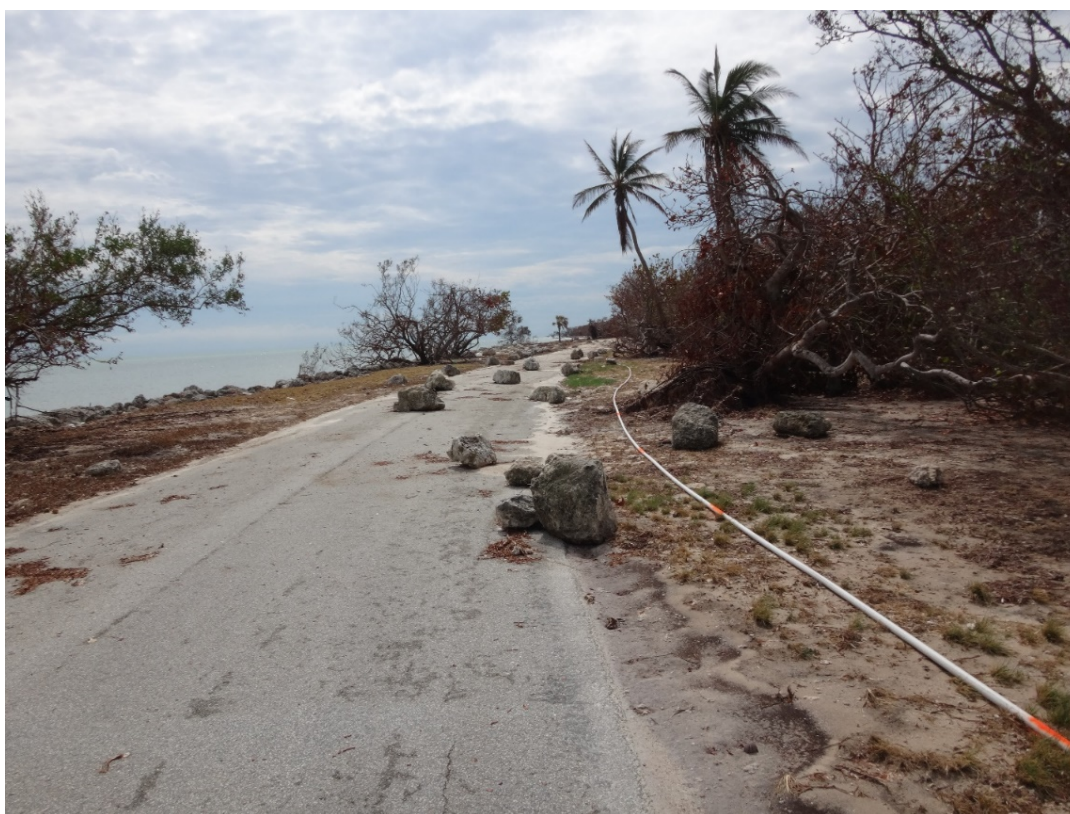
The 4.2-mile long island of Long Key has predominantly coarse-grained sand beaches. The eastern approximately 14,000 feet has mostly pocket beaches along a predominantly mangrove shoreline. Along the western 8,500 feet of the island is continuous beach averaging 25 feet in width. Of this beach segment, 5,700 feet are within the Long Key State Park and the western 2,800 feet front private development consisting of 14 single-family residences and five multi-family buildings. One mile of the state park beach is designated critically eroded. Hurricane Irma inflicted severe erosion and overwash along the entire beach front, as well as minor damage (level II damage) to 700 feet of boulder mound limerock revetment (Figure 63).

Figure 63. *The park road in Long Key State Park with overwash of revetment boulders.*
