Hurricane Irma
Post-Storm Beach Conditions and
Coastal Impact in Florida

Division of Water Resource Management
Florida Department of Environmental Protection

April 2018

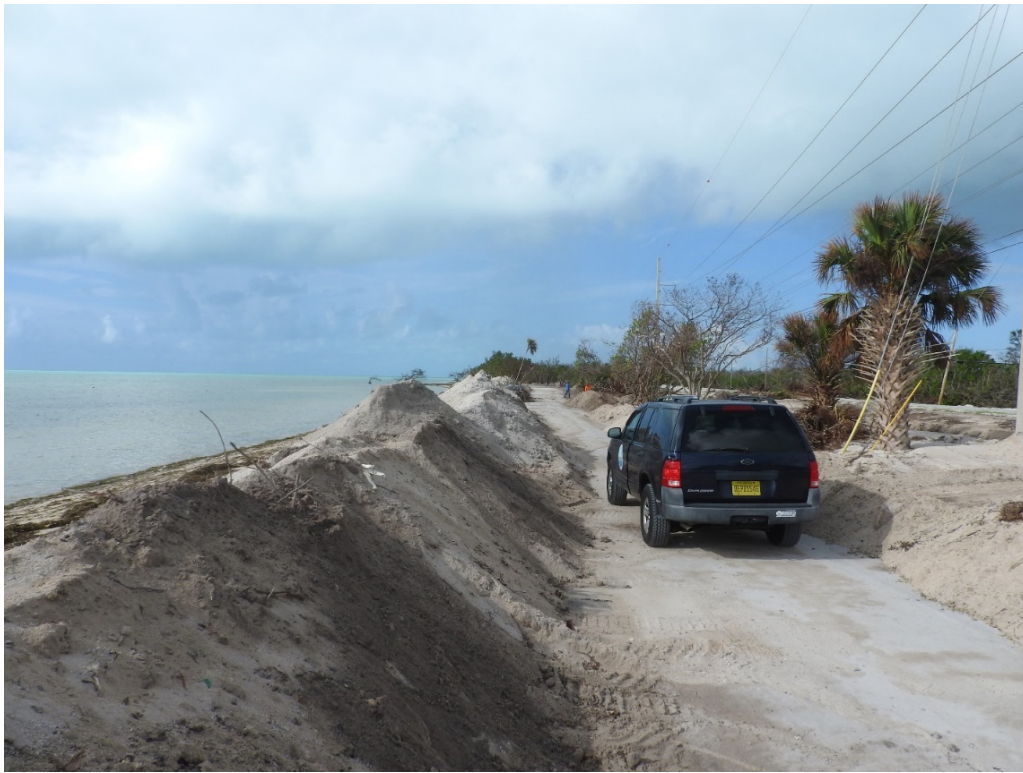
Figure 64. Staged overwash material in Long Key State Park.

Following the storm, much of the overwash sand throughout Long Key State Park was scraped into piles for the reconstruction of the campsites and nourishment of the beaches (Figure 64). All of the 60 beach front camp sites and one of the three bathhouses in the park were destroyed. In addition, approximately 4,100 feet of state park road was damaged. The private development at the western end of Long Key west of the state park sustained wind and flooding damage and three major structures were destroyed. The Long Key east bridge abutment was also severely eroded on its southern side.

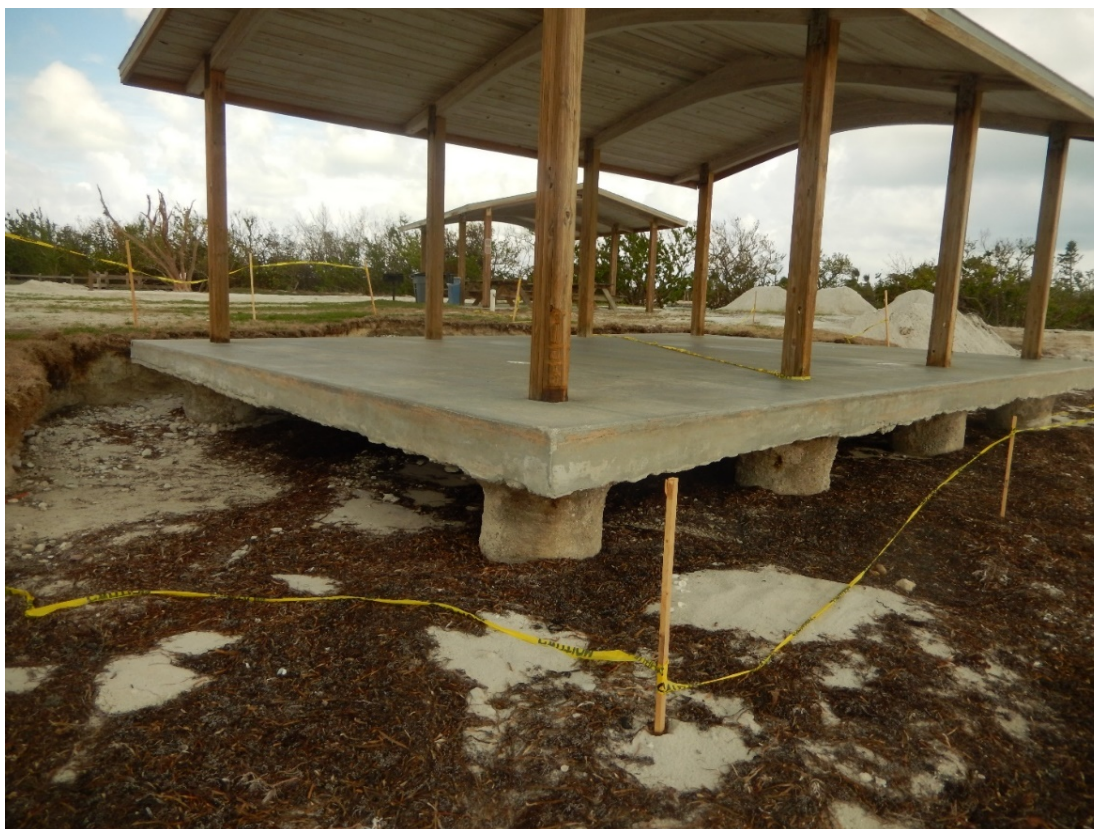
Little Crawl Key has a 1,500-foot beach that varies from 25 to 50 feet wide, which is within Curry Hammock State Park. This is the site of a truck-hauled beach restoration project constructed in 2008, with additional dune nourishment in 2011. The beach project was constructed with silicate sand, which has blended with the native calcium carbonate sediments on-site. Hurricane Irma inflicted major beach and dune erosion (condition IV) along the eastern approximately 400 feet of the beach, and moderate beach and dune erosion (condition III) along the western 1,100 feet of the beach. The erosion along the eastern stretch of beach has undermined two of the four pavilion structures (Figure 66).

Figure 66. Undermined pavilion at Curry Hammock State Park.

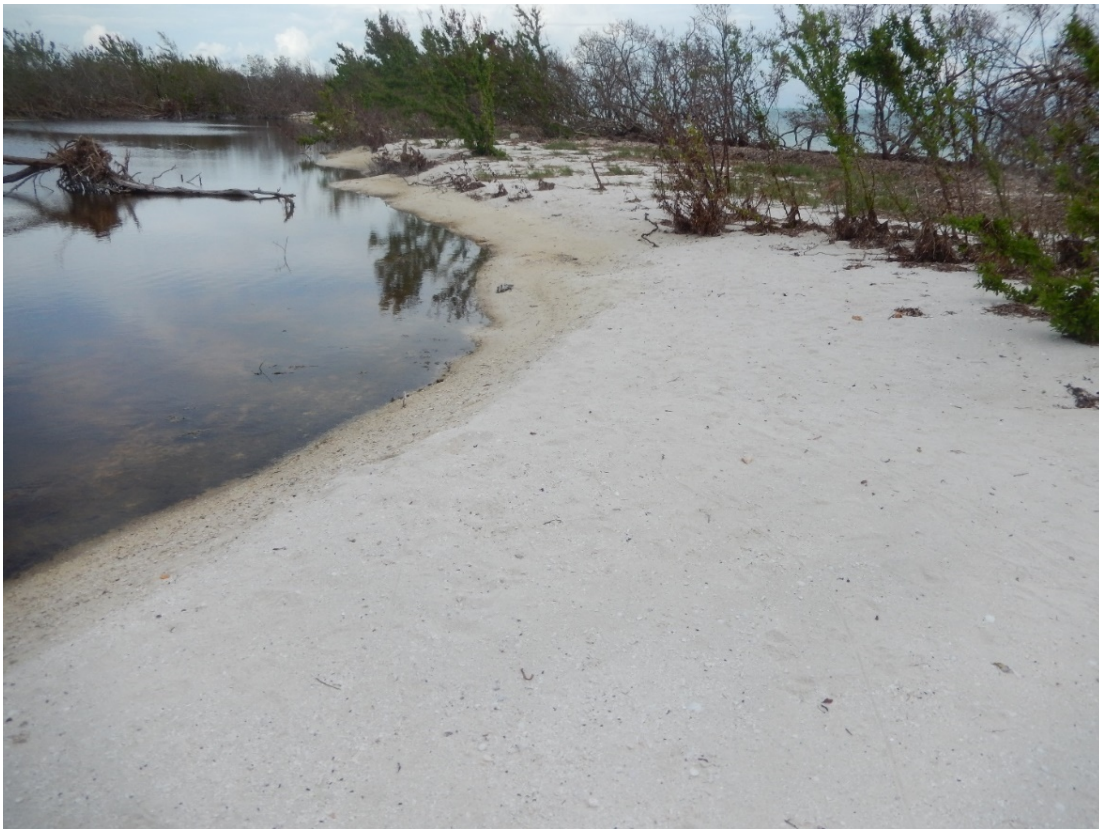
Figure 67. *Overwash of beach sediments off Coco Plum Beach (to the right of the image) into a lagoon (to the left of image).*

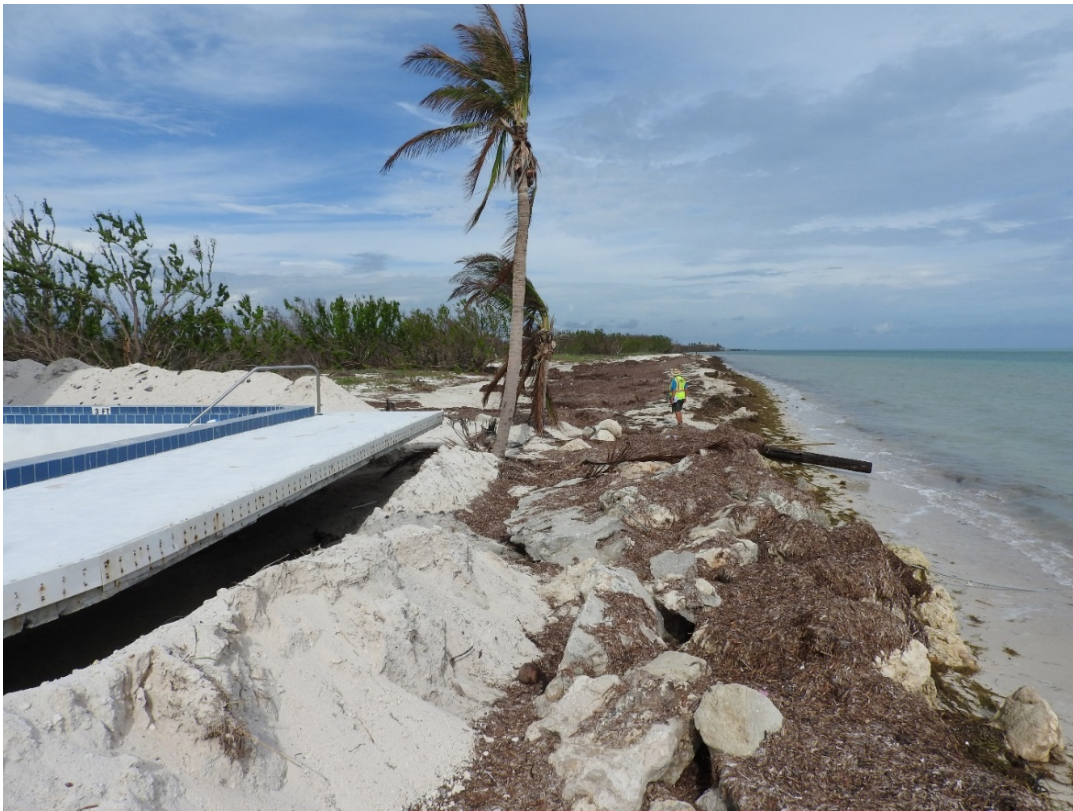
Figure 68. Damaged revetment and undermined pool at Coco Plum Beach.

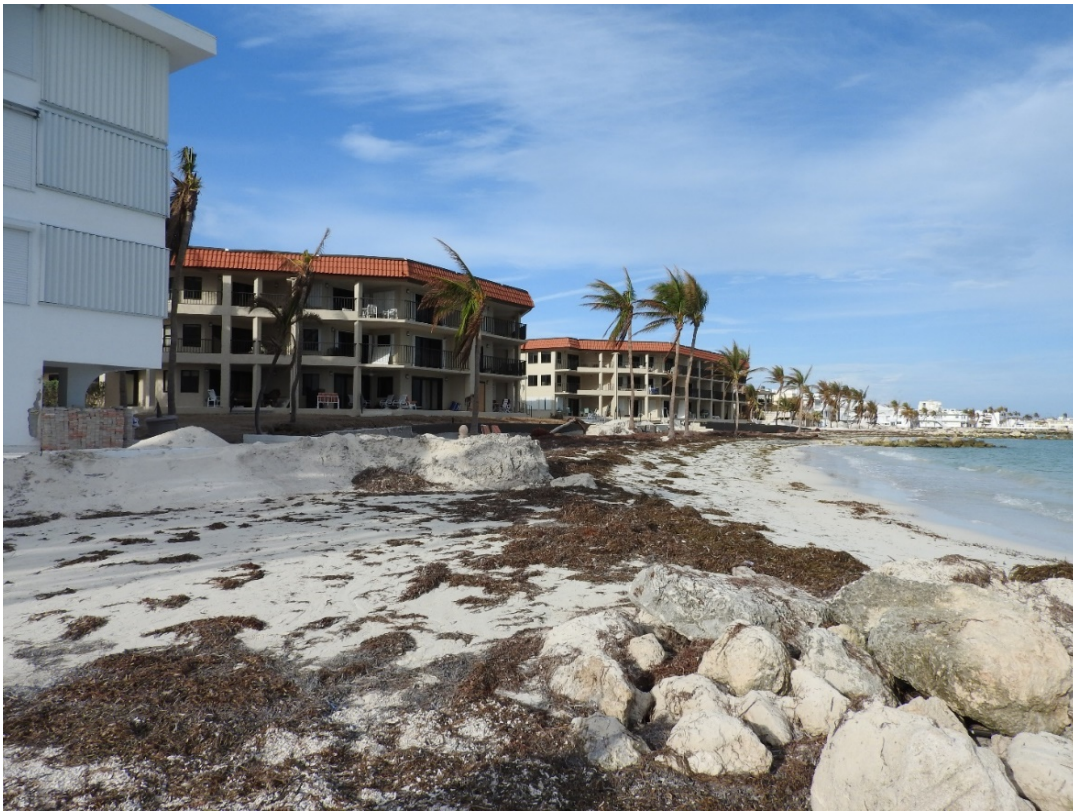
Figure 69. Major beach erosion, Key Colony Beach.

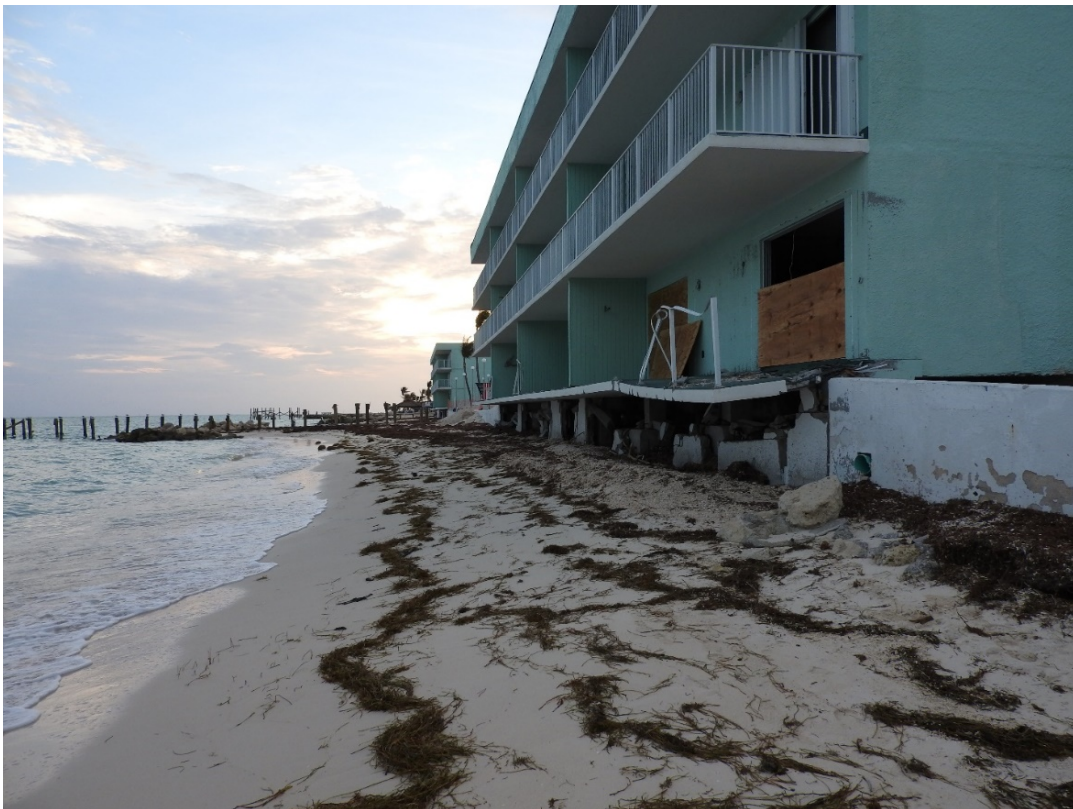
Figure 70. Building damage, Key Colony Beach.

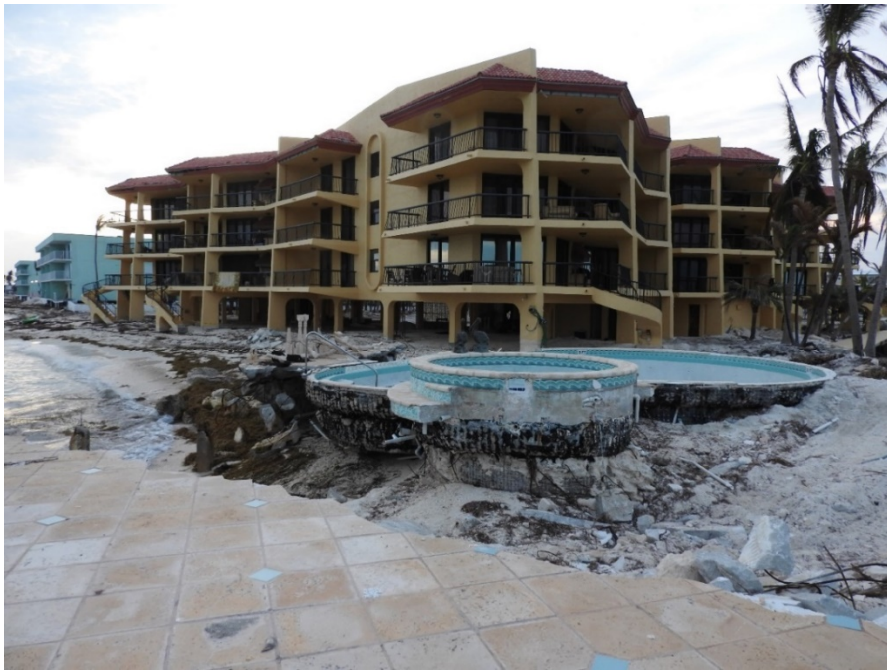
Figure 71. Major damage to shoreline development, Key Colony Beach.

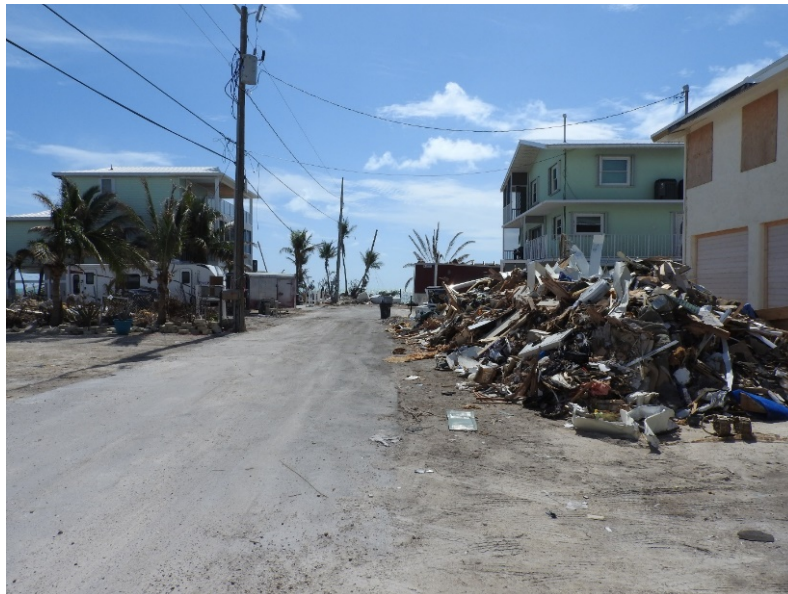
Figure 72. Debris piles throughout City of Marathon.

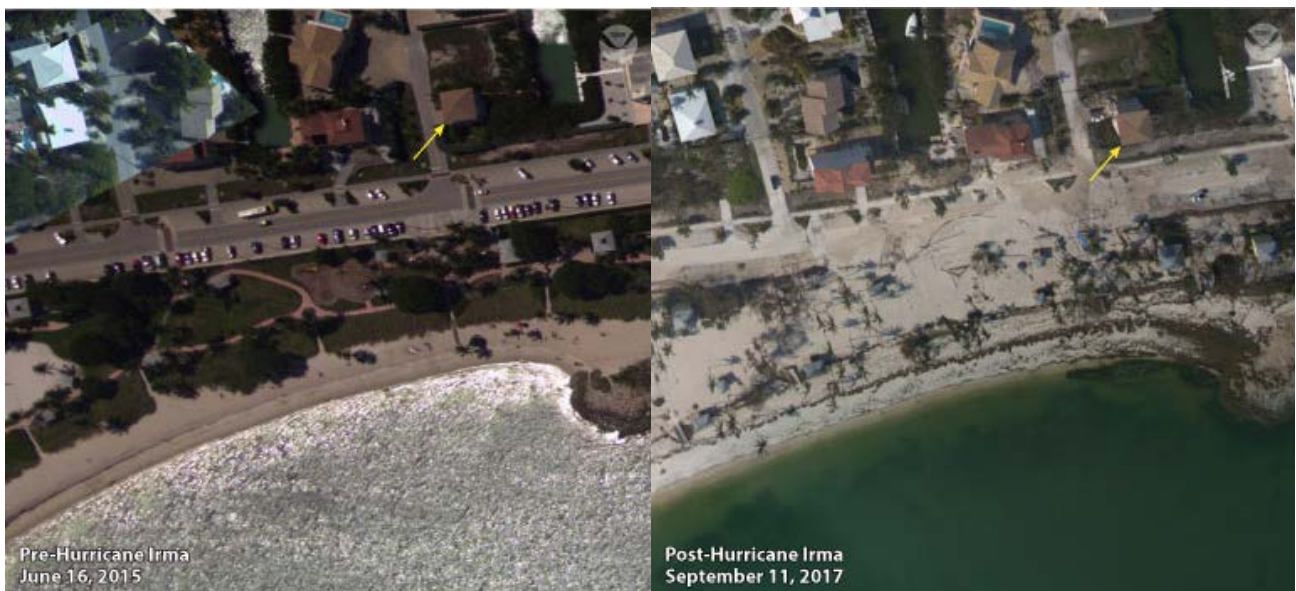
Figure 73. Sombrero Beach, Monroe County Park, impacted by the storm surge causing substantial overwash and park damage (Source: National Assessment of Coastal Change Hazards, St. Petersburg Coastal and Marine Science Center, USGS).

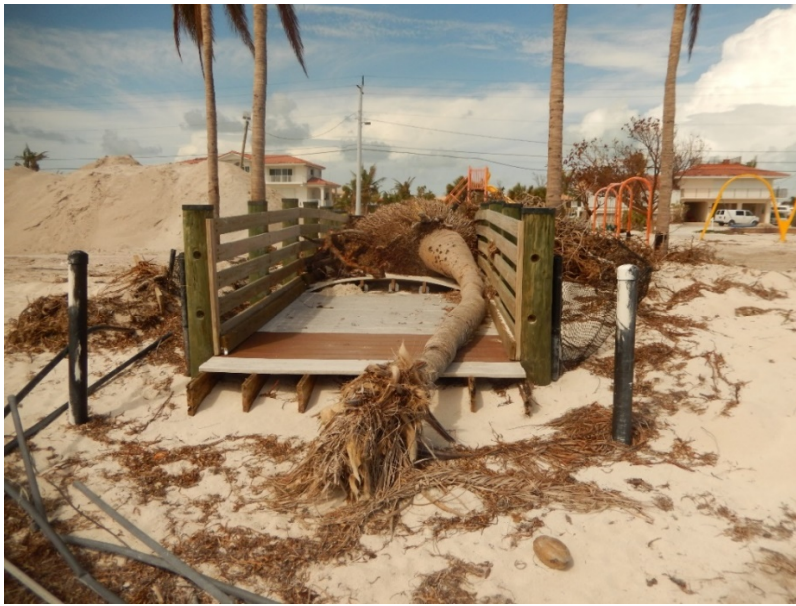
Figure 74. Damaged walkway and dunes, Sombrero Beach.

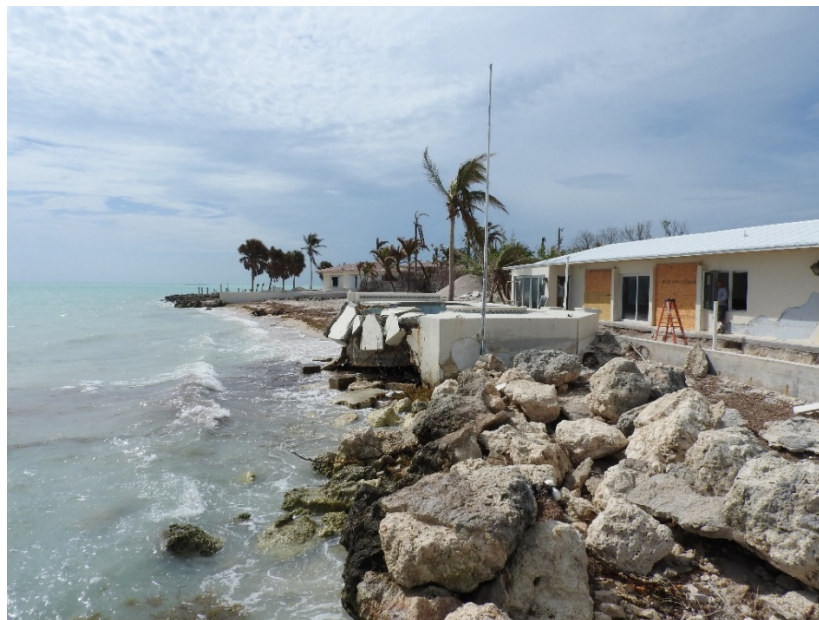
Figure 75. Tingler Island shoreline and structural damage, including a swimming pool.

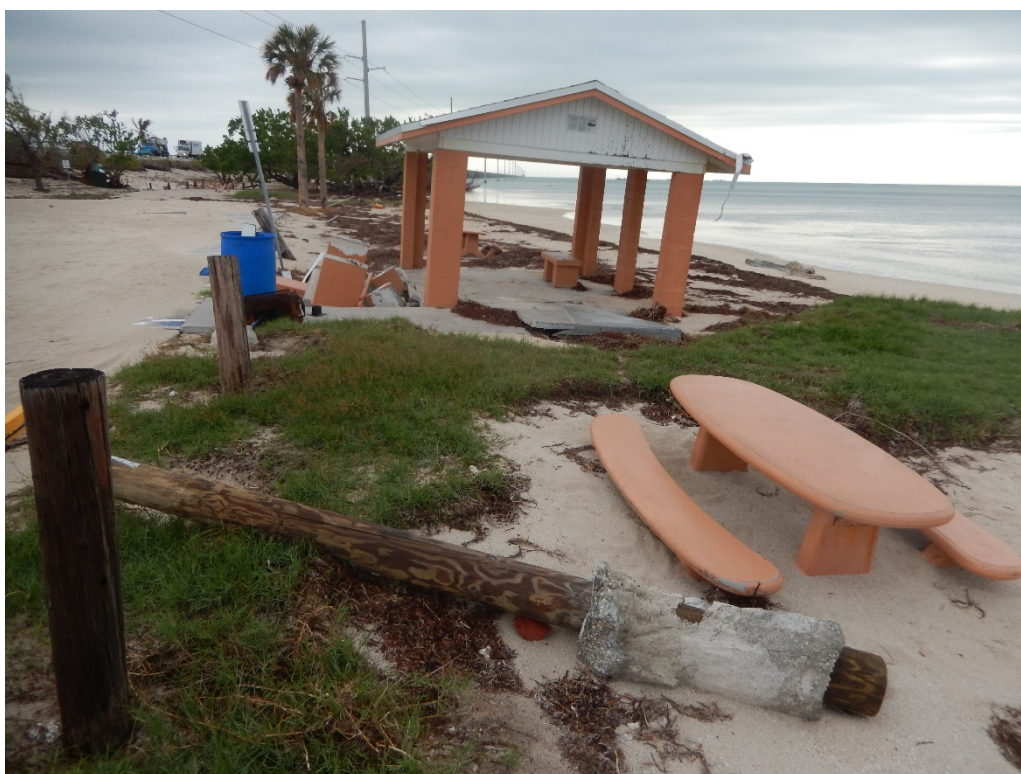
Figure 77. Monroe County park damages on Little Duck Key.

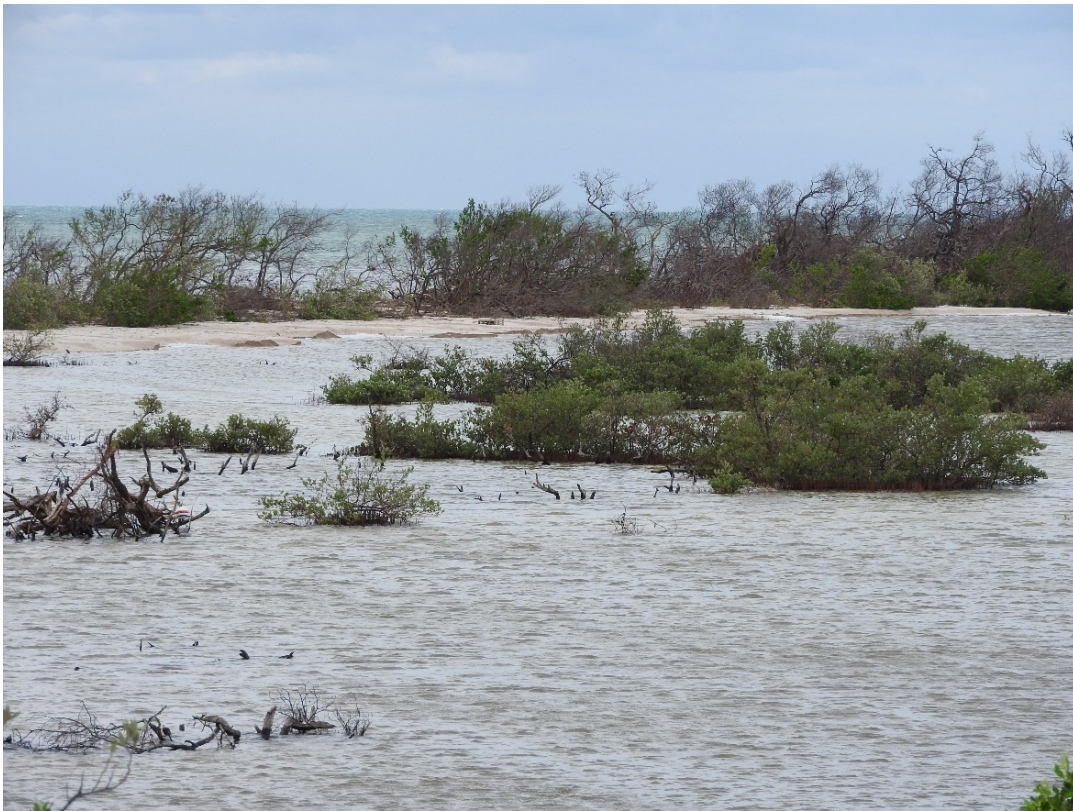
Figure 78. Ohio Key beach rolled over into lagoon by overwash.

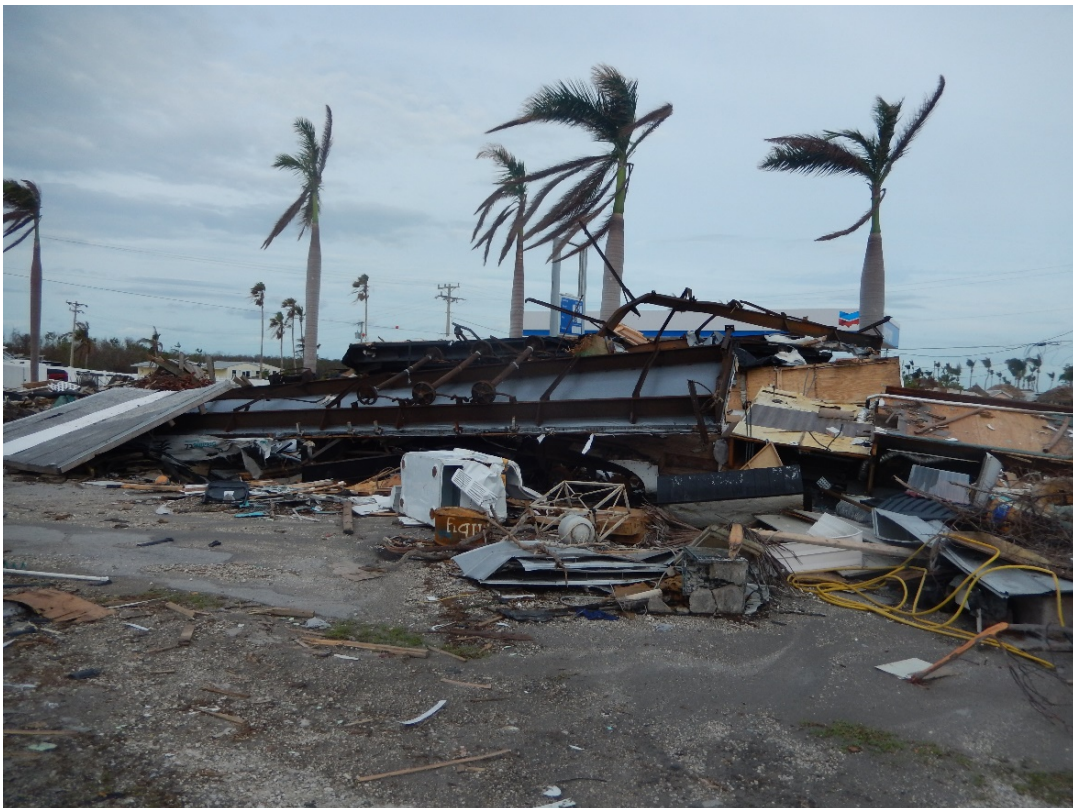
Figure 79. Trailer damage, Ohio Key Campgrounds.

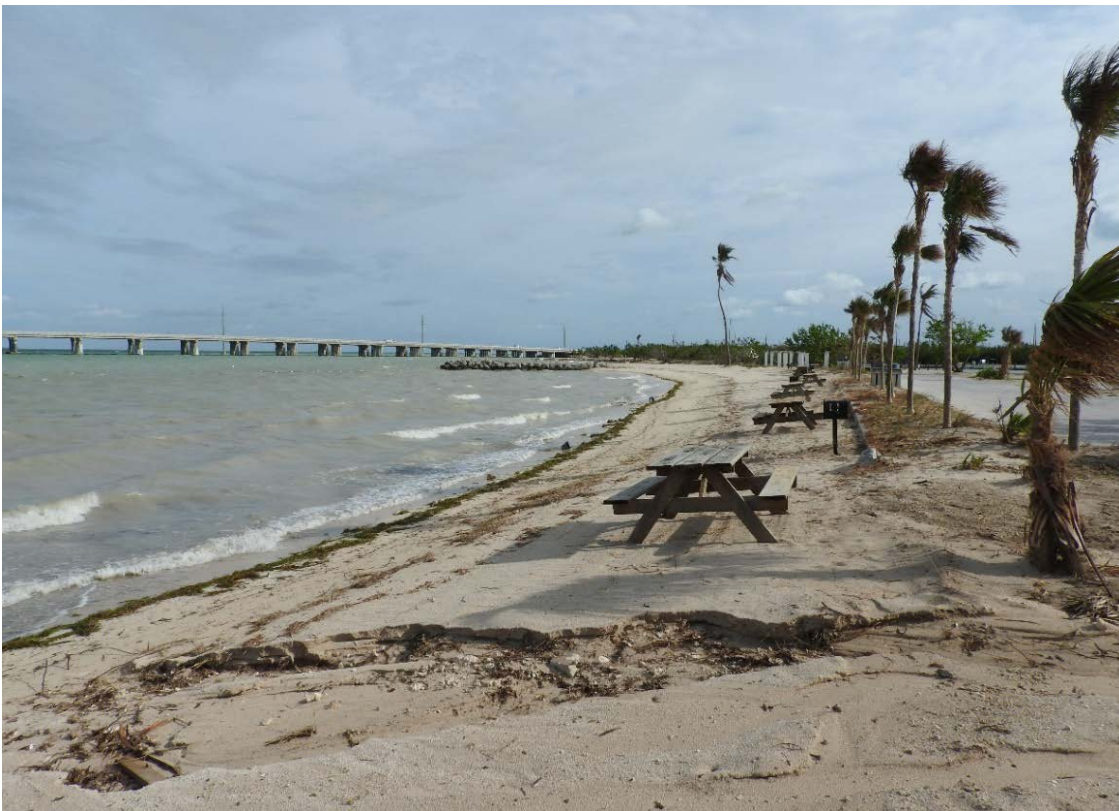
Figure 80. Calusa Beach erosion, Bahia Honda State Park (Picnic tables replace lost pavilions after the storm).

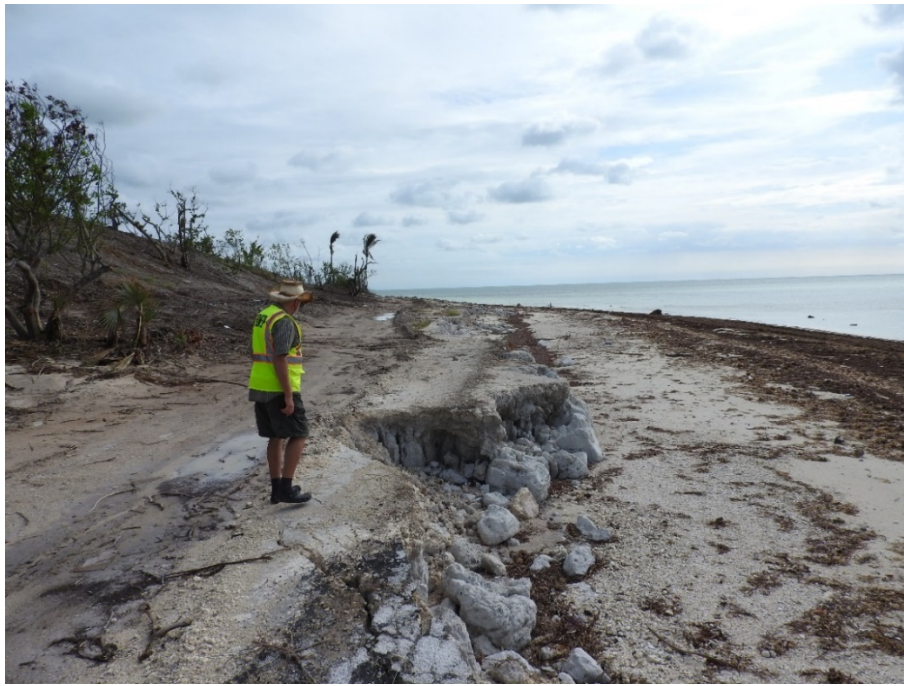
Figure 81. Severe beach erosion and road destroyed at west end of Bahia Honda Key.

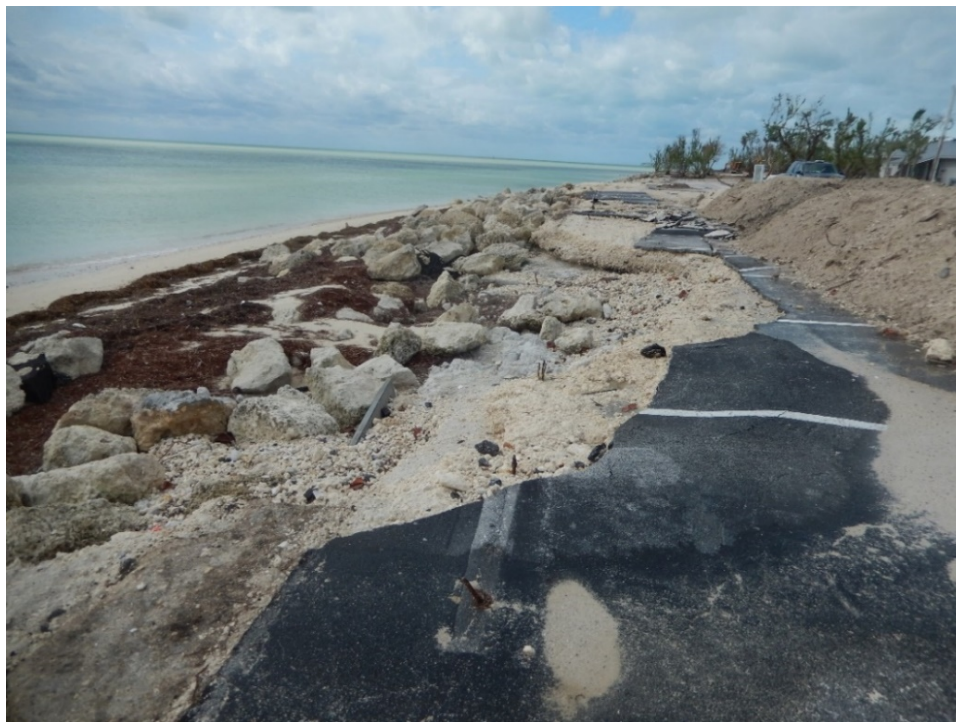
Figure 82. Revetment, access walkways, parking lot and all infrastructure for Loggerhead Beach was destroyed.

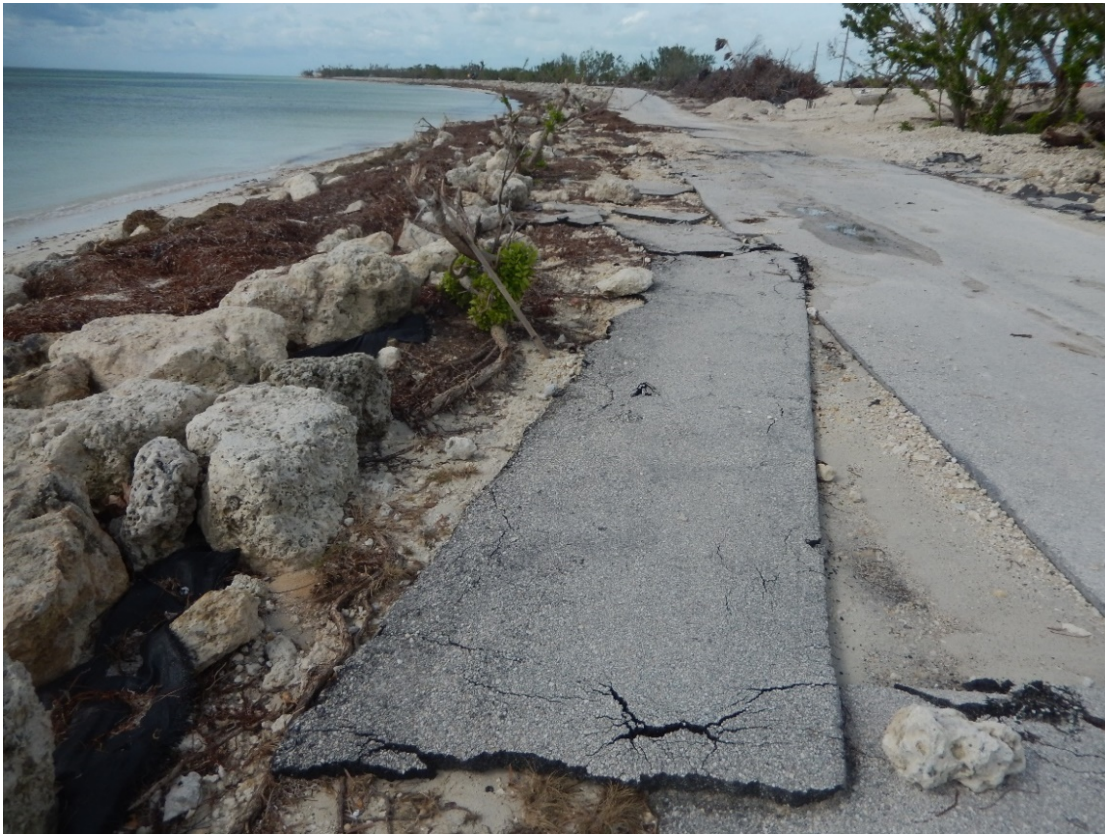
Figure 83. Bahia Honda State Park road and revetment damage.

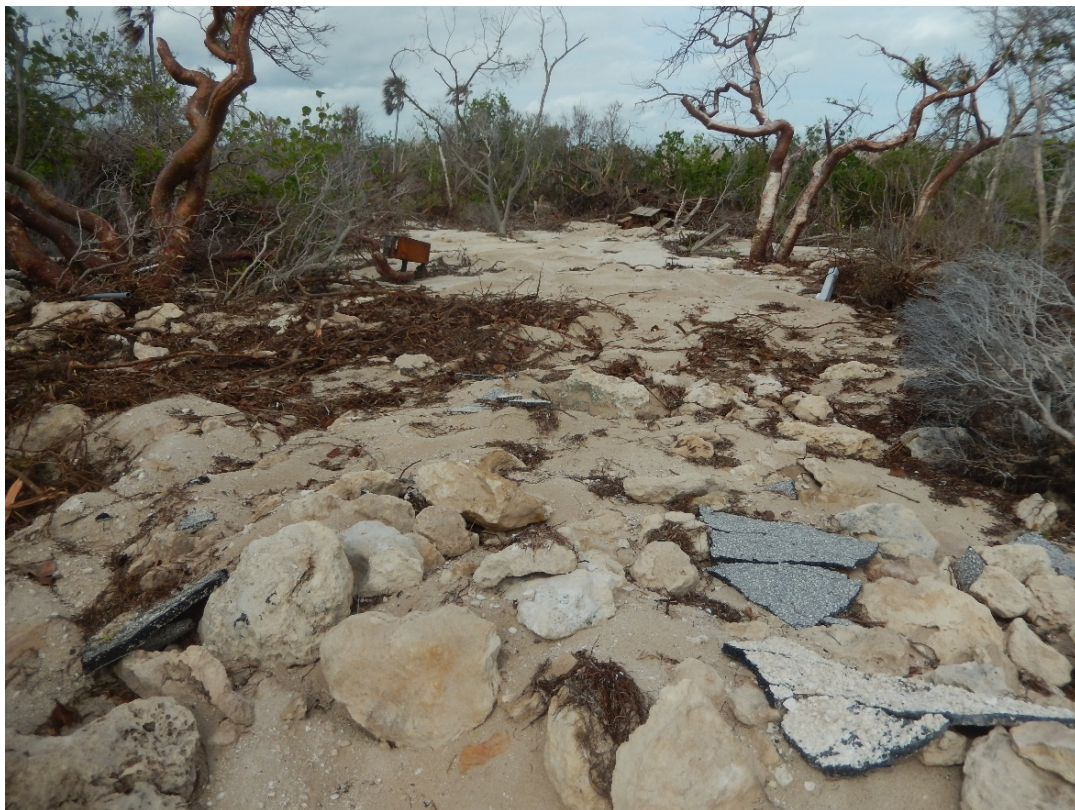
Figure 85. Destroyed road and campsites, Bahia Honda State Park.

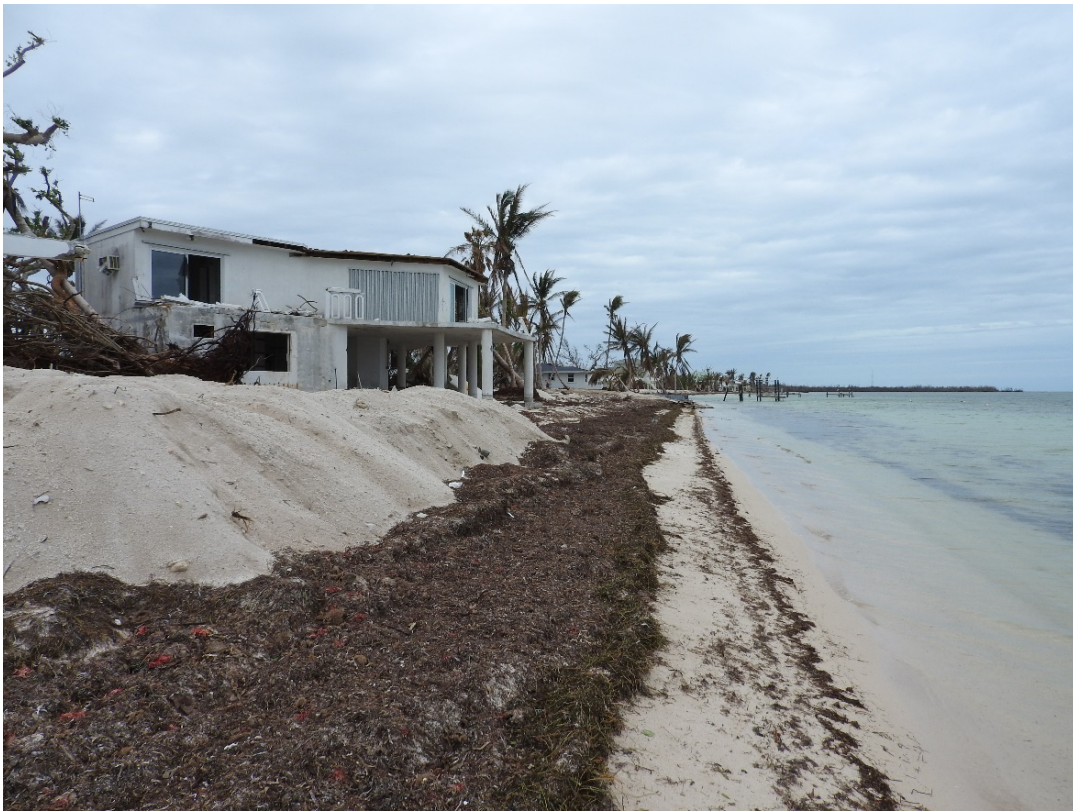
Figure 90. Major erosion and structural damage along Long Beach, Big Pine Key.

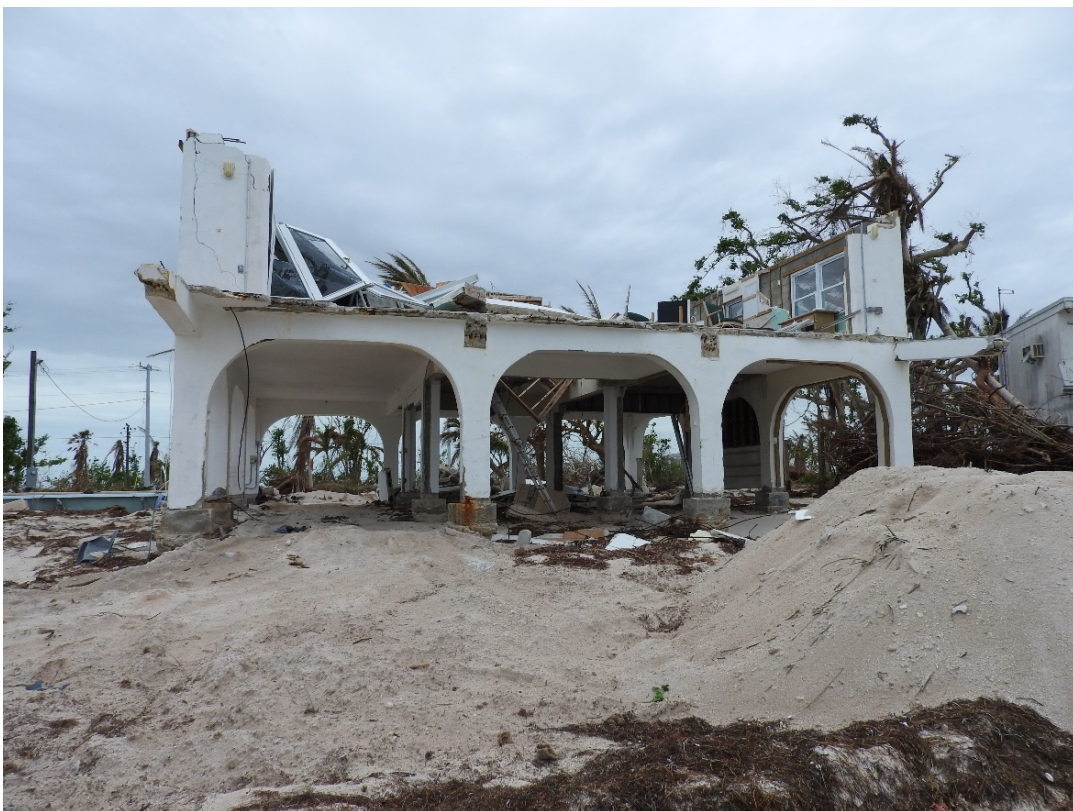
Figure 91. Single-family dwelling destroyed, Long Beach, Big Pine Key.

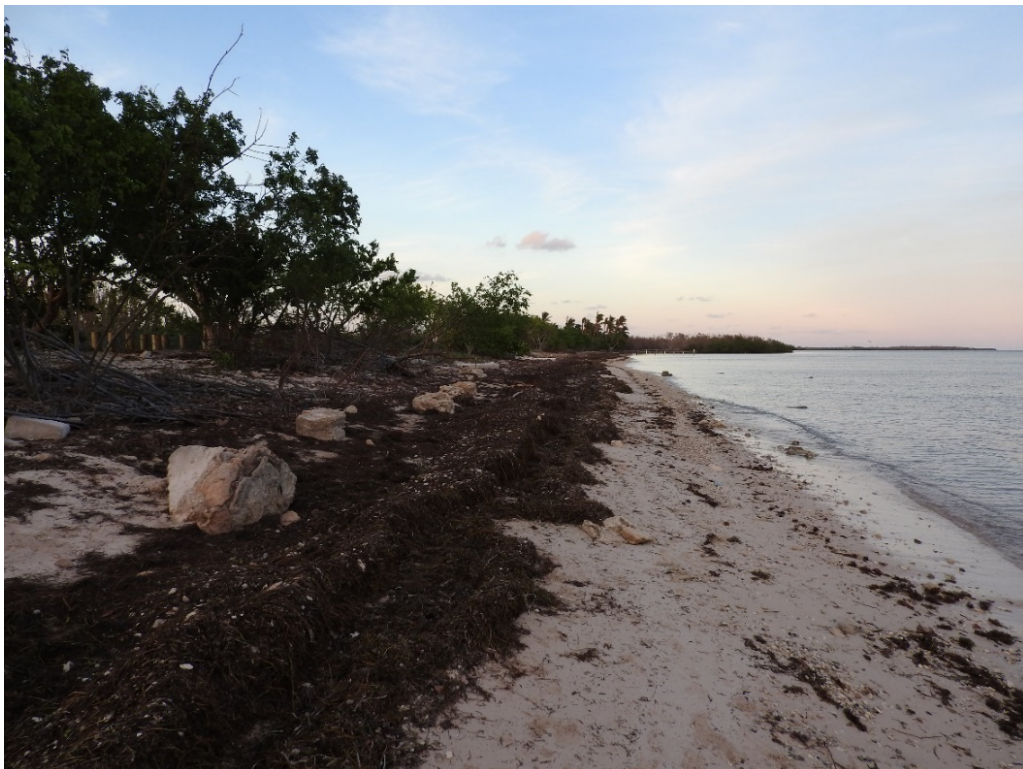
Figure 94. *Minor beach and dune erosion, Boca Chica Key.*

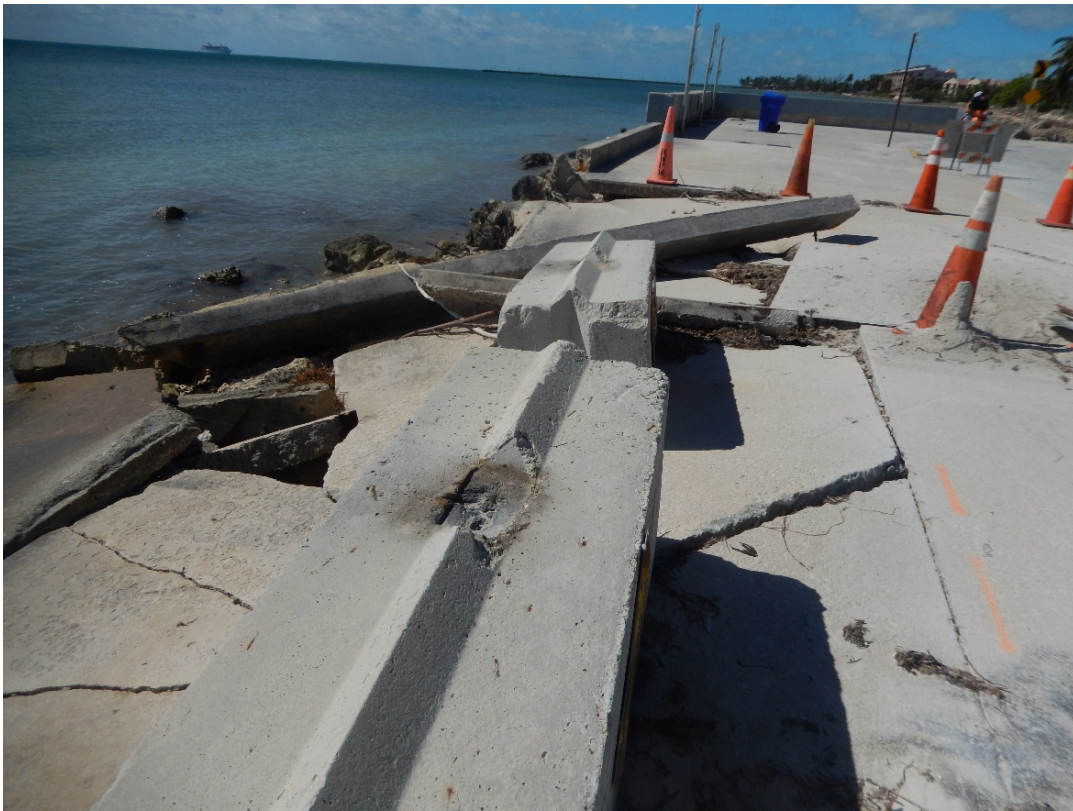
Figure 97. *Bertha Street end seawall damage, Key West.*
