HURRICANE DENNIS

SUPPLEMENTAL DAMAGE ASSESSMENT REPORT

Impact of Hurricane Dennis on Dog Island And Discussion of Post-Storm Recovery Responses

***Ralph R. Clark
Florida Department of Environmental Protection
Division of Water Resource Management
Bureau of Beaches and Coastal Systems
August 2005***

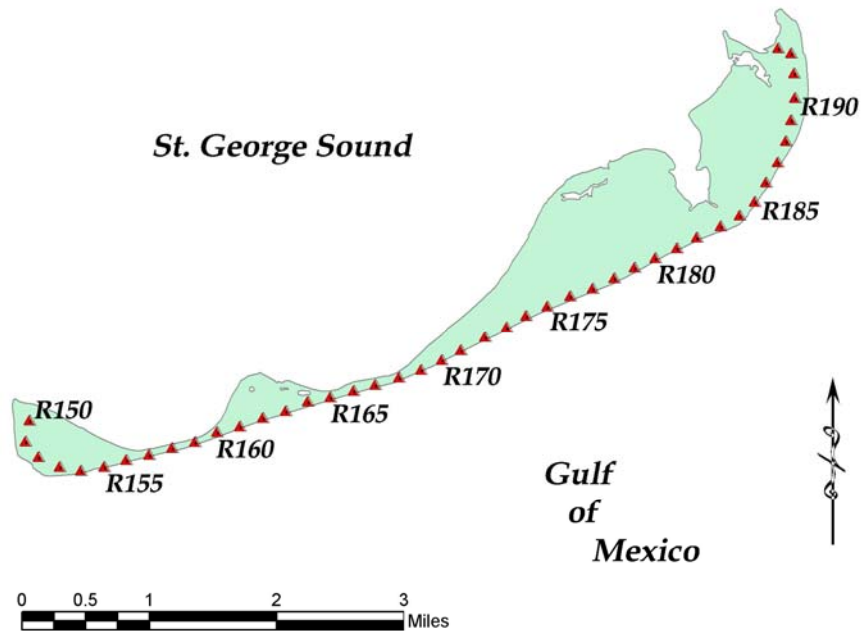
Figure 2. DEP range monuments on Dog Island, Franklin County.

On Friday, July 29, 2005, the beaches of Dog Island were inspected between R165 and R188 (Figure 2). Major beach and dune erosion (condition IV) was sustained throughout this area. Overwash with inland flooding was extensive where the dunes had breached or no longer existed.

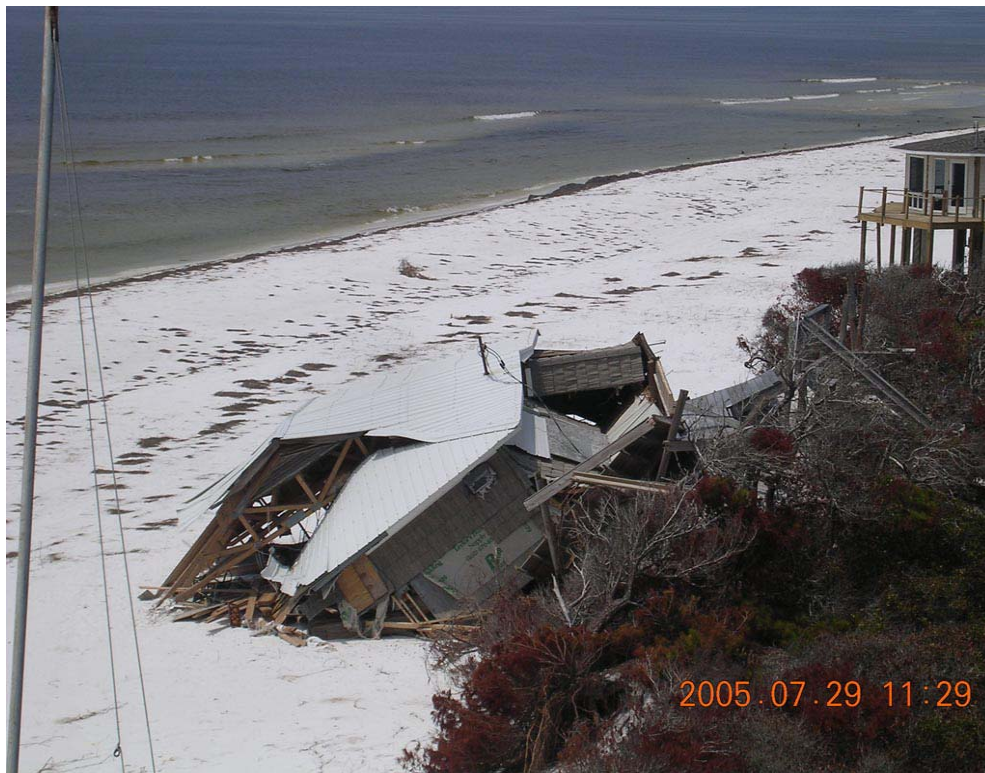
1. R163+50 (pile foundation)
2. R167+350 (pile foundation)
3. R169+700 (Photo 1)
4. R171+50 (soil bearing foundation behind wood bulkhead)
5. R173 (wind damage to superstructure; pile foundation okay)
6. R186+450 (dwelling totally destroyed)
7. R186+550 (dwelling totally destroyed)

Photo 1. Dwelling destroyed (R169.7)

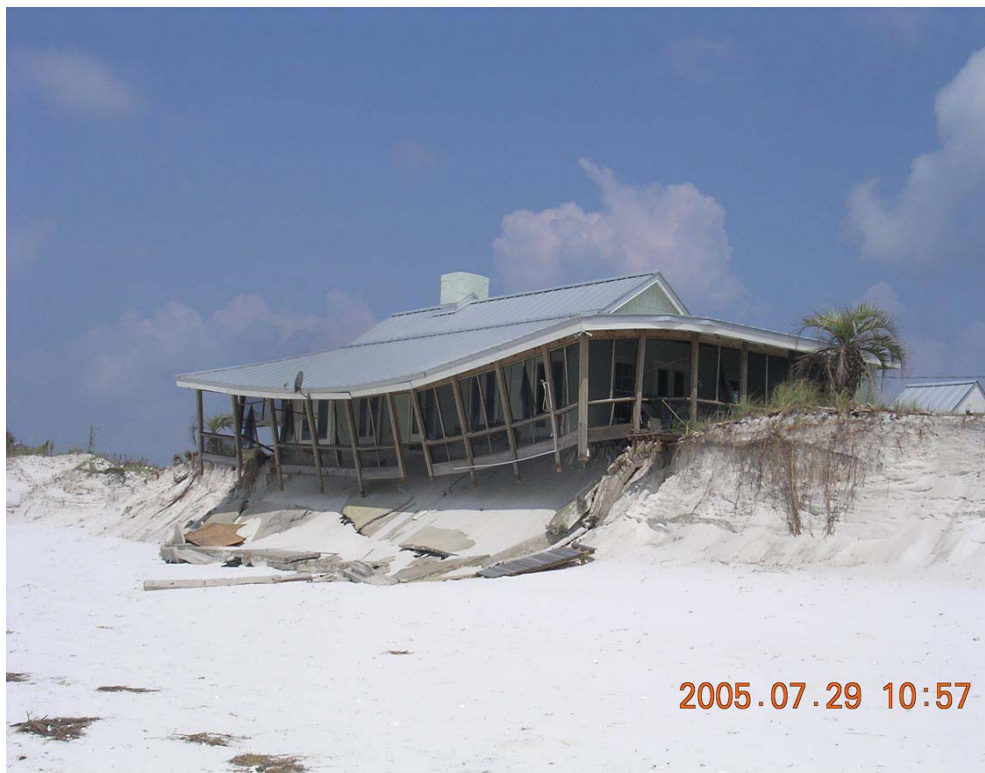
4. R172+550 (dwelling damaged)
5. R173+750 (1st floor damaged)
6. R176+200 (soil bearing foundation undermined; slab damaged) (Photo 2)
7. R180+350 (foundation piles suspended and damaged)
8. R180+550 (foundation piles suspended and damaged; wood bulkhead damaged)

Photo 2. Dwelling undermined and damaged (R176.2)

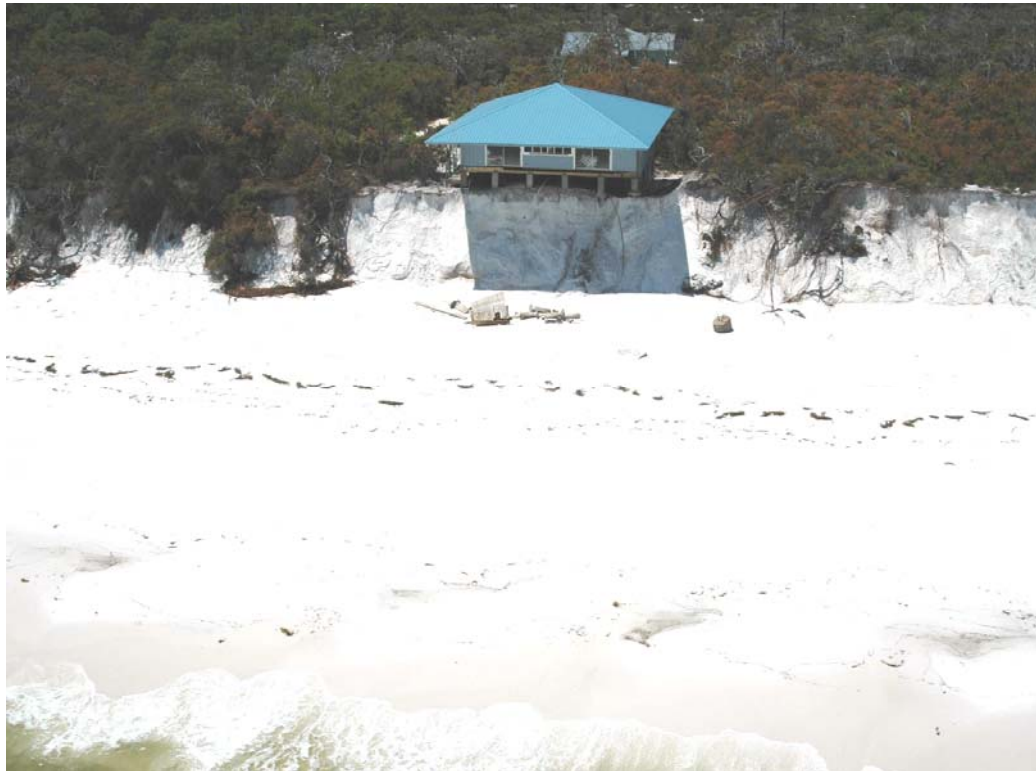
In addition to the dwellings damaged or destroyed, a number of dwellings are now in imminent danger of damage by a high frequency storm event and numerous others are threatened by another hurricane (Photos 3 & 4). In general, all structures that extend seaward of the established coastal construction control line are currently threatened. Approximately 43 single-family dwellings and one motel are currently threatened from another major storm.

Photo 3. Imminently endangered dwelling (R172.5)

locations is likely the most cost-effective solution to protecting structures on Dog Island. Relocating a threatened structure from a soil bearing foundation inland to a pile foundation provides additional time and protection from future storm flooding. For many of the threatened dwellings on Dog Island, relocation is the most recommended long-term solution. However, in some cases, properties have insufficient space to facilitate relocation. Also, individual structures may not be designed or constructed to be moved.

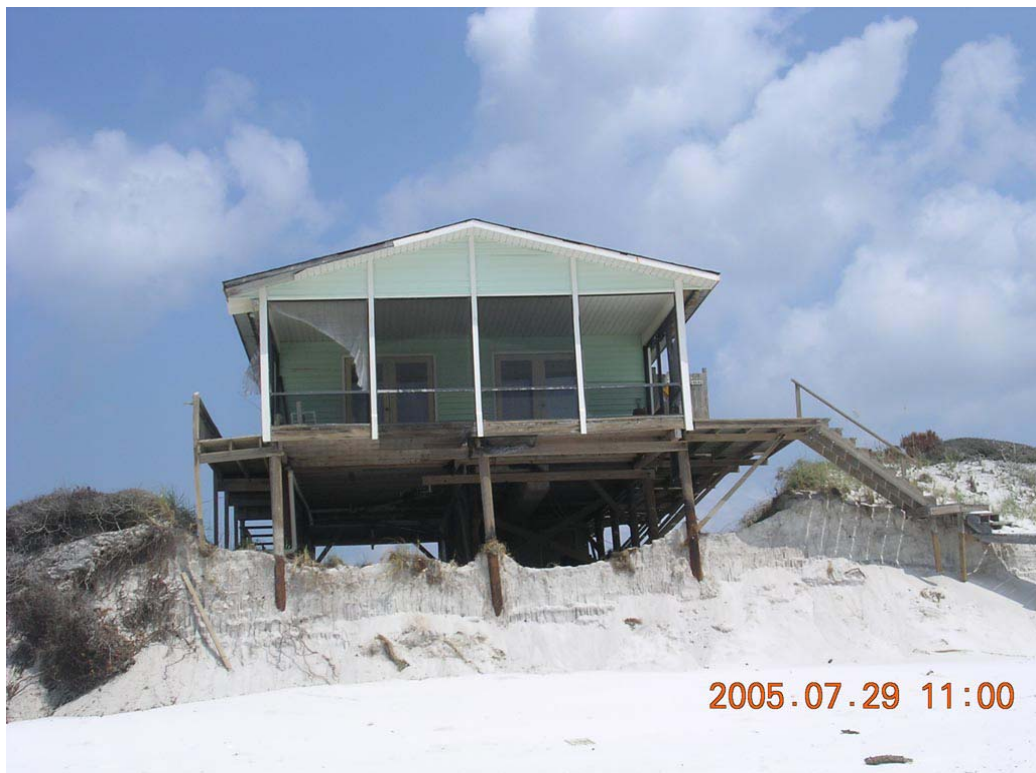
Photo 4. Imminently endangered pile-supported dwelling (R175)

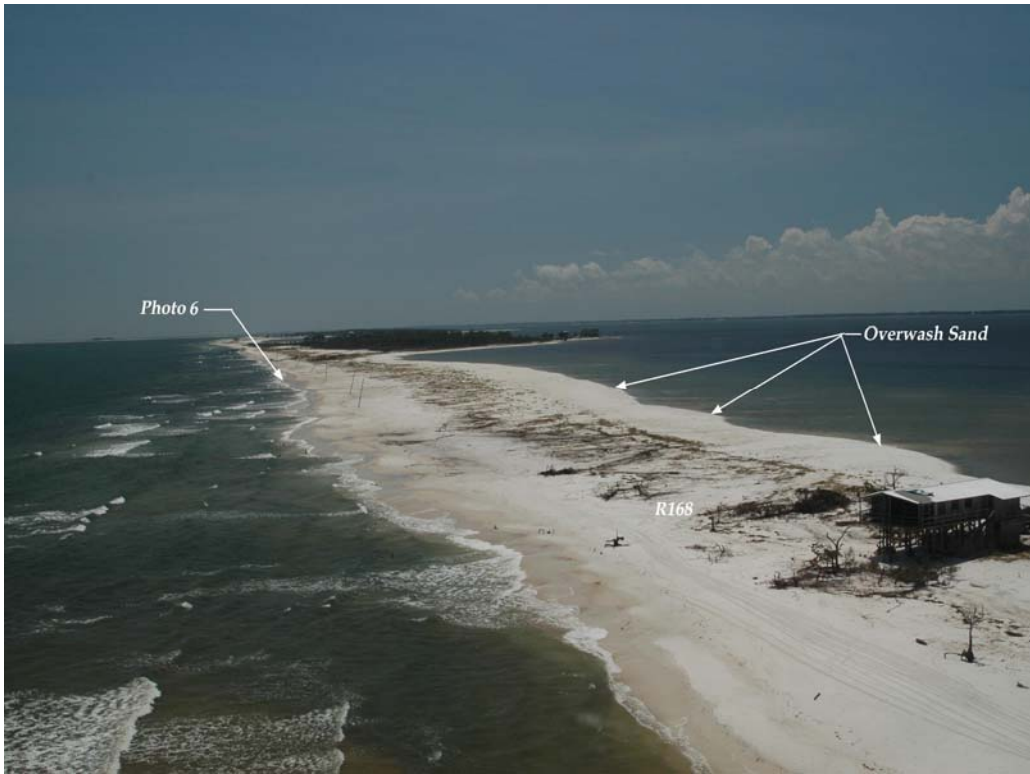
At the two "Narrows" of Dog Island, overwash sand is also being transported into St. George Sound (Photo 5). The loss of material into the sound at the eastern narrows specifically effectuates a major loss of beach from the reach between R165 and R175. Coupled with westward longshore transport conditions, storm surge conditions like that experienced during Hurricane Dennis will convey large quantities of sediment across the island and deposit the material into the sound. The exposed tree stumps in the foreshore slope of the beach found along the narrows and the connecting island land mass known as

Photo 5. Eastern Narrows (R163-R168)

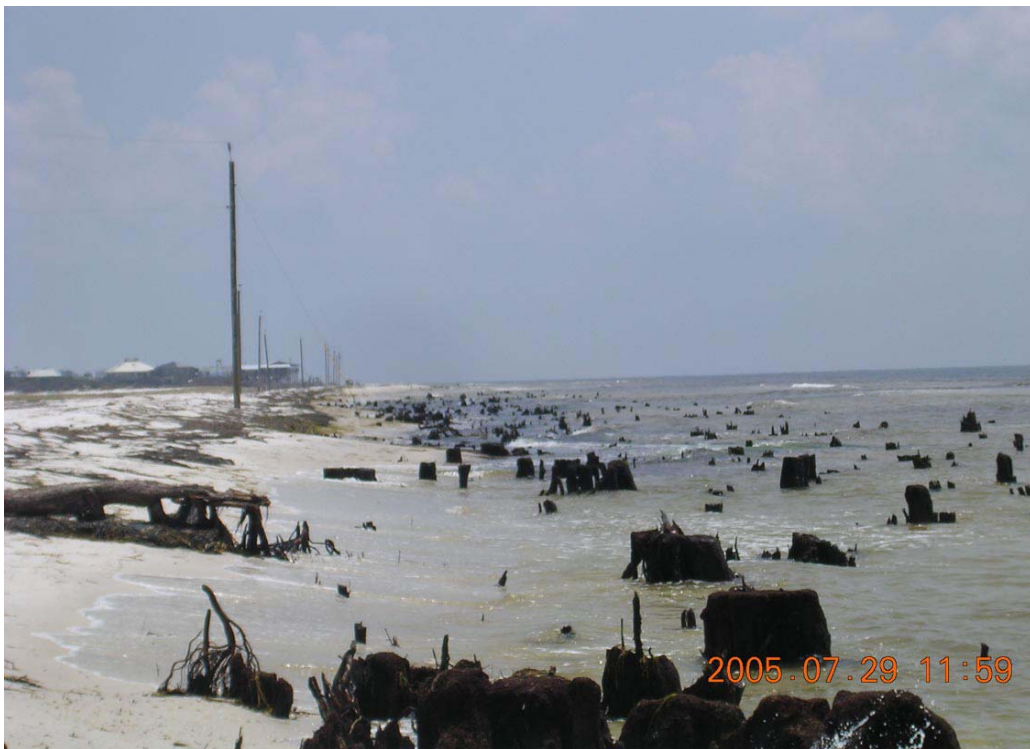
Cannonball Acres reveals the long-term erosion process, northward island migration and rollover growth of the sound shoreline (Photo 6).

Photo 6. Exposed tree stumps (R165)

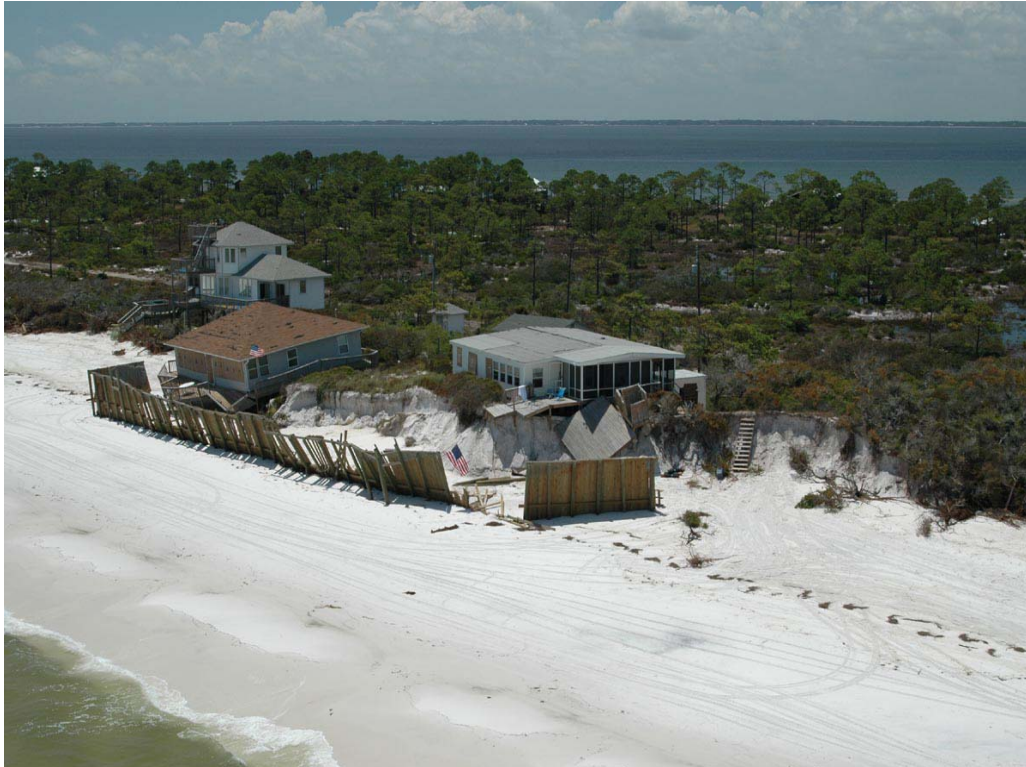
Photo 7. Wood bulkhead destroyed (R171)

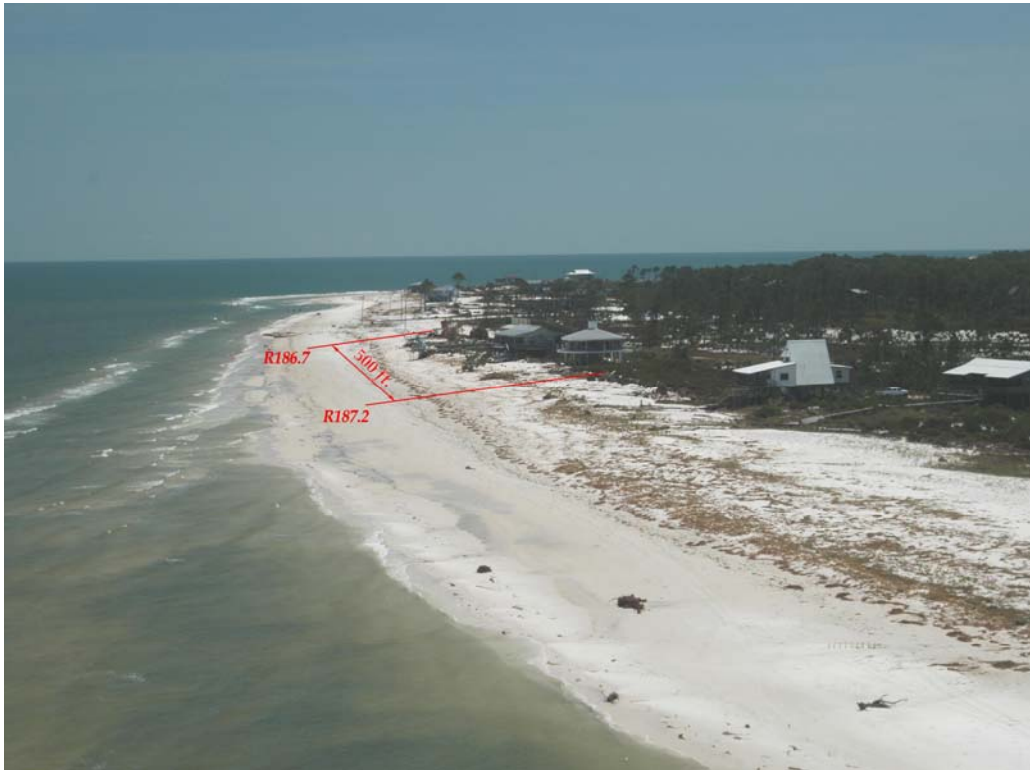
Photo 8. Potential area for beach scraping (R186.7-187.2)

On Dog Island there exists sufficient sediment along the recovering foreshore of the beach to facilitate a beach scraping project. Continuous segments of shoreline are preferred to be scraped than individualized, isolated properties. Typically, if properties are sufficiently protected from high frequency storm conditions by existing coastal protection structures, they would not be eligible for beach scraping. The three wood bulkheads on Dog Island have shown themselves to be insufficient to provide this protection, so these properties should not be excluded from an otherwise continuous scraping project.
