*Hurricane Michael Post-Storm  
Beach Conditions and Coastal Impact Report*

**Division of Water Resource Management  
Florida Department of Environmental Protection**

**January 2019  
(Revised April 2019)**

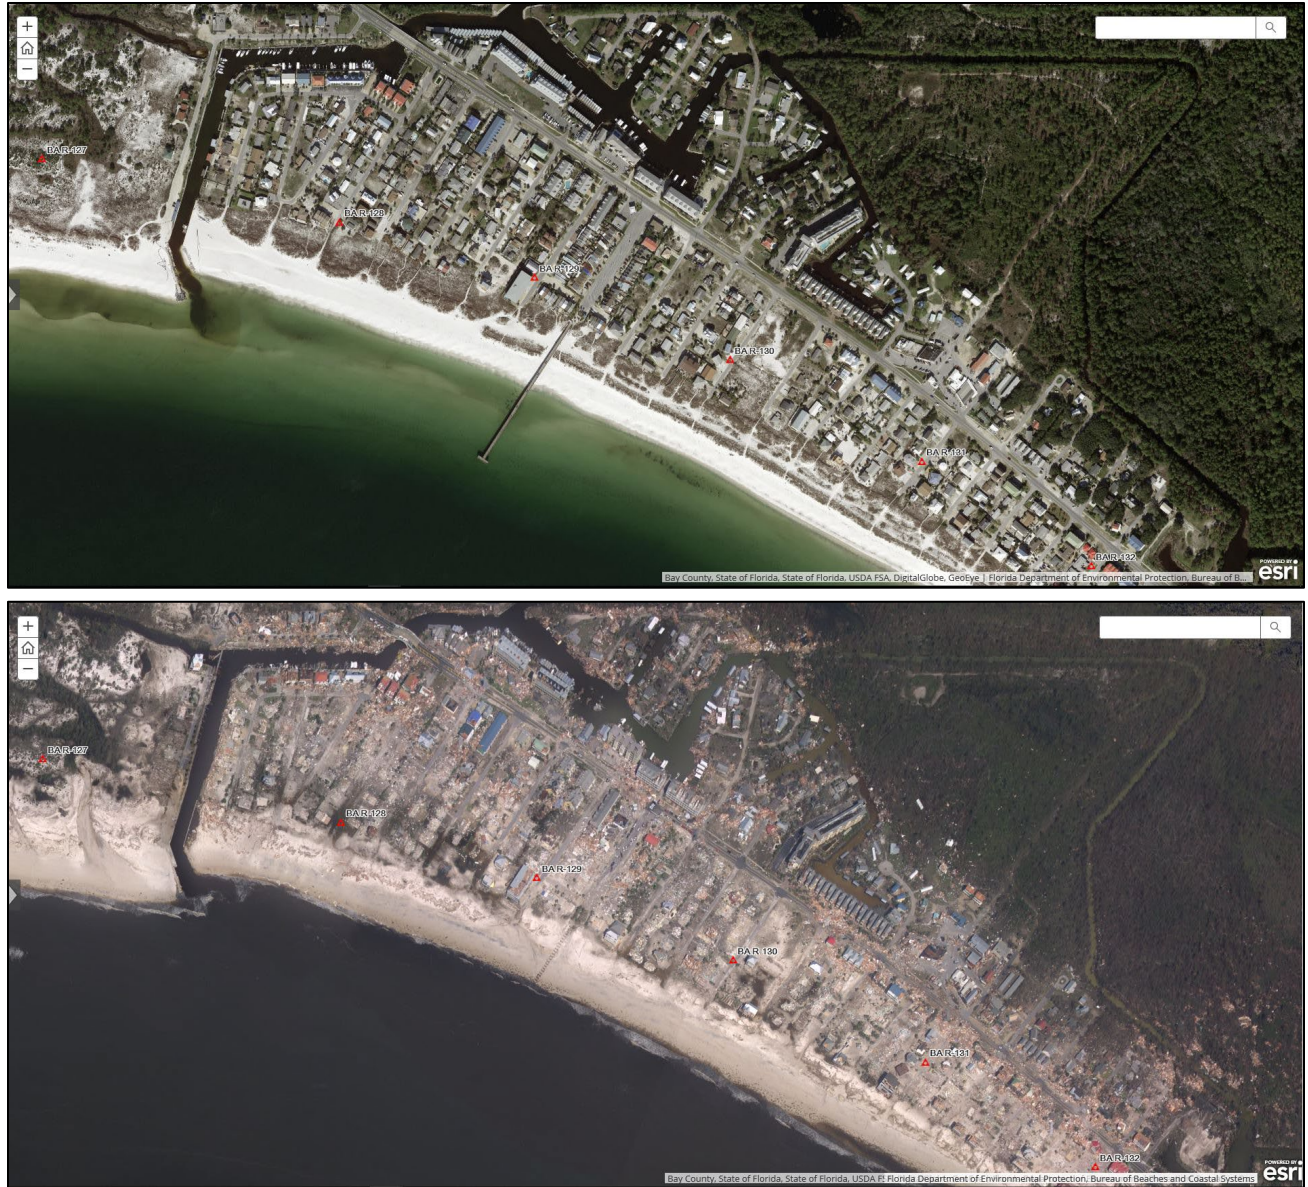
**Figure 8.** Aerial photo comparison of the severe damage in Mexico Beach (R127-R132). Source: Vexcel Imaging/ NICB Geospatial Intelligence Center.

To the east of Crooked Island, the most severe damage from Hurricane Michael was sustained along the mainland coast of eastern Bay County at Mexico Beach (**Figure 8**). On top of the storm surge, breaking waves caused the most severe damages. Many exterior water marks to 30 feet above sea level suggest the wave setup and wave uprush resulted in the destruction of most of the development seaward of U.S. Highway 98. Hurricane Michael's extreme storm tides and the high winds greatly exceeded the hurricane-resistant coastal construction standards of the Florida Building Code. Of the 210 buildings in Mexico Beach with major damage seaward of the Coastal Construction Control Line (CCCL), 180 buildings were destroyed, or roughly 85%. In addition, landward of the CCCL to the landward limit of the Coastal Building Zone, roughly 45% of the damaged buildings were destroyed. Within the Coastal

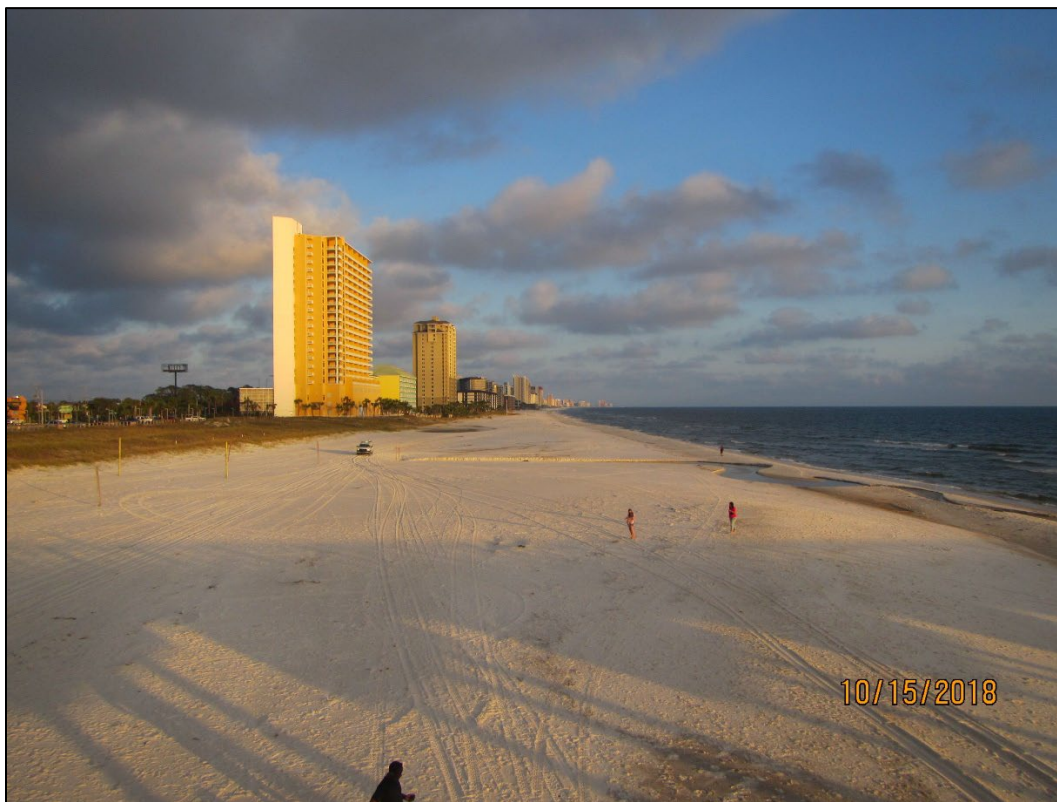
post-storm survey calculated a total loss of material for the project to be approximately -546,000 cubic yards. **Figure 11** shows post-storm beach conditions along the shore protection project near R57.

**Figure 11.** Beach erosion near R57, east of the M.B. Miller Pier, Panama City Beach.

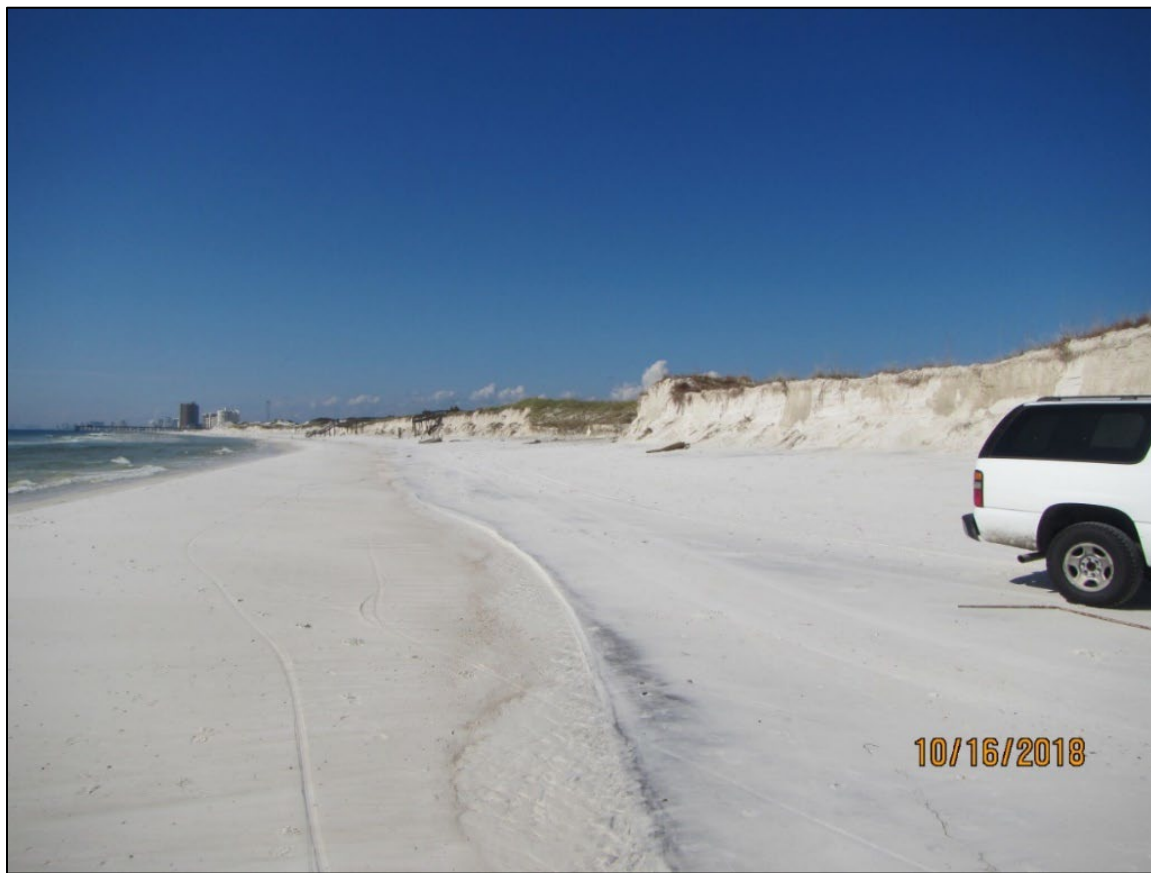
**Figure 12.** Major beach and dune erosion near R97, St. Andrews State Park.

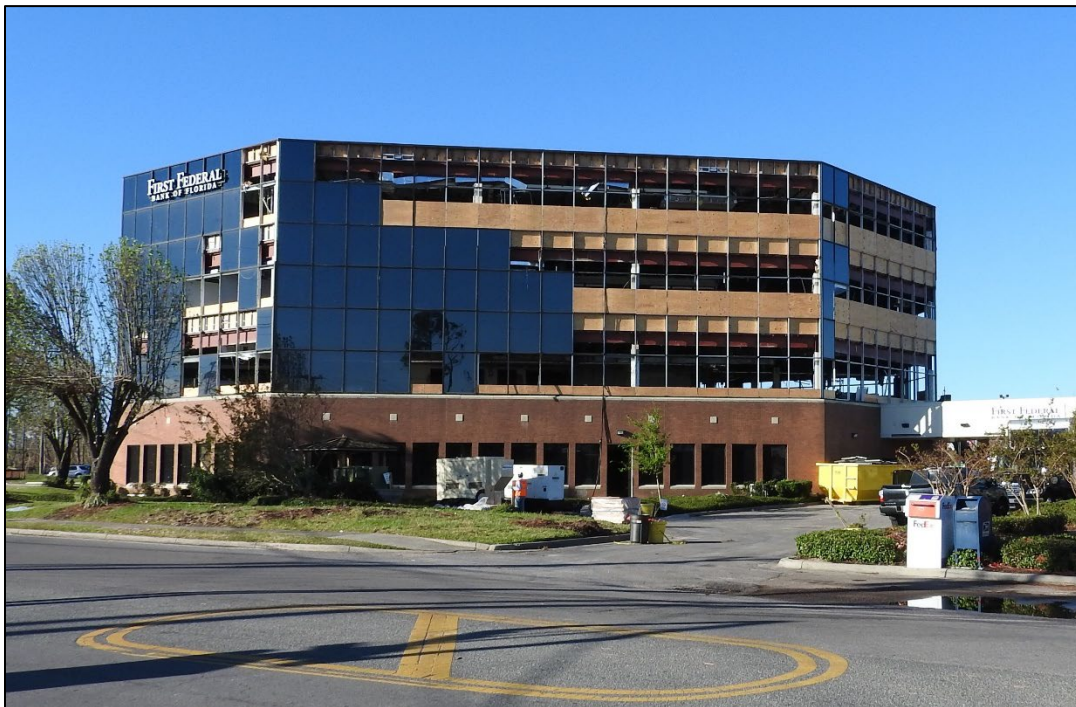
**Figure 15.** Bank with severe wind damage on 23rd Street, Panama City.

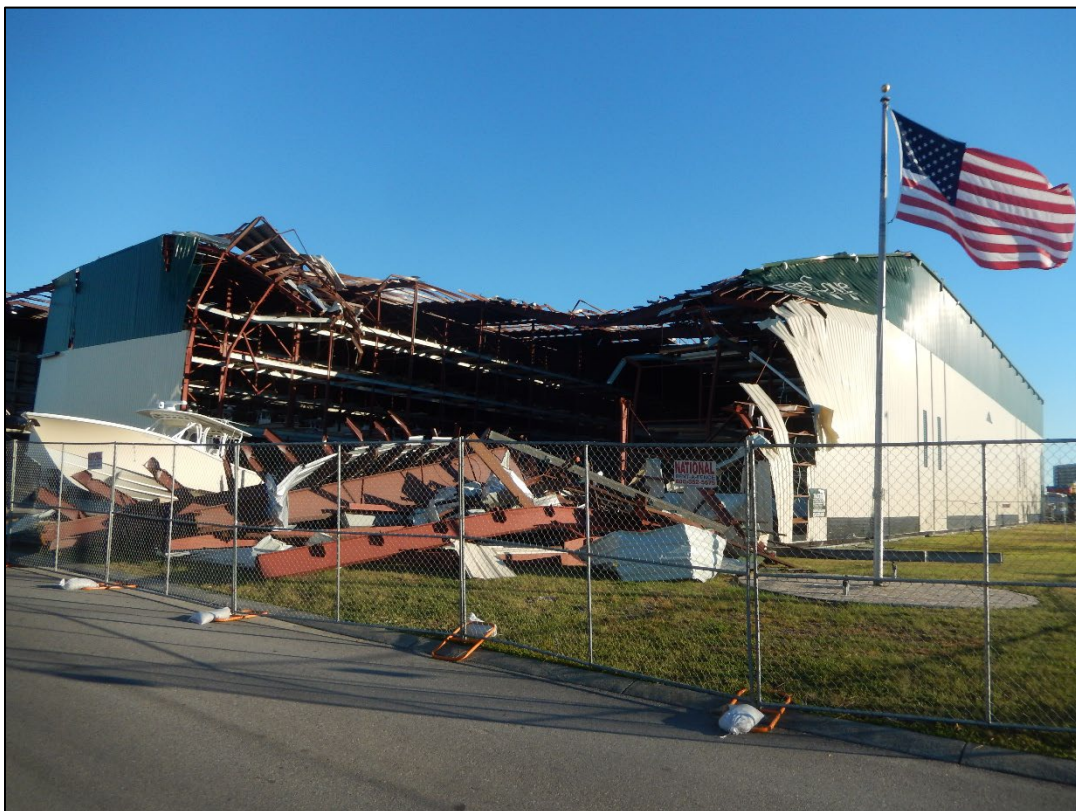
**Figure 16.** Dry storage marina with wind damage on Thomas Drive, Panama City Beach.

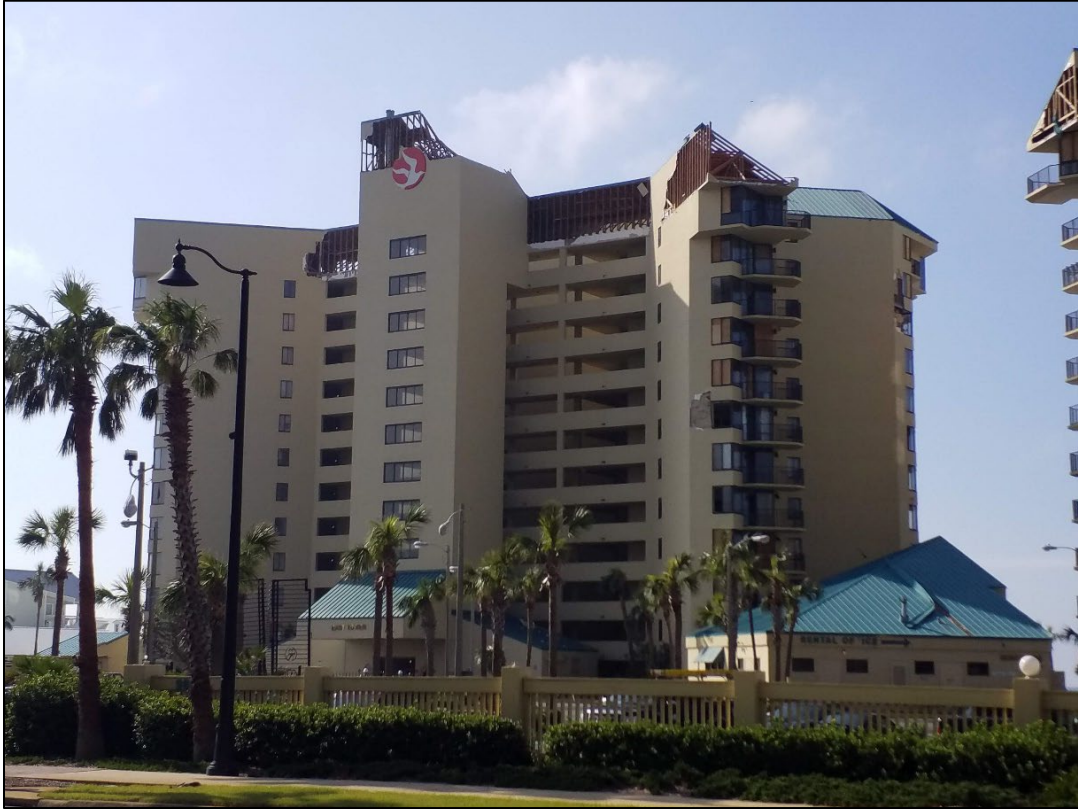
**Figure 17.** Wind damages on the Sunbird Condominiums near R67, Panama City Beach.

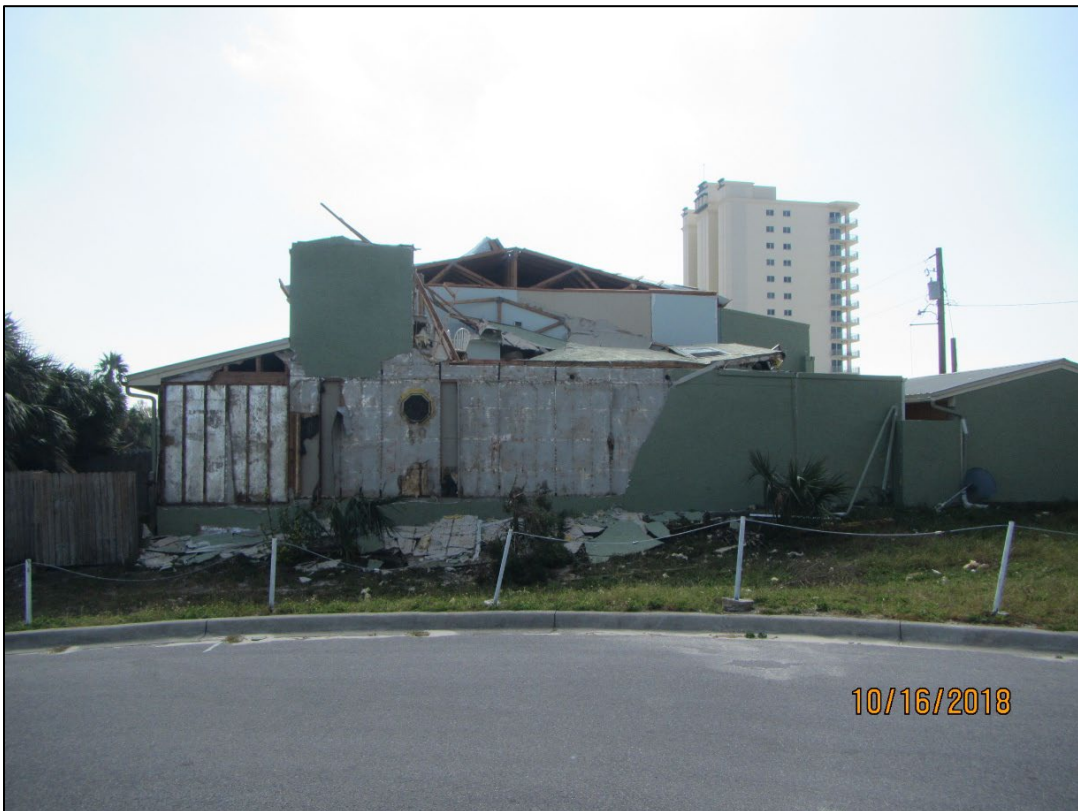
**Figure 18.** Wind damages on a multifamily dwelling near R73, Panama City Beach.

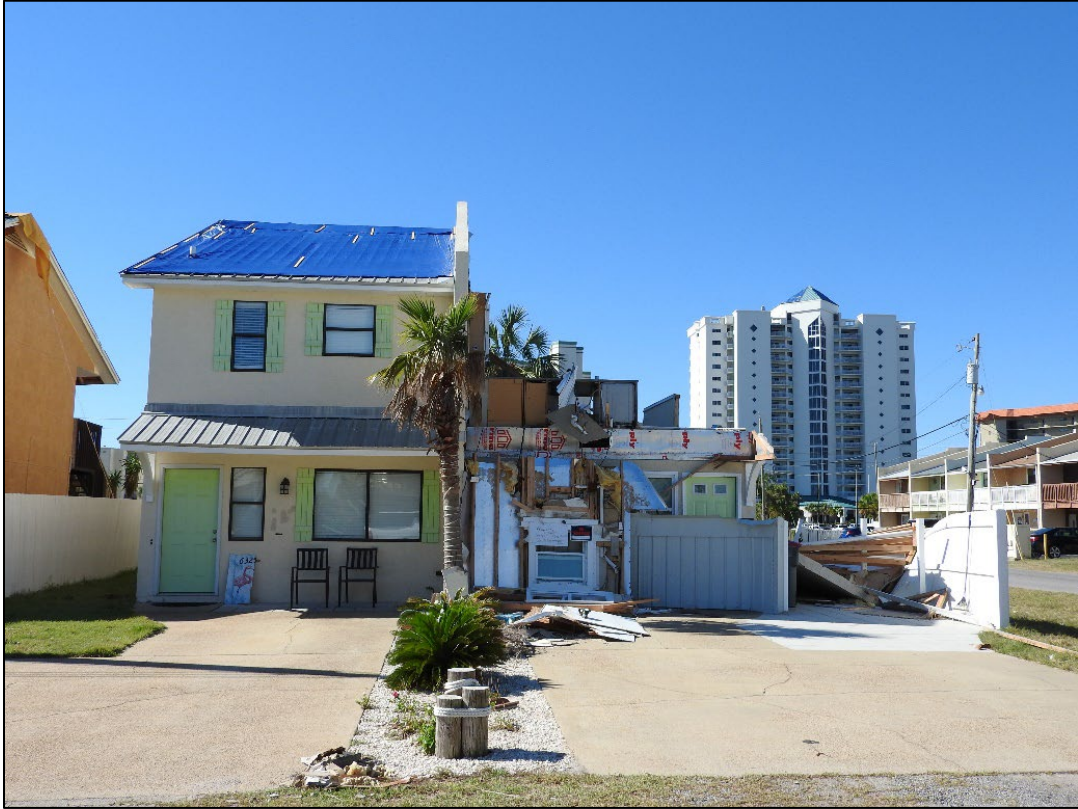
**Figure 19.** Roof damage and destroyed dwelling near R82, Panama City Beach.

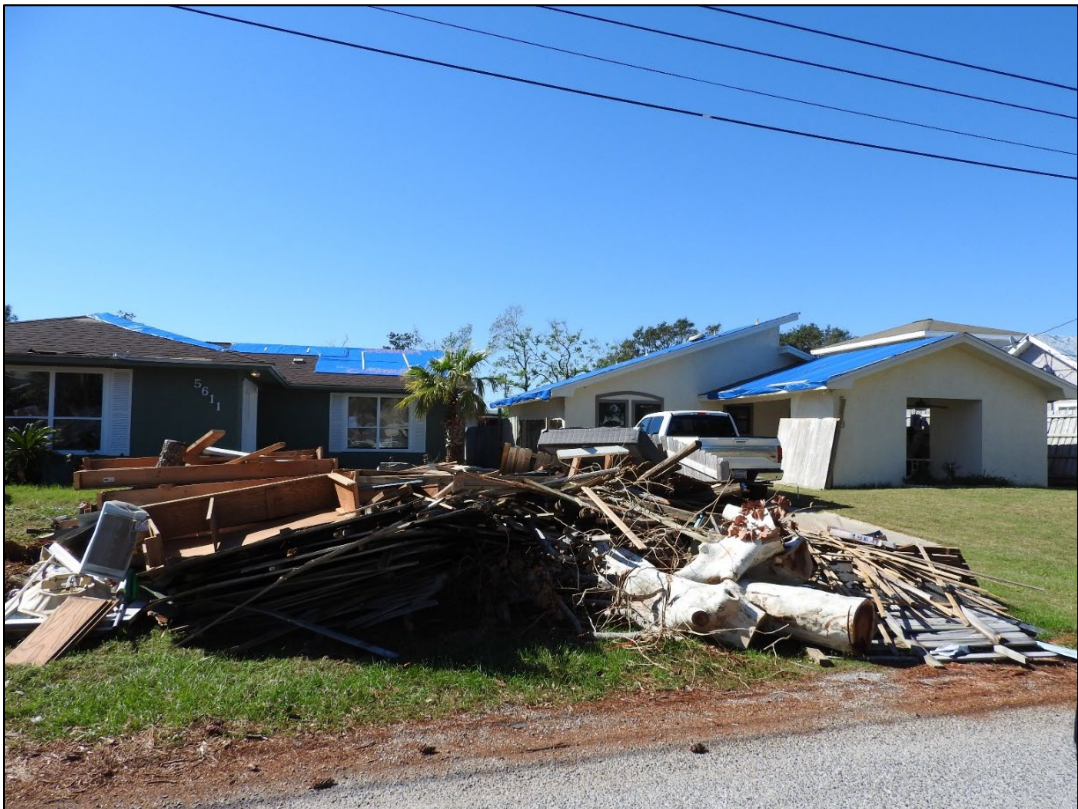
**Figure 20.** Roof damage on a single-family dwelling near R86, Panama City Beach.

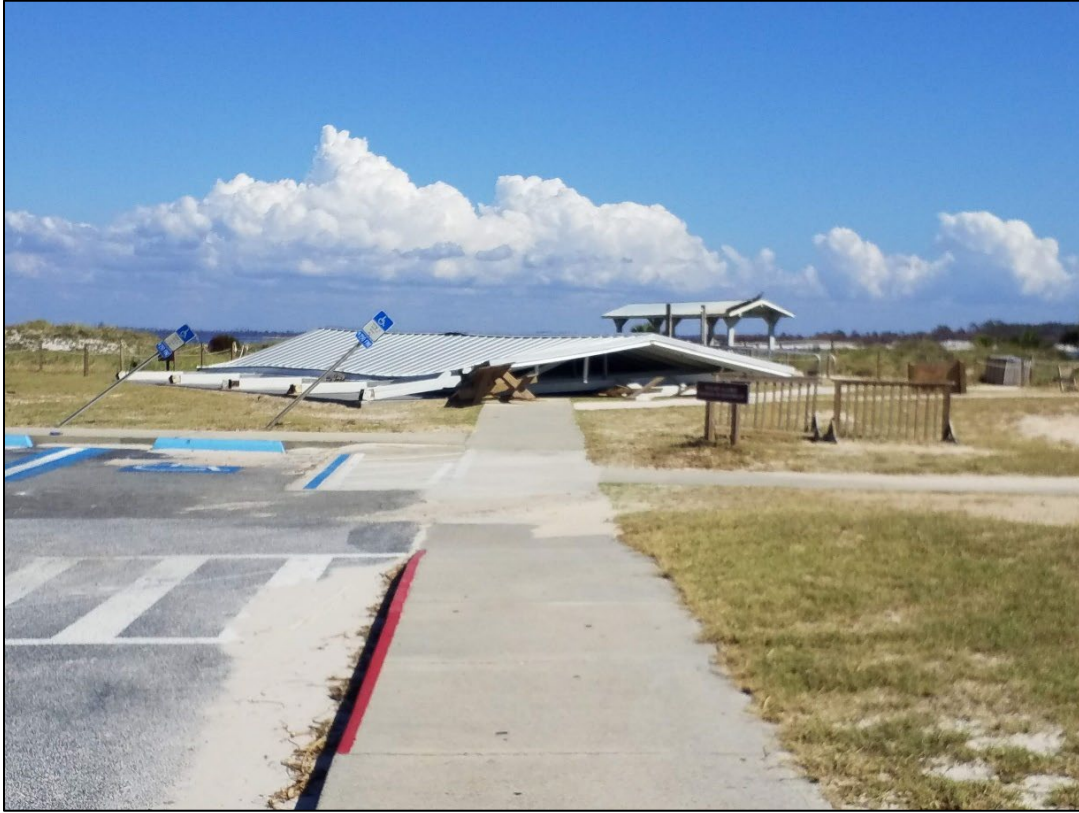
**Figure 21.** *Collapsed pavilion near R97, St. Andrews State Park.*

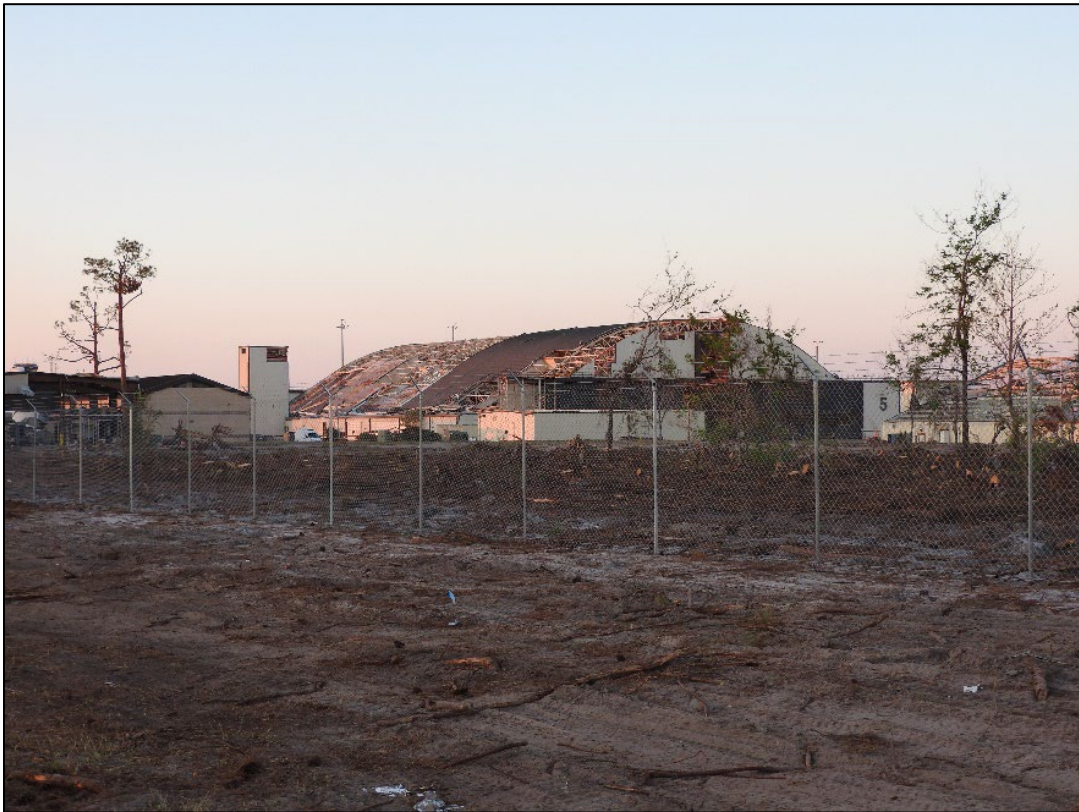
**Figure 22.** *Tyndall Air Force Base, aircraft hangar damage.*

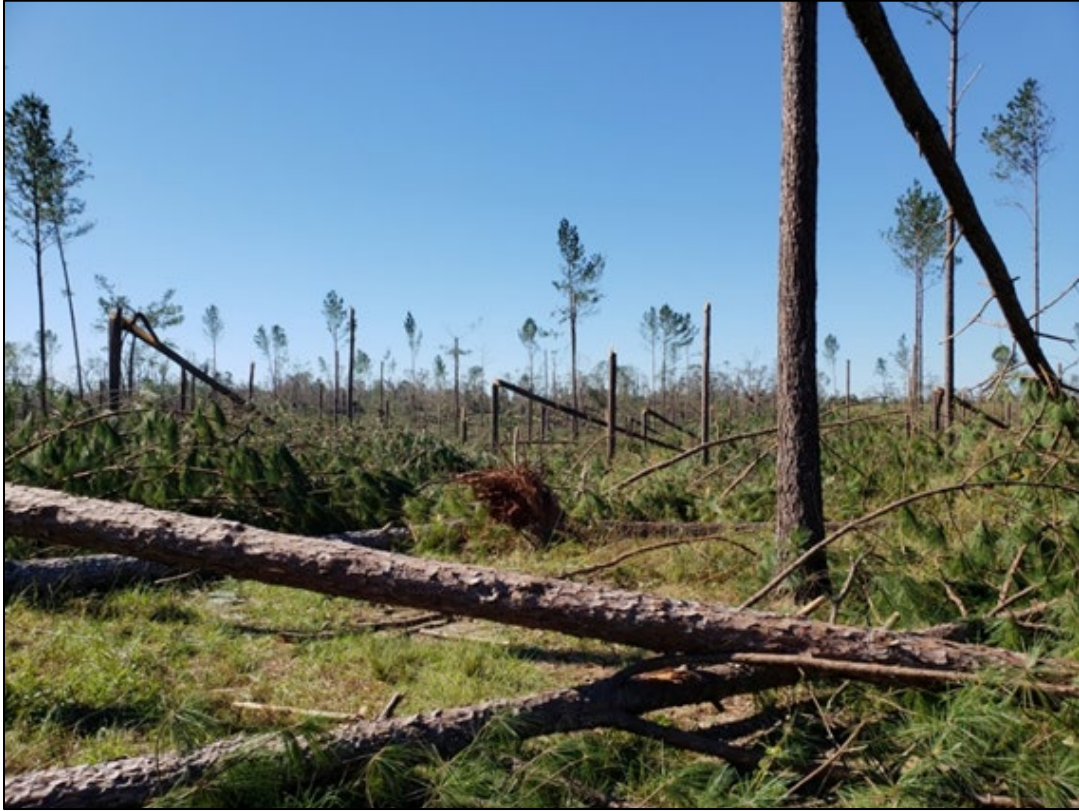
**Figure 23.** Bay County, pine forest leveled.

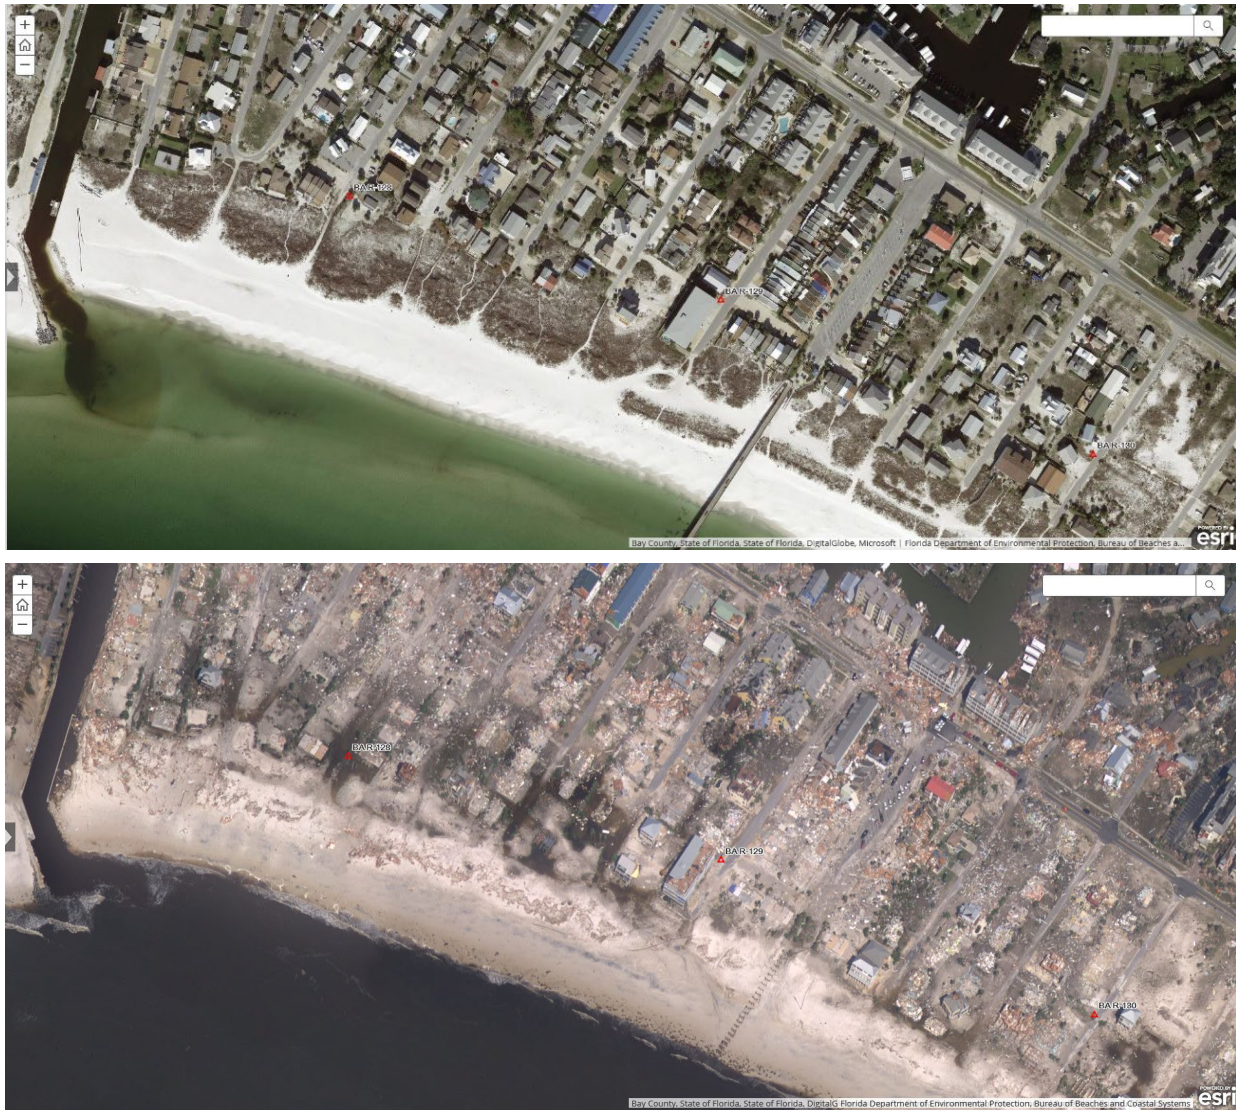
**Figure 25.** Aerial photo comparison of severe damage in Mexico Beach (R127.5-R130). Source: Vexcel Imaging/ NICB Geospatial Intelligence Center.

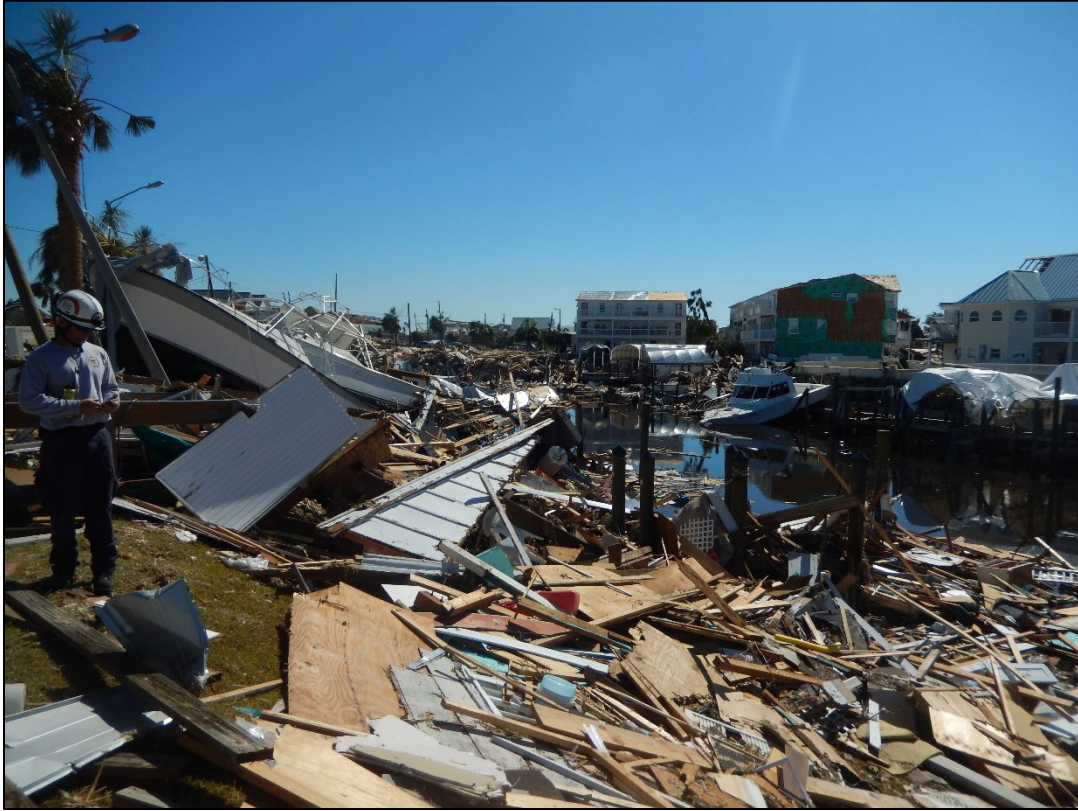
**Figure 26.** Debris and damages at Mexico Beach Canal, R127.5.

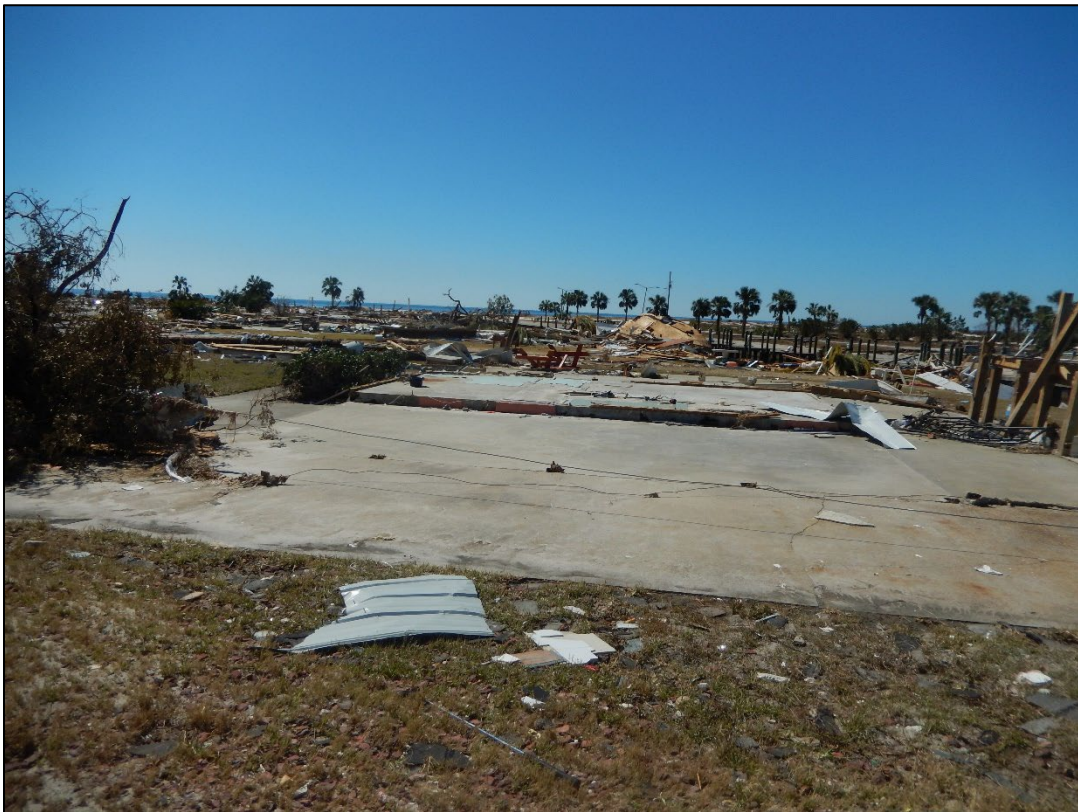
**Figure 27.** Rows of beach houses destroyed and removed by the storm surge, R127.5, Mexico Beach.

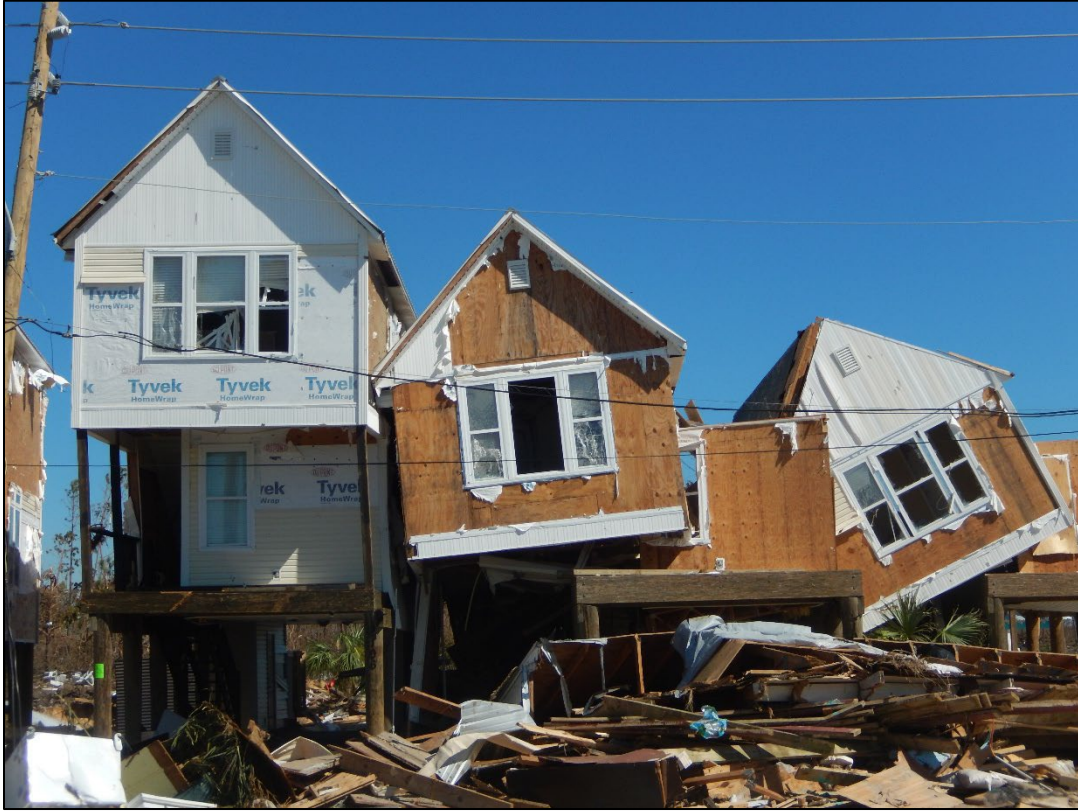
**Figure 28.** Beach dwellings north of U.S. 98 lifted off their foundations, R128, Mexico Beach.

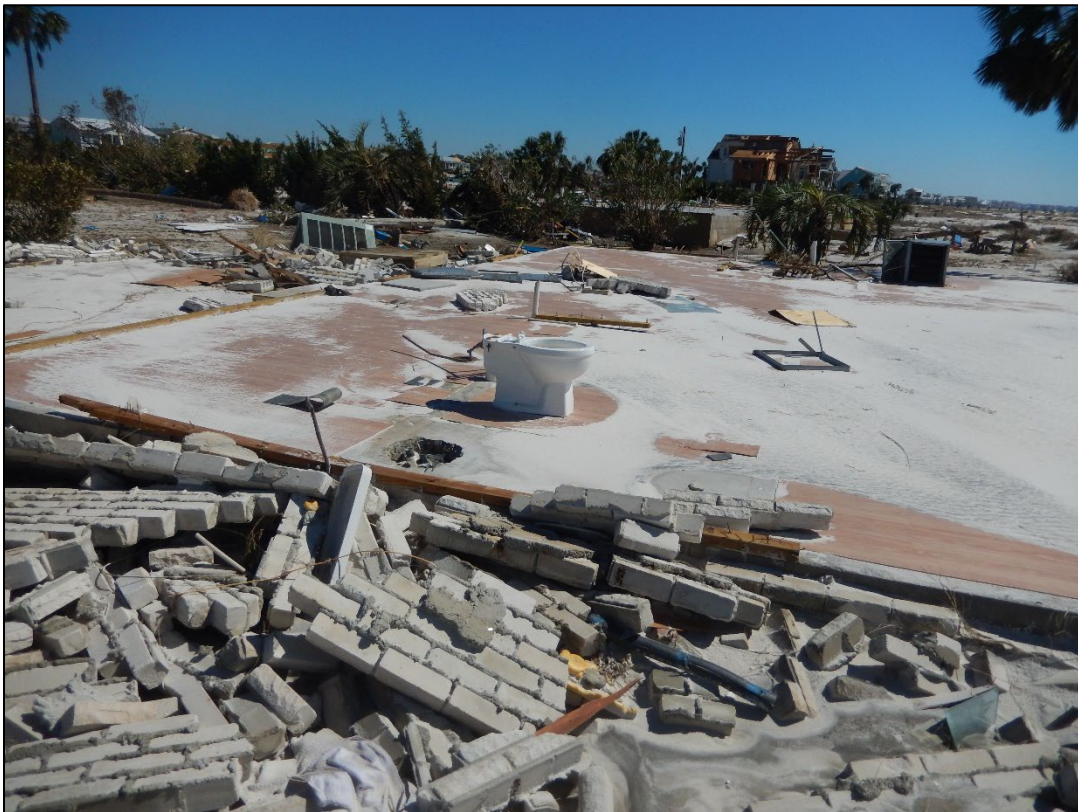
**Figure 29.** Remains of typical beach house destroyed near R128, Mexico Beach.

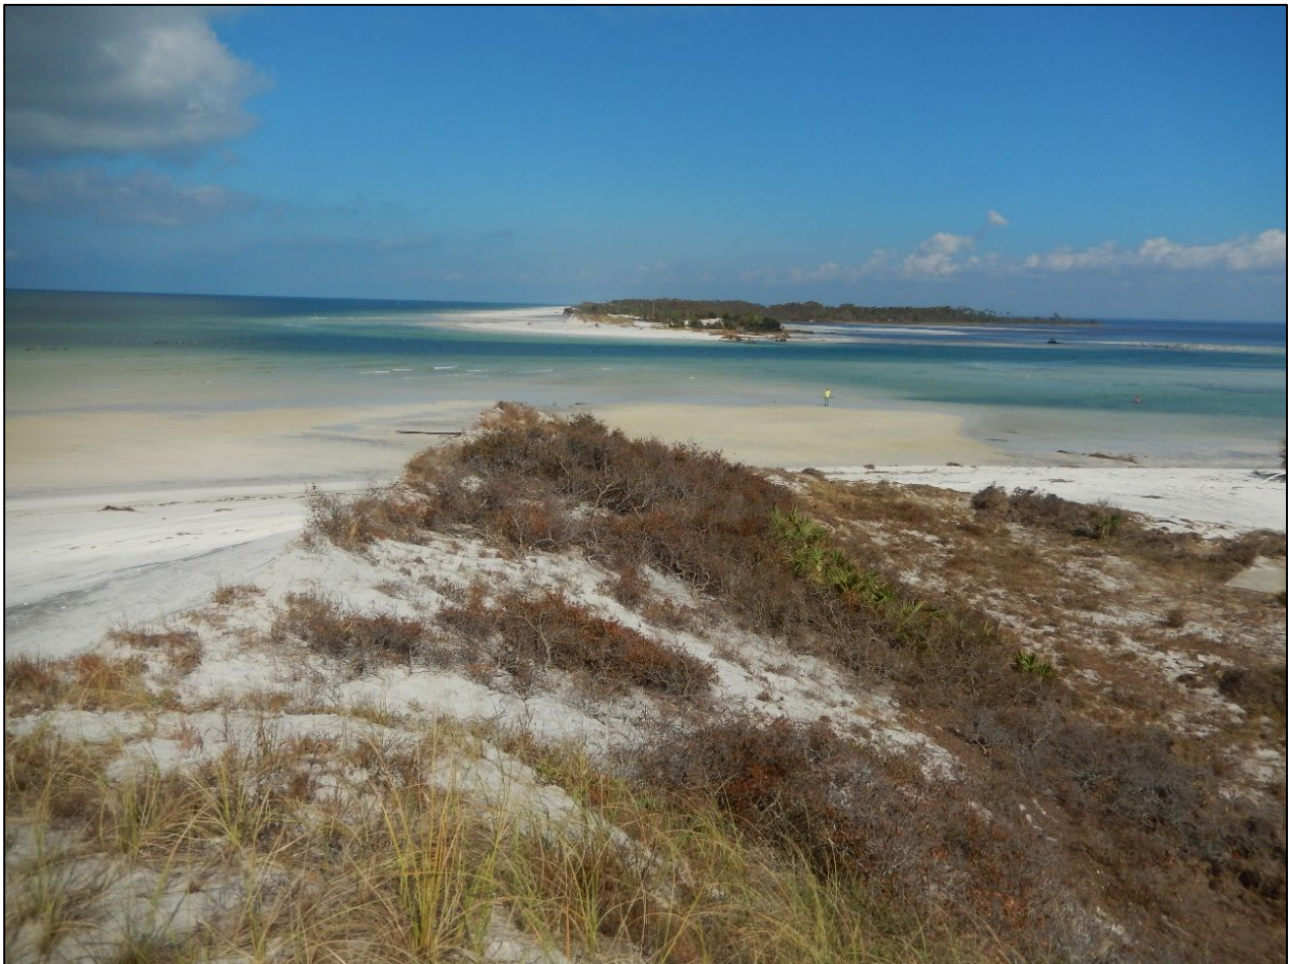
Hurricane Michael's greatest geomorphological impact to the Gulf County coast was a barrier breach near the midpoint of St. Joseph Peninsula. This breakthrough of the barrier peninsula occurred generally between R71 and R72, at a place called Eagle Harbor just north of the marina within T.H. Stone Memorial St. Joseph Peninsula State Park (**Figures 45-46**). To the north of the breach, northern St. Joseph Peninsula, now an island extending between R32 and R71, sustained a net loss of approximately one million cubic yards of beach and dune sand above MLW.

**Figure 45.** Breach across St. Joseph Peninsula between R71 and R72.

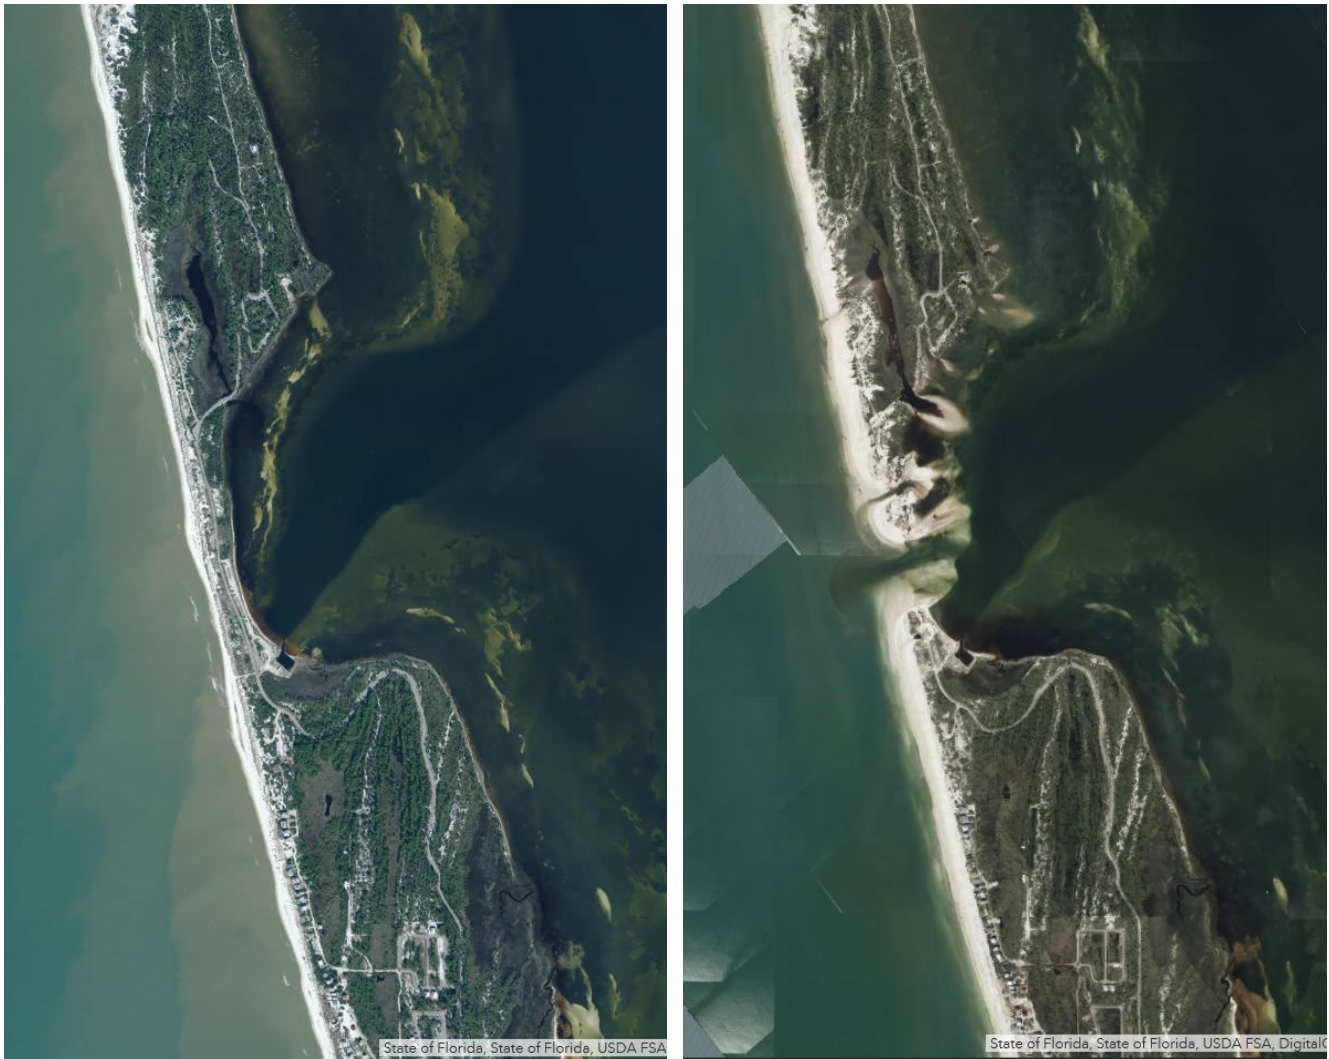
**Figure 46.** Before and after aerial photos of breach across St. Joseph Peninsula between R71 and R72 (Source: Vexcel Imaging/ NICB Geospatial Intelligence Center).

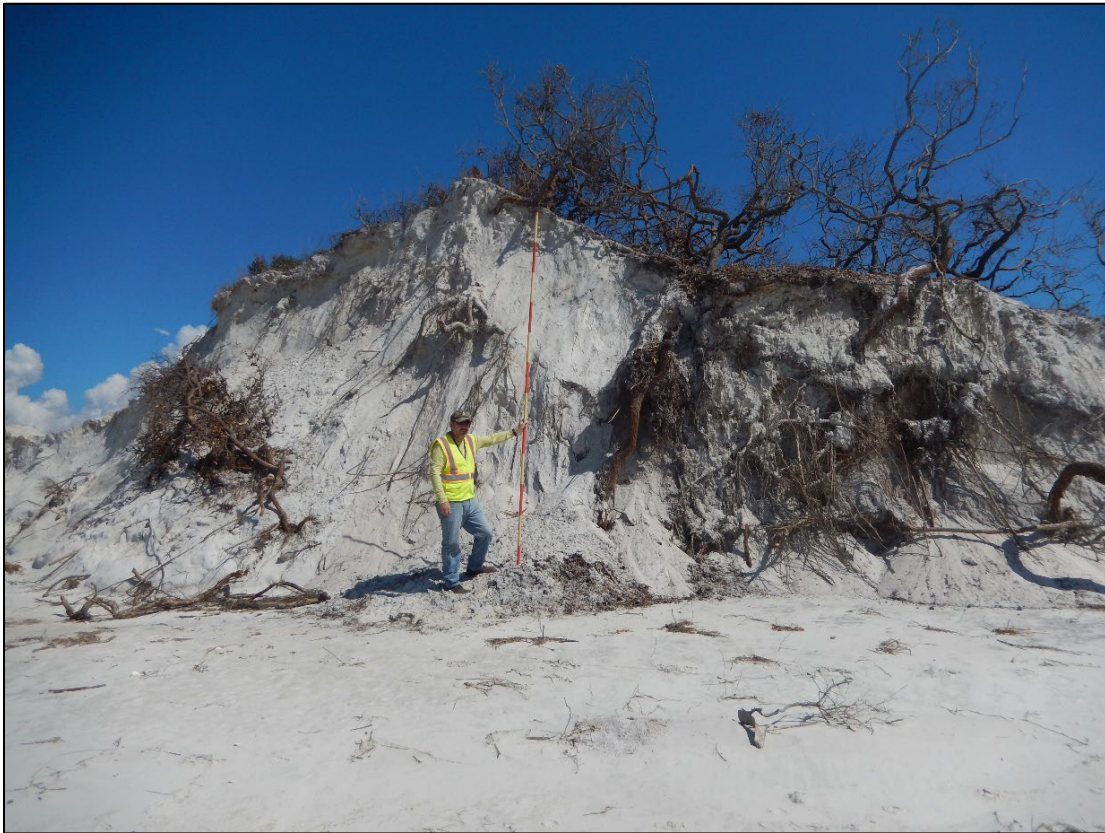
Major dune erosion at R74 within the state park is shown in **Figure 50**. Also, major dune erosion is seen looking south from R77 along the developed segment of St. Joseph Peninsula in **Figure 51**.

**Figure 50.** Major dune erosion (12-foot escarpment) near R74, St. Joseph Peninsula.

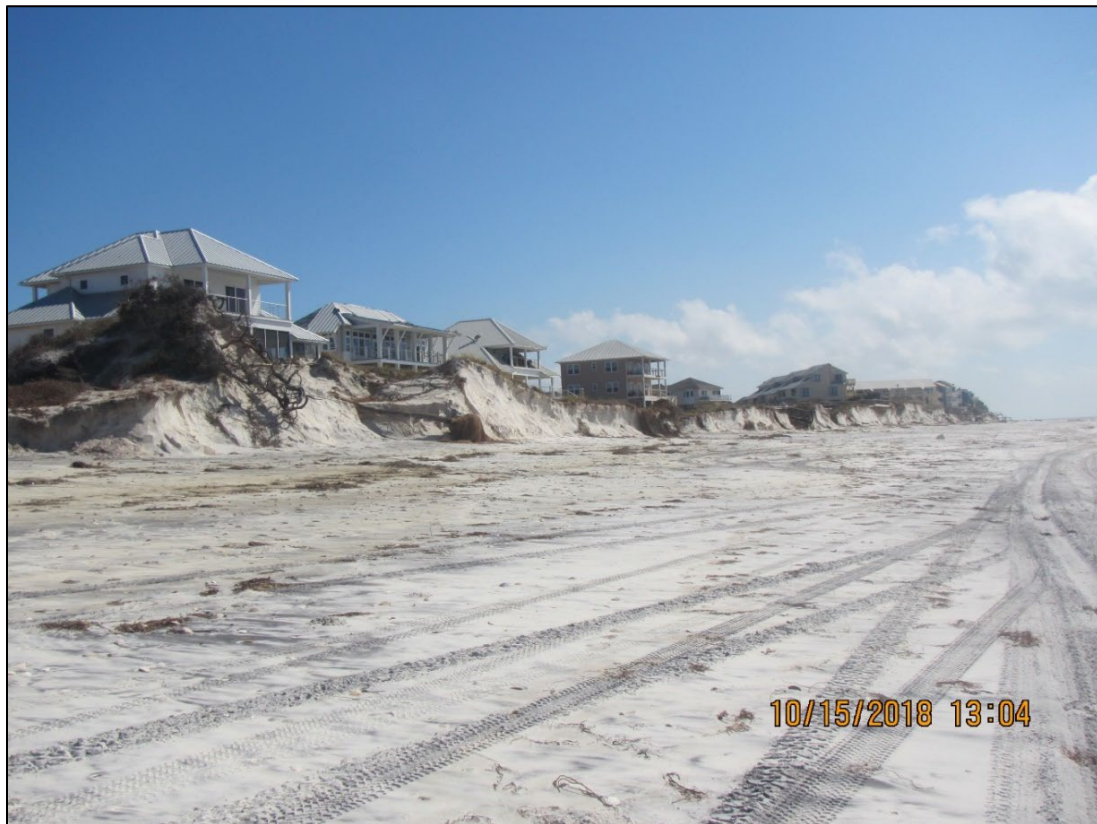
**Figure 51.** Major dune erosion, R77, St. Joseph Peninsula.

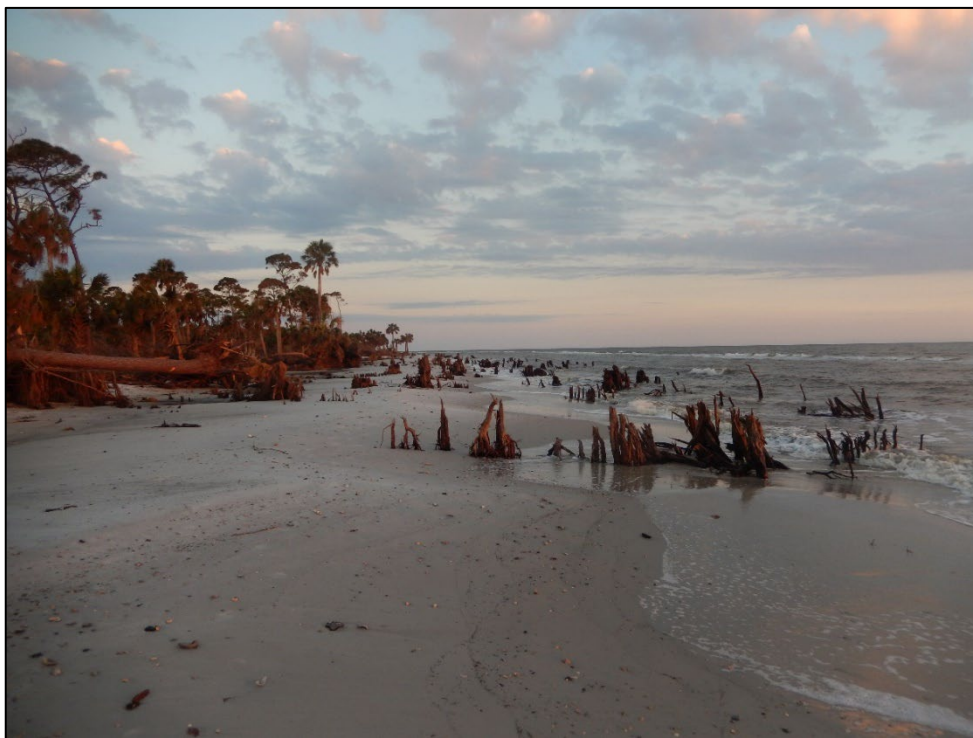
South of St. Joseph Peninsula, the west shore of Cape San Blas has a historic background erosion rate of -40 feet per year of shoreline recession. **Figure 52** shows the severe erosion conditions following Hurricane Michael near R110 at the site of the historic Cape San Blas Lighthouse, which was relocated to Port St. Joe in 2014. Another major geomorphological change to the Gulf County coast caused by Hurricane Michael was observed through the loss of approximately 660 feet off the southern tip of Cape San Blas (**Figure 53**).

**Figure 52.** Severe beach and dune erosion at Cape San Blas, R110.

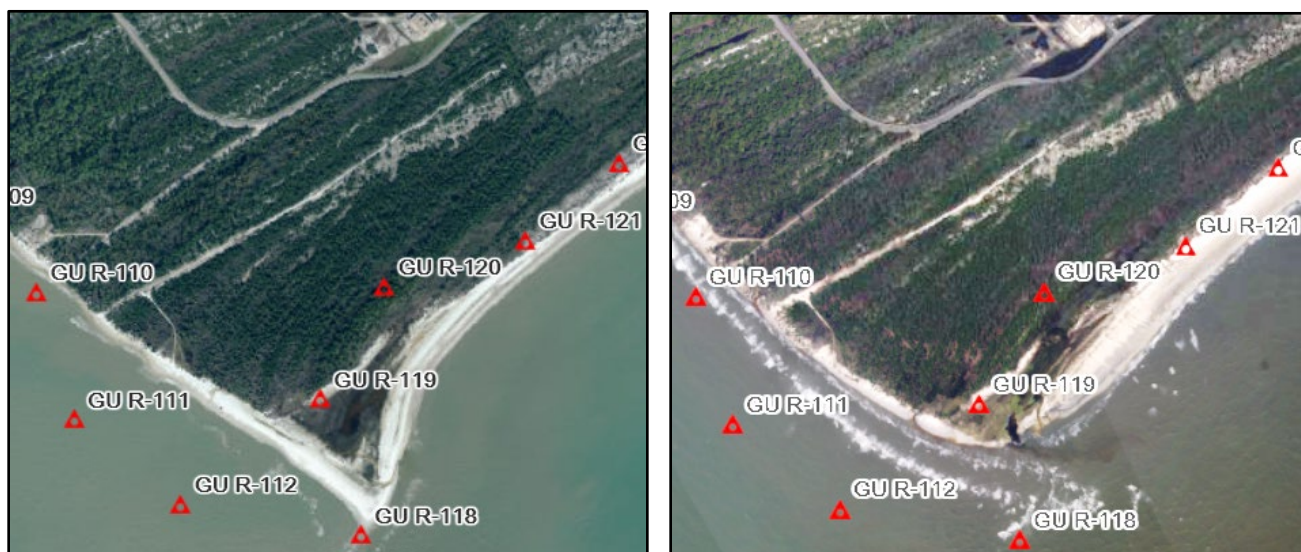
**Figure 53.** Before and after aerial photos of Cape San Blas showing the loss of 660 feet off the cape at R118. (Source: Vexcel Imaging/ NICB Geospatial Intelligence Center)
