*Hurricane Michael Post-Storm  
Beach Conditions and Coastal Impact Report*

**Division of Water Resource Management  
Florida Department of Environmental Protection**

**January 2019  
(Revised April 2019)**

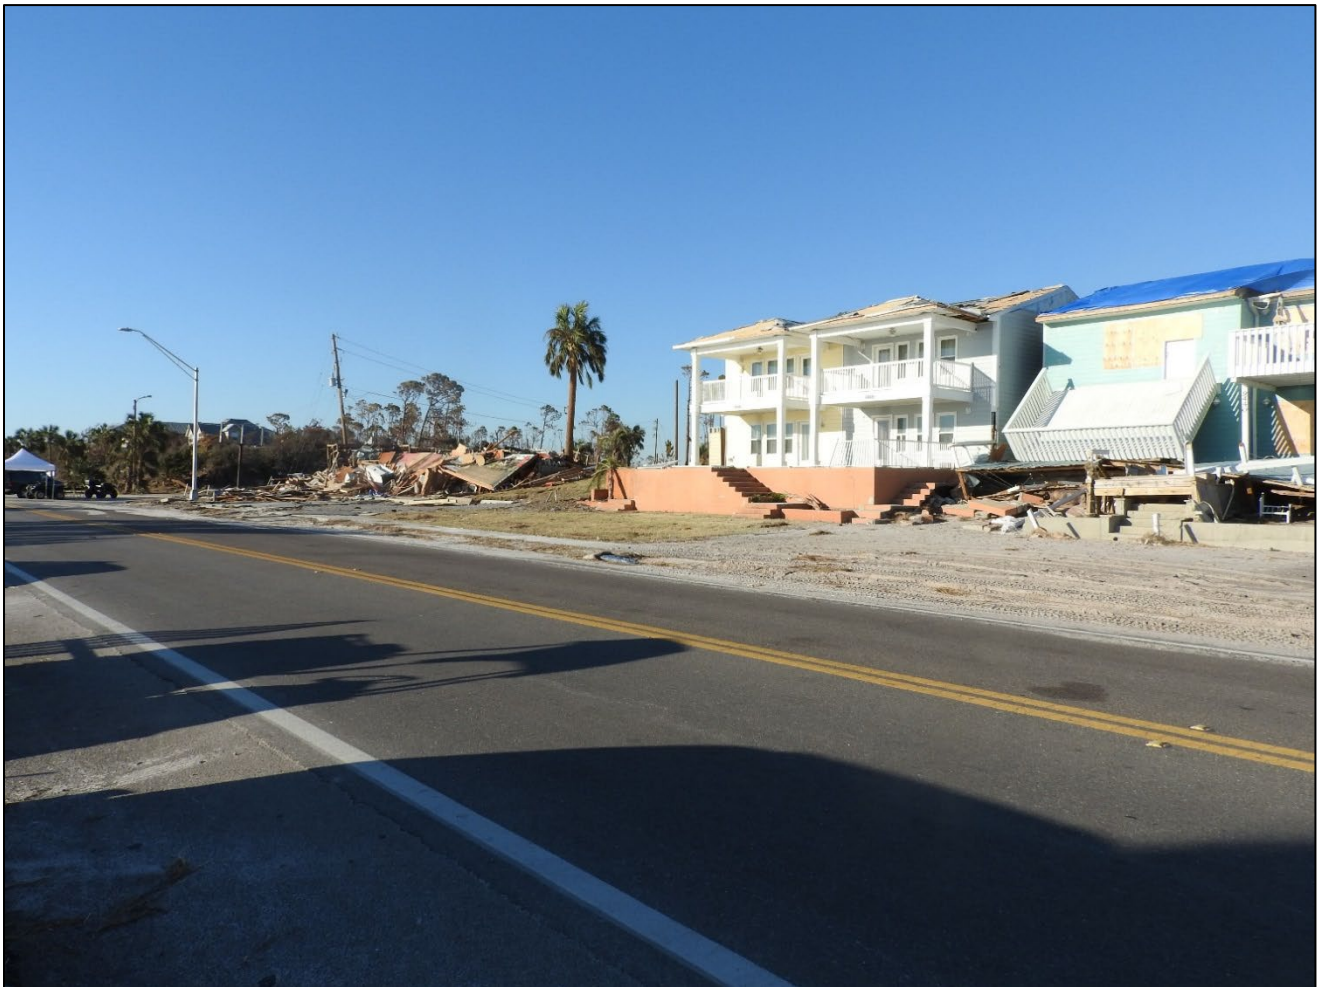
**Figure 54.** Site of high water mark of +21.2 feet NAVD along U.S. 98 and S.R. 386 near R1, Beacon Hill.

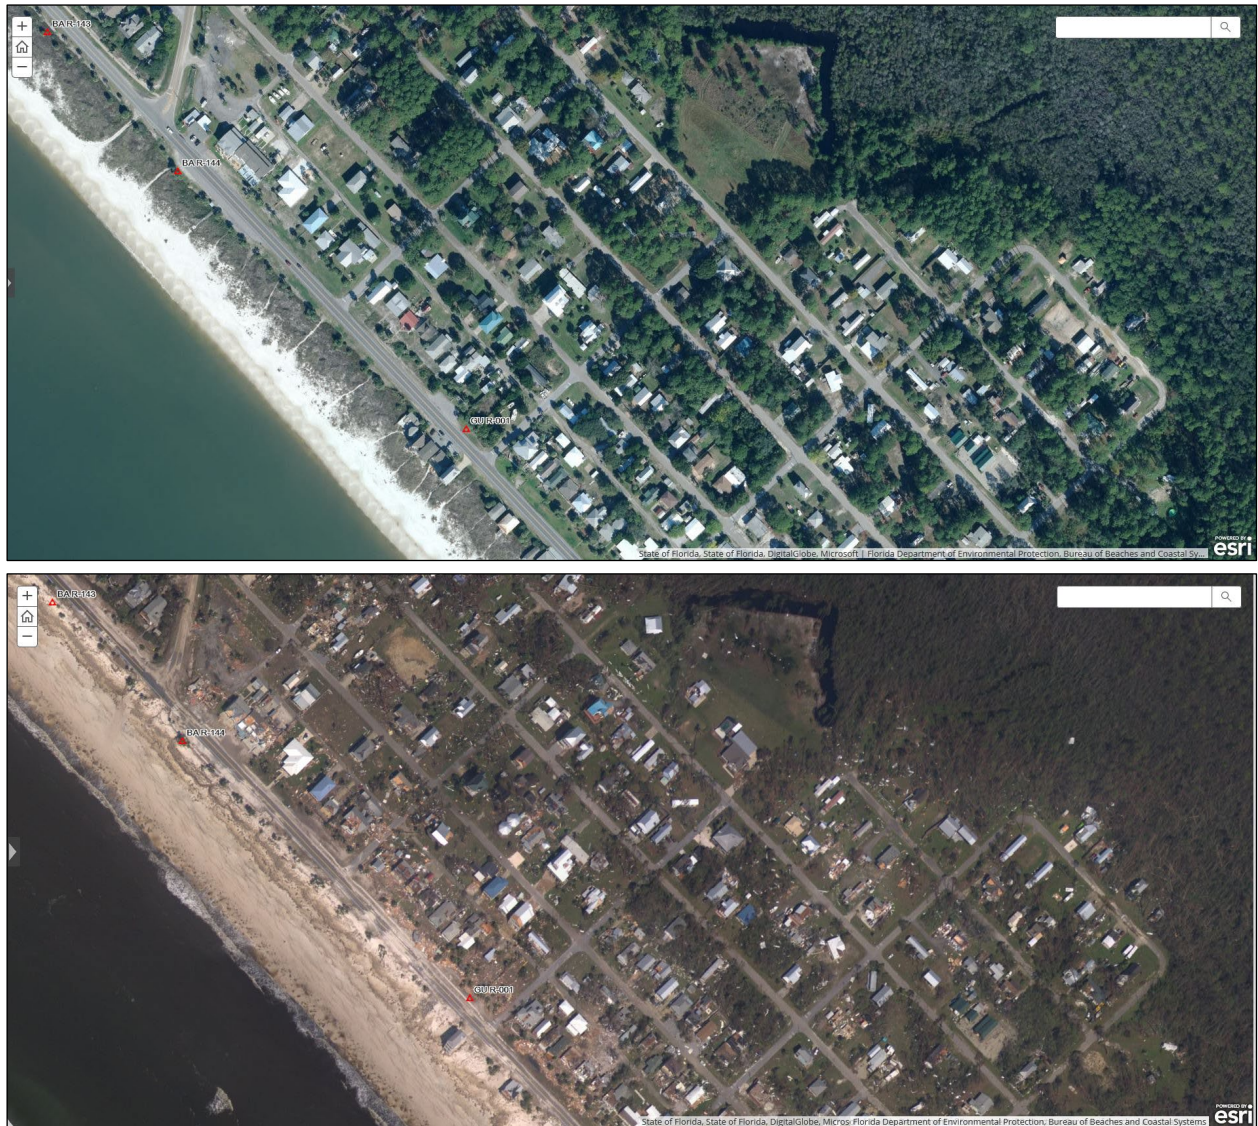
**Figure 55.** Before and after aerial photo comparison in Beacon Hill (RI). Source: Vexcel Imaging/ NICB Geospatial Intelligence Center.

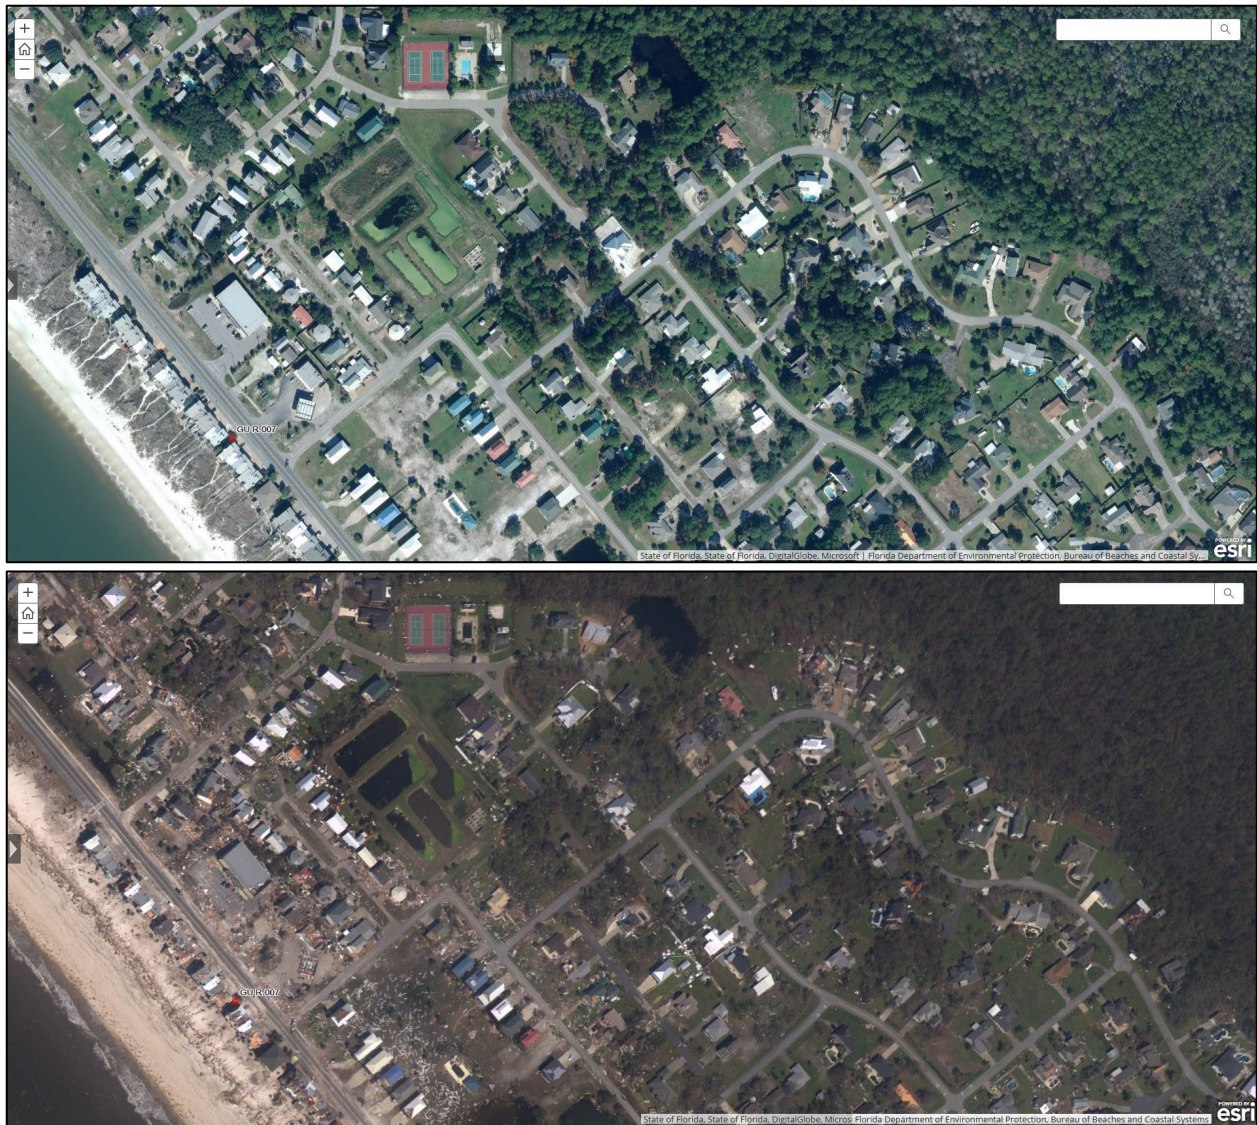
**Figure 60.** Aerial photo comparison in Beacon Hill (R7). Source: Vexcel Imaging/ NICB Geospatial Intelligence Center.

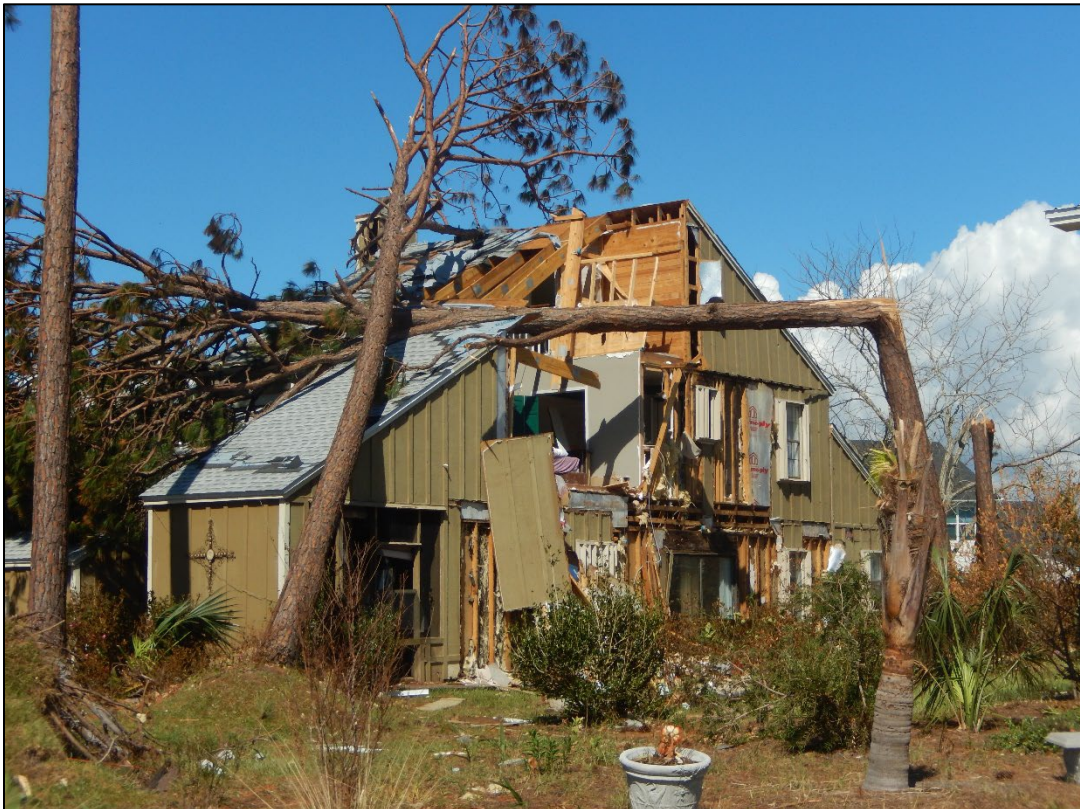
*Figure 62. Major damage to dwelling due to high winds and fallen trees, Beacon Hill.*

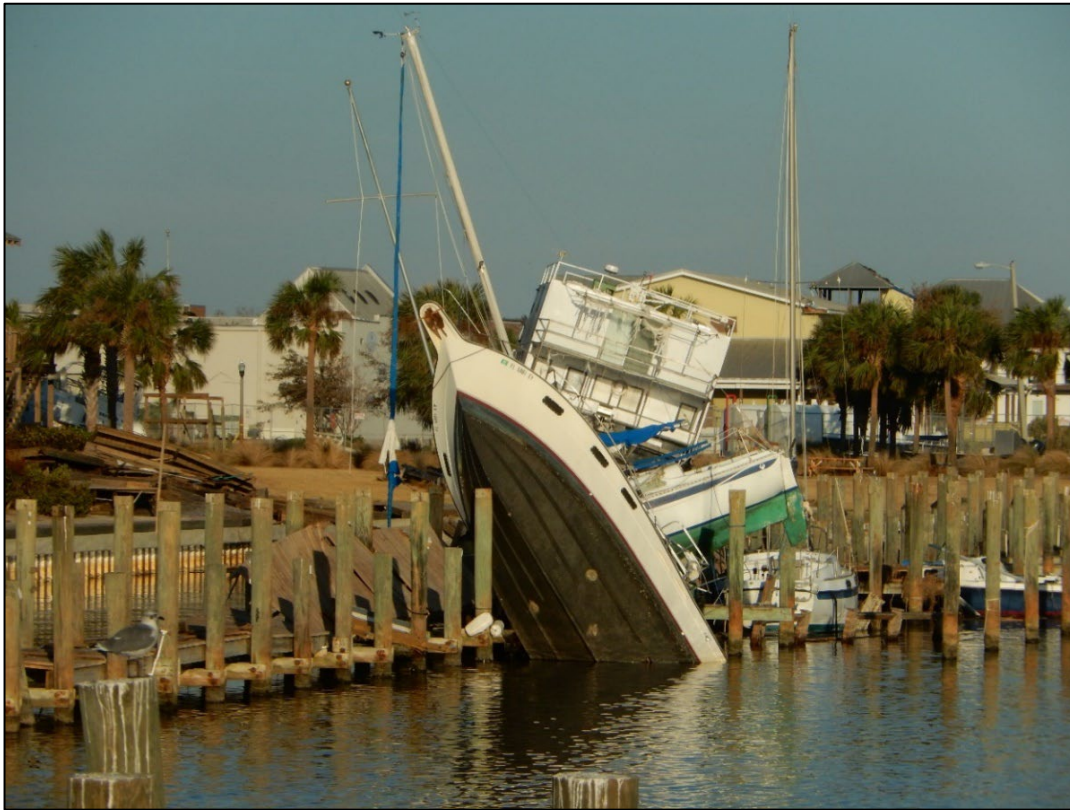
**Figure 63.** Marina damage due to the storm surge, Port St. Joe.

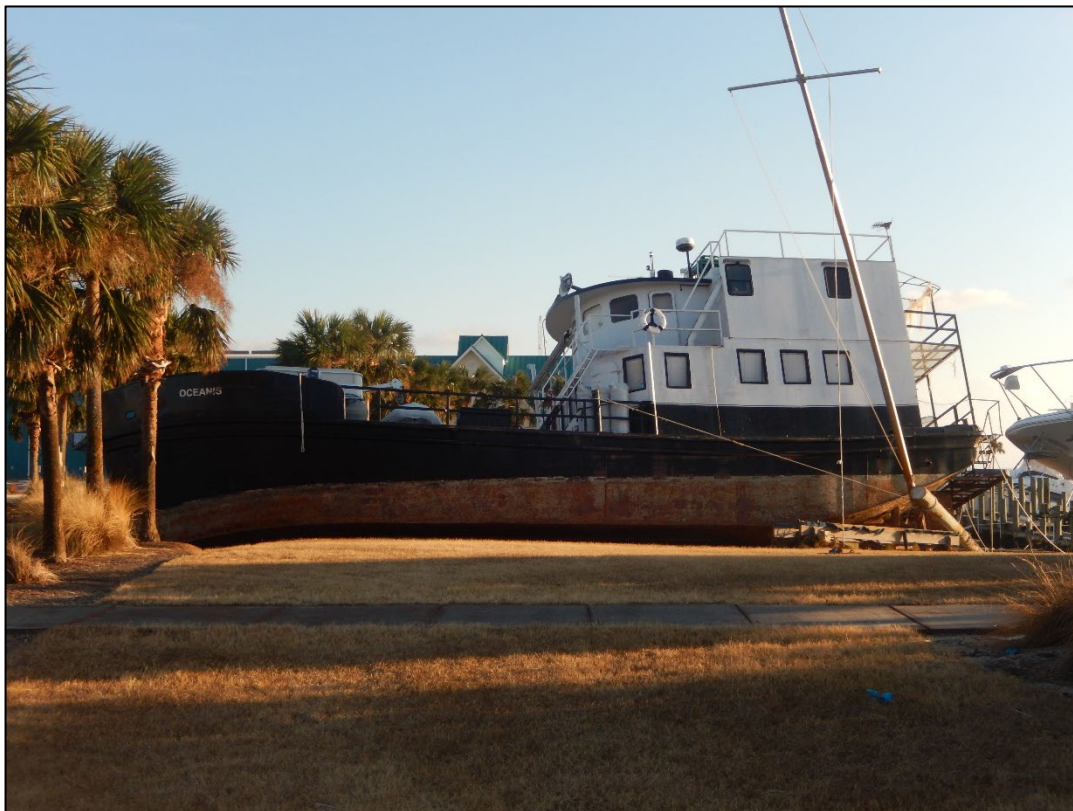
**Figure 64.** Ship carried onto upland by the storm surge, Port St. Joe.

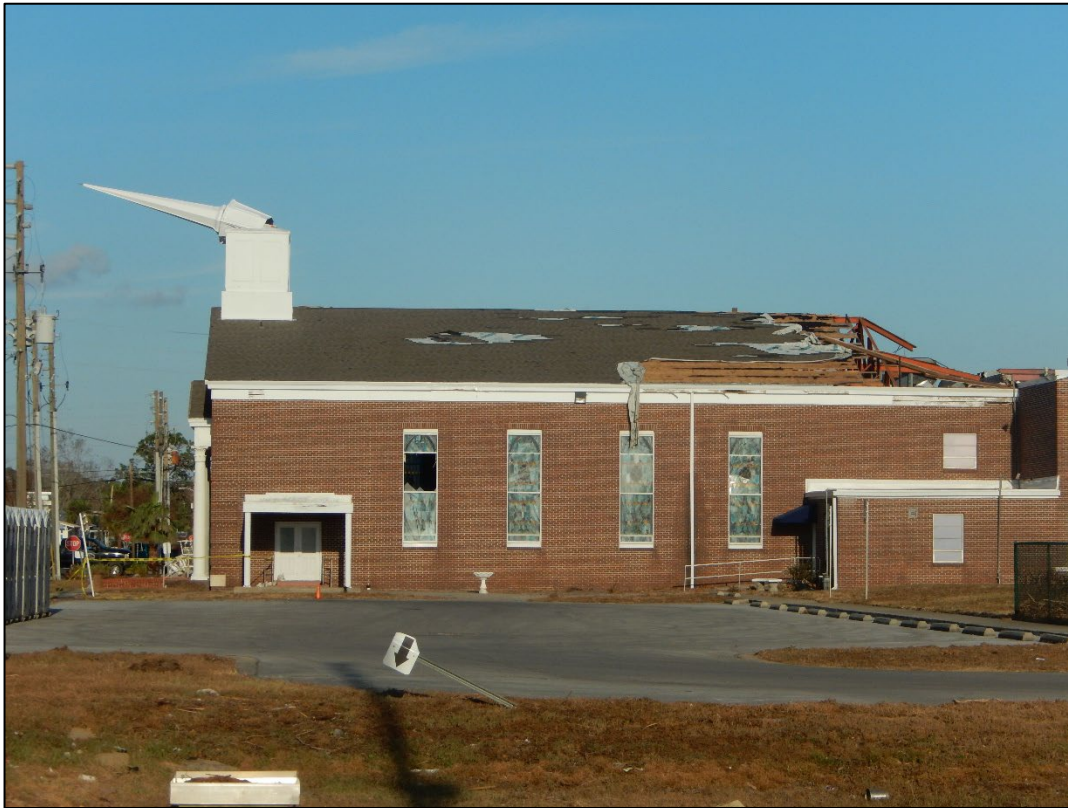
*Figure 65. First Baptist Church with major wind damage, Port St. Joe.*

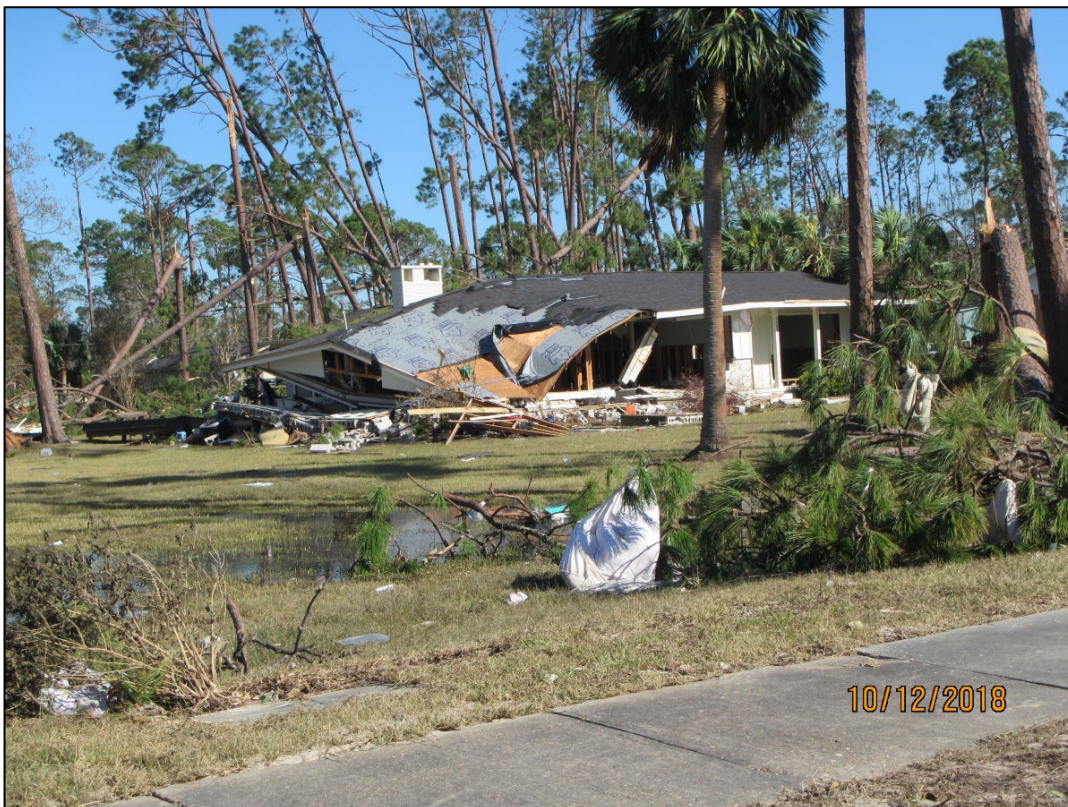
*Figure 66. Dwelling destroyed by the storm surge from St. Joseph Bay, Port St. Joe.*

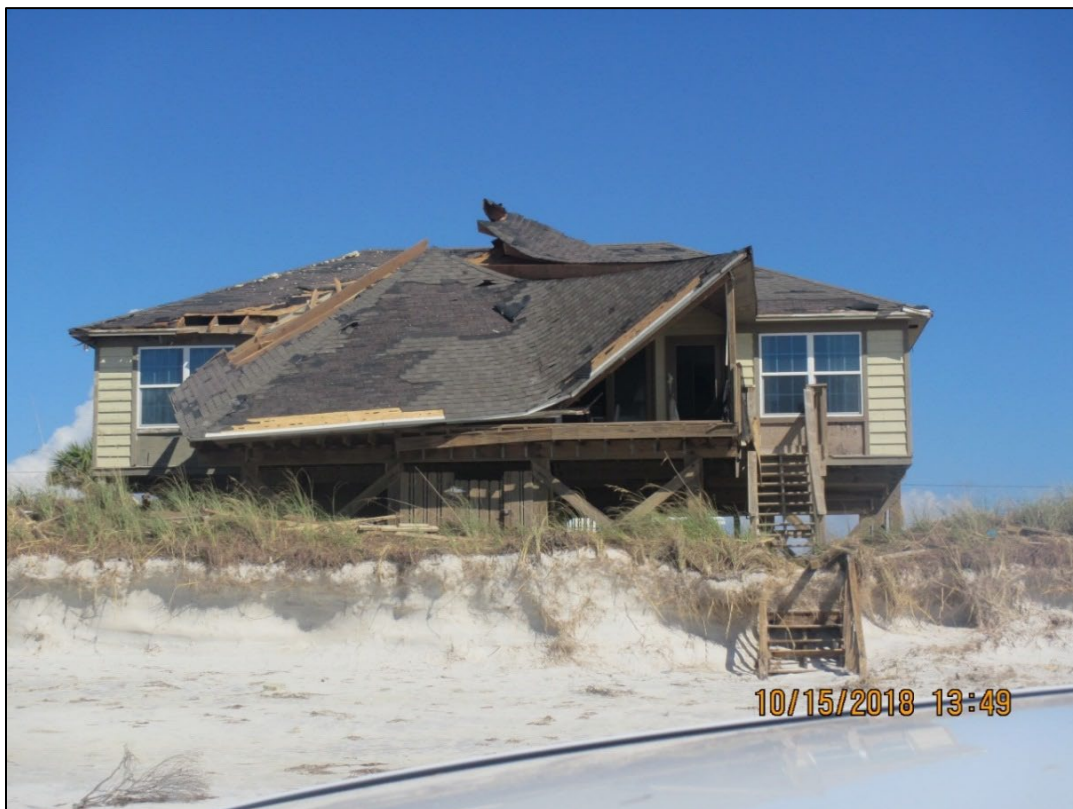
**Figure 68.** Major roof damage due to high winds near R85, St. Joseph Peninsula.

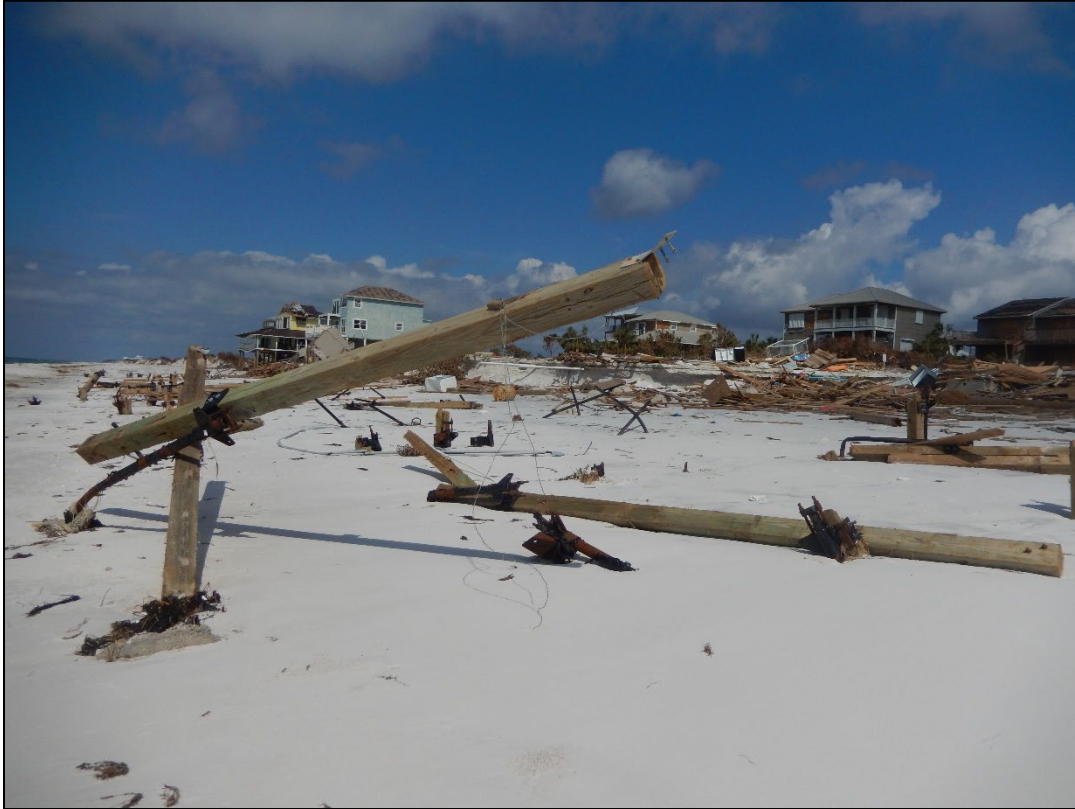
**Figure 69.** *Remains of four destroyed townhouse buildings on Nassau Lane near R90.5, St. Joseph Peninsula.*

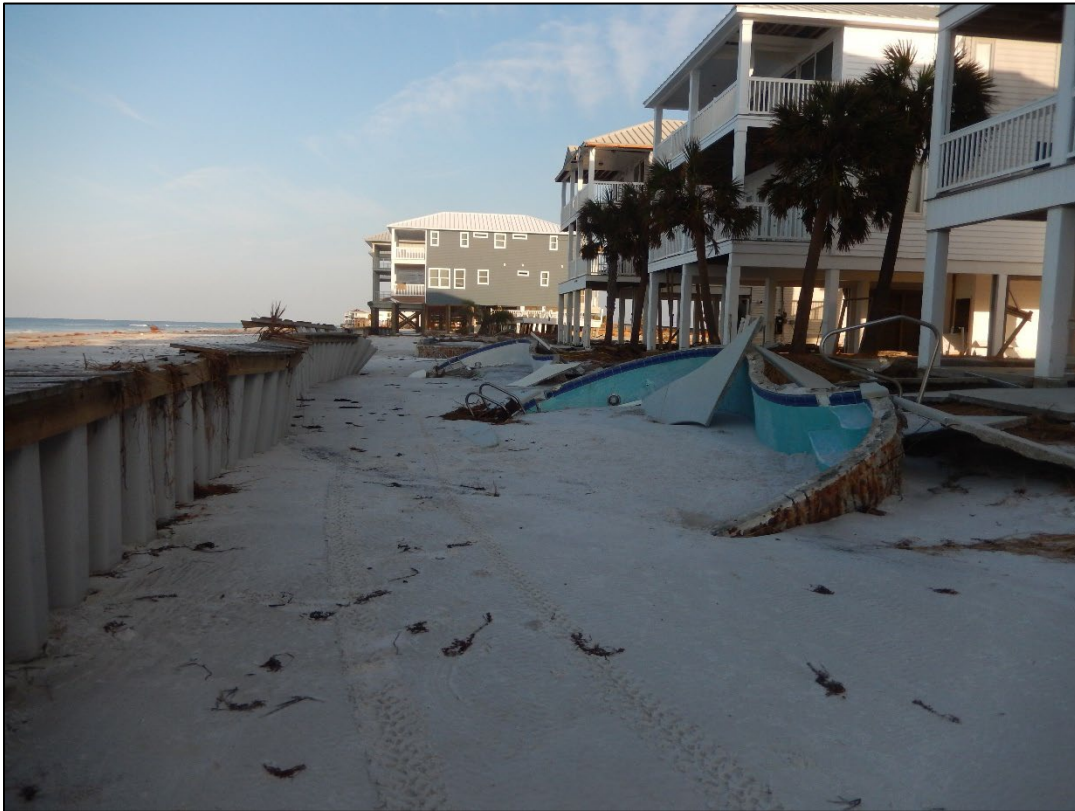
**Figure 73.** Major damage to bulkheads and swimming pools near R104.

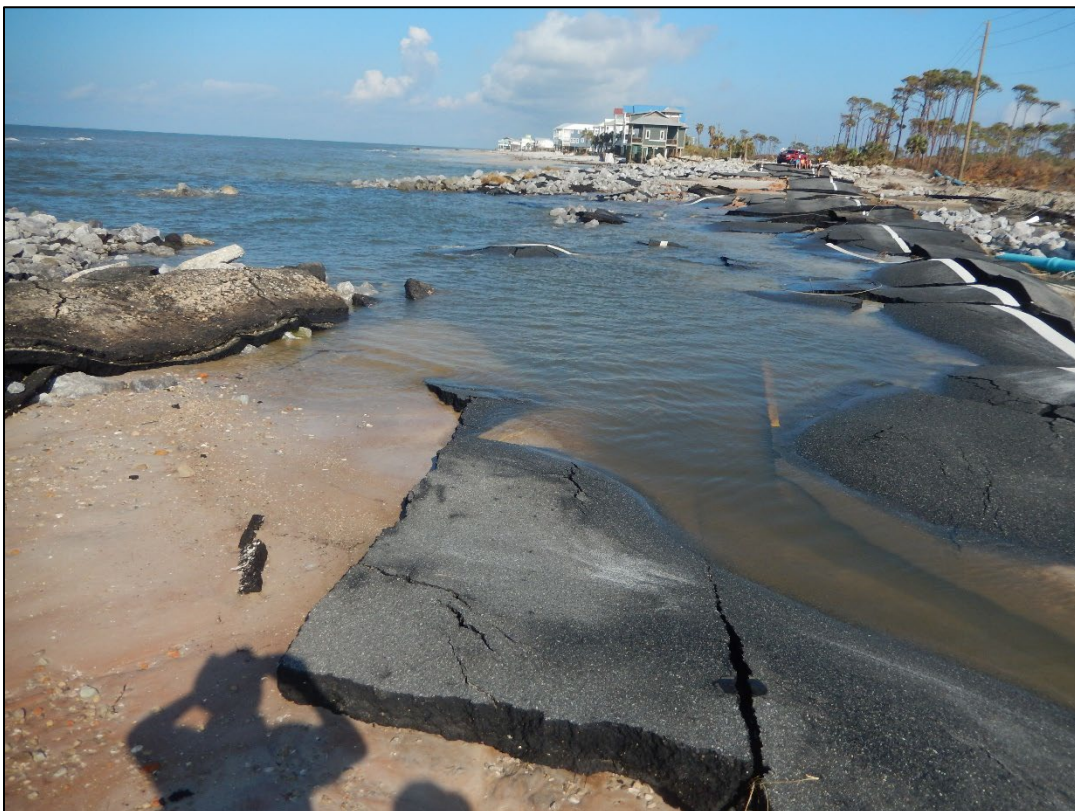
**Figure 74.** County Road 30E destroyed north of the Stump Hole boulder mound, R105.

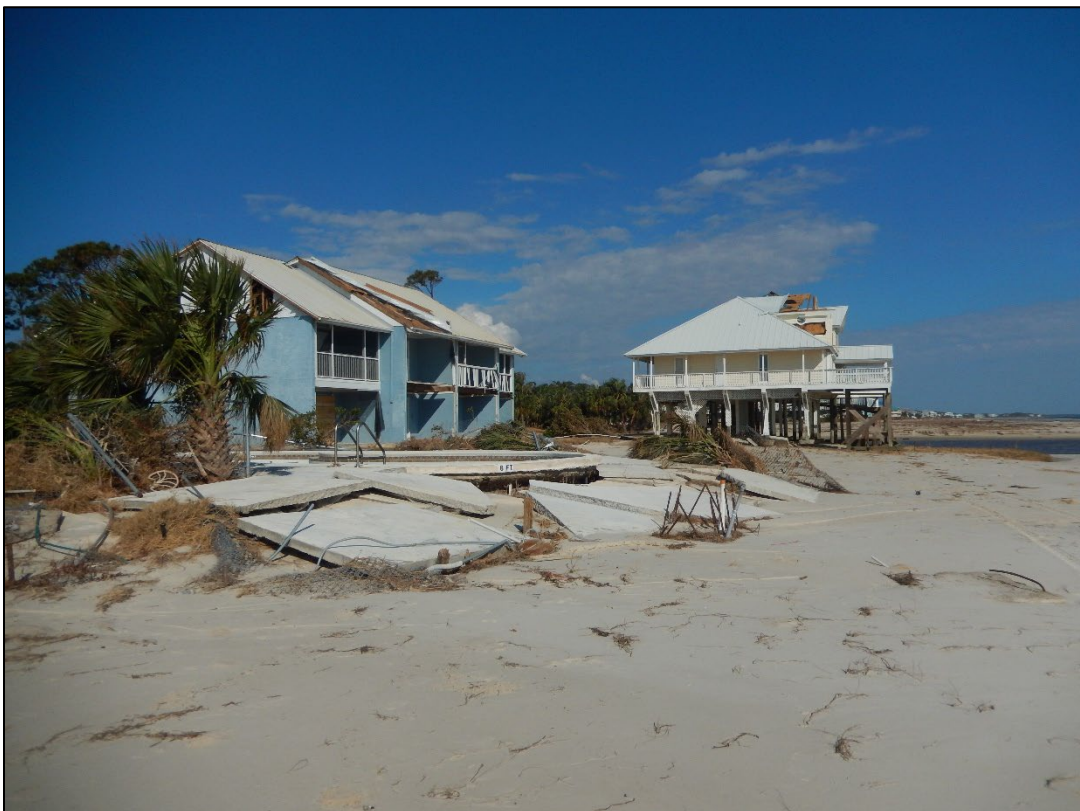
**Figure 76.** Storm surge damages at Money Bayou, R140.

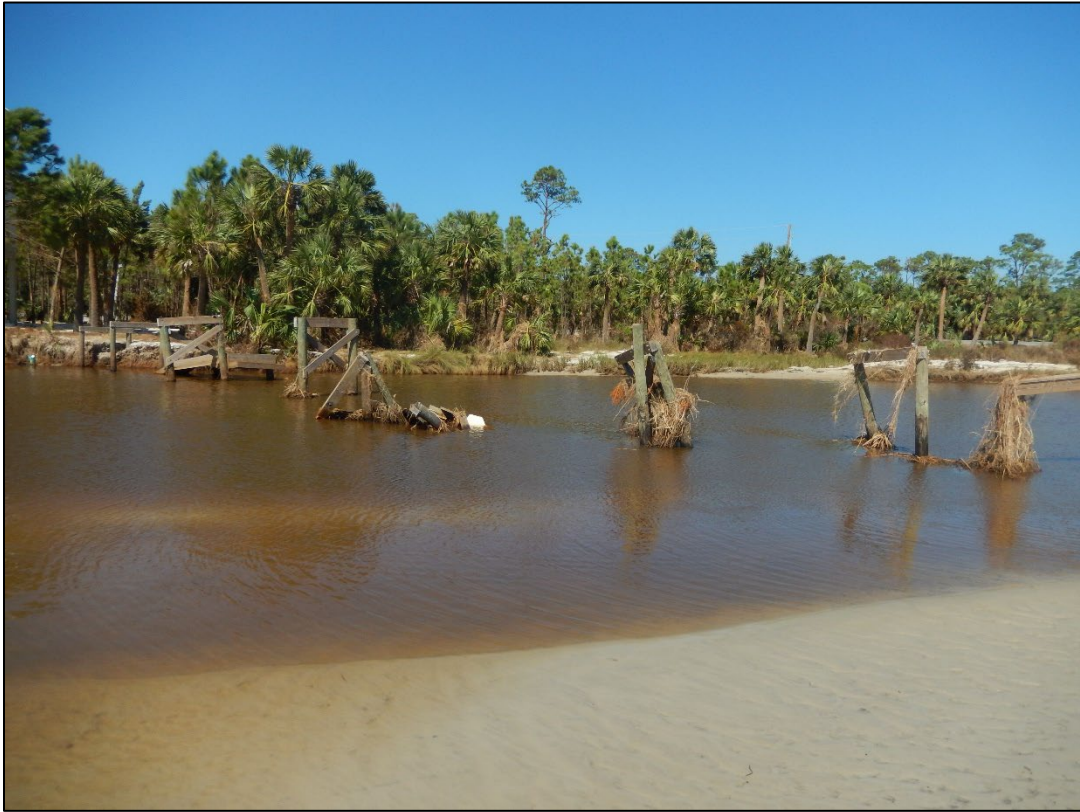
**Figure 77.** Bridge destroyed across Money Bayou, R140.5.

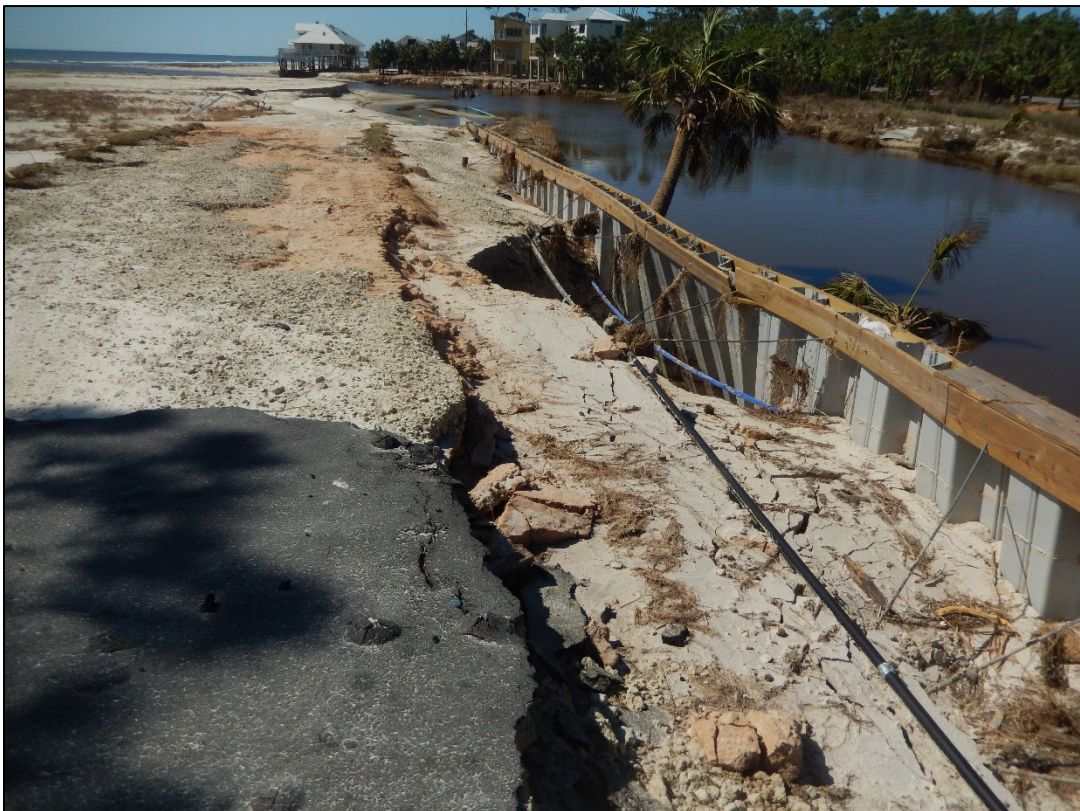
**Figure 78.** Bulkhead on Money Bayou damaged, R141.

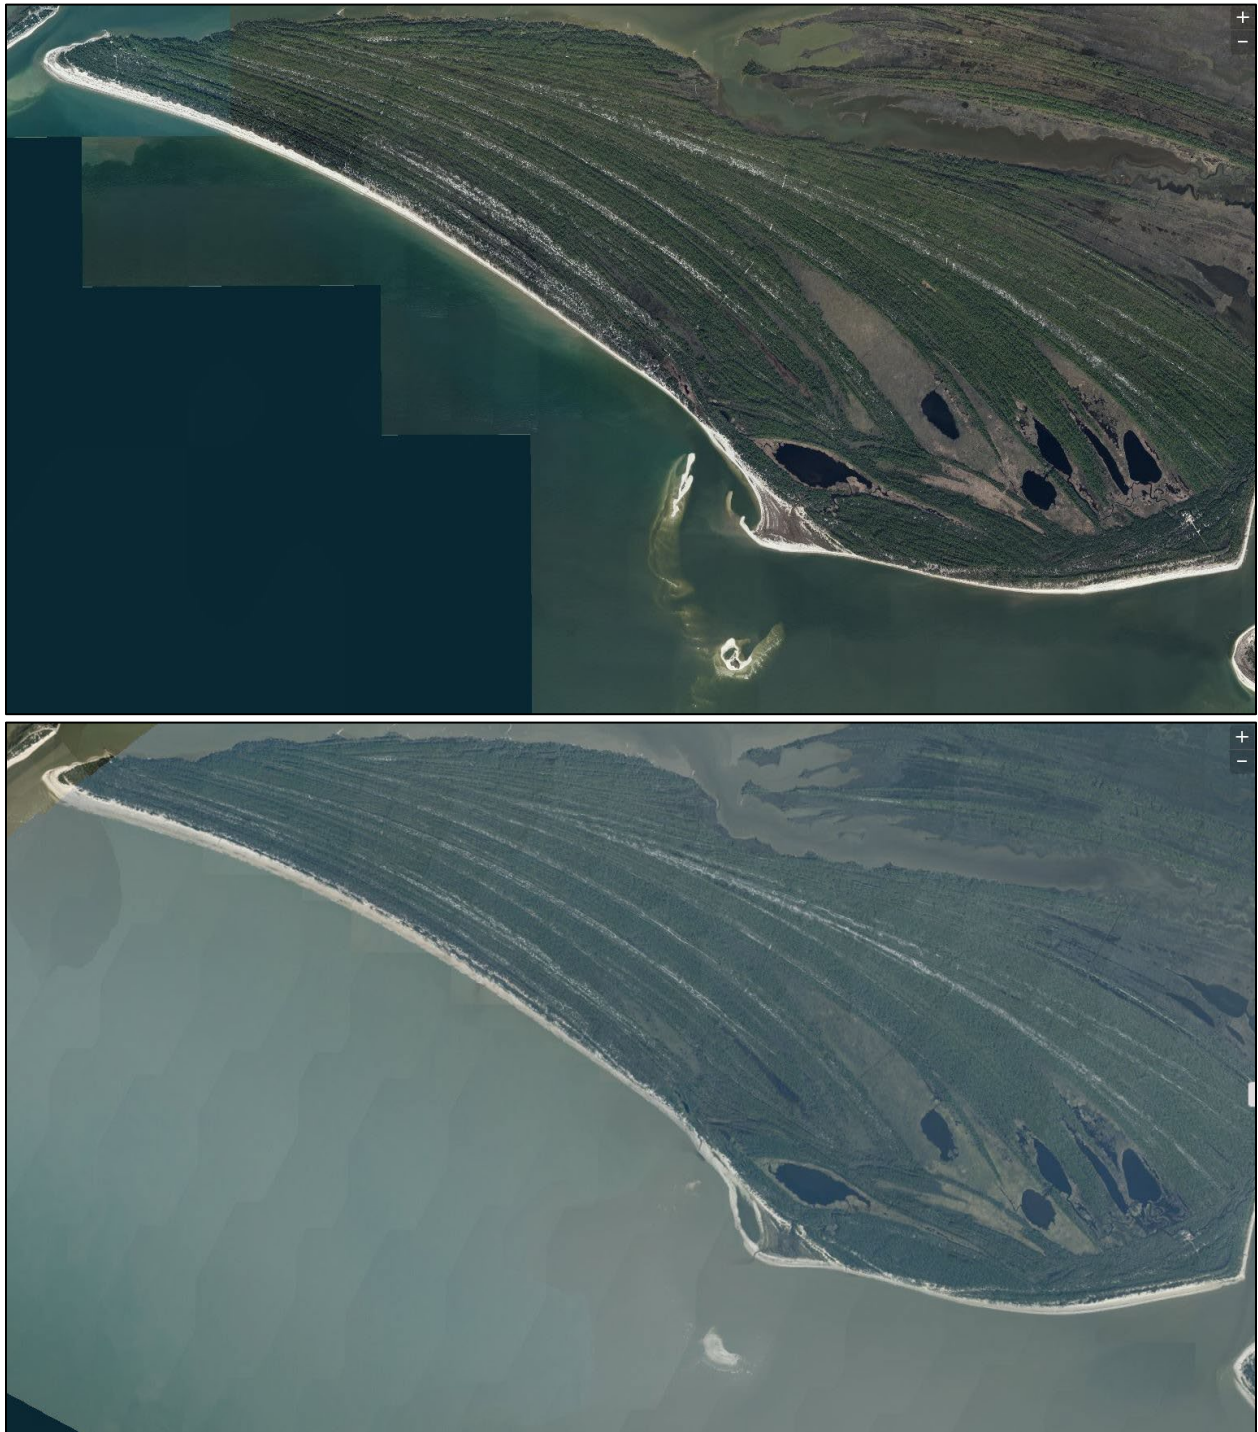
**Figure 80.** Before (above) and after (below) aerial photos showing major coastal changes to St. Vincent Island. Source: Vexcel Imaging/ NICB Geospatial Intelligence Center.

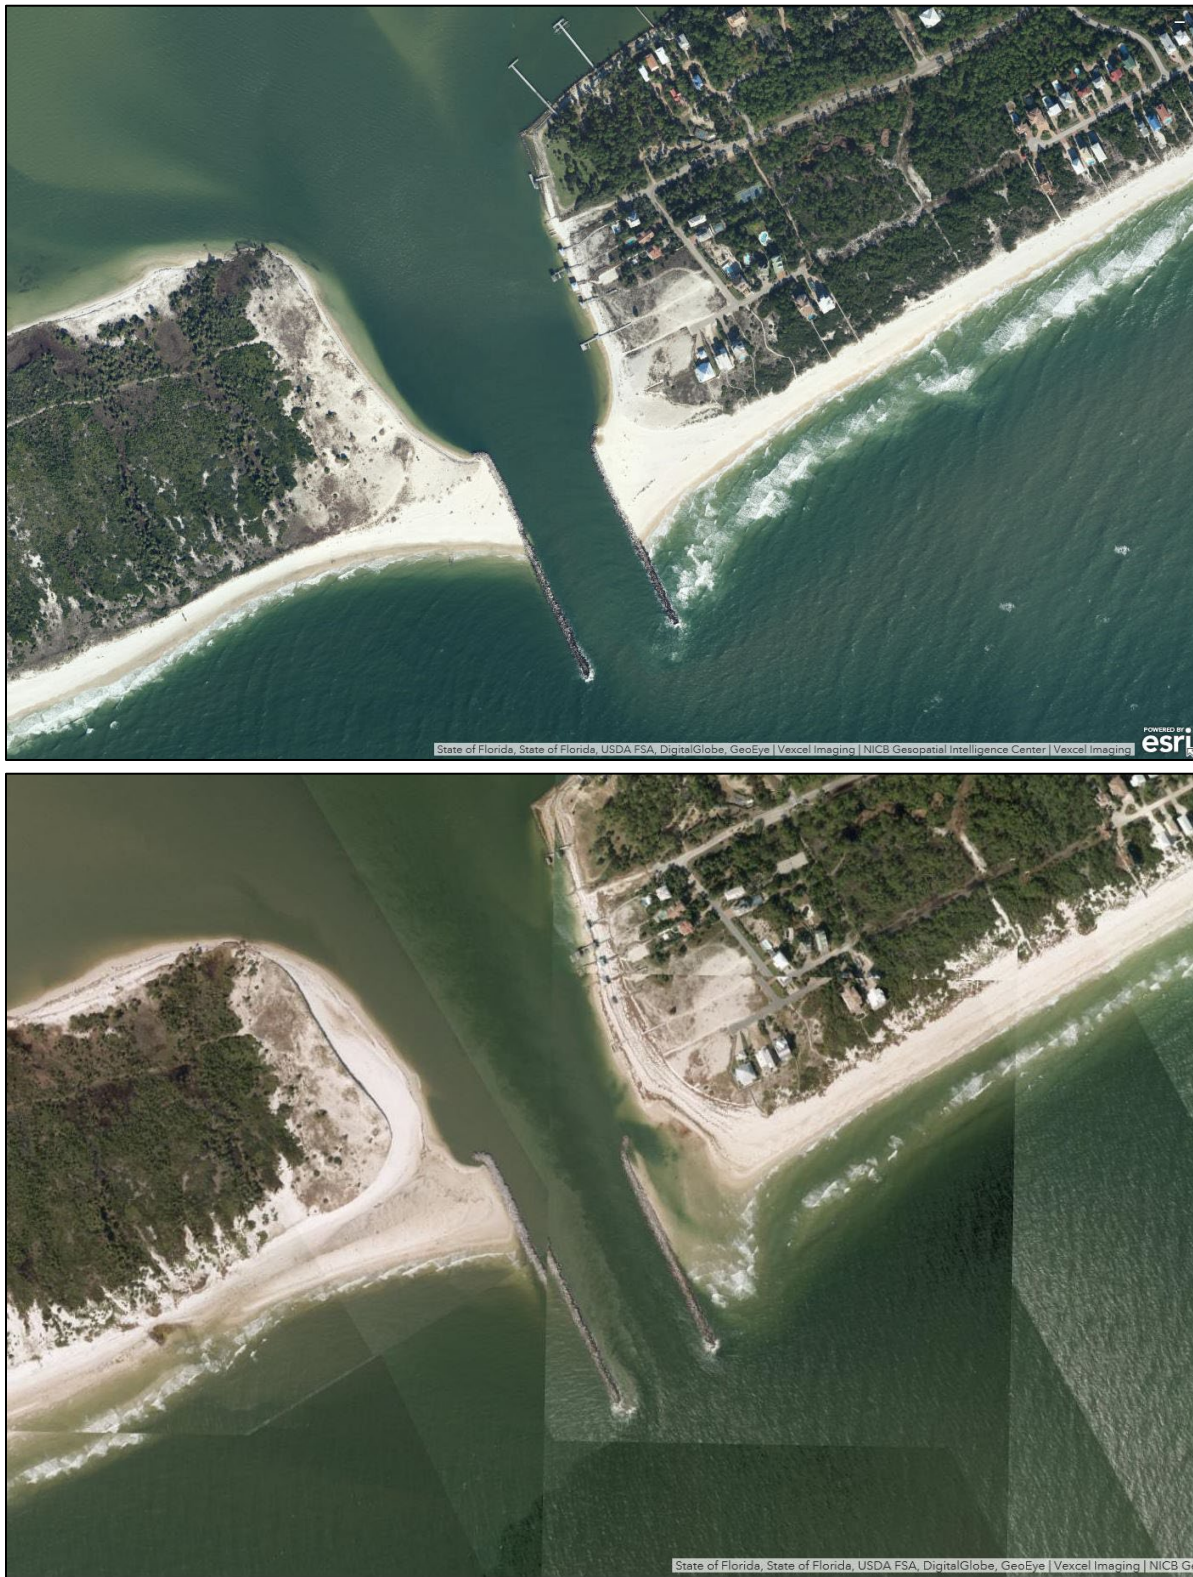
**Figure 81.** Before (above) and after (below) aerial photos showing breaching of the Bob Sikes Cut jetties from St. George Island, R51-R52. Source: Vexcel Imaging/ NICB Geospatial Intelligence Center.

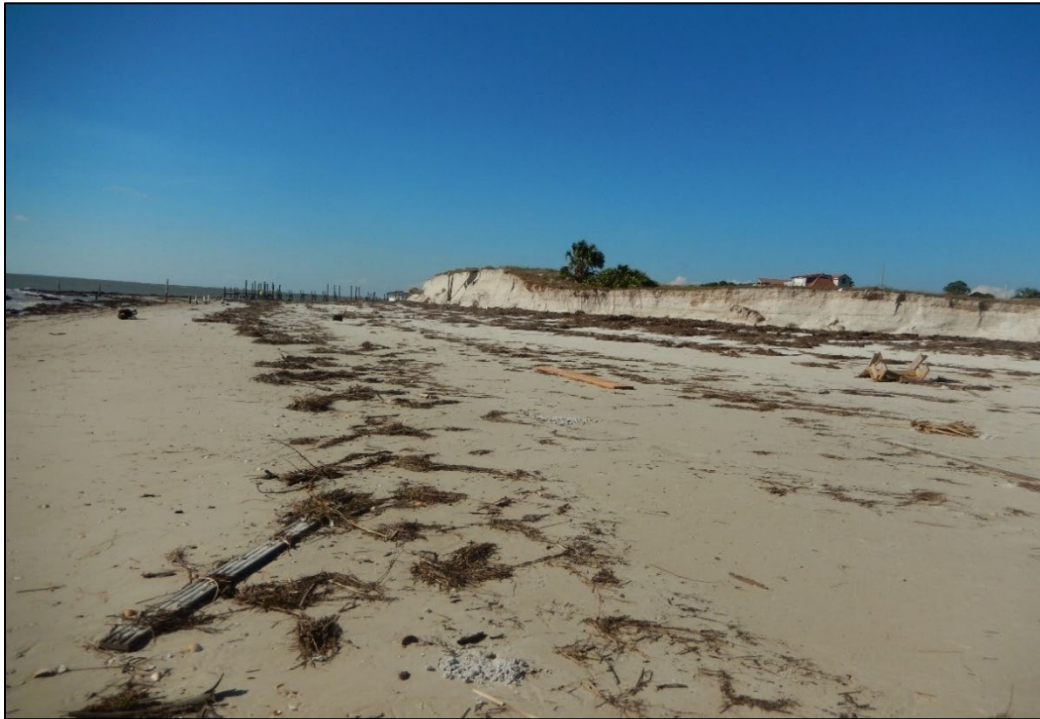
**Figure 83.** Major beach and dune erosion at Bob Sikes Cut at R52, St. George Island.

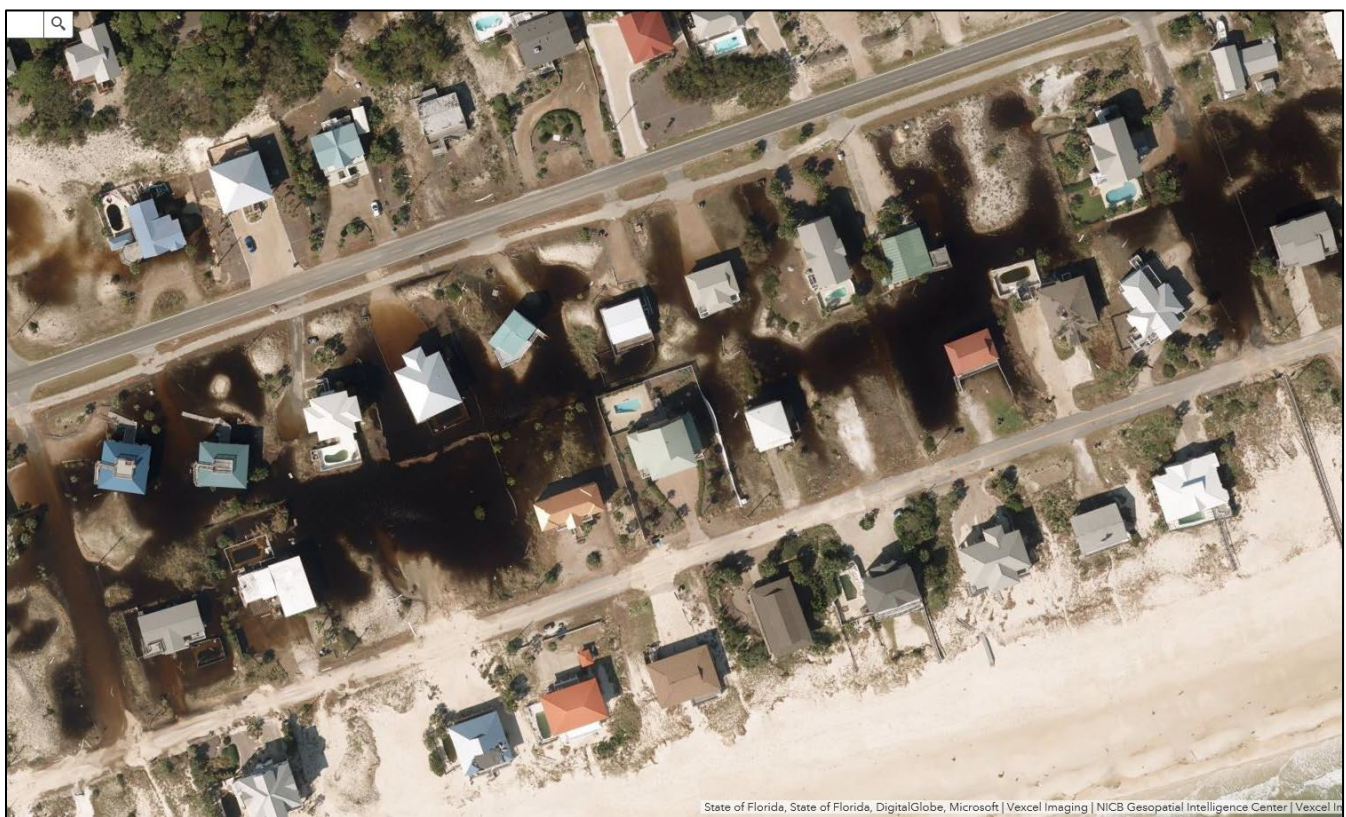
**Figure 85.** Flooded interdunal depression on St. George Island between R87-R99. Source: Vexcel Imaging/ NICB Geospatial Intelligence Center.

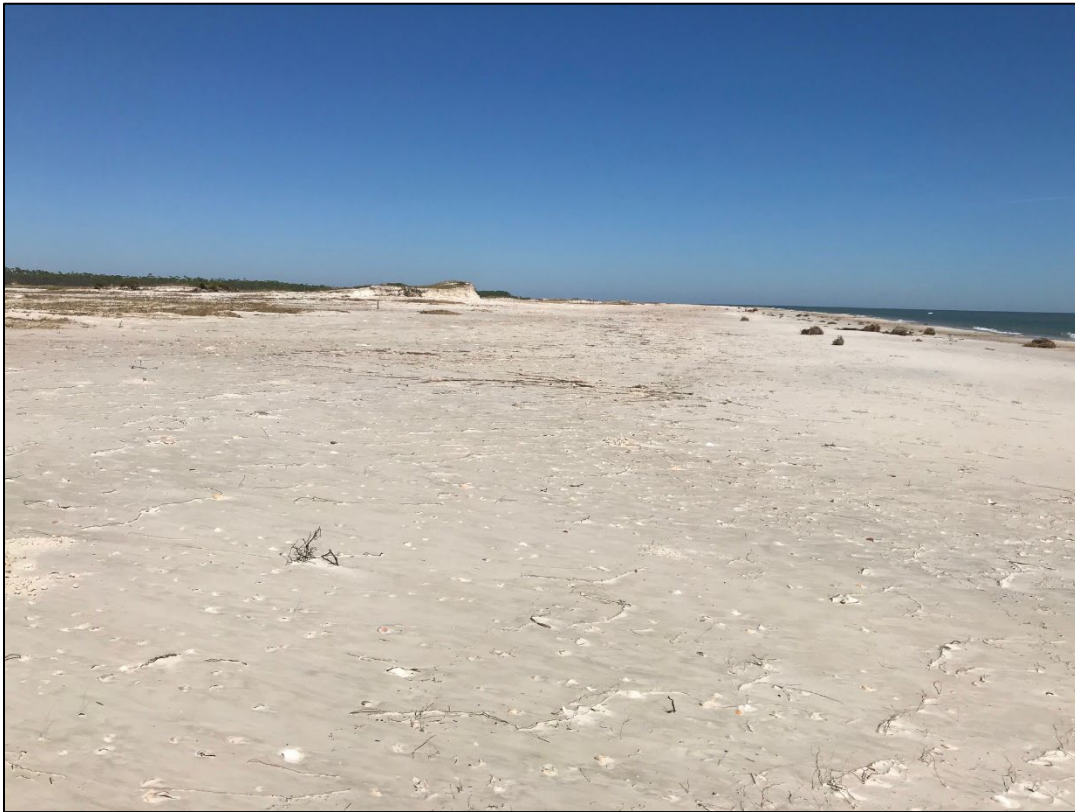
In the Dr. Julian G. Bruce St. George Island State Park, which extends along the eastern 8.4 miles of St. George Island between R105 and R149, major beach and dune erosion (Condition IV) was sustained (**Figure 86**).

**Figure 86.** Dunes leveled across St. George Island State Park.

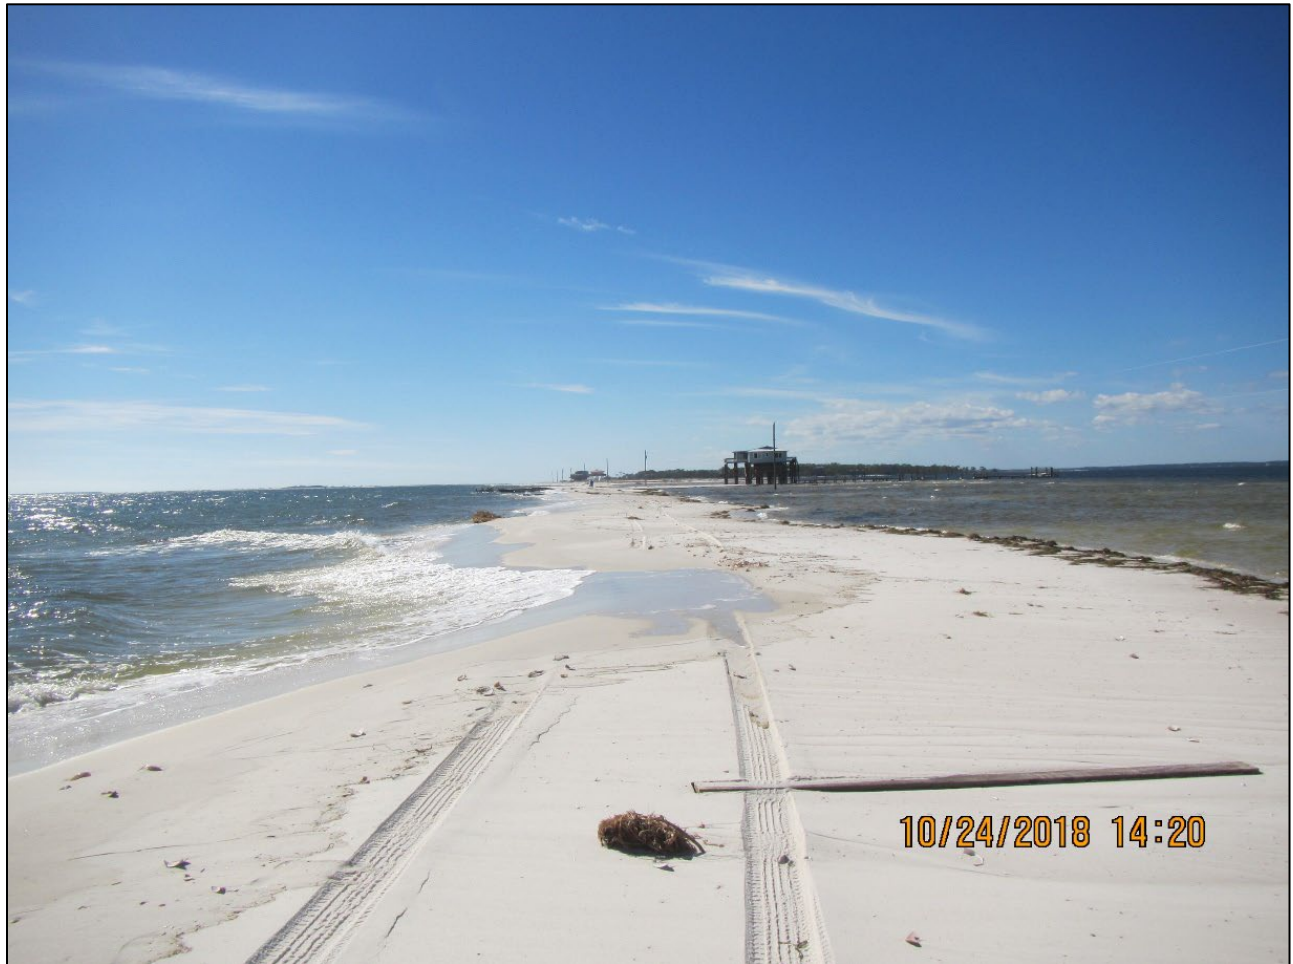
**Figure 87.** Narrows near R159, Dog Island.
