*Hurricane Michael Post-Storm  
Beach Conditions and Coastal Impact Report*

**Division of Water Resource Management  
Florida Department of Environmental Protection**

**January 2019  
(Revised April 2019)**

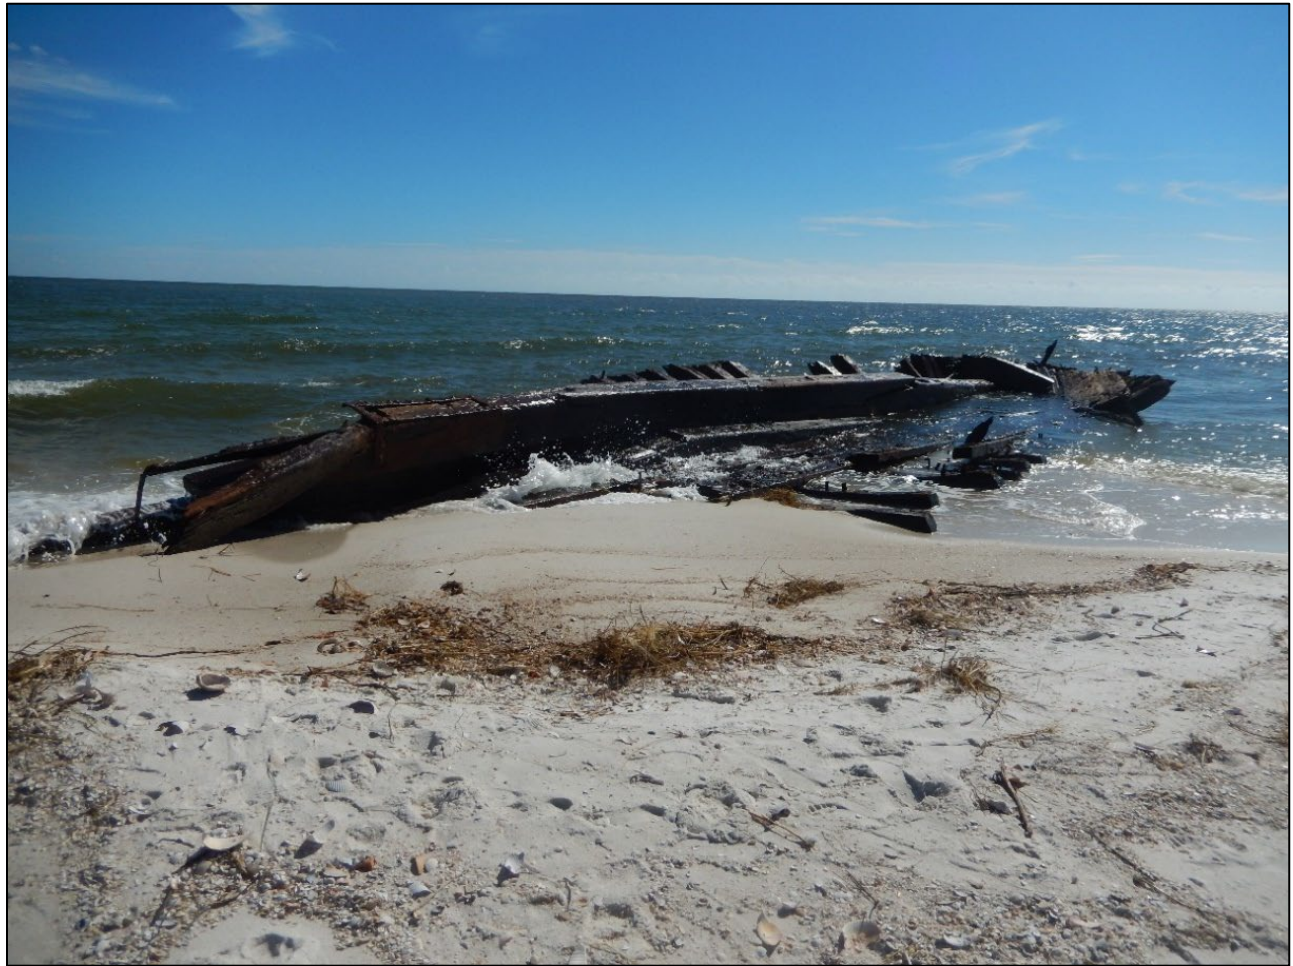
**Figure 88.** 19<sup>th</sup> century shipwreck uncovered by erosion near R158, Dog Island.

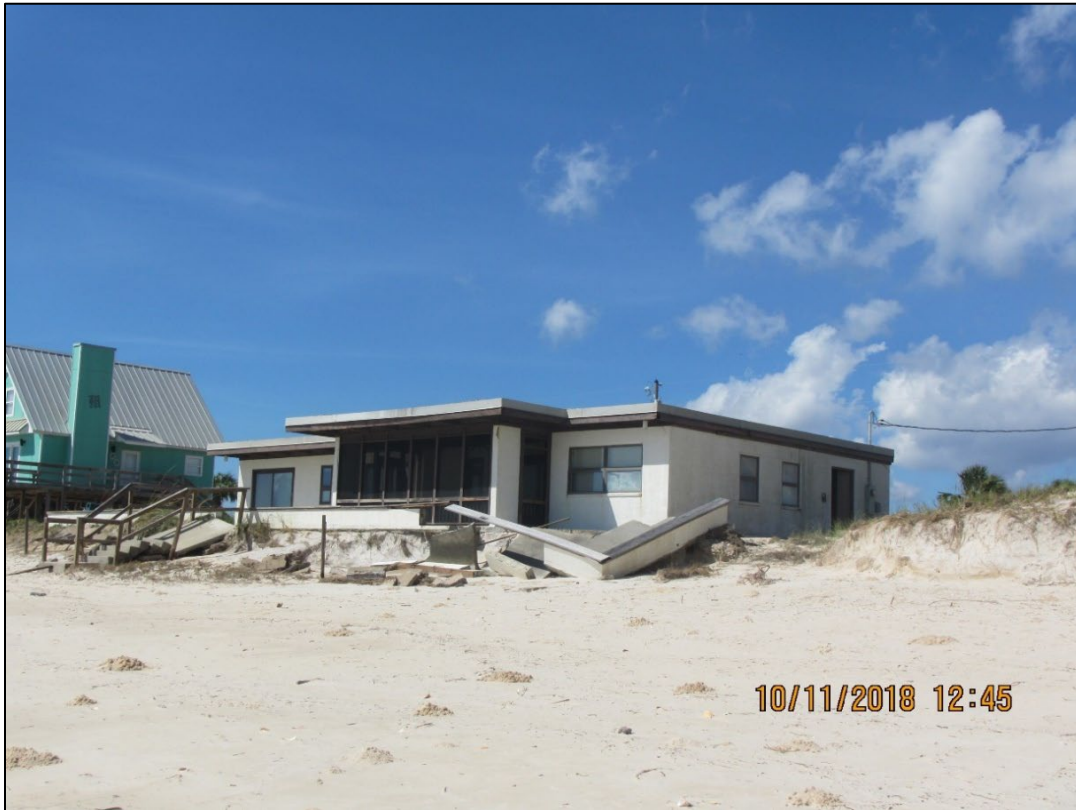
**Figure 89.** Dwelling damaged near R78, St. George Island.

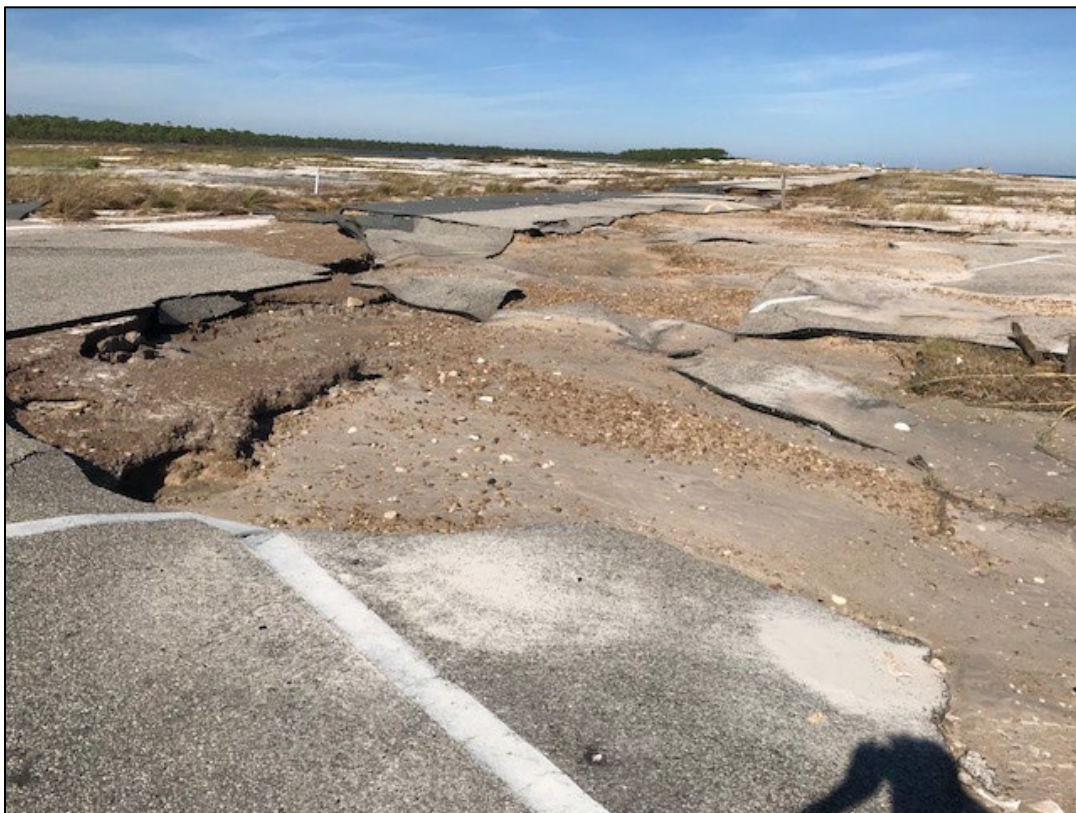
**Figure 90.** State park road destroyed near R108, St. George Island.

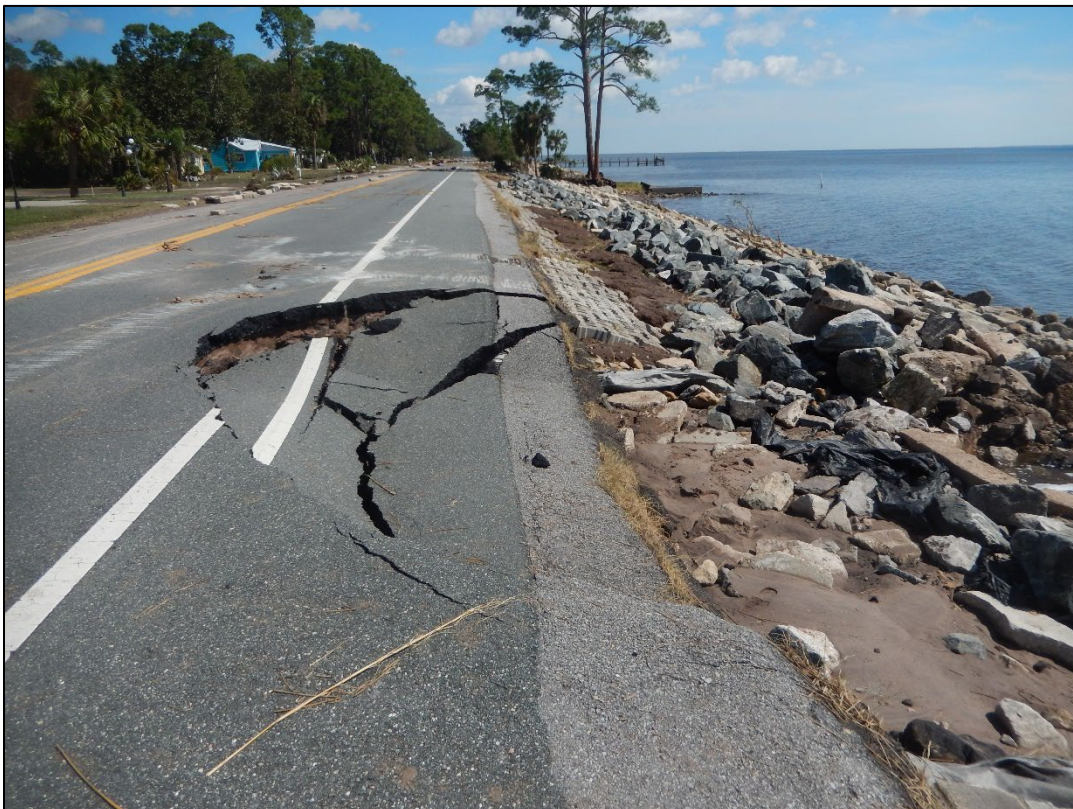
**Figure 92.** U.S. Highway 98 damaged near Eastpoint.

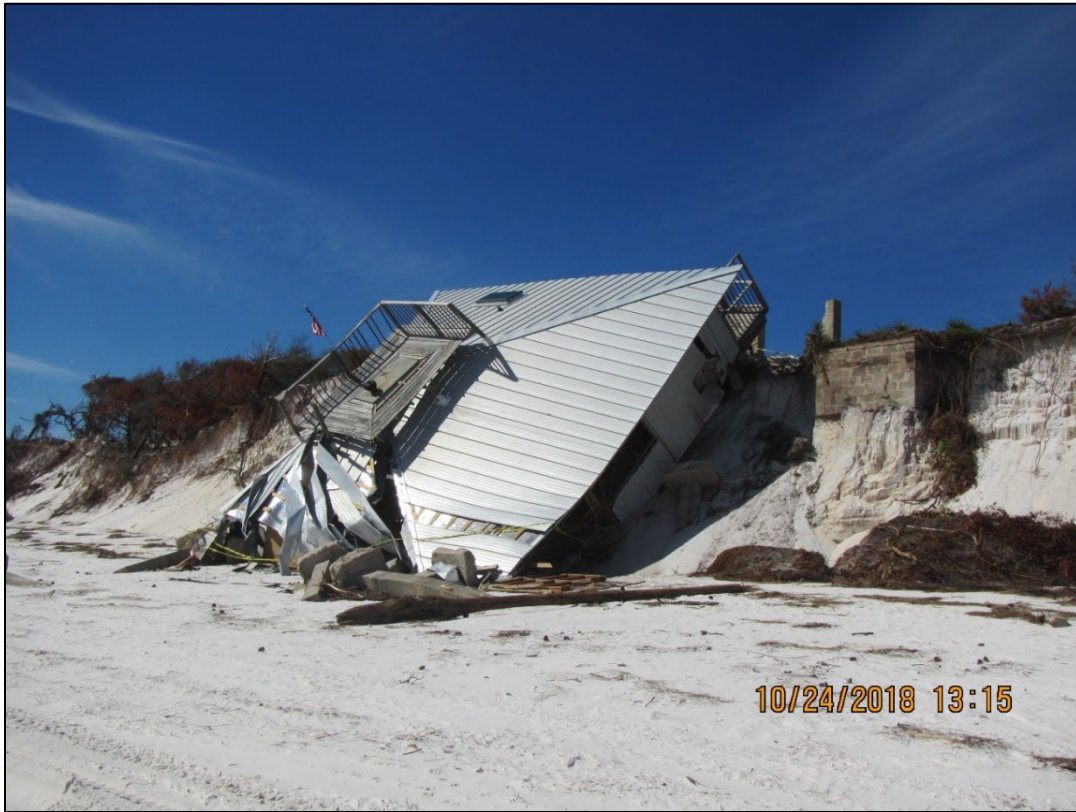
**Figure 93.** Dwelling destroyed near R173, Dog Island.

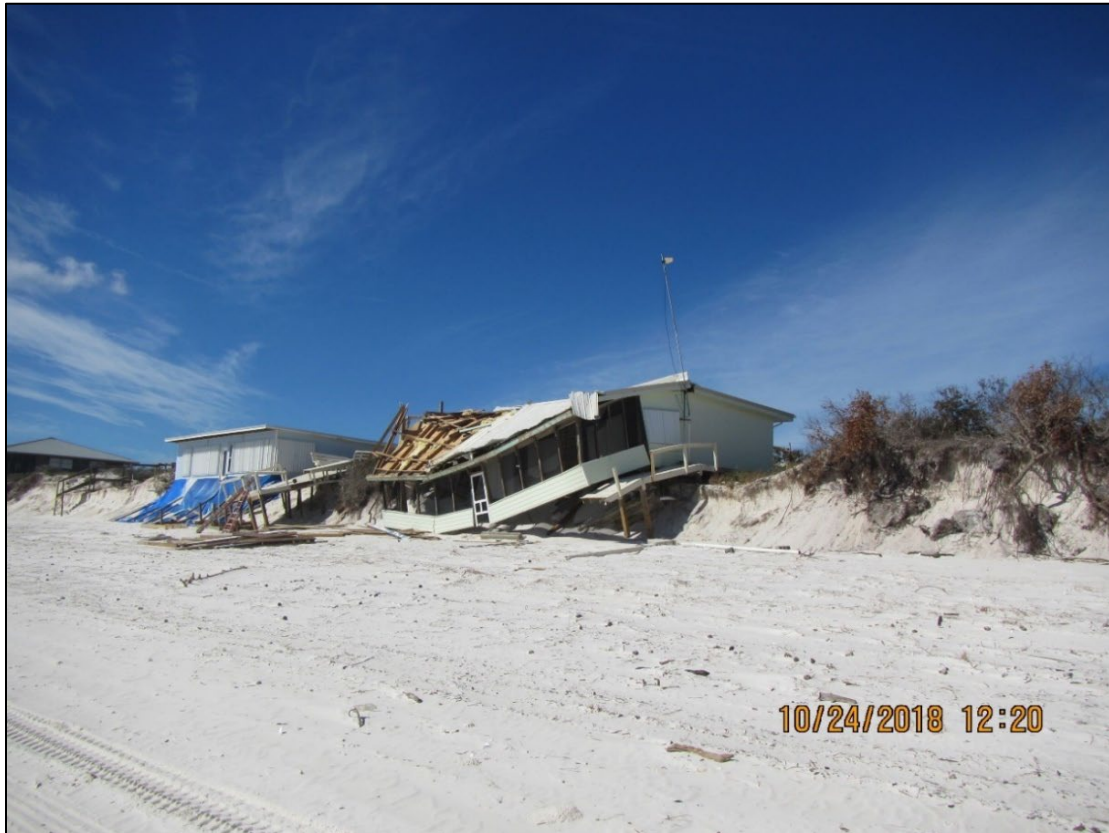
**Figure 97.** Dwelling destroyed near R179, Dog Island.

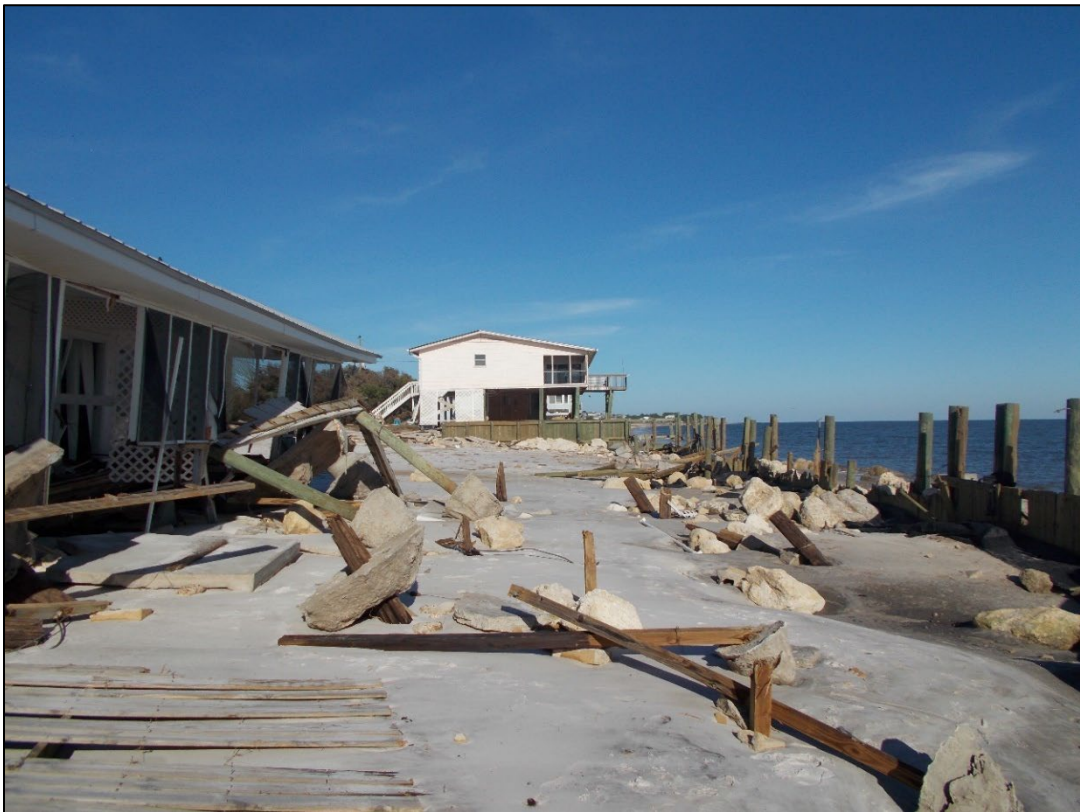
*Figure 102. Dwelling and bulkhead damaged near R214.5, Southwest Cape.*

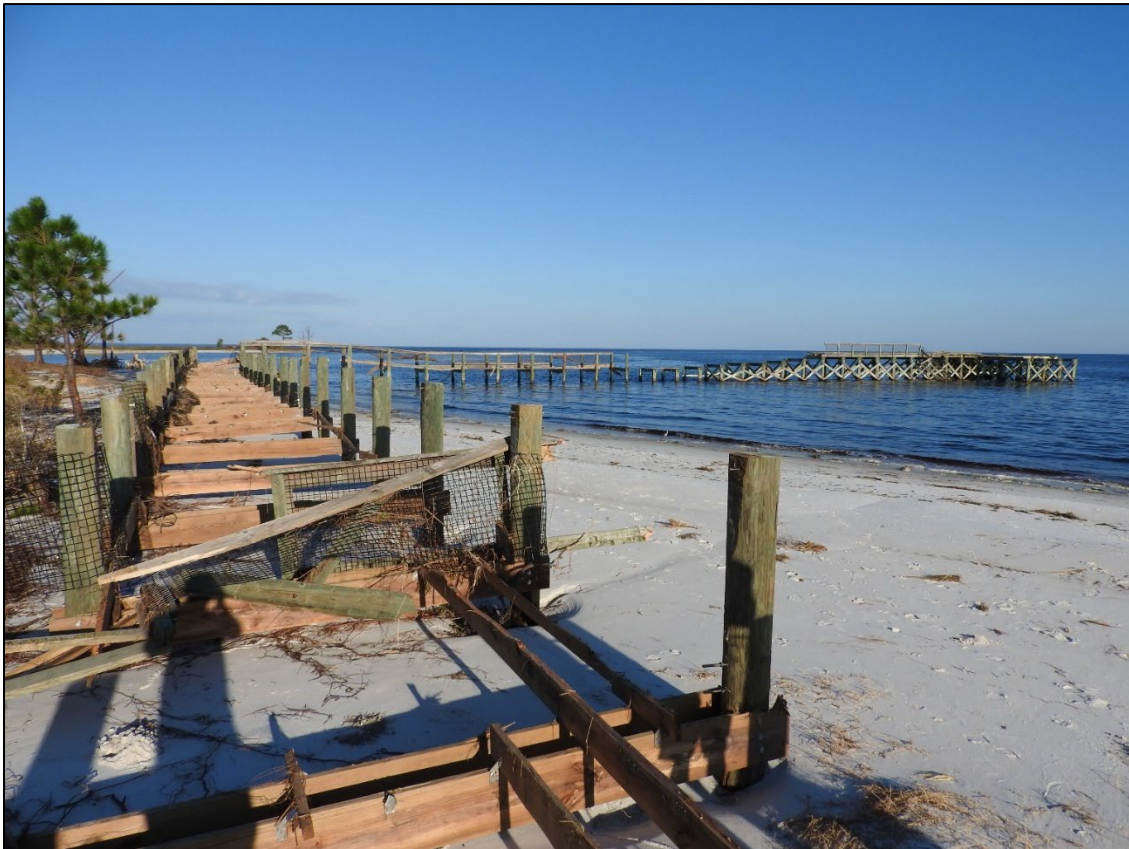
**Figure 104.** Fishing pier and access walkway damaged at Mashes Sands, V303.

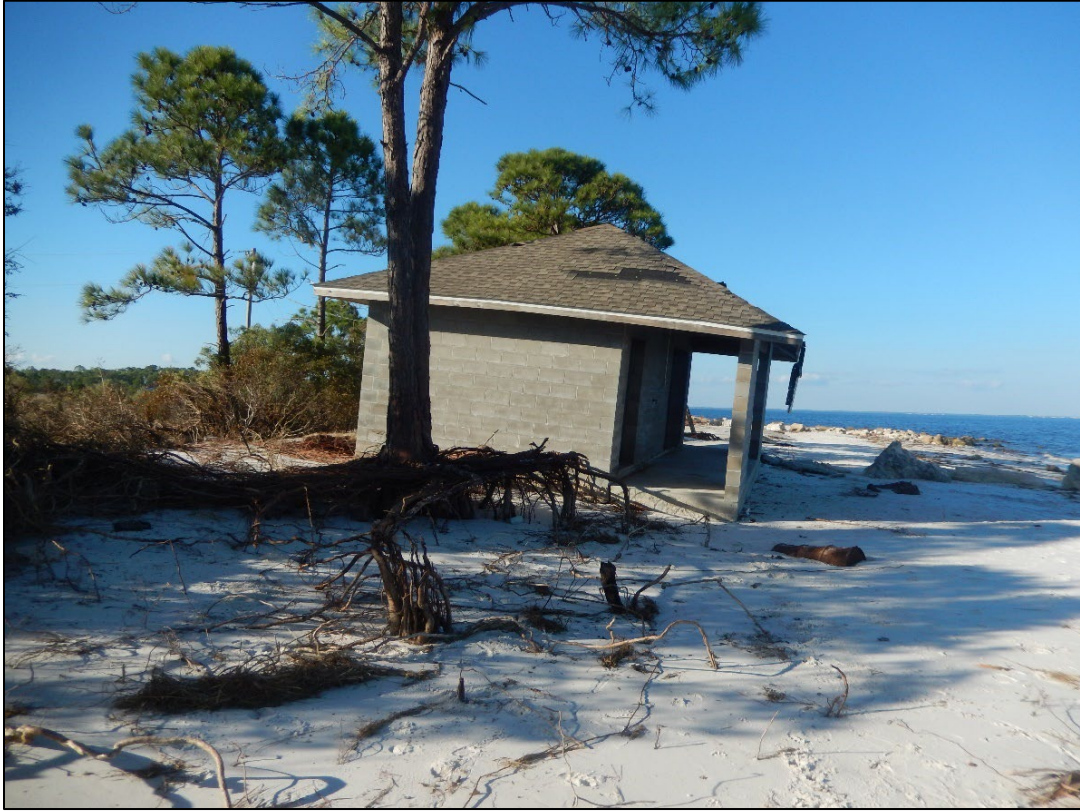
**Figure 105.** Bathhouse destroyed at Mashas Sands, V314.

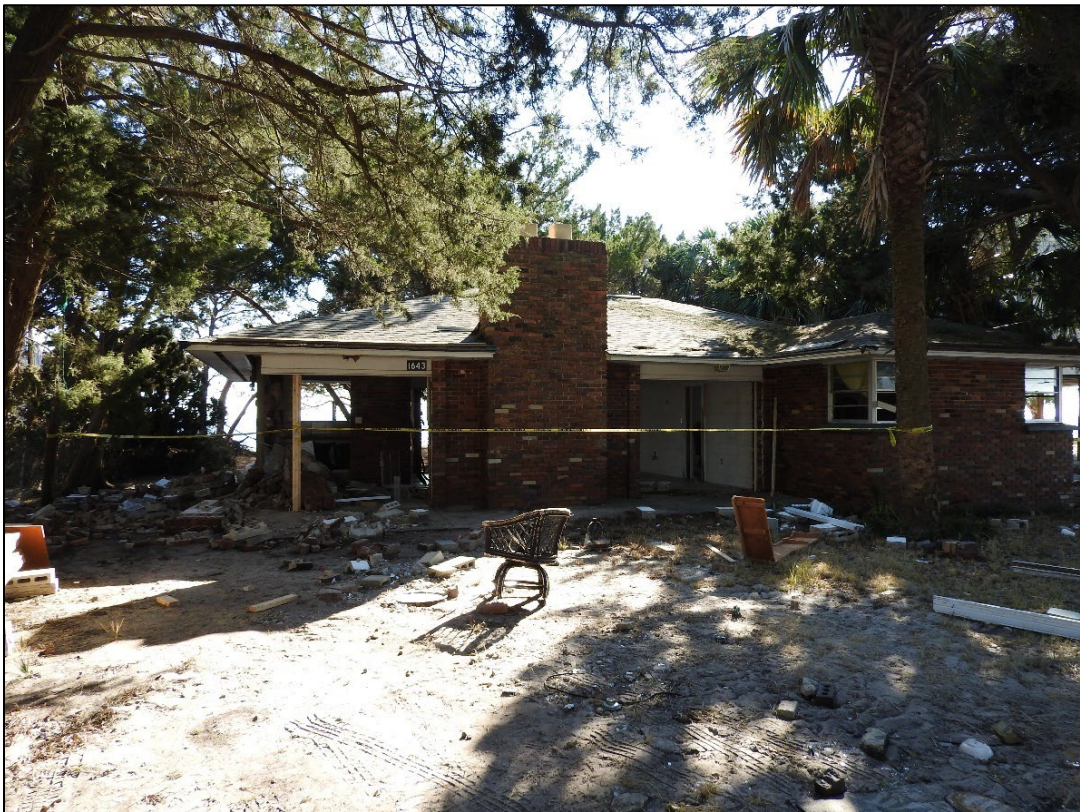
**Figure 106.** Dwelling with major damage from the storm surge at Shell Point, V342.

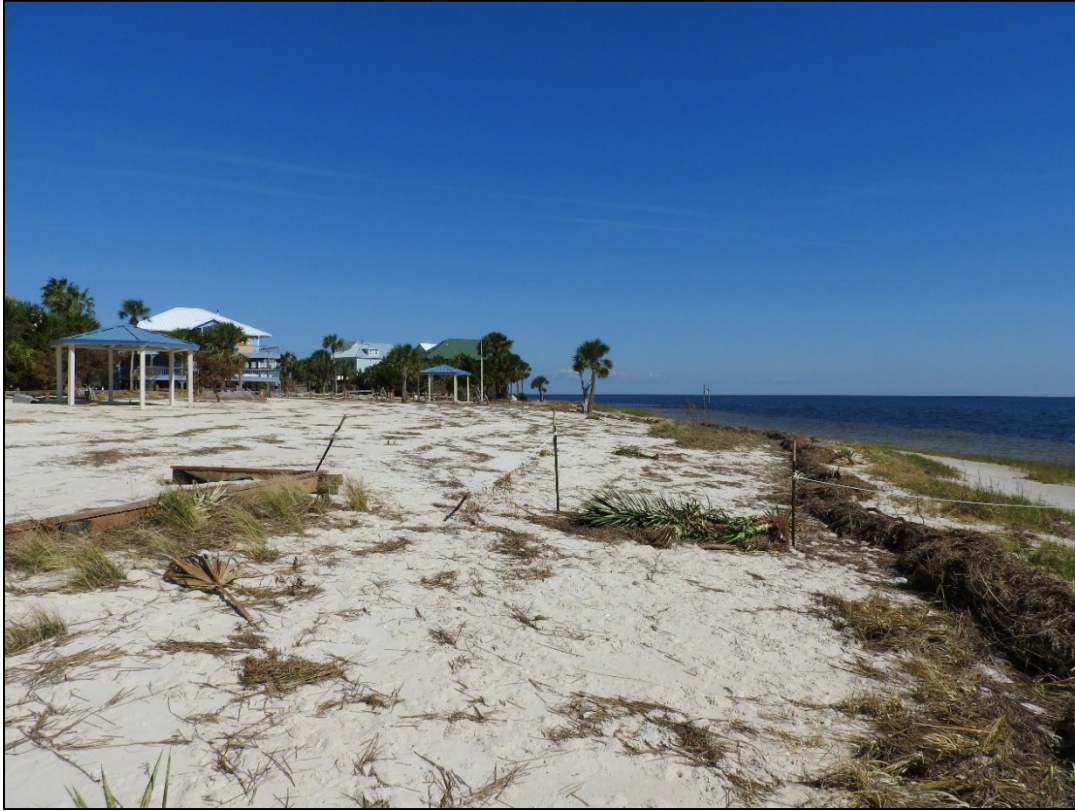
**Figure 107.** *Minor erosion to public beach at Shell Point, V355.*

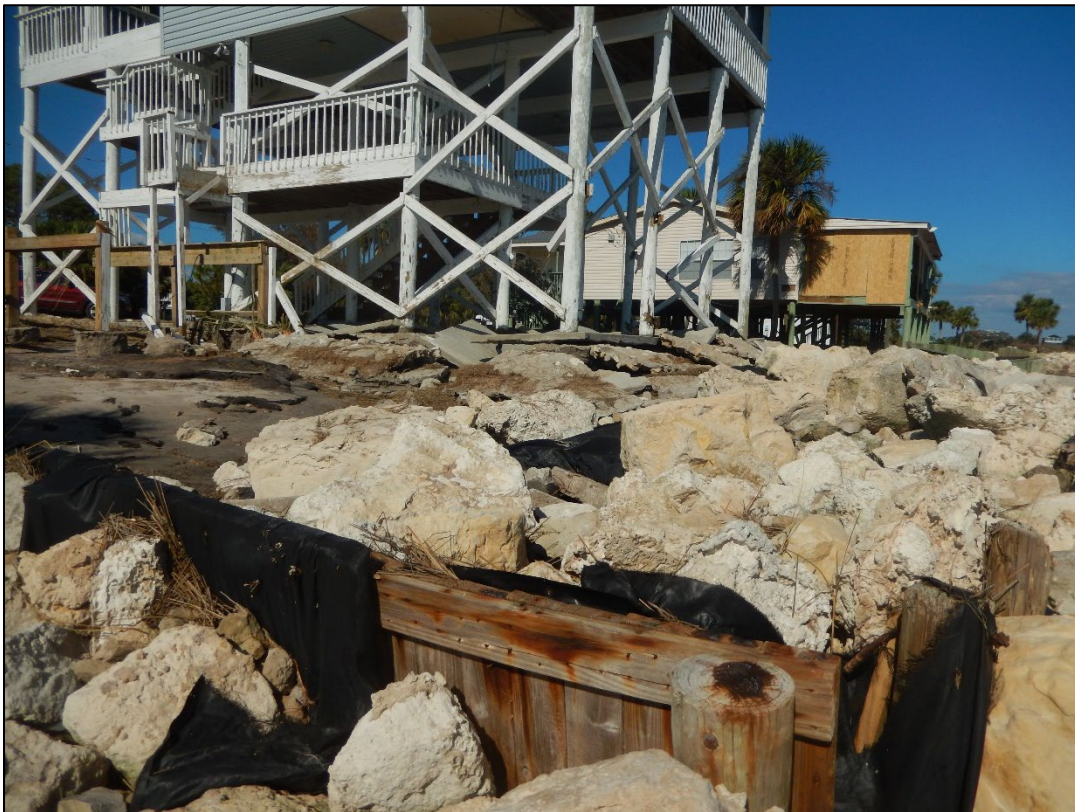
**Figure 108.** *Rock revetment damaged and dwelling with parking slab and bracing damage at Shell Point, V361.*
