Bill Baggs Cape Florida State Park

**APPROVED
Unit Management Plan**

**STATE OF FLORIDA
DEPARTMENT OF ENVIRONMENTAL
PROTECTION**

**Division of Recreation and Parks
October 11, 2012**

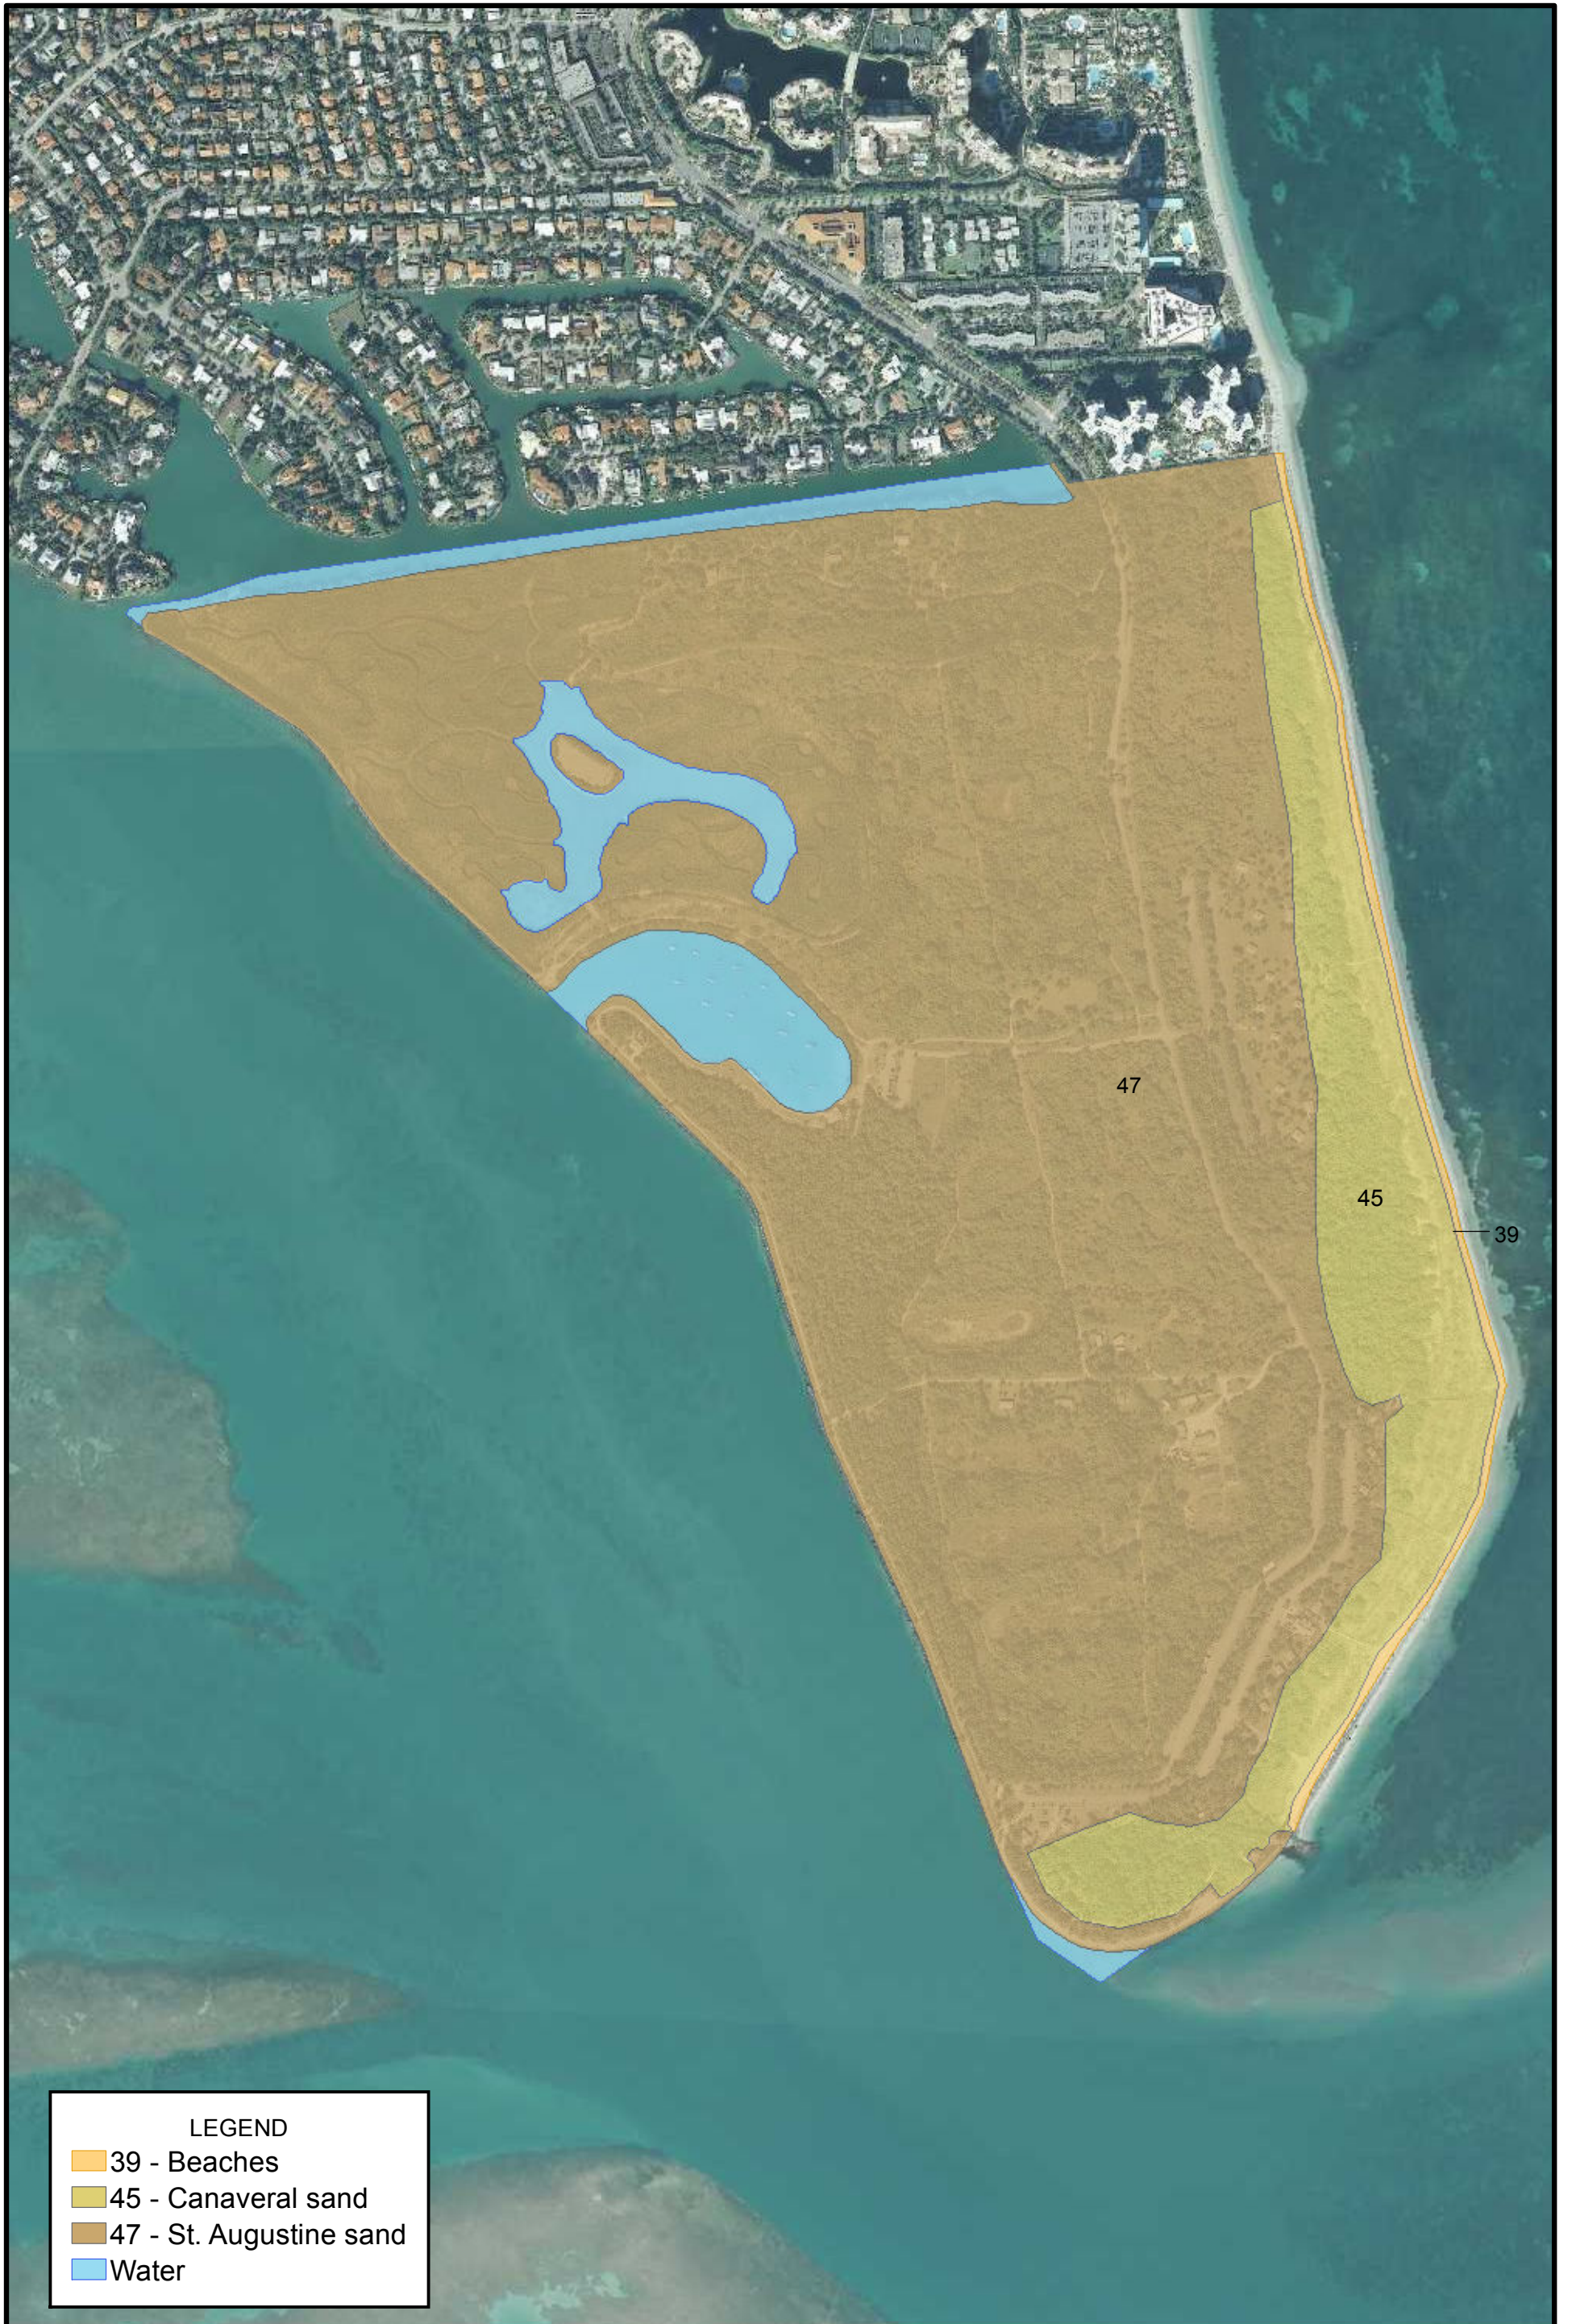
Today, only three soil types are found at Bill Baggs Cape Florida State Park (see Soils Map). St. Augustine sand now covers a much greater extent of the park and has buried the areas of Kesson muck. Beaches and Canaveral sand are still present in areas unaffected by the fill activities. Addendum 4 contains detailed descriptions of the soil types within the park.

Beaches are the soil type found on the tide- and surf-washed Atlantic shoreline of the park. It is composed of calcium carbonate particles derived from fragments of marine animals and plants, and of quartz sand.

Canaveral sand appears in the dune ridges behind Cape Florida's beach and in a low area west of the Cape Florida Lighthouse. It may also be present in a 200-foot wide swathe along the south side of Pines Canal, where soil excavated from the canal was

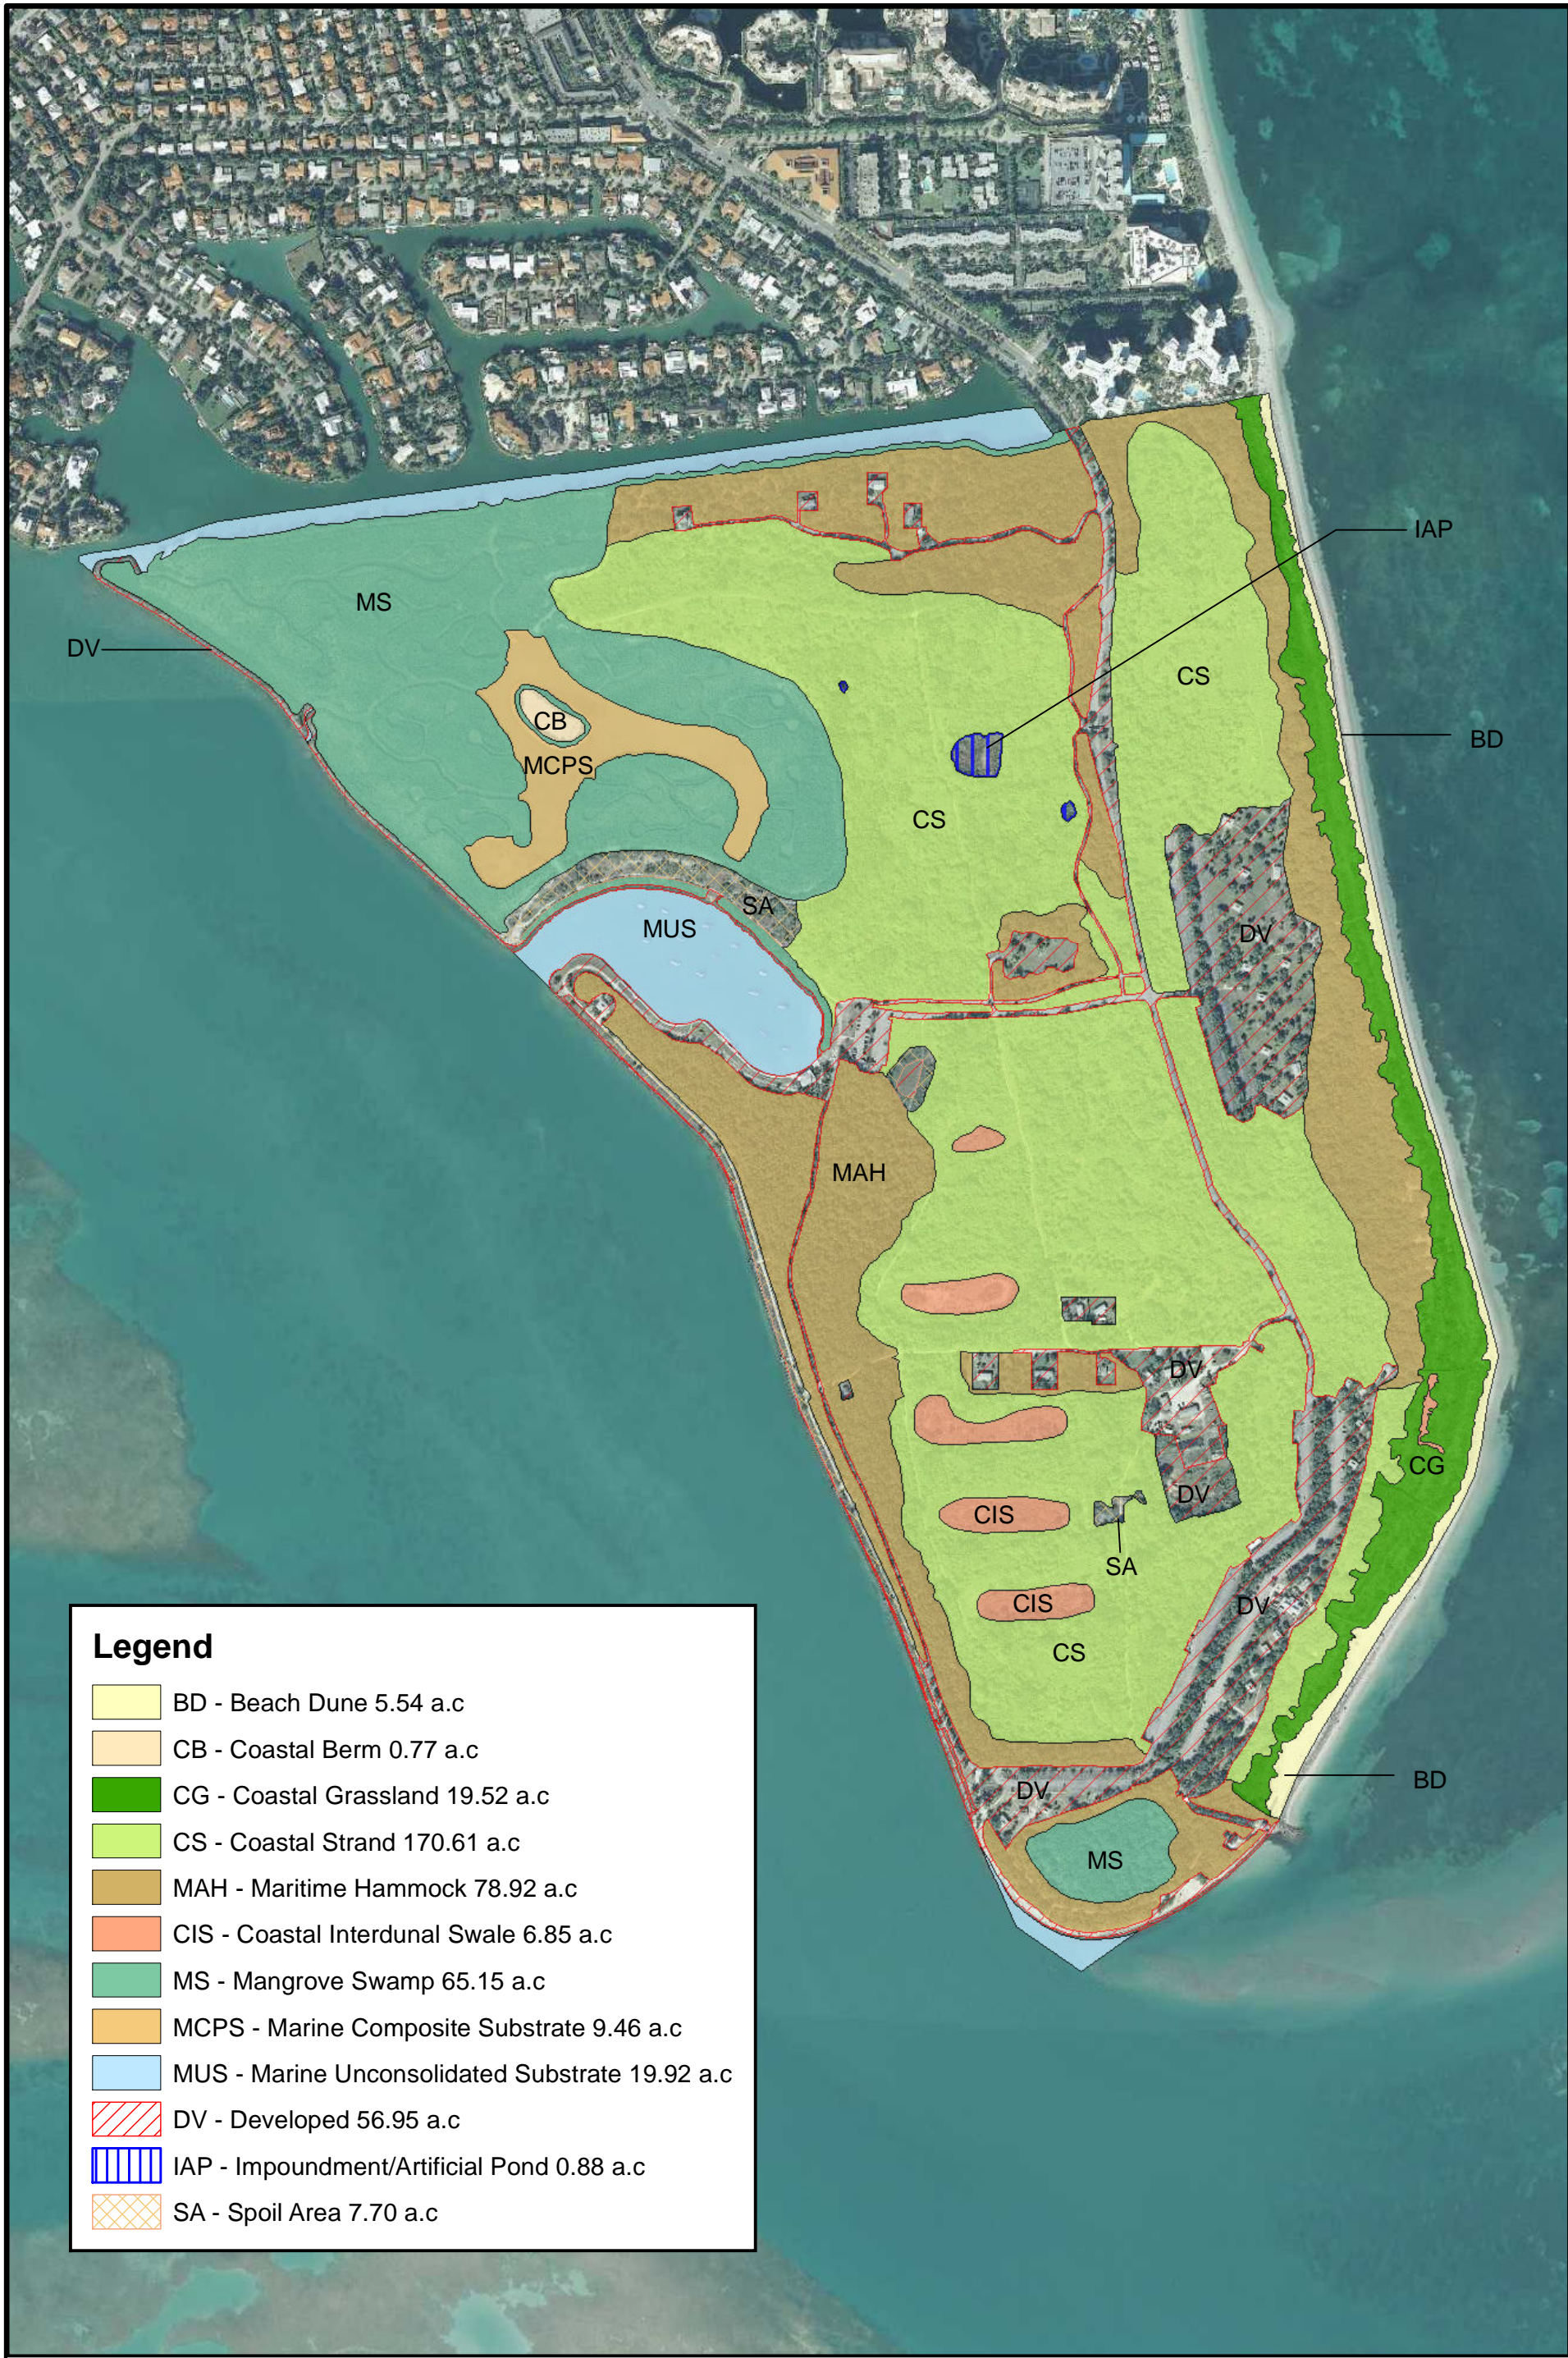
This section of the management plan describes and assesses each of the natural communities found in the state park. It also describes the desired future condition (DFC) of each natural community and identifies the actions that will be required to bring the community to its DFC. Specific management objectives and actions for natural community management, exotic species management, imperiled species management and restoration are discussed in the Resource Management Program section of this component.

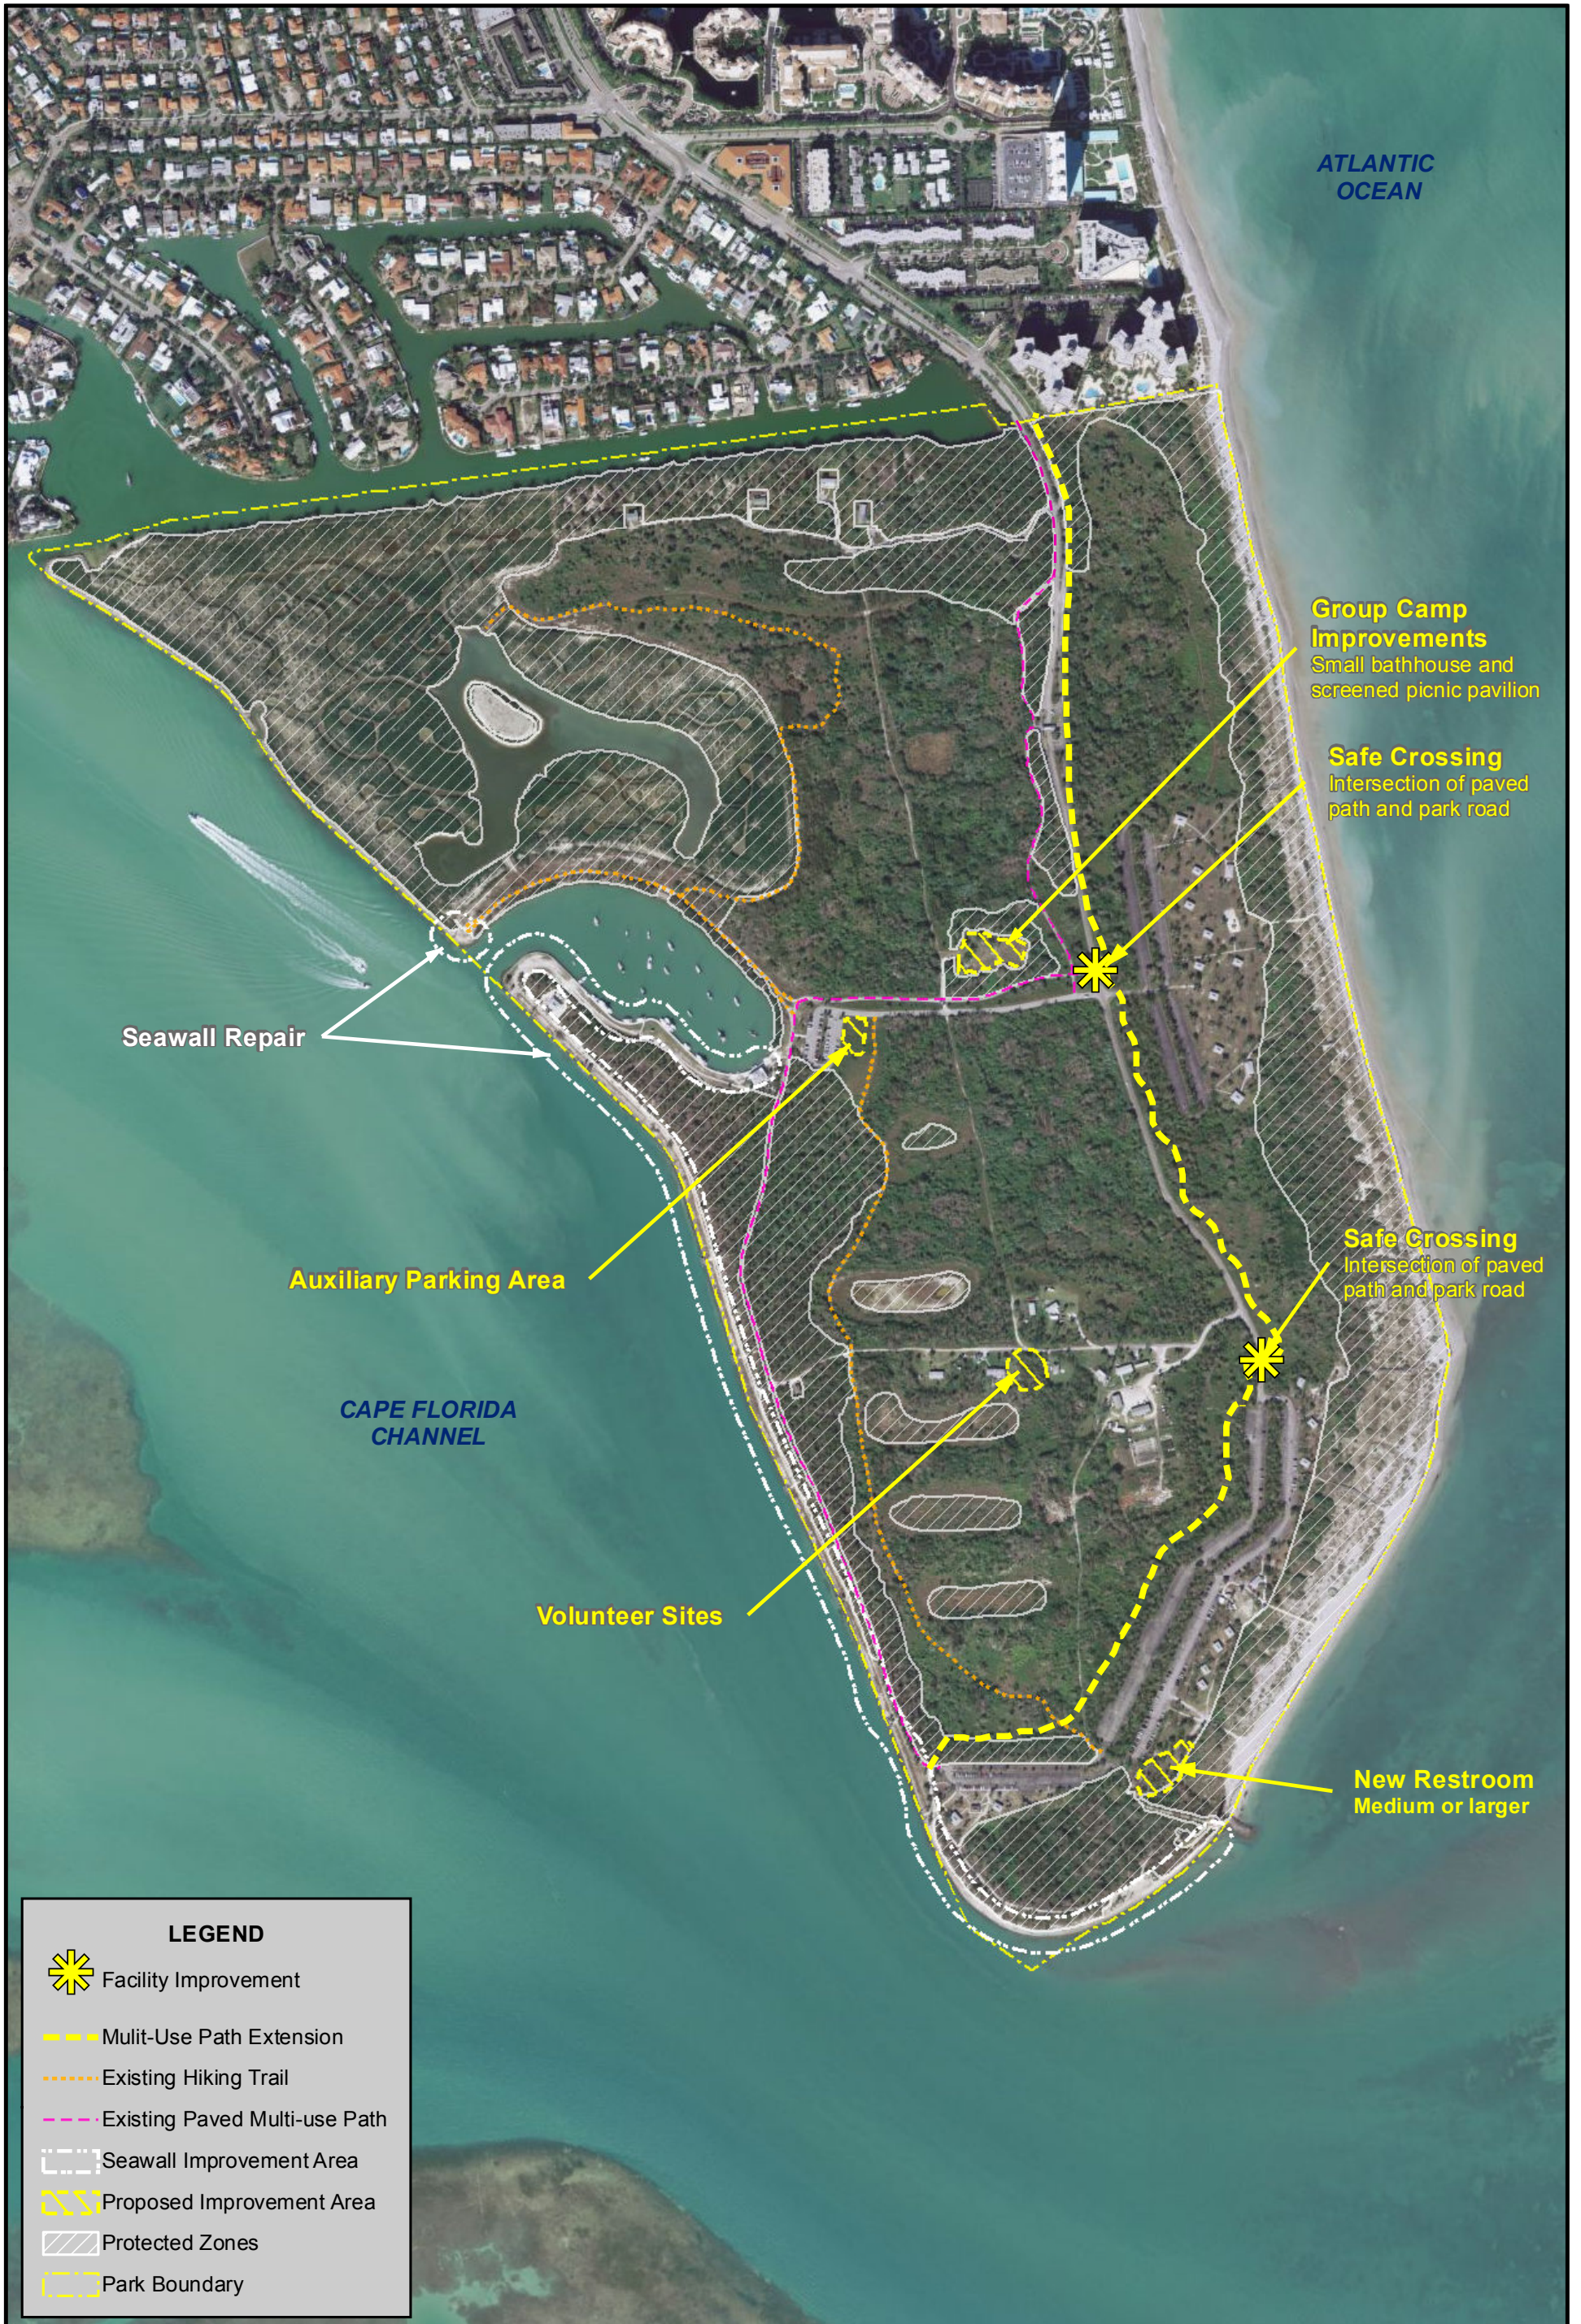
Seawall Repair

Auxiliary Parking Area

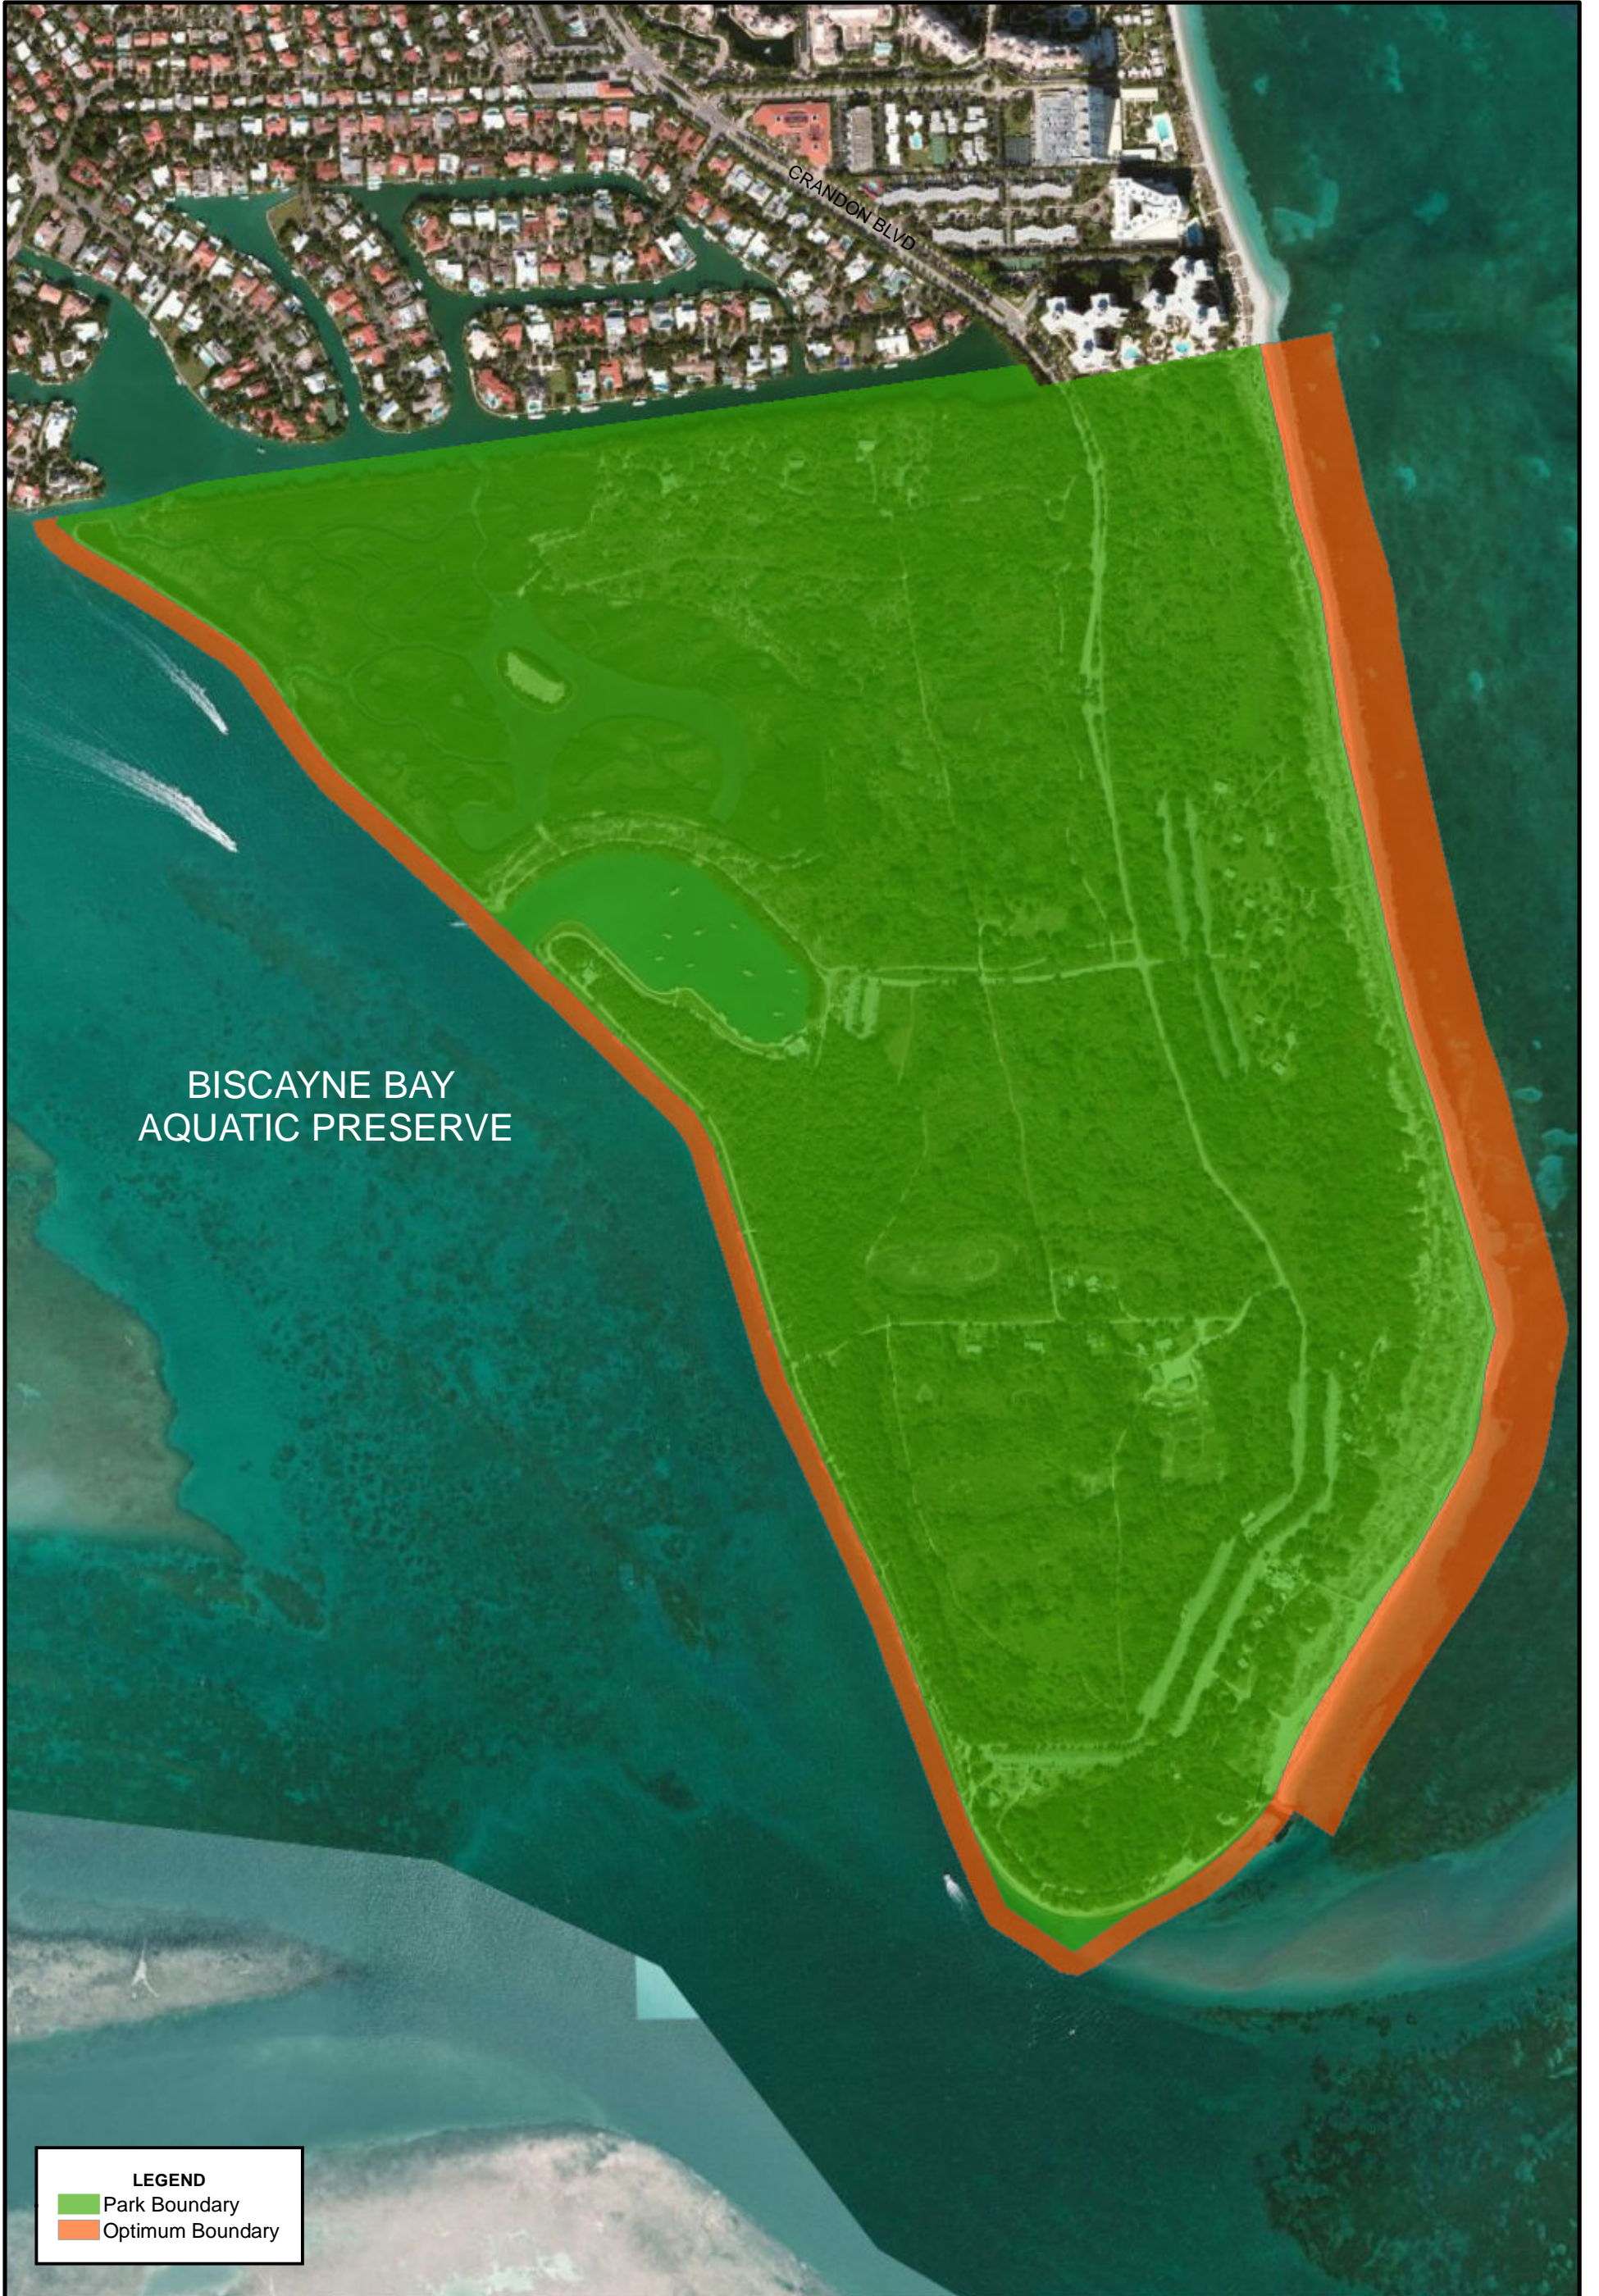
An area of sovereign submerged land is identified within the park's optimum boundary. For the protection of visitor safety and management of natural resources, it is recommended that the park boundary be extended to include the designated swimming area and the submerged area just off the seawall. On the Atlantic beach side, from the northern boundary to the lighthouse jetty, the park boundary should extend out 300 feet to encompass the defined swimming area. On the west side, from the lighthouse jetty to the center of Pines Canal, the park boundary should extend out 100 feet from the edge of the seawall.
