Cantonment Digester Incident

Preliminary Air and Environmental Monitoring and Sampling Summary

Prepared on: February 6, 2017

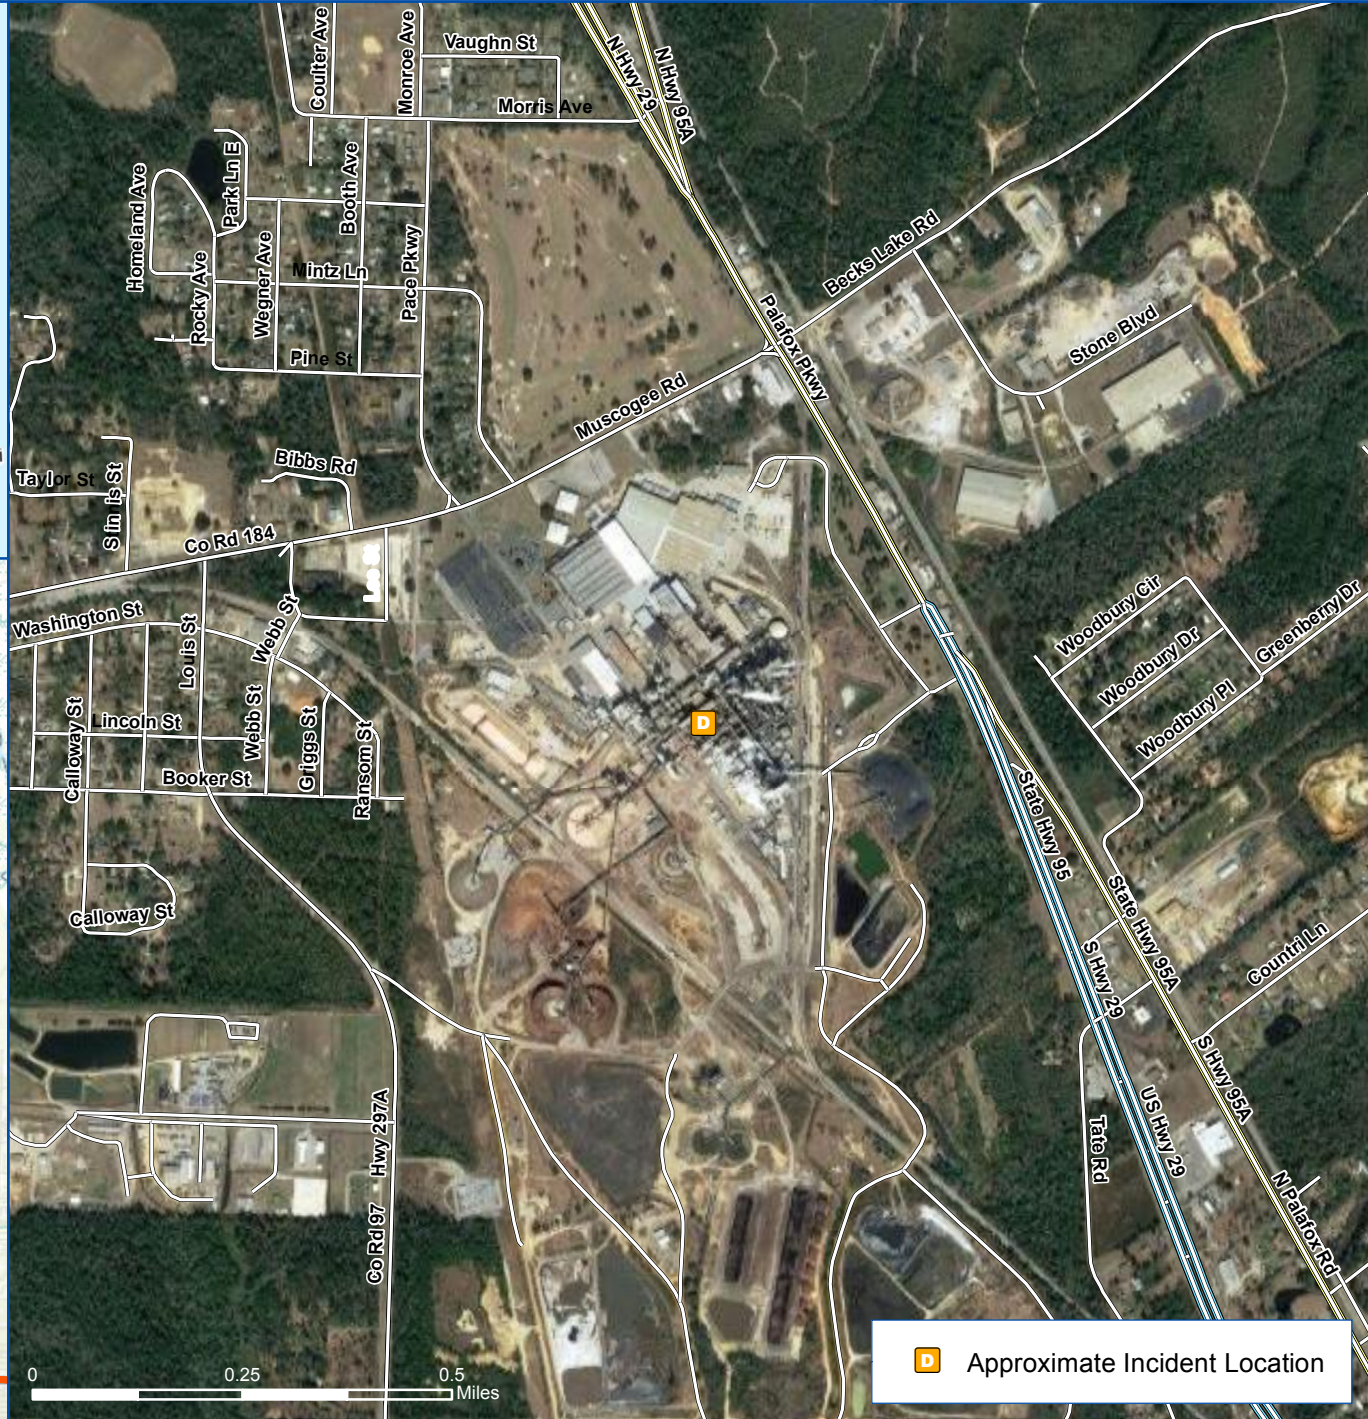
Real-Time Air Monitoring and Analytical Air Sampling Locations

Approximate Incident Location

Real-time air monitoring was initiated as a precaution on January 23 in the community to document and quantify levels of sulfur compounds, primarily hydrogen sulfide (H₂S), emanating from the mill digester wood pulp material. All instrumentation was calibrated at least once per day, or per manufacturer’s recommendations. Target analytes were measured as H₂S, dimethyl sulfide (DMS), dimethyl disulfide (DMDS), and methanethiol (methyl mercaptan) using handheld instruments such as RAESystems MultiRAE Pro and Gastec colorimetric detection tubes. **Appendix I** contains real-time air monitoring locations and analytical air sampling locations.

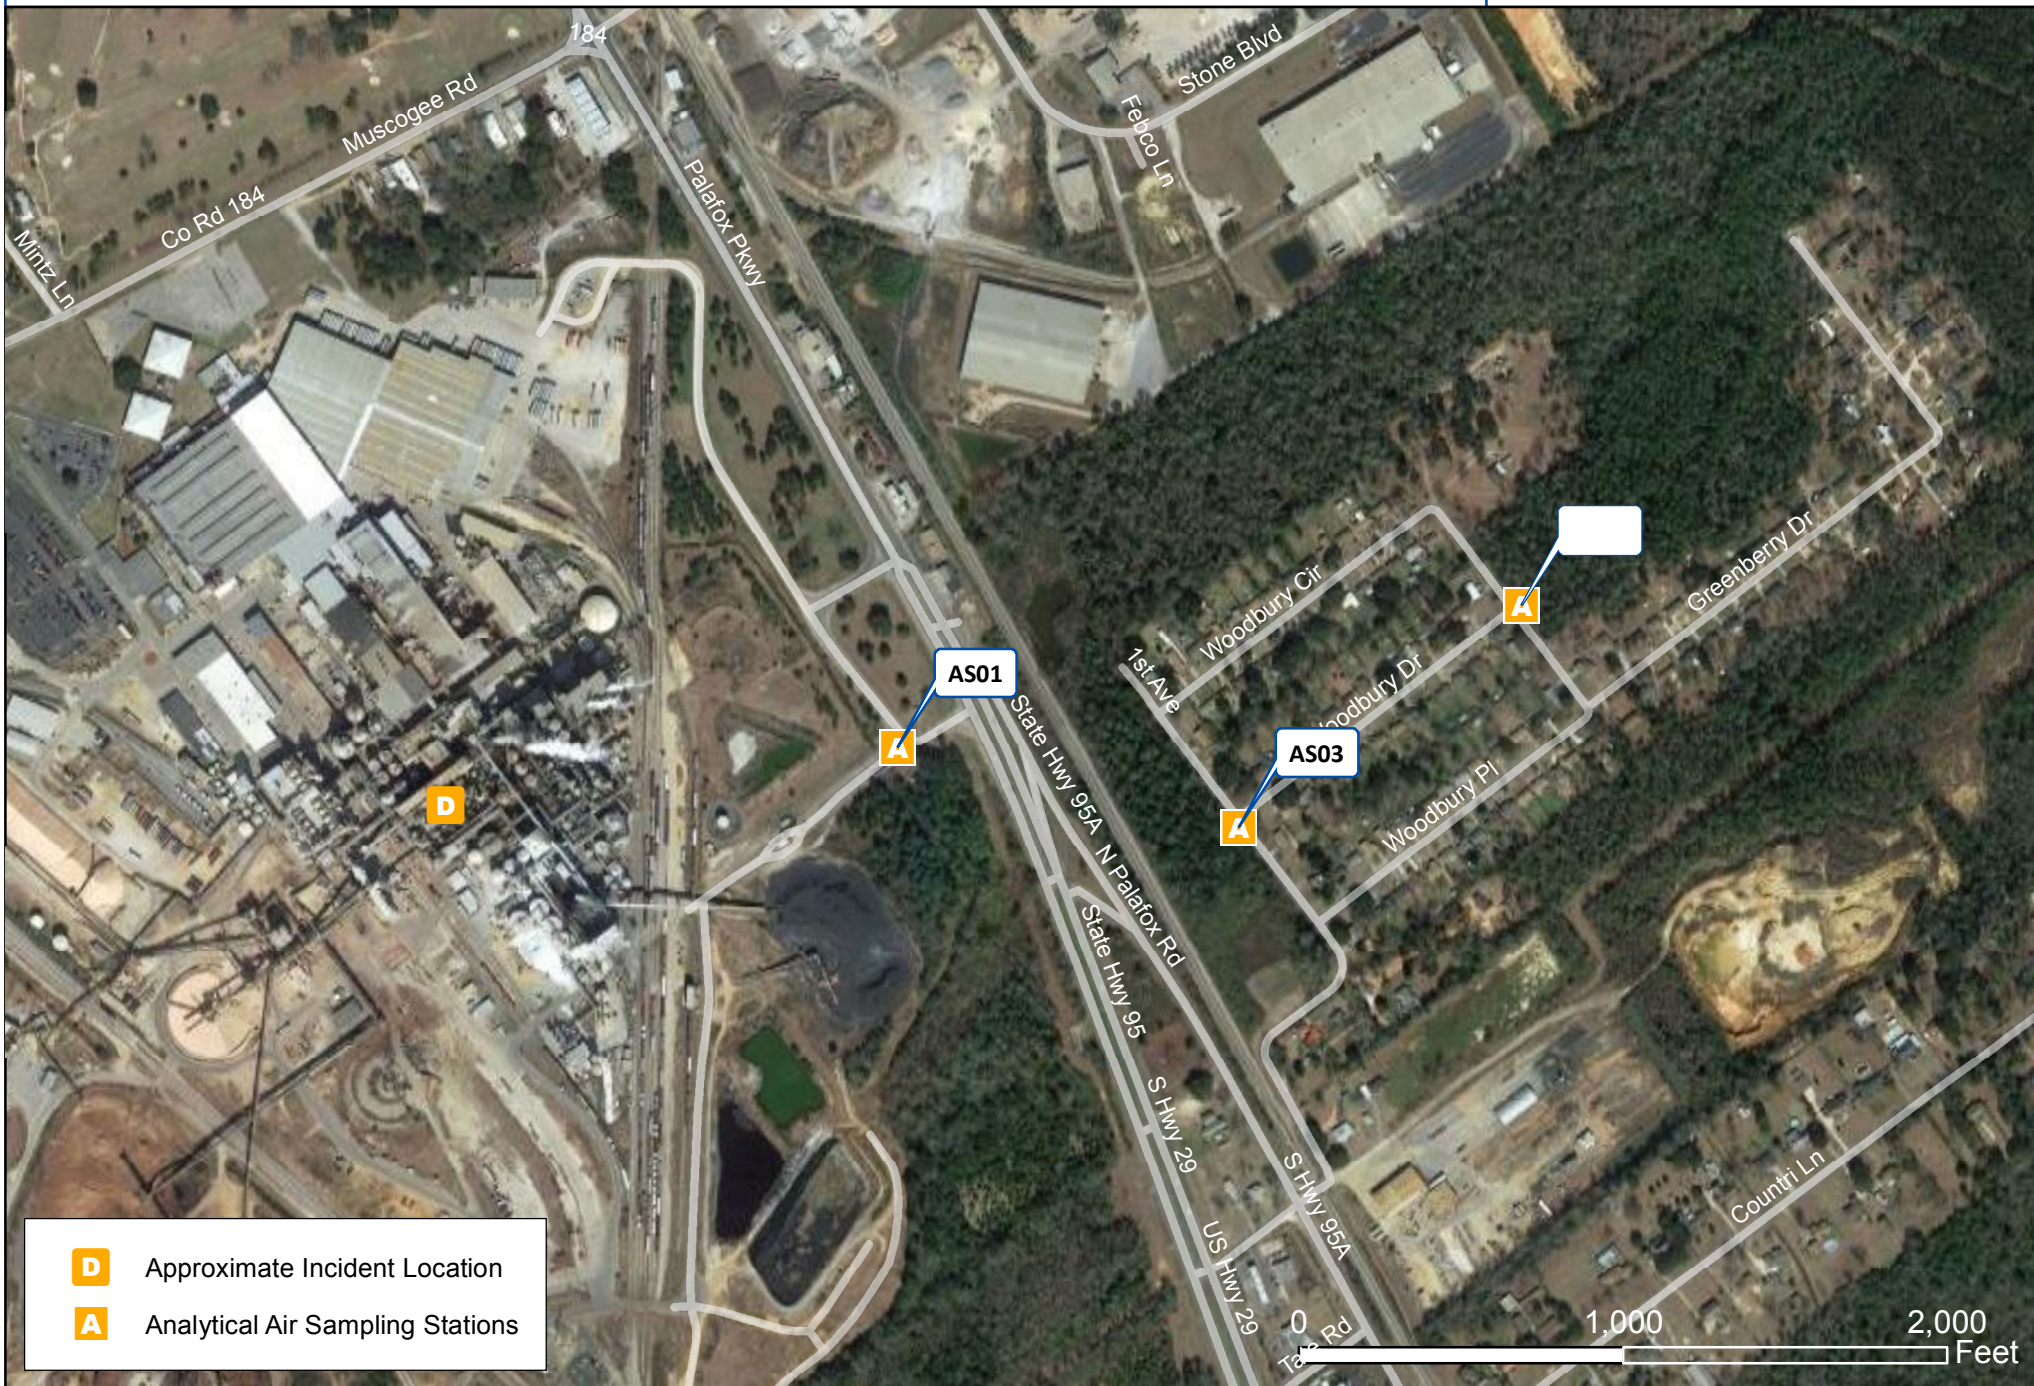
Analytical air sampling began on January 25, 2017 to assess concentrations of H₂S and DMS in ambient air in the community. All samples were sent to American Industrial Hygiene Associate (AIHA) accredited laboratories for analysis of H₂S and DMS using laboratory derived analytical methods. Results to date are presented below in Table 2.

- Approximate Incident Location
- Analytical Air Sampling Stations

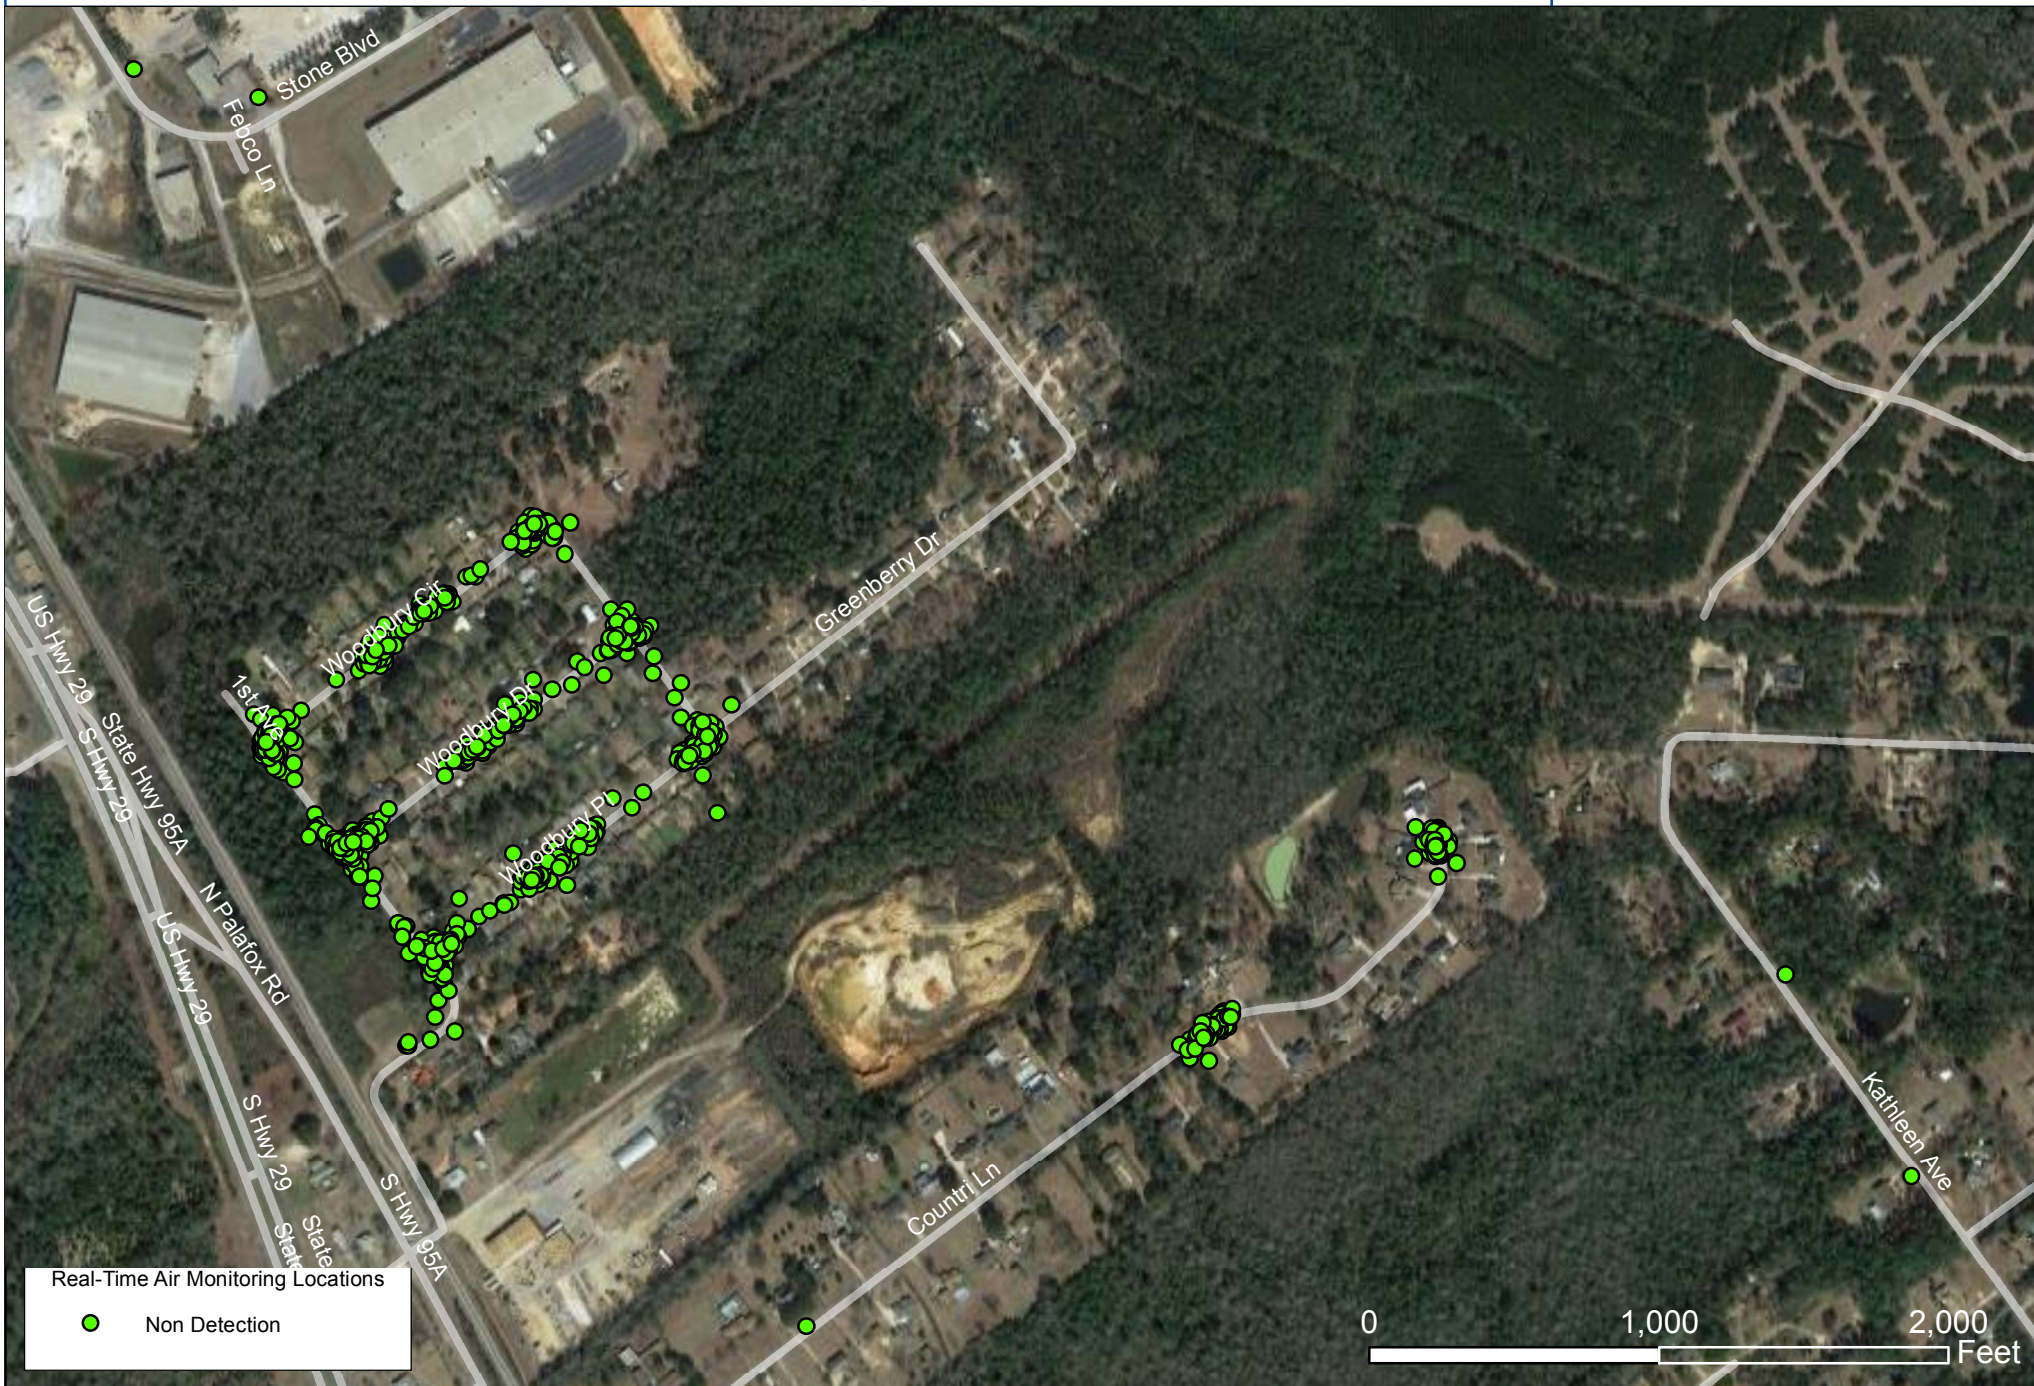
Real-Time Air Monitoring Locations

During this monitoring period, no detections of target analytes occurred using hand-held air monitoring equipment. Table 1, presented below, summarizes data for hand-held instruments.

● Non Detection
