BMA Hardbottom Cell-Wide Monitoring Plan 2015 Update

Cheryl Miller, President, Coastal Eco-Group Inc.

2015 BMA Survey Timeline and Progress

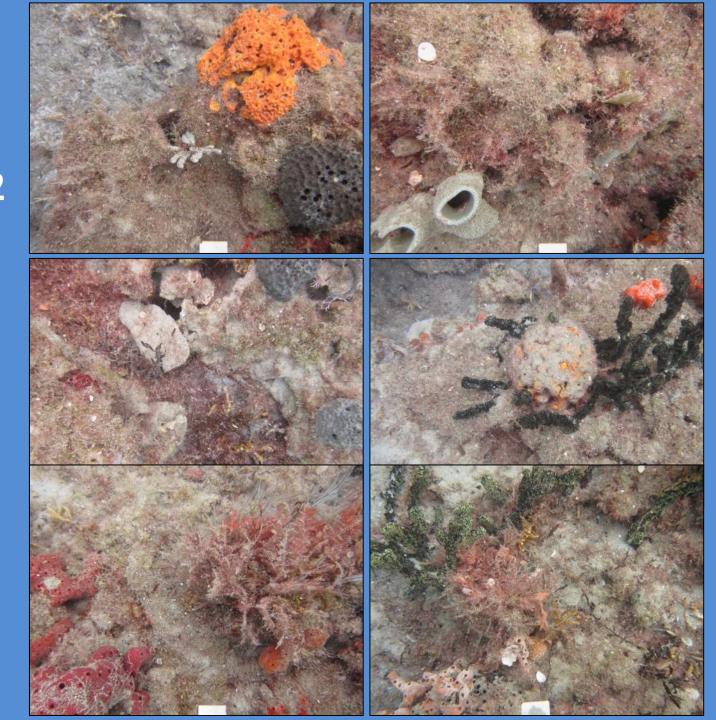
Offshore
Monitoring
Station R-92
Pointcount
Images
7/16/2015 Baseline
Monitoring Survey

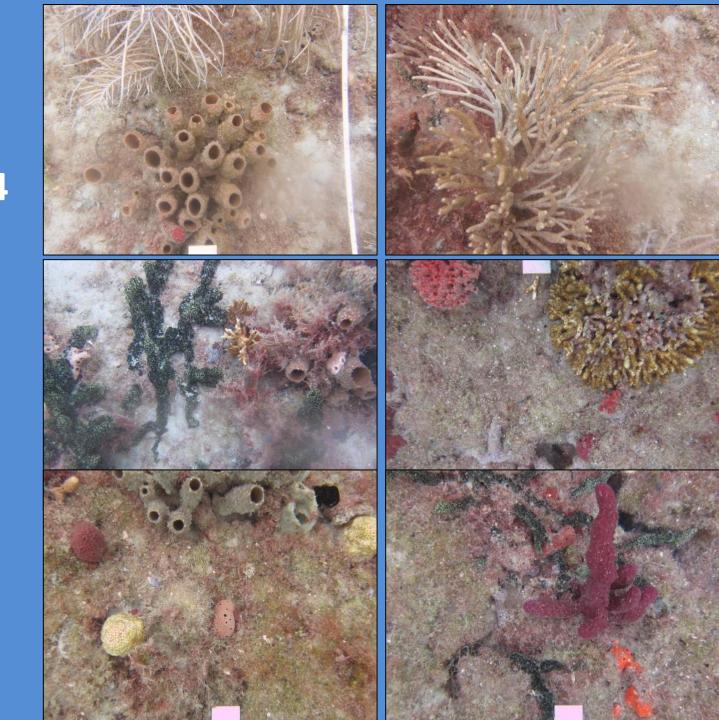
Offshore
Monitoring
Station R-94
Pointcount
Images
7/16/2015 Baseline
Monitoring Survey

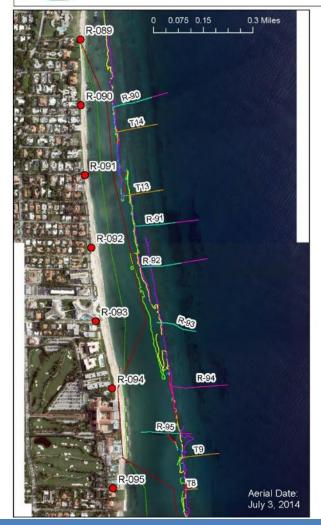
Comparison of Pre-Construction Hardbottom Edge Mapping Surveys October 2011, November 2013 and July 2014

October 25, 2011 Hardbottom Edge Relief No Relief Data High Relief Intermediate Relief Low Relief **DNR Monuments** Mid-Town 2014 **ETOF** Mid-Town 2014 CTOF 2014 Mid-Town Regulatory Transects 2014 Mid-Town Sediment Transects 2014 BMA Transects and Extensions

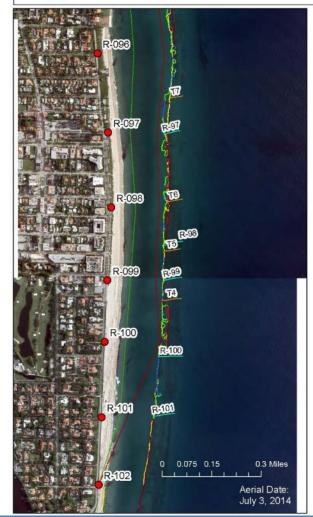
Comparison of Pre-Construction Hardbottom Edge Mapping Surveys October 2011, November 2013 and July 2014

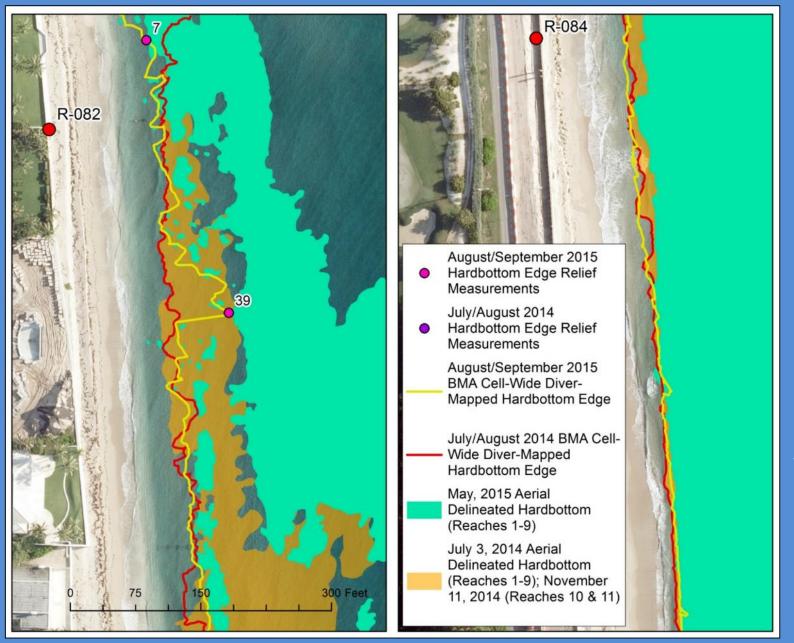
May 20, 2015 Aerial

Variability in nearshore exposure in Reach 2- 2014 vs. 2015

This variability in hardbottom exposure highlights the importance of more frequent aerial surveys and mapping and in situ diver edge mapping.

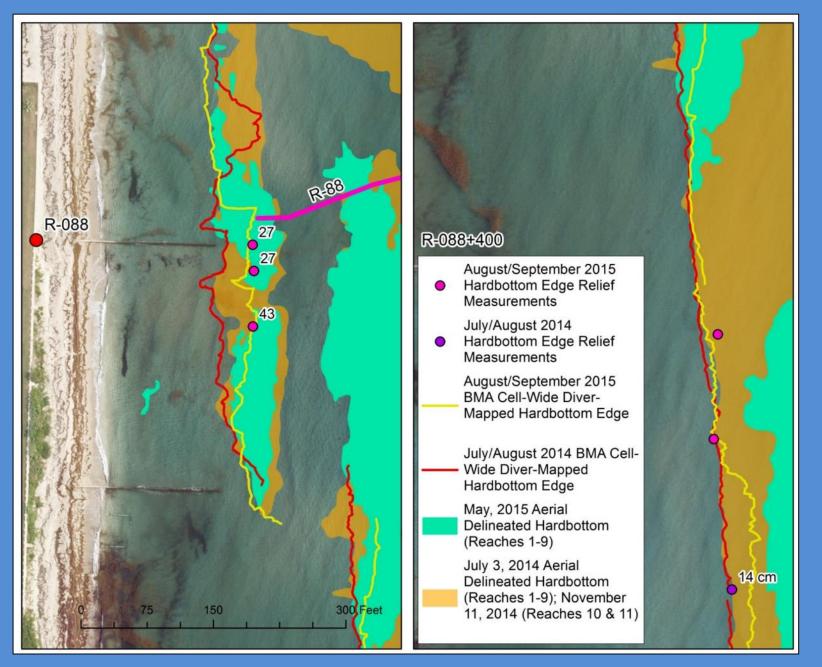
May 20, 2015 Aerial

Variability in nearshore exposure in Reach 3 north of Mid-Town Project
