Figure 2
Site Vicinity Map
Former Indian River State College
Fort Pierce, St. Lucie County, Florida

Figure 3
Water Wells within a 1-mile Radius
Former Indian River State College
Fort Pierce, St. Lucie County, Florida

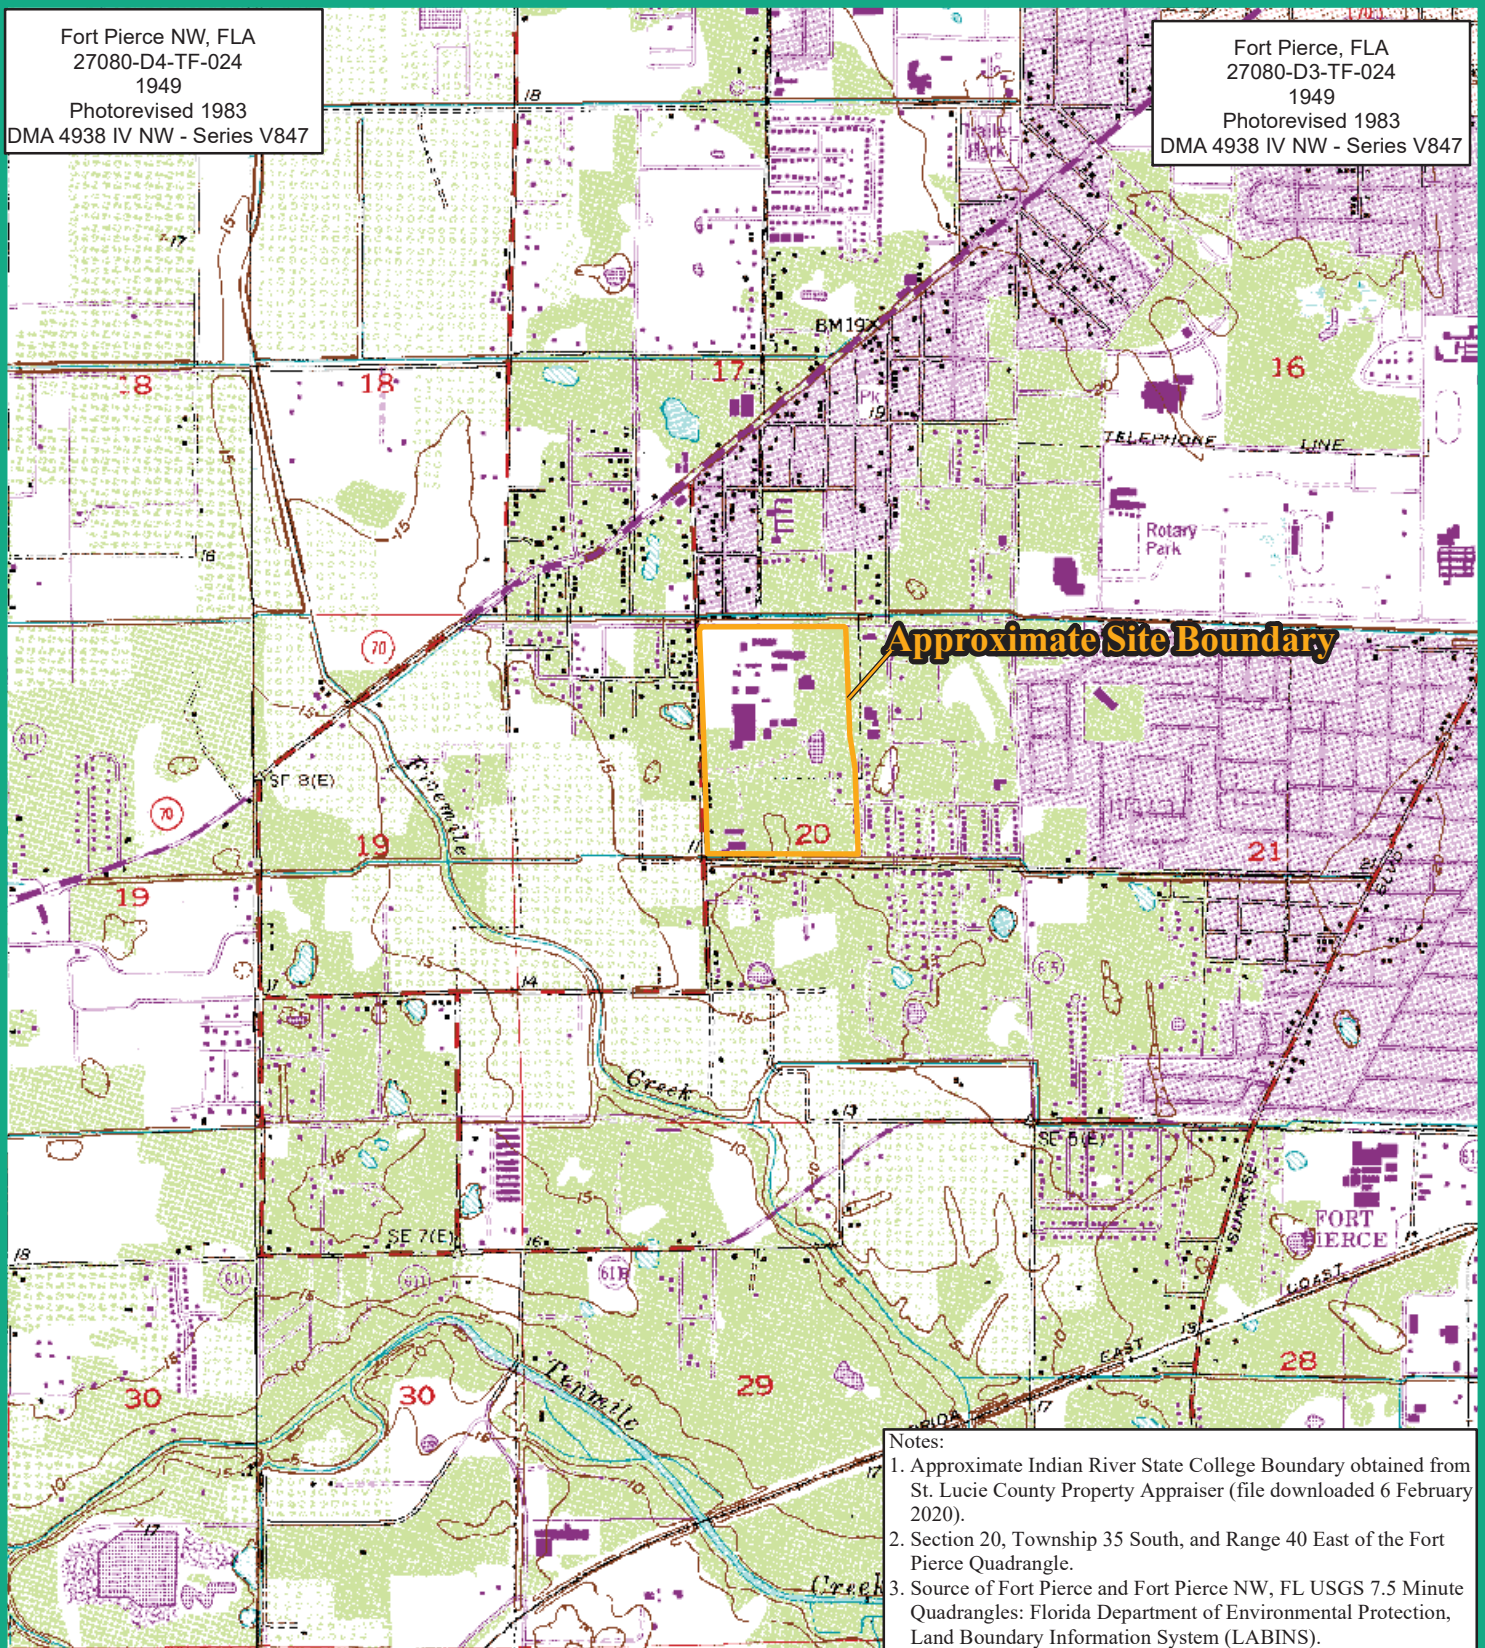
Figure 1
USGS Site Topographic Map
Former Indian River State College
Fort Pierce, St. Lucie County,
Florida

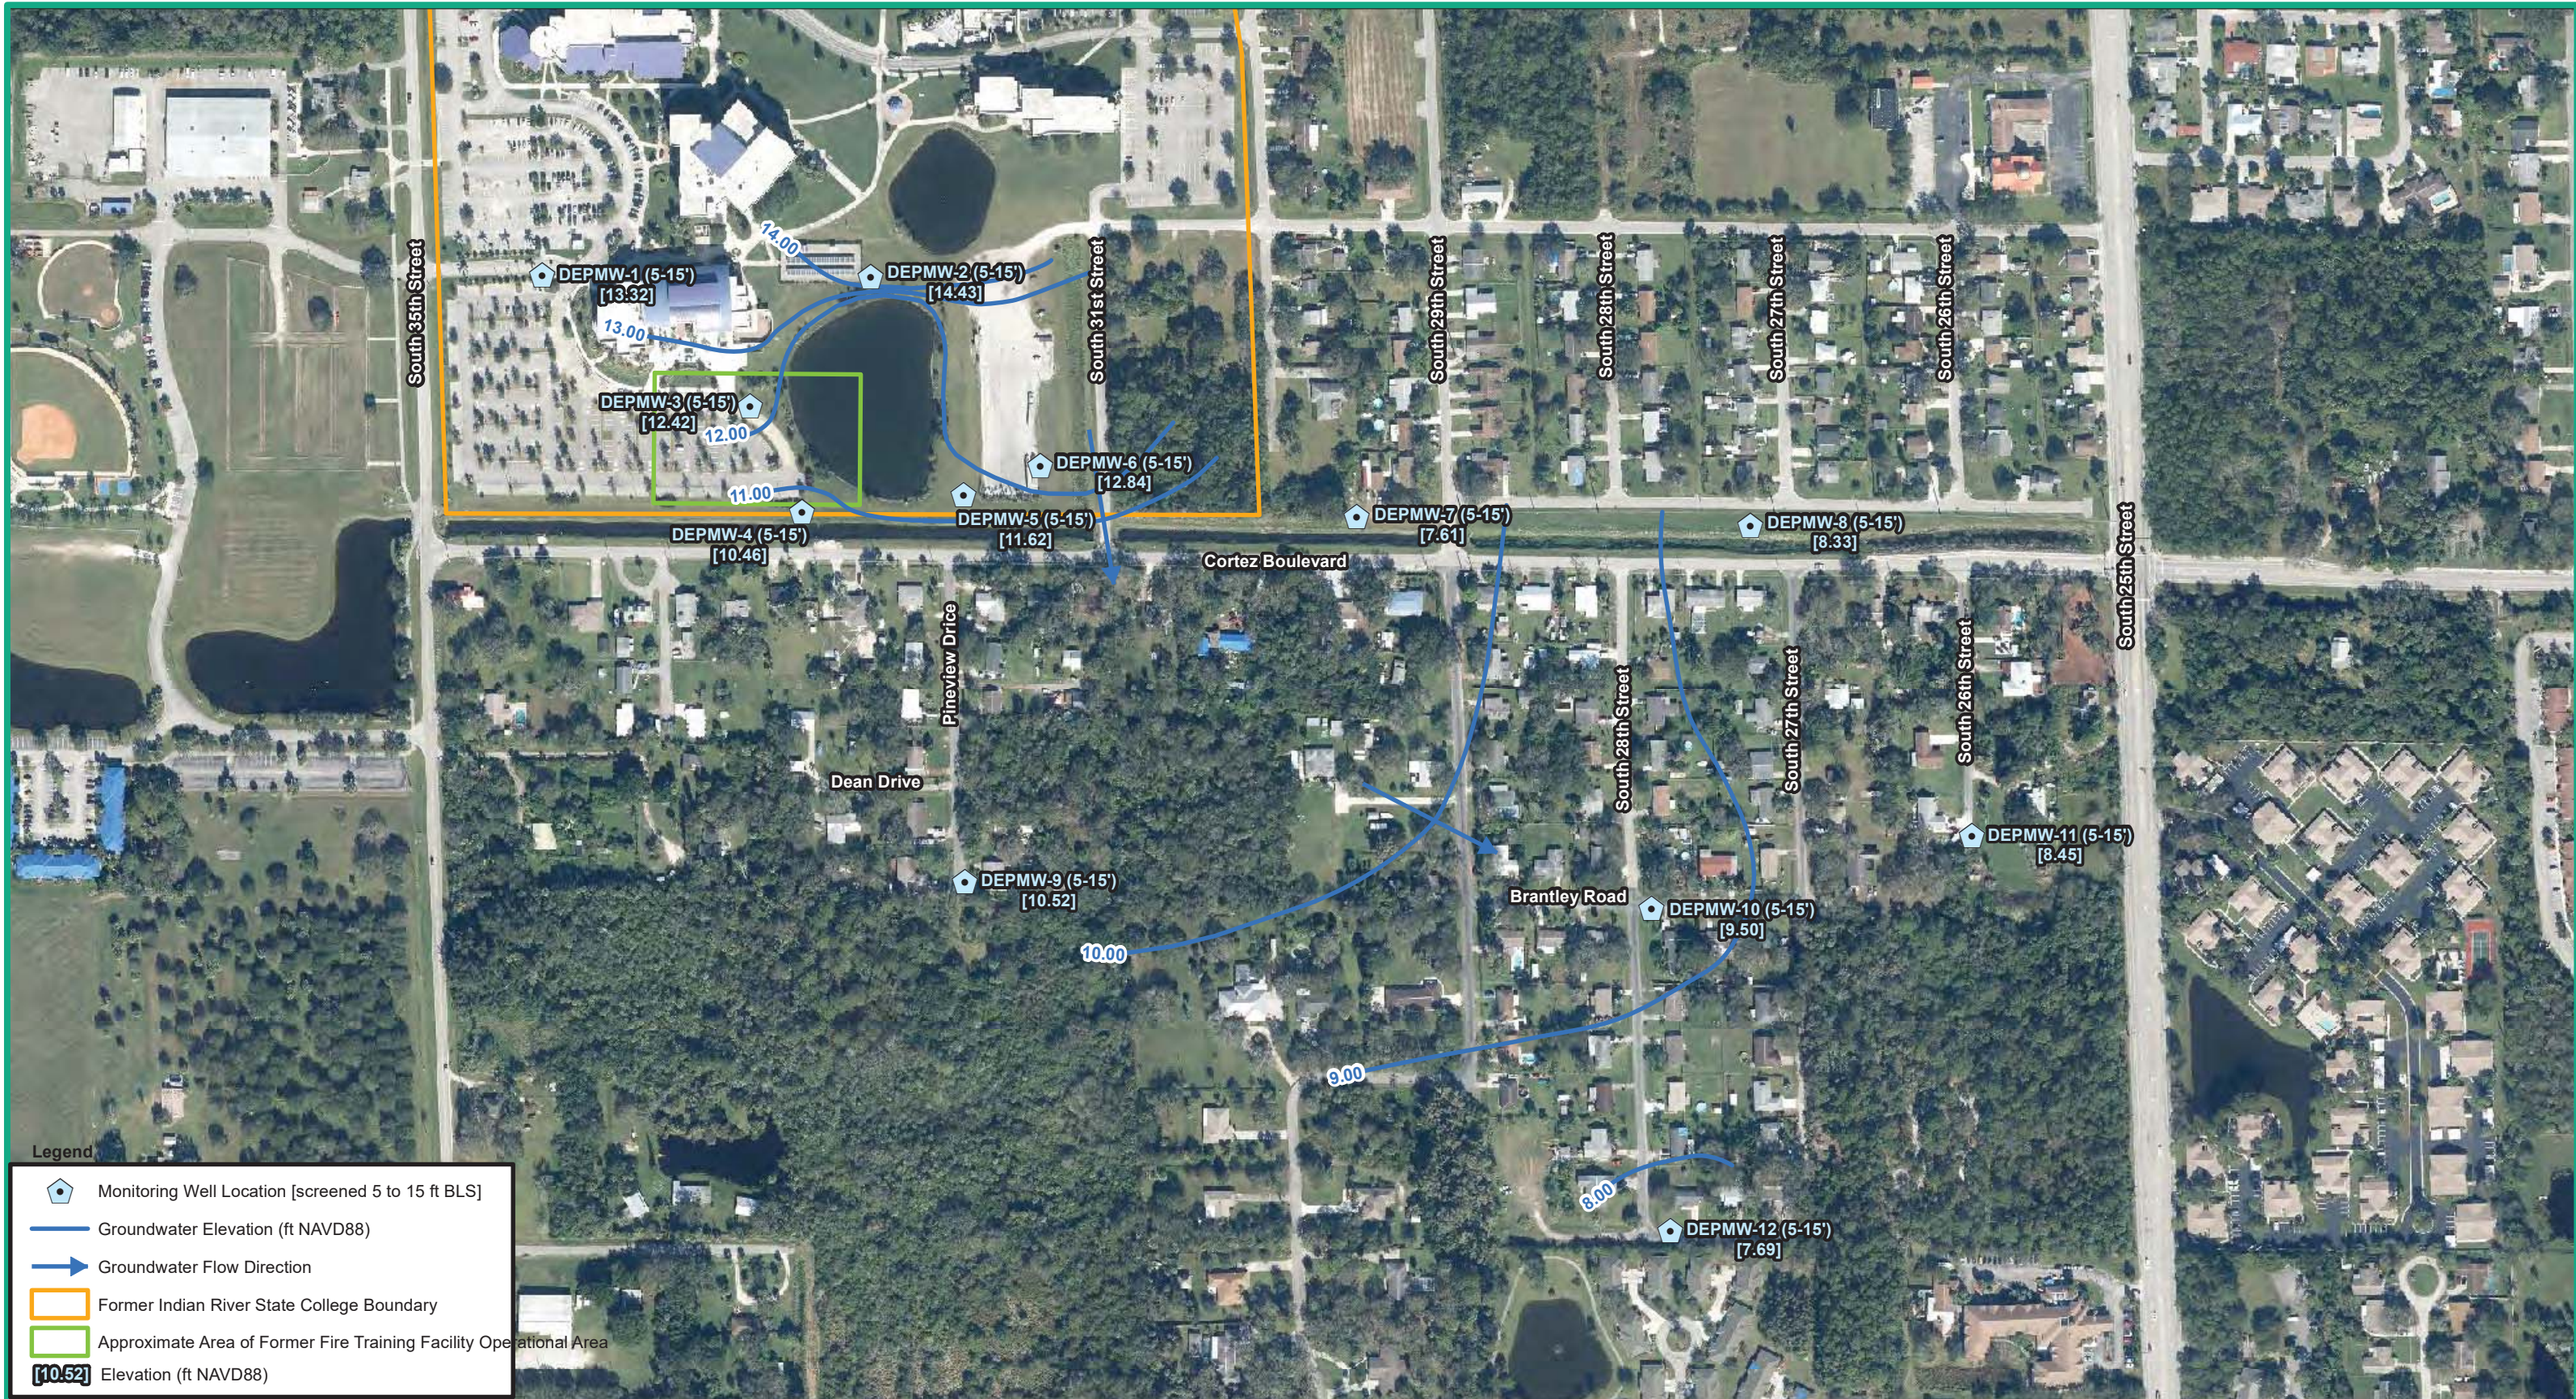
Figure 5
Groundwater Elevation Contour Map 5 to 15 ft BLS
Former Indian River State College
Fort Pierce, St. Lucie County, Florida

1. NAVD88 indicates North American Vertical Datum of 1988.
2. ft BLS indicates feet below land surface.
3. Depth-to-water measurements were collected 18 May 2020.
4. Water level of the ditch parallel to Cortez Boulevard was not considered when developing groundwater elevation contours.
5. Water level elevation of retention pond was assumed approximately 11.5 feet based on field observation.
6. Approximate Indian River State College Boundary obtained from St. Lucie County Property Appraiser (file downloaded 6 February 2020).
7. Source of 2017 aerial: Florida Department of Transportation Aerial Photo Look Up System website.

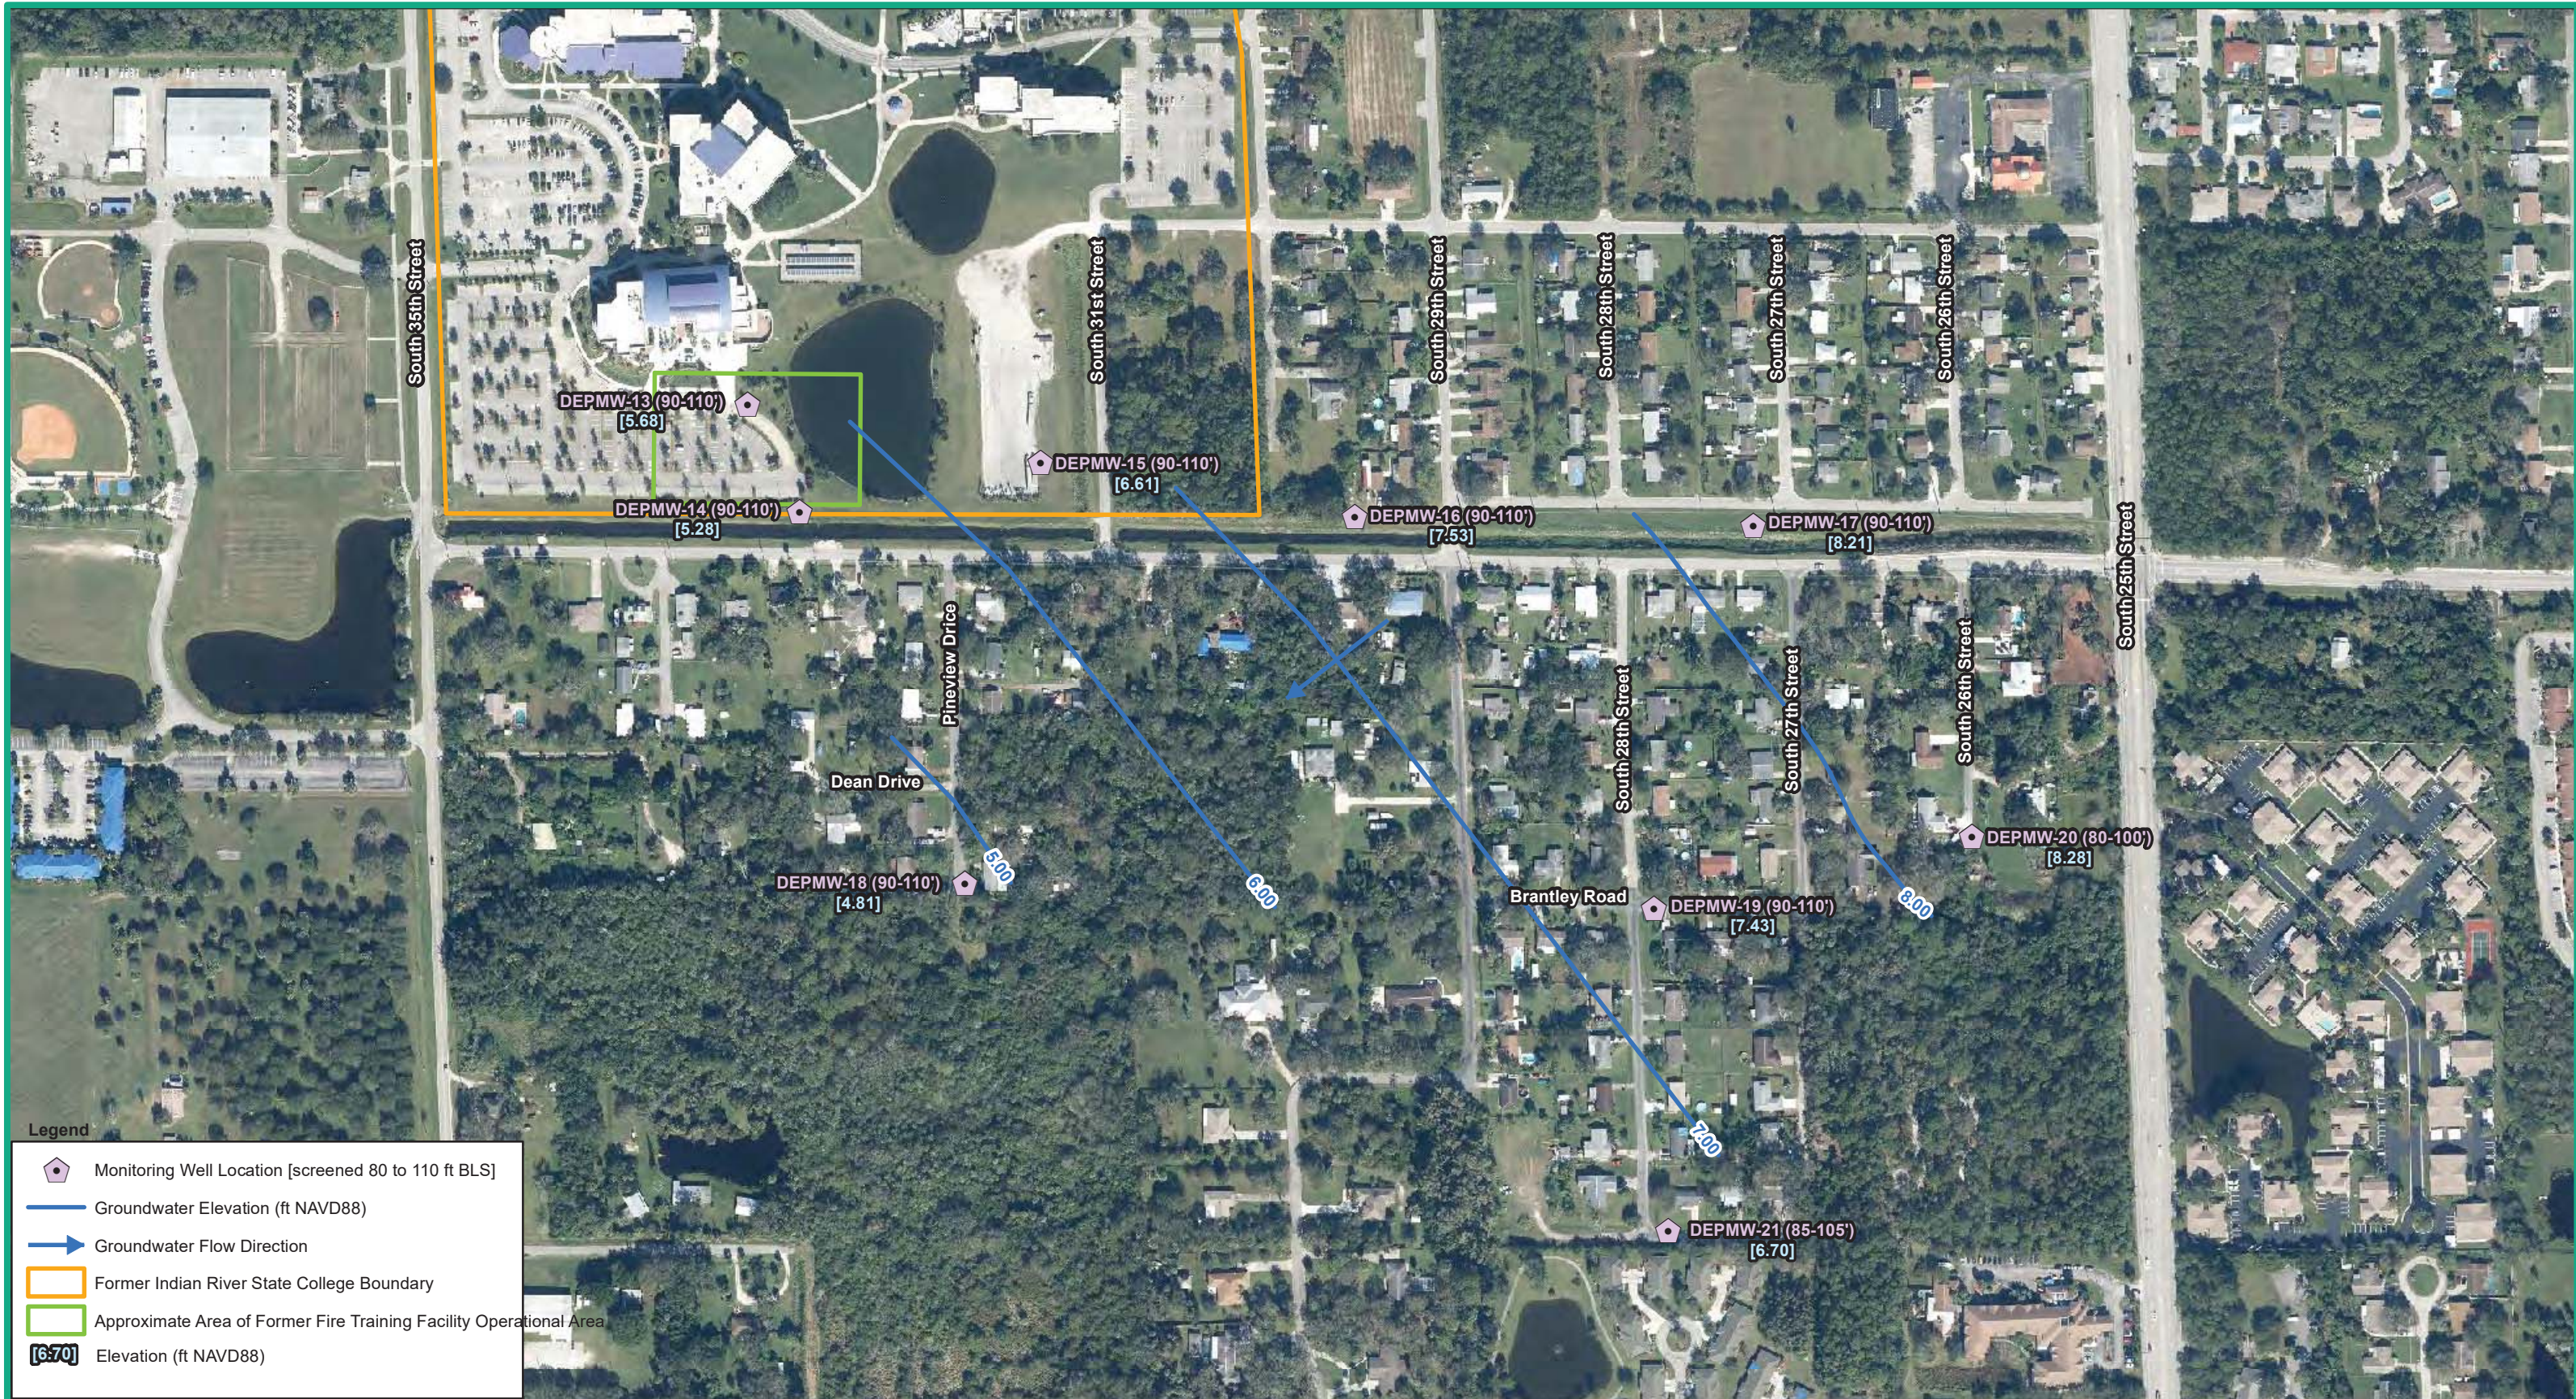
Figure 6
Groundwater Elevation Contour Map 80 to 110 ft BLS
Former Indian River State College
Fort Pierce, St. Lucie County, Florida

1. NAVD88 indicates North American Vertical Datum of 1988.
2. ft BLS indicates feet below land surface.
3. Depth-to-water measurements were collected 18 May 2020.
4. Approximate Indian River State College Boundary obtained from St. Lucie County Property Appraiser (file downloaded 6 February 2020).
5. Source of 2017 aerial: Florida Department of Transportation Aerial Photo Look Up System website.

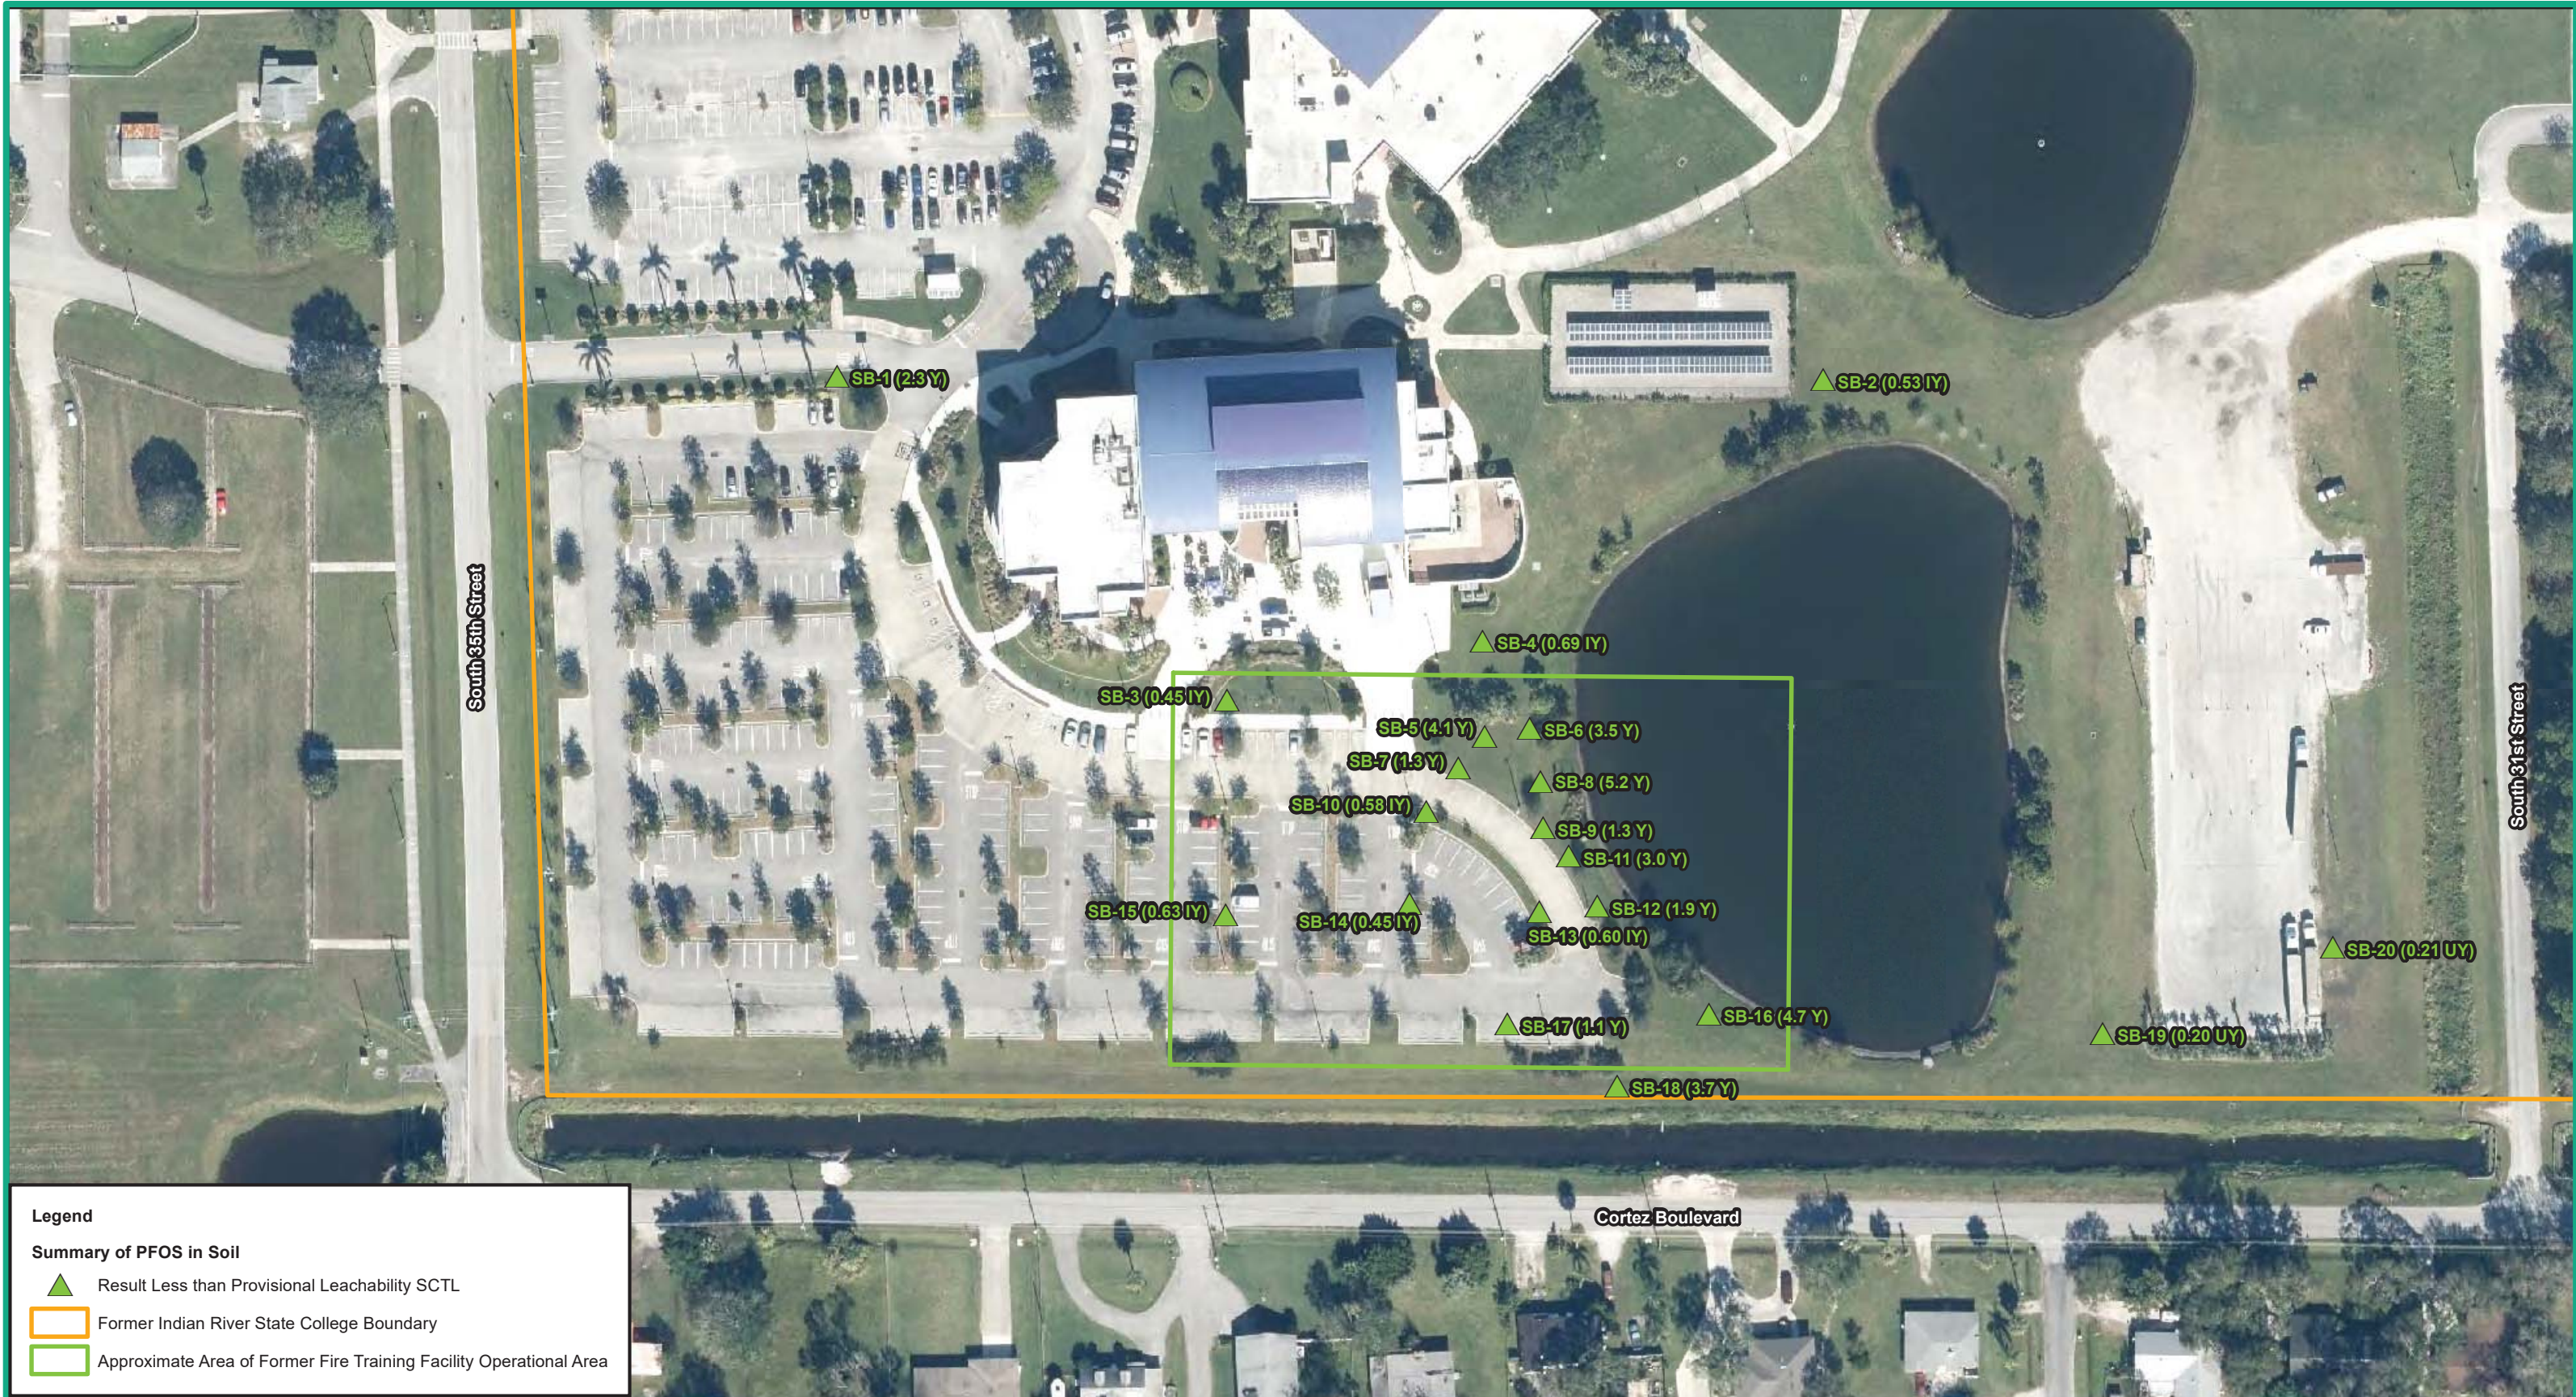
Figure 10
PFOS Results in Soil from 0 to 0.5 ft BLS
Former Indian River State College
Fort Pierce, St. Lucie County, Florida

1. Results and screening criteria are presented in micrograms per kilogram ($\mu\text{g}/\text{Kg}$).
2. I indicates result is between the laboratory method detection limit (MDL) and the laboratory practical quantitation limit.
3. U indicates that the compound was analyzed for but not detected (the MDL is shown).
4. Y indicates the laboratory analysis was from an unpreserved or improperly preserved sample.
5. ft BLS indicates feet below land surface.
6. Approximate Indian River State College Boundary obtained from St. Lucie County Property Appraiser (file downloaded 6 February 2020).
7. Source of 2017 aerial: Florida Department of Transportation Aerial Photo Look Up System website.

Provisional Cleanup Target Level	Perfluorooctanesulfonic acid (PFOS)
Leachability SCTL	7
Residential SCTL	1,300
Industrial SCTL	25,000

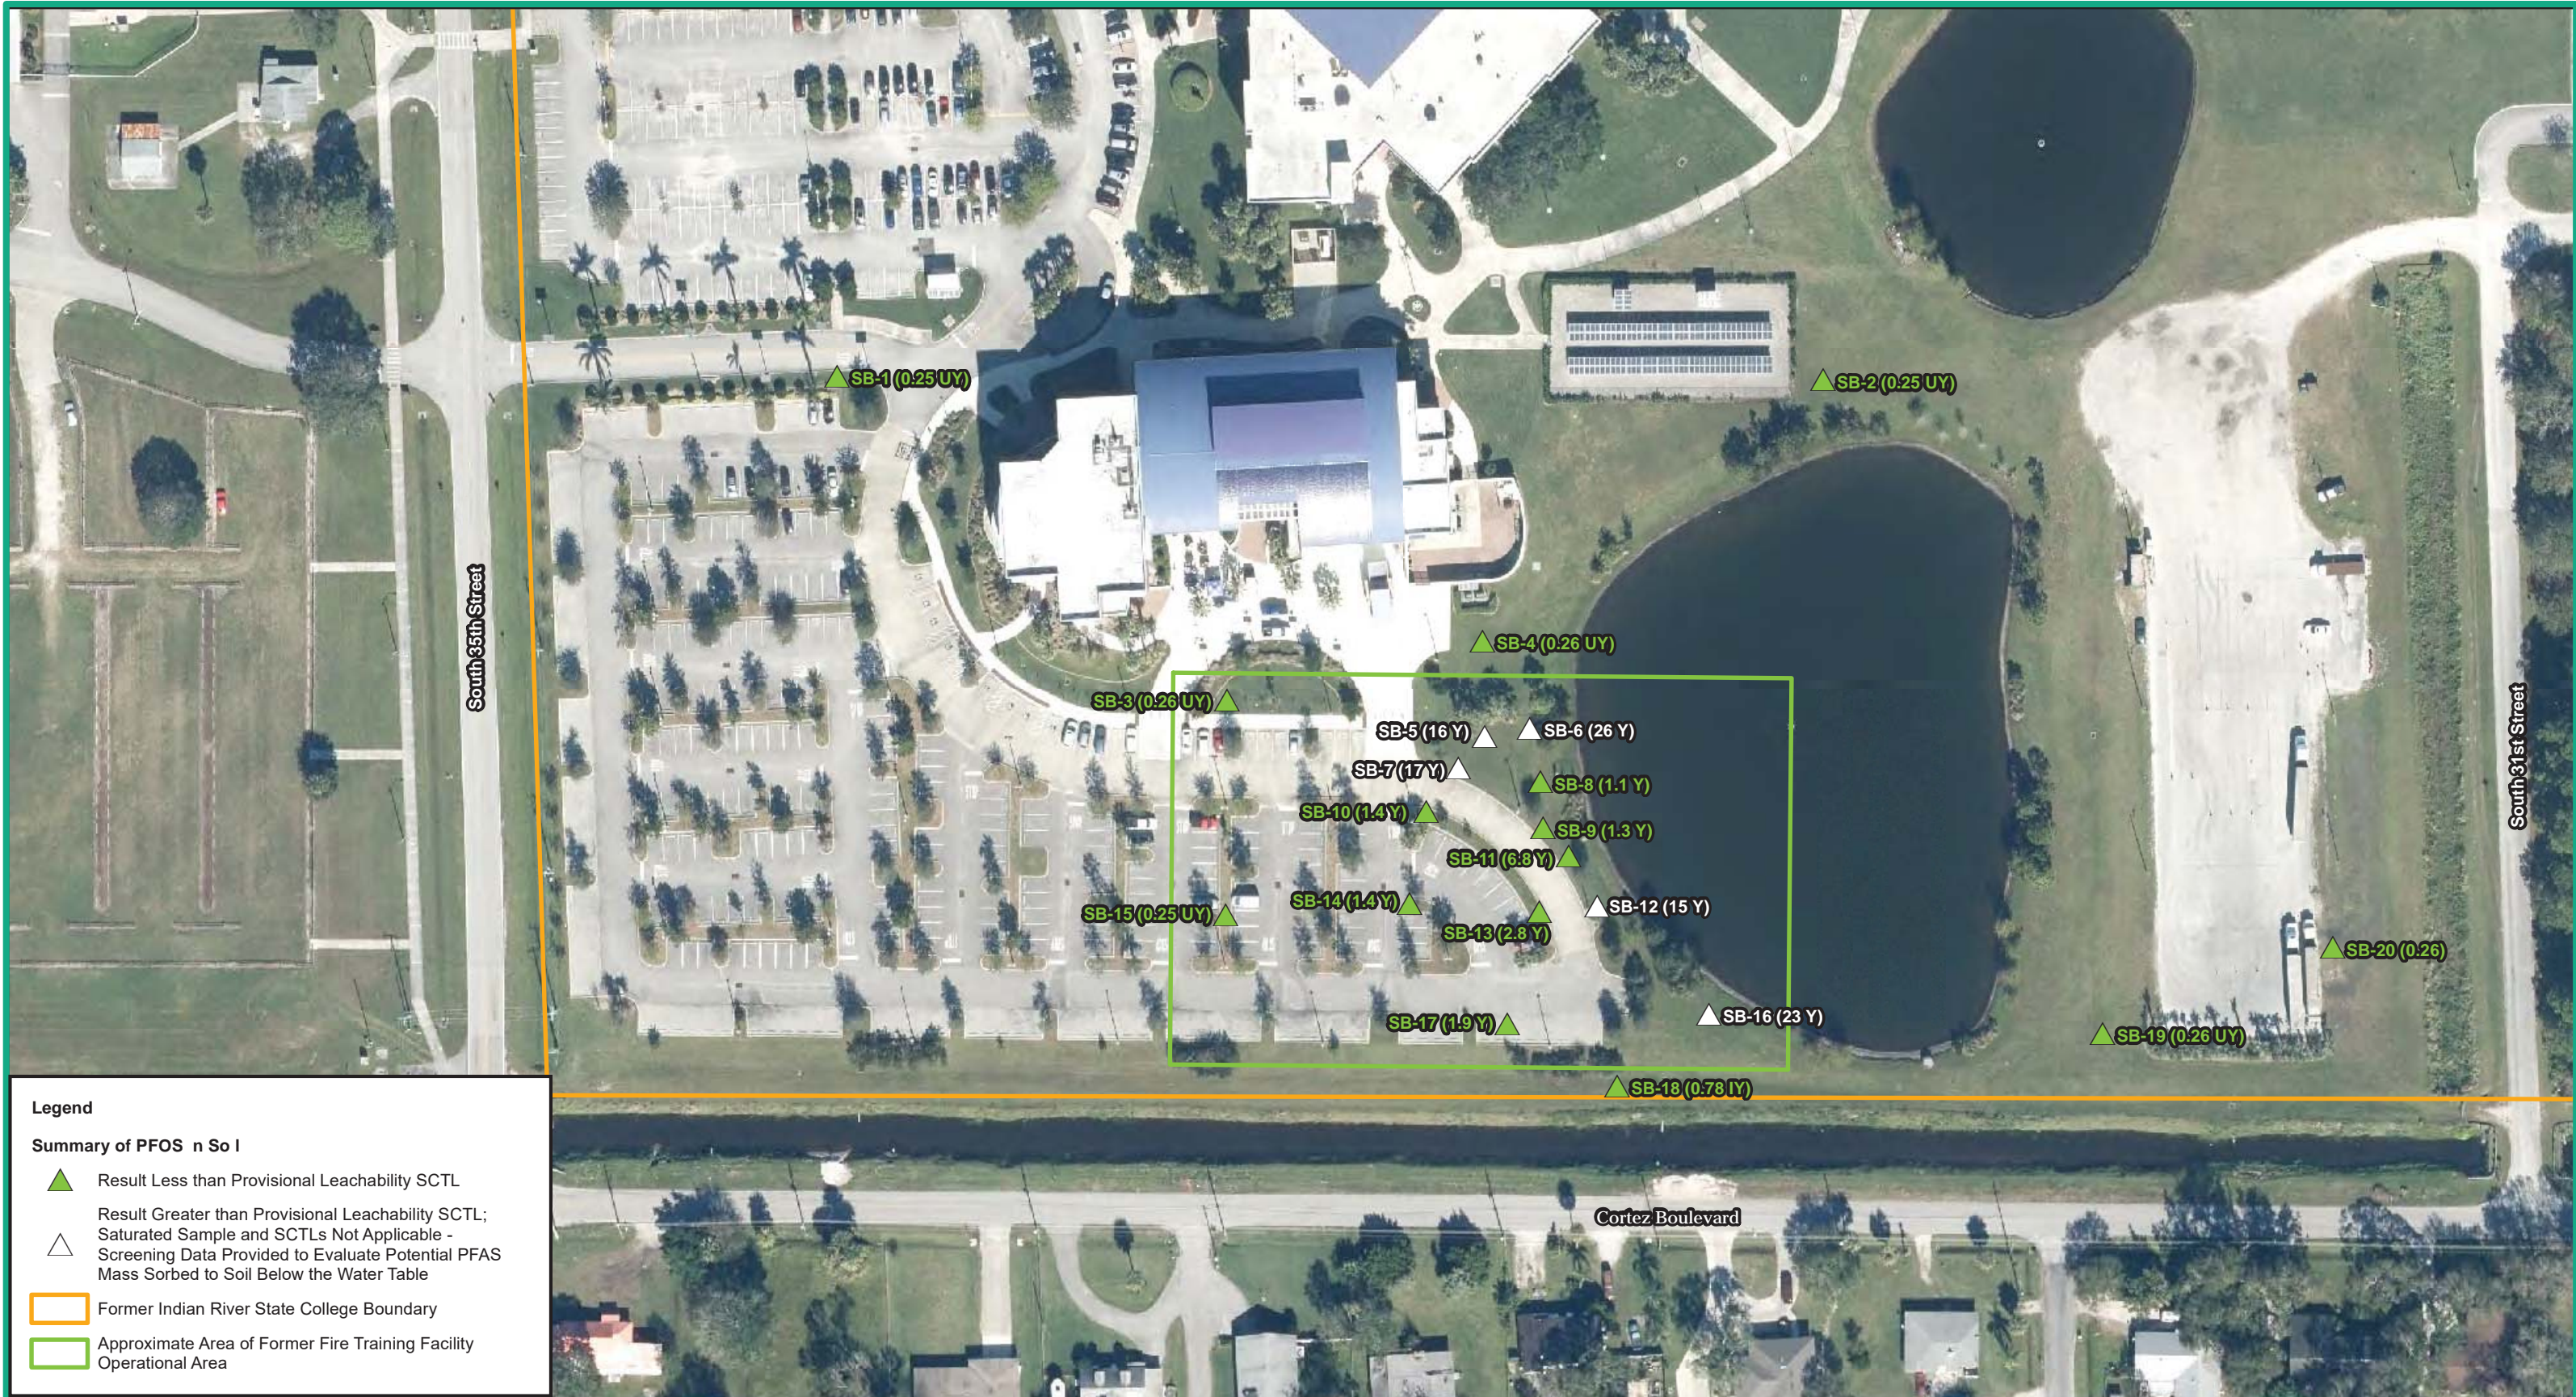
Figure 14
PFOS Results in Soil from 8 to 10 ft BLS
Former Indian River State College
Fort Pierce, St. Lucie County, Florida

- Notes:**
1. Results and screening criteria are presented in micrograms per kilogram ($\mu\text{g}/\text{Kg}$).
 2. I indicates result is between the laboratory method detection limit (MDL) and the laboratory practical quantitation limit.
 3. U indicates that the compound was analyzed for but not detected (the MDL is shown).
 4. Y indicates the laboratory analysis was from an unpreserved or improperly preserved sample.
 5. ft BLS indicates feet below land surface.
 6. Approximate Indian River State College Boundary obtained from St. Lucie County Property Appraiser (file downloaded 6 February 2020).
 7. Source of 2017 aerial: Florida Department of Transportation Aerial Photo Look Up System website.

Provisional Cleanup Target Level	Perfluorooctanesulfonic acid (PFOS)
Leachability SCTL	7
Residential SCTL	1,300
Industrial SCTL	25,000

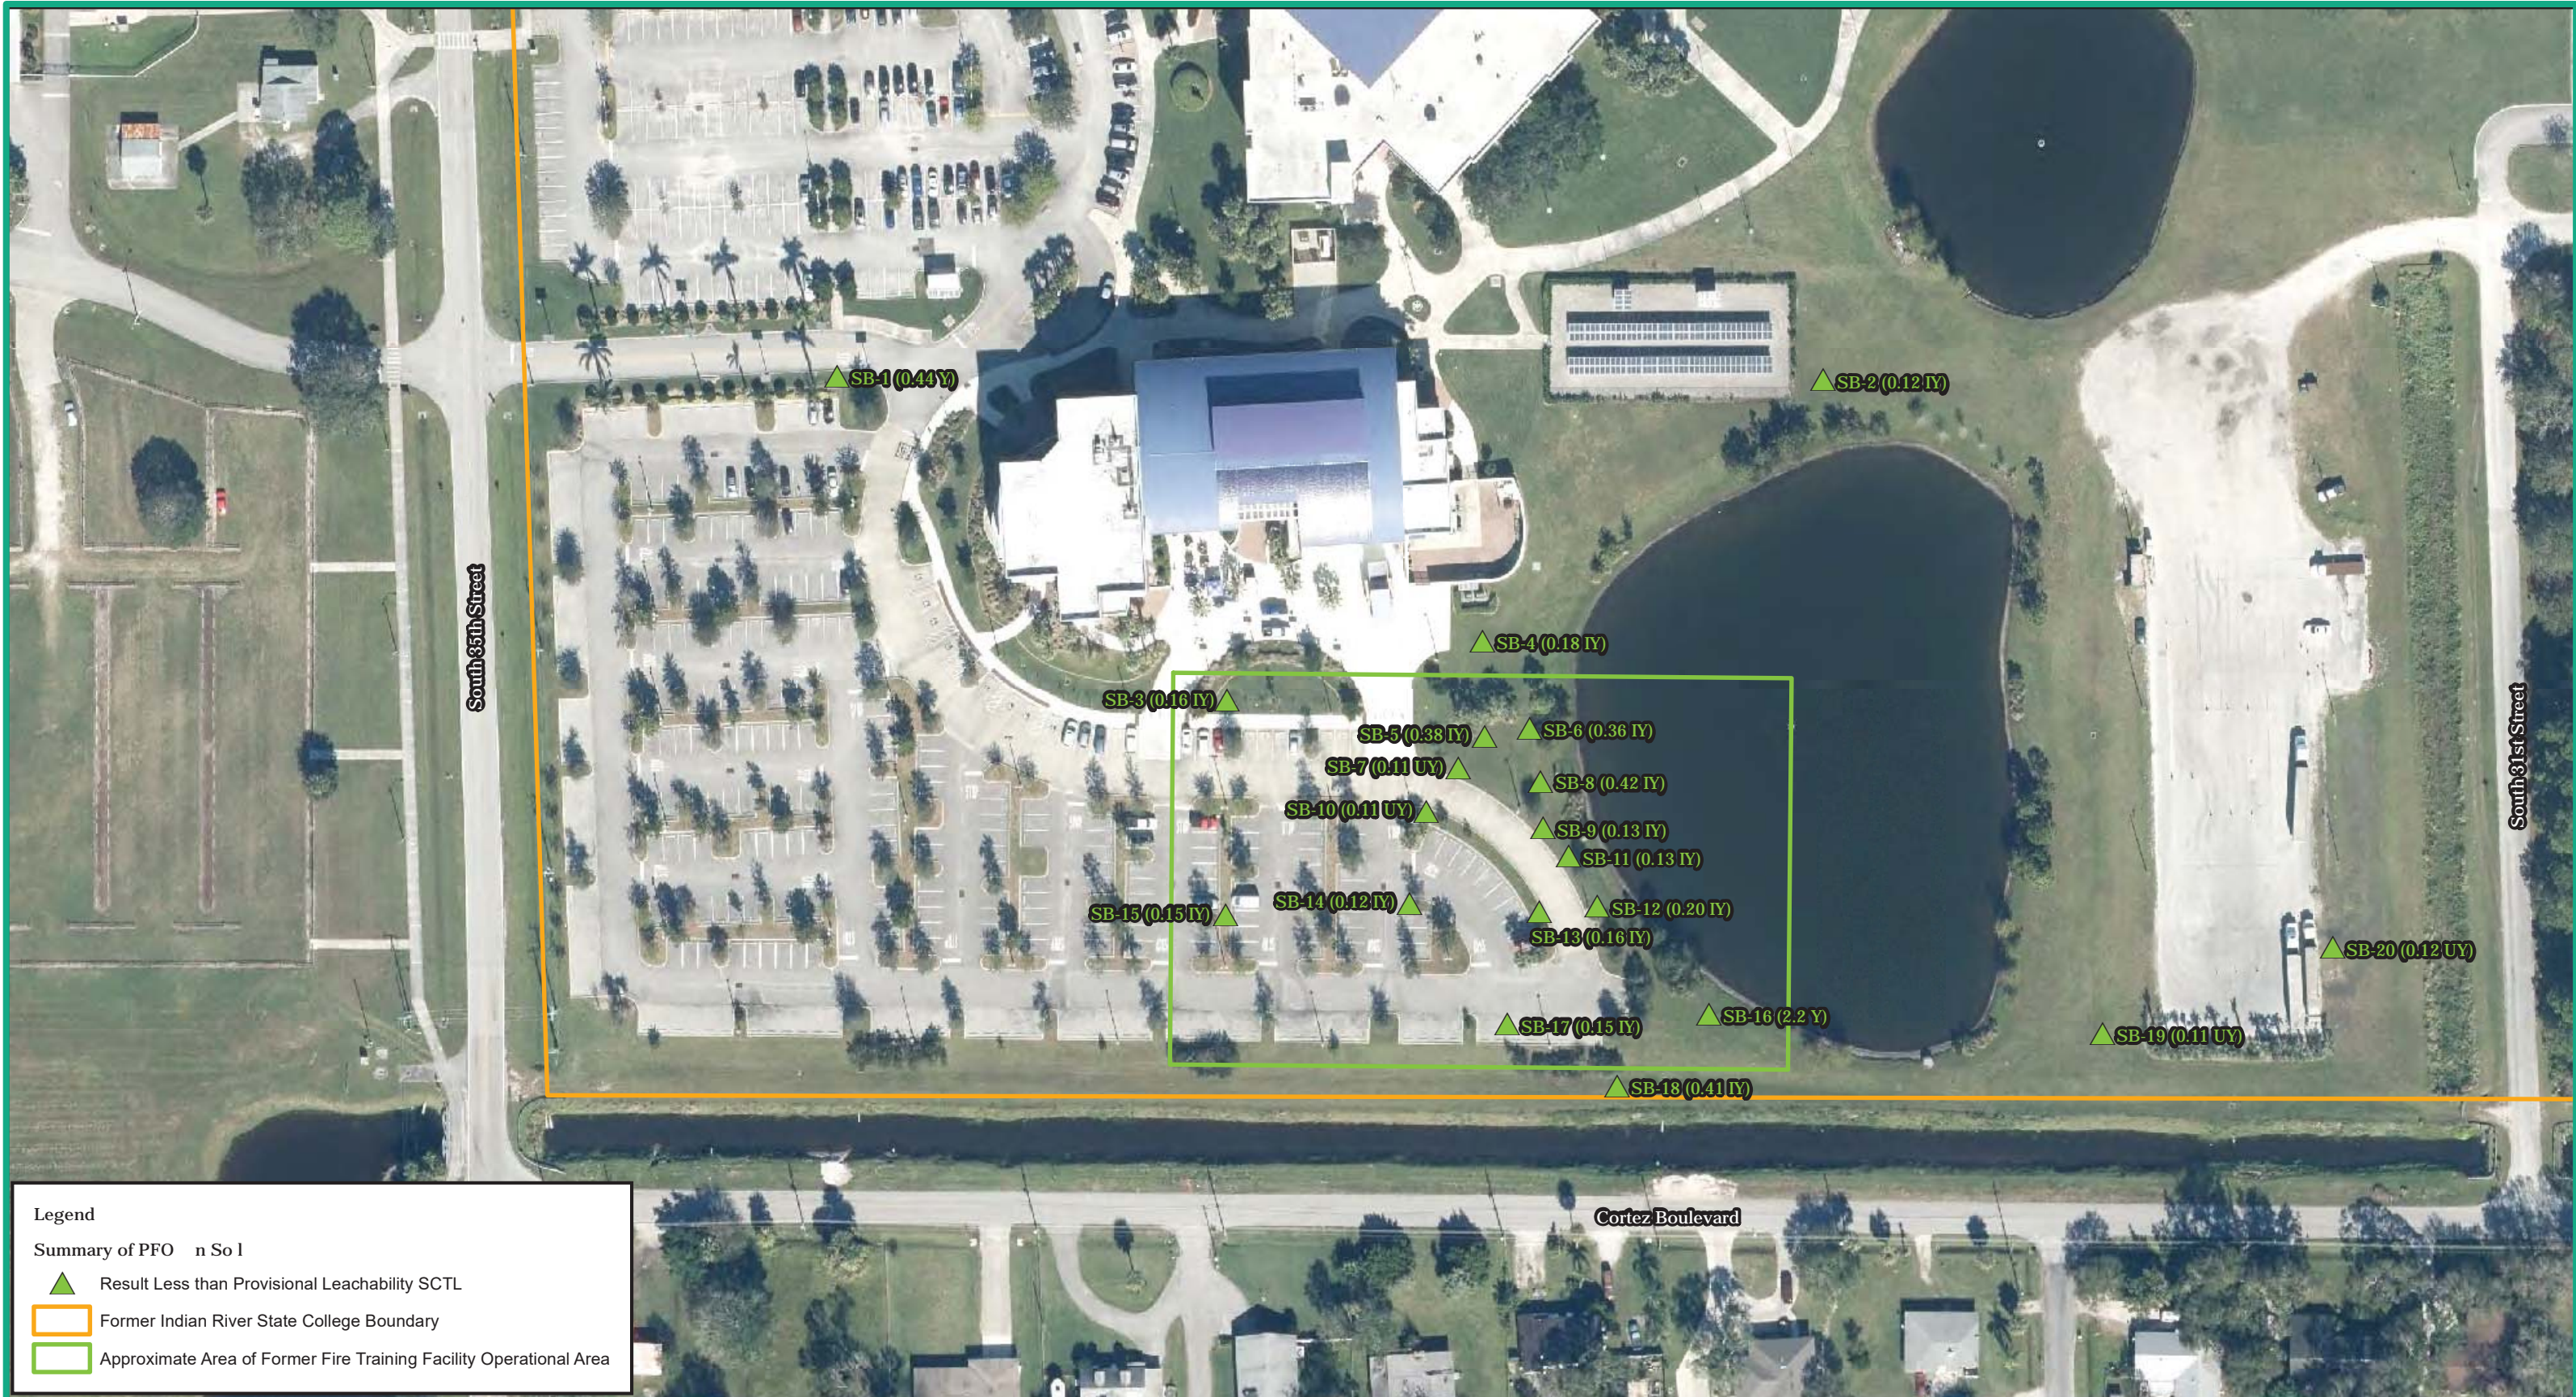
Figure 17
PFOA Results in Soil from 2 to 4 ft BLS
Former Indian River State College
Fort Pierce, St. Lucie County, Florida

1. Results and screening criteria are presented in micrograms per kilogram ($\mu\text{g}/\text{Kg}$).
2. I indicates result is between the laboratory method detection limit (MDL) and the laboratory practical quantitation limit.
3. U indicates that the compound was analyzed for but not detected (the MDL is shown).
4. Y indicates the laboratory analysis was from an unpreserved or improperly preserved sample.
5. ft BLS indicates feet below land surface.
6. Approximate Indian River State College Boundary obtained from St. Lucie County Property Appraiser (file downloaded 6 February 2020).
7. Source of 2017 aerial: Florida Department of Transportation Aerial Photo Look Up System website.

Provisional Cleanup Target Level	Perfluorooctanoic acid (PFOA)
Leachability SCTL	2
Residential SCTL	1,300
Industrial SCTL	25,000
