Figure 2
Site Vicinity Map
Former Indian River State College
Fort Pierce, St. Lucie County, Florida

Figure 3
Water Wells within a 1-mile Radius
Former Indian River State College
Fort Pierce, St. Lucie County, Florida

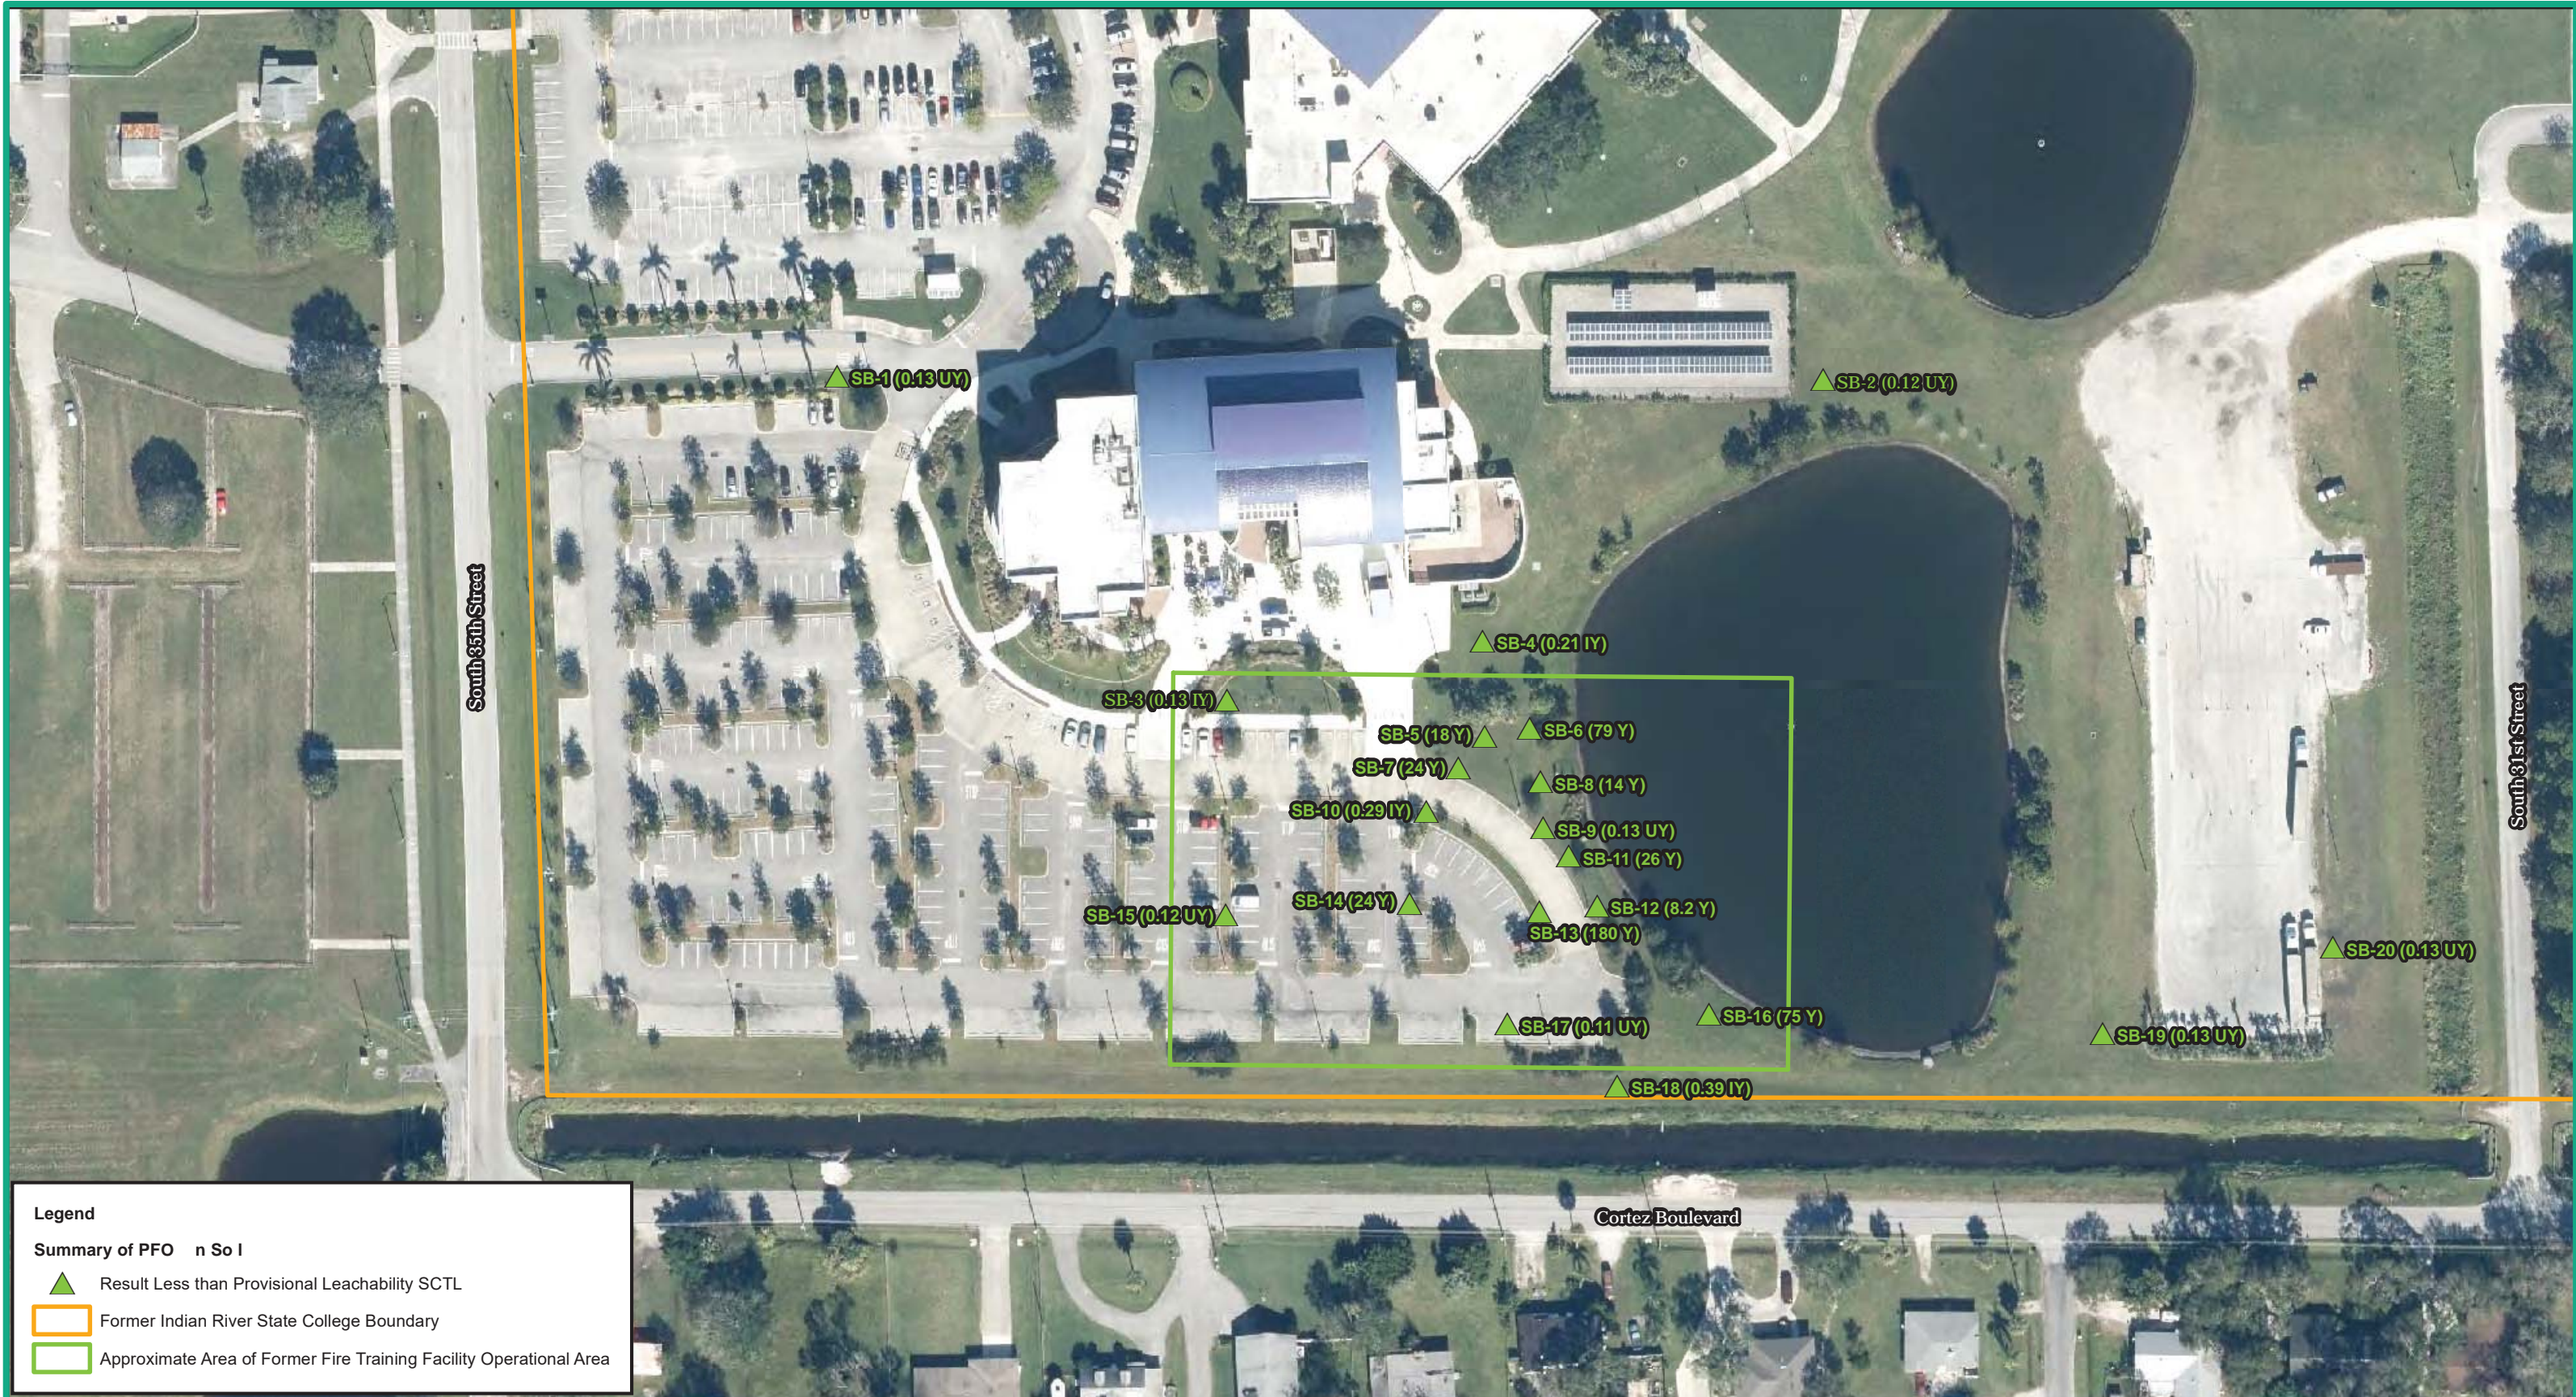
Figure 18
PFOA Results in Soil from 5 to 7 ft BLS
Former Indian River State College
Fort Pierce, St. Lucie County, Florida

- Results and screening criteria are presented in micrograms per kilogram ($\mu\text{g}/\text{Kg}$).
- I indicates result is between the laboratory method detection limit (MDL) and the laboratory practical quantitation limit.
- U indicates that the compound was analyzed for but not detected (the MDL is shown).
- Y indicates the laboratory analysis was from an unpreserved or improperly preserved sample.
- 5 ft BLS indicates feet below land surface.
- Approximate Indian River State College Boundary obtained from St. Lucie County Property Appraiser (file downloaded 6 February 2020).
- Source of 2017 aerial: Florida Department of Transportation Aerial Photo Look Up System website.

Provisional Cleanup Target Level	Perfluorooctanoic acid (PFO ₈)
Leachability SCTL	2
Residential SCTL	1,300
Industrial SCTL	25,000
