**FANNING SPRINGS
STATE PARK**
Park Chapter

SUWANNEE RIVER REGION

Fanning Springs State Park

Planning Region: Suwannee River

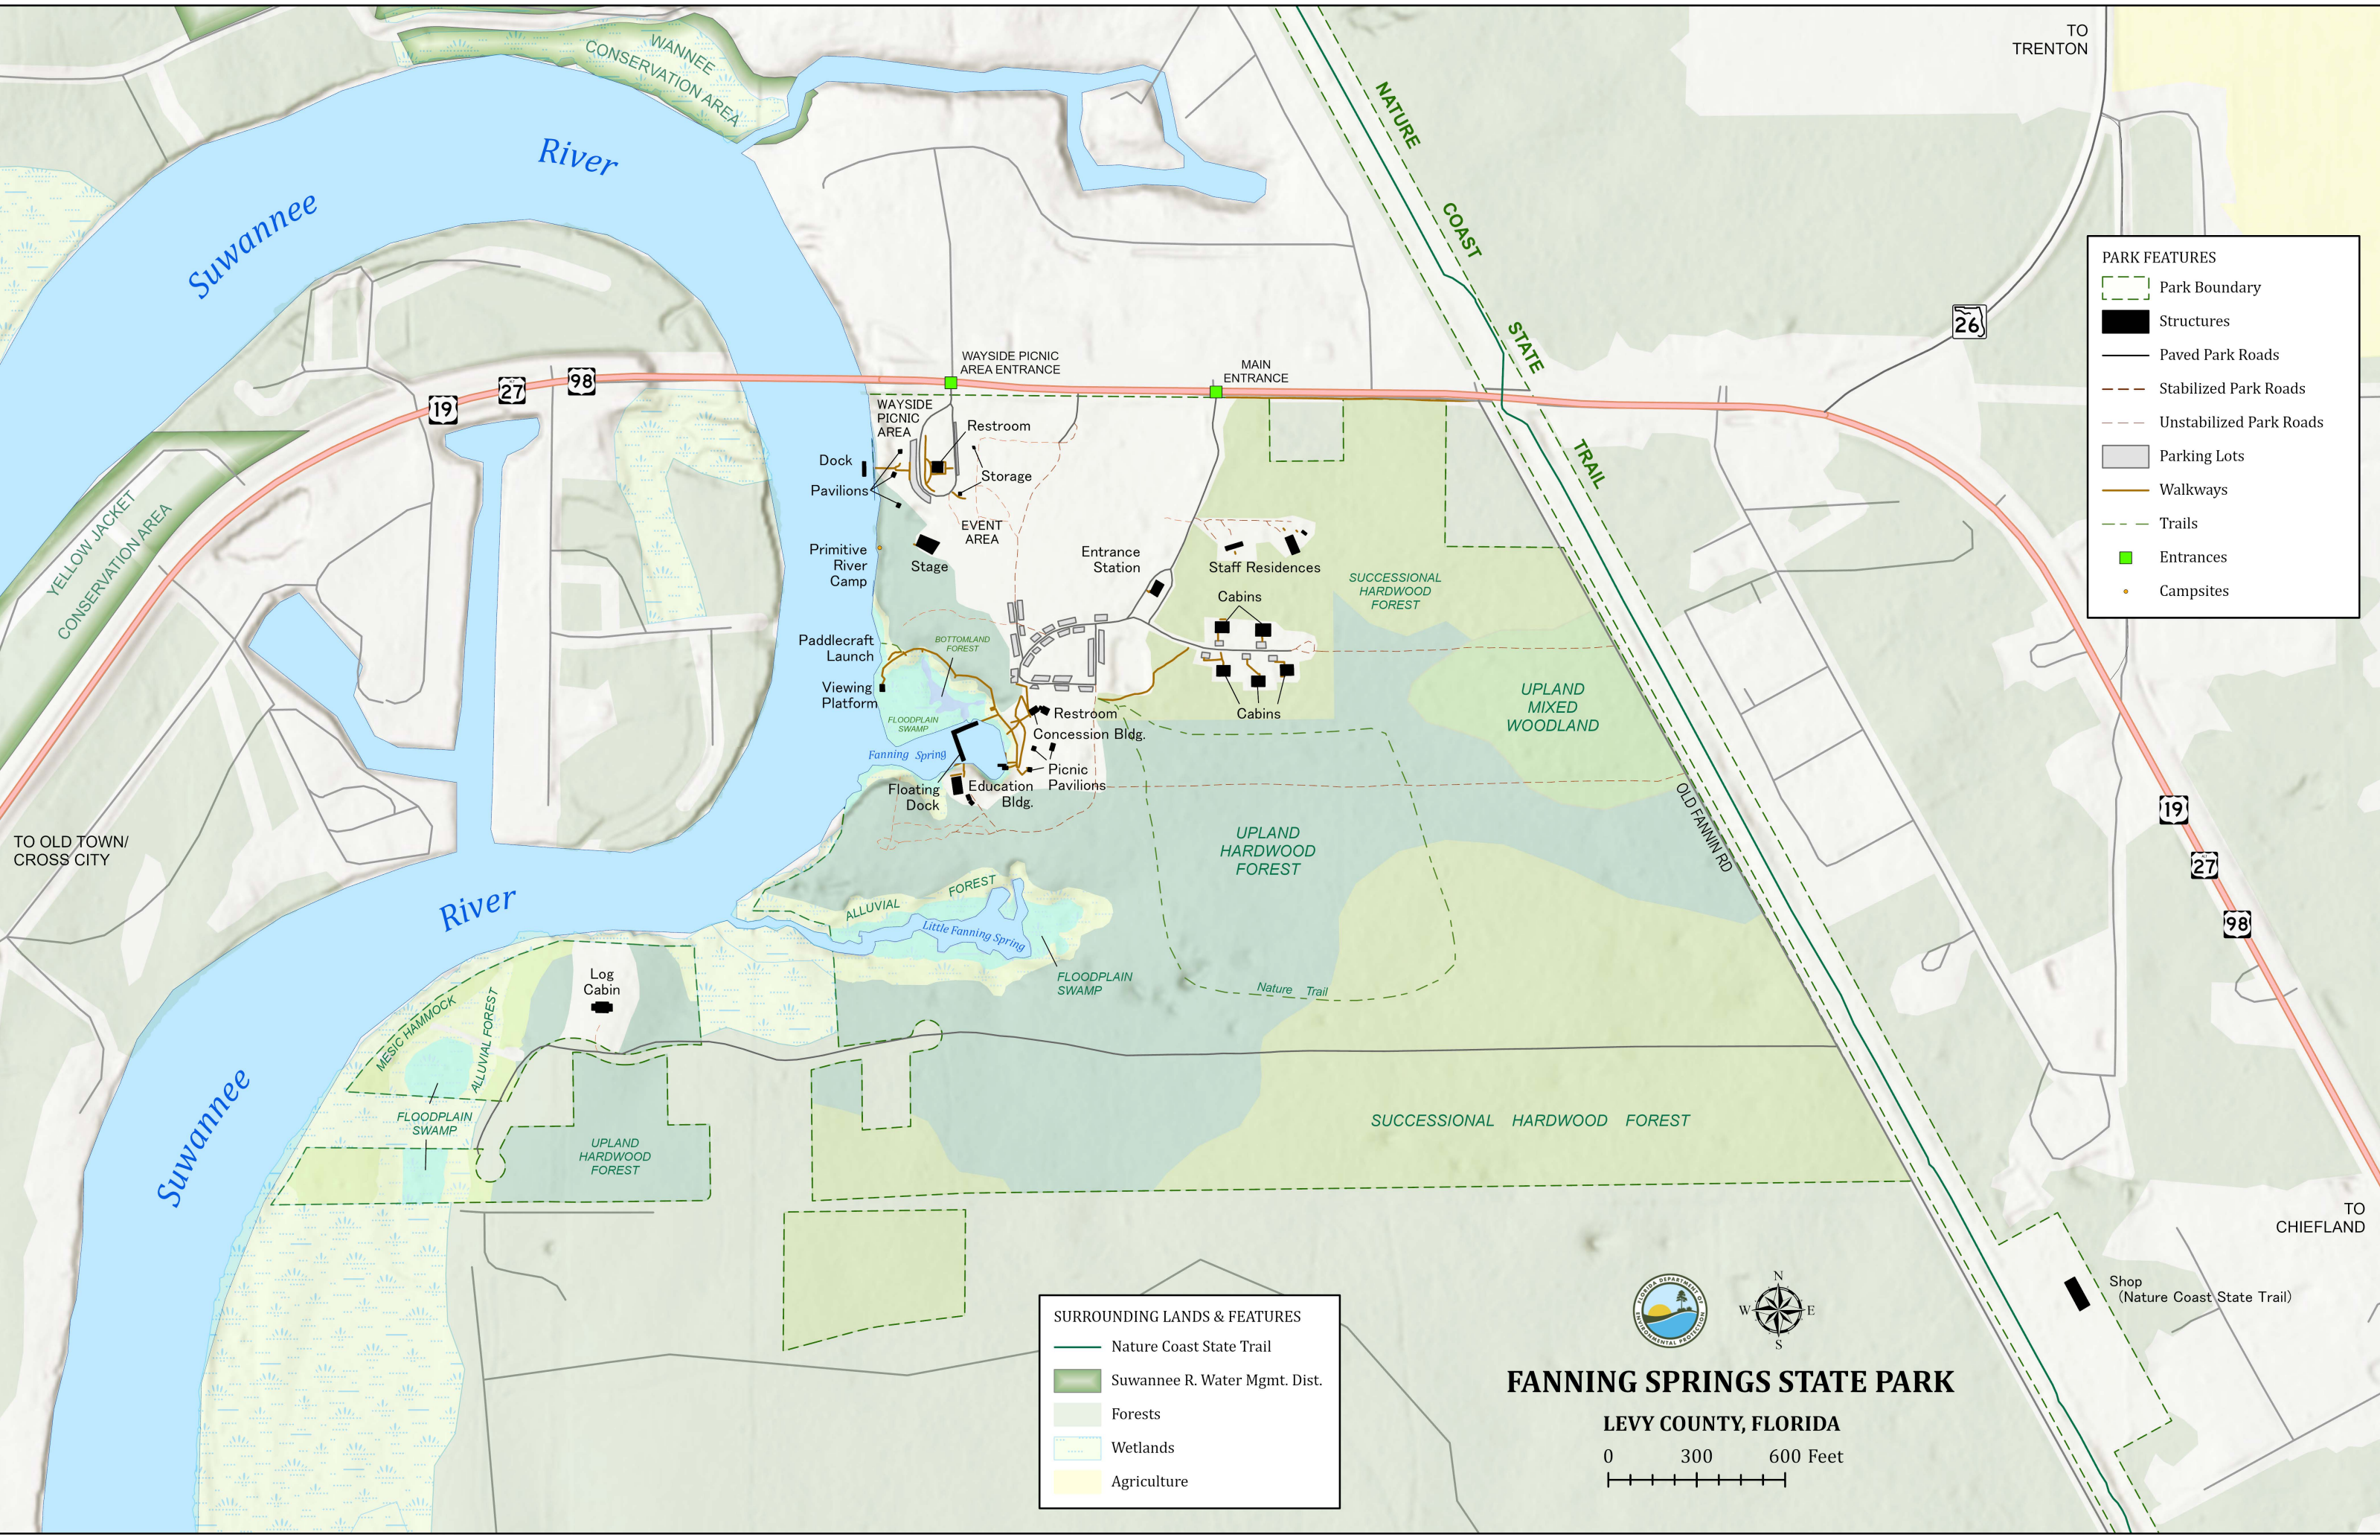
PARK FEATURES

- Park Boundary
- Structures
- Paved Park Roads
- Stabilized Park Roads
- Unstabilized Park Roads
- Parking Lots
- Walkways
- Trails
- Entrances
- Campsites

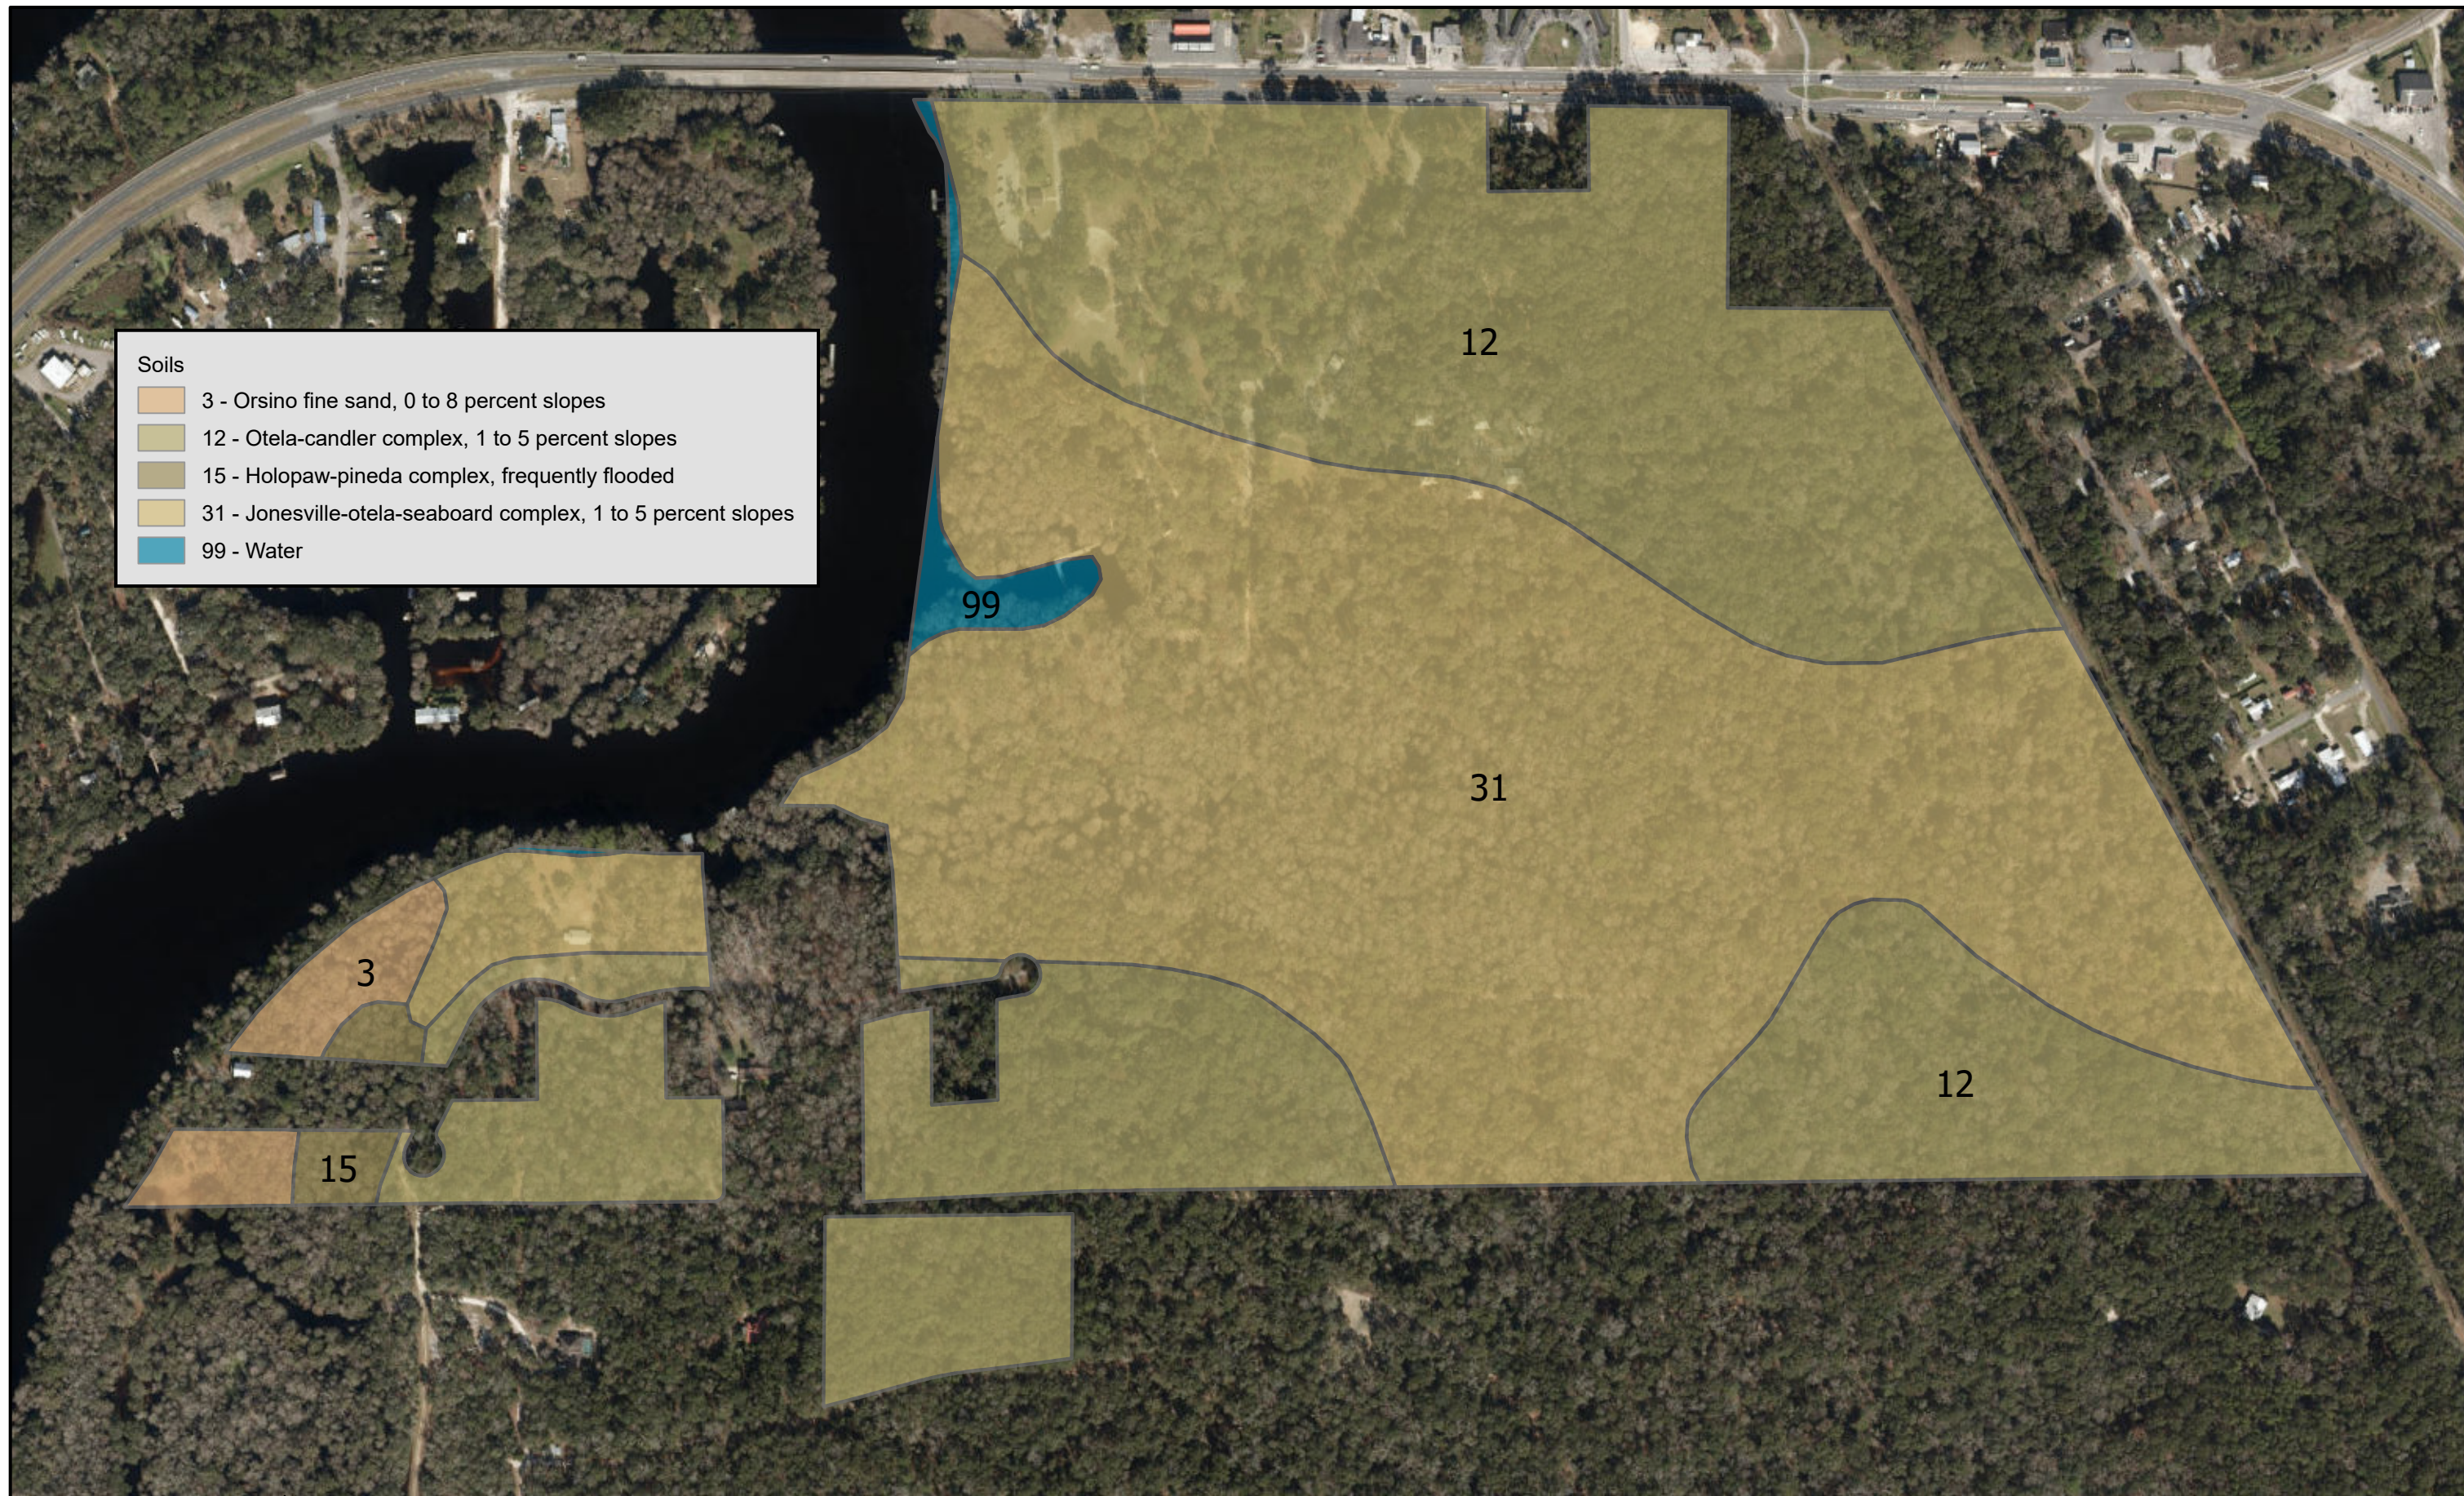
FANNING SPRINGS STATE PARK
Soils

Four soil types exist within Fanning Springs State Park (see Soils Map). Addendum 3 contains complete soils descriptions. The upland soils found in the park are generally well drained to excessively drained, whereas soils within the floodplain of the Suwannee River tend to be poorly drained. The Levy County soil survey characterizes most of the soils found within the park as very deep, except for the Seaboard soils in the Jonesville-Otela-Seaboard complex. In these soils, limestone underlies the sand at a relatively shallow depth (Slabaugh et al. 1996).
