APPENDIX B - FIELD DATA SHEETS

An Evaluation of the Effectiveness of Mitigation Banking in Florida: Ecological Success and Compliance with Permit Criteria

Final Report

May 2007

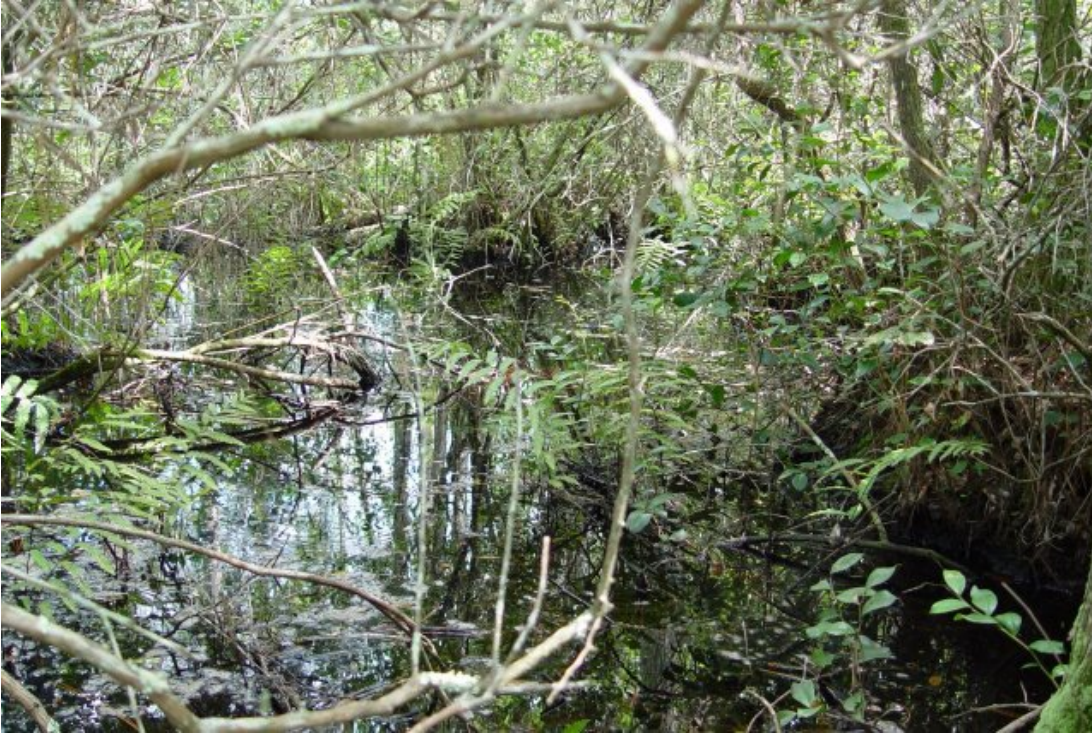
(A)

Figure B-1.2. Site photos of Barberville Mitigation Bank A) interior of Barb_CYP B) Barb_MAR looking west across the marsh.

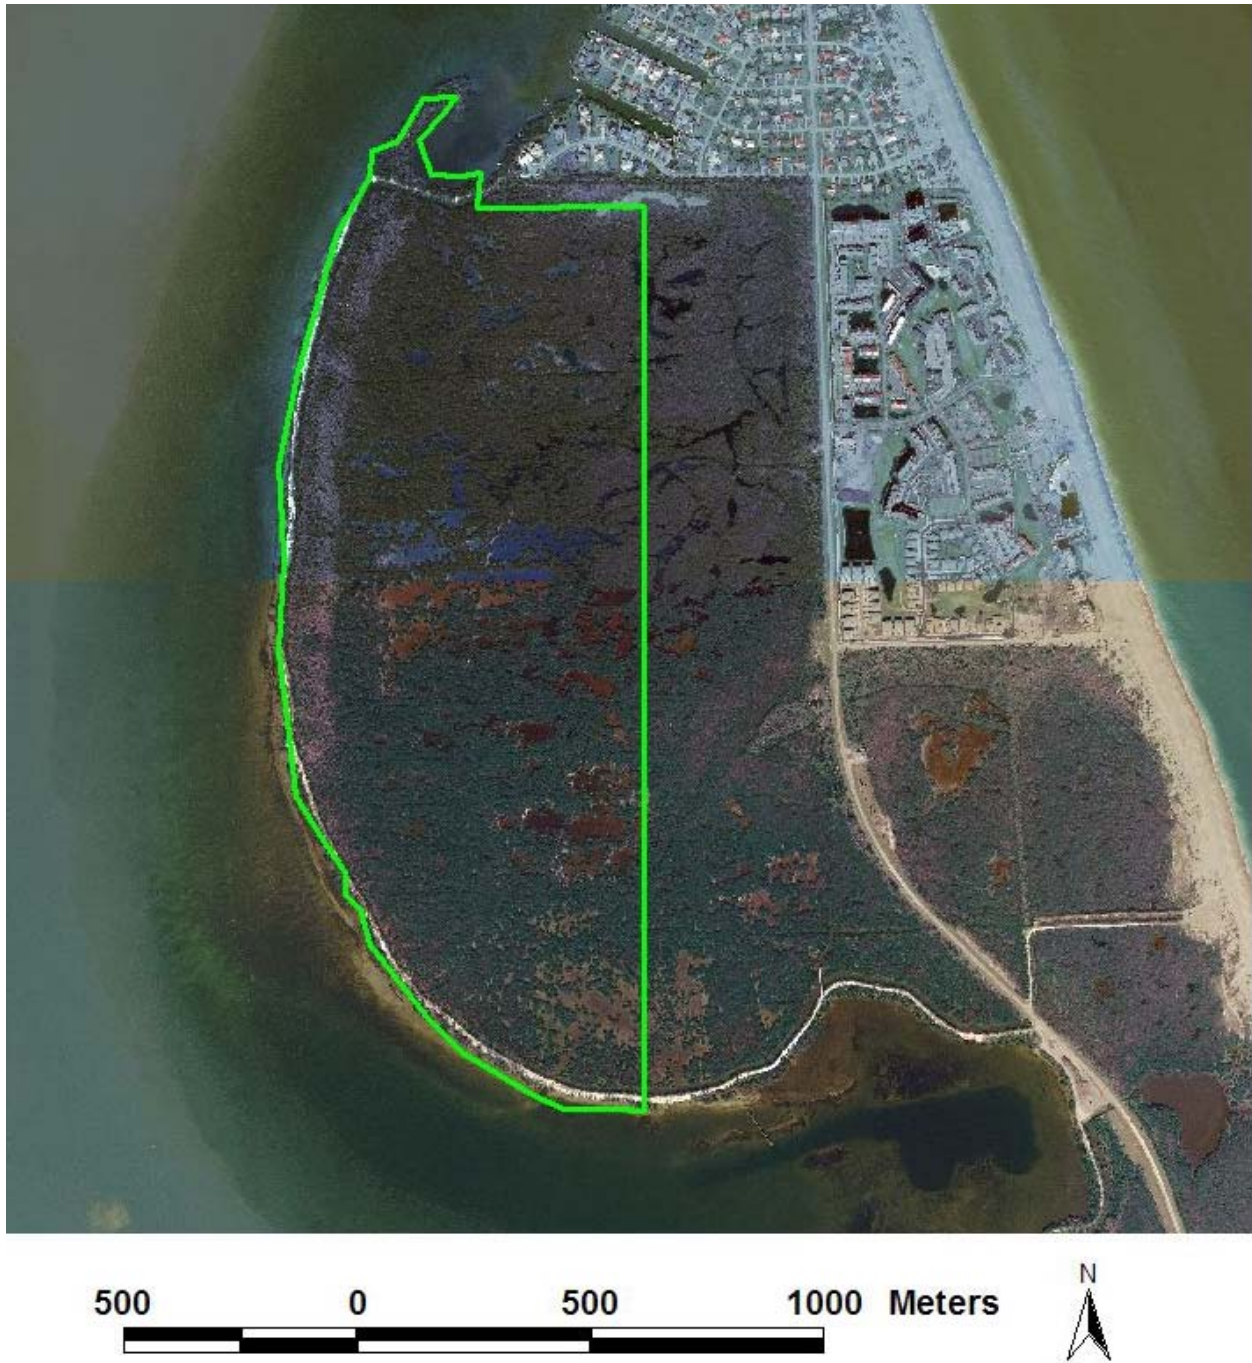
Figure B-2.1. Landscape location of Bear Point Mitigation Bank (green line). Boundary of the wetland assessment area Bear_MAN includes the entire wetland mitigation bank (green line).

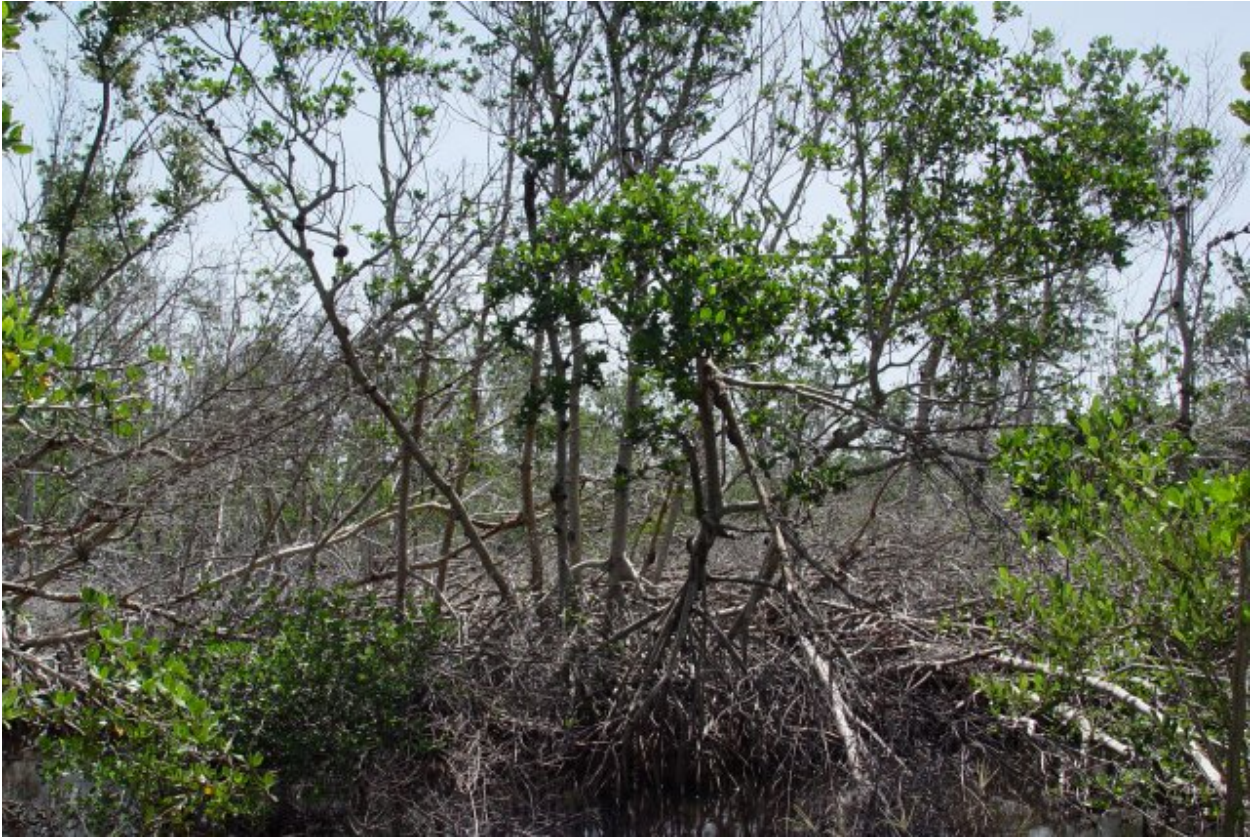
Figure B-2.2. Site photo of Bear Point Mitigation Bank looking east from the berm at Bear_MAN.

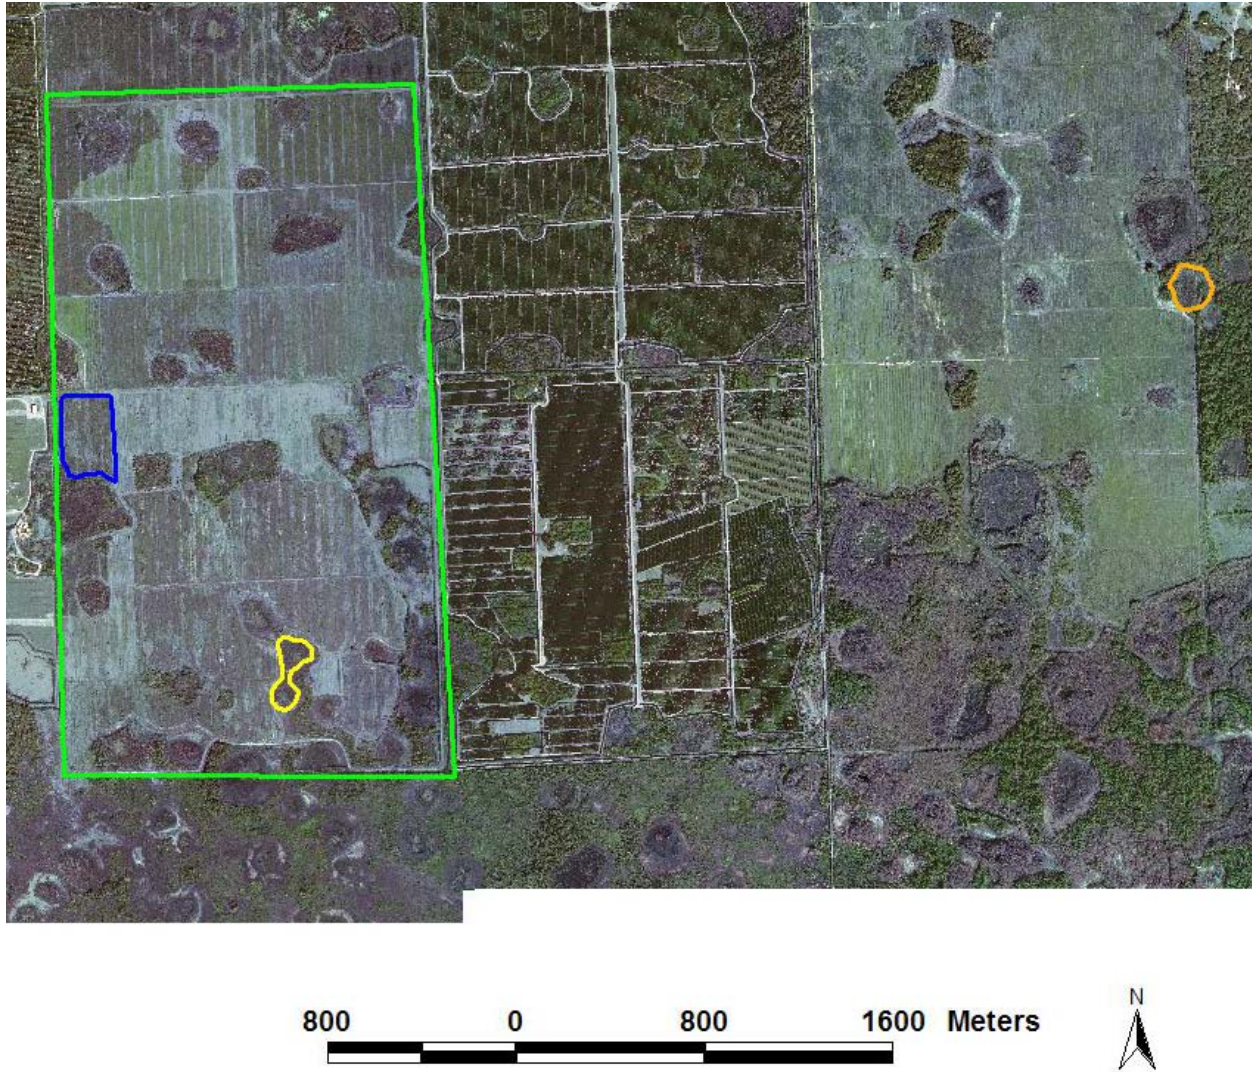
Figure B-3.1. Landscape location of Big Cypress Mitigation Bank (green line). Boundary of the wetland assessment areas BigC_FL A (blue line), BigC_MAR_1 (orange line), and BigC_MAR_2 (yellow line) shown. BigC_MAR_1 (orange line) is in Phase II, Phase II boundary not shown.

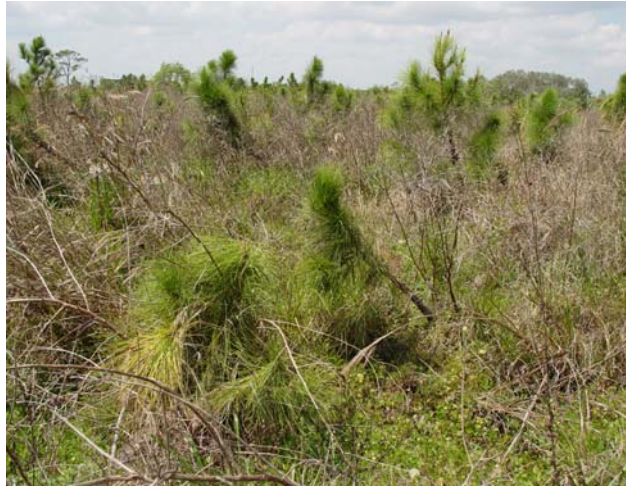
(A)

Figure B-3.2. Site photo of Big Cypress Mitigation Bank: A) BigC_FLA looking west; B) interior of BigC_MAR_1 looking north; C) interior of southern depression of BigC_MAR_2.

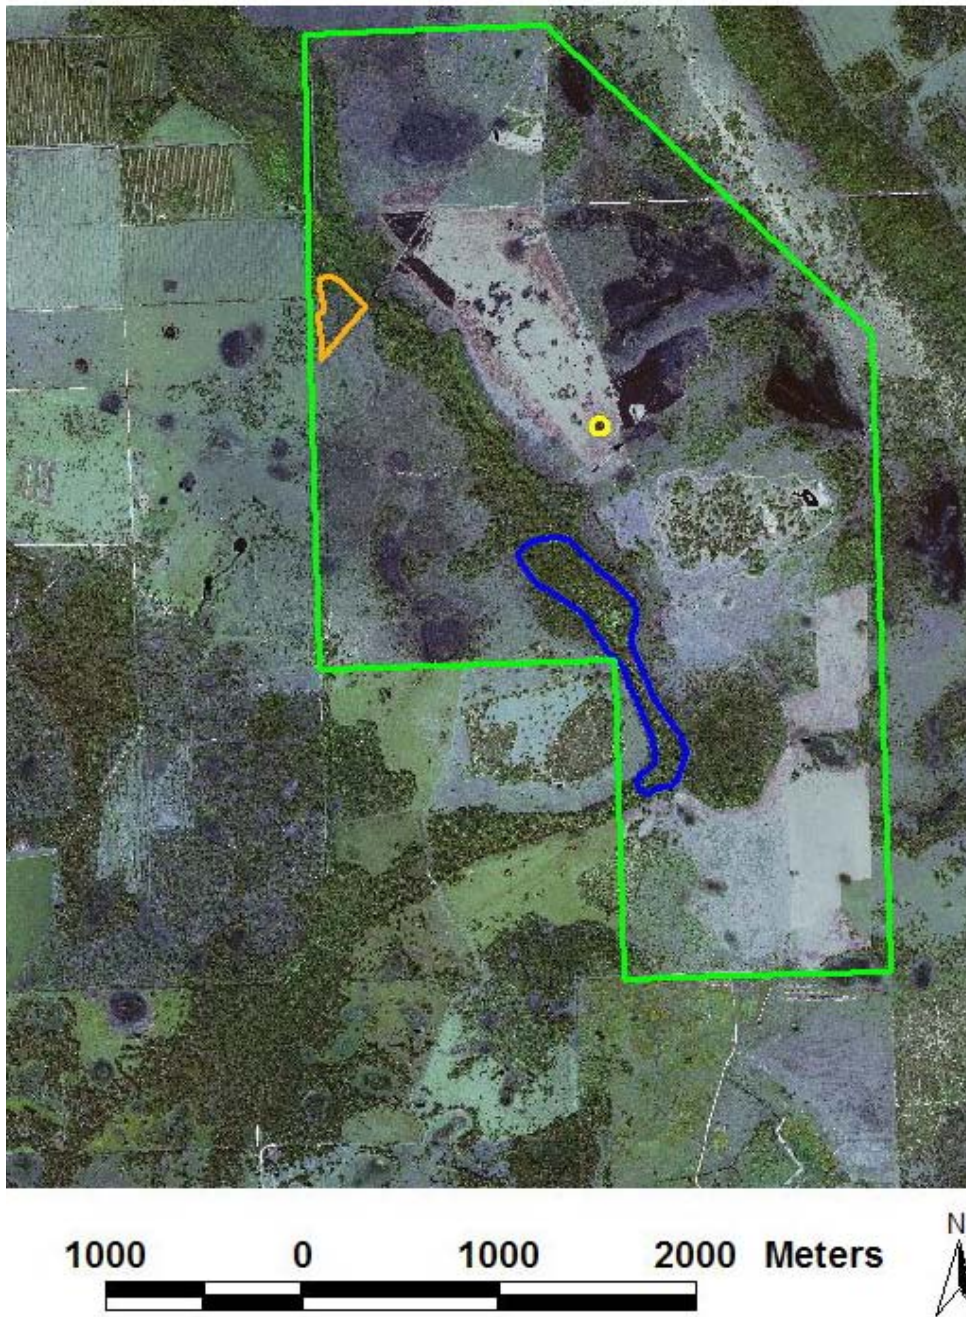
Figure B-4.1. Landscape location of Bluefield Ranch Mitigation Bank (green line). Boundary of the wetland assessment areas Blue_BOT (blue line), Blue_FLA (orange line), and Blue_MAR (yellow line) shown.

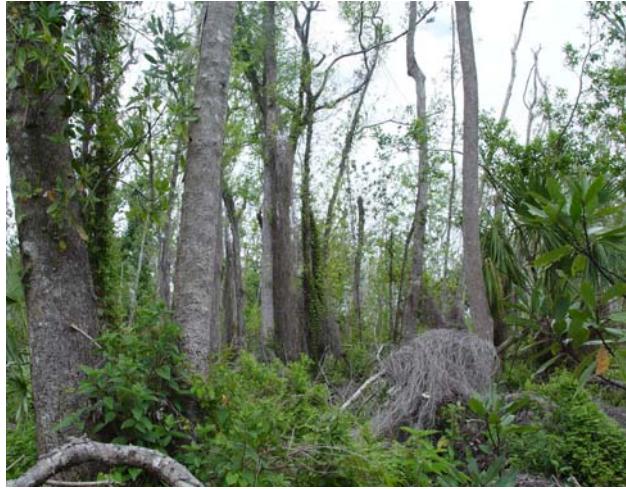
(A)

Figure B-4.2. Site photo of Bluefield Ranch Mitigation Bank: A) Blue_BOT interior with treated and re-sprouting Japanese climbing fern (*Lygodium japonicum*); B) groundcover in Blue_FLA; C) looking west across Blue_MAR, note there are shrubs in center of marsh.

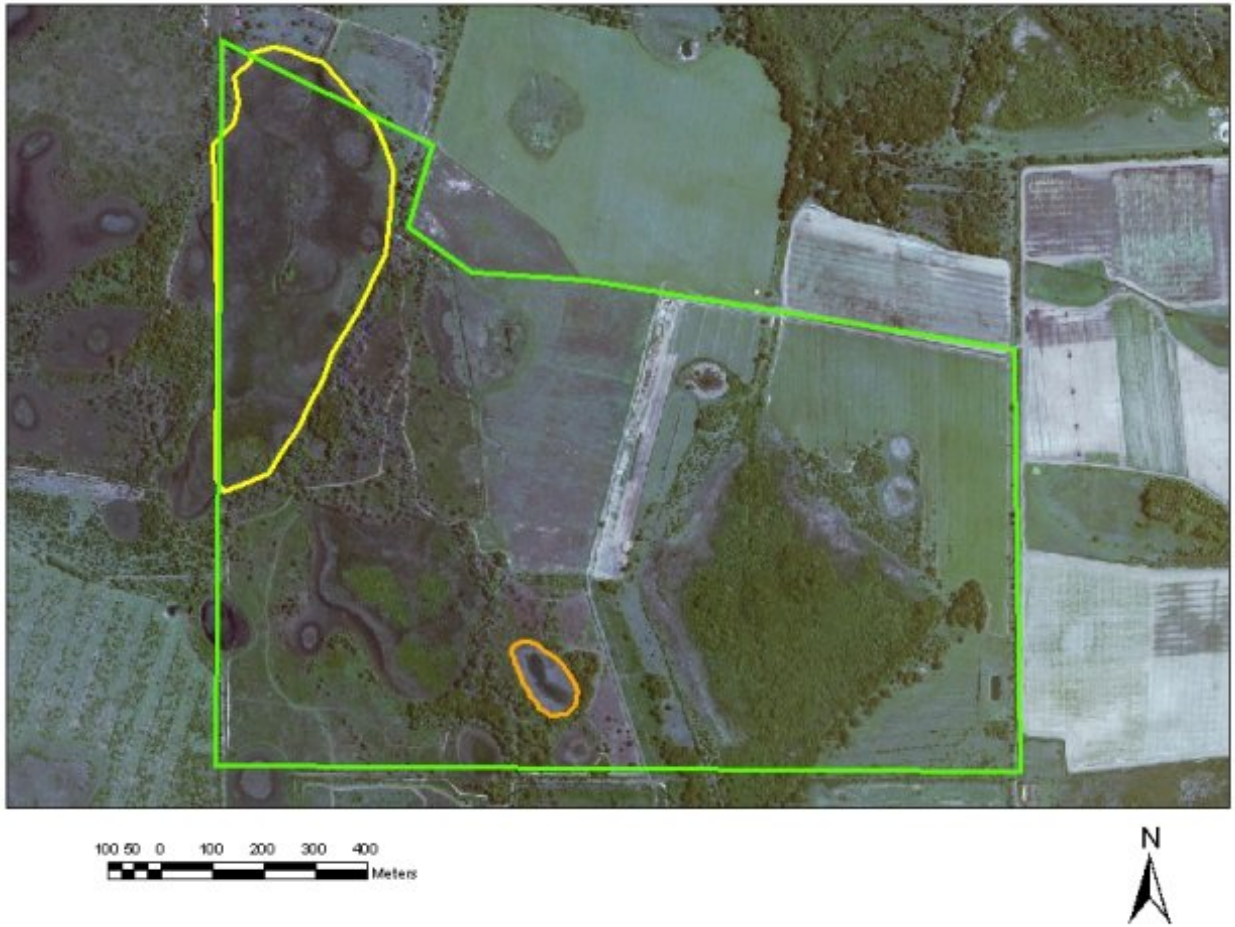
Figure B-5.1. Landscape location of Boran Ranch Mitigation Bank, only the outline of Phase one is shown. Phase two is to the east.

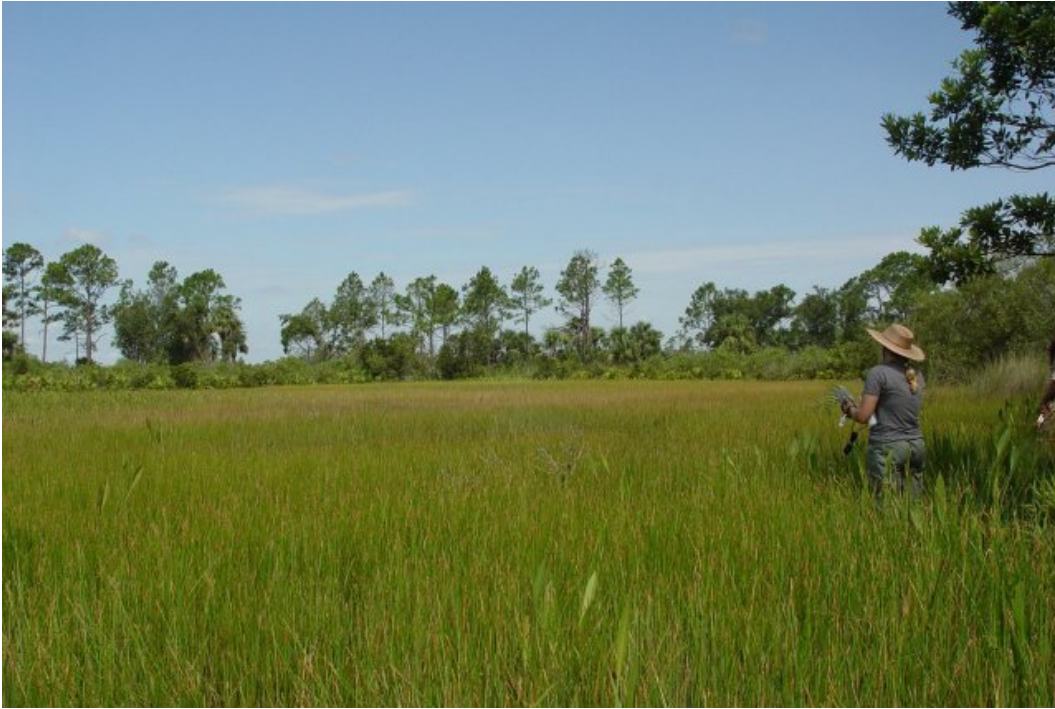
Figure B-5.2. Site photos of Boran Ranch Mitigation Bank Phase I (A) Looking north from eastern edge of Bora_MAR_1 (B) Looking southwest across Bora_MAR_2 towards willow head with a wading bird rookery.

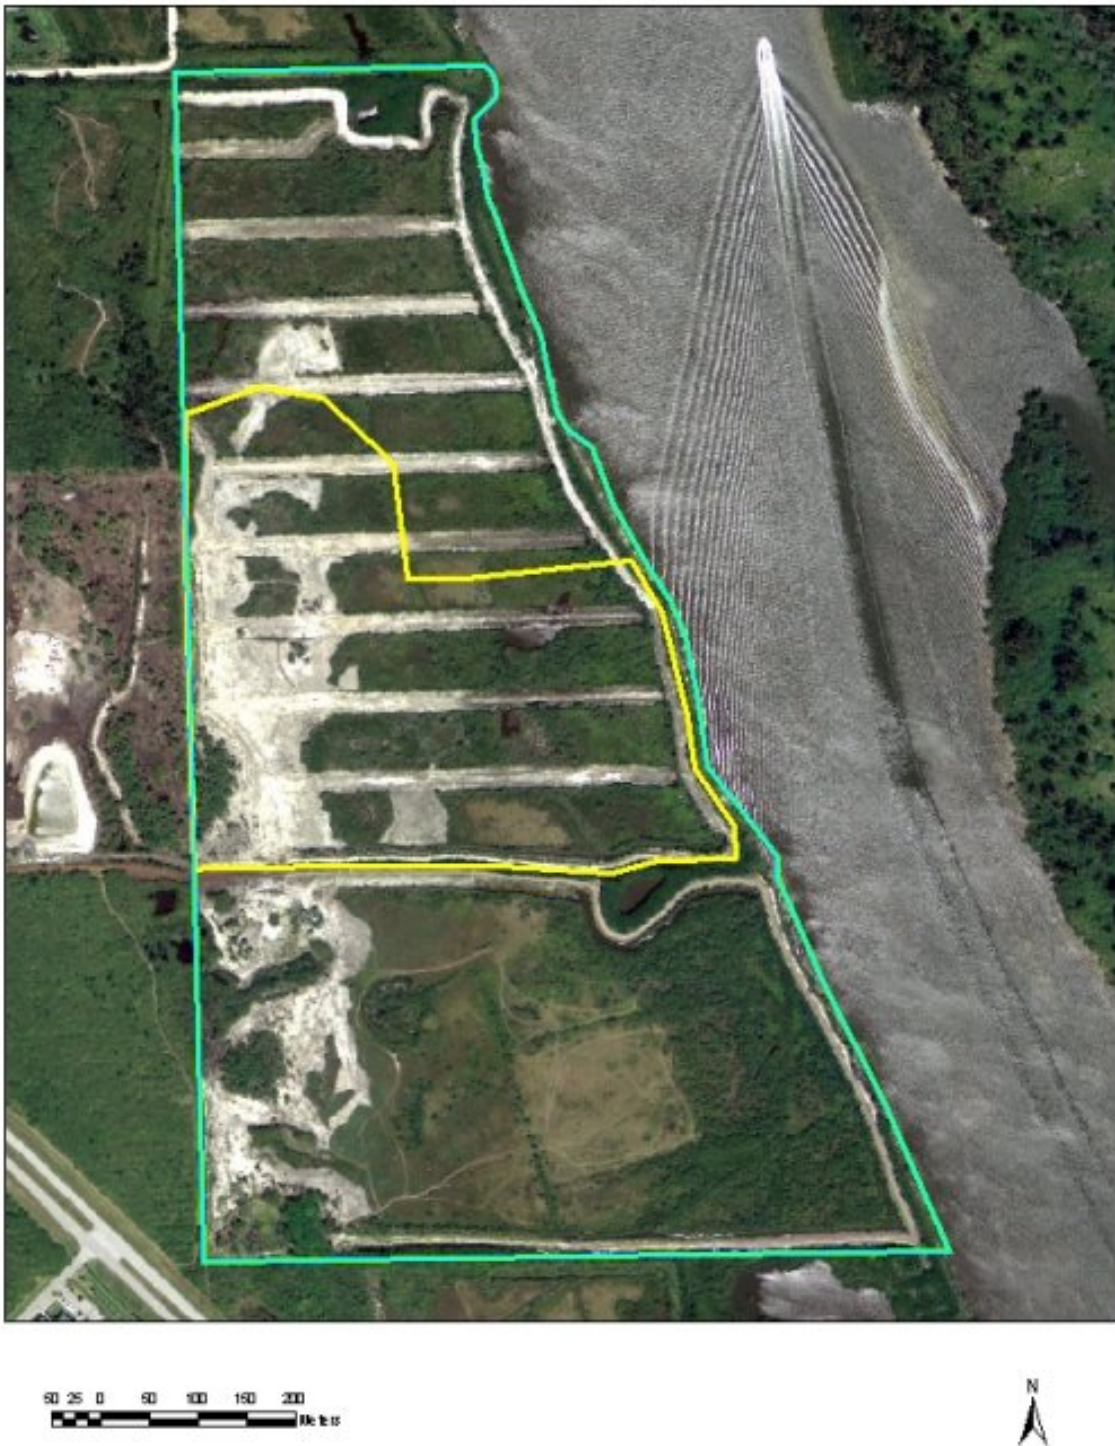
Figure B-6.1. Landscape location of CGW Mitigation Bank (green line). Boundary of the wetland assessment area in yellow is CGW_MAN, it includes 19 ha of saltwater marsh and mangroves.

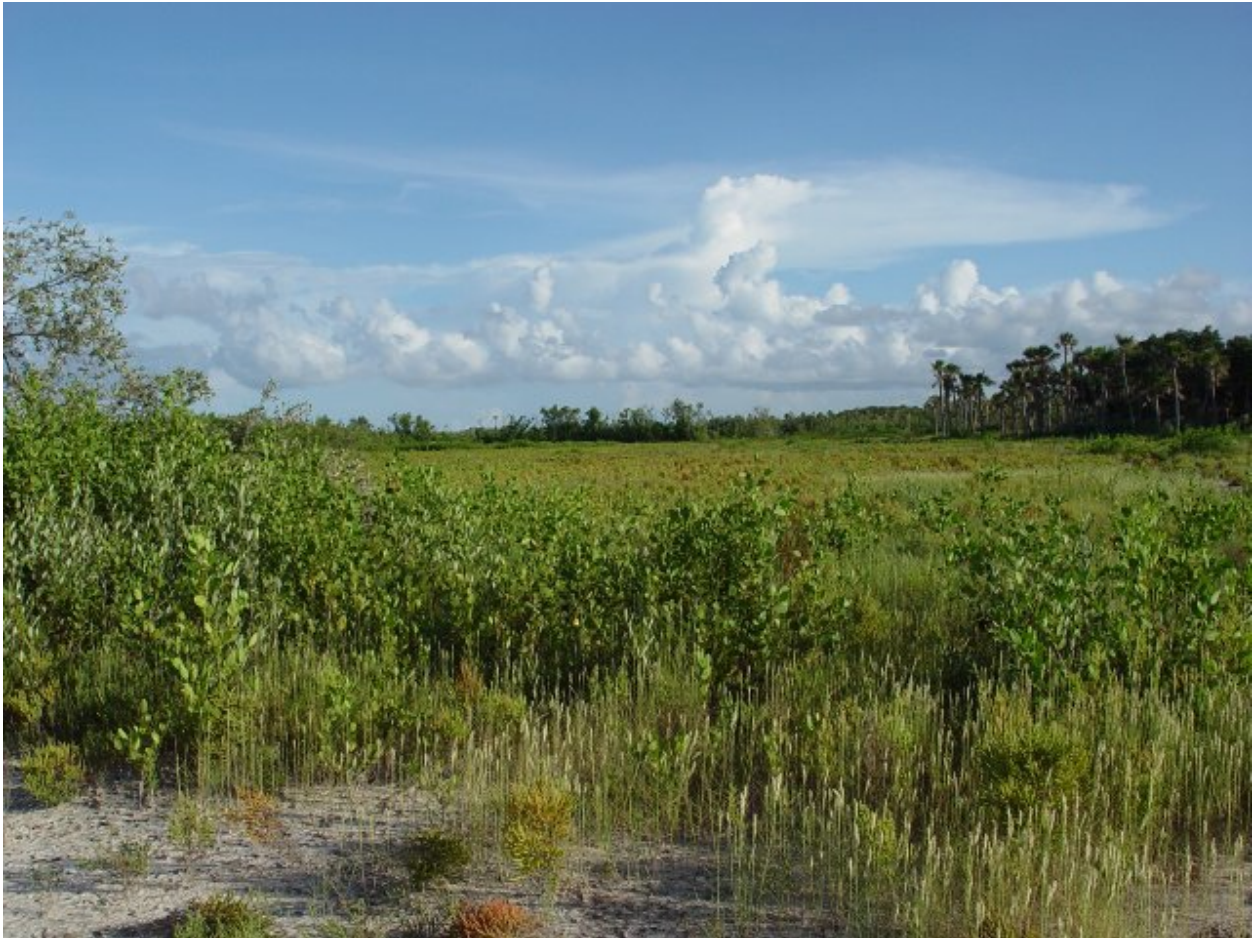
Figure B-6.2. Site photo of CGW Mitigation Bank naturally recruited mangroves and high marsh vegetation in the foreground looking northwest across assessment CGW_MAN.

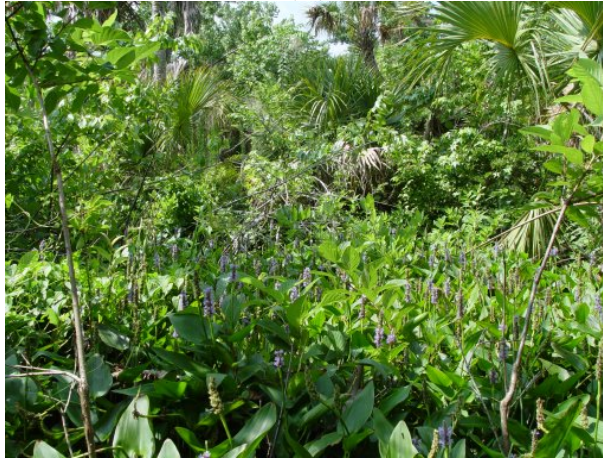
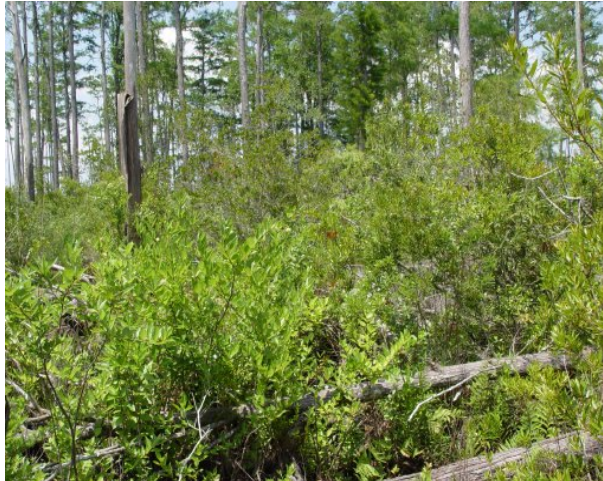
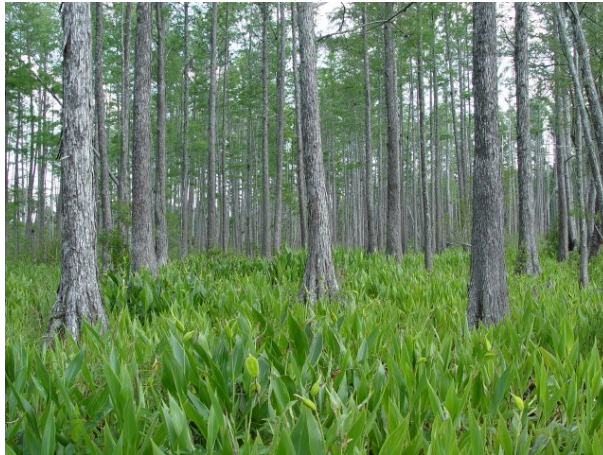
Figure B-7.2. Site photos of A) an opening in the canopy allows for flowering pickerel weed (*Pontederia cordata*) in the ground cover of CoCa_FOR B) shrubby wax myrtle (*Myrica cerifera*) and button bush (*Cephalanthus occidentalis*) dominate the open areas of a cypress dome CoCa_CYP_1 impacted by wildfire and hurricanes C) bandana-of-the-Everglades (*Canna flaccida*) dominates the under story of cypress swamp CoCa_CYP_2

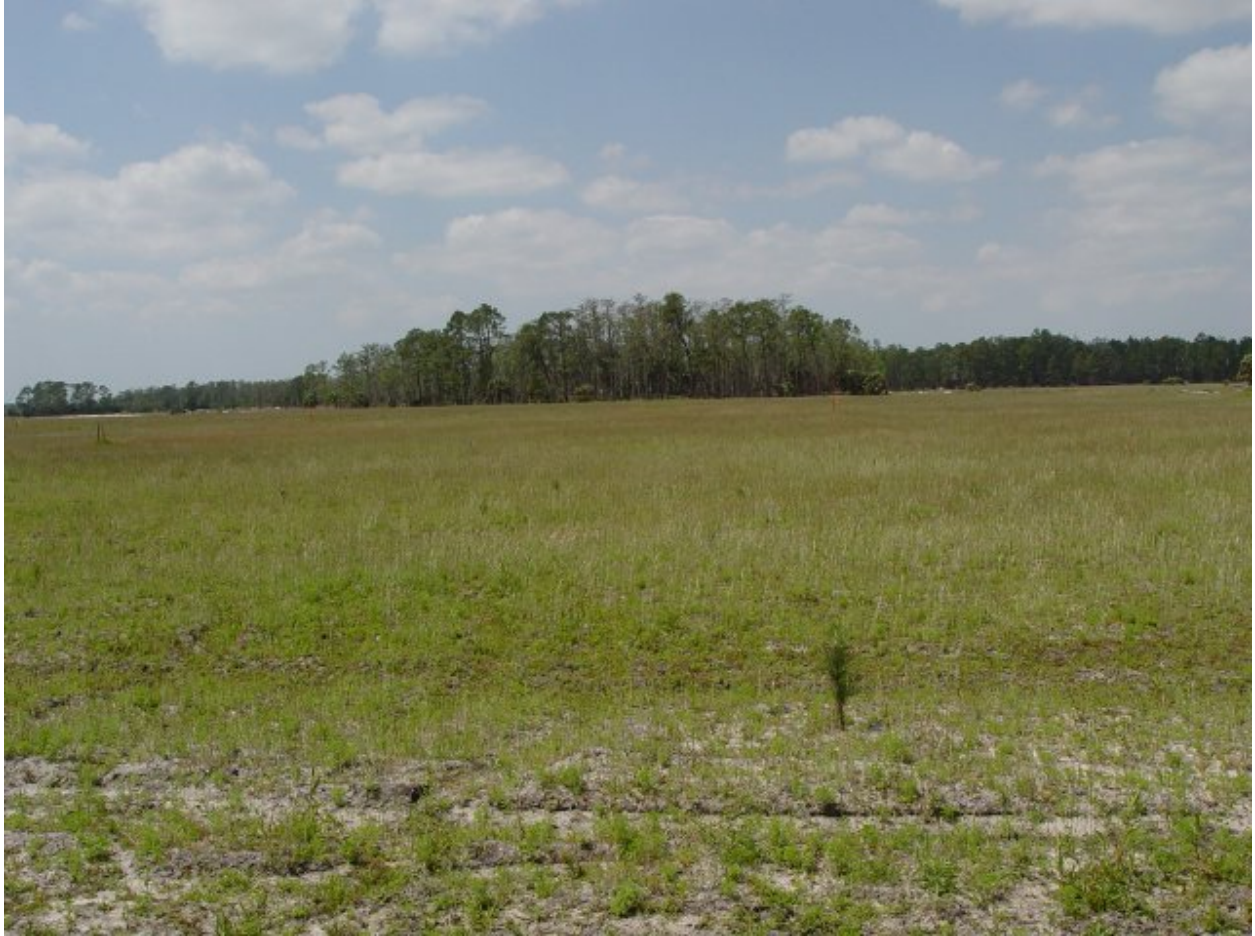
Figure B-8.2. Site photo of recently planted and seeded hydric pine flatwoods assessment area Cork_FLA at Corkscrew Regional Mitigation Bank.

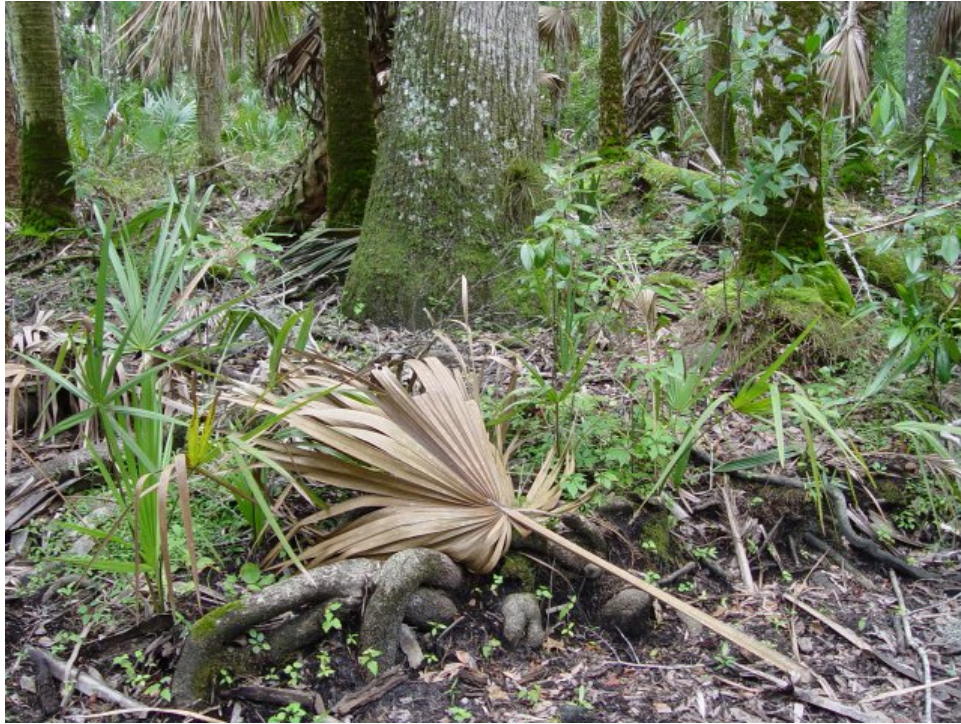
(A)

Figure B-9.2. Site photos of East Central Florida Mitigation Bank site assessment areas A) loop roots and gum tree (*Nyssa biflora*) in cabbage palm hammock ECF1_HAM impacted by restored canal B) looking east from restored canal at Christmas Creek ECF1_FOR

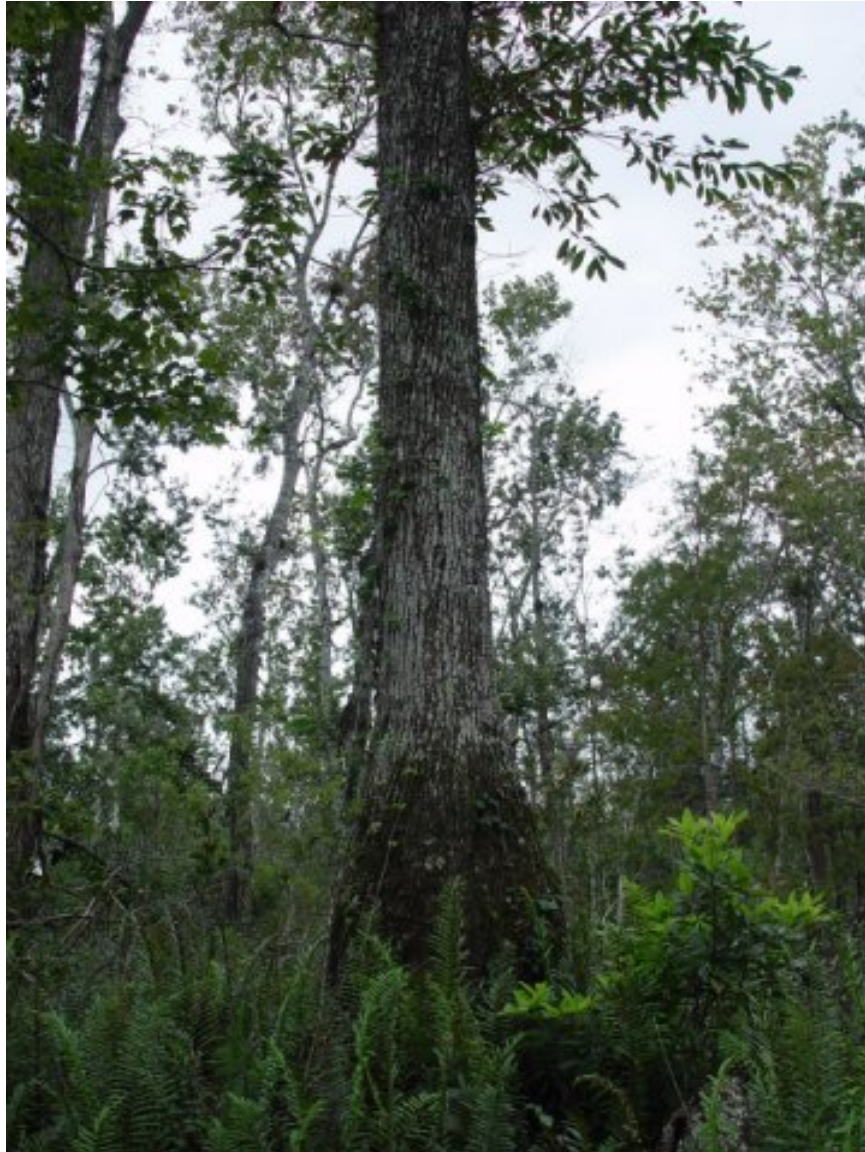
Figure B-11.2. Site photo of Florida Mitigation Bank assessment area FLMB_FOR a wetland forested mixed system adjacent to a large marsh. This forested system has been impacted by years of hydrologic impacts and more recent hurricanes.

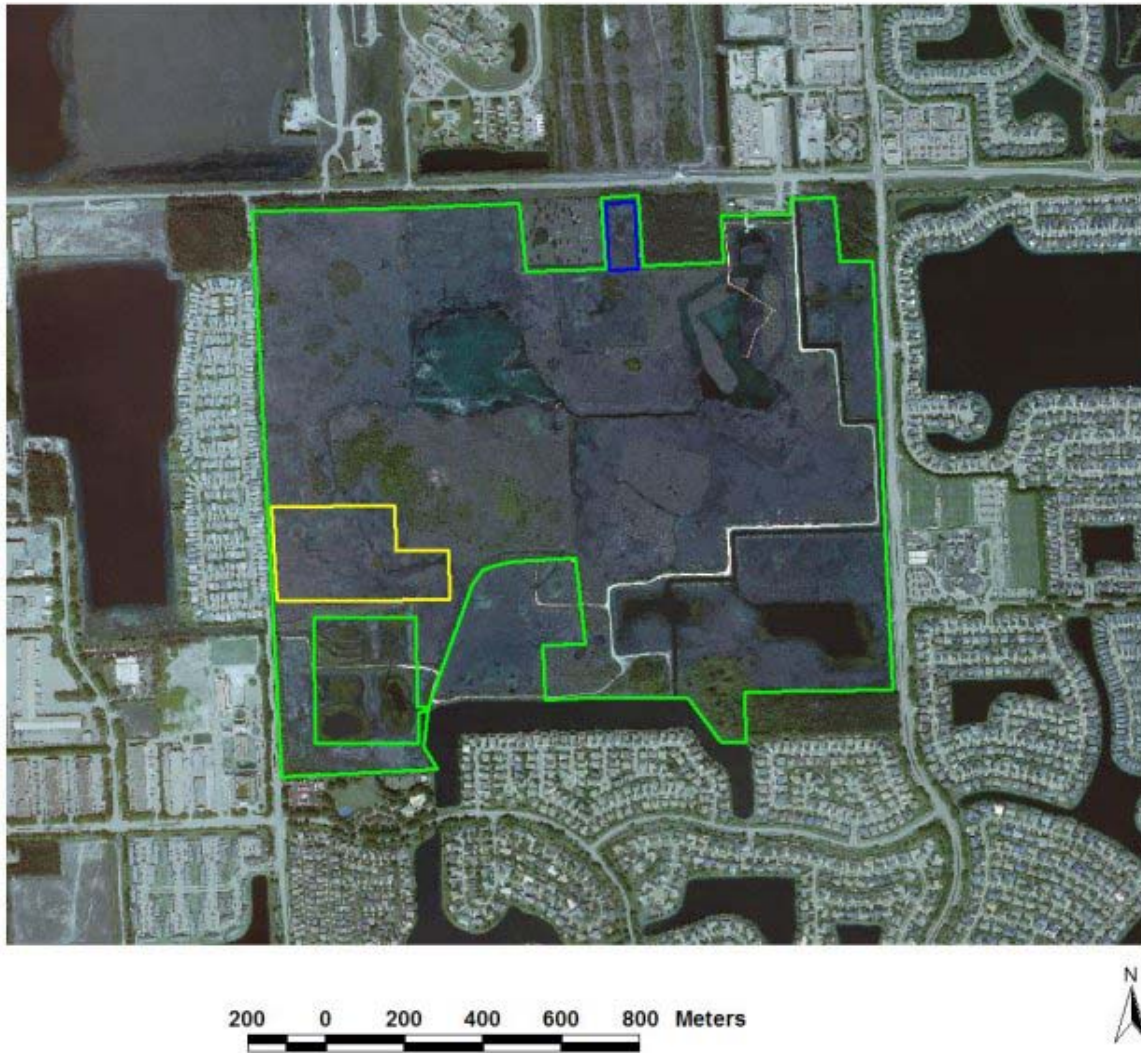
Figure B-12.1. Landscape location of Florida Wetlandsbank (green line). Boundary of the wetland assessment areas FLWt_MAR_1 in yellow and FLWt_MAR_2 outlined in blue, represent different phases of restoration of organic Everglades flats communities.

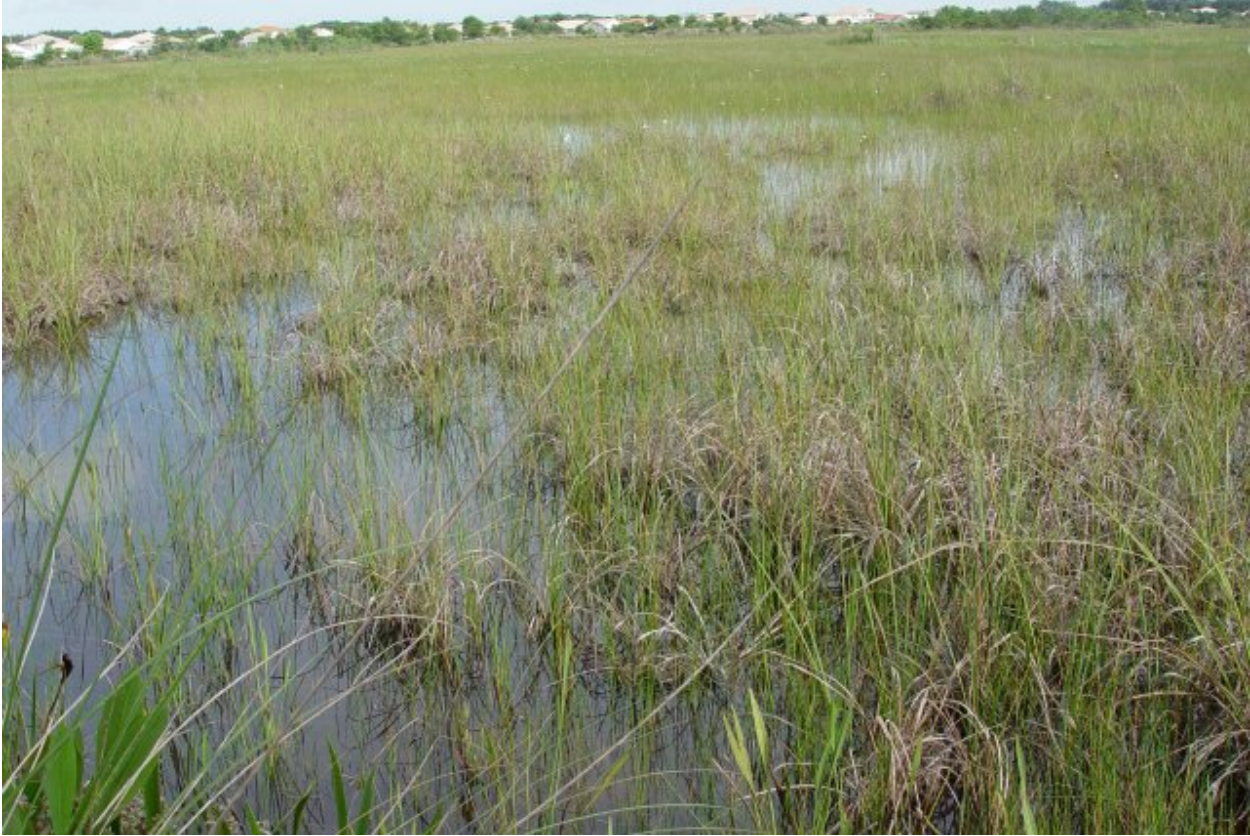
Figure B-12.2. Site photos of Florida Wetlandsbank assessment areas FLWt_MAR_1 the first phase to begin restoration with time zero occurring in 1995. There is no site photo for FLWt_MAR_2 one of the last phases to be restored with time zero in 1999.

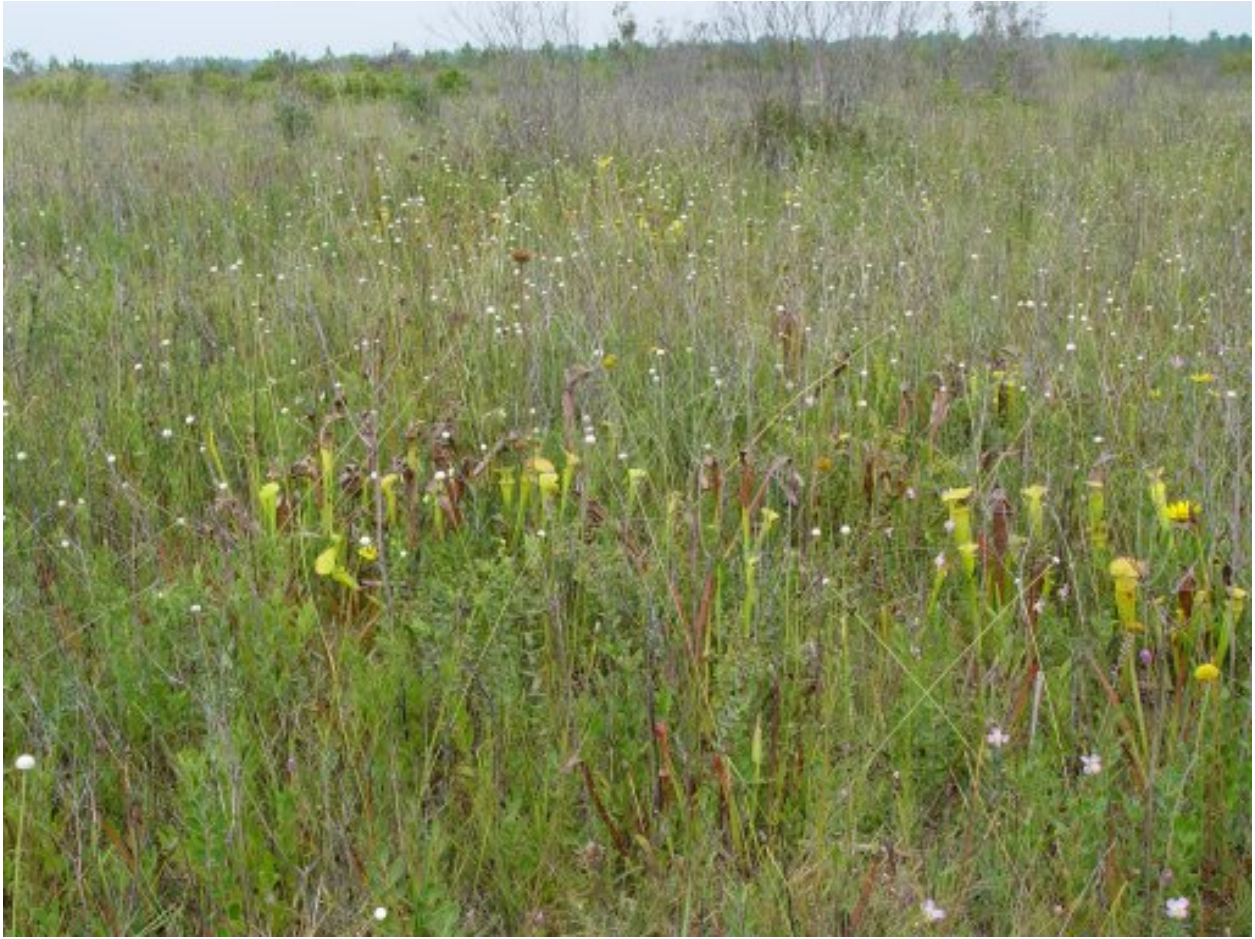
Figure B-13.2. Site photo of Garcon Peninsula Mitigation Bank assessment area Garc_FLA with yellow pitcherplant (*Sarracenia flava*) pitcher plant featured in the foreground.

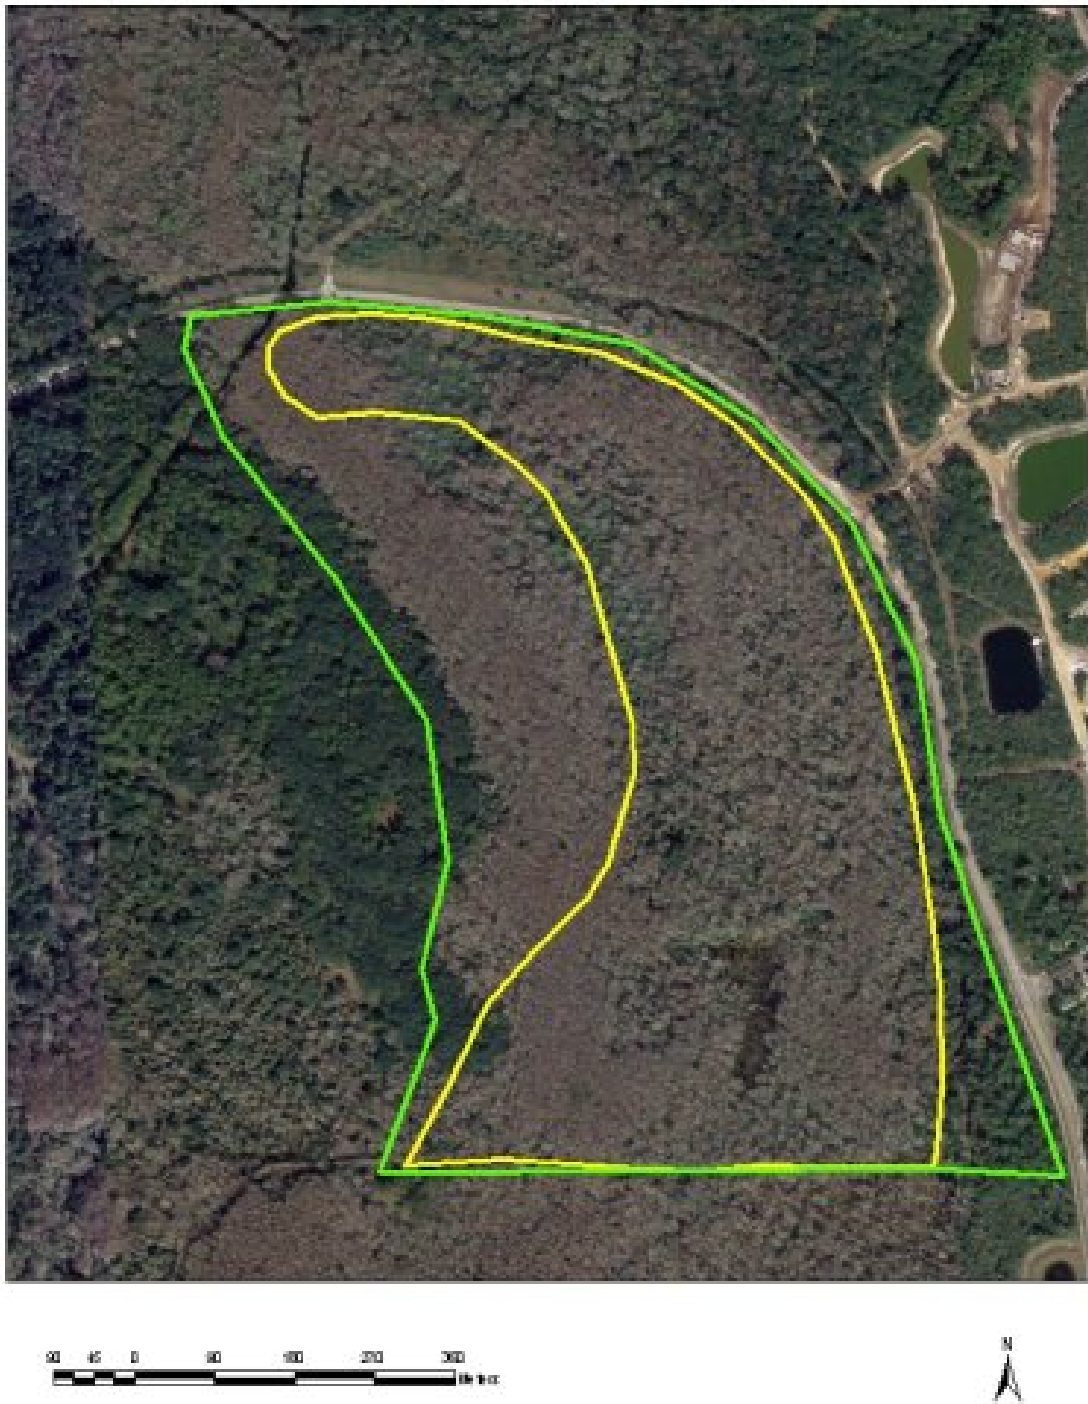
Figure B-14.1. Landscape location of Graham Swamp Mitigation Bank (green line) is estimated, as areas within this boundary have been used for mitigation projects not included as part of the larger mitigation bank. Boundary of the wetland assessment area Grhm_FOR in yellow includes most of the wetland mitigation bank.

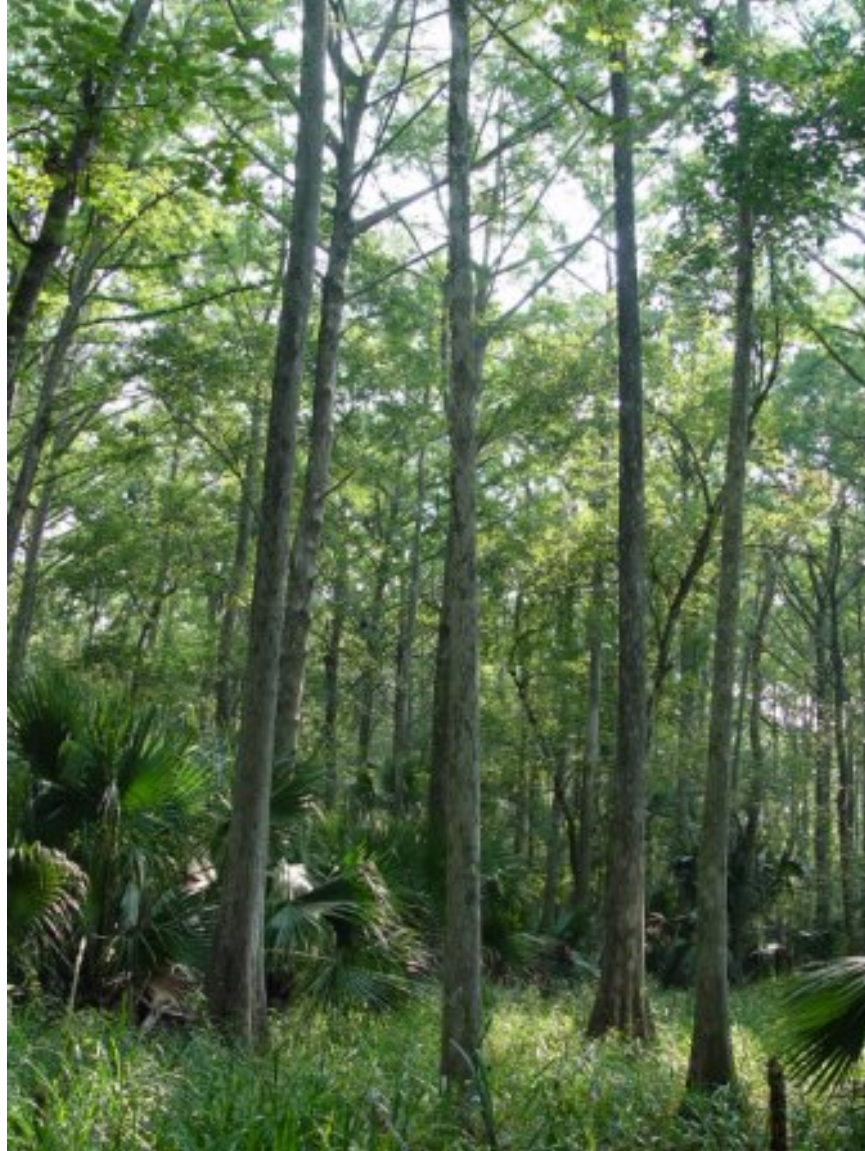
Figure B-14.2. Site photo of Graham Swamp Mitigation Bank assessment area Grhm_FOR.

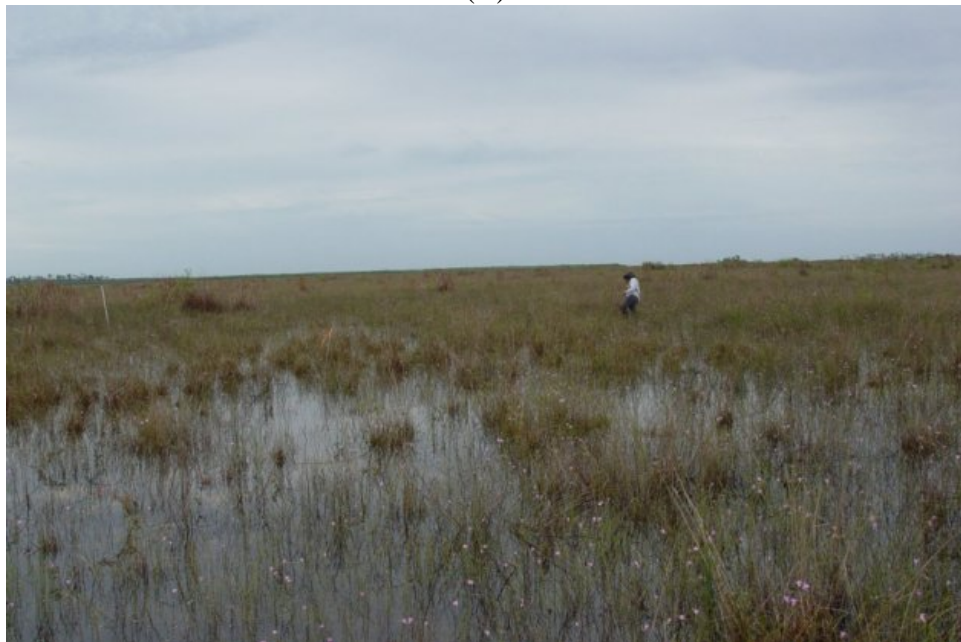
(B)

Figure B-15.2. Site photo of rocky glades assessment areas A) HID_MAR_1, the oldest portion of the bank with time zero starting in 1989 and B) HID_MAR_2 with time zero starting in 2001.
