APPENDIX B - FIELD DATA SHEETS

An Evaluation of the Effectiveness of Mitigation Banking in Florida: Ecological Success and Compliance with Permit Criteria

Final Report

May 2007

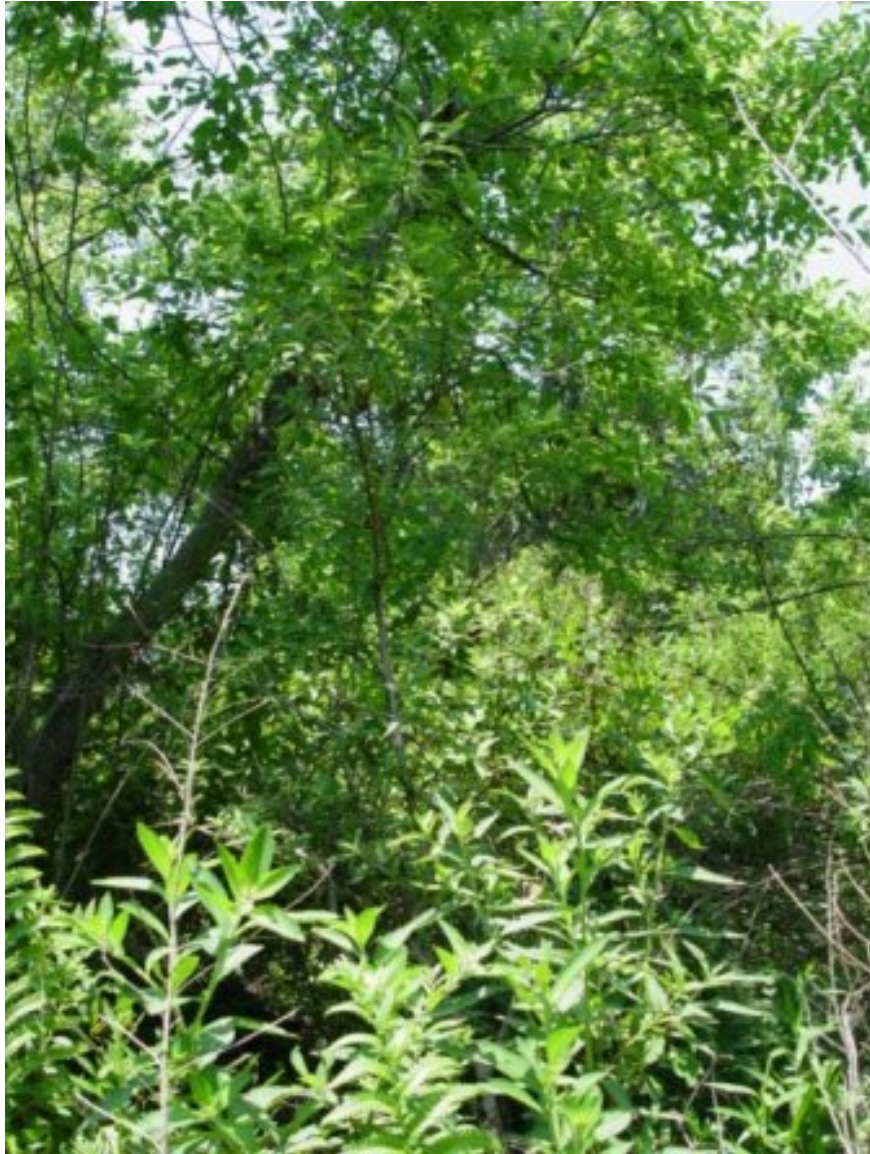
Figure B-16.2. Site photo of Lake Louisa and Green Swamp Mitigation Bank assessment area Loui_SHR in phase II.

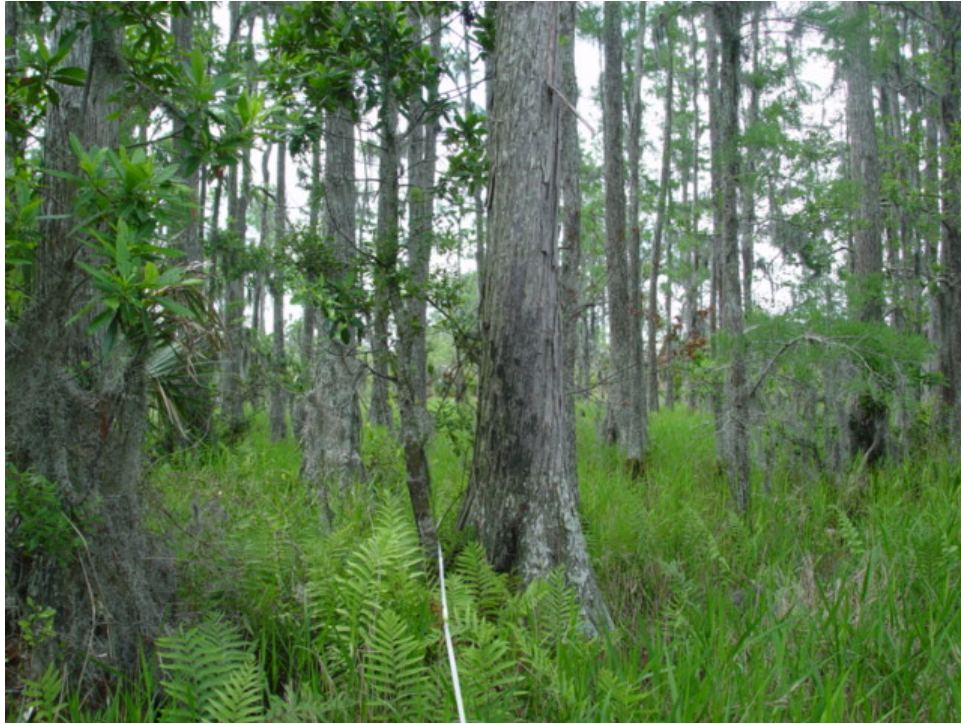
(A)

Figure B-17.2. Site photo of Lake Monroe Mitigation Bank assessment areas A) Monr_CYP, a cypress dome in an intact flatwoods and scrub, and B) Monr_MAR, a marsh surrounded by pasture.

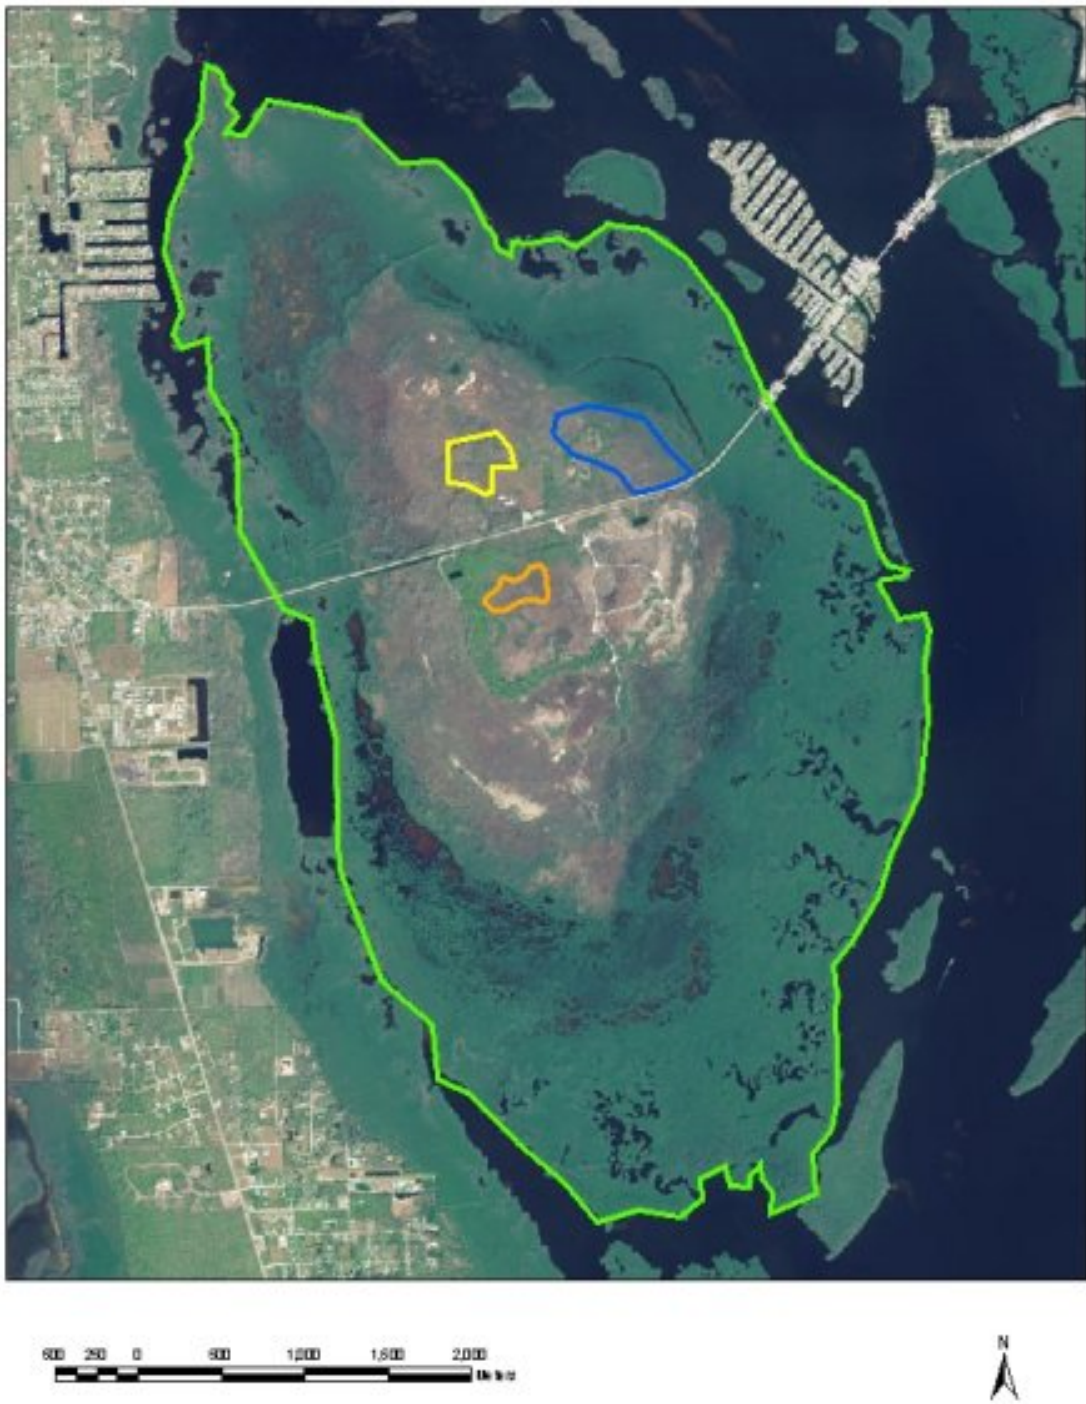
Figure B-18.1. Landscape location of Little Pine Island Mitigation Bank (green line). LPI_MAR is a marsh assessment area outlined in orange. LPI_SLT_1 outlined in yellow was assessed prior to restoration activities involving removal of melaleuca trees. LPI_SLT_2 is a restored salt marsh area outlined in blue.

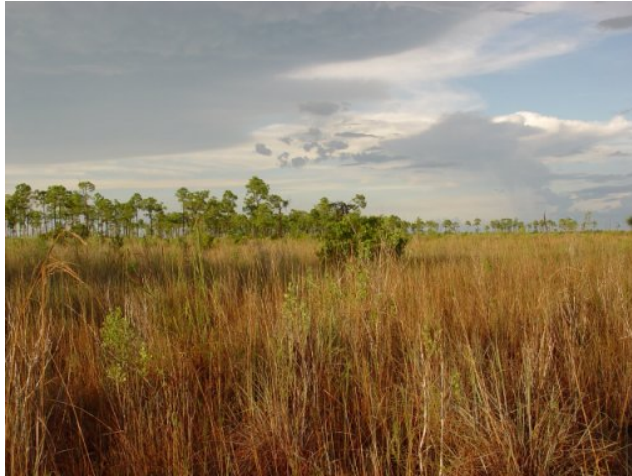
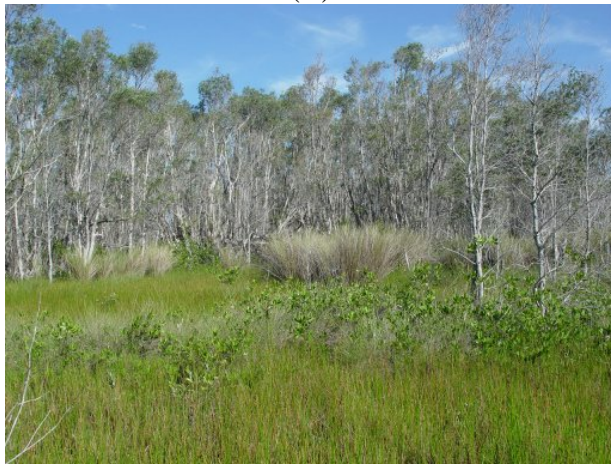
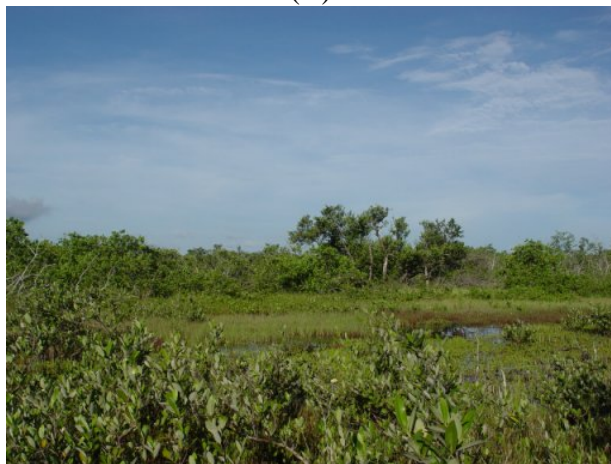
Figure B-18.2. Site photos of Little Pine Island Mitigation Bank. A) LPI_MAR B) LPI_SLT_1 C) LPI_SLT_2.

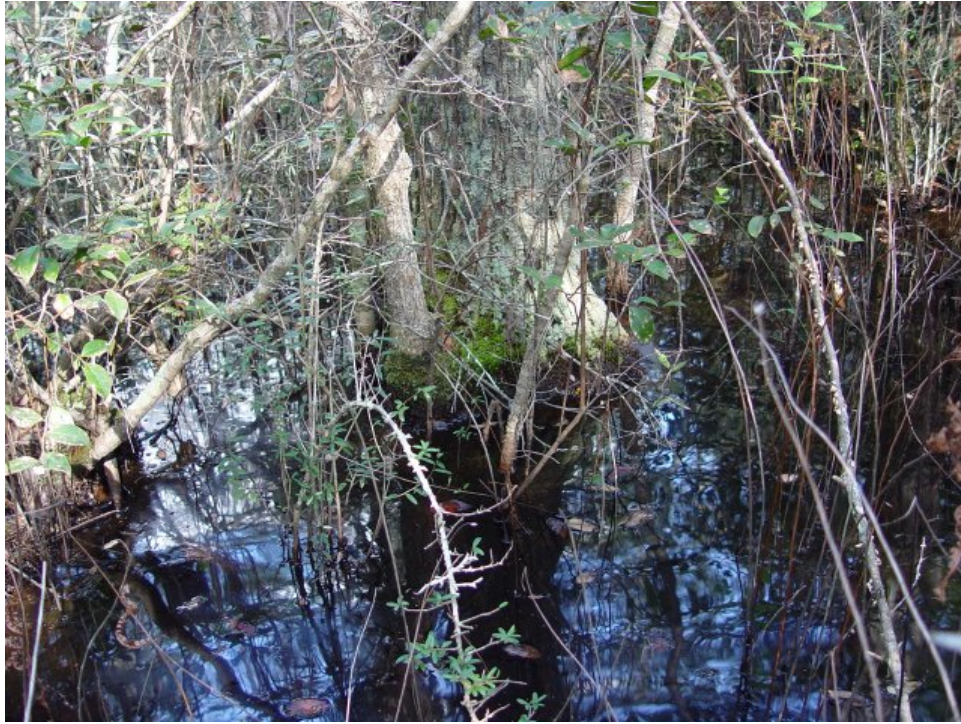
Figure B-19.2. Site photos of Loblolly Mitigation Bank. (A) Lob_CYP_1 is located in an area still planted in rows for silviculture at the time of the assessment. (B) Lob_CYP_2 is located within an area that had been clear cut prior to the time of wetland assessment.

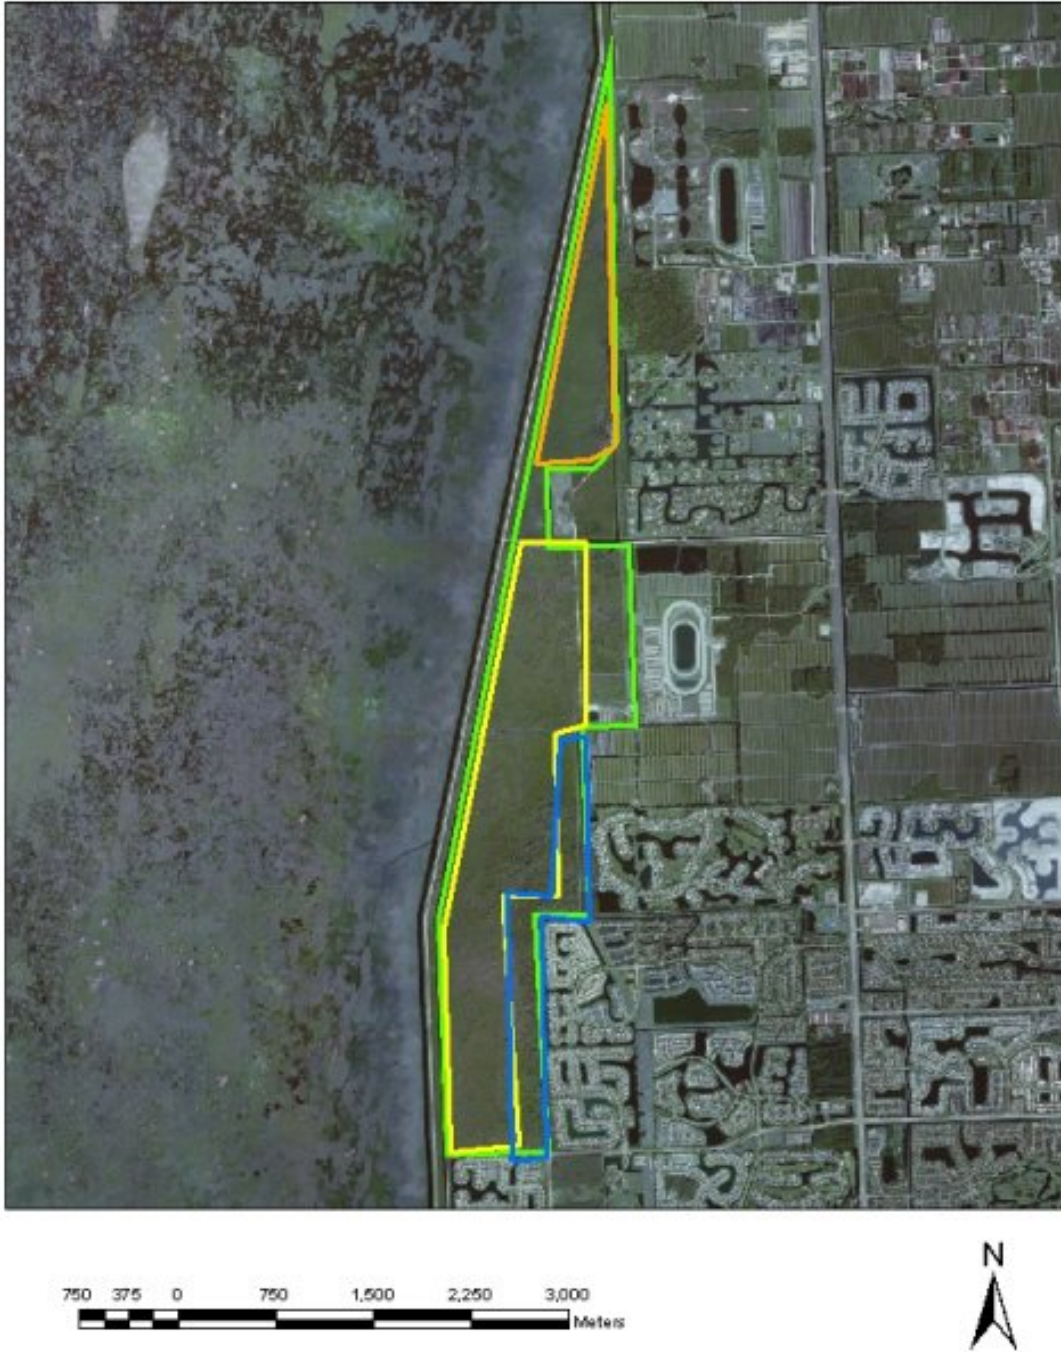
Figure B-20.1. Landscape location of Loxahatchee Mitigation Bank (green line). Boundary of the wetland assessment areas Lox_SHR outlined in orange, Lox_CYP outlined in blue, and Lox_FOR outlined in yellow.

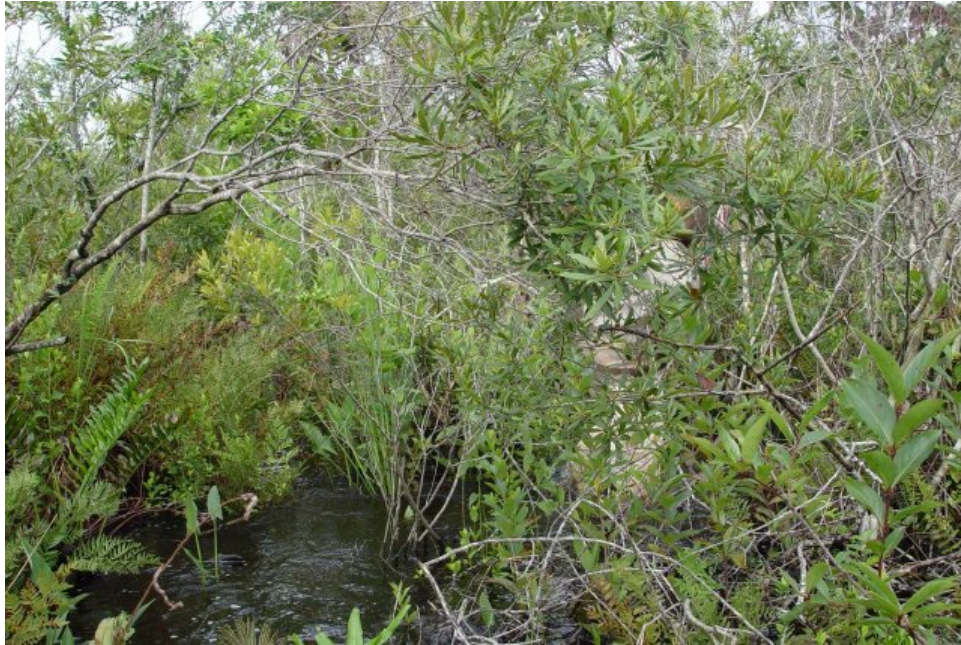
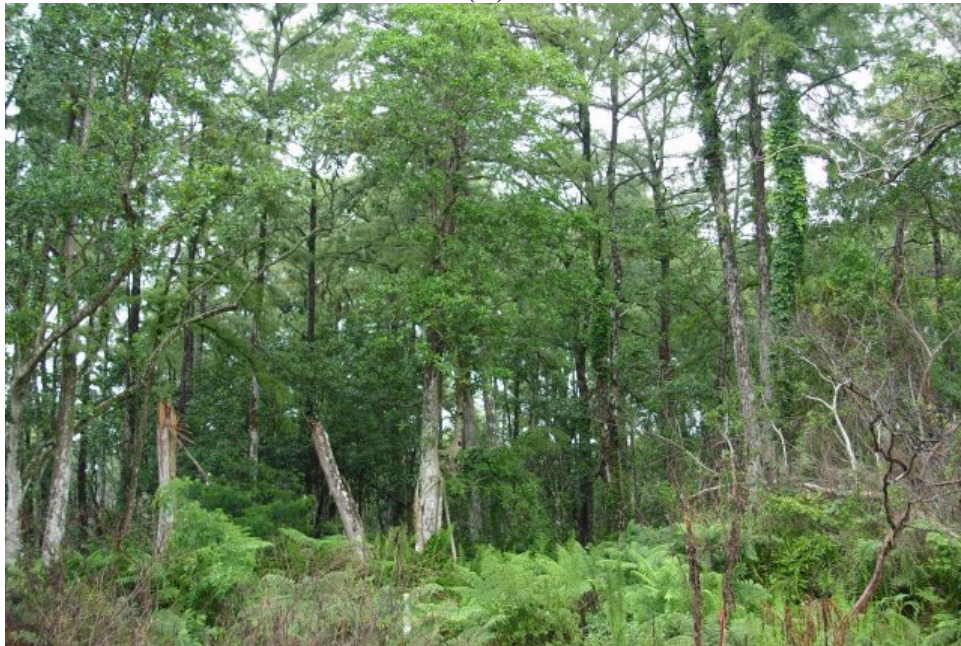
Figure B-20.2. Site photos of (A) Lox_SHR, and (B) Lox_CYP. Lox_FOR does not have a site photo.

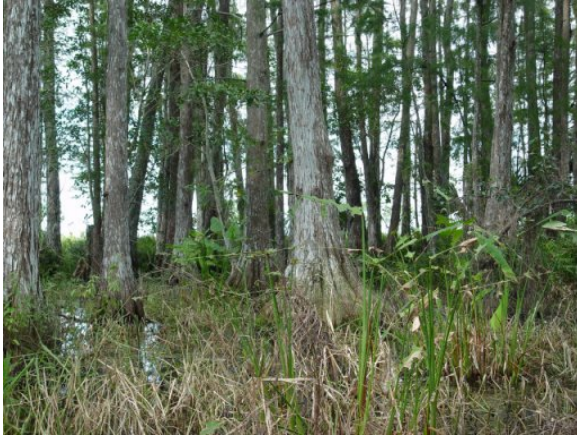
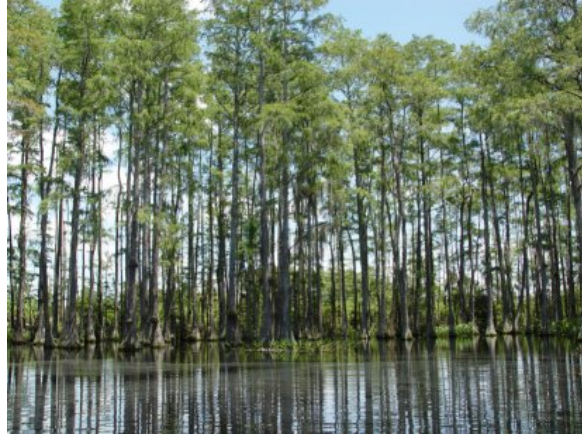
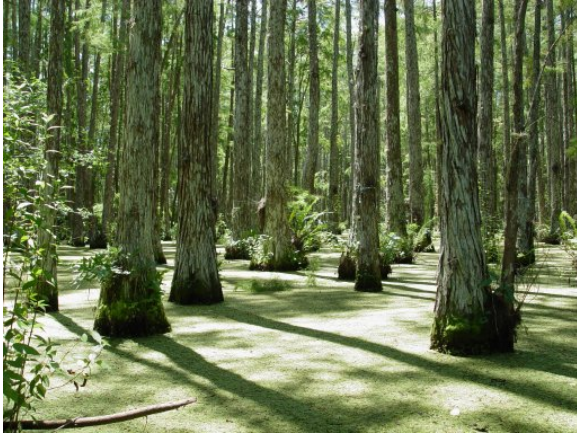
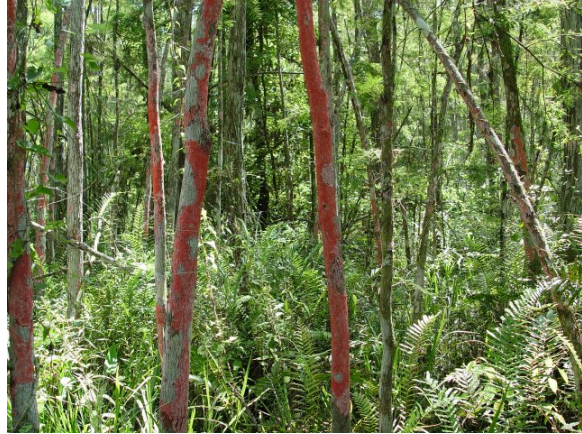
Figure B-21.2. Site photos of (A) Pant_CYP_1 (B) Pant_CYP_2 (C) Pant_CYP_3 and (D) Pant_FOR.

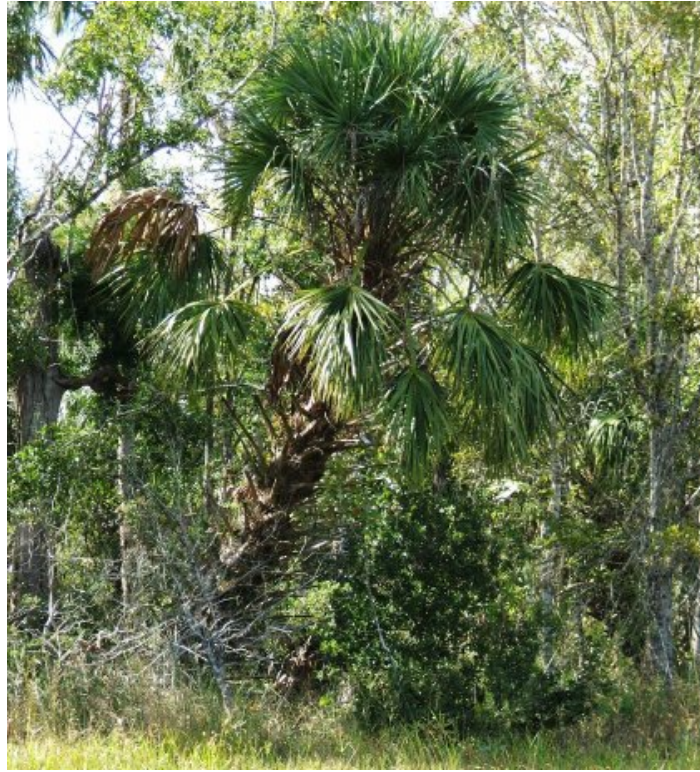
Figure B-22.2. Site photos of assessment area photos of (A) the outer edge of Reed_BOT and (B) Reed_FOR at Reedy Creek Mitigation Bank. Reed_FOR is located in pasture in a phase that had not begun restoration at the time of site visit.

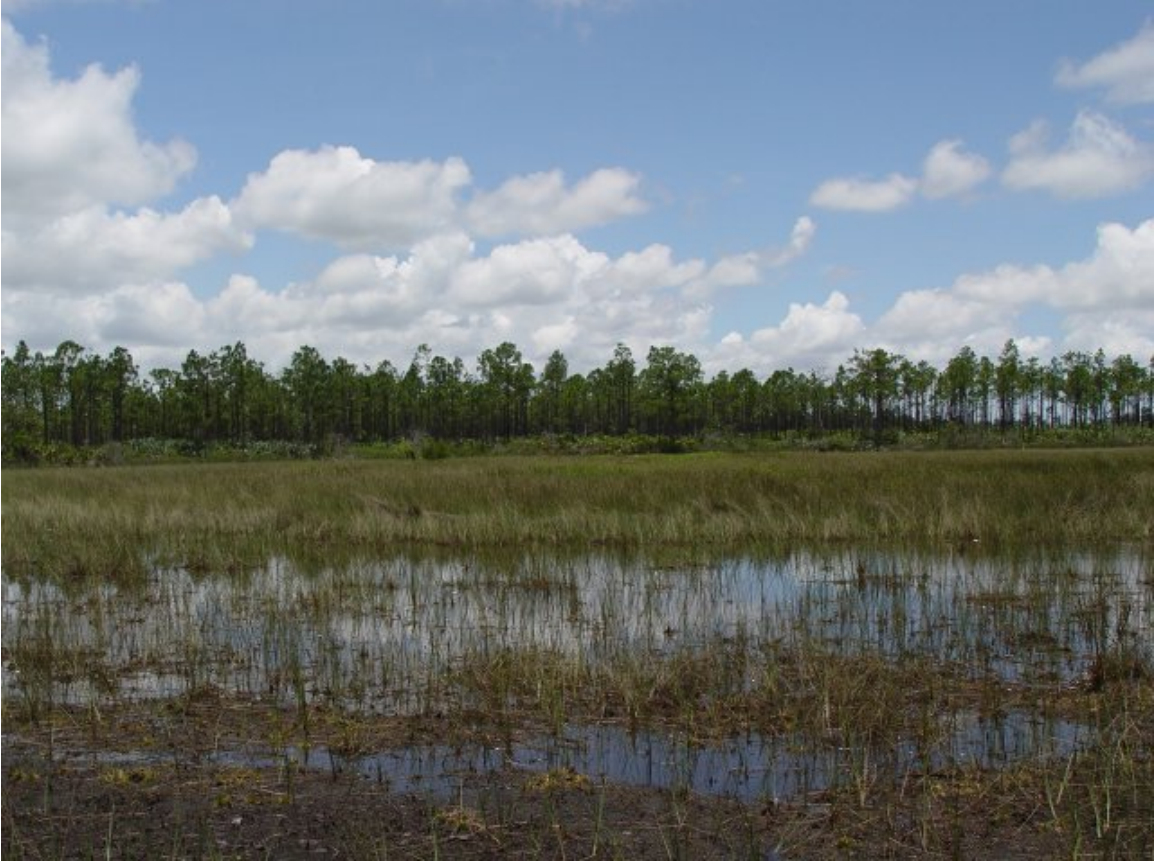
Figure B-23.2. Site photo of assessment area RG_MAR at RG Reserve Mitigation Bank.

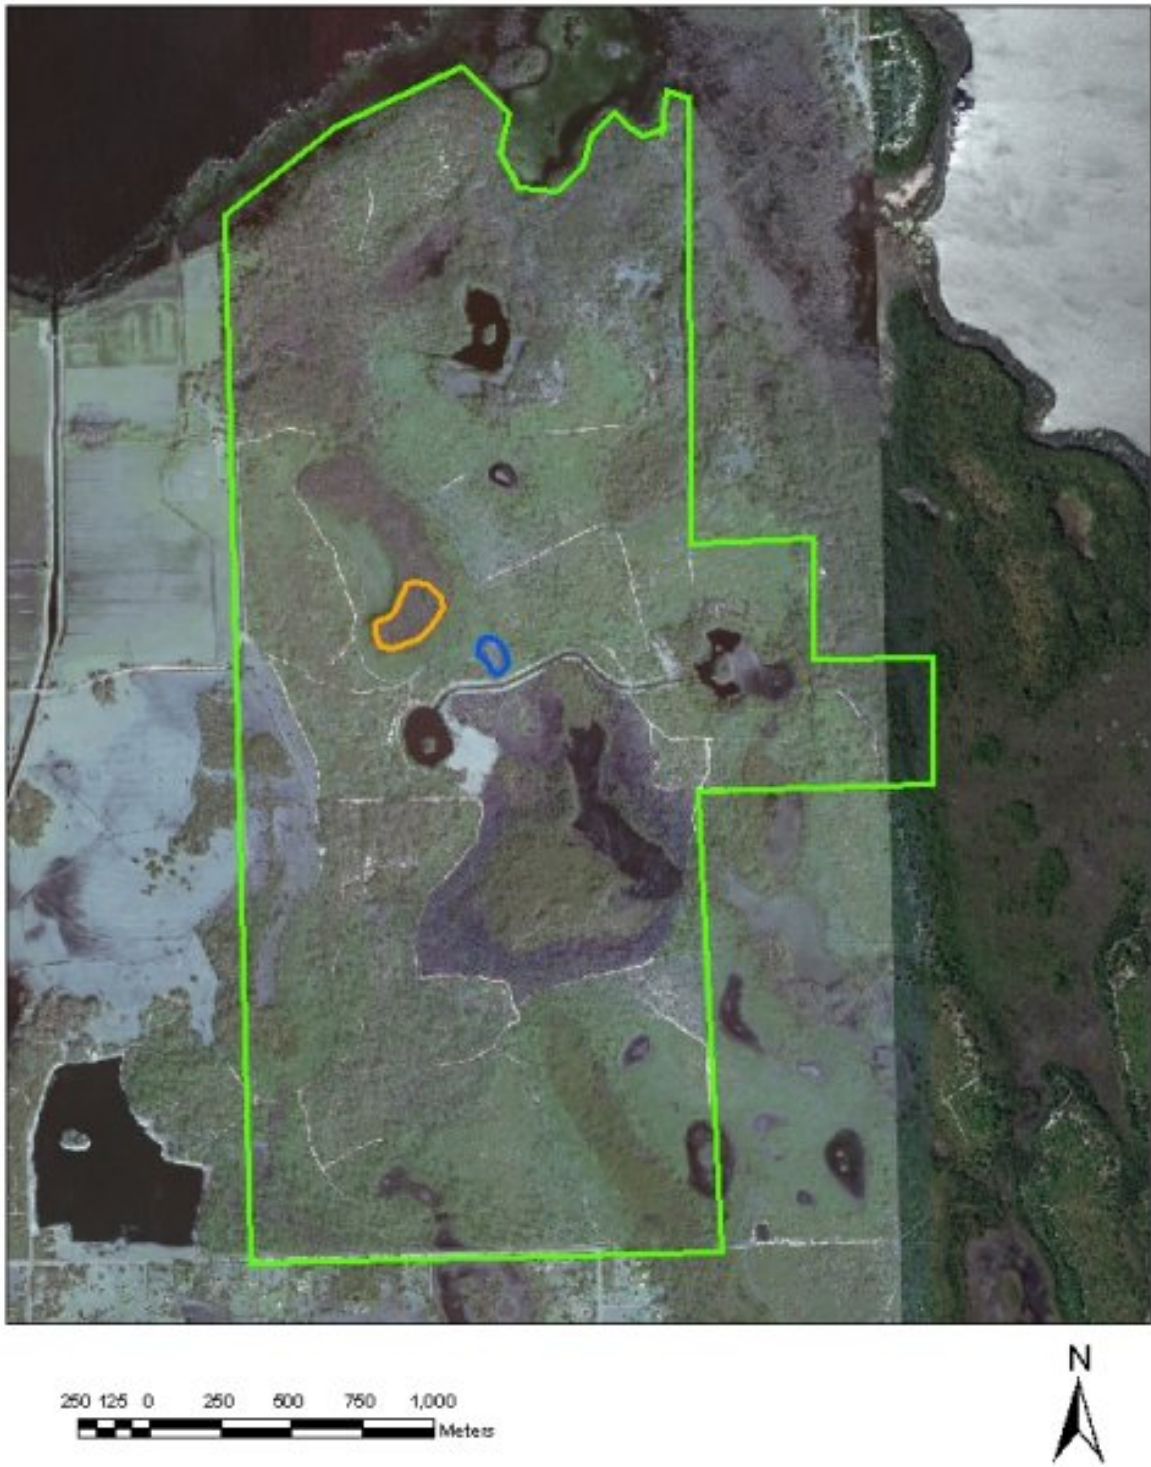
Figure B-24.1. Landscape location of Split Oak Mitigation Bank (green line). Boundaries of the wetland assessment areas are outlined in orange (SpIO_CYP) and blue (SpIO_MAR).

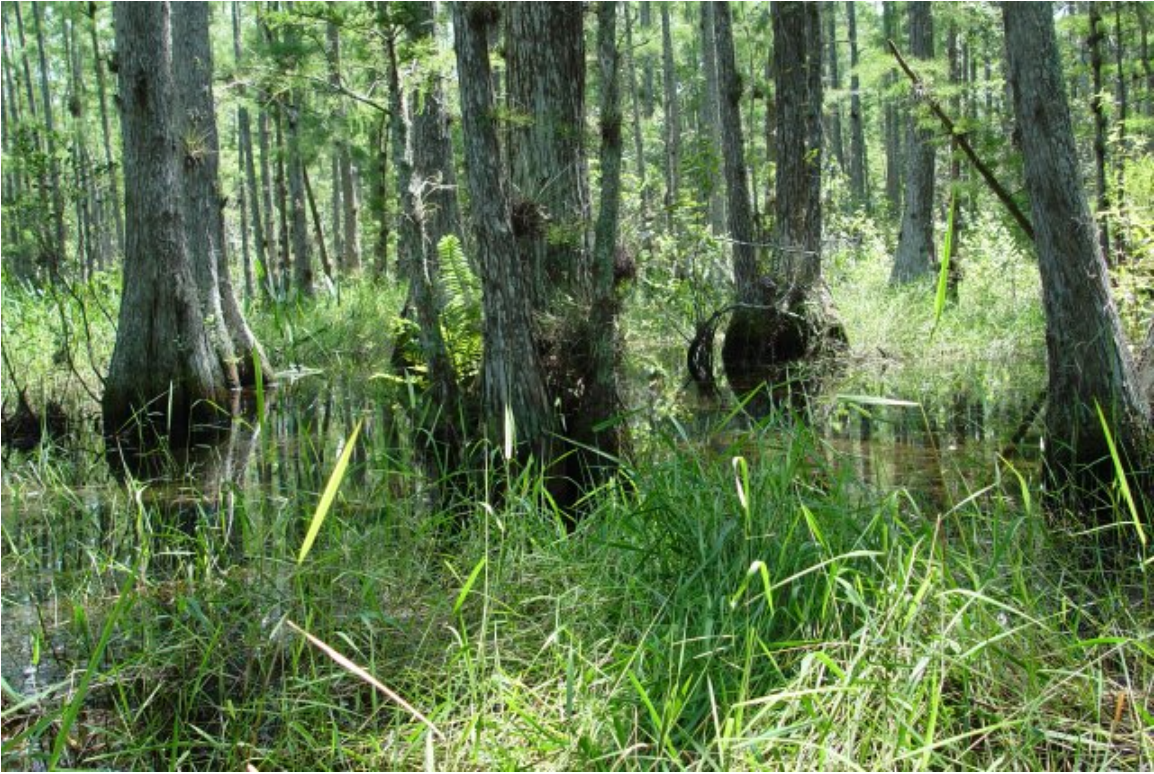
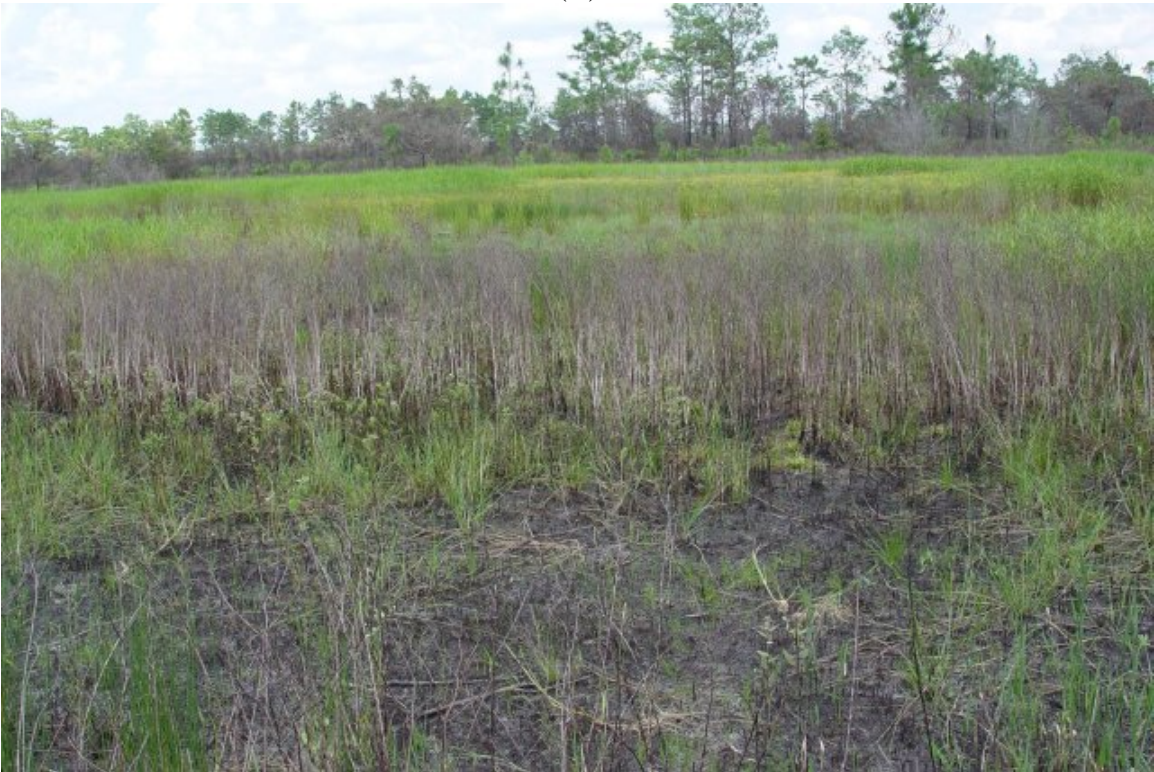
Figure B-24.2. Site photos of wetland assessment areas (A) SpIO_CYP and (B) SpIO_MAR.

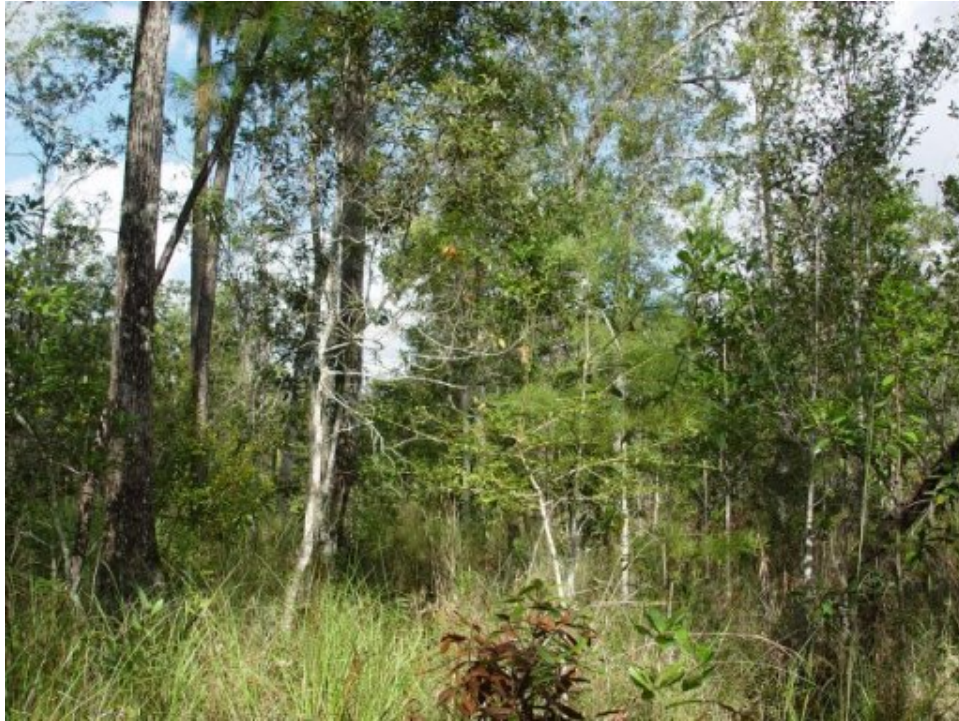
Figure B-25.2. Site photos of assessment areas (A) Sun_FOR_1 and (B) Sun_FOR_2 at Sundew mitigation bank. At the time of site visit little mitigation activity had been initiated.

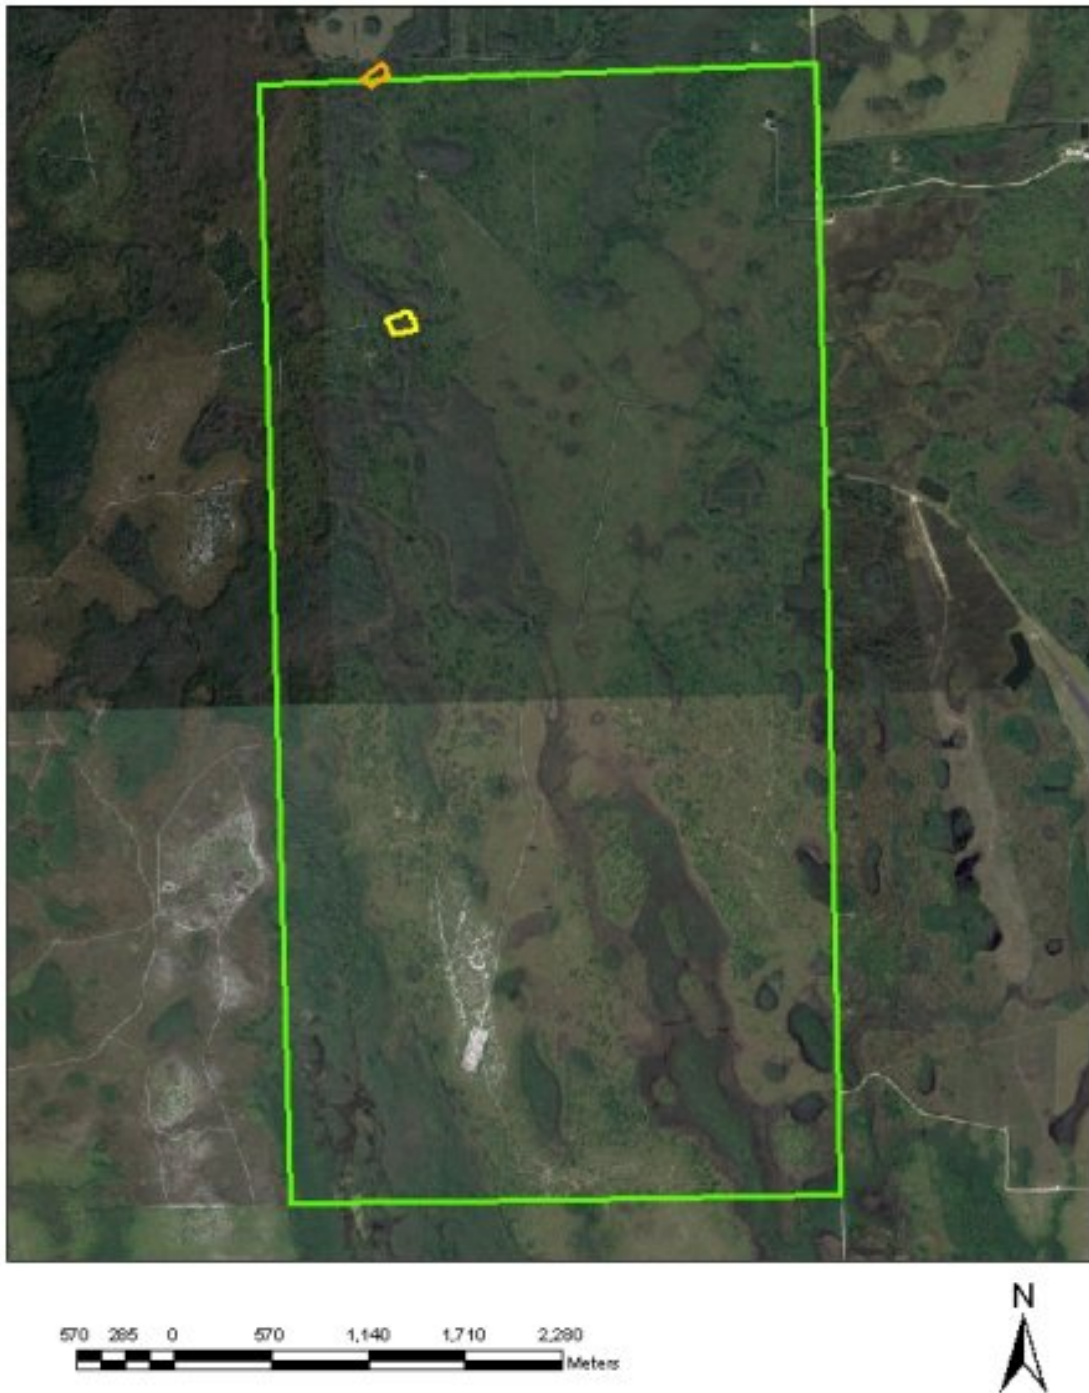
Figure B-26.1. Landscape location of TM Econ Mitigation Bank (green line). Boundary of the wetland assessment area TMEc_CYP_1 is outlined in orange and TMEc_CYP_2 is outlined in yellow.

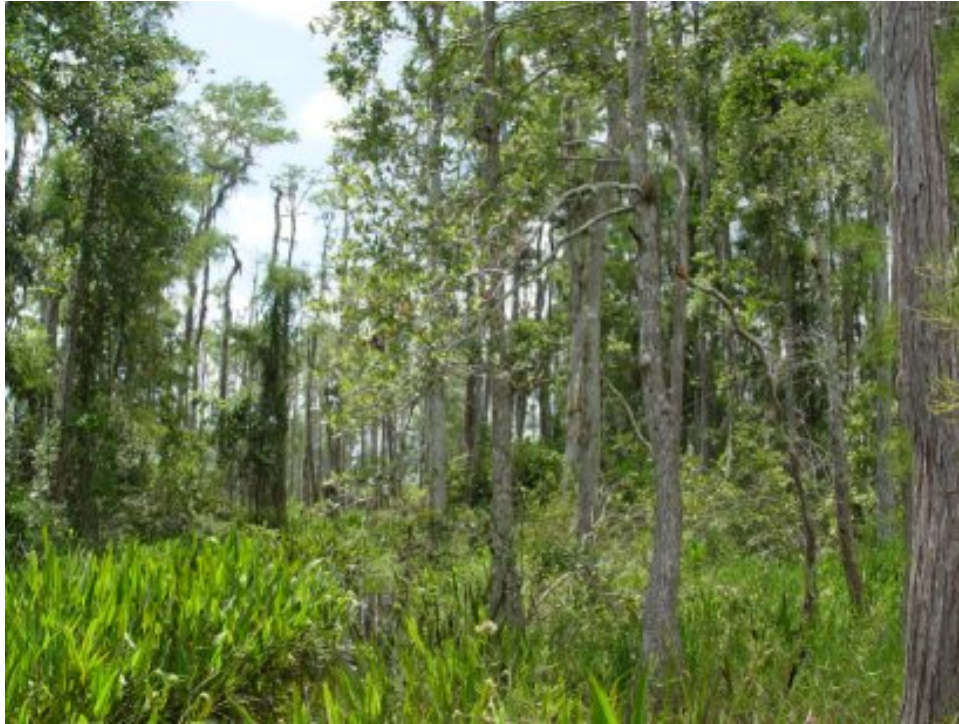
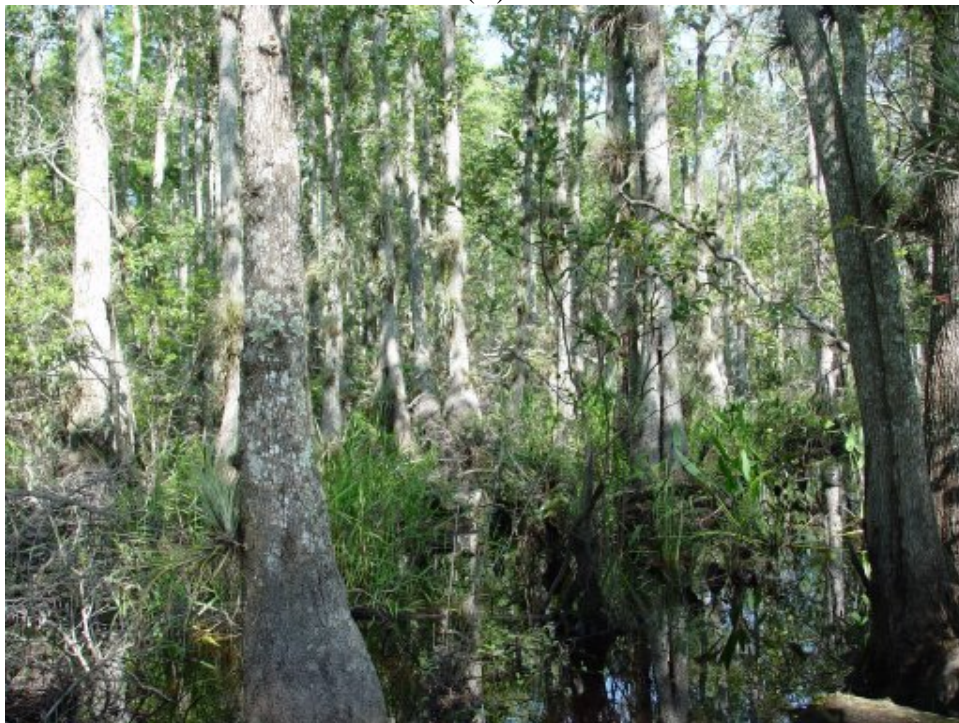
Figure B-26.2. Site photos of wetland assessment areas (A) TMEc_CYP_1 and (B) TMEc_CYP_2 at TM Econ mitigation bank.

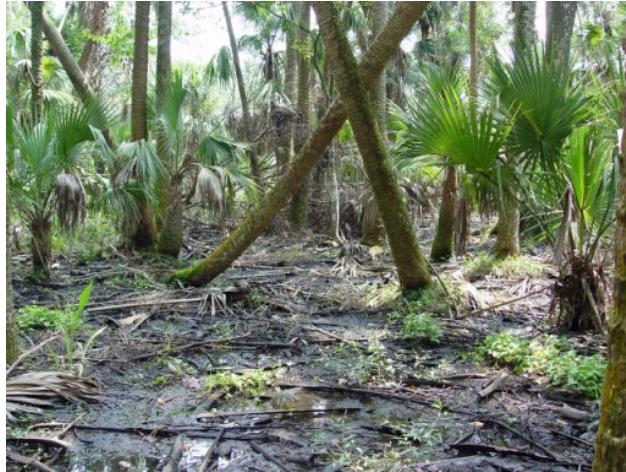
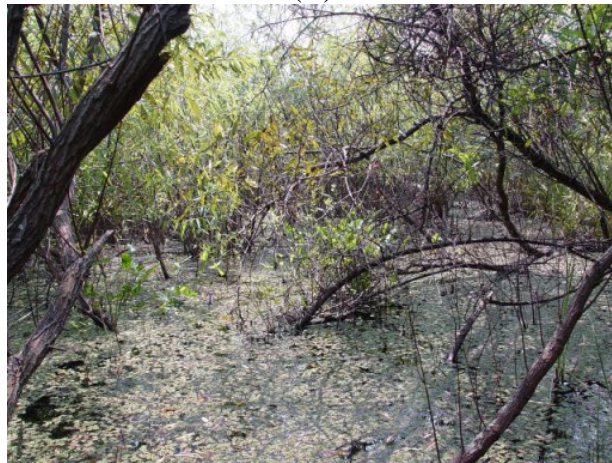
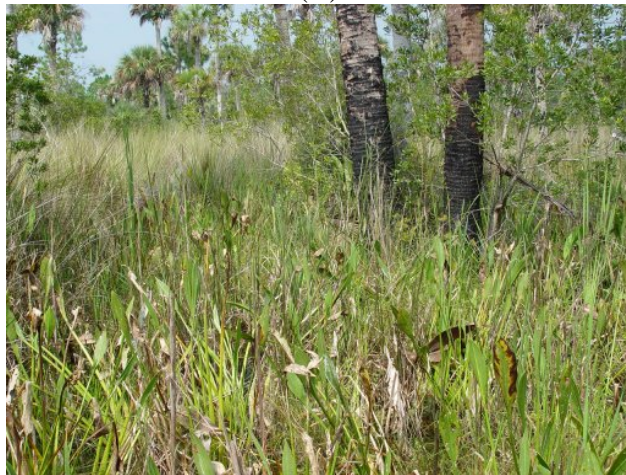
Figure B-27.2. Site photos of wetland assessment areas (A) Toso_FOR, (B) Toso_SHR and (C) Toso_MAR.

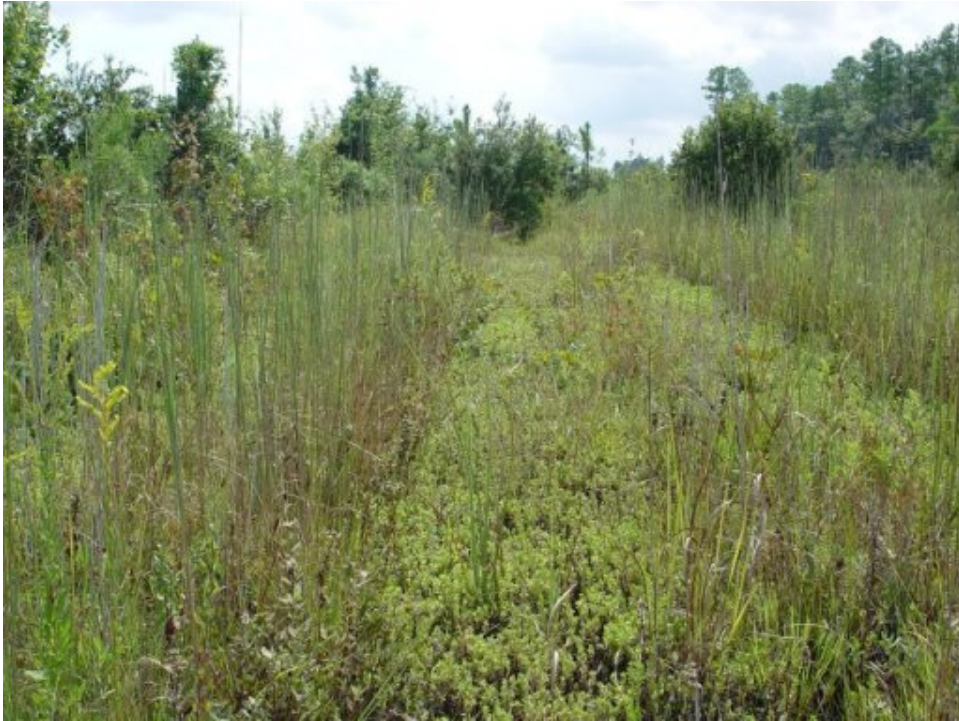
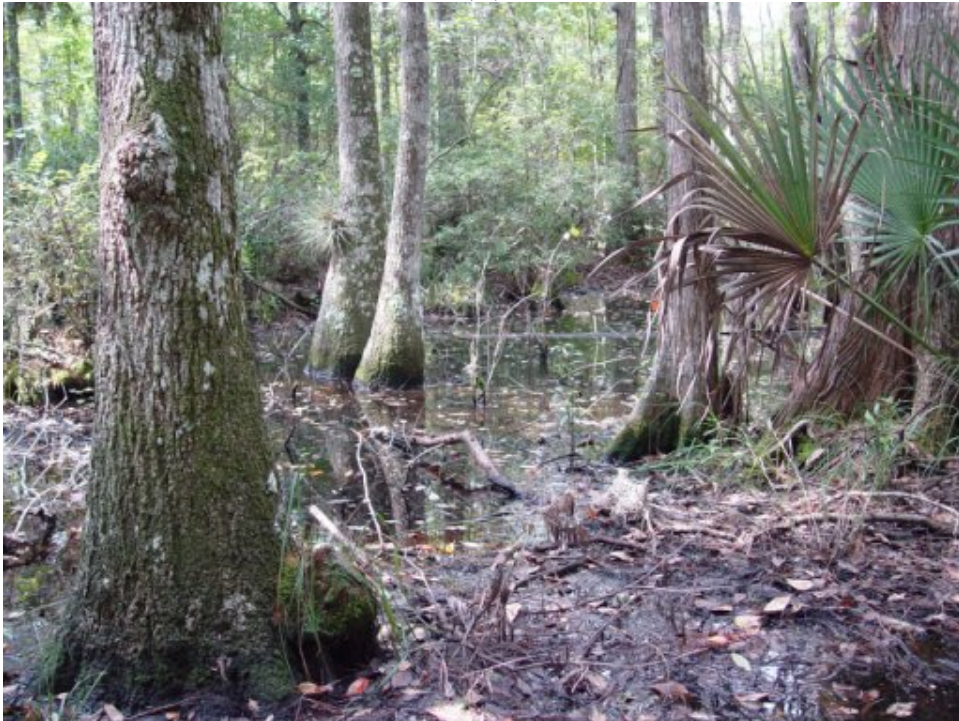
Figure B-28.2. Site photos of (A) Tup_PRA and (B) Tup_FOR.
