***Hurricane Ian & Hurricane Nicole Post-Storm  
Beach Conditions and Coastal Impact Report***

**Office of Resilience and Coastal Protection**

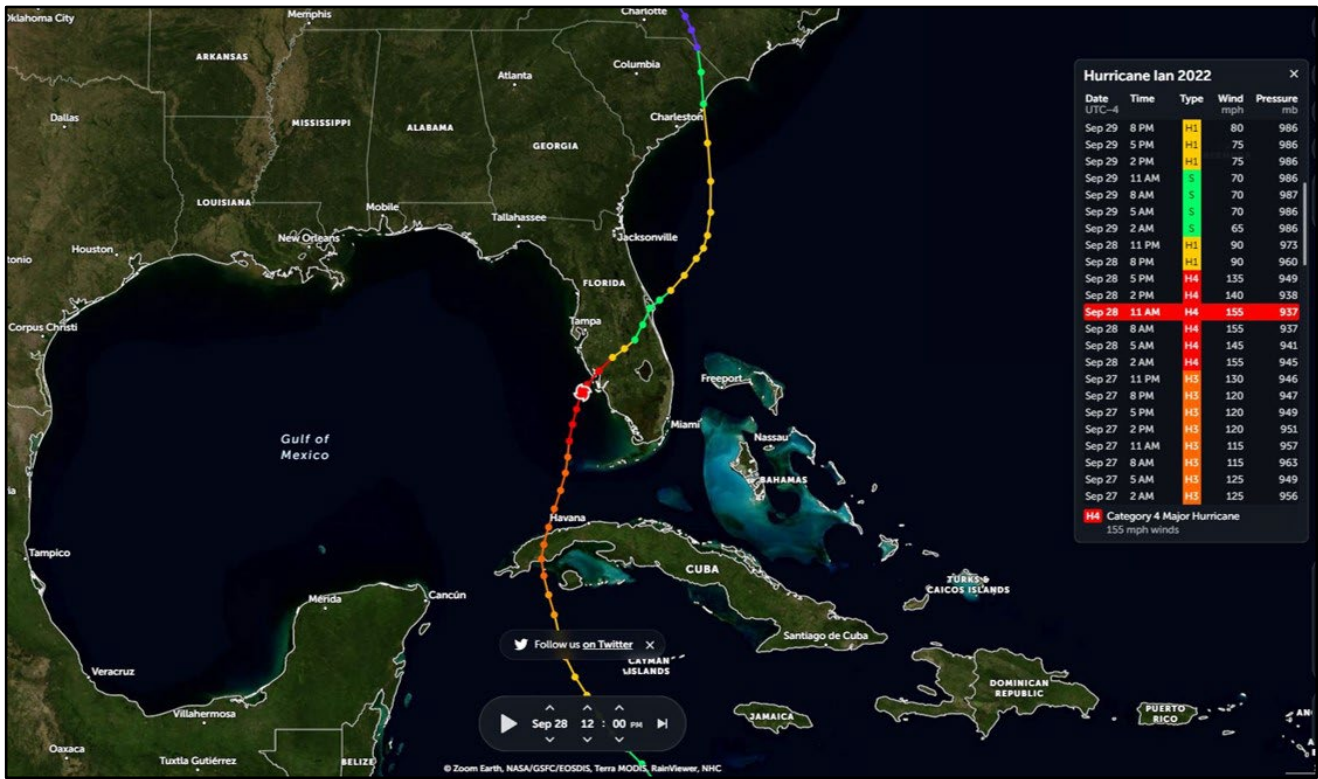
Figure 2. Hurricane Ian track (Source: Zoom Earth).

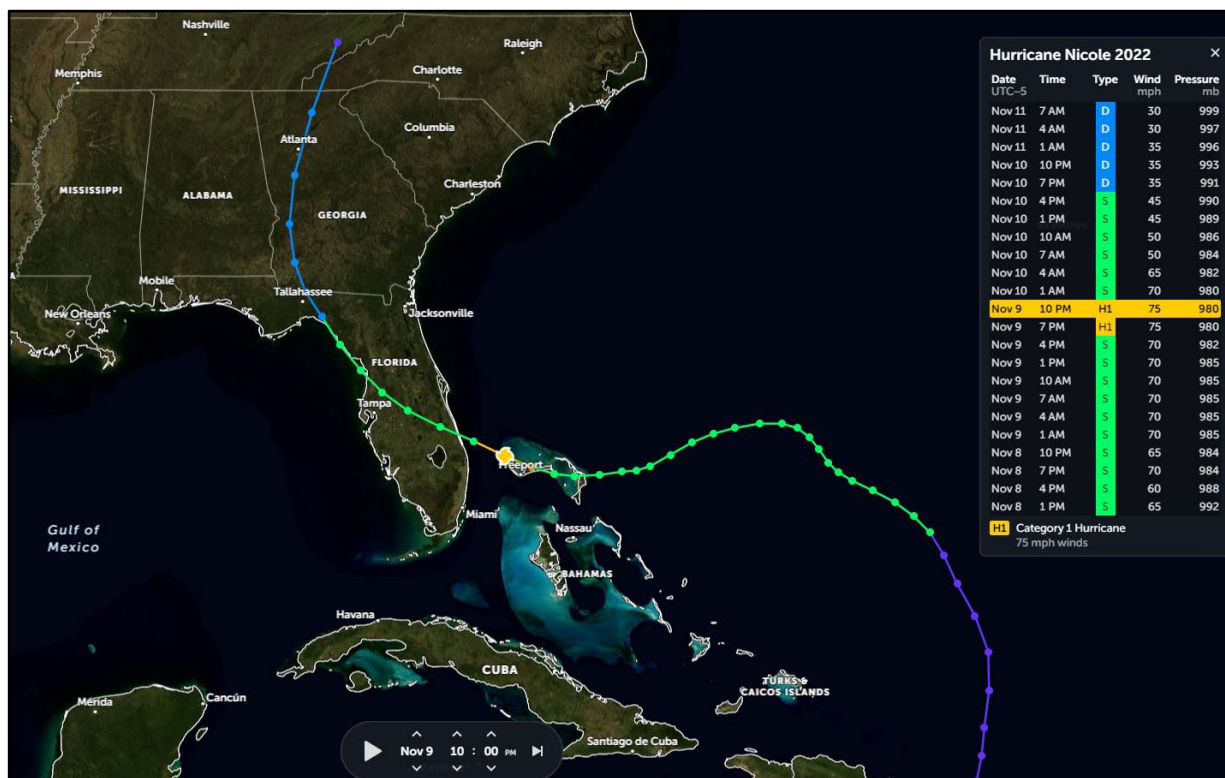
**Figure 7.** Hurricane Nicole track (Source: Zoom Earth).

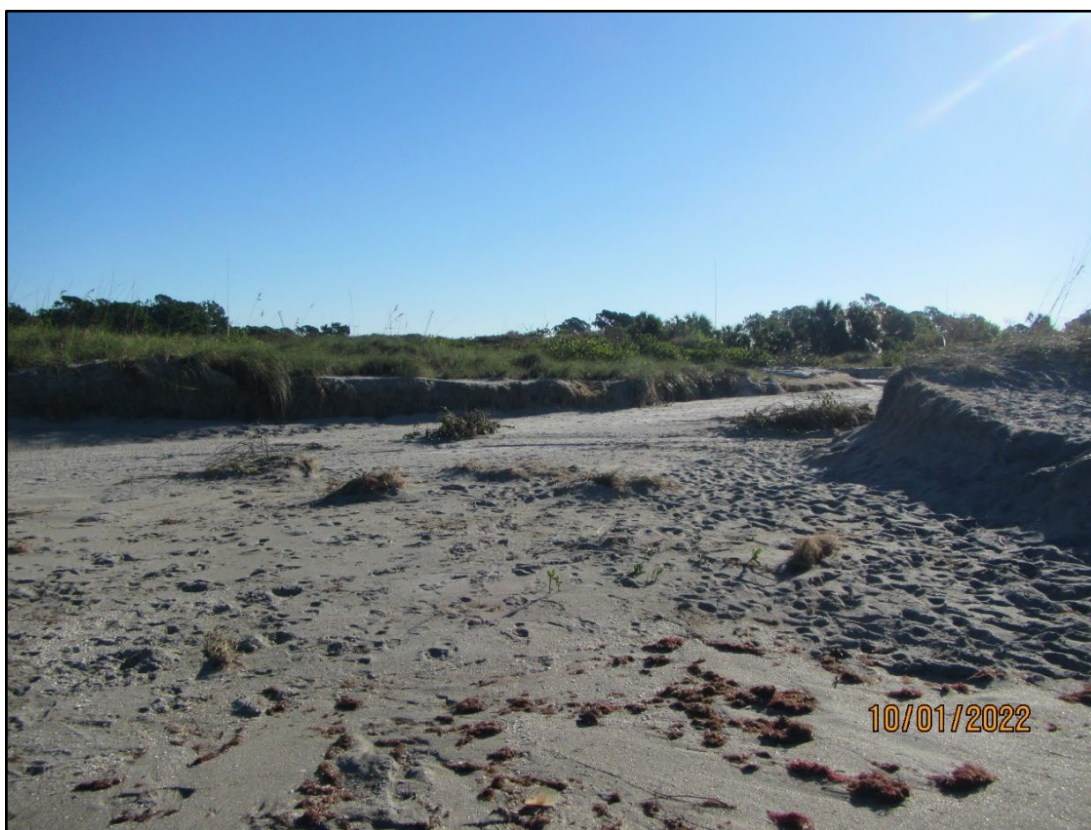
**Figure 14.** Storm water runoff gullies, Venice Beach (R-130).

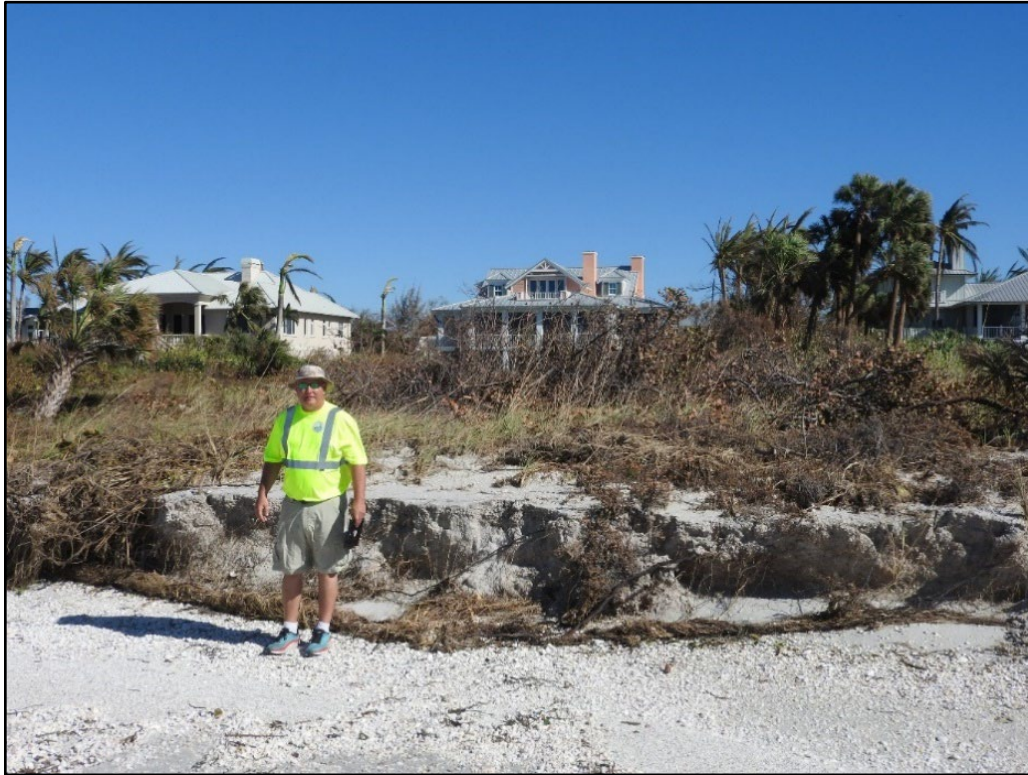
**Figure 20.** Minor beach and dune erosion, northern Gasparilla Island (R-59).

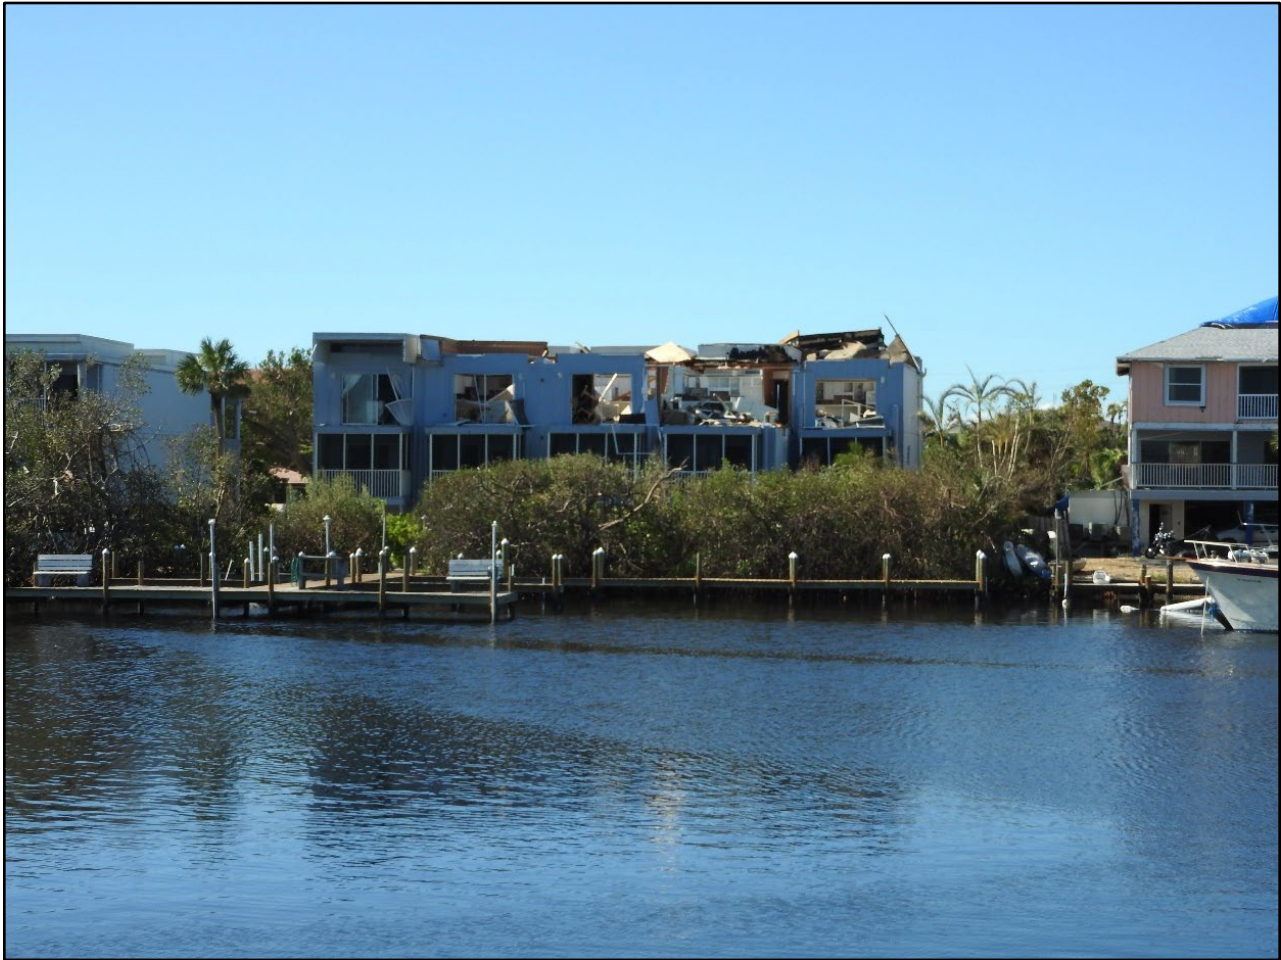
**Figure 21.** Condominiums destroyed in Englewood Beach (R-11).

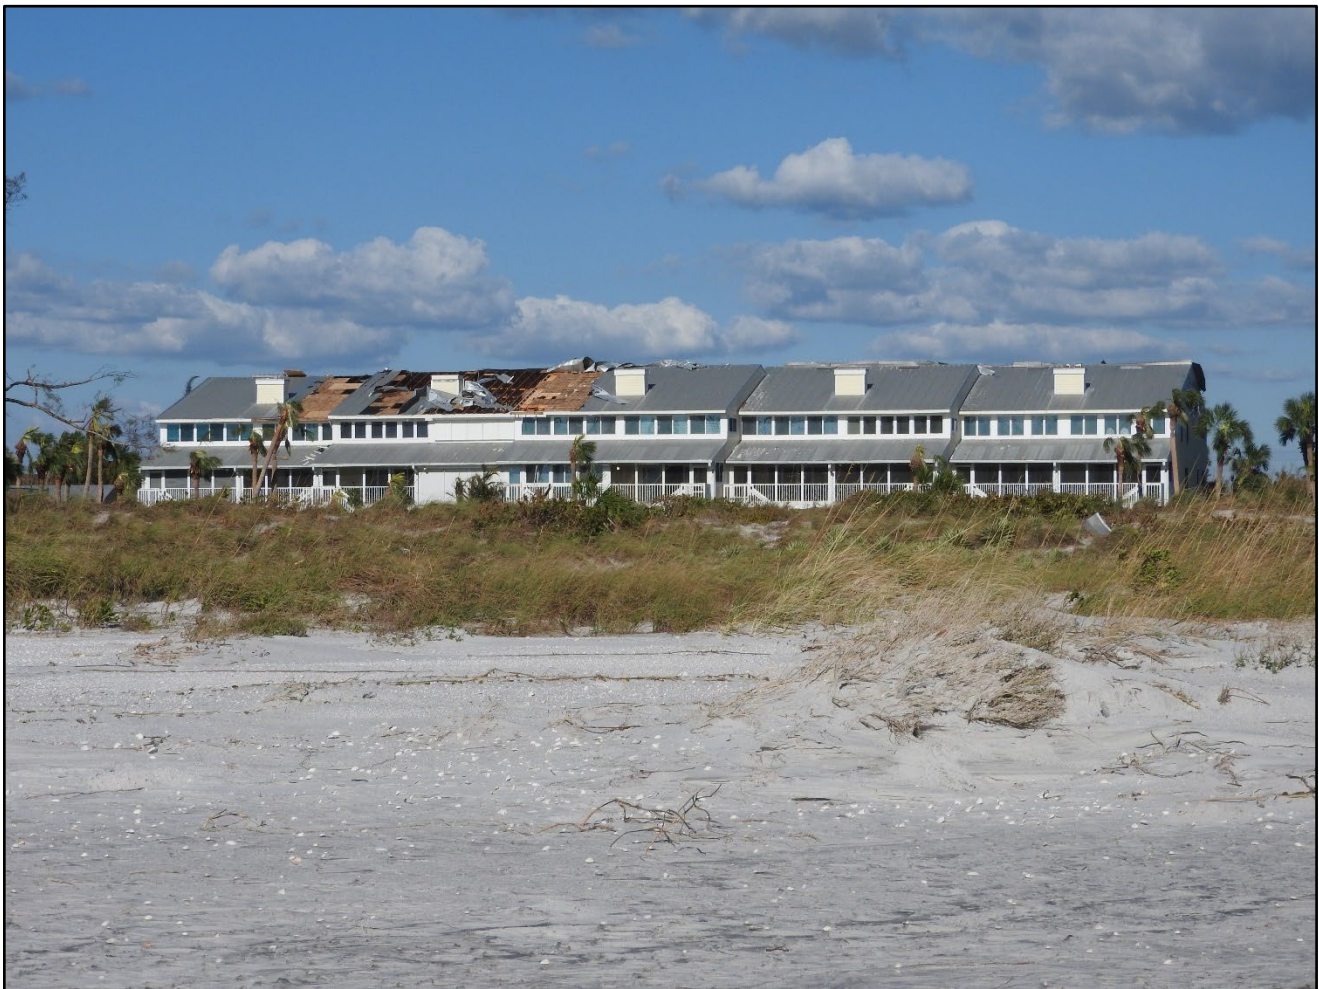
**Figure 25.** Major roofing damage on condominiums on northern Gasparilla Island (R-64).

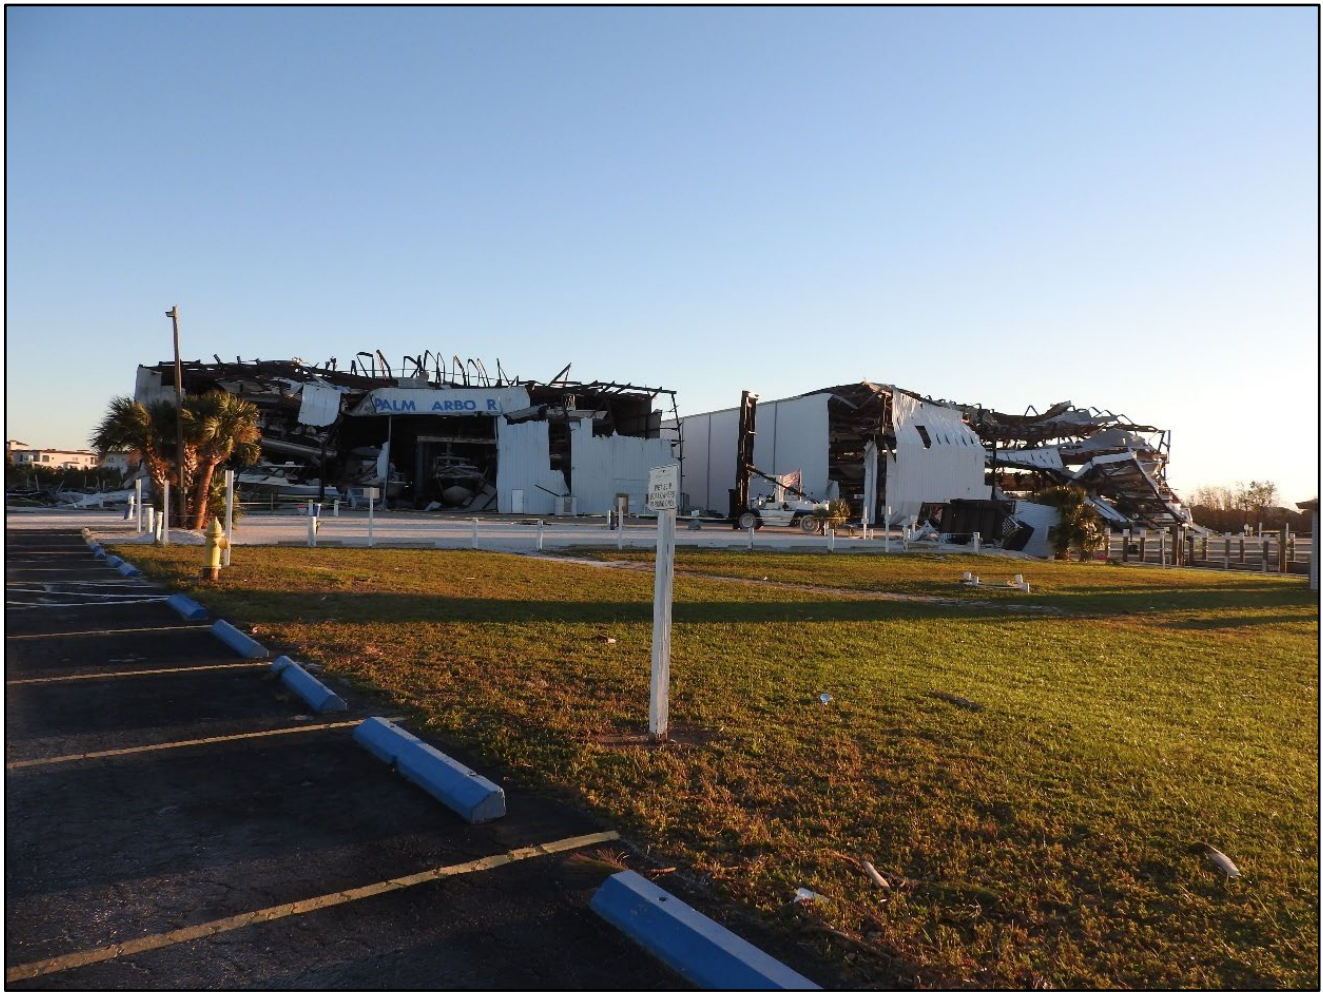
**Figure 26.** Palm Harbor Marina destroyed in Placida.

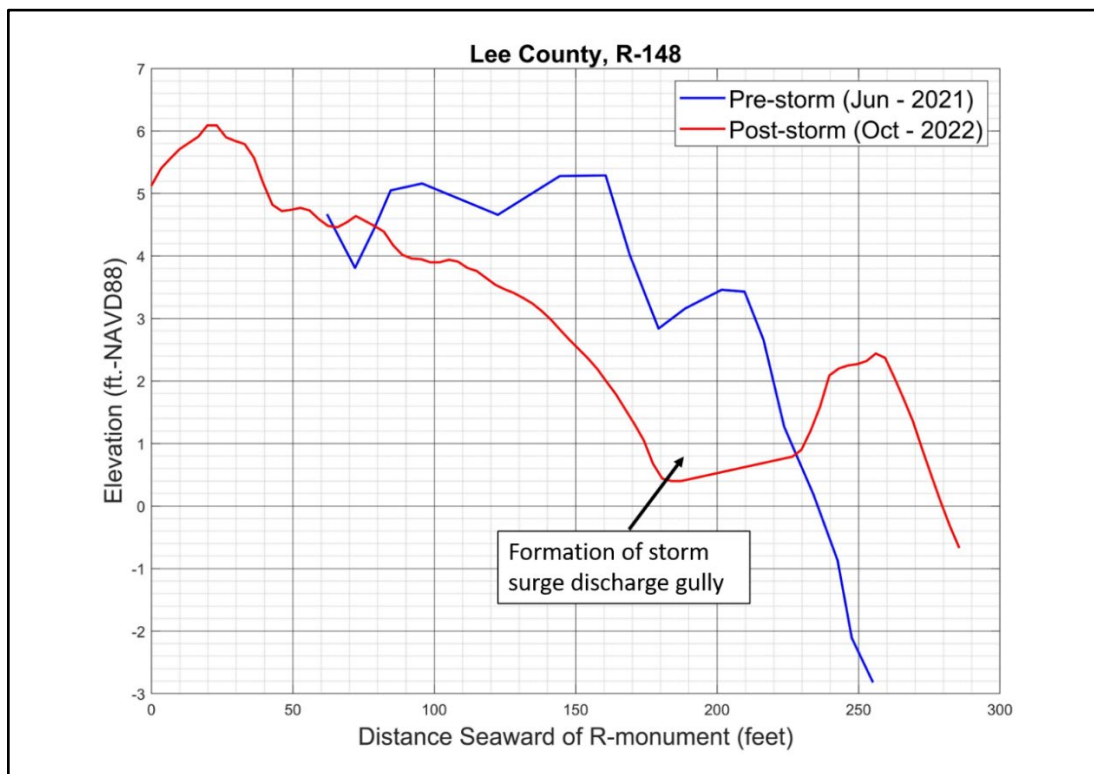
**Figure 29.** Pre- and post-storm profiles show formation of storm discharge gully in Sanibel Island, (R-148).

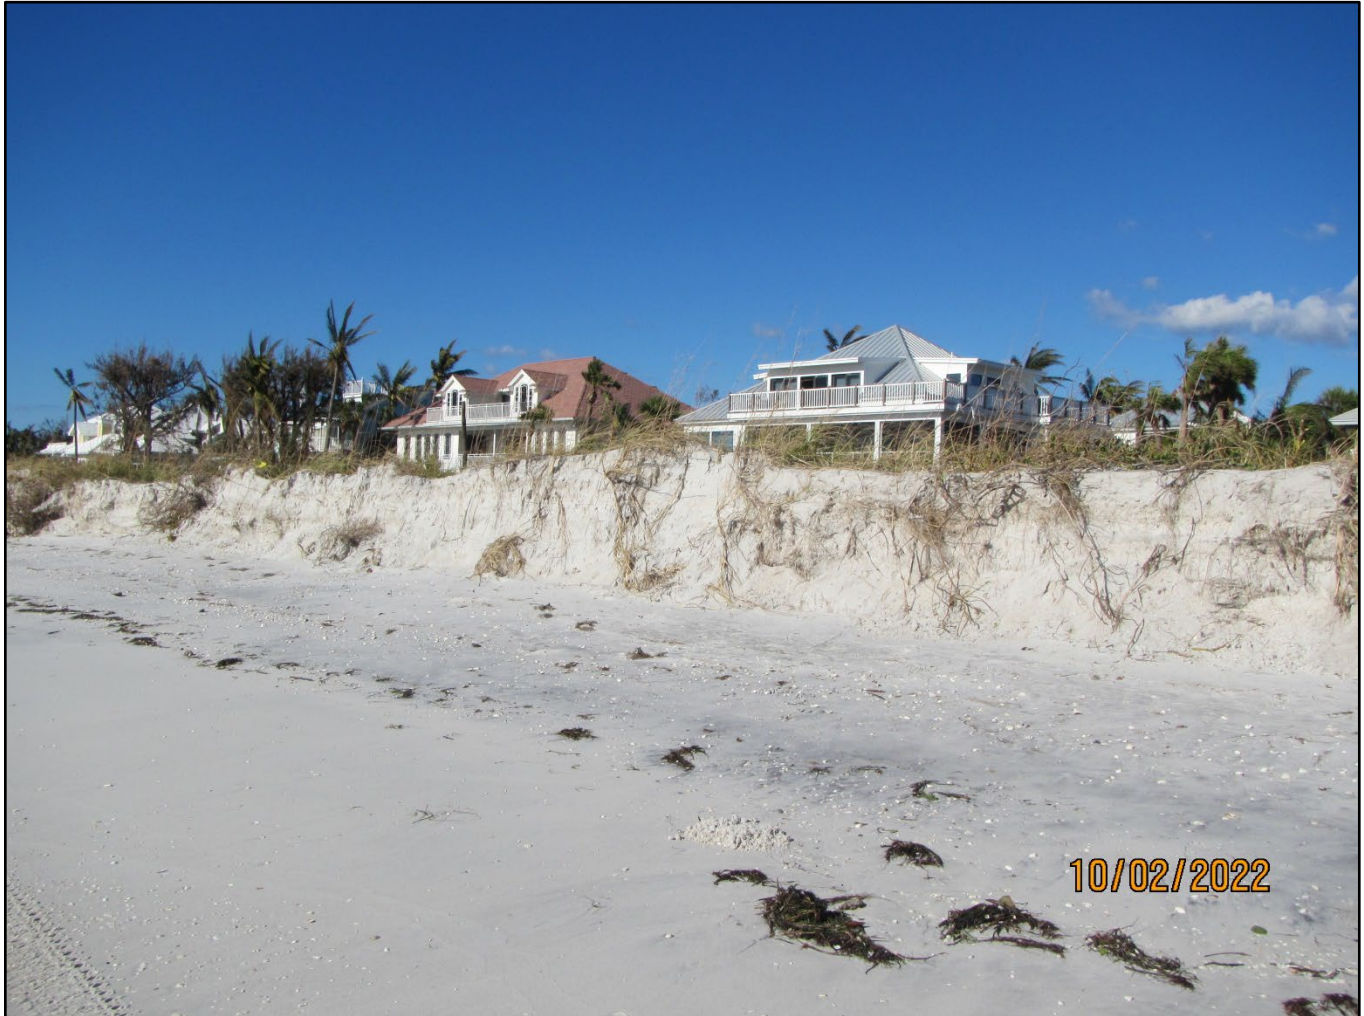
**Figure 30.** Condition II erosion at R-2 in Lee County near the county line between Charlotte and Lee Counties.

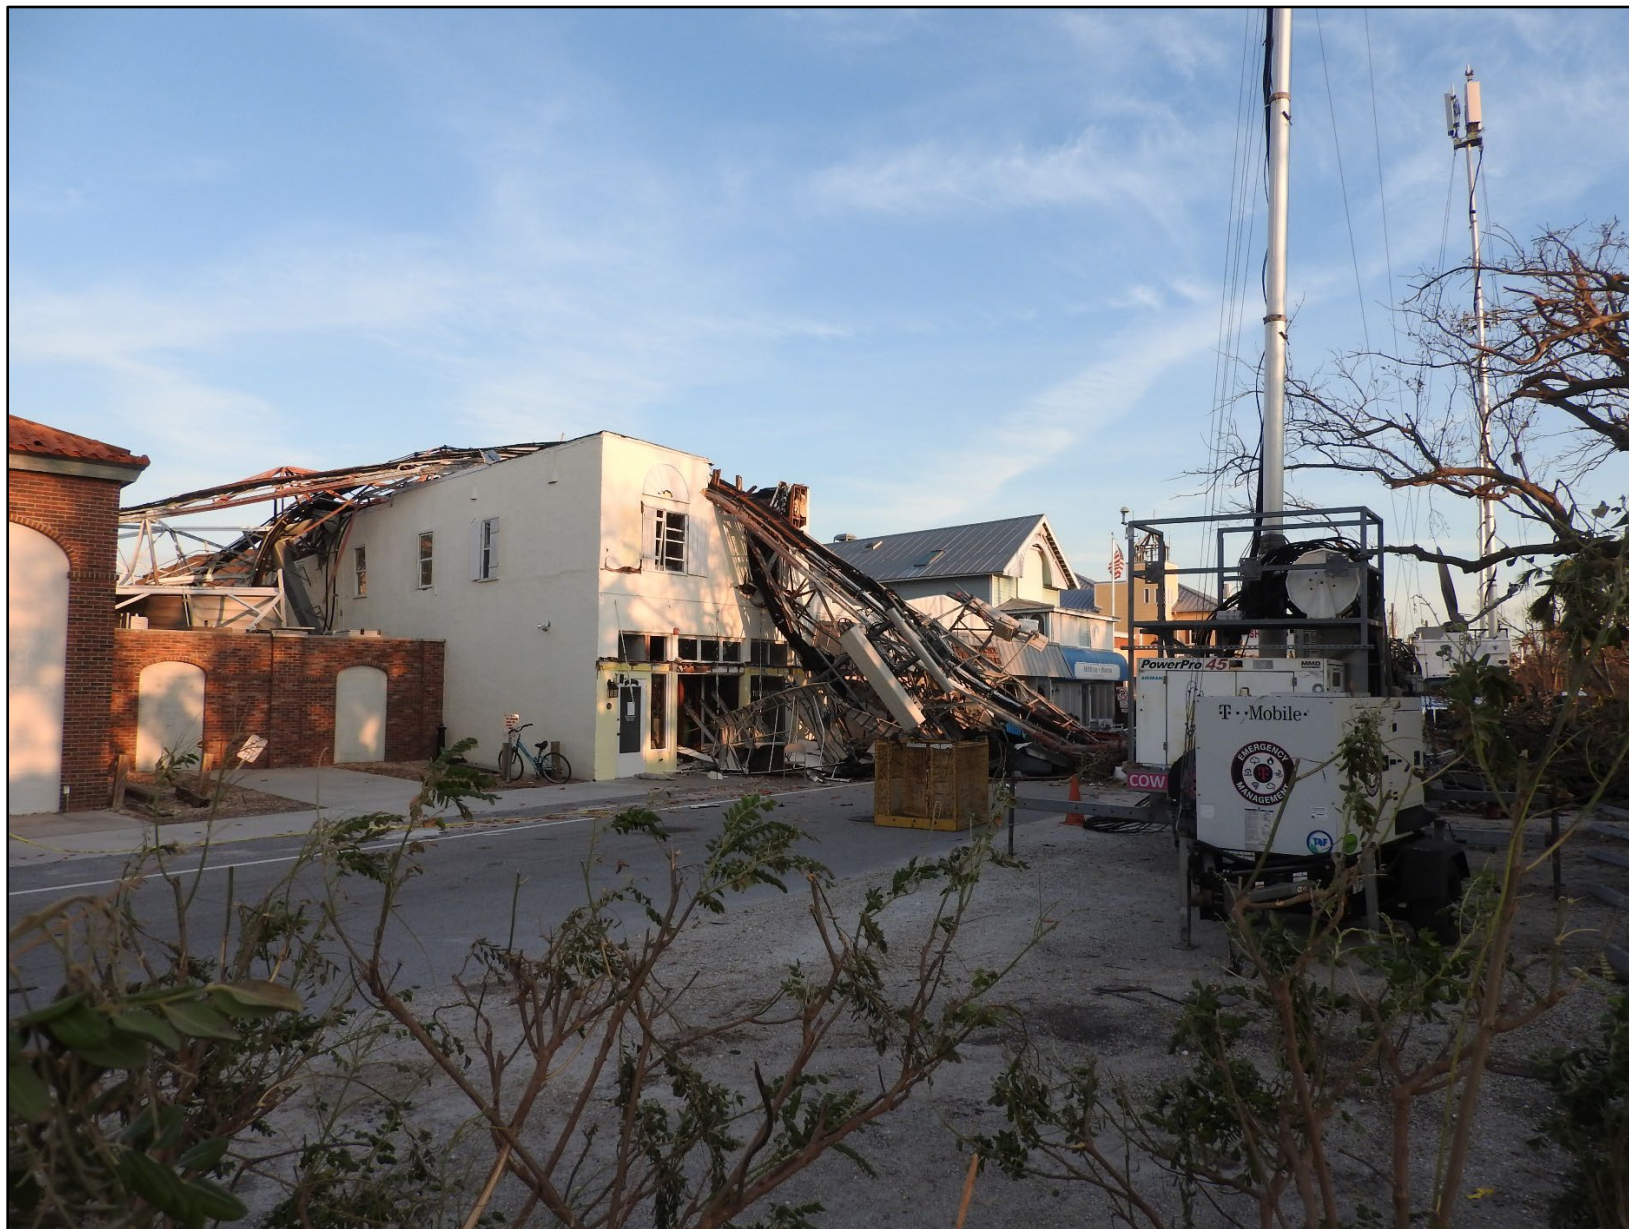
**Figure 31.** Collapse of an older cell tower onto the local bakery in Boca Grande from hurricane winds landward of R-14.

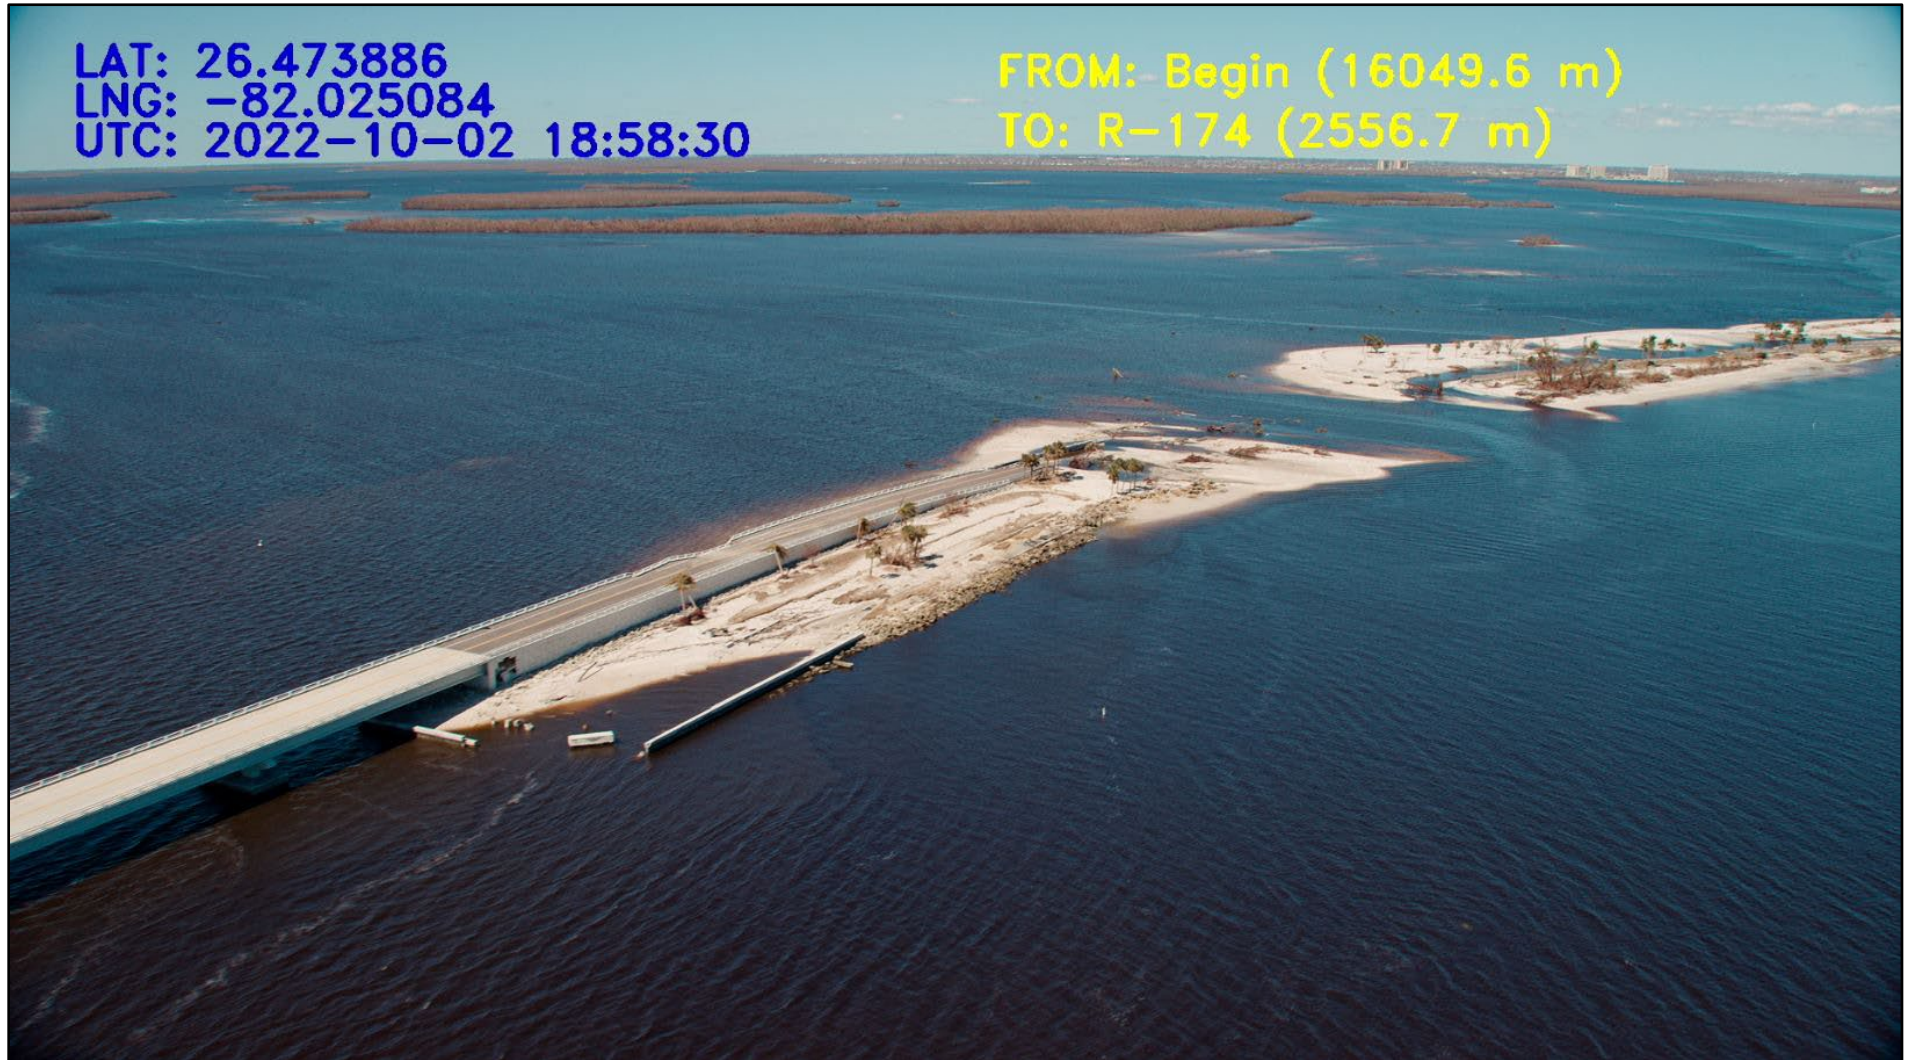
**Figure 34.** Sanibel Island bridge and causeway destroyed. (Image source: Active Camera Systems and Camera Copters).

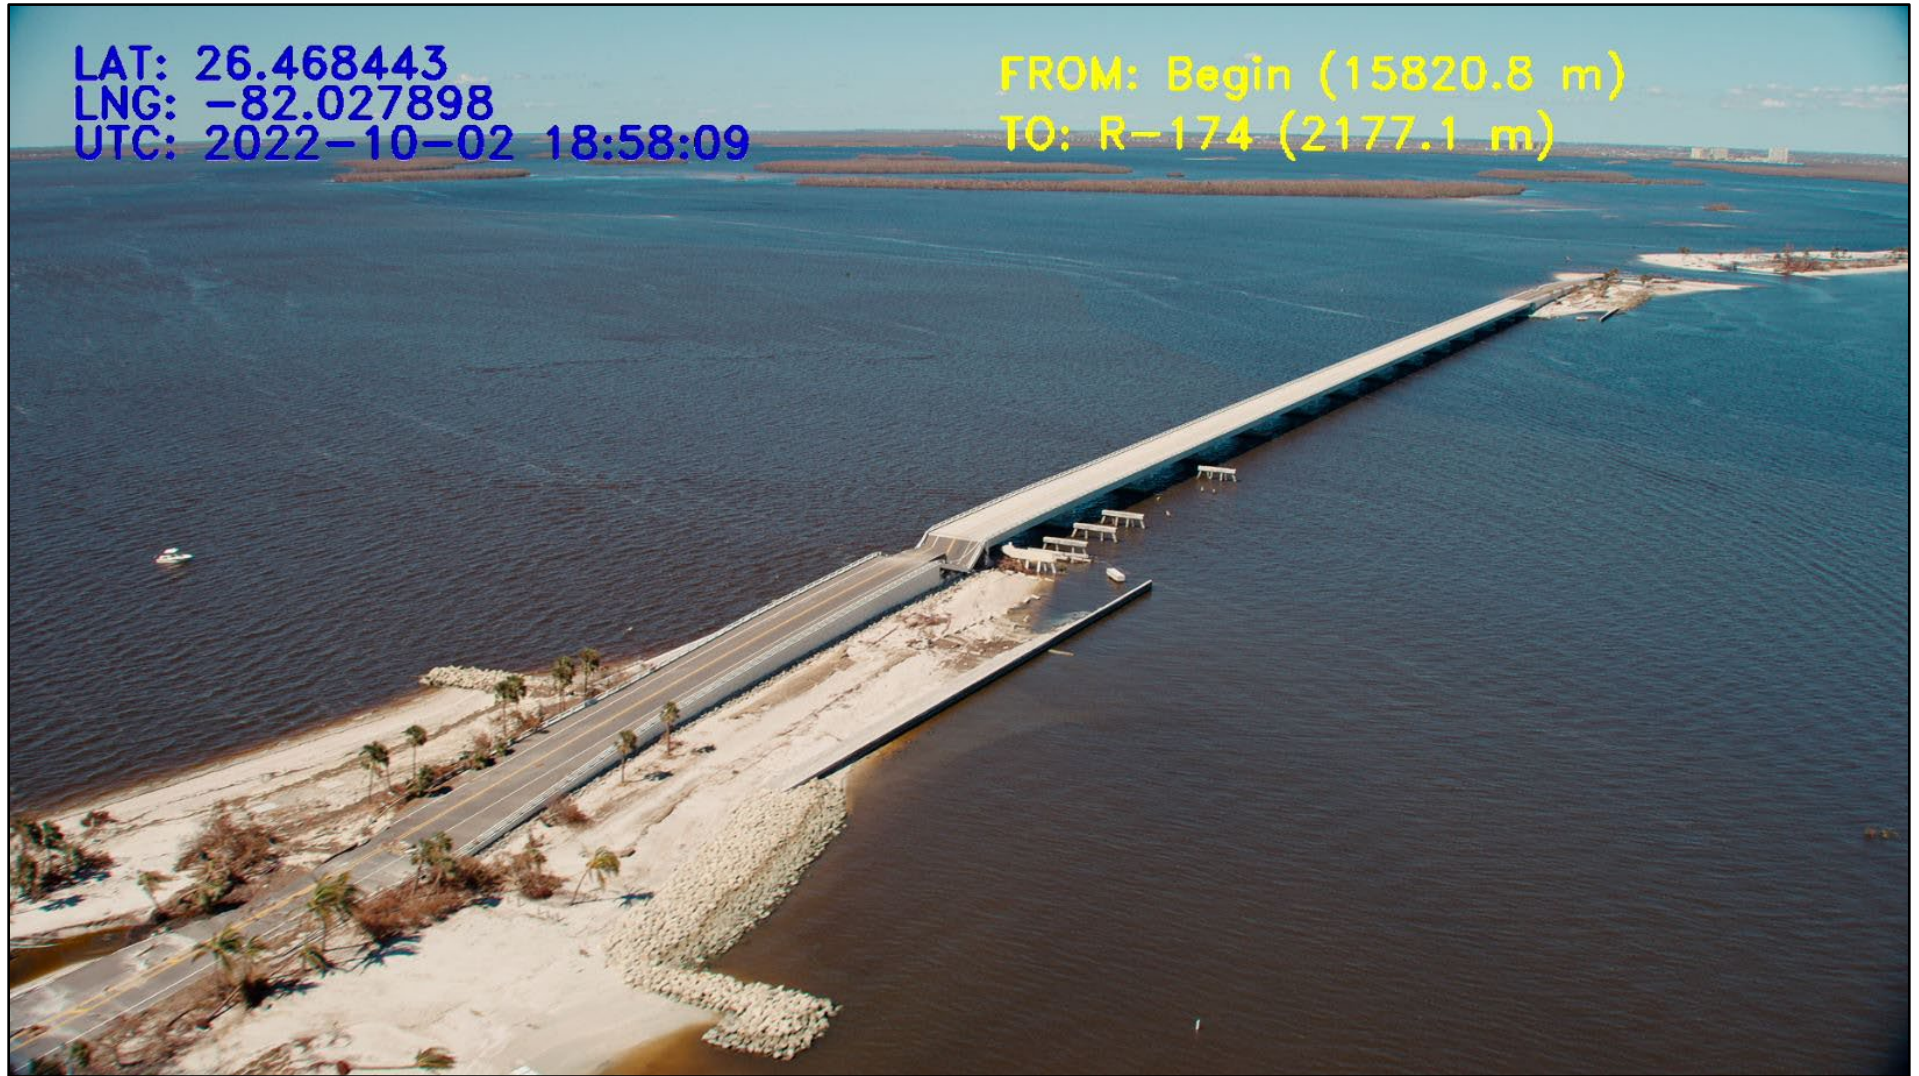
**Figure 35.** Sanibel Island bridge and causeway destroyed. (Image source: Active Camera Systems and Camera Copters).

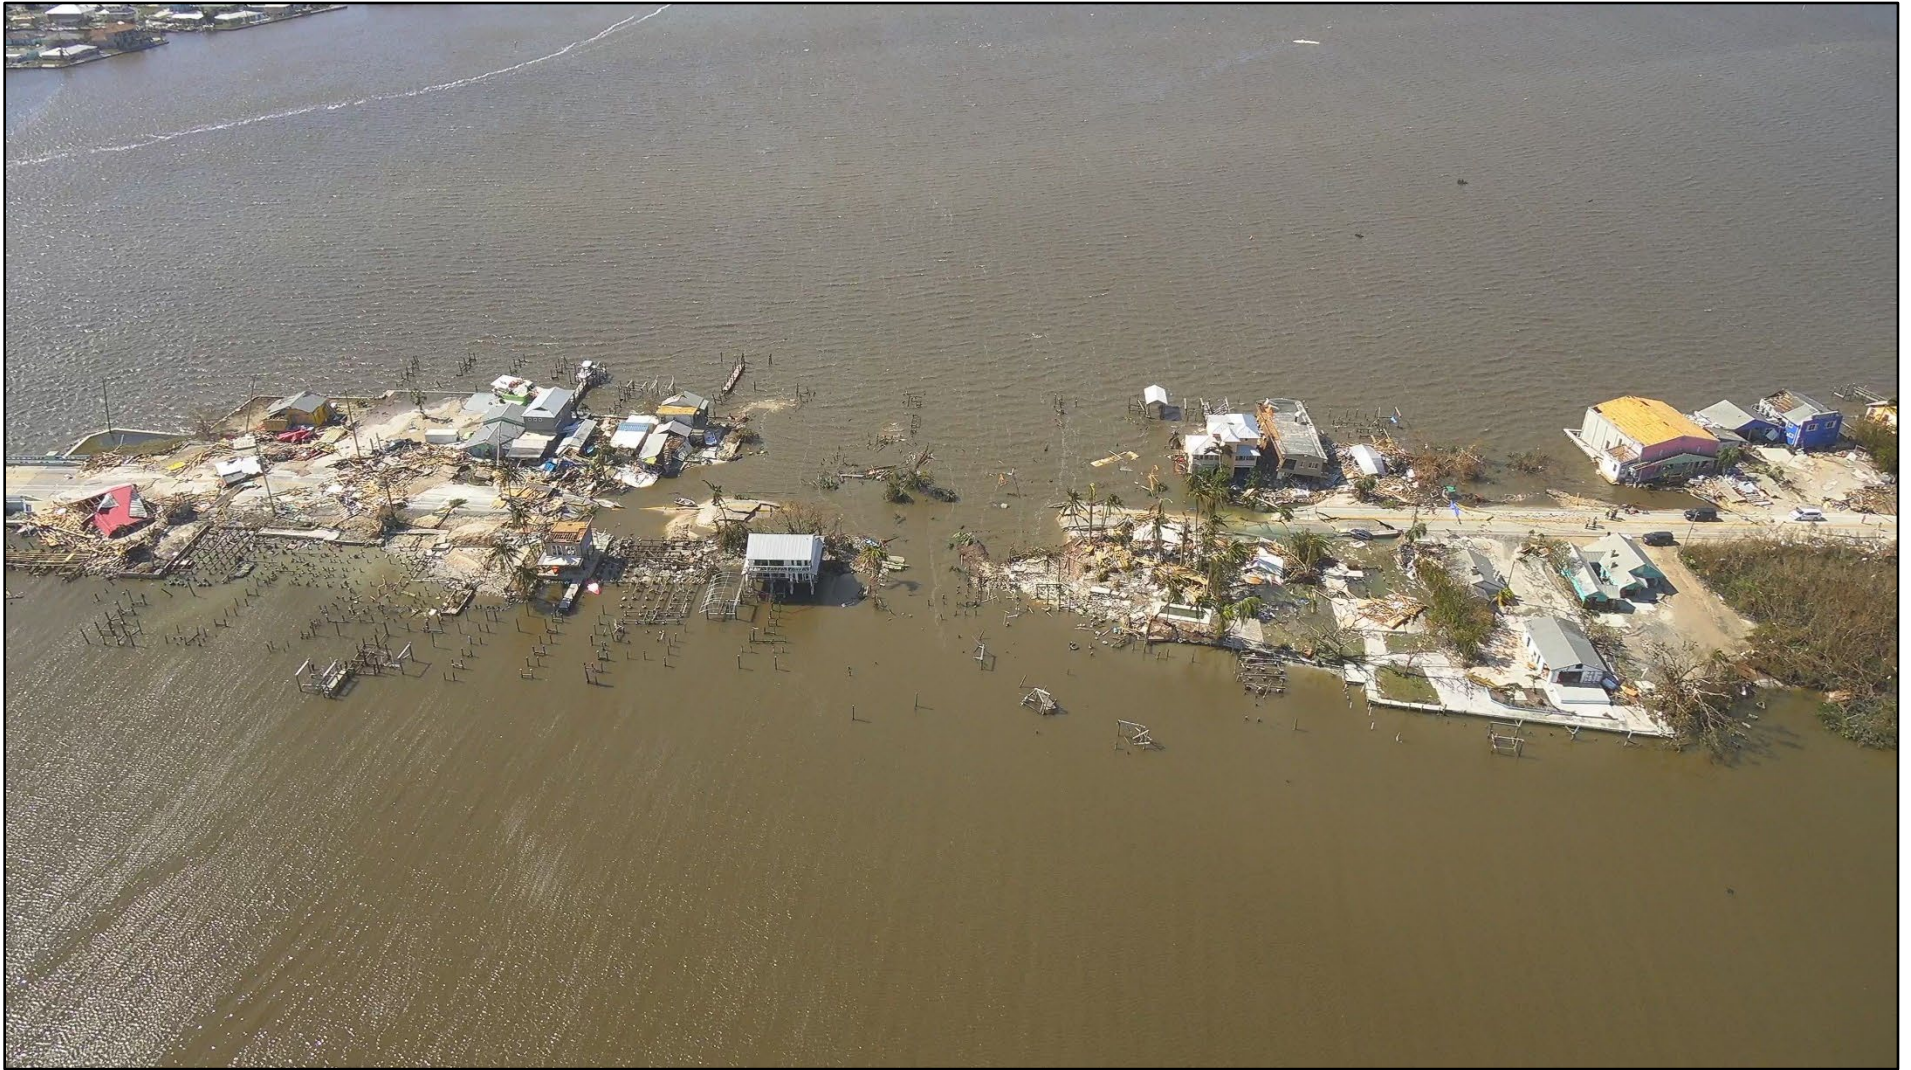
**Figure 36.** Pine Island causeway destroyed. Photo courtesy of Florida State University - Emergency Management and Homeland Security Program/ Florida UAS-1. Photo taken on September 29<sup>th</sup>, 2022.

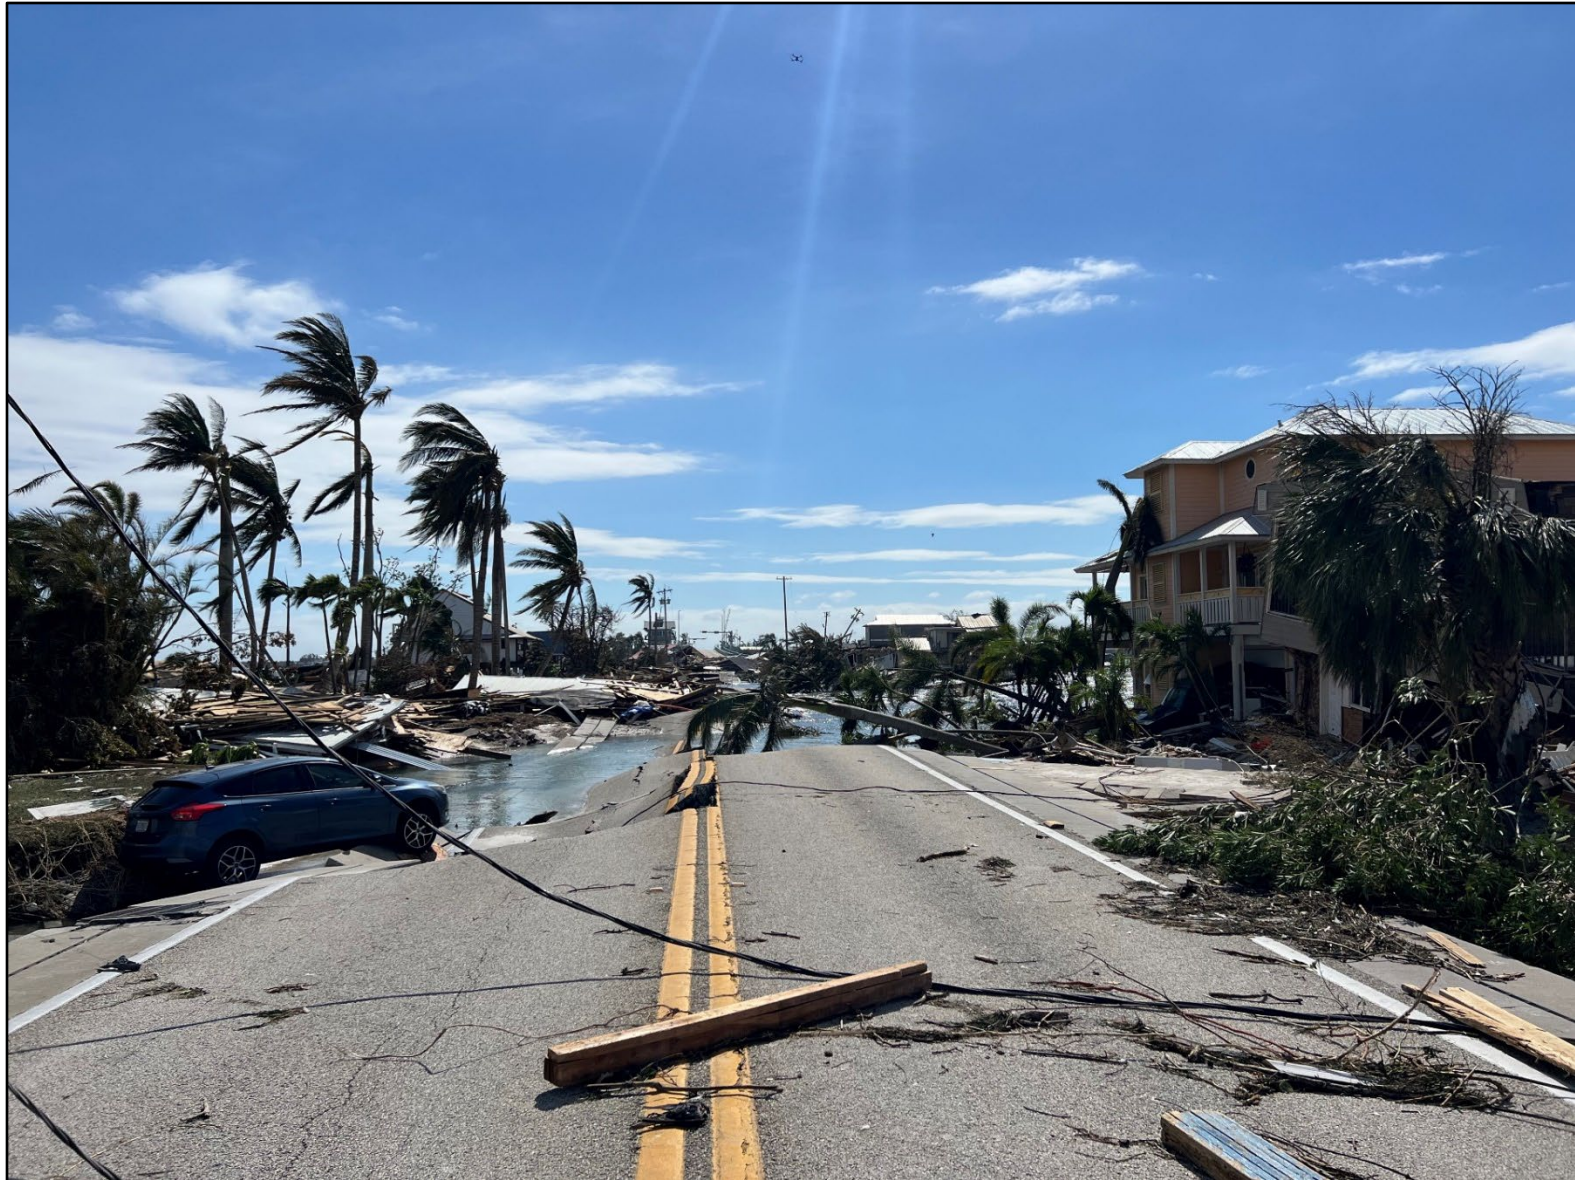
**Figure 37.** Pine Island causeway destroyed. Photo courtesy of Florida State University - Emergency Management and Homeland Security Program/ Florida UAS-1. Photo taken on September 29<sup>th</sup>, 2022.

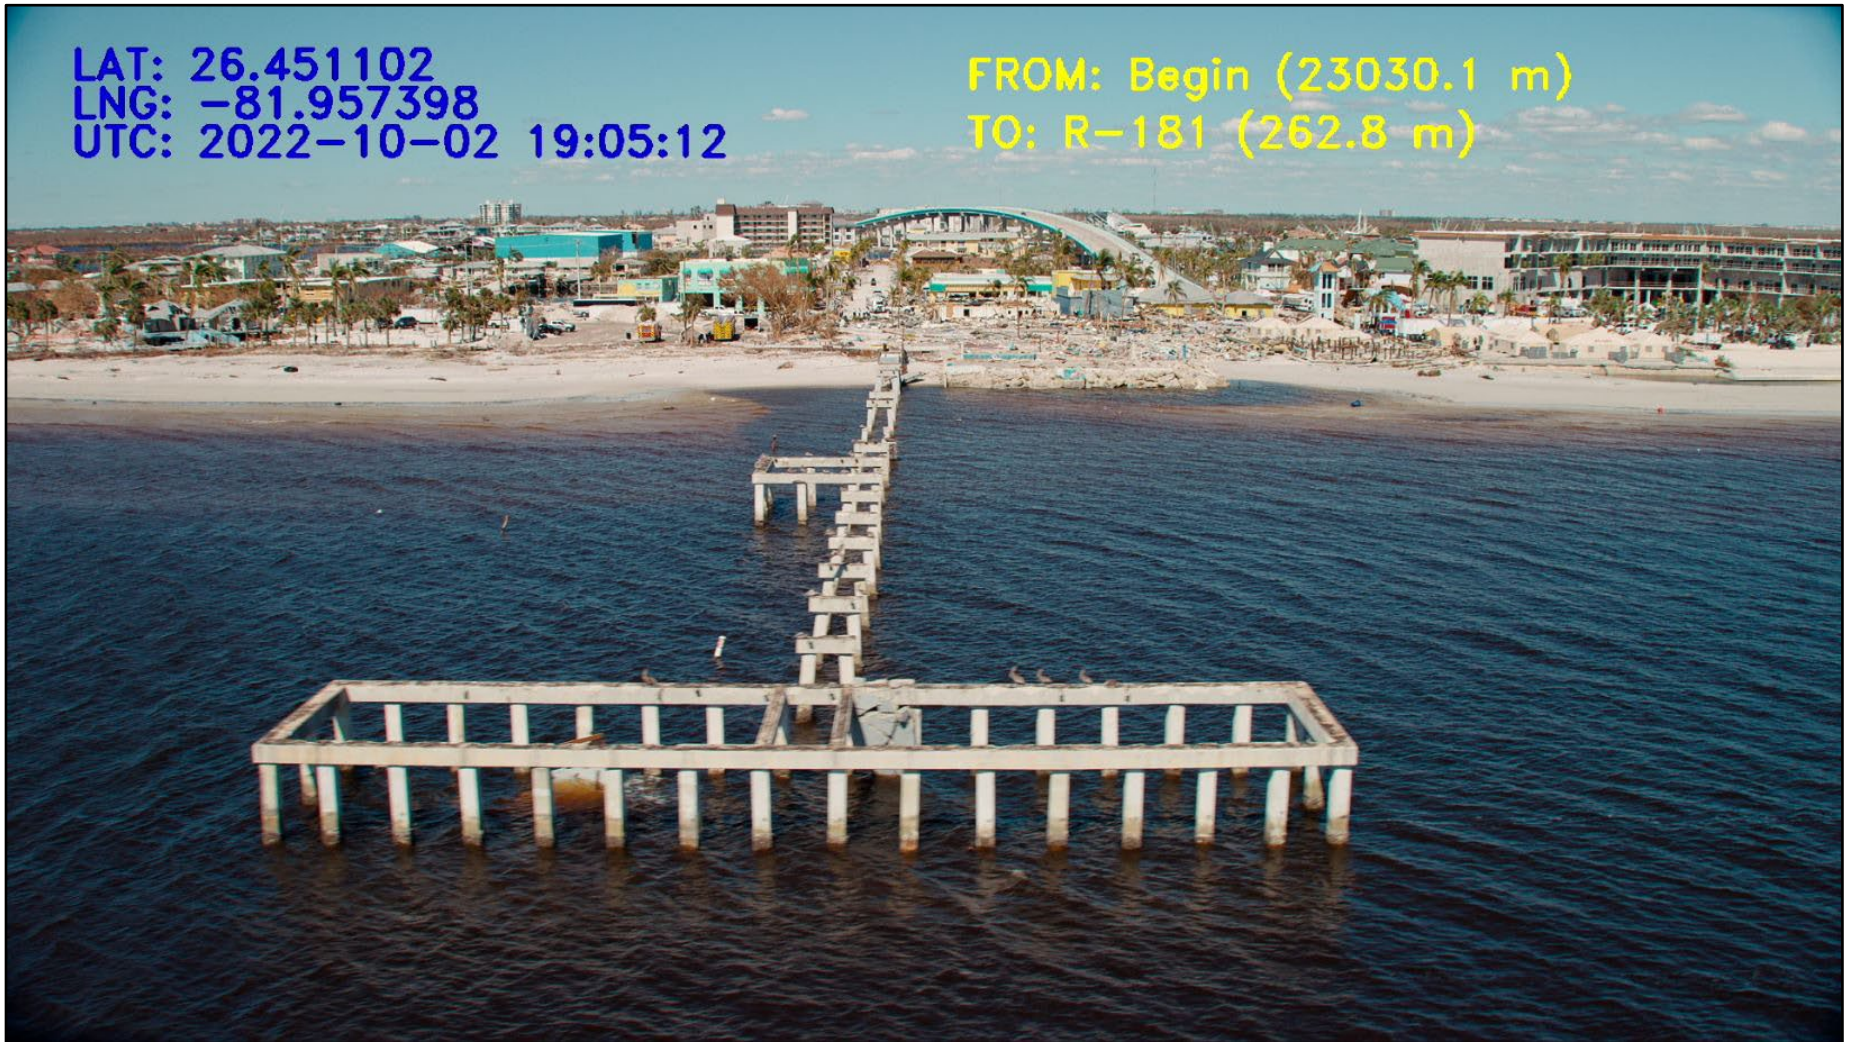
**Figure 38.** Ft. Myers Beach structures and pier with major damages, R-181 (Image source: Active Camera Systems and Camera Copters).
