***Hurricane Ian & Hurricane Nicole Post-Storm  
Beach Conditions and Coastal Impact Report***

**Office of Resilience and Coastal Protection**

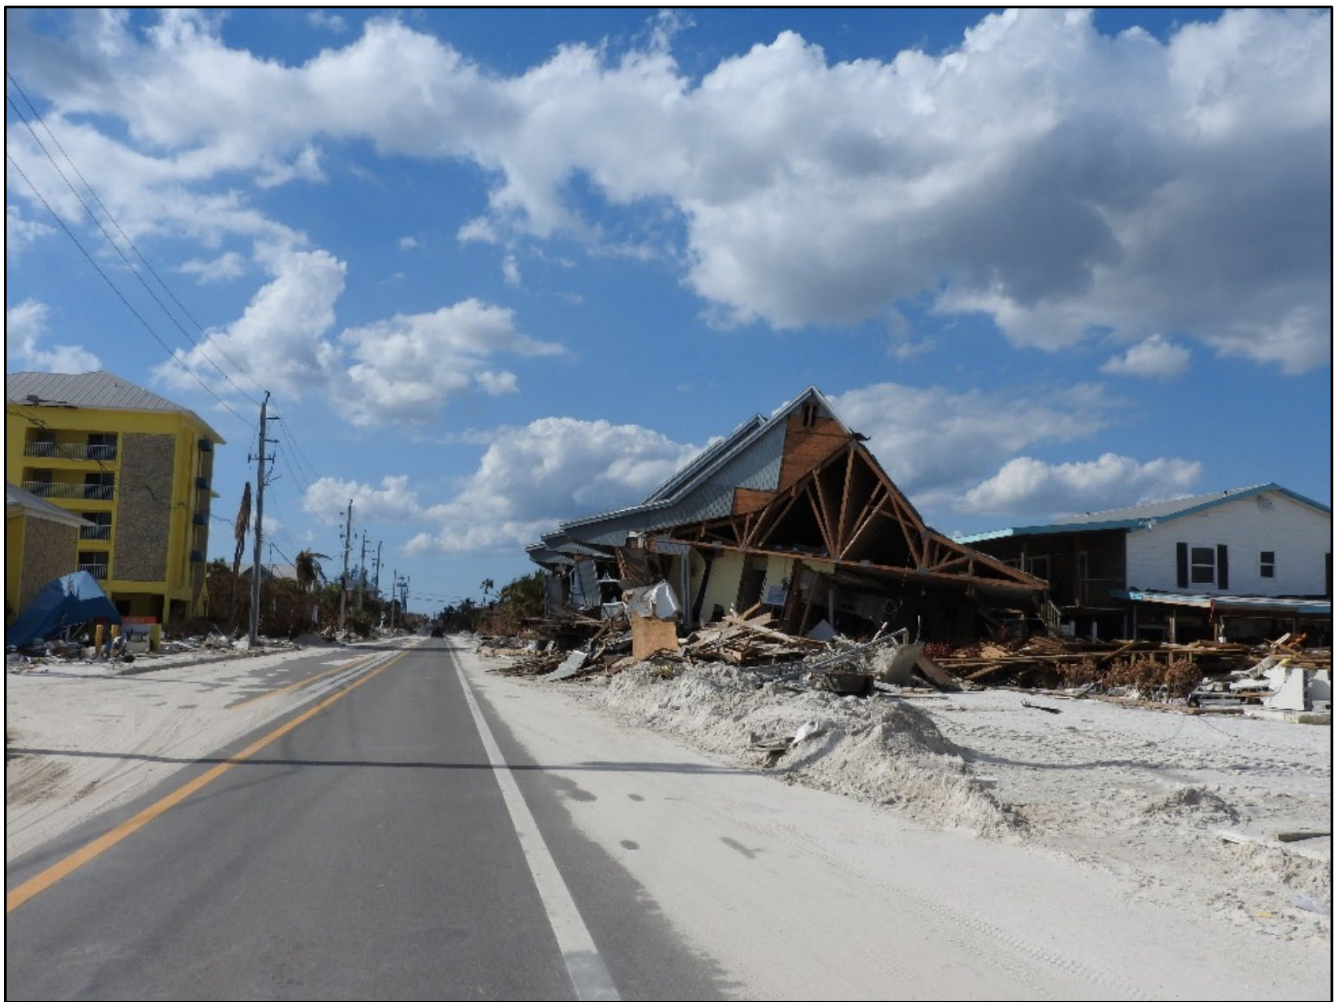
**Figure 39.** Storm surge transported Lahaina resort structures across Estero Blvd. (R-196).

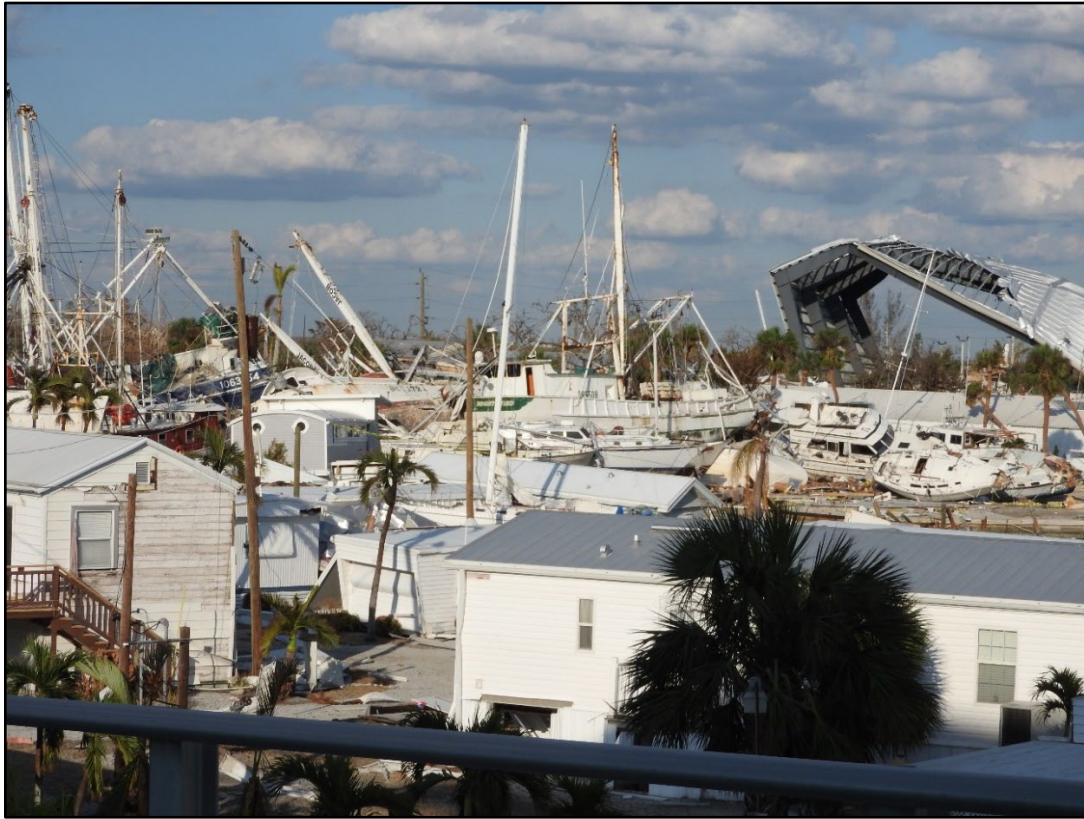
**Figure 41.** Major damages at the Gulf Marine Yachtworks at bayside of Ft. Myers Beach (R-181).

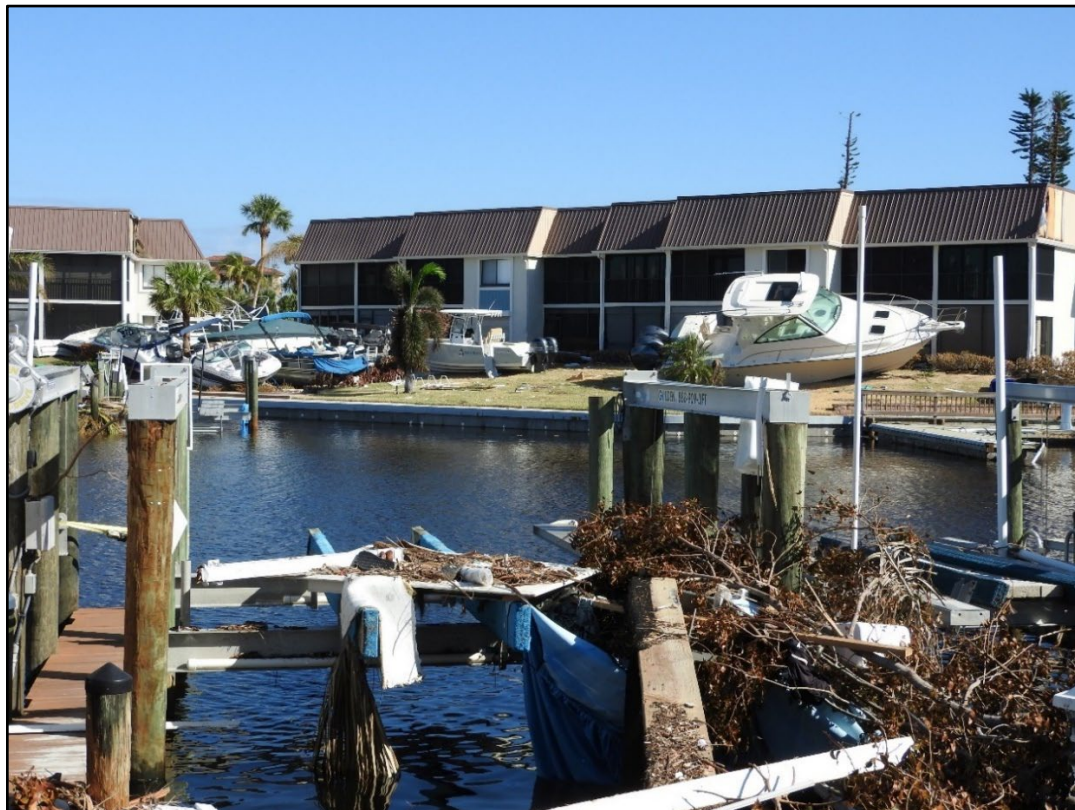
**Figure 42.** Stranded boats on the yards of multi-family dwellings at Ft. Myers Beach (R-203).

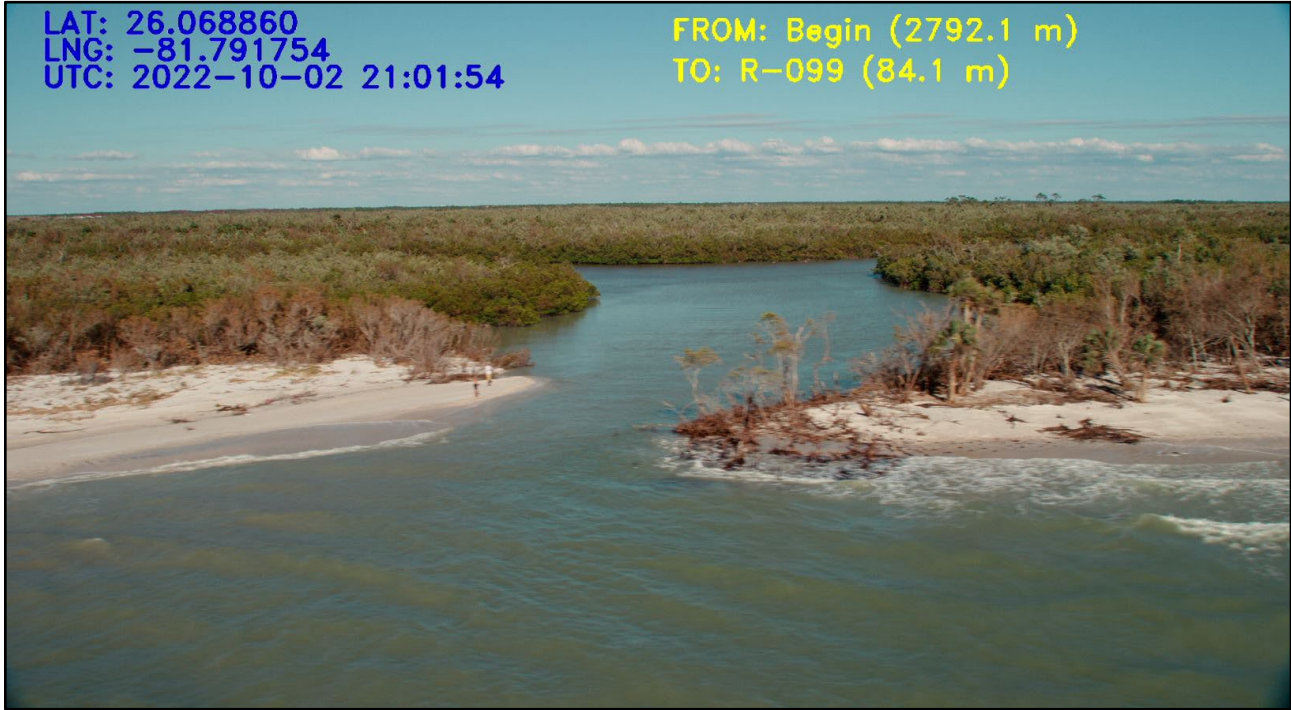
**Figure 49.** Major breach across Keewaydin Island (R-99).

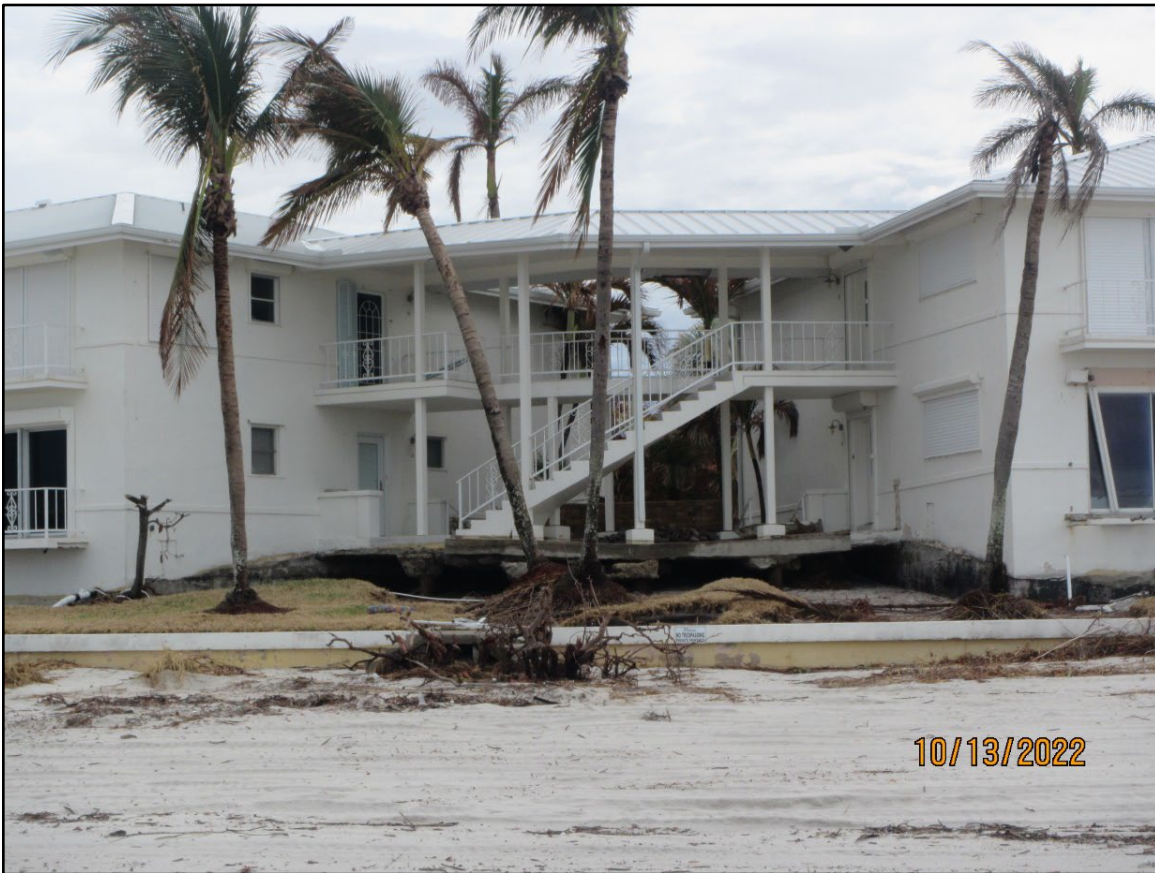
**Figure 50.** Understructure damage in Naples (R-60).

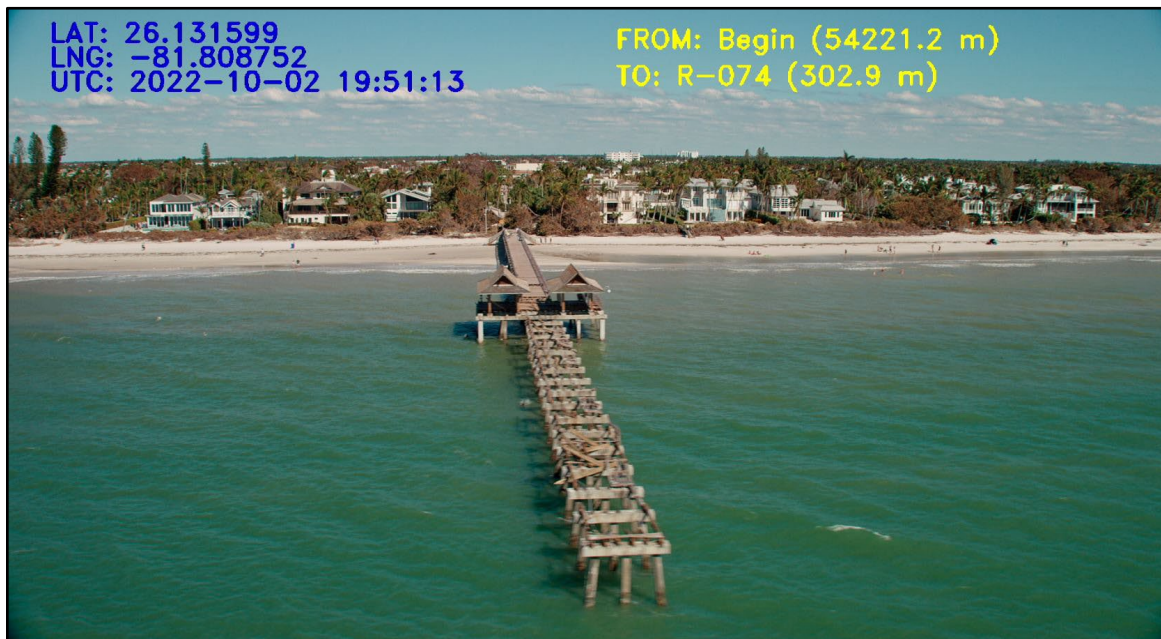
**Figure 51.** Damage to the Naples Pier (R-74).

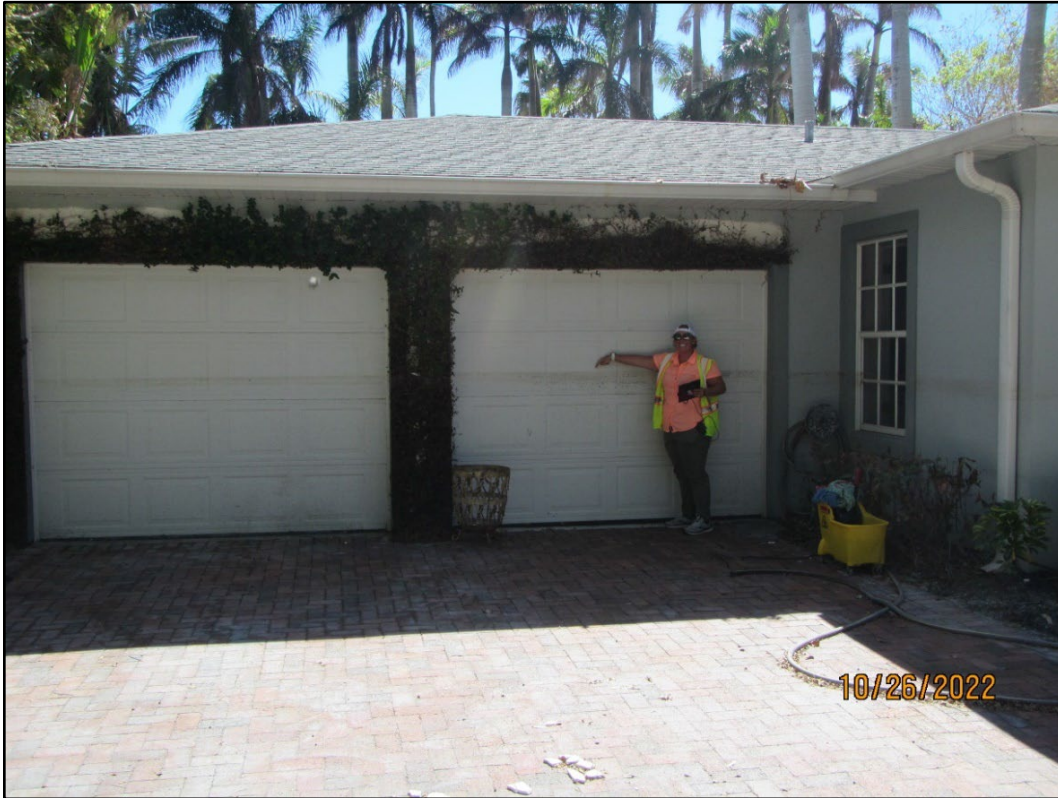
**Figure 52.** High water mark shown on a single-family dwelling, Naples (R-71).

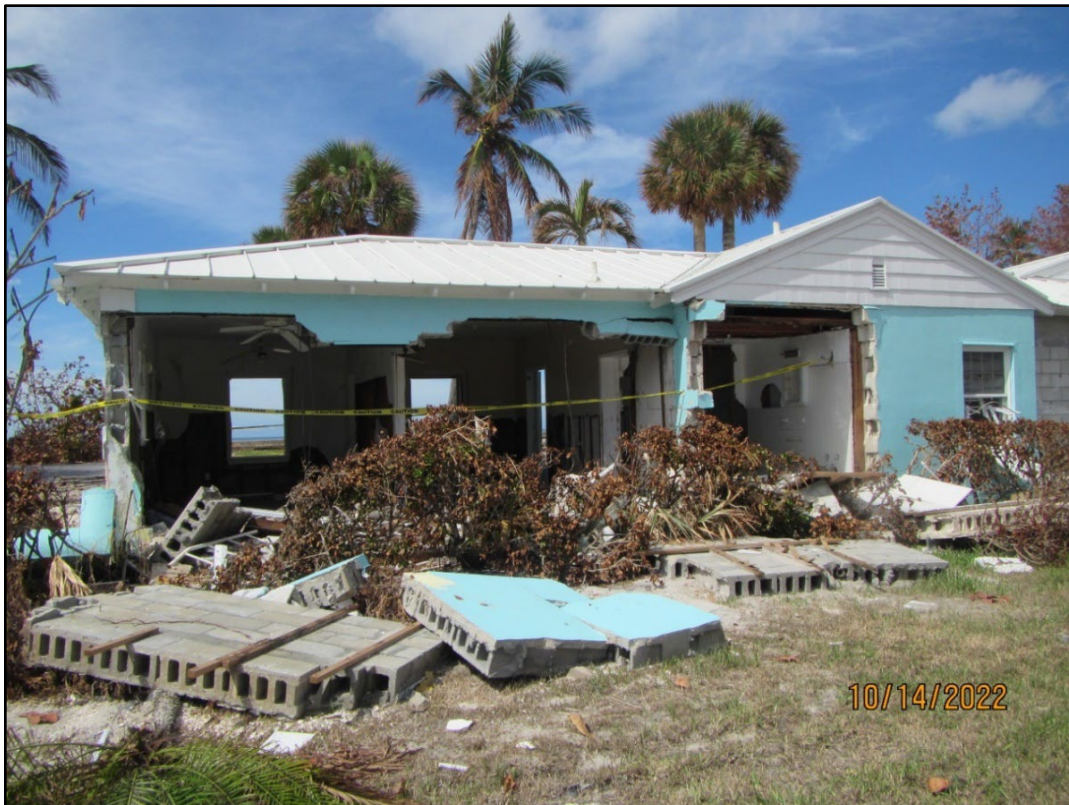
**Figure 53.** Single-family dwelling with storm surge damage, Naples (R-85).

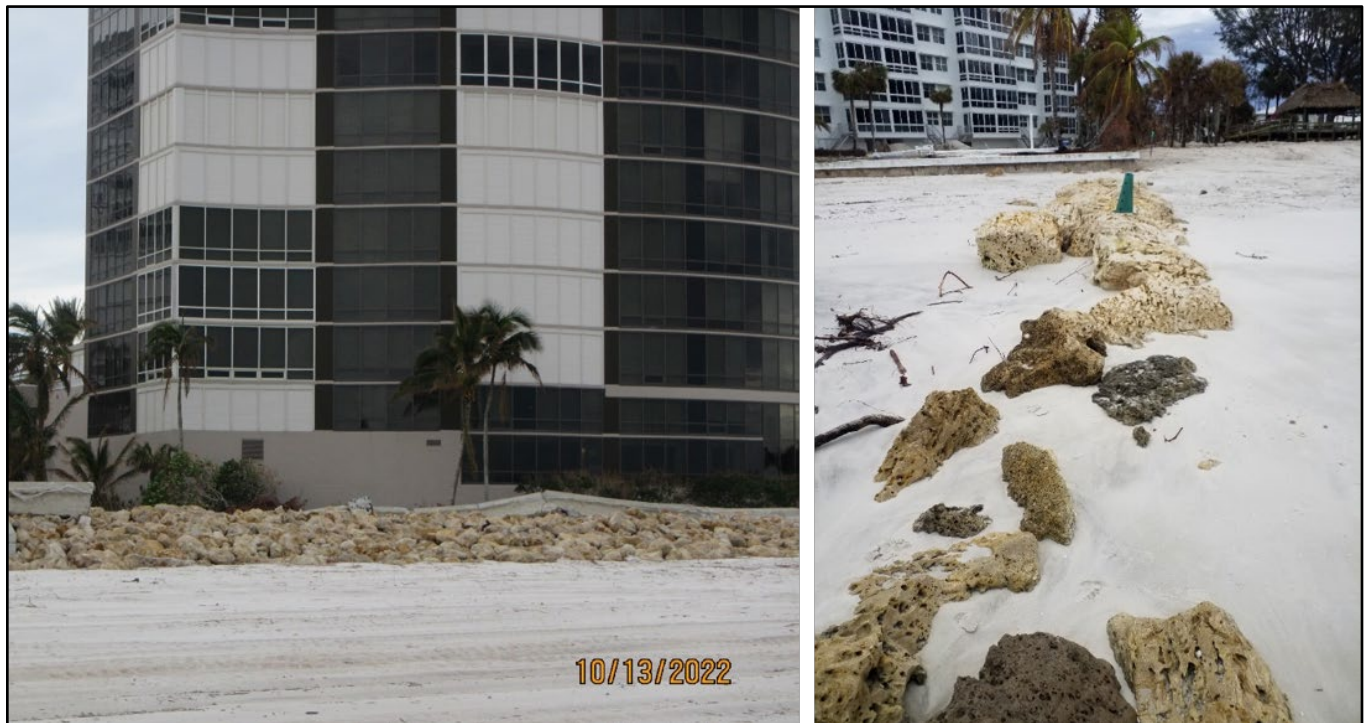
**Figure 54.** Concrete seawall collapsed in Naples at R-47 (left) and buried groin exposed at R-58 (right).

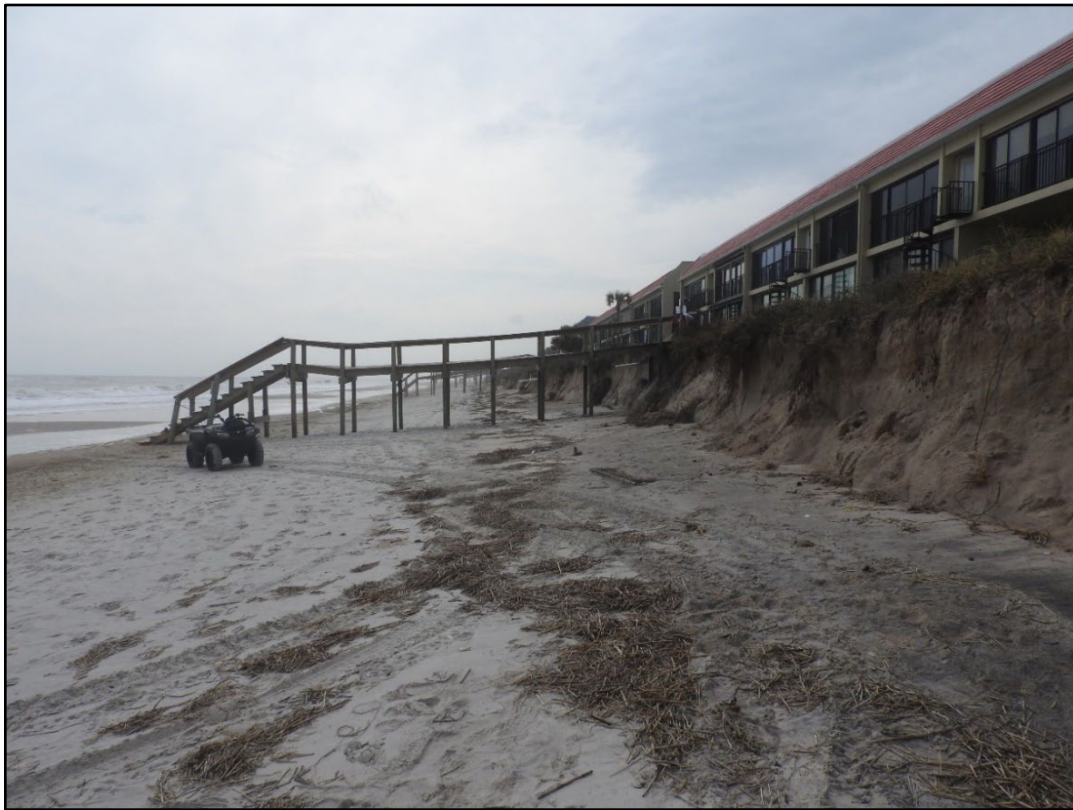
**Figure 56.** Major beach and dune erosion in Ponte Vedra (R-15).

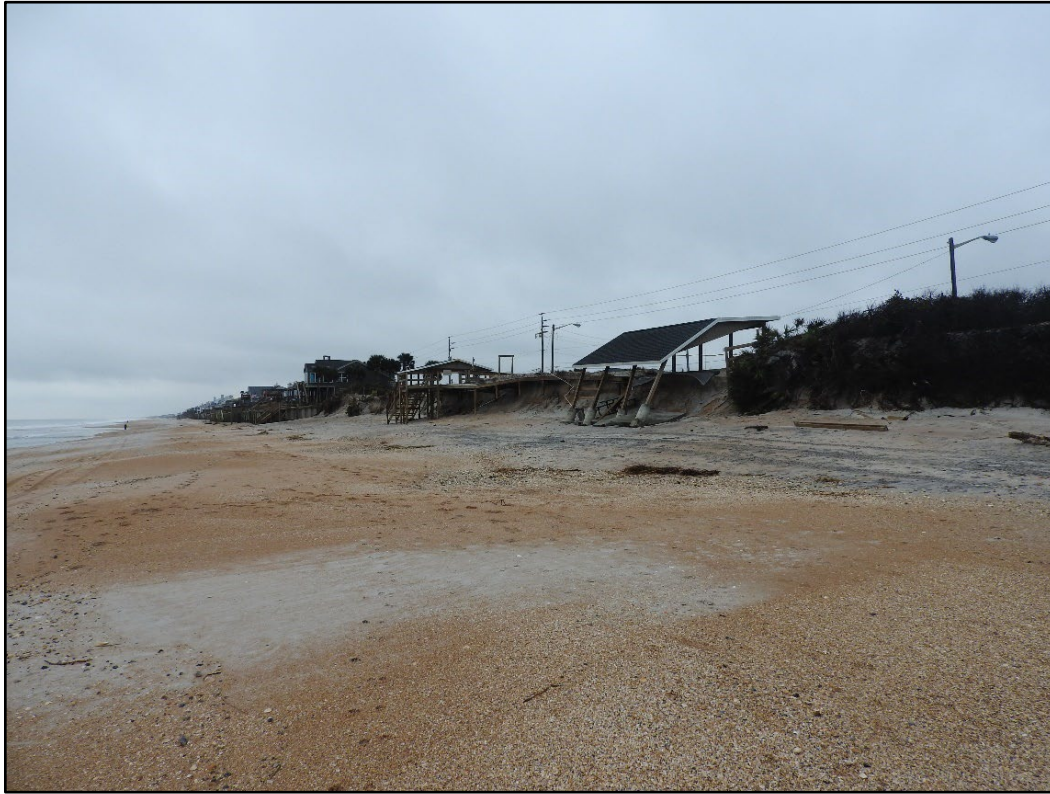
**Figure 58.** Major damage to a pavilion due to erosion in a county park in South Ponte Vedra (R-95).

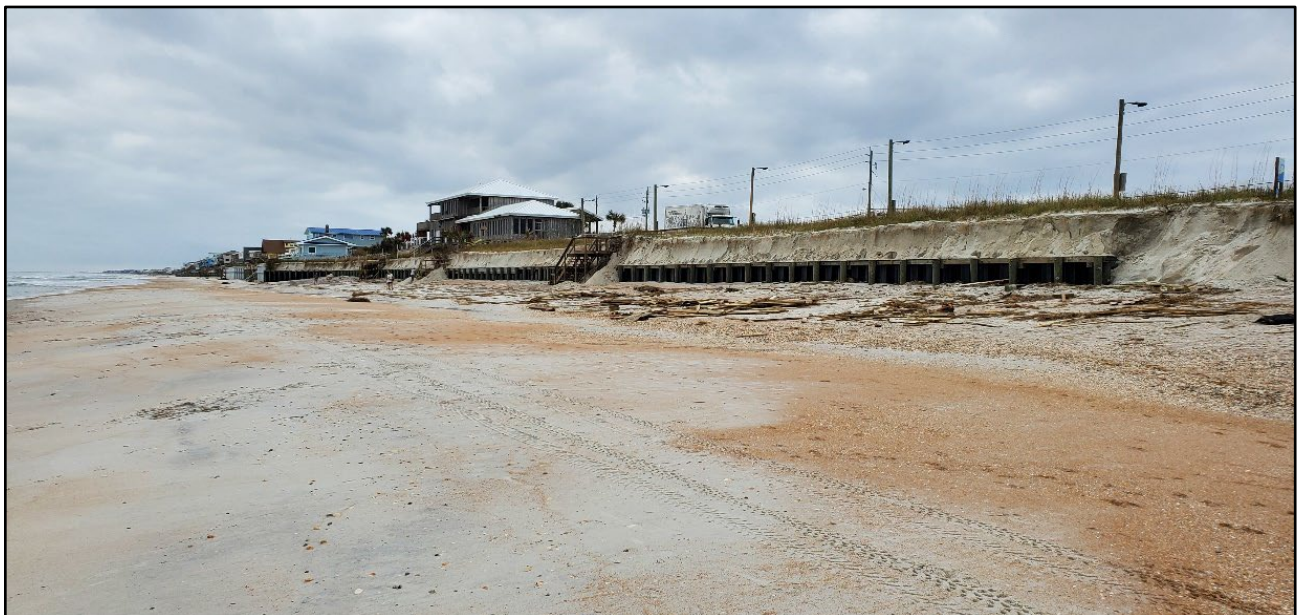
**Figure 59.** Major beach and dune erosion at the Reef Restaurant, South Ponte Vedra Beach (R-109).

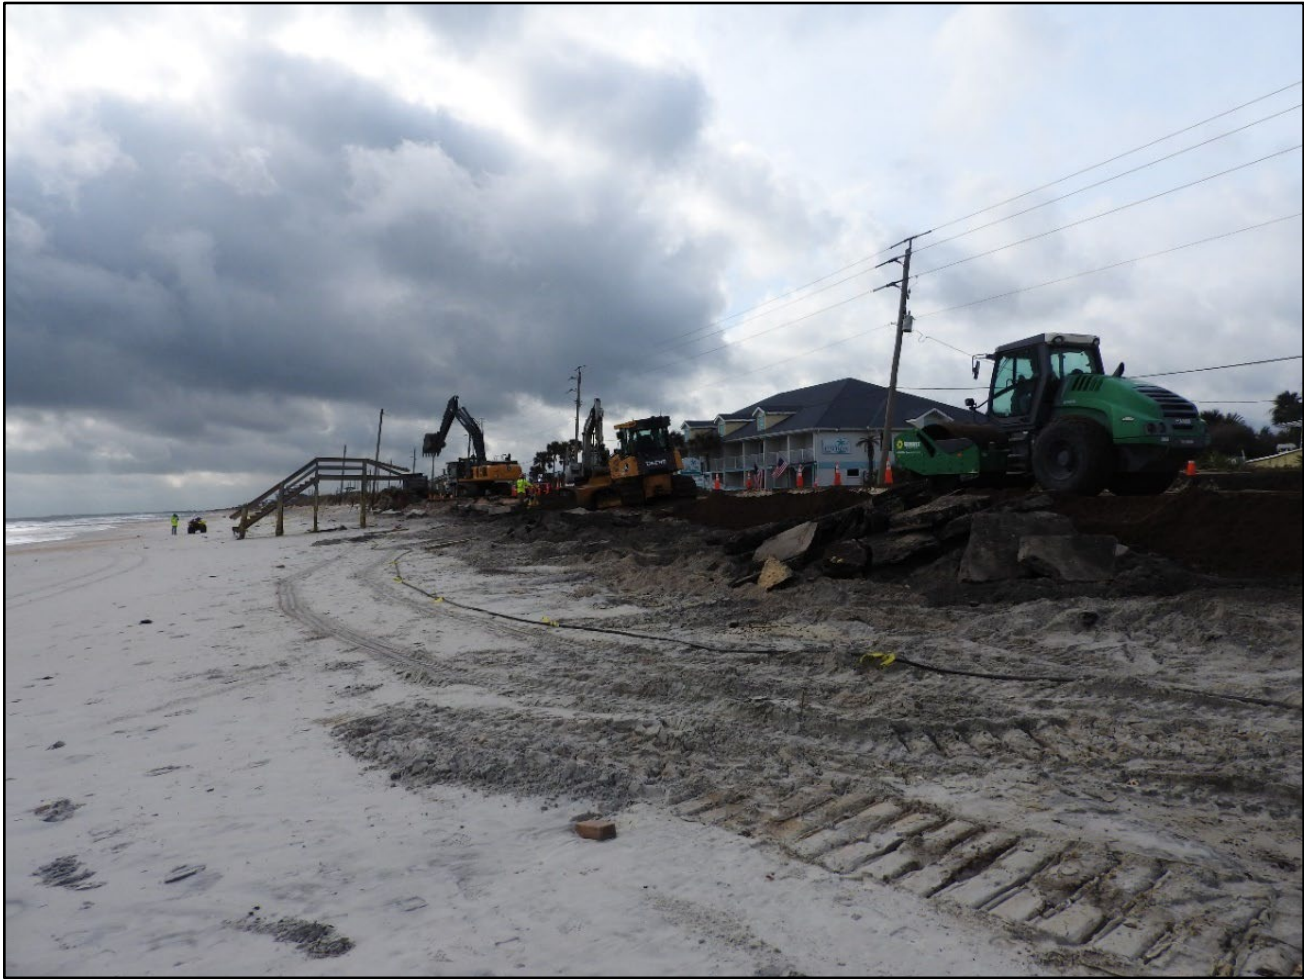
**Figure 60.** Major beach and dune erosion and road damage at Vilano Beach (R-115).

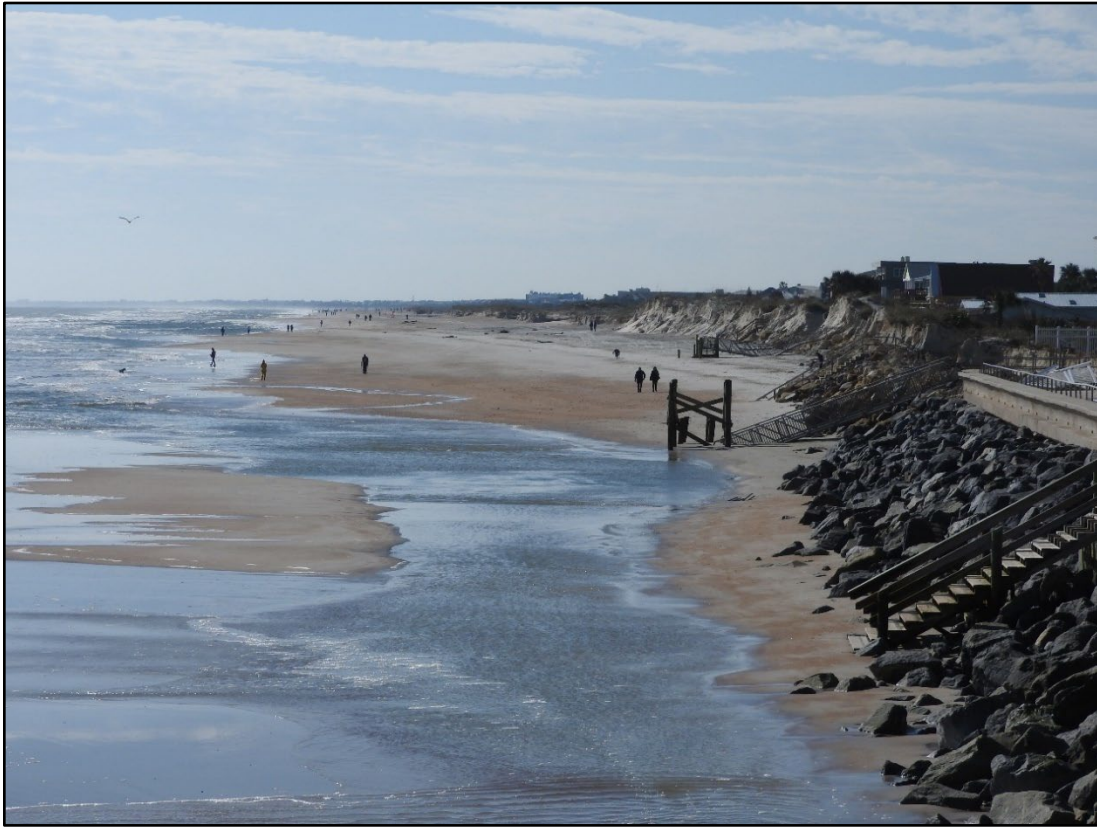
**Figure 61.** Major beach and upland erosion at St. Augustine Beach, looking south from pier (R-142).

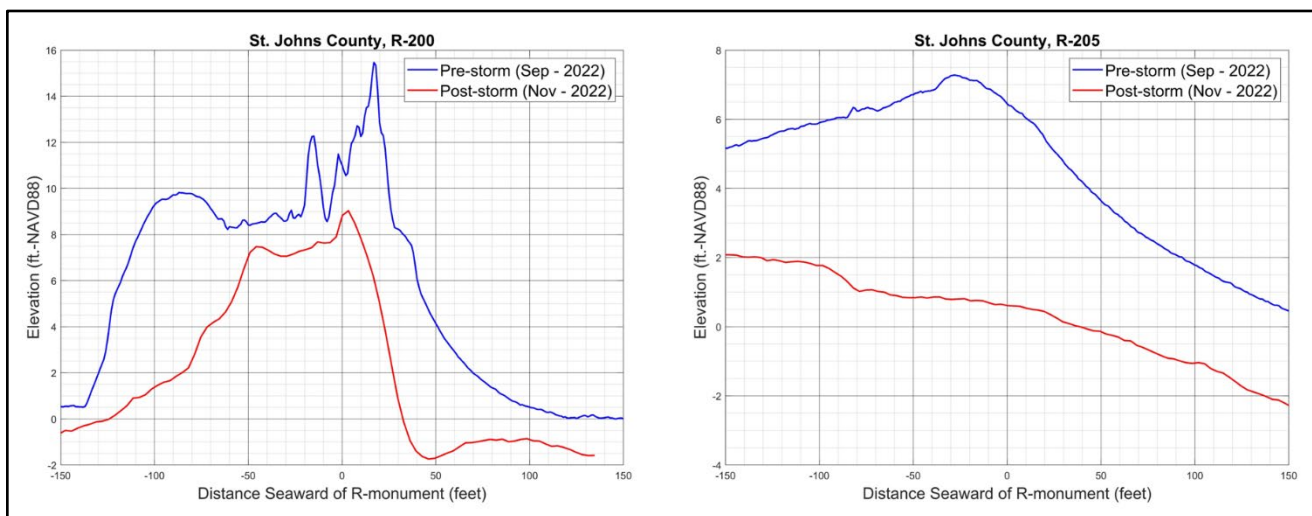
**Figure 68.** Coastal barrier breaches are evident from pre- and post-storm profiles at Summer Haven.

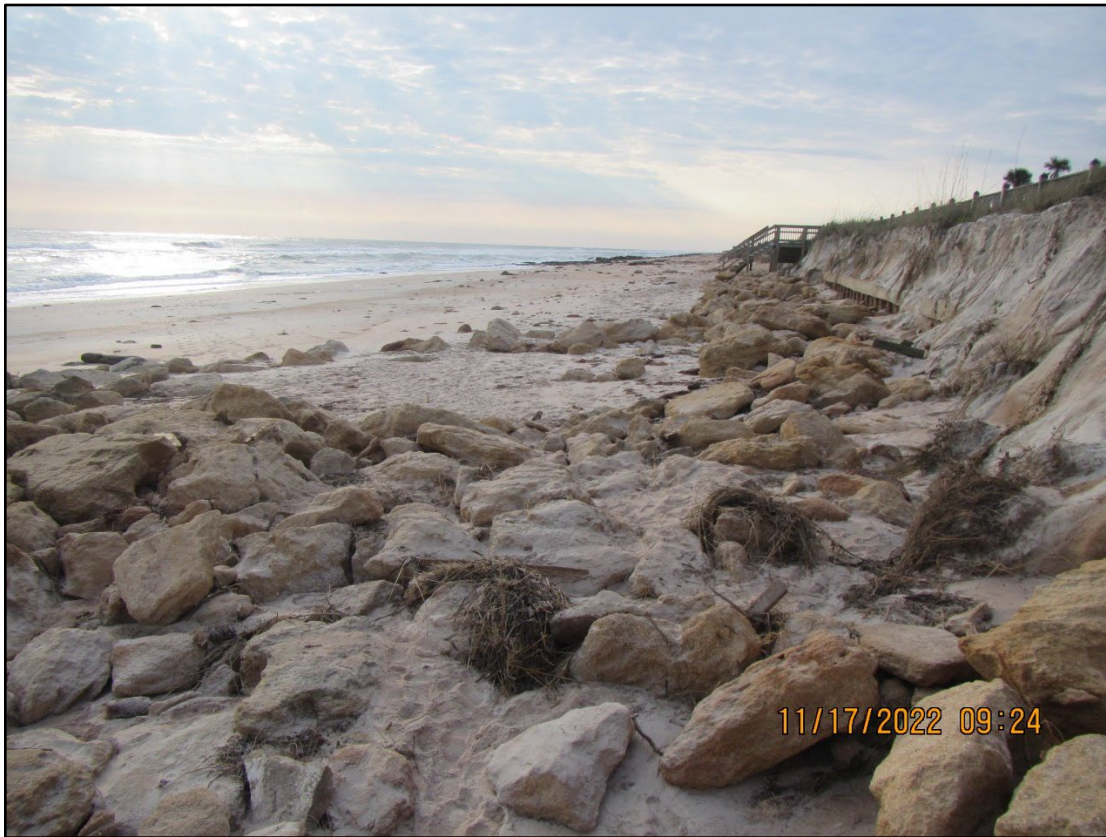
**Figure 70.** Major beach and dune erosion at Marineland's River to Sea Preserve (R3).

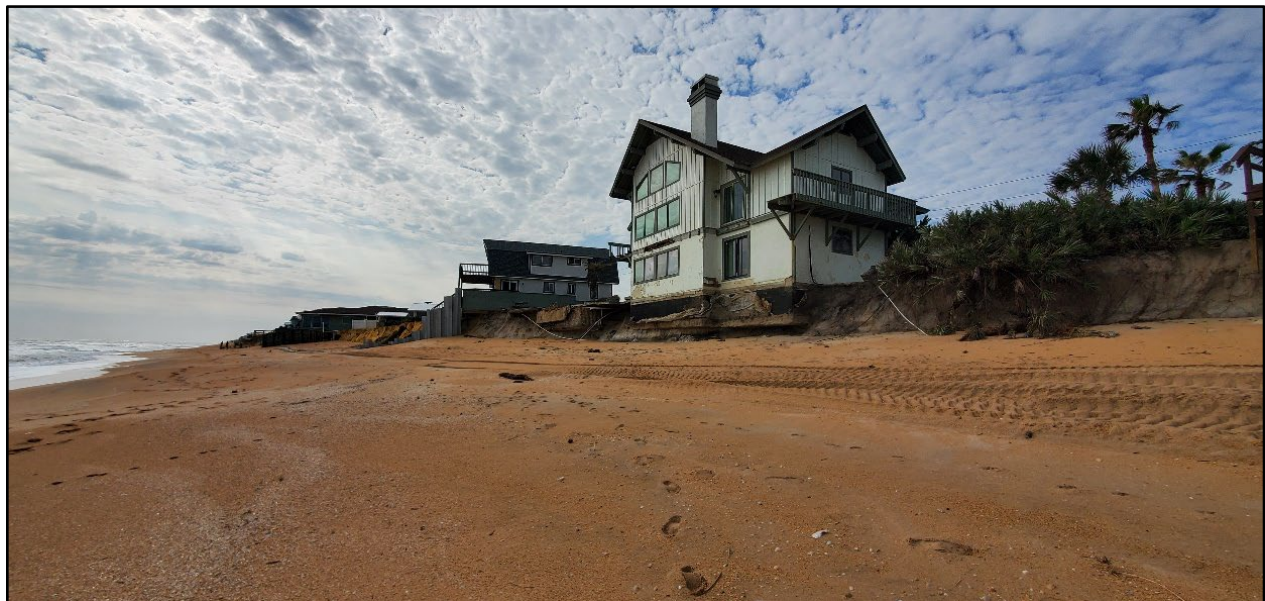
**Figure 74.** Single-family dwelling with first floor damage and major pool damage in Beverly Beach (R-53).

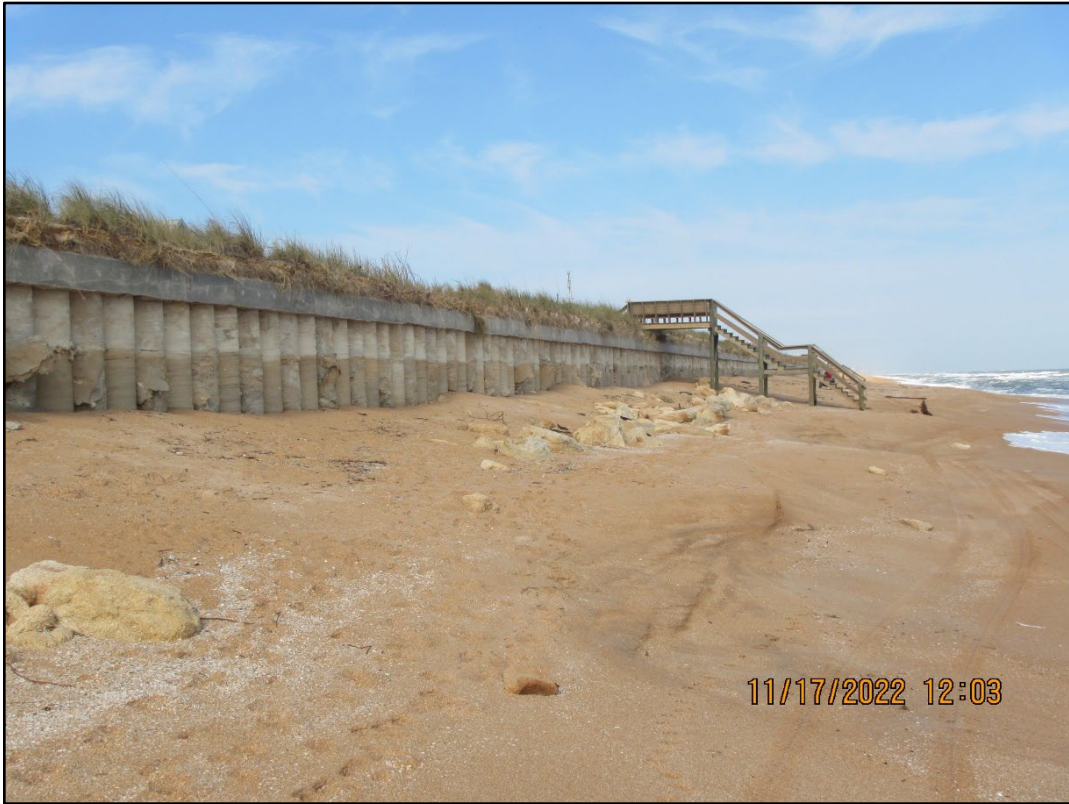
**Figure 75.** Major beach and dune erosion exposed the new secant wall constructed by the Florida Department of Transportation (R-66).

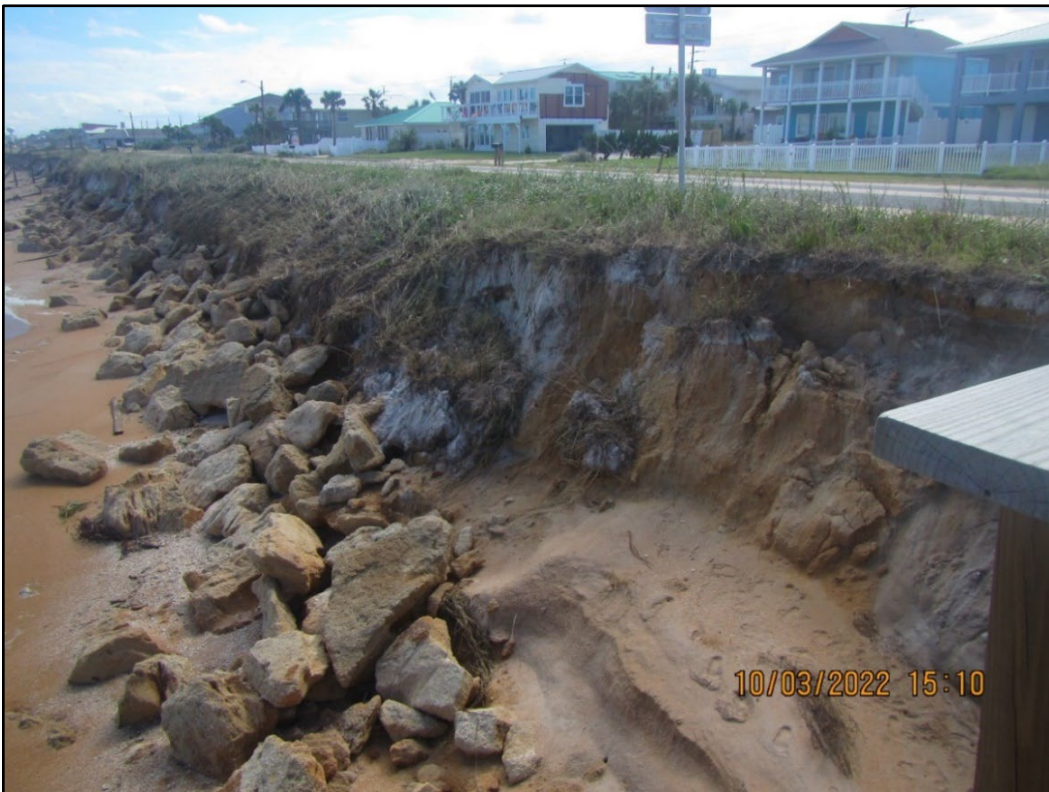
**Figure 78.** Major revetment damage due to Hurricane Ian south of the pier (R-80).

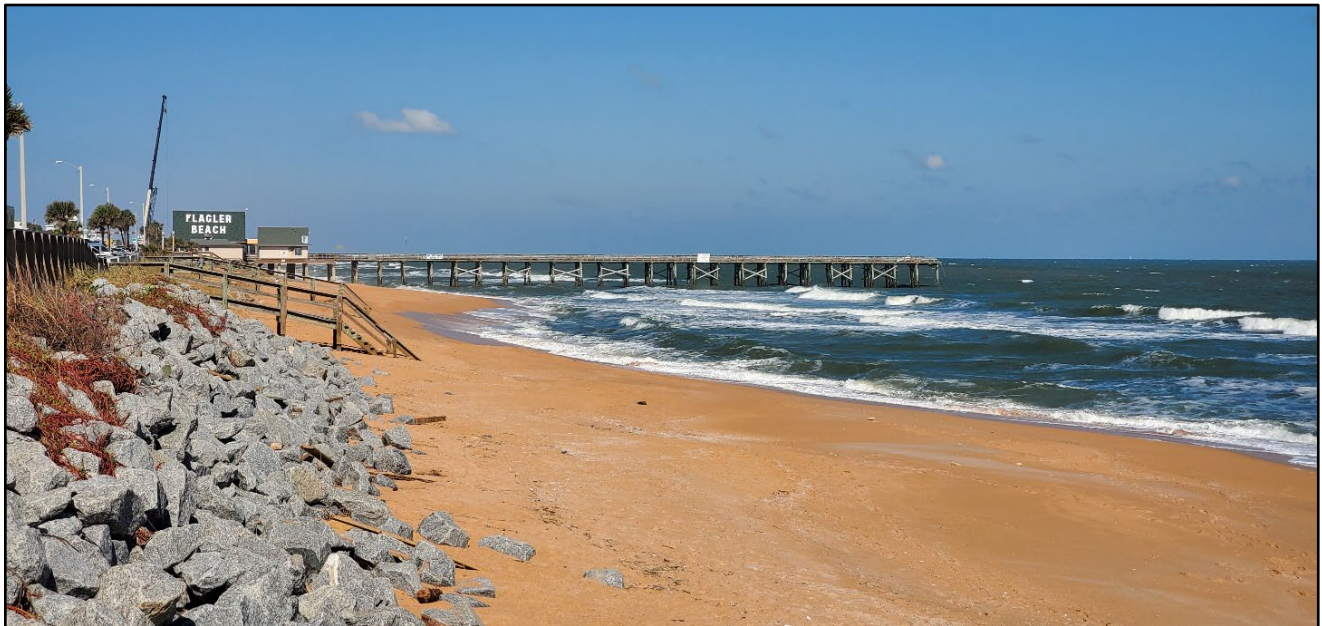
**Figure 79.** Flagler Beach Fishing Pier with 165 ft. of the seaward end destroyed (R-79).

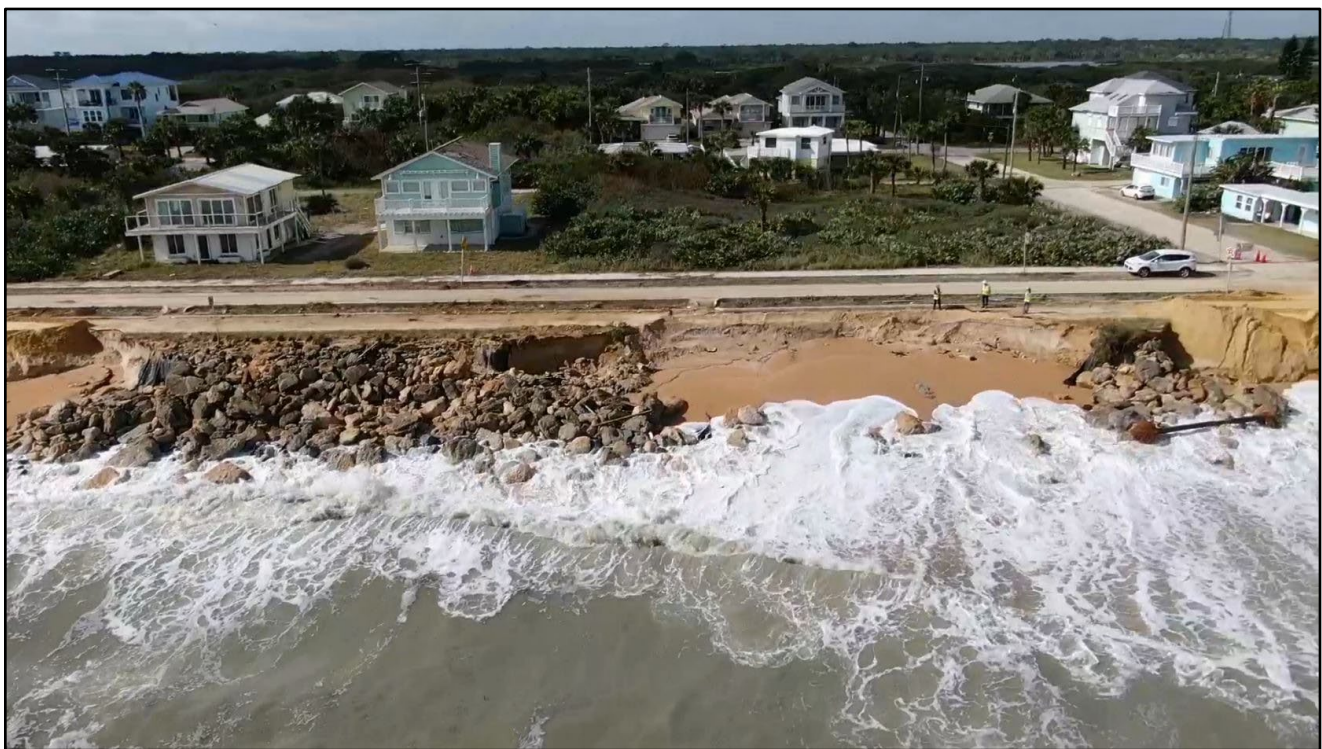
**Figure 80.** A1A revetment and road damage after Hurricane Nicole in Flagler Beach at 17<sup>th</sup> Street South (R-88) [Drone footage courtesy of Olsen Associates and Flagler County].

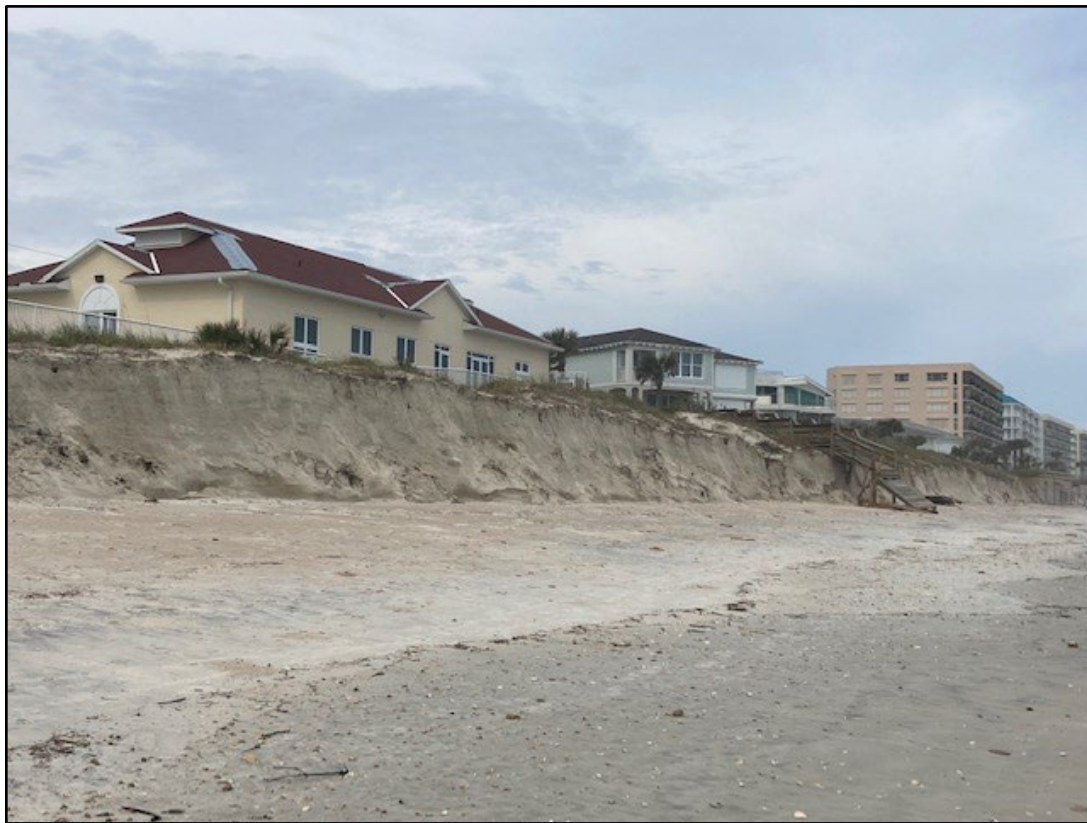
**Figure 83.** Severe dune erosion threatening upland properties in the Town of Ponce Inlet (R138).

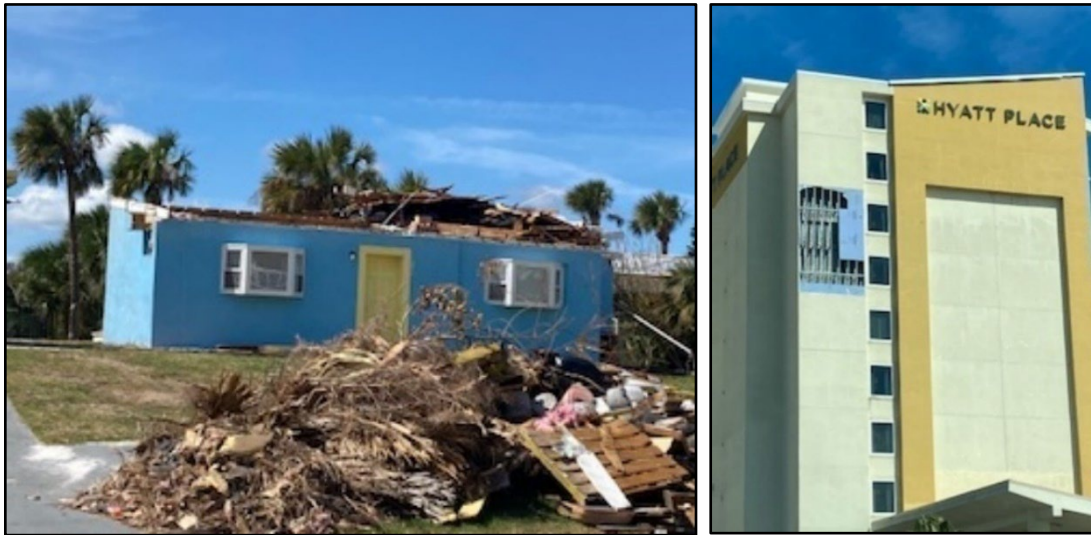
**Figure 84.** Roof blown off dwelling (left, R94); siding damage on hotel (right, R111).

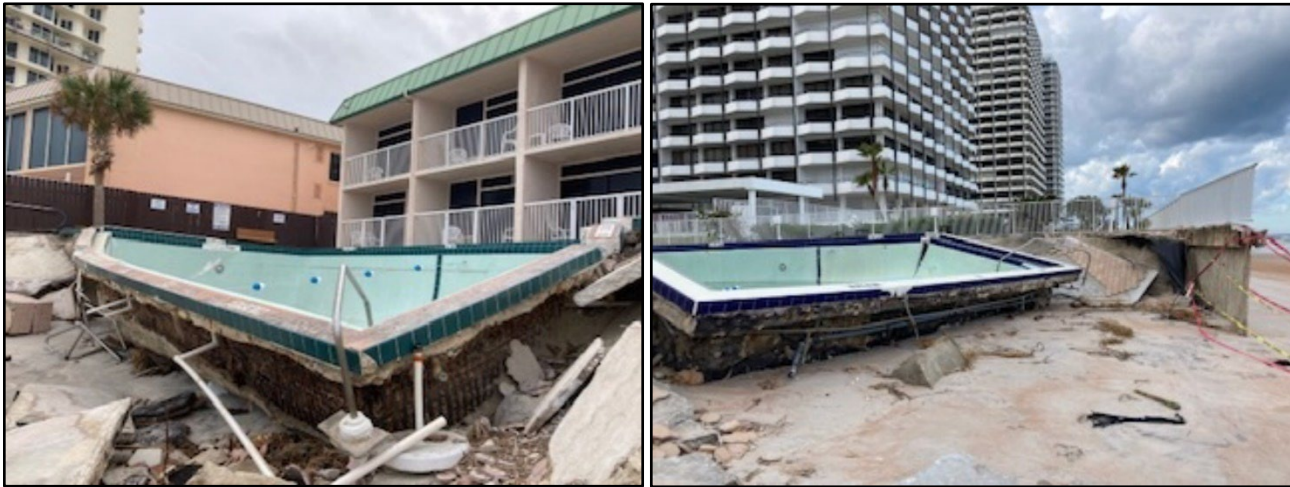
**Figure 85.** Swimming pools destroyed with seawall failure (R101).
