***Hurricane Ian & Hurricane Nicole Post-Storm  
Beach Conditions and Coastal Impact Report***

**Office of Resilience and Coastal Protection**

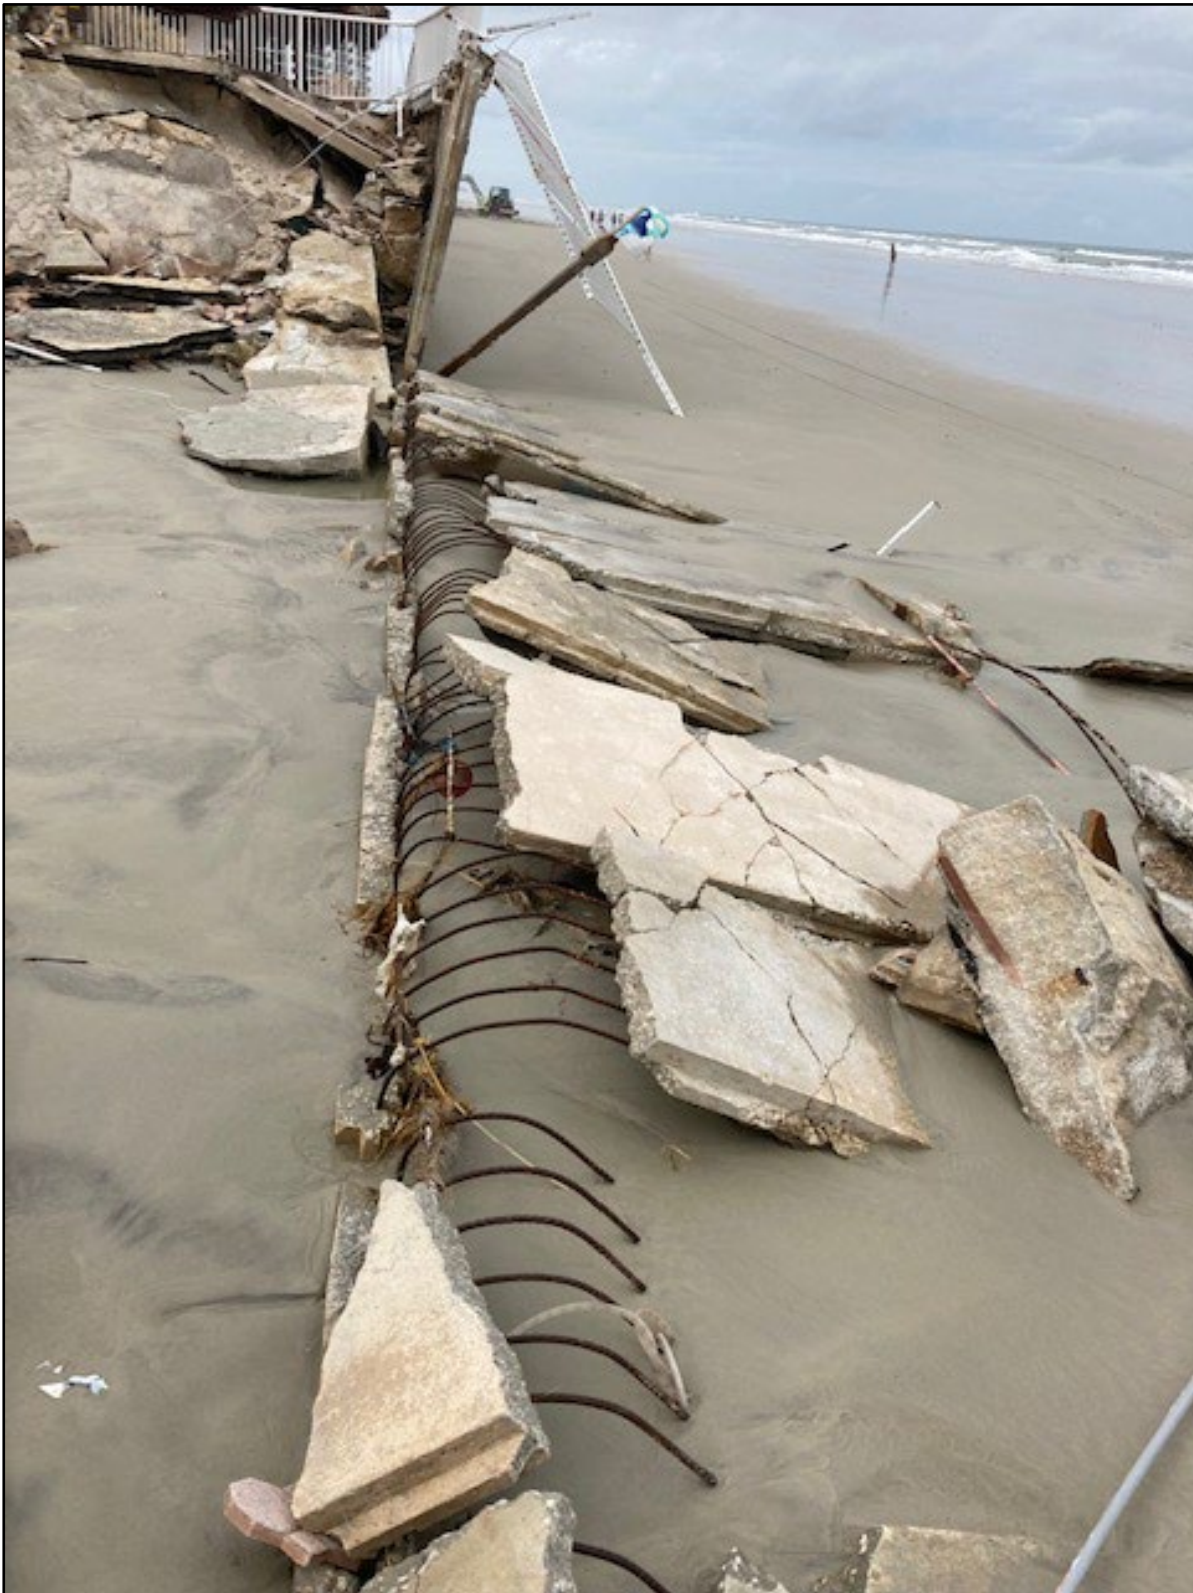
**Figure 87.** Seawall failure due to inadequate panel thickness of only 4 inches.

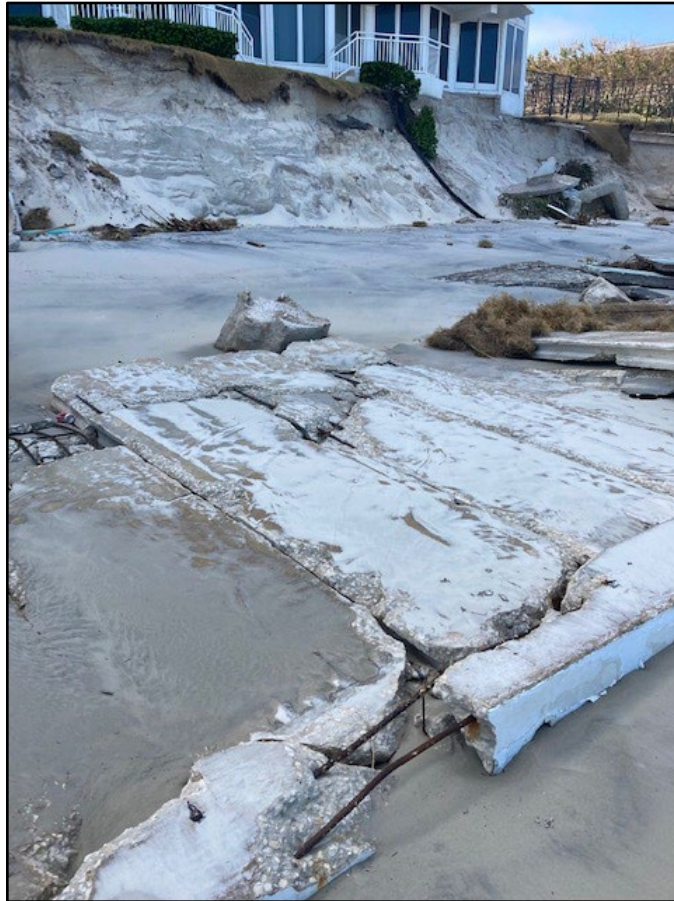
**Figure 88.** Old seawall with corroded reinforcing steel in Daytona Beach Shores (R116).

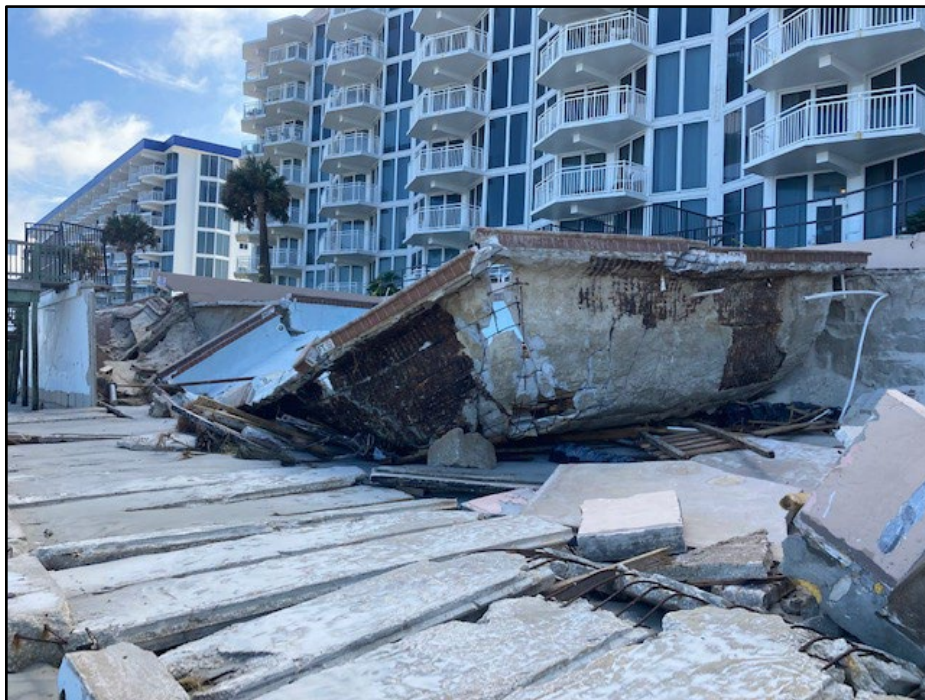
**Figure 89.** Seawall destroyed with inadequate pile penetration resulting in a destroyed swimming pool (R116).

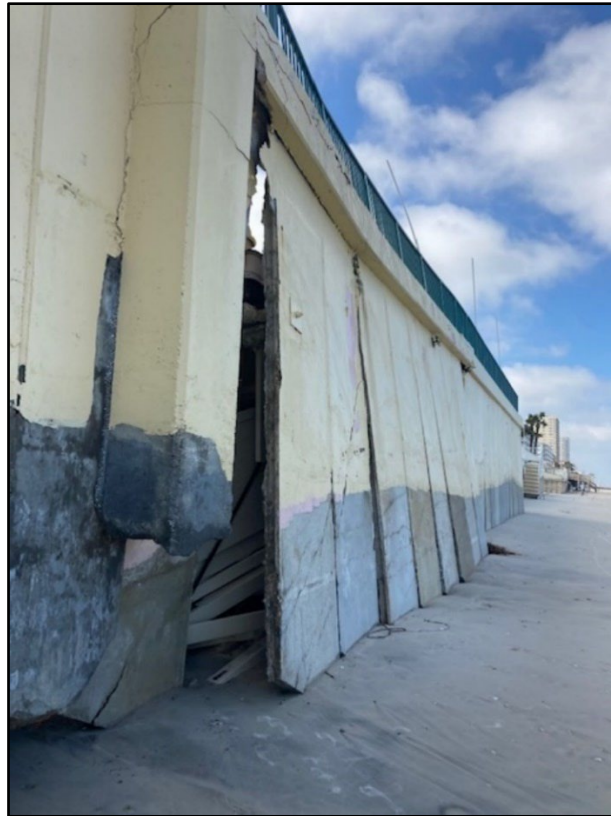
**Figure 90.** Inadequate sheet pile penetration.

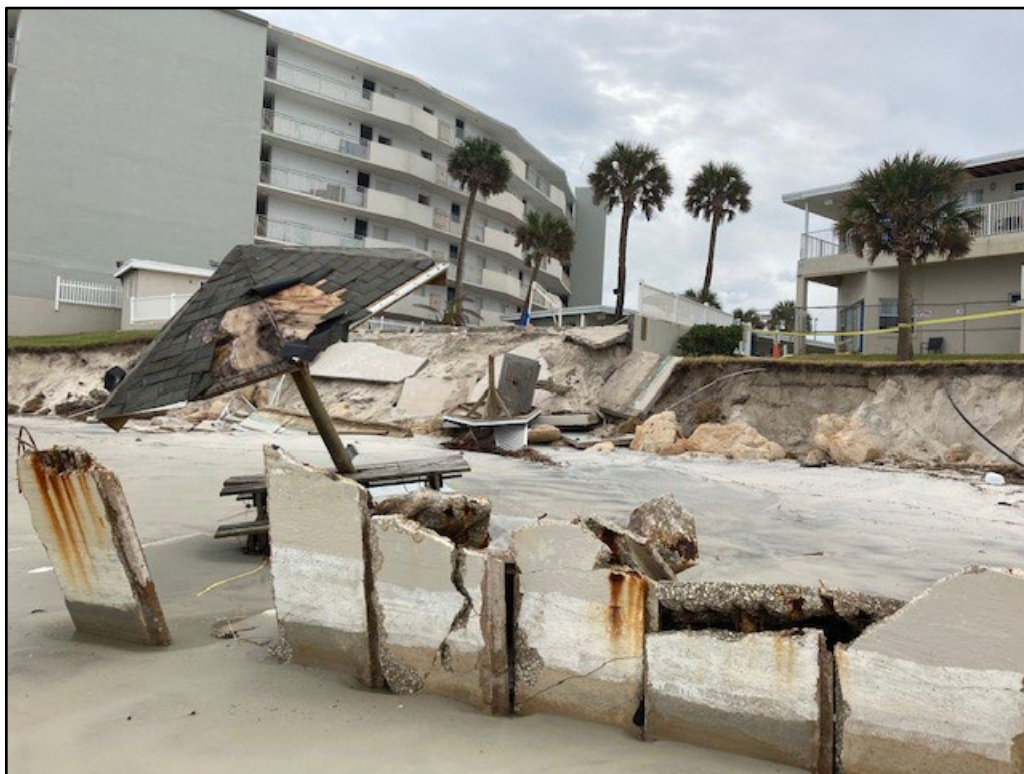
**Figure 91.** Old seawall destroyed by wave impact loads resulting in substantial loss of property in Daytona Beach Shores (R99).

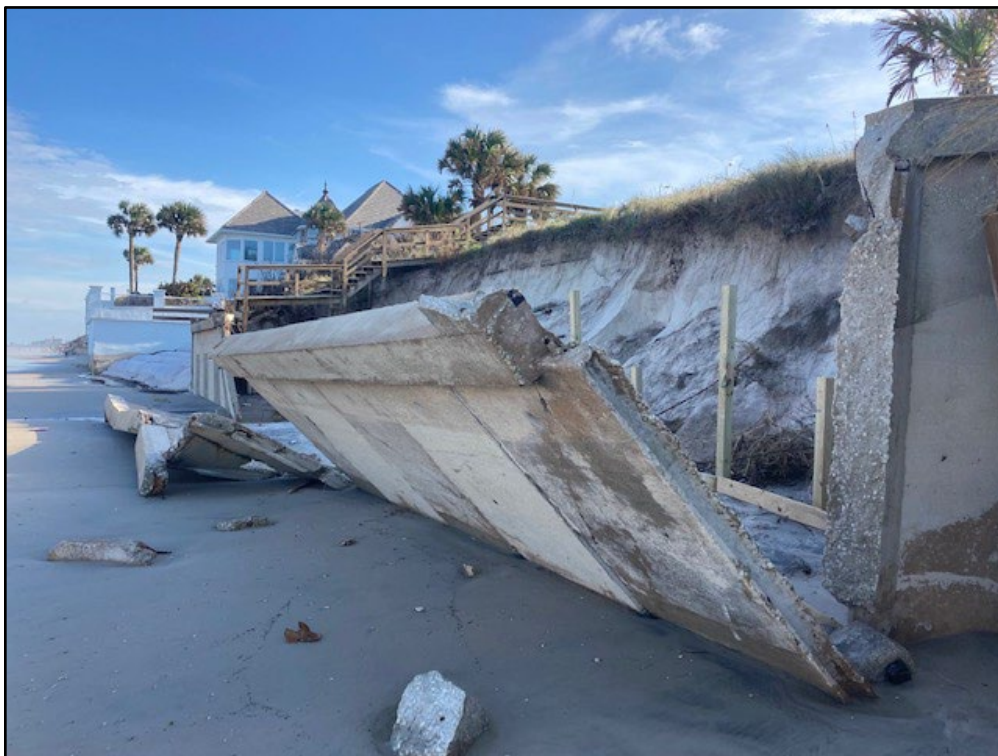
**Figure 93.** Seawall failure due to beach profile lowering and lack of tie-backs in Wilbur by the Sea (R124).

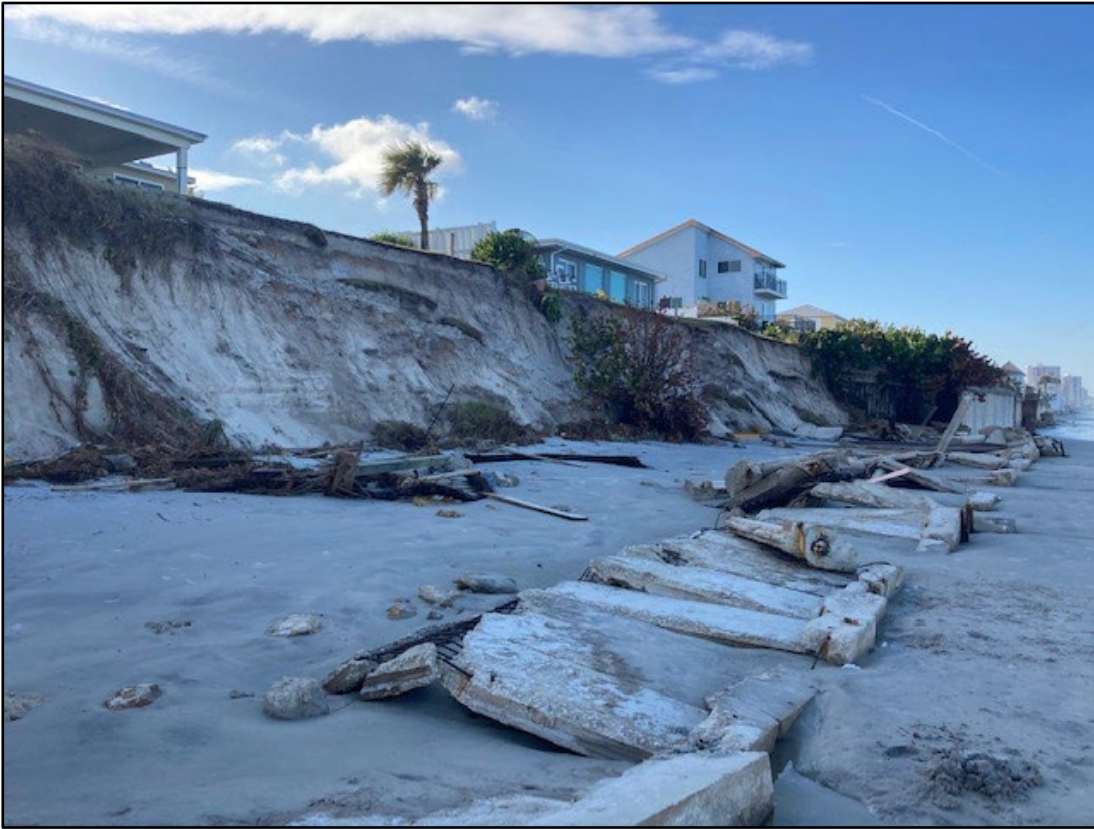
**Figure 94.** Catastrophic seawall collapse with loss of upland property in Wilbur by the Sea (R125).

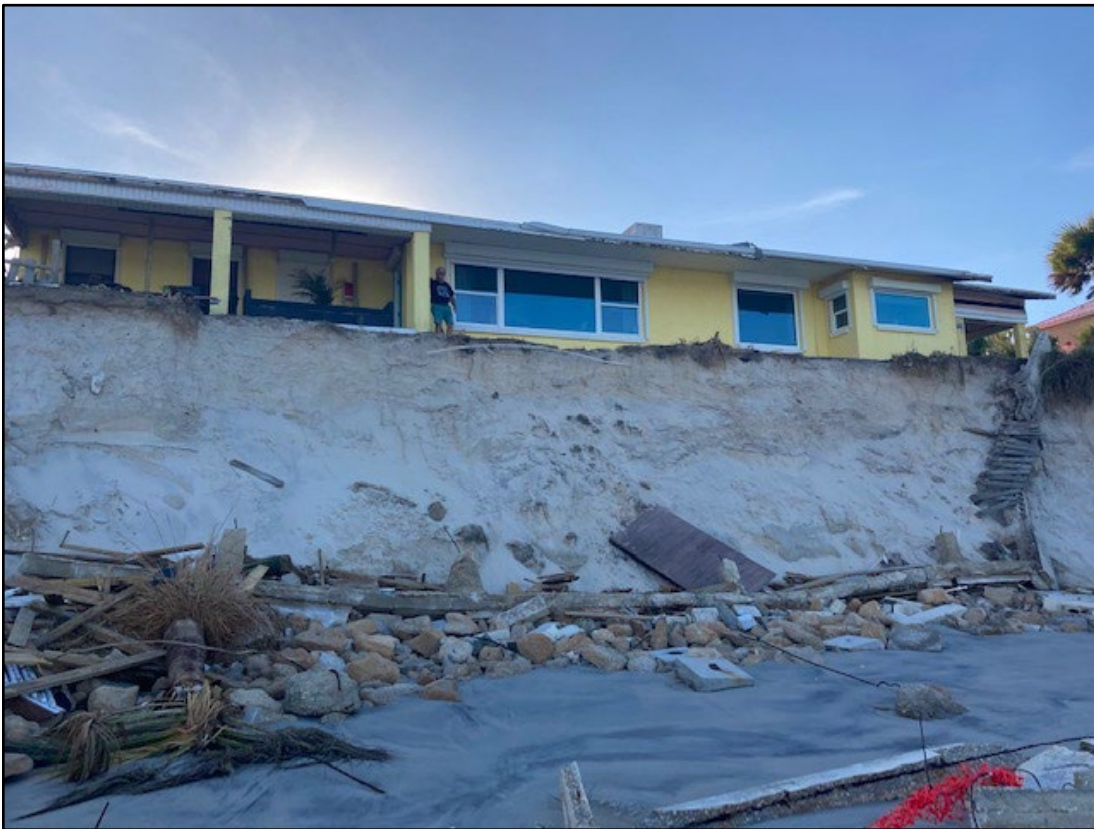
**Figure 95.** Wilbur-by-the-Sea dwelling threatened following seawall failure (R125).

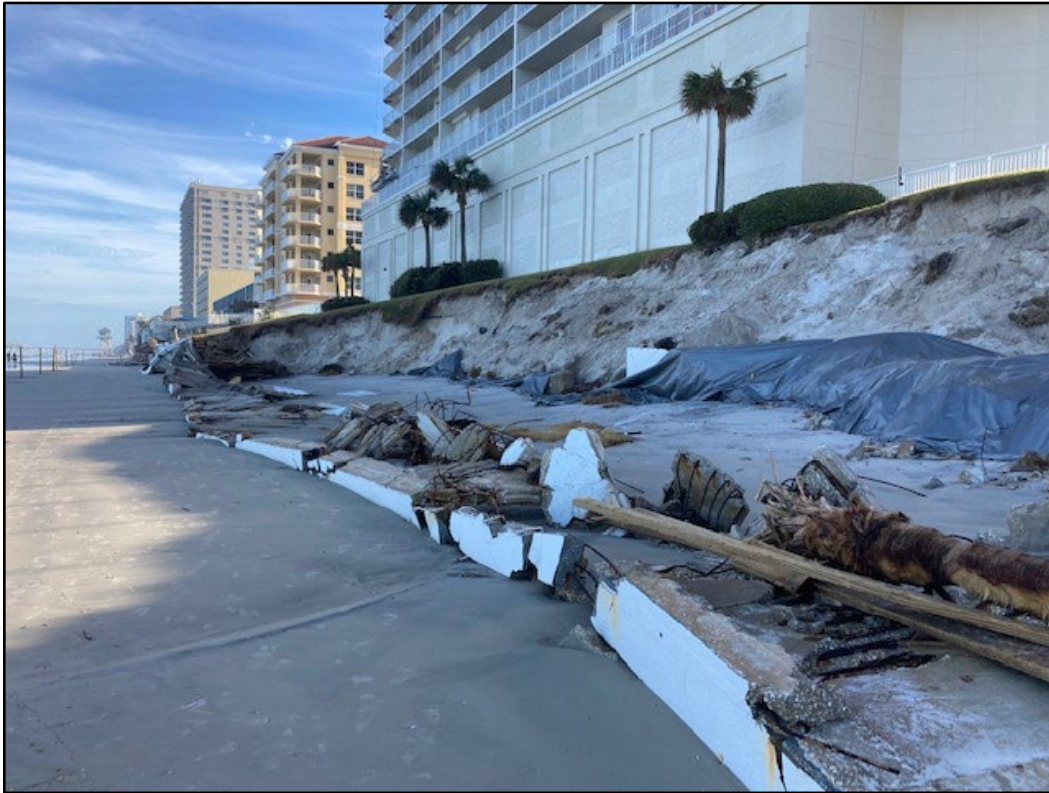
**Figure 96.** Catastrophic seawall failure threatens condominium in Daytona Beach Shores (R114).

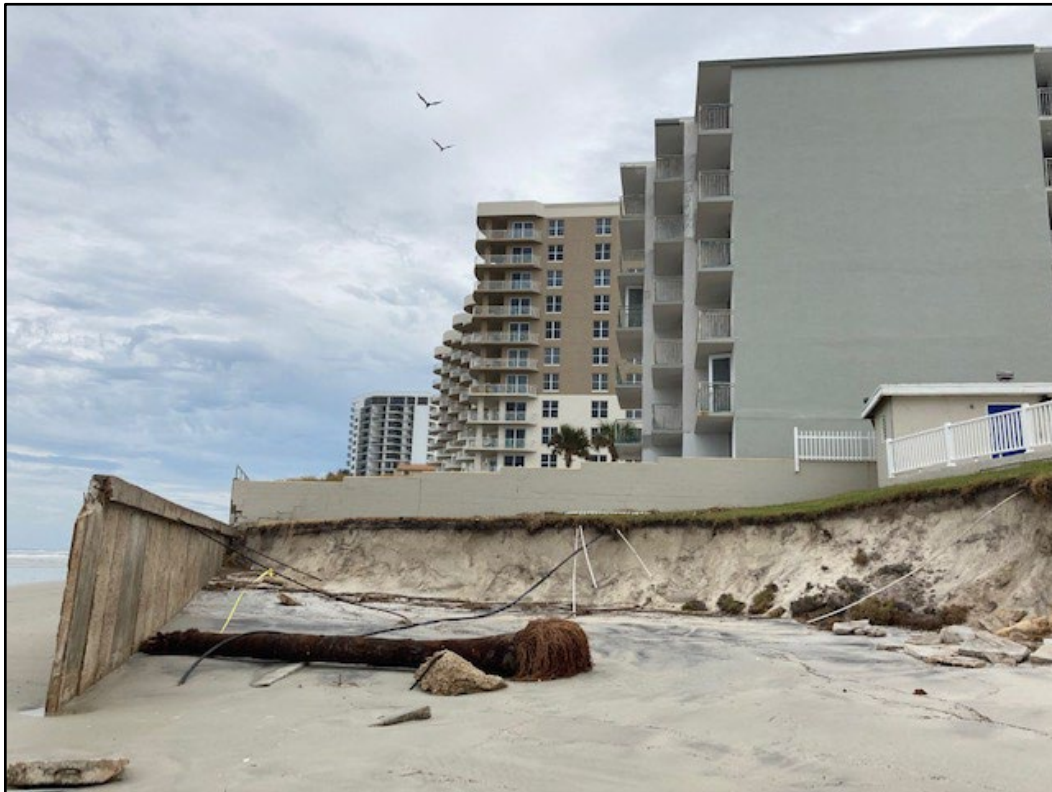
**Figure 97.** Substantial loss of property with seawall failure.

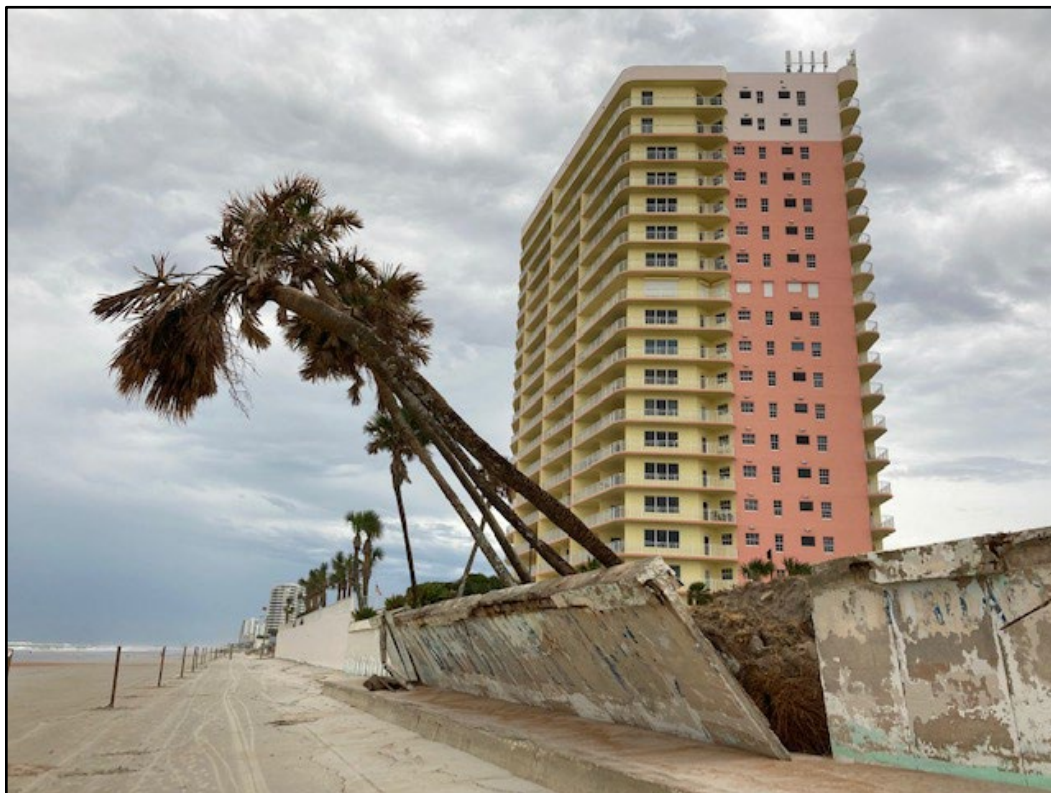
**Figure 99.** Inadequate seawall tie-backs, wall thickness and pile penetration (R-71.5).

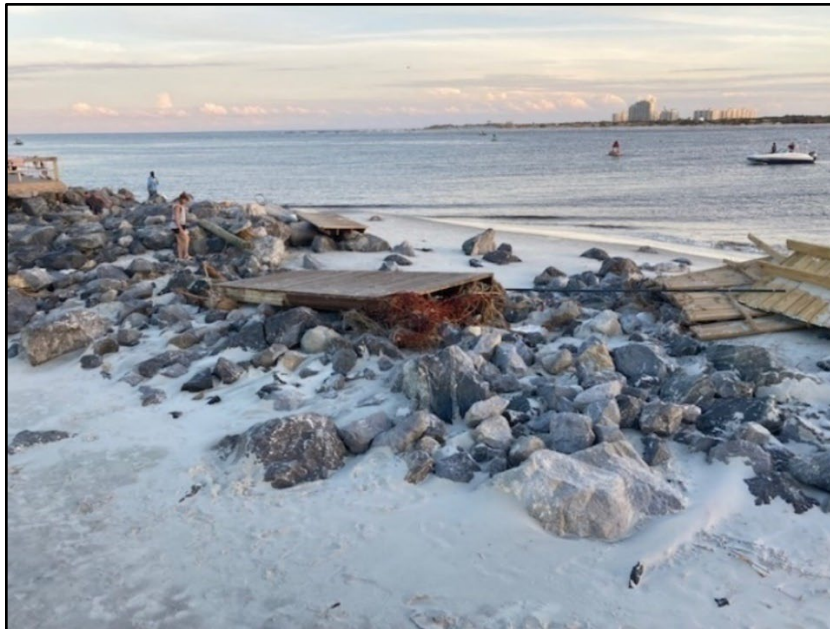
**Figure 100.** Damaged north jetty to Ponce de Leon Inlet (R-148).

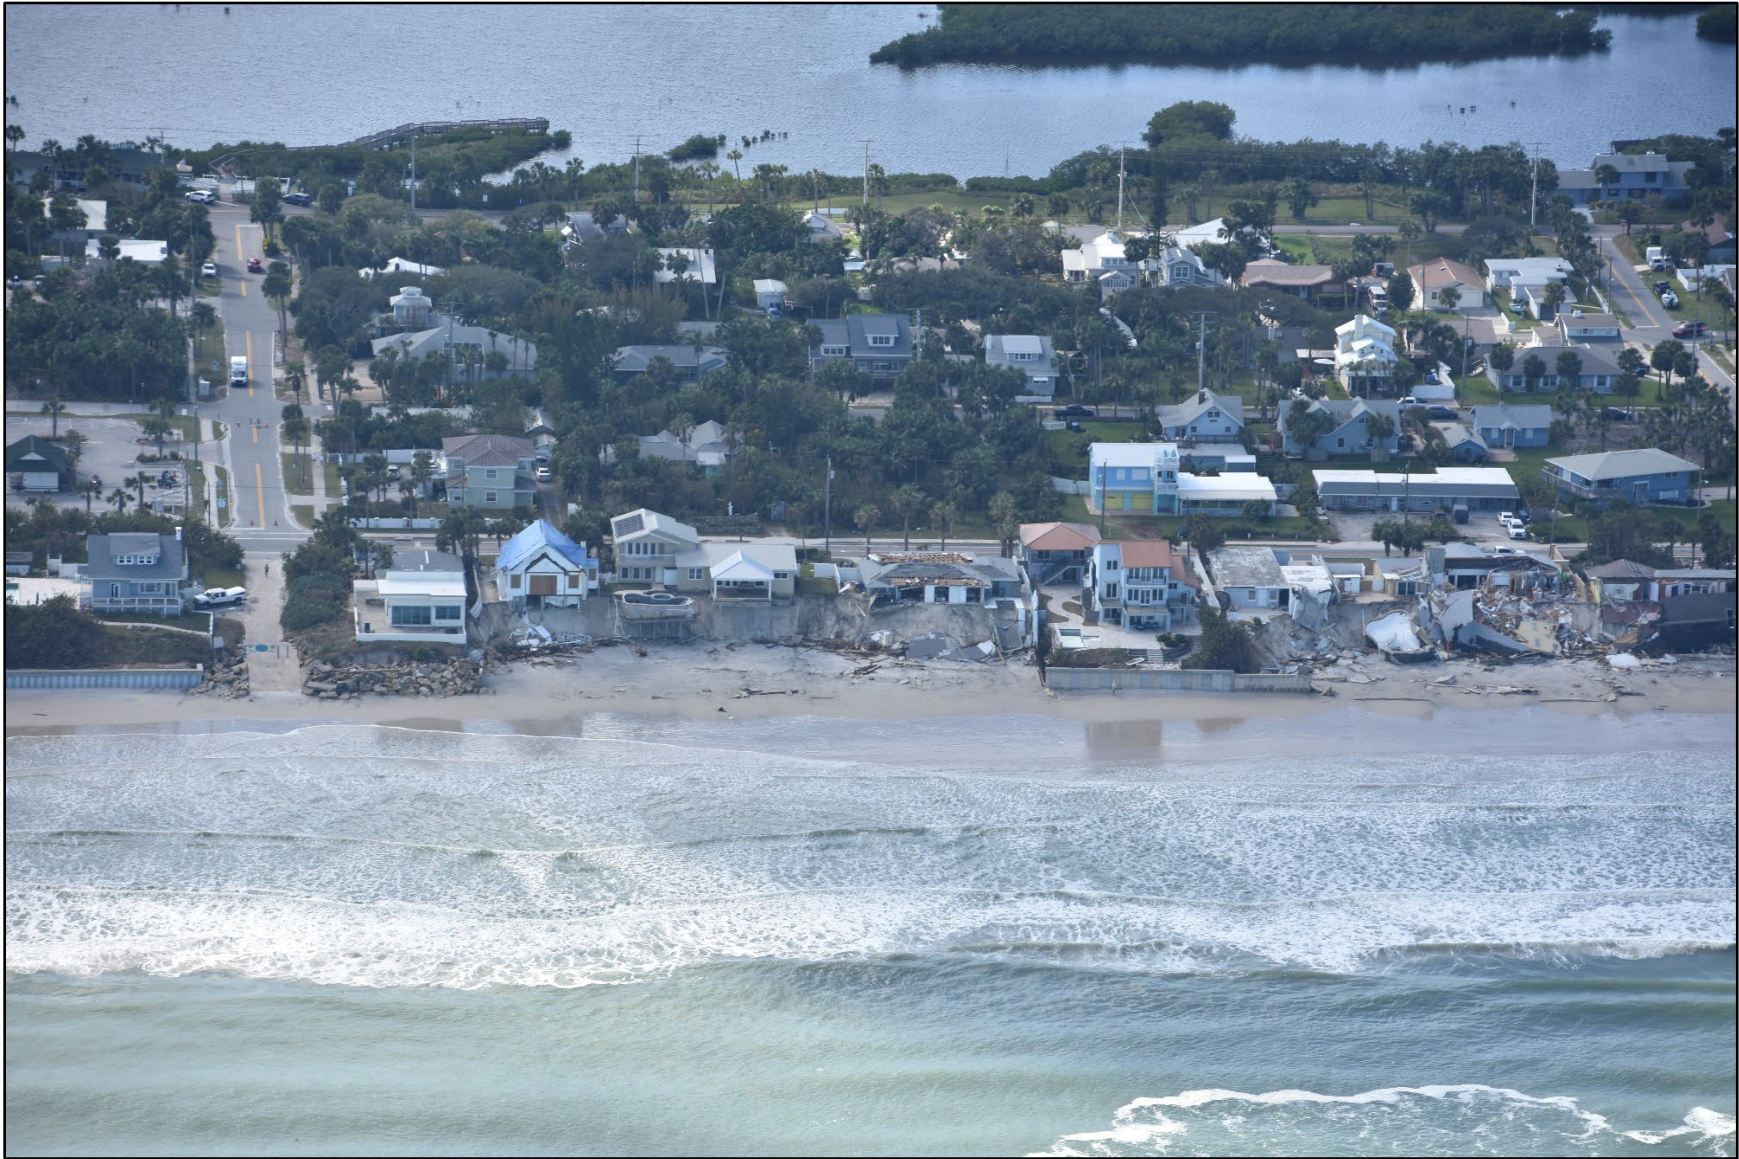
**Figure 102.** Major erosion damages to seawalls and upland properties at Toronita Avenue in Wilbur by the Sea (R-125).  
[Credit: Oblique aerial photo by the Civil Air Patrol, November 12, 2022.]

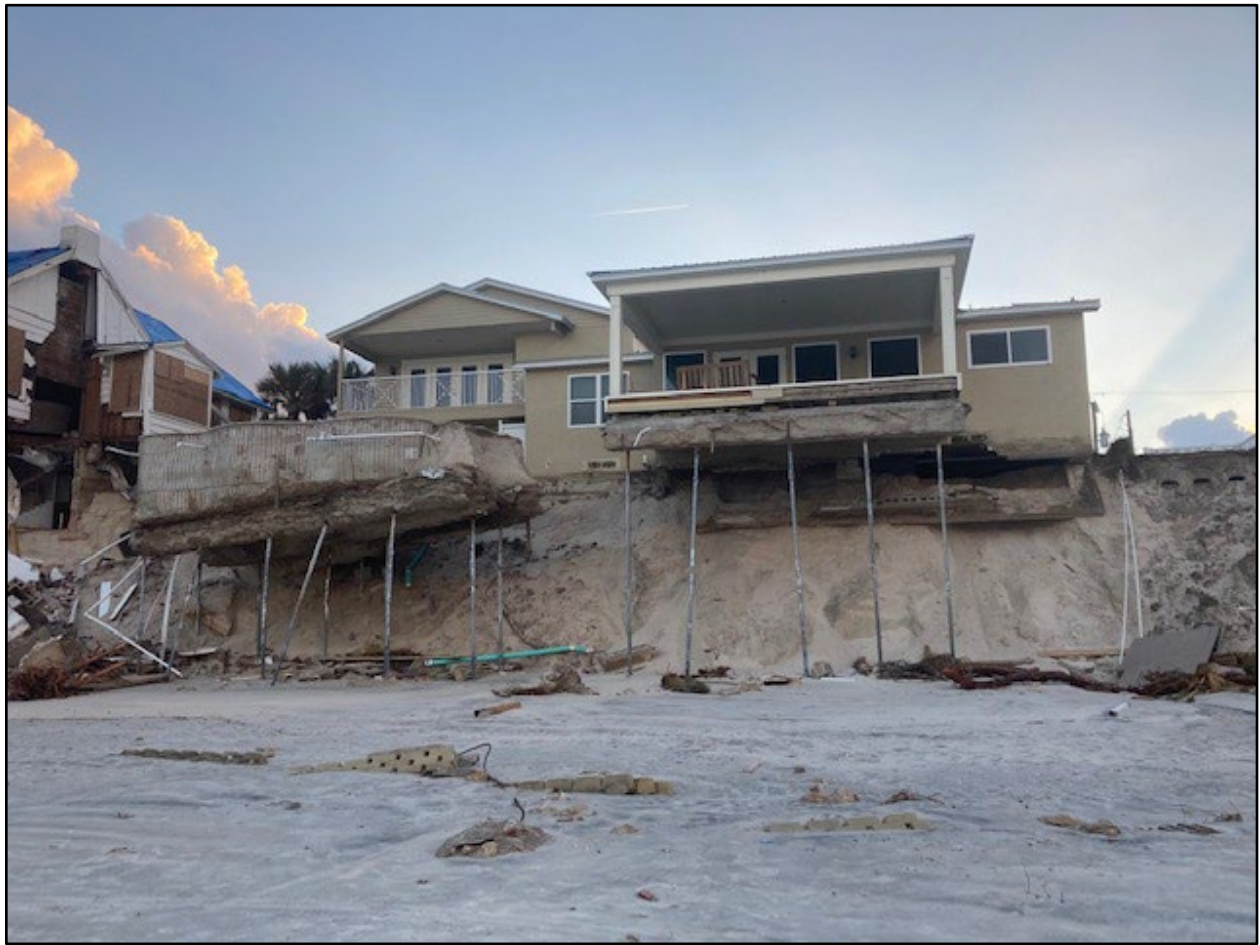
**Figure 103.** House and pool in imminent danger from major beach and dune erosion .

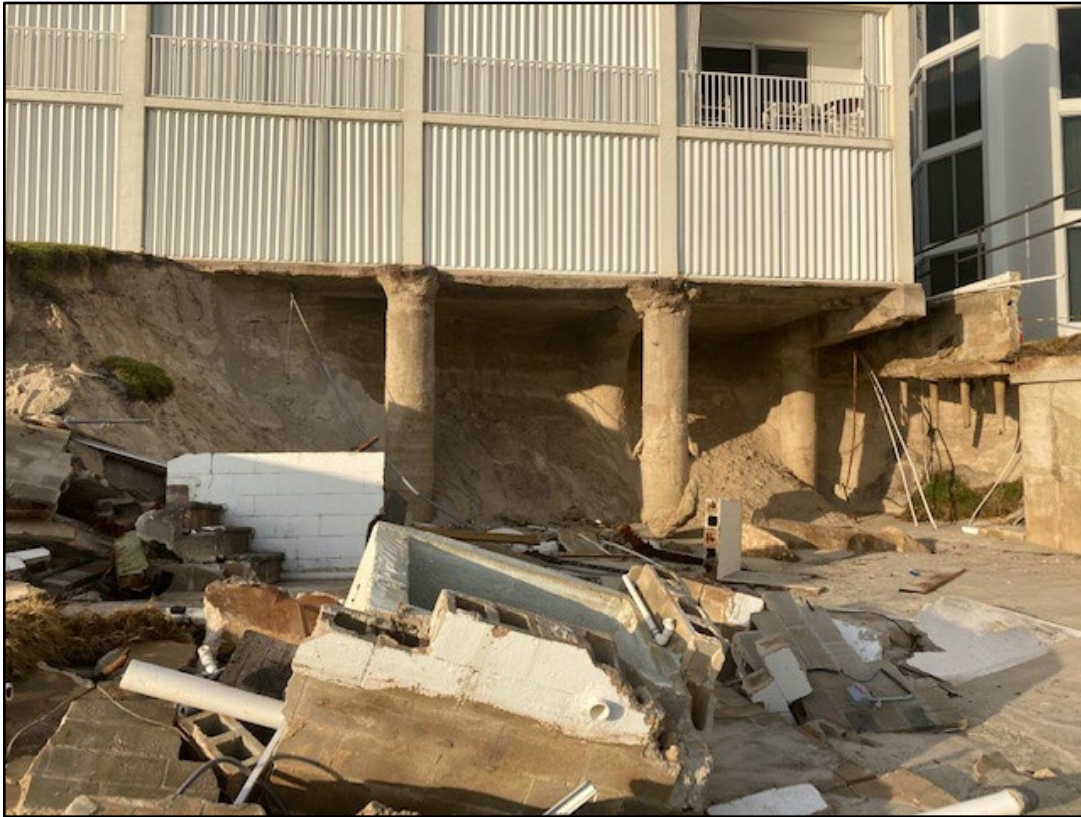
**Figure 105.** Threatened multifamily dwelling with foundation piles suspended (R117).

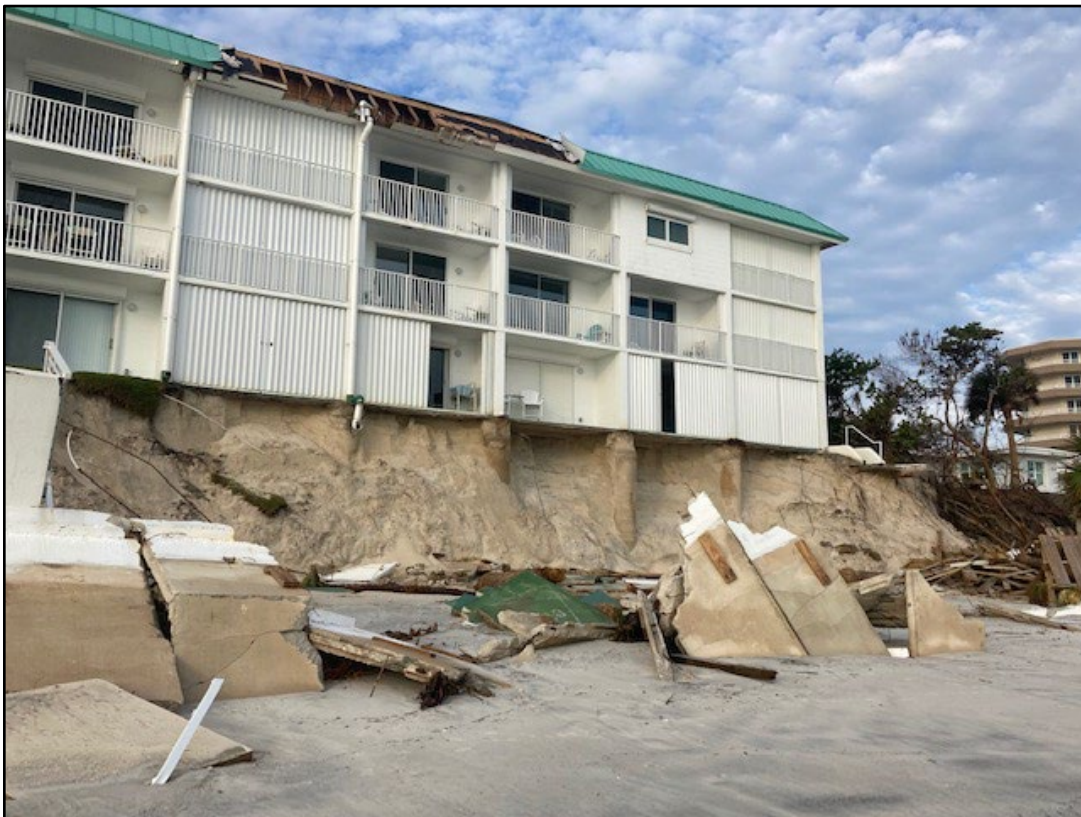
**Figure 106.** Condominium in imminent danger with roofing and siding damages.

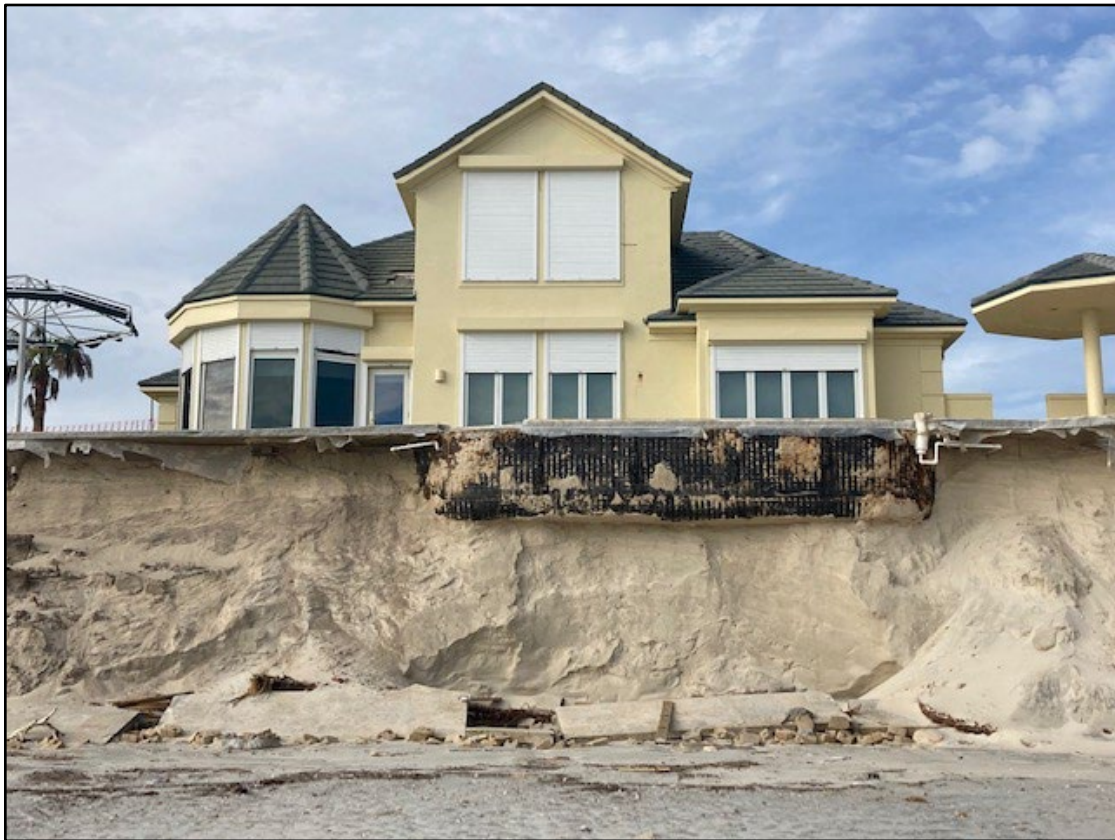
**Figure 107.** House and pool in imminent danger, Wilbur-by-the-Sea (R122).

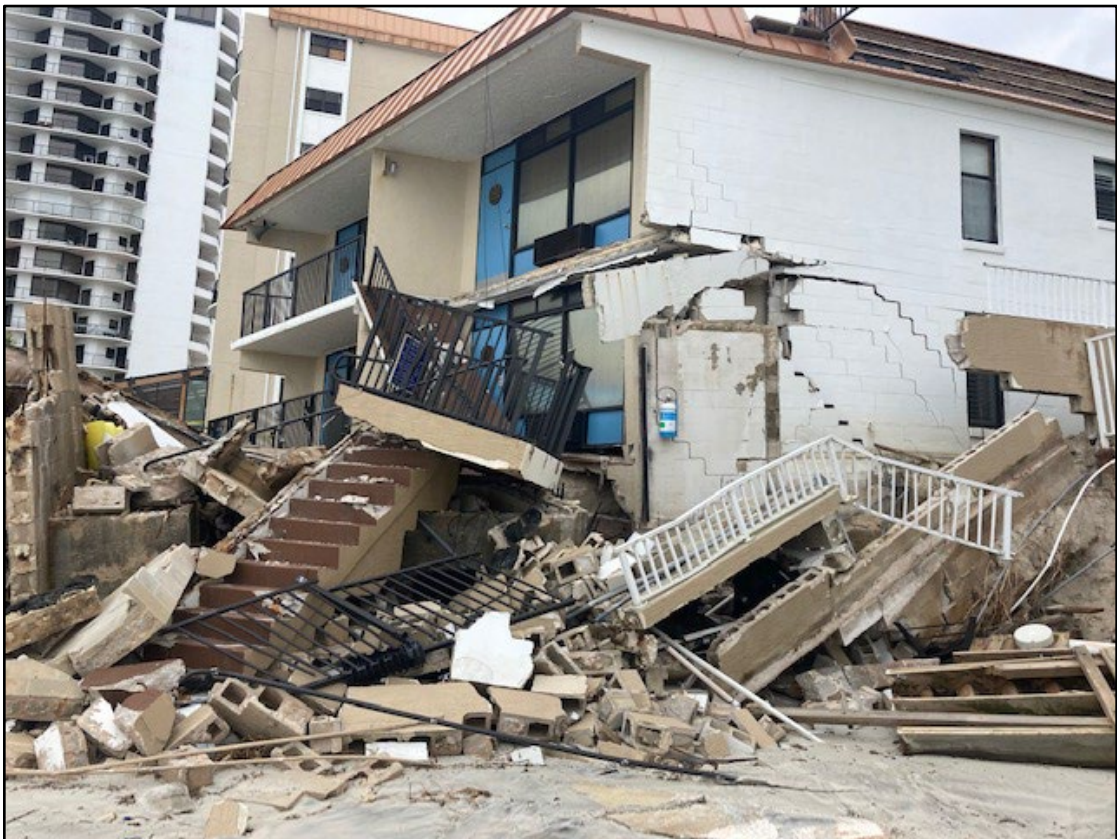
**Figure 118.** Damaged multifamily dwelling in Volusia County.

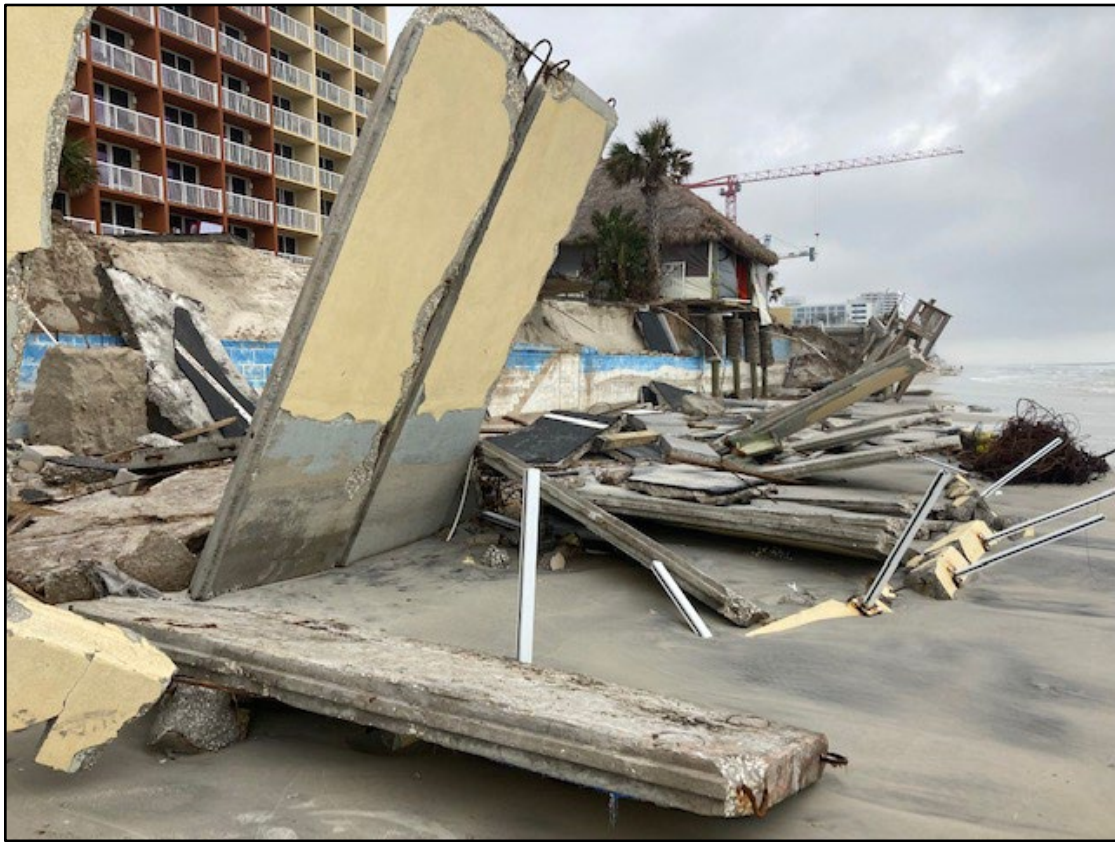
**Figure 119.** More seawall damage by Hurricane Nicole.

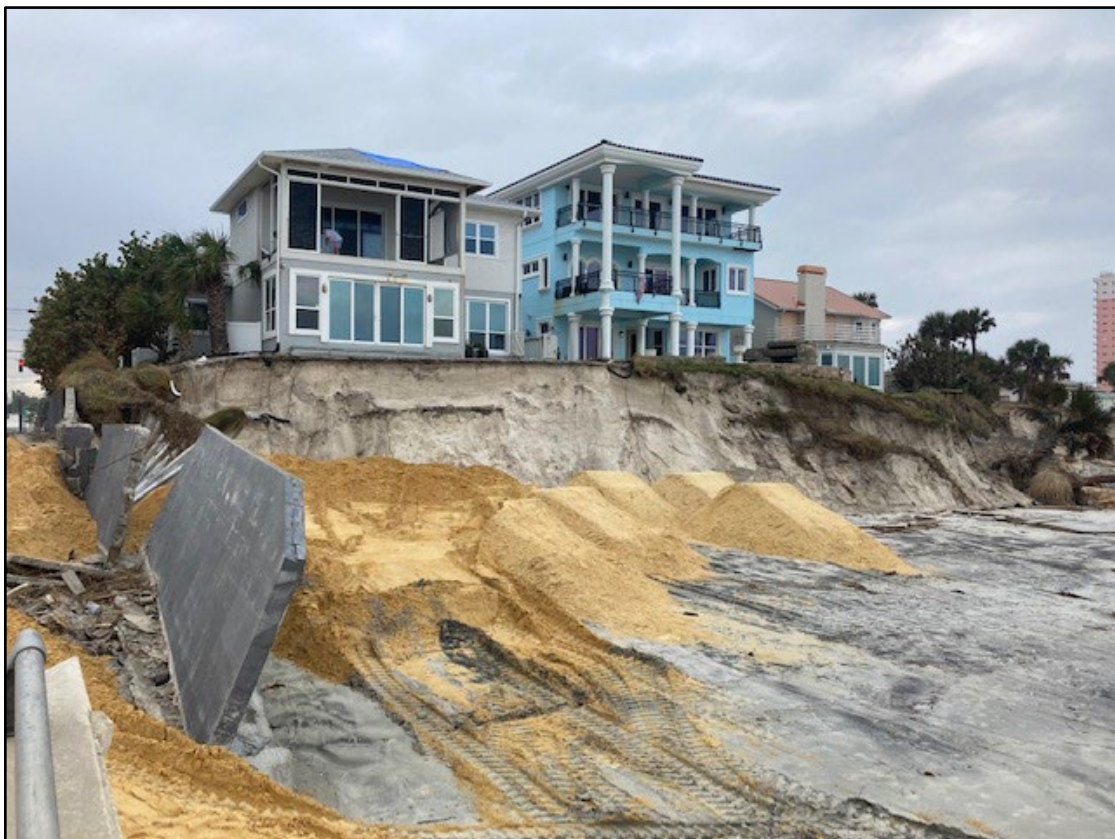
**Figure 120.** More threatened houses following severe erosion in Daytona Beach Shores (R-103).
