BASIN MANAGEMENT ACTION PLAN

FINAL PHASE 2

for Fecal Coliforms

in the Lower St. Johns River Basin Tributaries I

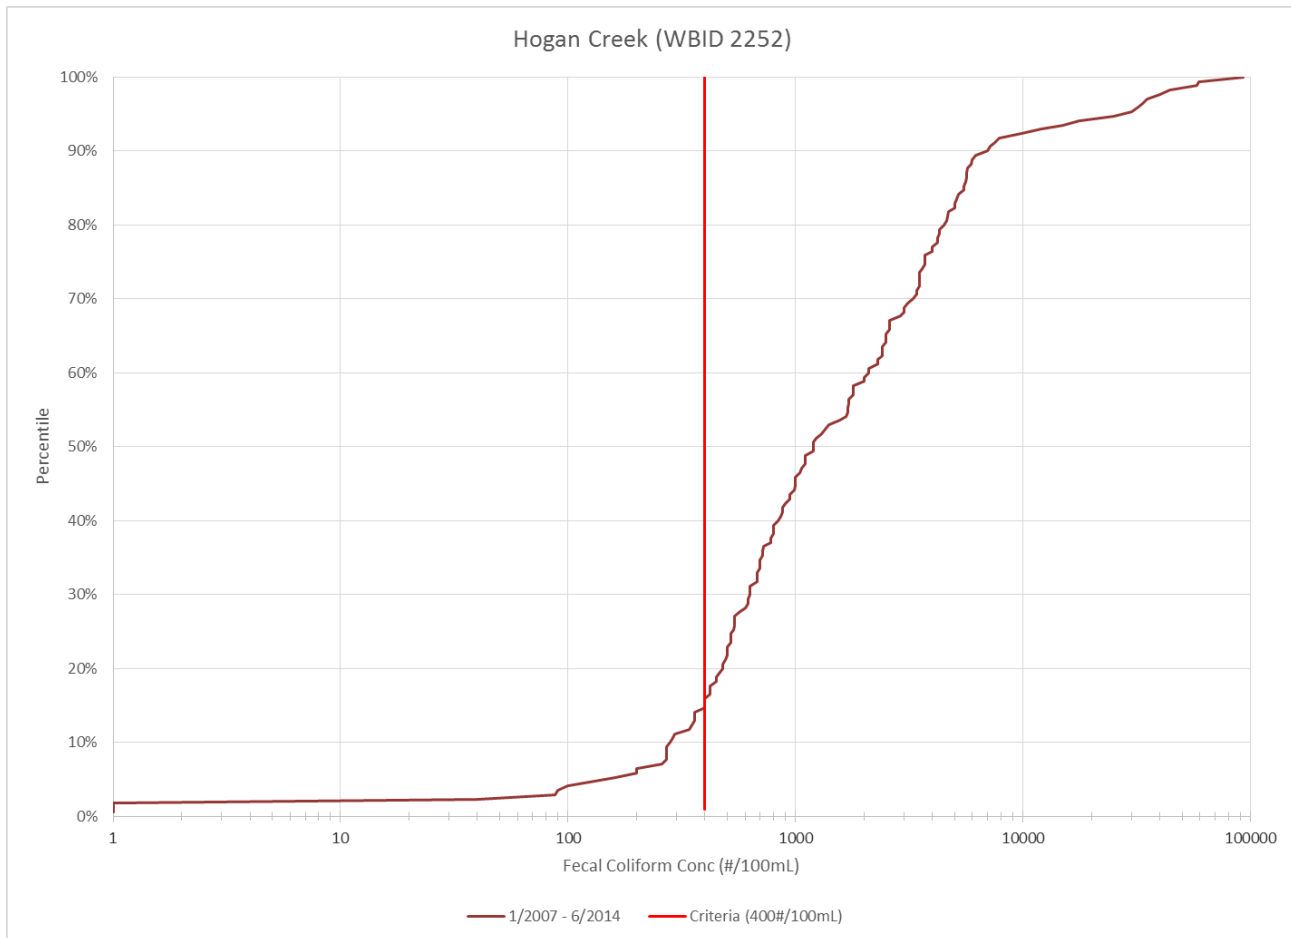
FIGURE 5: CUMULATIVE FREQUENCY OF FECAL COLIFORM RESULTS IN HOGAN CREEK COMPARED TO THE WATER QUALITY STANDARD

When the water quality standard is being met, all or most of the results will be to the left of the 400 count line, meaning that most of the samples were at or below the water quality standard.

In reference to water quality standards, the waterbodies are assessed based on the number of exceedances over 400 CFU/100 mL. Based on the number of samples taken in a given data period, a limited number of exceedances is allowed before the water body is considered to be impaired. While the charts showing the trends over time are helpful to see how the coliform levels are changing, from a compliance standpoint, the number of exceedances is the primary consideration. **Figure 5** shows the cumulative percentage of the fecal coliform results in Hogan Creek and how they compare to the standard of 400 CFU/100 mL.

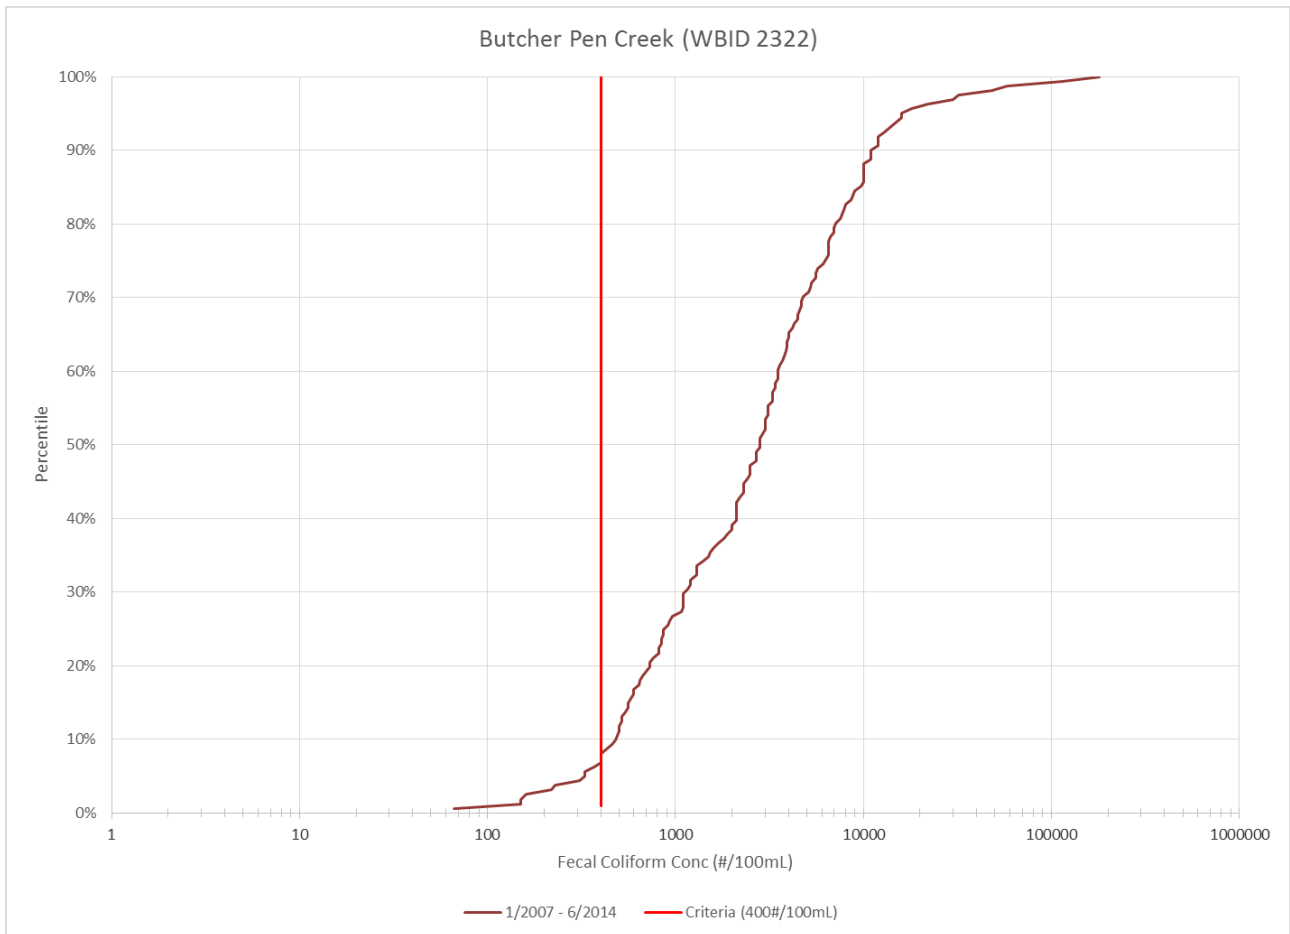
FIGURE 7: CUMULATIVE FREQUENCY OF FECAL COLIFORM RESULTS IN BUTCHER PEN CREEK COMPARED TO THE WATER QUALITY STANDARD

When the water quality standard is being met, all or most of the results will be to the left of the 400 count line, meaning that most of the samples were at or below the water quality standard.

In reference to water quality standards, the waterbodies are assessed based on the number of exceedances over 400 CFU/100 mL. Based on the number of samples taken in a given data period, a limited number of exceedances is allowed before the water body is considered to be impaired. While the charts showing the trends over time are helpful to see how the coliform levels are changing, from a compliance standpoint, the number of exceedances is the primary consideration. **Figure 7** shows the cumulative percentage of the fecal coliform results in Butcher Pen Creek and how they compare to the standard of 400 CFU/100 mL.

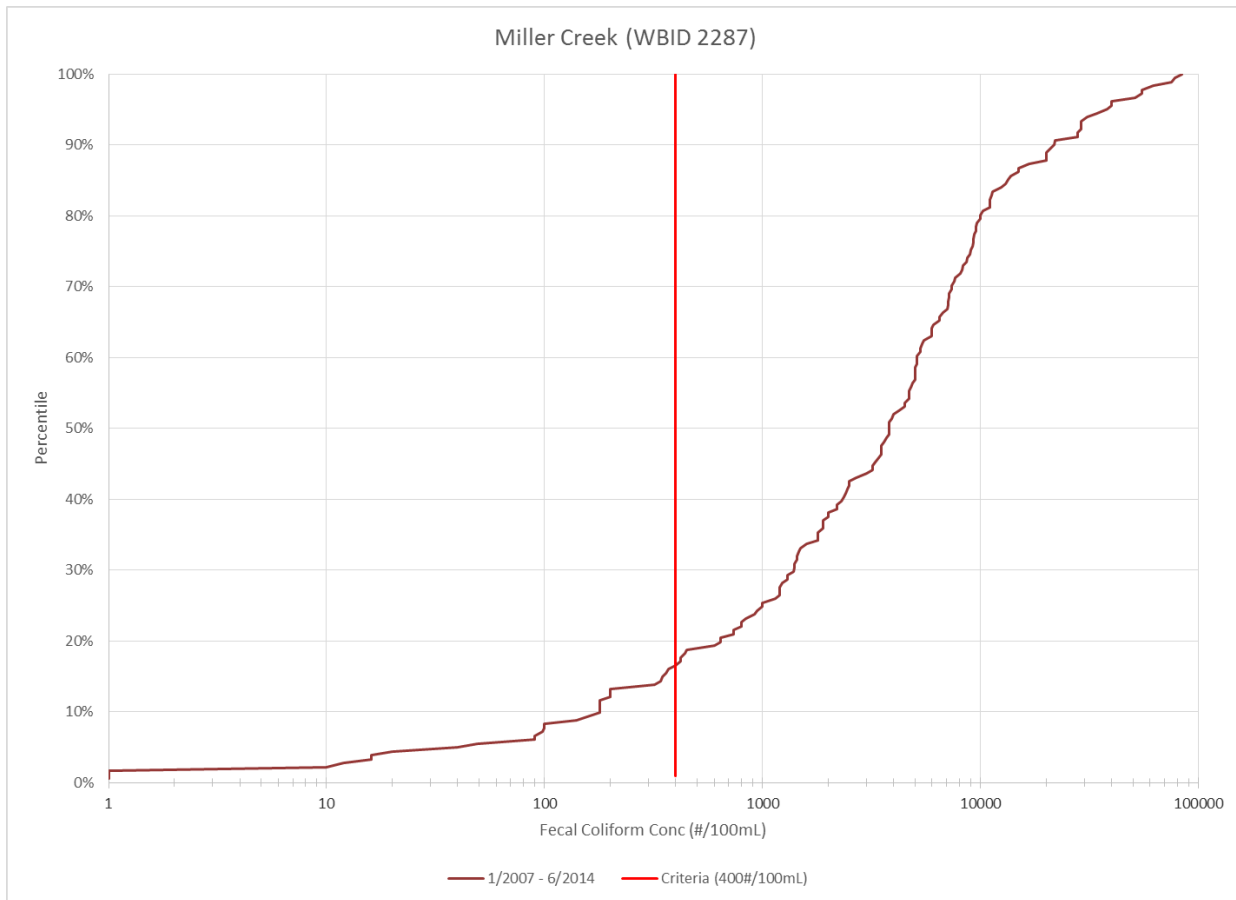
FIGURE 9: CUMULATIVE FREQUENCY OF FECAL COLIFORM RESULTS IN MILLER CREEK COMPARED TO THE WATER QUALITY STANDARD

When the water quality standard is being met, all or most of the results will be to the left of the 400 count line, meaning that most of the samples were at or below the water quality standard.

In reference to water quality standards, the waterbodies are assessed based on the number of exceedances over 400 CFU/100 mL. Based on the number of samples taken in a given data period, a limited number of exceedances is allowed before the water body is considered to be impaired. While the charts showing the trends over time are helpful to see how the coliform levels are changing, from a compliance standpoint, the number of exceedances is the primary consideration. **Figure 9** shows the cumulative percentage of the fecal coliform results in Miller Creek and how they compare to the standard of 400 CFU/100 mL.

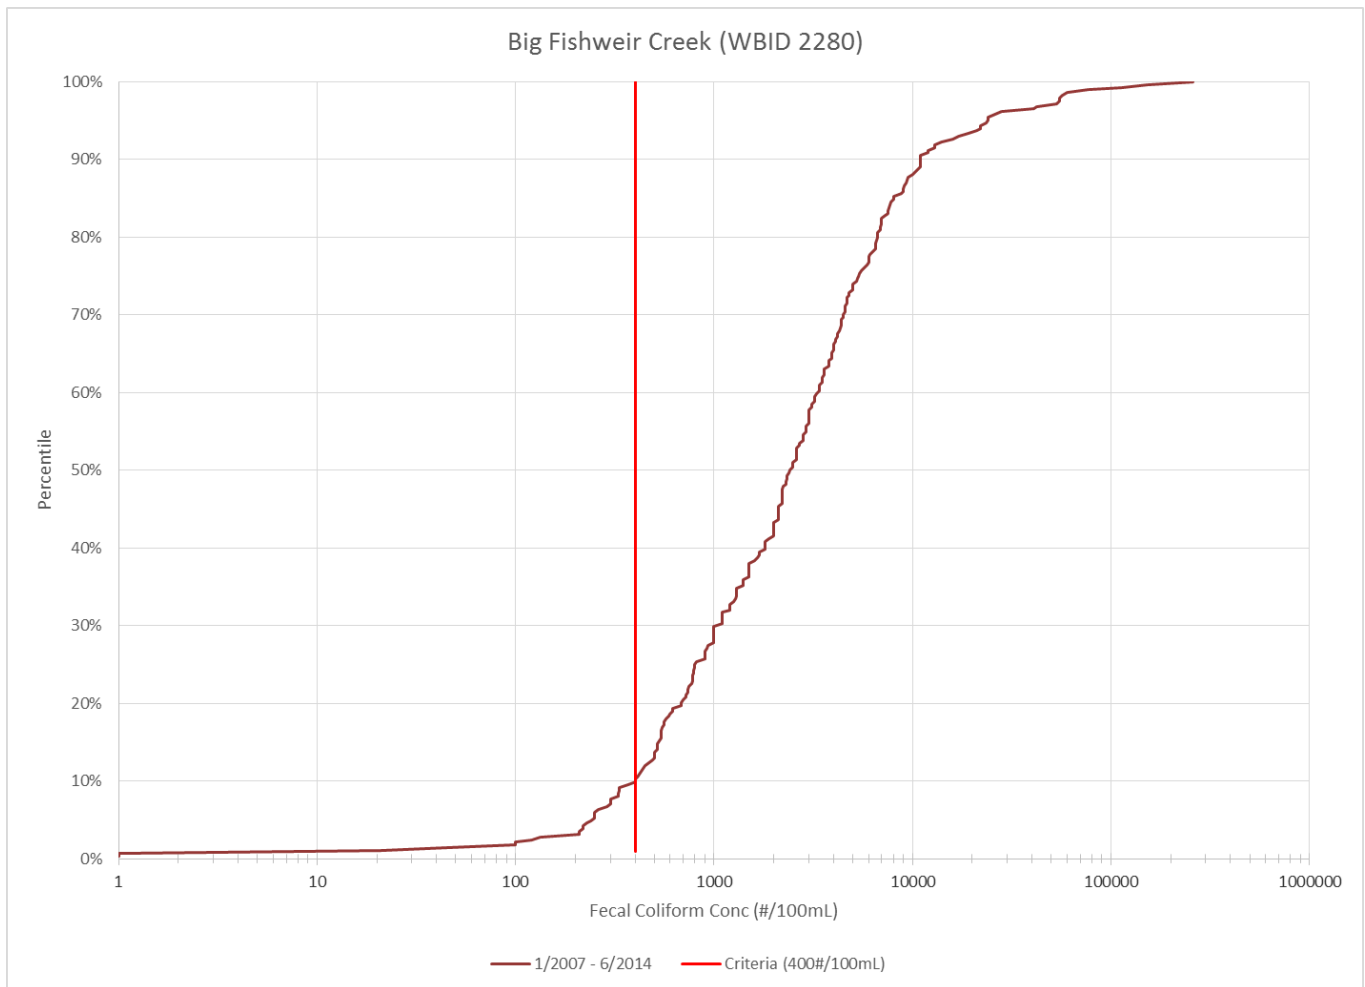
FIGURE 13: CUMULATIVE FREQUENCY OF FECAL COLIFORM RESULTS IN BIG FISHWEIR CREEK COMPARED TO THE WATER QUALITY STANDARD

When the water quality standard is being met, all or most of the results will be to the left of the 400 count line, meaning that most of the samples were at or below the water quality standard.

In reference to water quality standards, the waterbodies are assessed based on the number of exceedances over 400 CFU/100 mL. Based on the number of samples taken in a given data period, a limited number of exceedances is allowed before the water body is considered to be impaired. While the charts showing the trends over time are helpful to see how the coliform levels are changing, from a compliance standpoint, the number of exceedances is the primary consideration. **Figure 13** shows the cumulative percentage of the fecal coliform results in Big Fishweir Creek and how they compare to the standard of 400 CFU/100 mL.

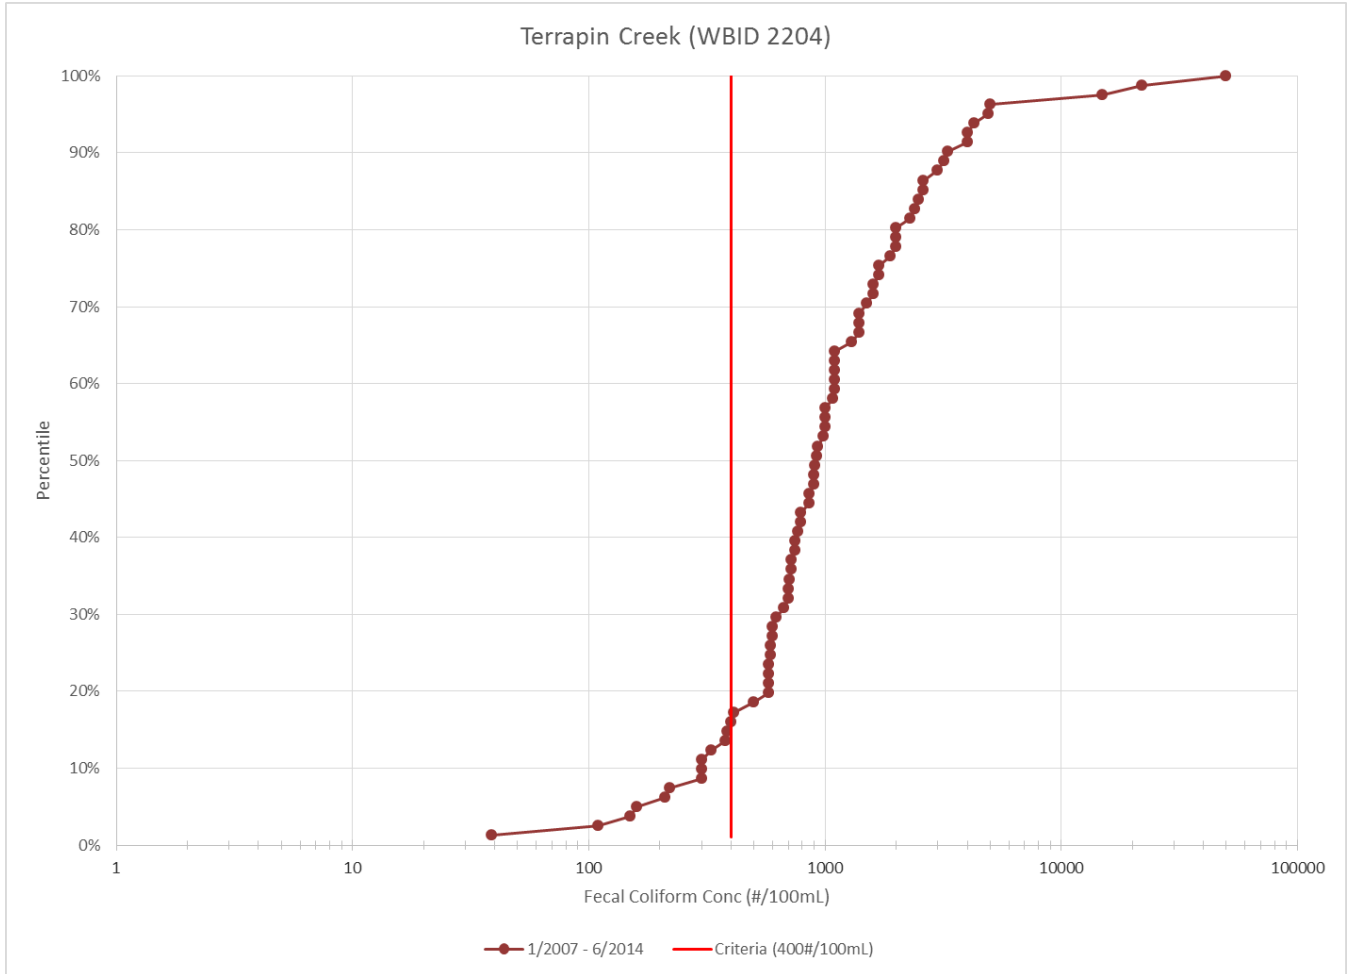
FIGURE 17: CUMULATIVE FREQUENCY OF FECAL COLIFORM RESULTS IN TERRAPIN CREEK COMPARED TO THE WATER QUALITY STANDARD

When the water quality standard is being met, all or most of the results will be to the left of the 400 count line, meaning that most of the samples were at or below the water quality standard.

In reference to water quality standards, the waterbodies are assessed based on the number of exceedances over 400 CFU/100 mL. Based on the number of samples taken in a given data period, a limited number of exceedances is allowed before the water body is considered to be impaired. While the charts showing the trends over time are helpful to see how the coliform levels are changing, from a compliance standpoint, the number of exceedances is the primary consideration. **Figure 17** shows the cumulative percentage of the fecal coliform results in Terrapin Creek and how they compare to the standard of 400 CFU/100 mL.

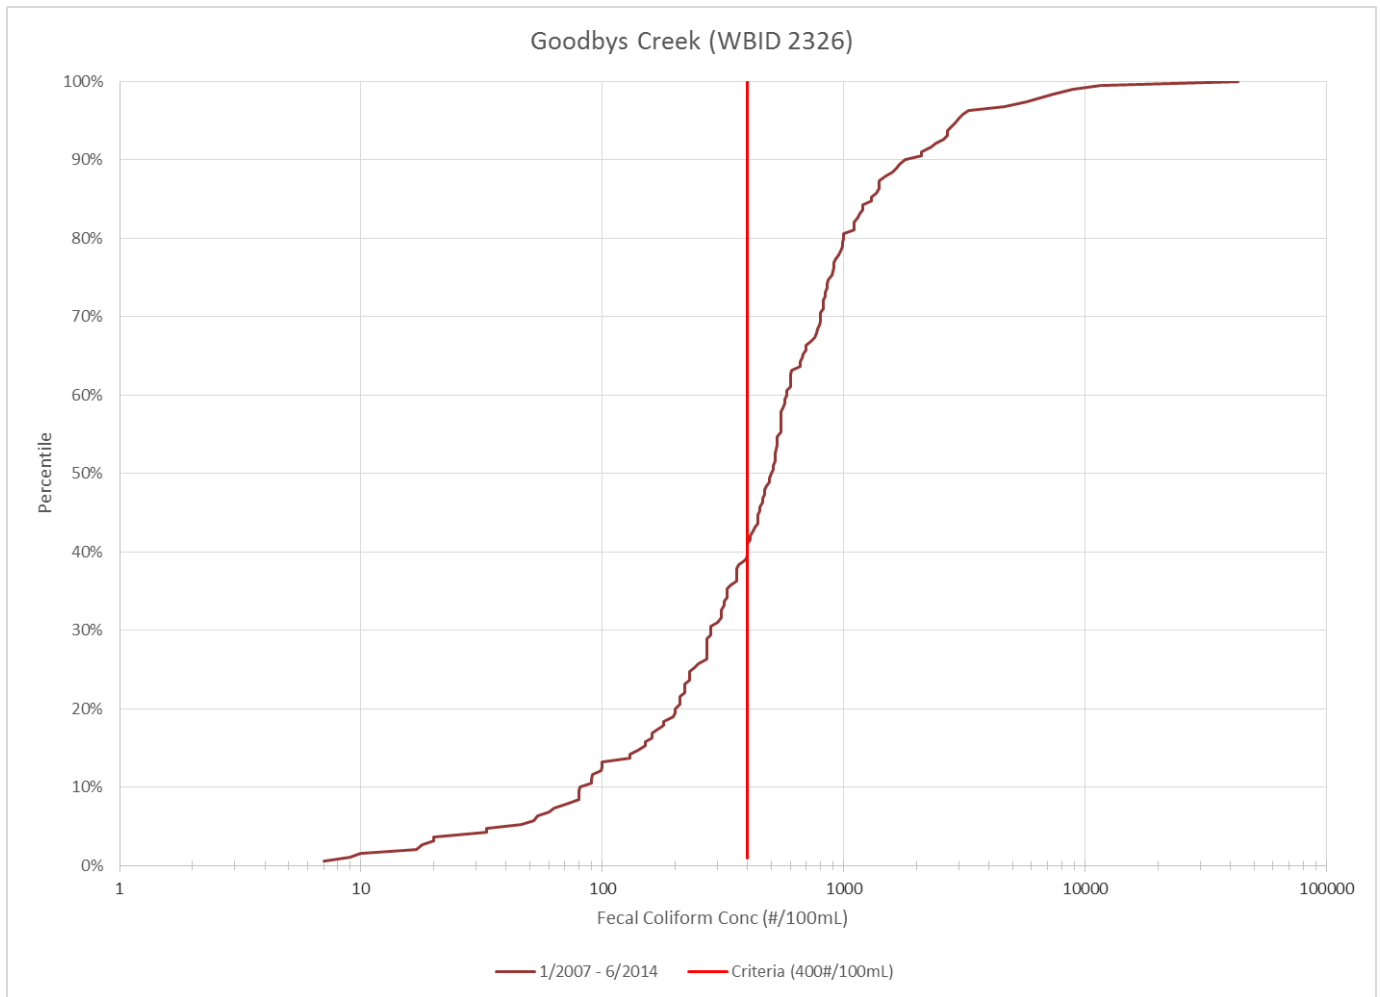
FIGURE 19: CUMULATIVE FREQUENCY OF FECAL COLIFORM RESULTS IN GOODBYS CREEK COMPARED TO THE WATER QUALITY STANDARD

When the water quality standard is being met, all or most of the results will be to the left of the 400 count line, meaning that most of the samples were at or below the water quality standard.

In reference to water quality standards, the waterbodies are assessed based on the number of exceedances over 400 CFU/100 mL. Based on the number of samples taken in a given data period, a limited number of exceedances is allowed before the water body is considered to be impaired. While the charts showing the trends over time are helpful to see how the coliform levels are changing, from a compliance standpoint, the number of exceedances is the primary consideration. **Figure 19** shows the cumulative percentage of the fecal coliform results in Goodbys Creek and how they compare to the standard of 400 CFU/100 mL.

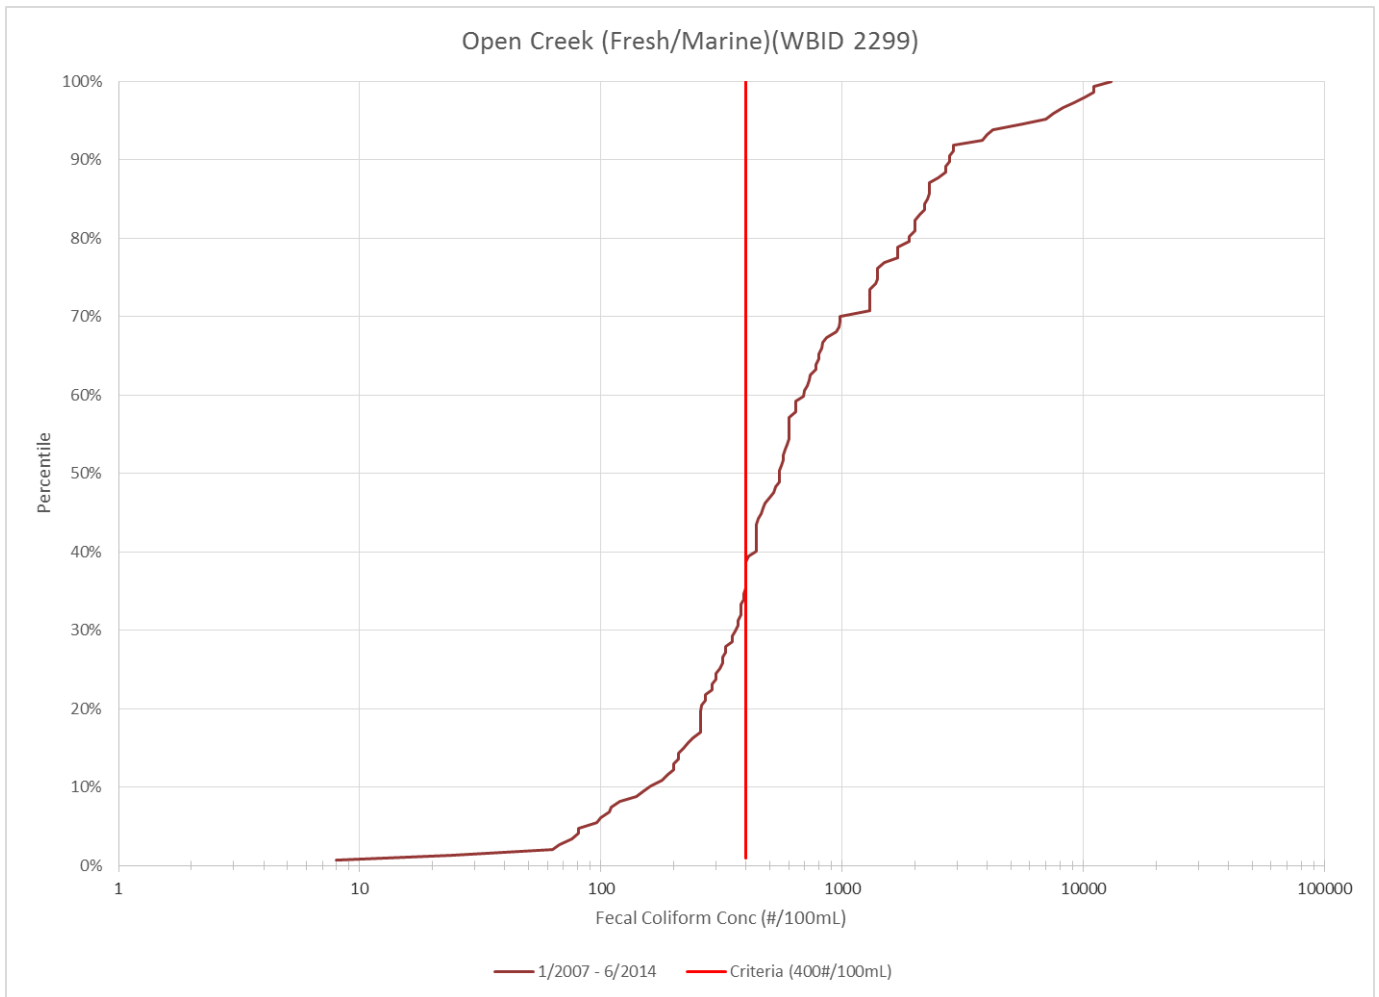
FIGURE 21: CUMULATIVE FREQUENCY OF FECAL COLIFORM RESULTS IN OPEN CREEK COMPARED TO THE WATER QUALITY STANDARD

When the water quality standard is being met, all or most of the results will be to the left of the 400 count line, meaning that most of the samples were at or below the water quality standard.

In reference to water quality standards, the waterbodies are assessed based on the number of exceedances over 400 CFU/100 mL. Based on the number of samples taken in a given data period, a limited number of exceedances is allowed before the water body is considered to be impaired. While the charts showing the trends over time are helpful to see how the coliform levels are changing, from a compliance standpoint, the number of exceedances is the primary consideration. **Figure 21** shows the cumulative percentage of the fecal coliform results in Open Creek and how they compare to the standard of 400 CFU/100 mL.
