# Solids Facilities Observations Memorandum

PREPARED FOR: City of St. Petersburg  
COPY TO: Alliance for Bayway Communities, Eckerd College  
PREPARED BY: CH2M  
DATE: October 23, 2015  
PROJECT NUMBER: 666518  
REVISION NO.: FINAL

The objective of this TM is to summarize findings from site visits to the SWWRF, NWWRF and NEWRF. The site visits and the findings described here focus on current biosolids production and the capacity and condition of existing treatment facilities at each WRF. Pictures taken during these site visits are included in Appendix A.

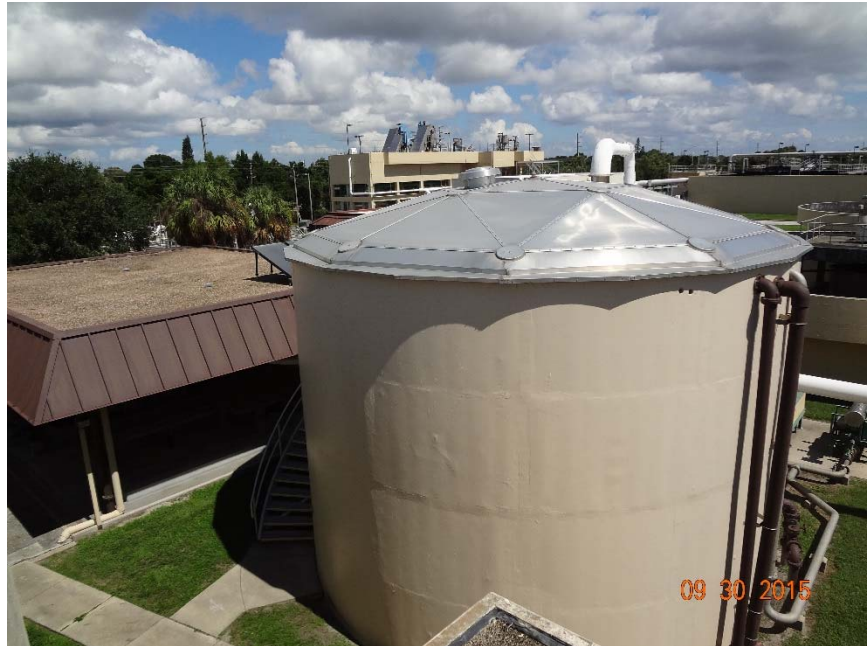
Figure SWWRF-1. Sludge Storage Tank  
*Southwest WRF*

Waste solids are pumped from the secondary treatment process to the Sludge Storage Tank which is in good condition (Figure SWWRF-1). The Sludge Storage Tank is sized to provide operational flexibility, but it not large enough to store solids if a downstream process were out of service for an extended [eriod]. The thickening facility is located in the Gravity Belt Thickener (GBT) Building in the northwest portion of the plant site adjacent to the anaerobic digesters (Figure SWWRF-2). The GBT Building is open on the sides and includes one Ashbrook GBT and auxiliary equipment. The building and equipment is in moderate condition. The current biosolids treatment process does not require thickening, but operations continues to maintain this facility for future use. The City has indicated that a second GBT will need to be installed to meet demand and serve as a backup.

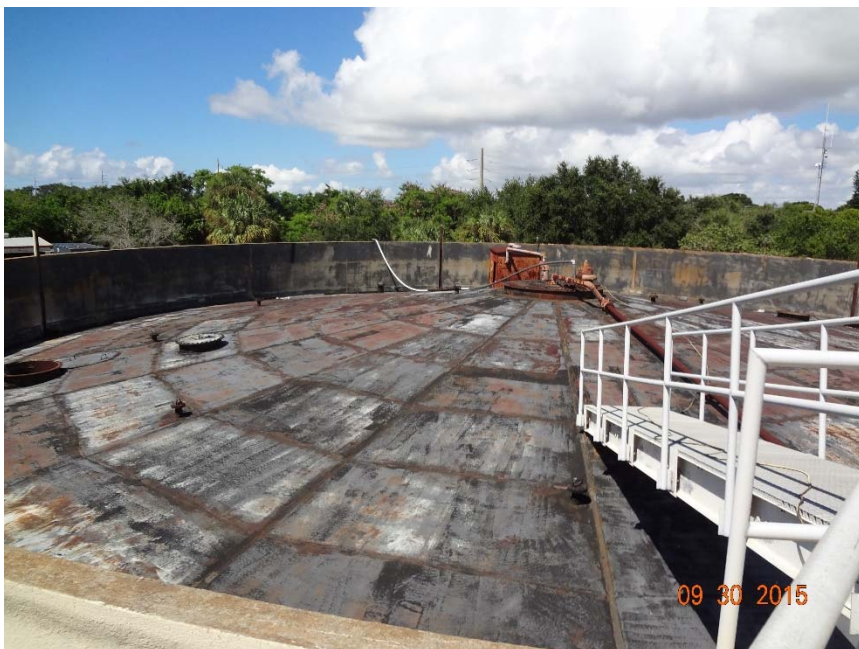
The three existing digesters at SWWRF have been out of service for at least three years. The floating cover on each digester is in poor condition and some cracking in the tanks have been observed by operations (Figure SWWRF-3 and SWWRF-4). Auxiliary pumping, piping and mixing associated with these digesters appears in moderate condition and has been well maintained (Figure SWWRF-5 and SWWRF-

Figure SWWRF-3. Anaerobic Digester No. 1 Floating Cover  
*Southwest WRF*

Figure SWWRF-4. Anaerobic Digester No. 2 Floating Cover  
*Southwest WRF*

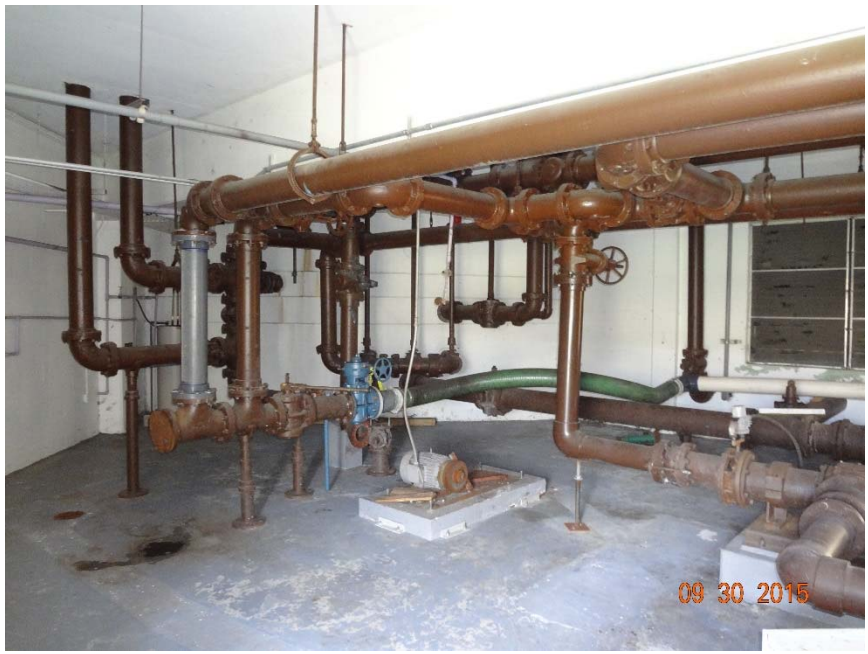
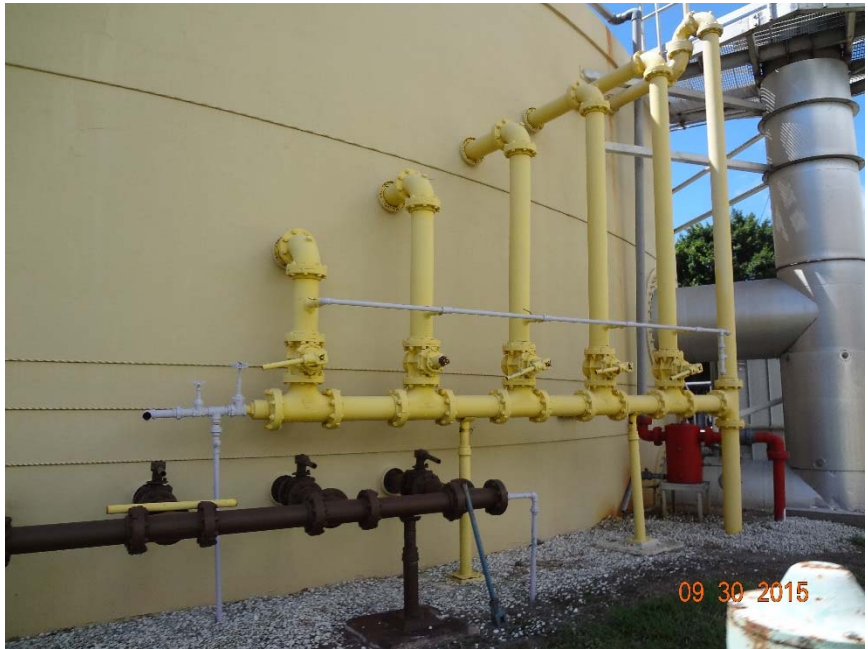
6). However the original digester facility was constructed in 1955 and therefore much of the equipment, including the gas heaters and components are past the expected useful life.

Figure SWWRF-5. Anaerobic Digester No. 1 and No. 2 Piping  
*Southwest WRF*

Figure SWWRF-6. Anaerobic Digester Decant No. 3 Piping and Draft Tube Mixer  
*Southwest WRF*

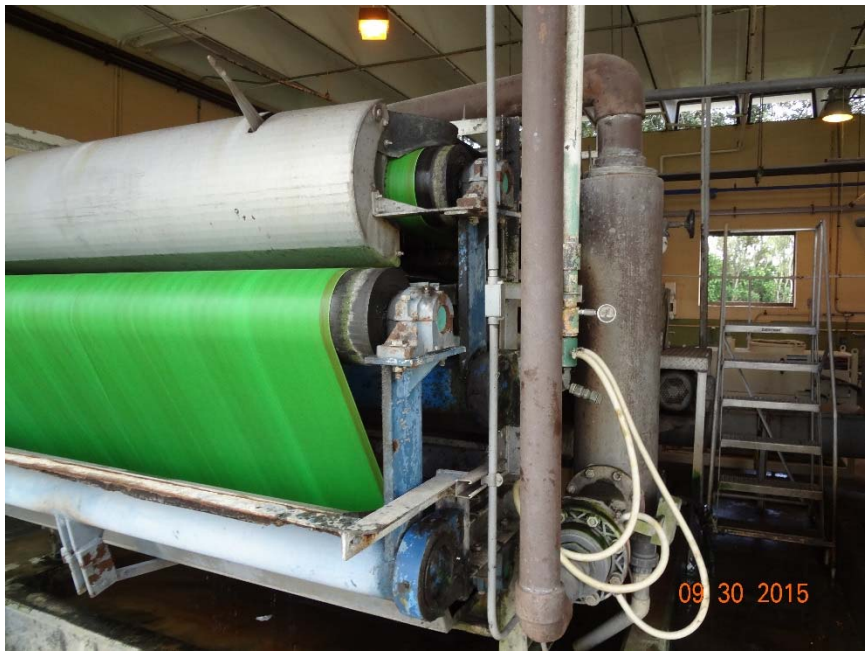
Figure SWWRF-7. Belt Filter Press  
*Southwest WRF*

The SWWRF utilizes belt filter presses (BFPs) for dewatering prior to the Bioset process (Figure SWWRF-7). The BFPs, installed in the 1980s, are in moderate condition and are at or near the end of their useful life. The polymer includes two dry polymer make-up units installed in 1985, and they appear to be in moderate condition. An upgrade to a new emulsion polymer system is in progress. Some auxiliary equipment in the Sludge Dewatering Building has been upgraded. The dewatered sludge feeds into a screw conveyor system which is in moderate condition.

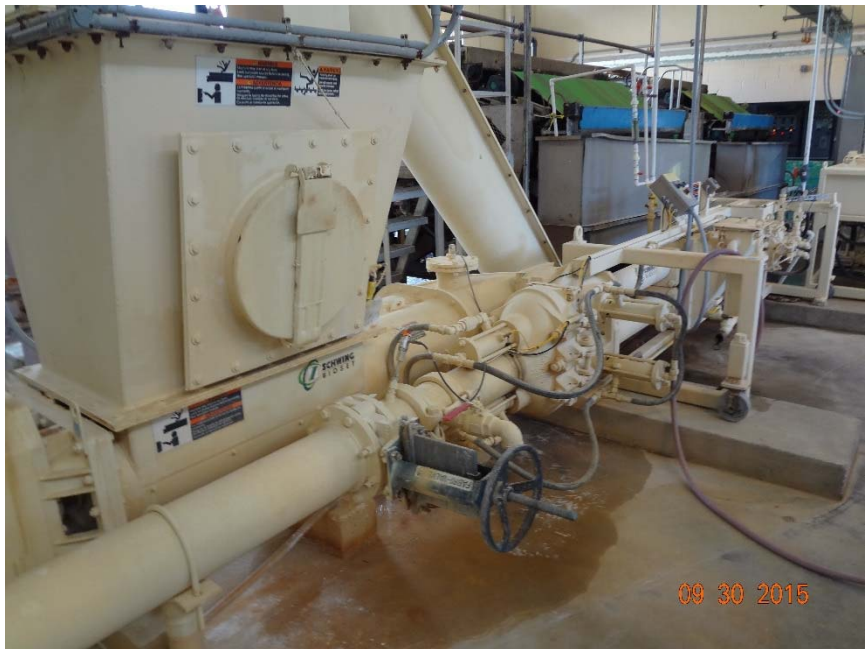
Figure SWWRF-8. Bioset System  
*Southwest WRF*

A Bioset system was installed at SWWRF in 2012 as an interim replacement of the treatment capacity of the failing digesters before the new digesters as part of the Biosolids to Energy Project. The Bioset process operates between 10-12 hours per day, seven days a week by adding lime to the dewatered sludge which maintains elevated temperature and pH levels in order to stabilize the biosolids (Figure SWWRF-8 and SWWRF-9). The Bioset process has been approved to produce Class A biosolids. Operations indicated that this process and the low metals present in the raw wastewater allow SWRF to produce a Class AA biosolid. The addition of the Bioset reactor as part of the conveyance upgraded a portion of the truck loading area which overall appeared in moderate to good condition.

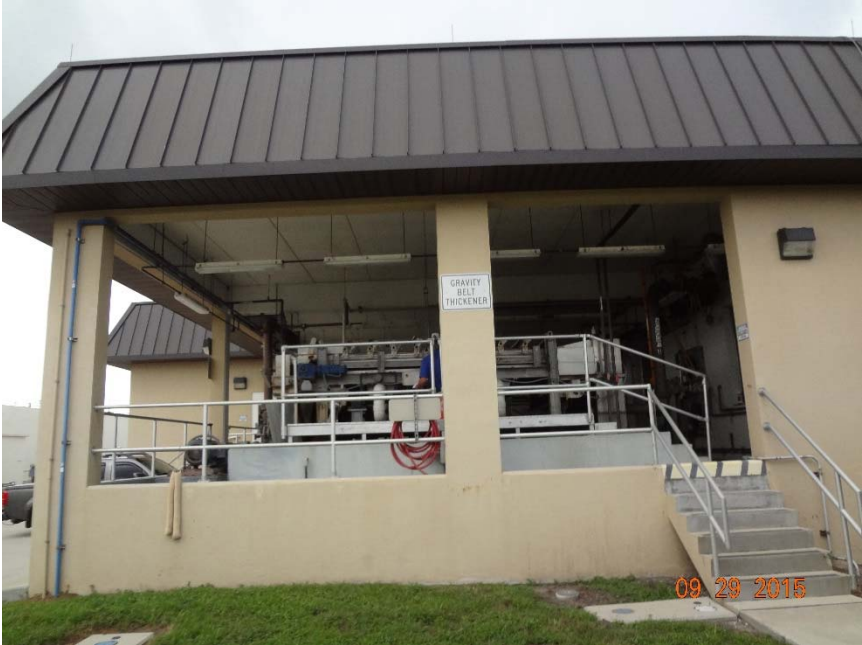
Figure NEWRF-1. Gravity Belt Thickener  
*Northeast WRF*

Waste activated sludge from the secondary process is thickened by two Ashbrook GBTs. Both GBTs appear in good condition with one in service approximately 6 years and another in service 15 years. Operations indicated good performance from the GBTs as NEWRF thickens to an average of 8.2% solids with a maximum of 9.2% and a minimum of 7.1% in order to maximize detention time in the one in-service digester. The GBT Building and auxiliary facilities also appeared in good condition (Figure NEWRF-1). Thickened sludge is pumped to the anaerobic digester with one of three progressing cavity pumps. These pumps appear in good condition and operations did not indicate any significant operational or maintenance related issues (Figure NEWRF-2).

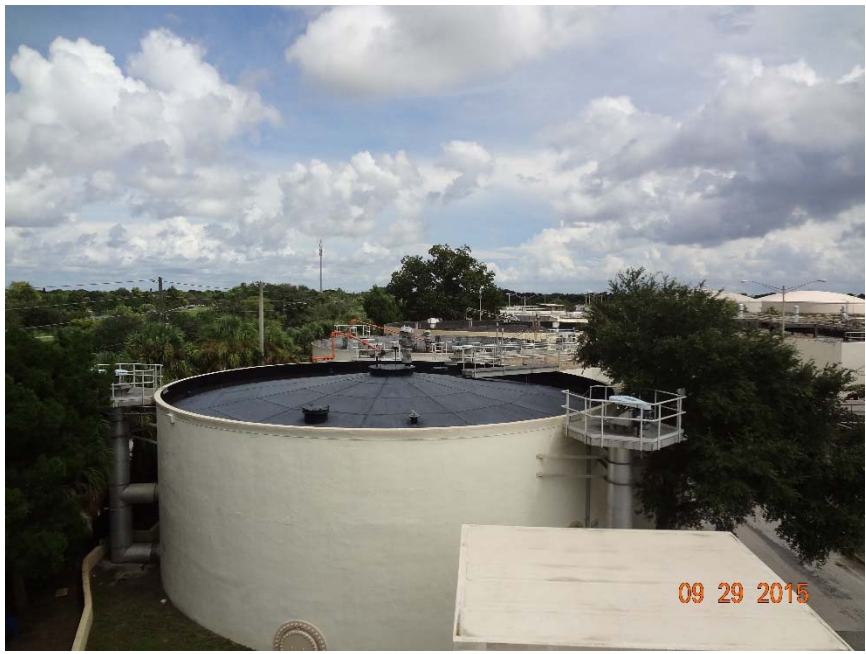
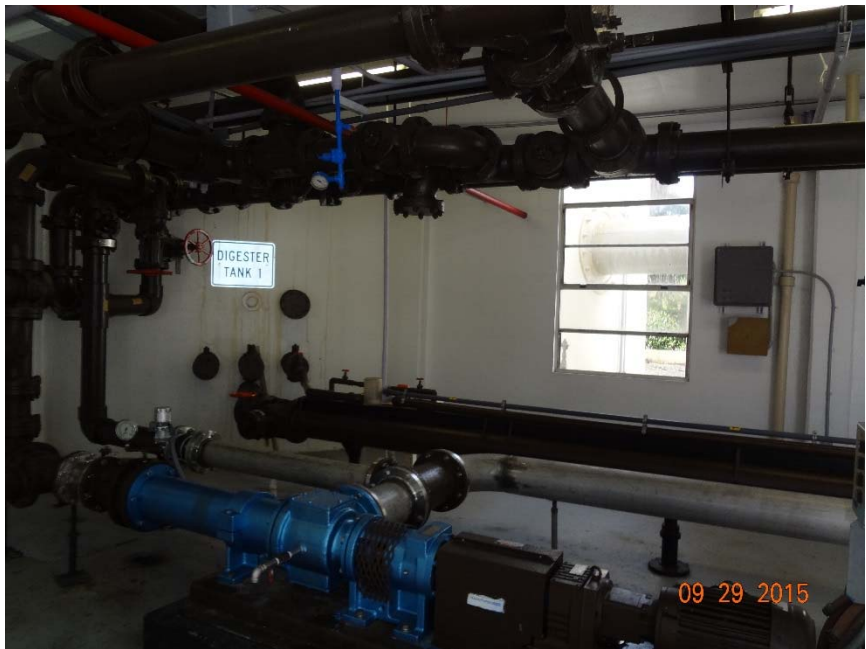
The NEWRF has three anaerobic digesters. Digesters No. 1 and No. 2 were constructed in 1955 and share a building with auxiliary piping and pumping. Digester No. 3 was added in the 1980s. In 2012 Digester No. 1 was relined and its floating cover rehabilitated (Figure NEWRF-3 and NEWRF-4). Digester No. 1 appears in moderate to good condition. Volatile gas produced in the digester is burned through an adjacent flare which appears in moderate condition (Figure NEWRF-5).

Figure NEWRF-3. Anaerobic Digester No. 1  
*Northeast WRF*

Figure NEWRF-4. Anaerobic Digesters No. 1 and No. 2 Pumping  
*Northeast WRF*

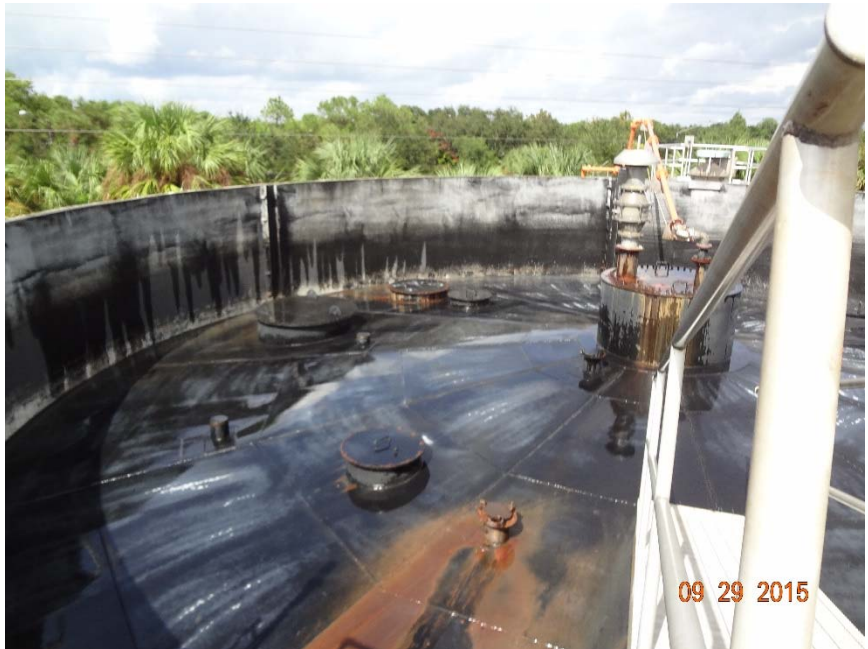
Figure NEWRF-6. Anaerobic Digester No. 2 Floating Cover  
*Northeast WRF*

Currently Digester No. 1 is the only digester in service as the poor condition of the floating covers require Digesters No. 2 and No. 3 be out of service (Figure NEWRF-6). Digester No. 2 had a membrane failure causing seepage through the walls; however, Digester No. 3 can be used for storage as needed. The original digester facility was constructed in 1955 and much of the equipment is past its useful life including the gas heater system.

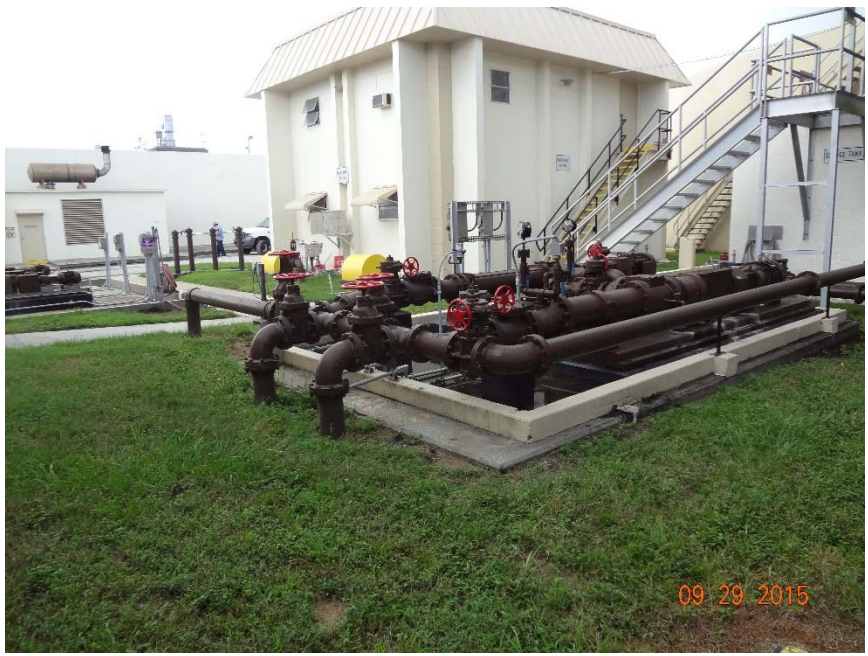
Figure NEWRF-7. Sludge Feed Pump Station  
*Northeast WRF*

The digested sludge is transferred to dewatering via another progressing cavity pump station. These pumps appeared in good condition and operations did not indicate any operational or maintenance related issues (Figure NEWRF-7).

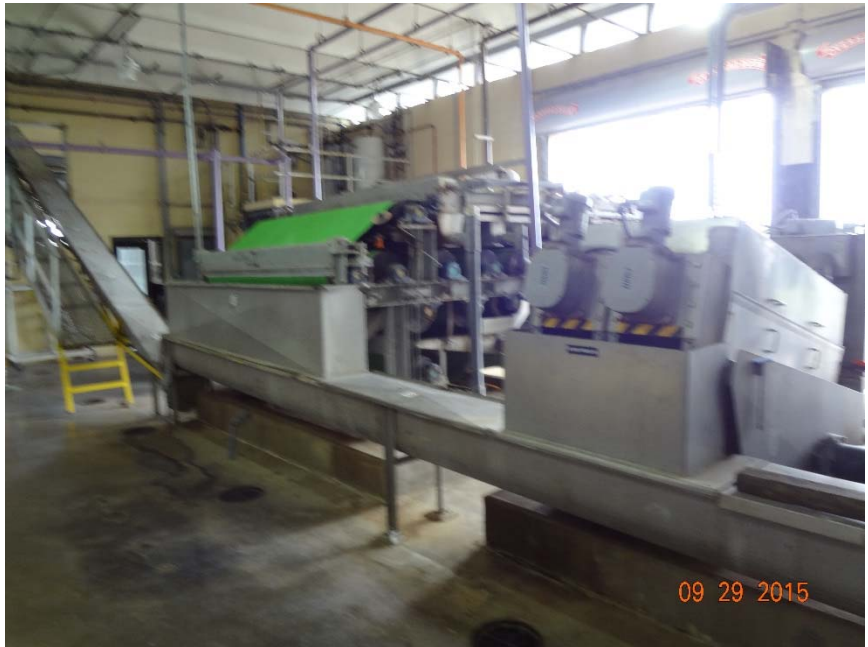
Figure NEWRF-8. Dewatering Building  
*Northeast WRF*

The dewatering process includes one BFP (in service approximately 30 years) and two screw presses added in 2013 (Figure NEWRF-8). The BFP is maintained as a backup to the two screw presses which operate continuously. The dewatering process includes three Siemens Polyblend polymer blending units. These appear in excellent condition (Figure NEWRF-9). The screw presses are in good condition and operations indicated they can produce a dewatered product with up to 18% solids (Figure NEWRF-10). The City indicated that the hauled sludge from NEWRF had an average solids content of 16.1% with a maximum of 17.8% and a minimum of 14.1% so far during 2015.

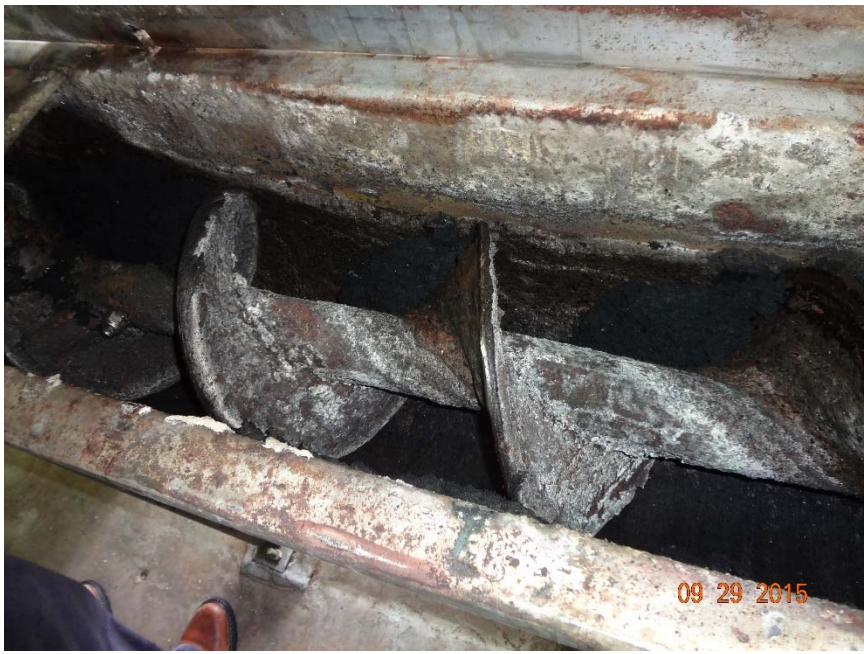
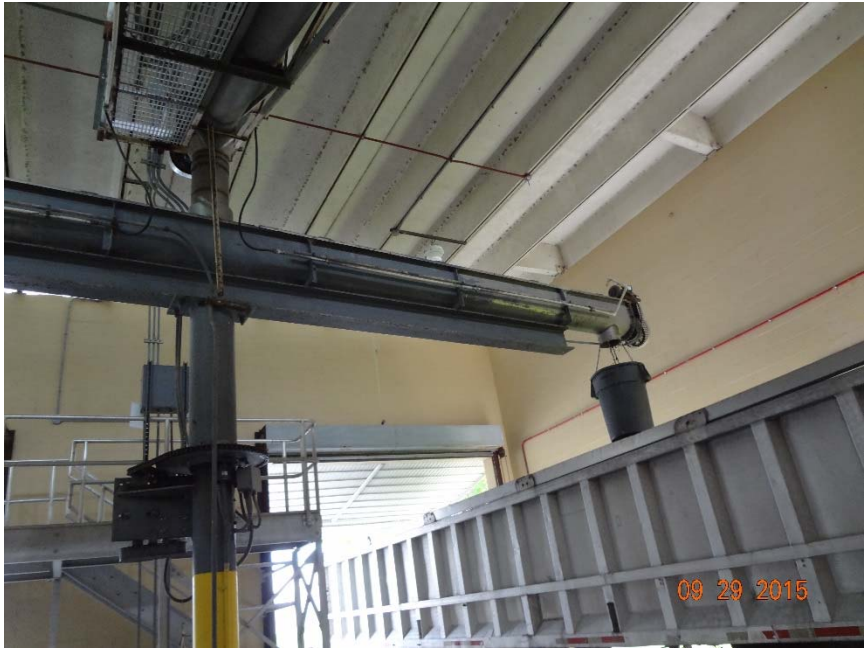
The dewatered sludge is fed into a screw conveyor which shows some wear on the trough and screw but no significant corrosion. The conveyor system includes a flat section which receives the dewatered biosolids, an inclined shaftless screw that transfers the product to the truck loading area, and a final section which can rotate and has a reversing motor to fill either of the two truck bays. Operations indicated there were no major operational or maintenance related issues with the conveyors (Figure NEWRF-11 and NEWRF-12).

Figure NEWRF-11. Screw Conveyor  
*Northeast WRF*

Figure NEWRF-12. Truck Loading  
*Northeast WRF*

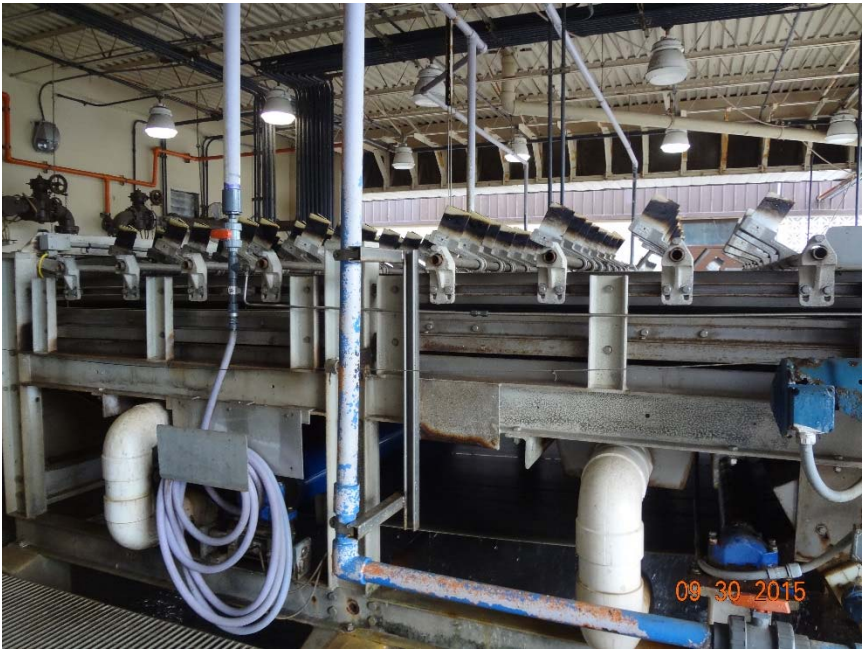
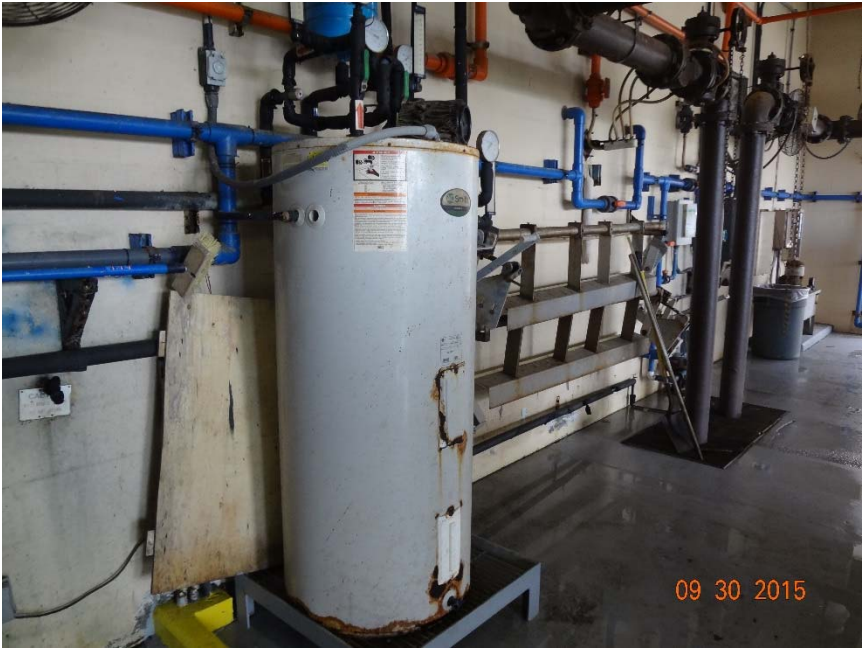
The auxiliary equipment (for example, polymer storage feed system and wash water system) in the thickening process has not been upgraded and did show some wear (Figure NWWRF-1 and NWWRF-2). The polymer feed system currently uses a dry polymer, which requires excess dosing. The City has indicated that a new liquid polymer mixing and feed system is purchased and ready to be installed.

Figure NWWRF-1. Gravity Belt Thickener  
*Northwest WRF*

Figure NWWRF-2. Gravity Belt Thickener Piping  
*Northwest WRF*

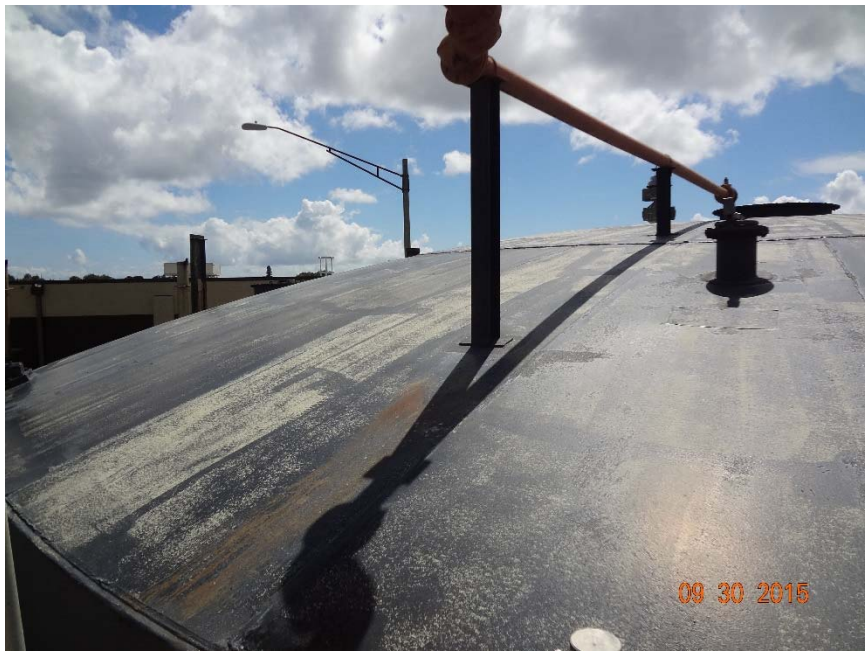
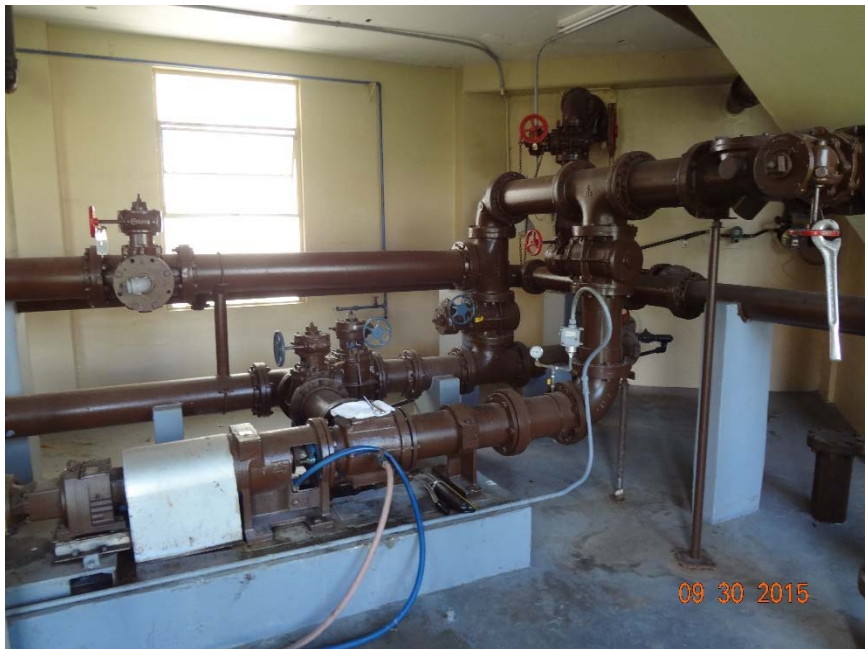
The NWWRF has four anaerobic digesters onsite, however only two are in service. Digester No. 1 and No. 2, originally constructed in the 1950s, continue to produce Class B biosolids through a reduction in volatile solids (Figure NWWRF-3 and NWWRF-4) although Digester No. 1 has a hole in the gas collector skirt. Digesters No. 1 and No. 2 have gas collector style covers. Volatile gas produced in the digesters is burned through an adjacent flare which appears in moderate condition.

Figure NWWRF-3. Anaerobic Digester No. 1  
*Northwest WRF*

Figure NWWRF-4. Anaerobic Digester No. 1 and No. 2 Pumping  
*Northwest WRF*

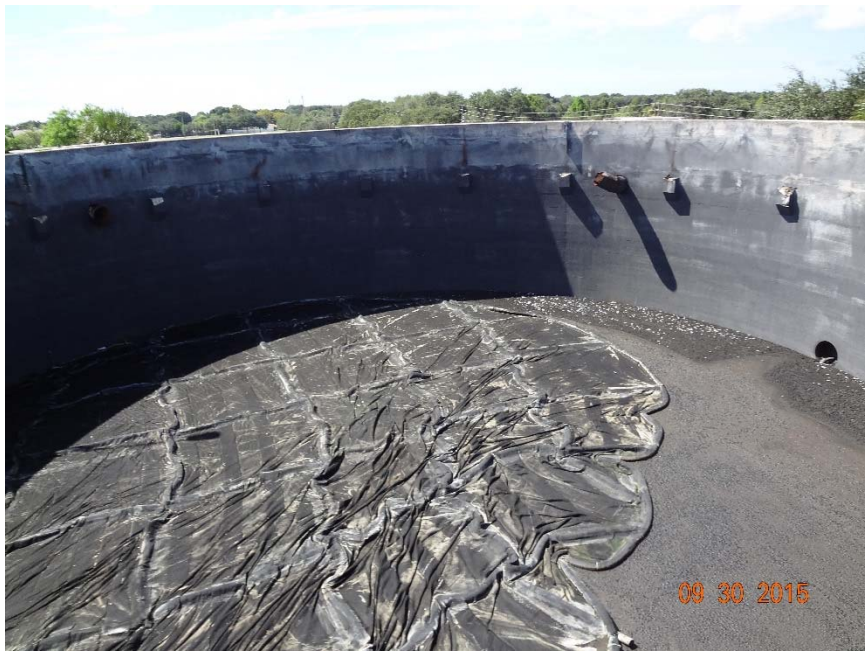
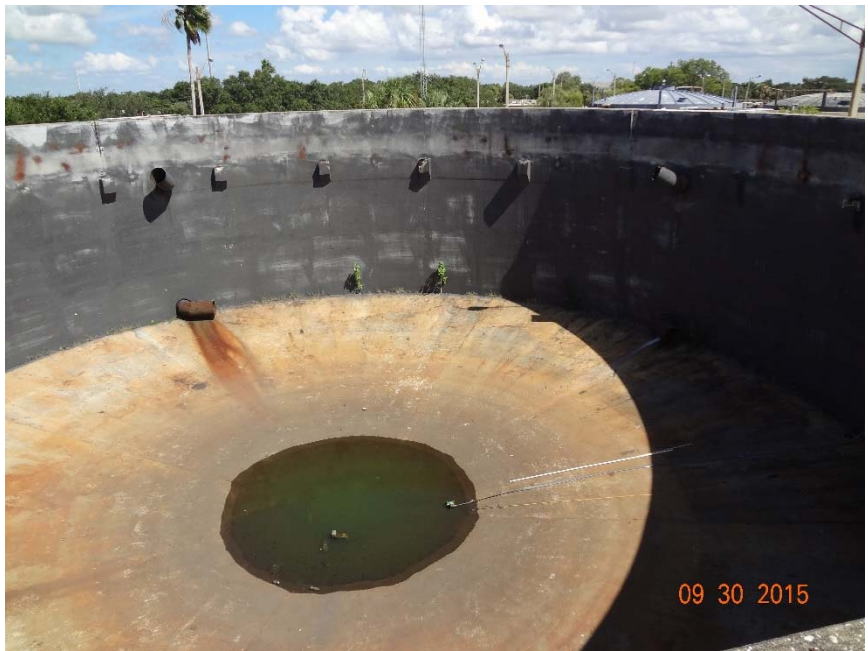
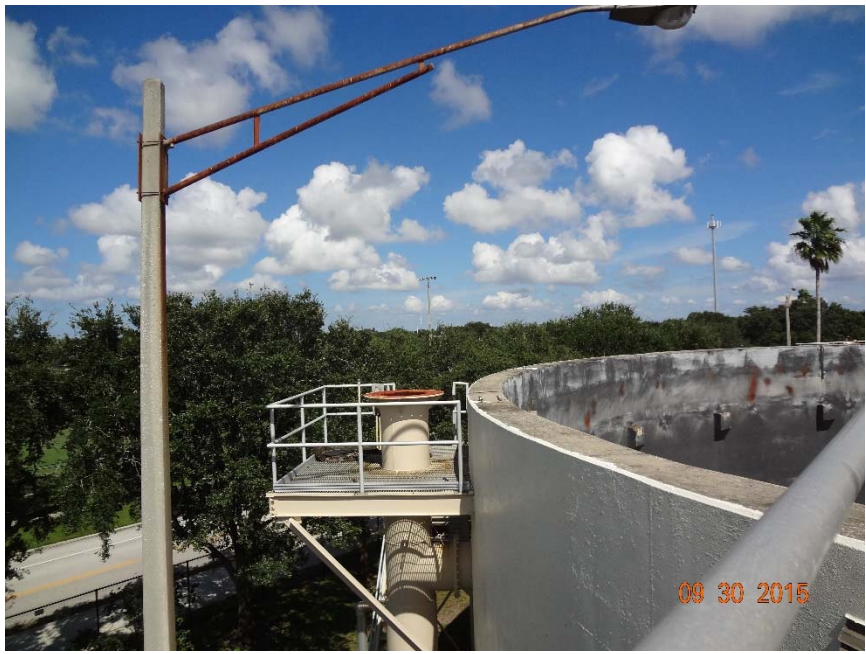
Digesters No. 3 and No. 4 have been out of service for several years. Digesters No. 3 and No. 4 had floating covers. These floating covers were in poor condition, collapsed, and have been removed. Digester No. 3 is used for sludge storage as needed (Figures NWWRF-5, NWWRF-6 and NWWRF-7).

Figure NWWRF-5. Anaerobic Digester No. 3  
*Northwest WRF*

Figure NWWRF-6. Anaerobic Digester No. 4  
*Northwest WRF*

Figure NWWRF-7. Anaerobic Digester No. 4 Draft Tube Mixer  
*Northwest WRF*

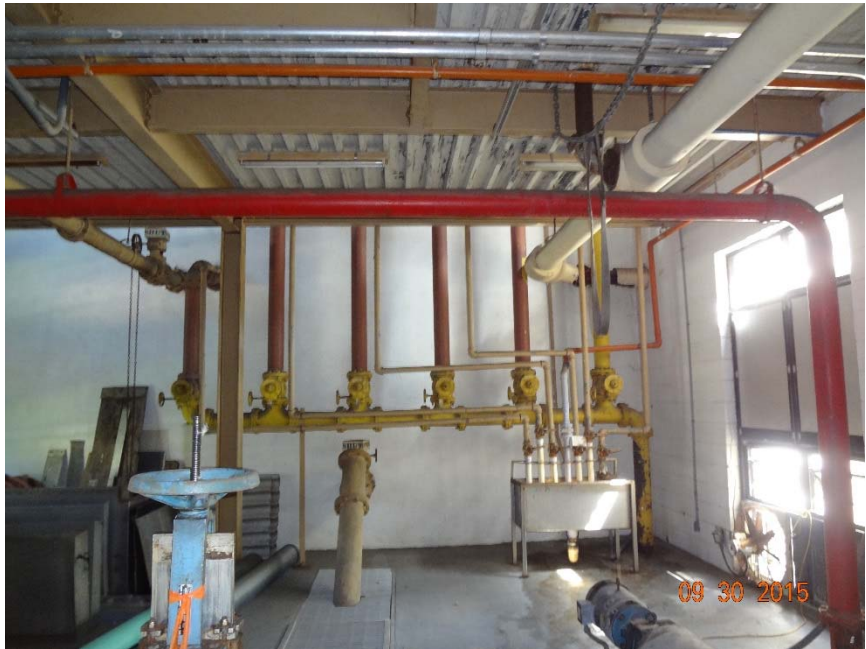
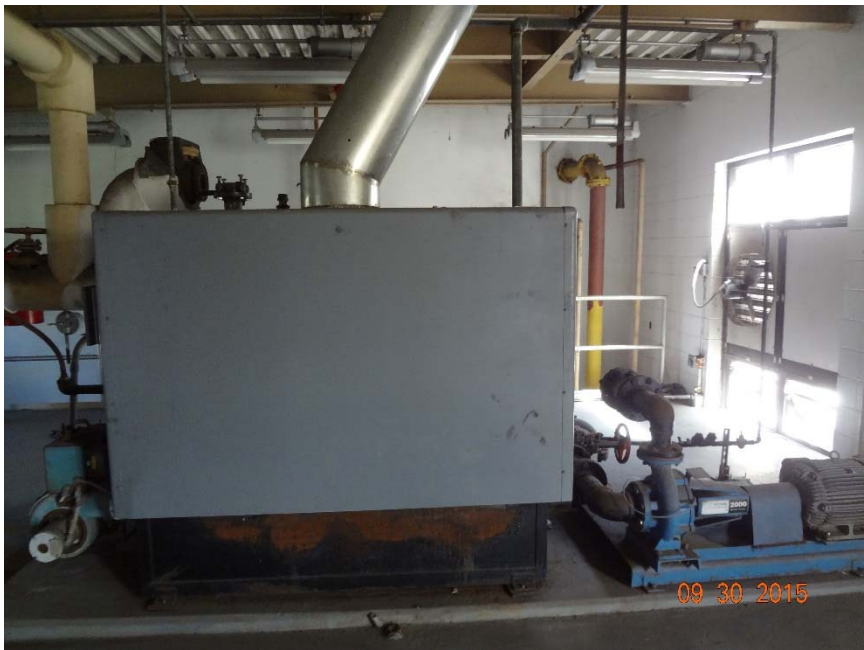
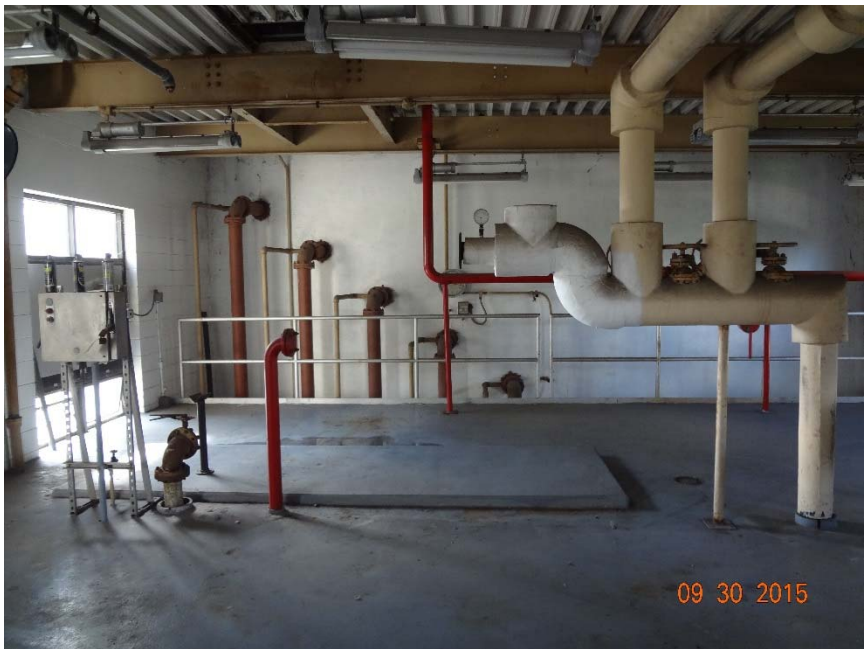
The auxiliary equipment that supports Digester No. 3 and No. 4 includes a gas heater with the capability to generate heat using natural gas or digester gas. The equipment appeared in poor condition. Operations had no working knowledge of that equipment as they have not been operated in several years (Figure NWWRF-8, NWWRF-9 and NWWRF-10).

Figure NWWRF-8. Anaerobic Digesters No. 3 and No. 4 Building Second Floor  
*Northwest WRF*

Figure NWWRF-9. Anaerobic Digesters No. 3 and No. 4 Gas-fired Heater  
*Northwest WRF*

Figure NWWRF-10. Anaerobic Digester Building Third Floor  
*Northwest WRF*

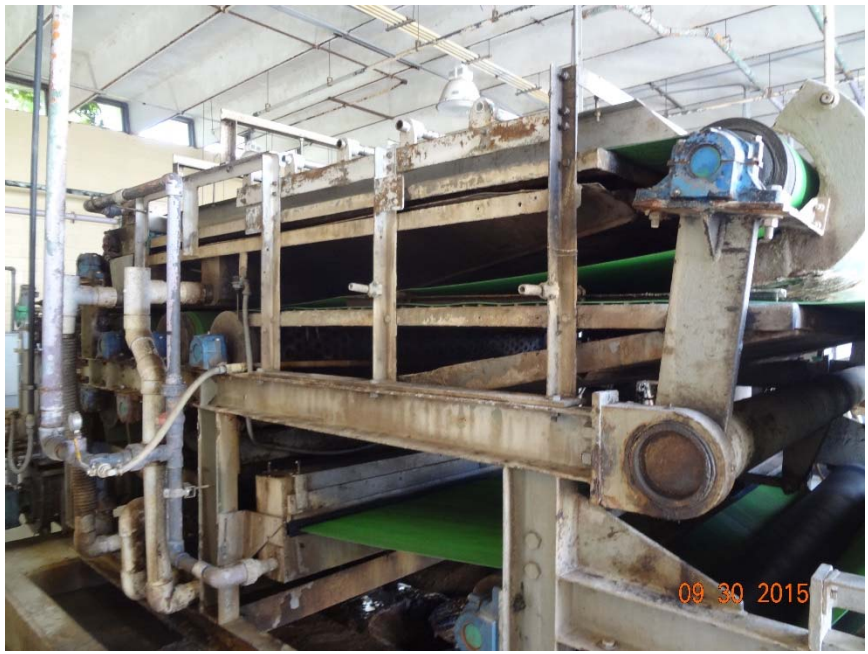
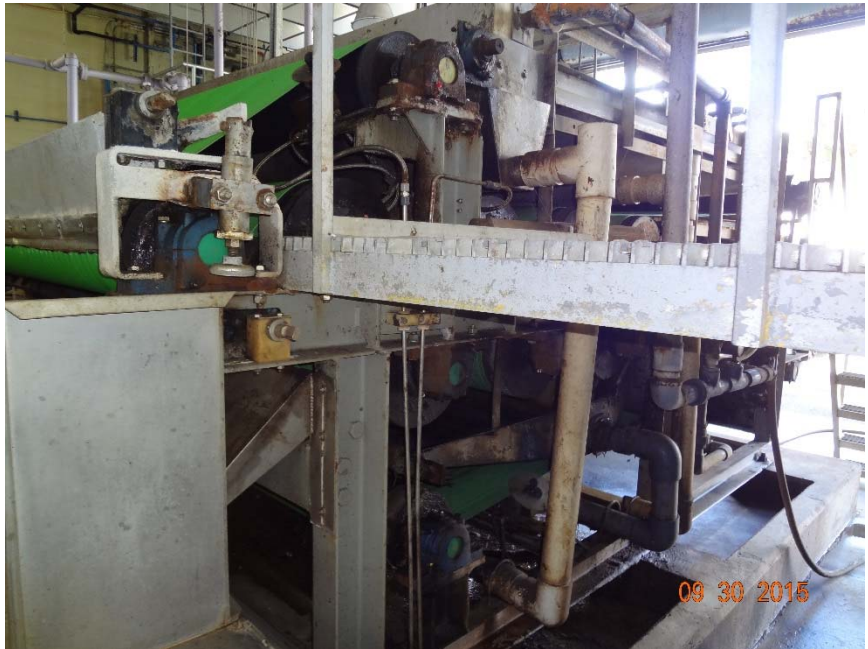
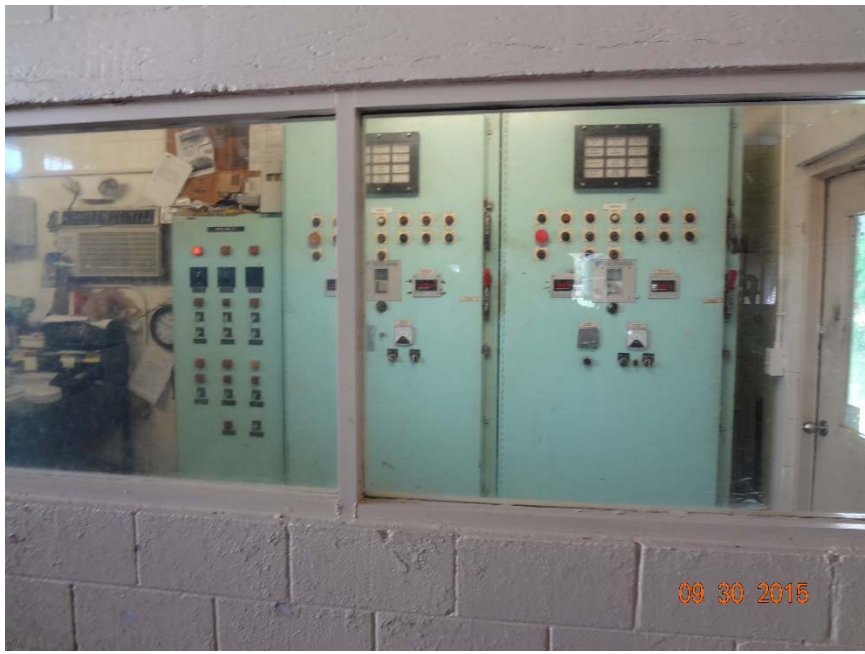
The dewatering process at NWWRF consists of two Ashbrook BFPs, a polymer storage and feed system, conveyors and truck loading. The BFPs are in moderate to poor condition and near the end of their useful life (Figure NWWRF-11, NWWRF-12 and NWWRF-13). Operations indicated the BFPs require frequent maintenance to remain in service. The BFPs have recently yielded an average solids content of 13.5% with a minimum of 11.2% and a maximum of 14.9%. This dewatering performance is lower than the other facilities and on the low end of expected BFP performance, which is likely due to the poor condition of the equipment.

The electrical equipment at dewatering is in poor condition and at the end of the useful life. Operations indicated that many parts are obsolete and difficult to find. The polymer storage and feed system is also in moderate to poor condition and near the end of its useful life. An ongoing project will upgrade the existing system to liquid polymer blending system similar to that at SWWRF and NEWRF (Figure NWWRF-14 and NWWRF-15).

Figure NWWRF-11. Belt Filter Press  
*Northwest WRF*

Figure NWWRF-12. Belt Filter Press  
*Northwest WRF*

Figure NWWRF-13. Belt Filter Press Electrical Room  
*Northwest WRF*

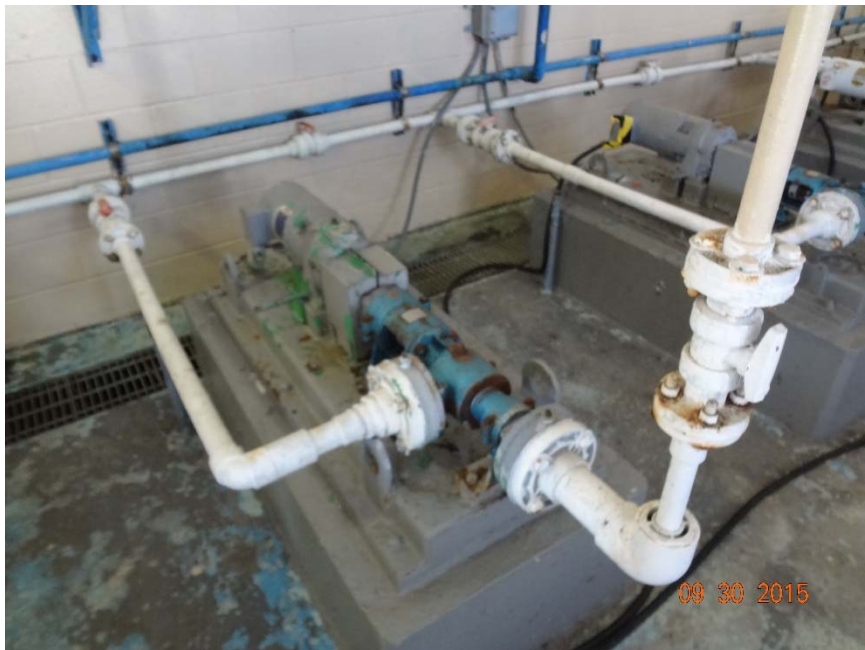
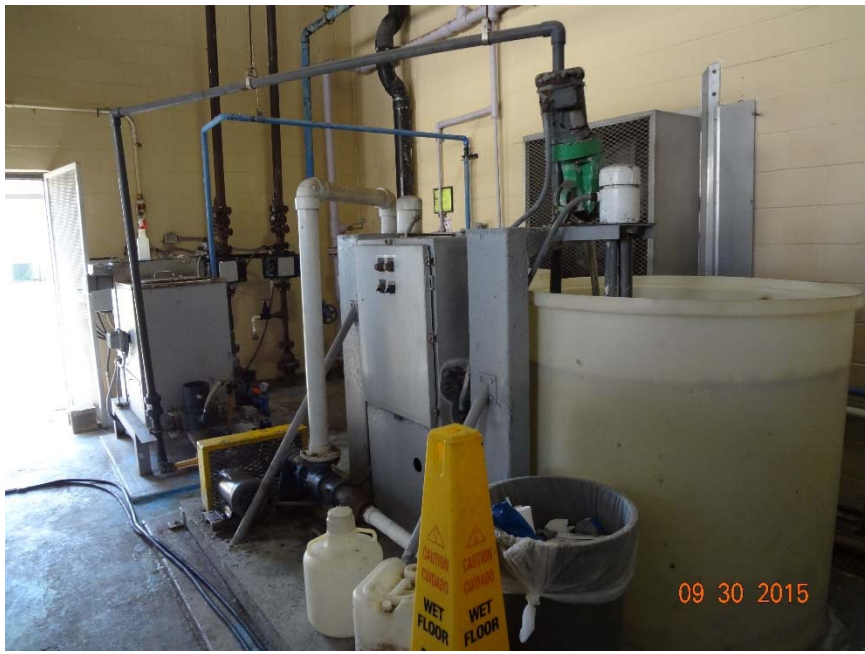
Figure NWWRF-14. Dewatering Polymer Pumping  
*Northwest WRF*

Figure NWWRF-15. Dewatering Polymer Storage and Feed  
*Northwest WRF*

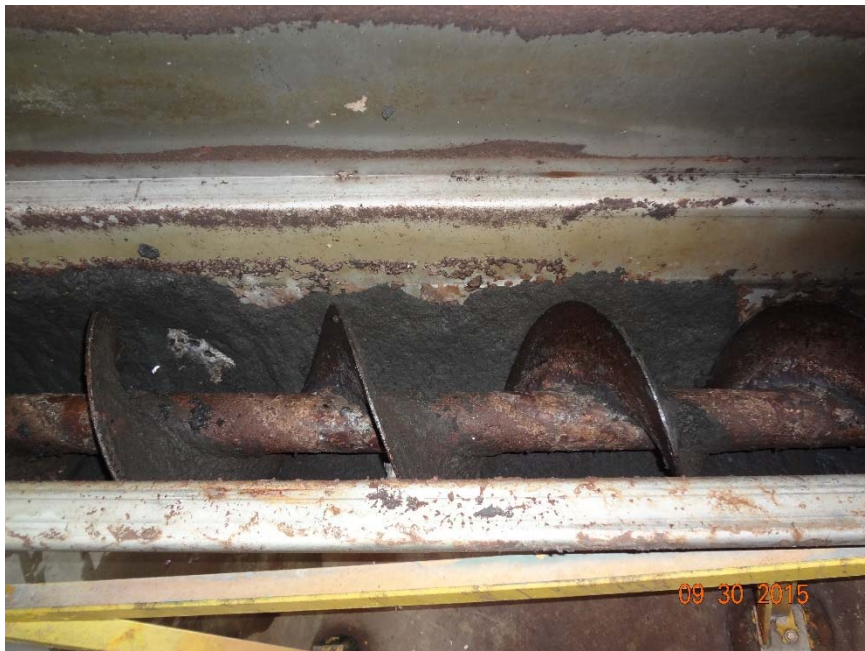
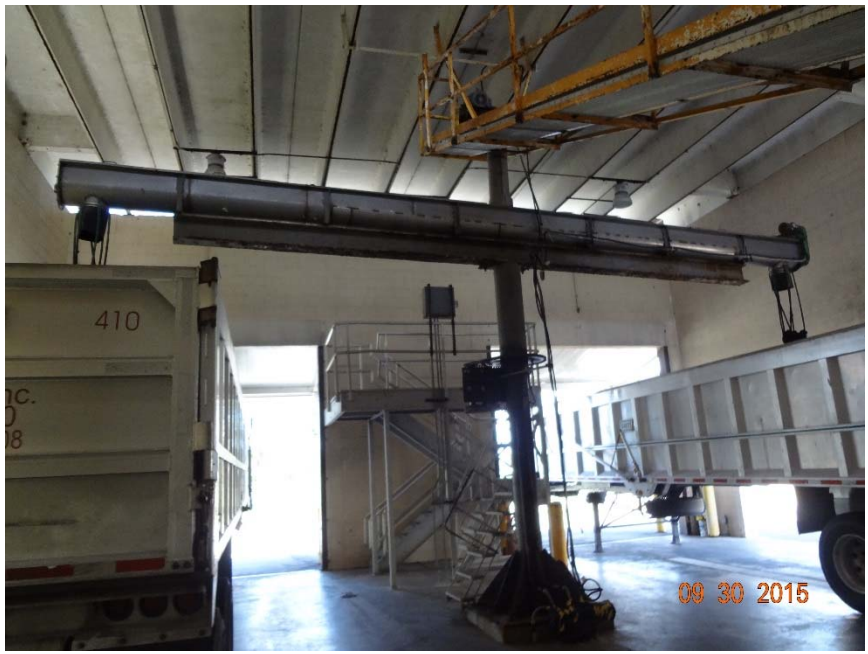
The conveyor system is similar to the NEWRF, but shows more signs of wear and corrosion (Figure NWWRF-16 and NWWRF-17).

Figure NWWRF-16. Dewatered Sludge Conveyor  
*Northwest WRF*

Figure NWWRF-17. Truck Loading  
*Northwest WRF*
