Figure 10
Summary of Analytical Results in Soil
Palm Beach State College
4200 South Congress Avenue
Lake Worth, Palm Beach County, Florida

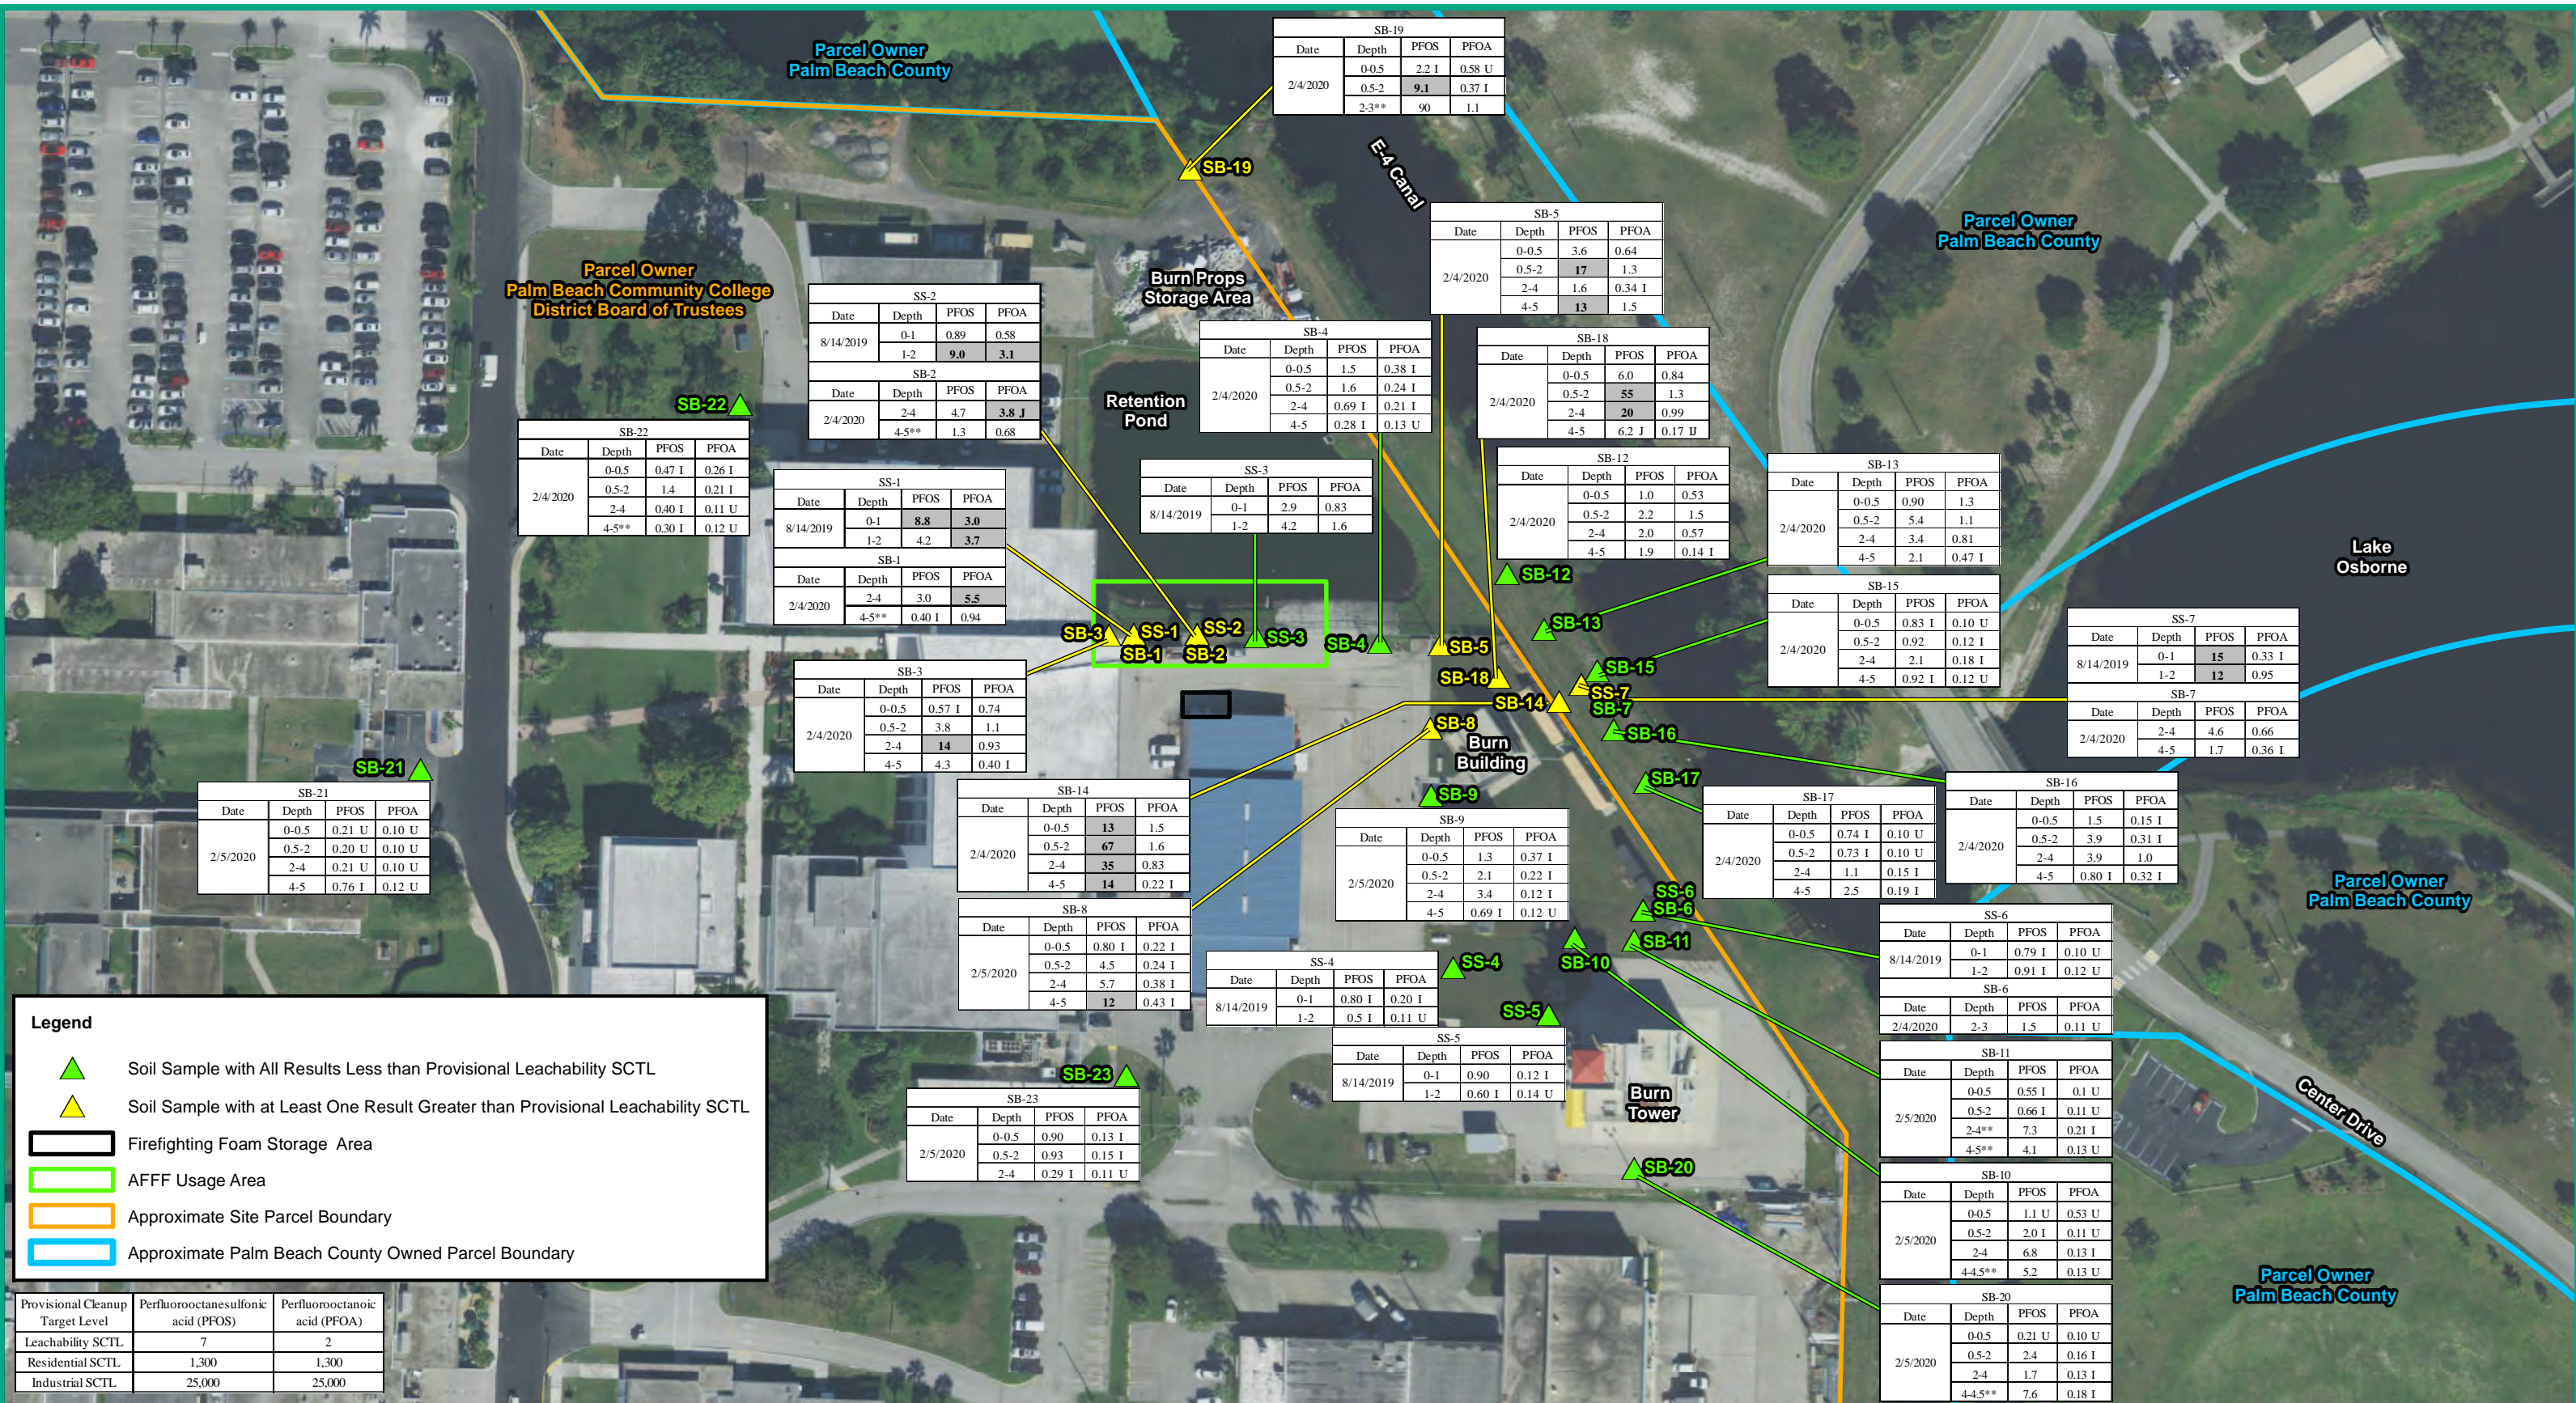
5. Depth is presented in feet (ft) below land surface (BLS).
 6. Gray shaded, bold text indicates an exceedance of the Florida Department of Environmental Protection provisional leachability soil cleanup target level (SCTL).

7. ** indicates saturated soil sample; results not compared to FDEP provisional SCTL. See Table 4 for depth to water measurements collected in monitoring wells.
