**Background:** The opportunity to create the 207 Rail-Trail presented itself with the availability of an abandoned length of Florida East Coast Railway Company railroad Right-of-Way (ROW), that runs along approximately 12 miles of State Road 207 in St. Johns County. The Florida Department of Transportation (FDOT) purchased the ROW, and while it is owned by FDOT, it will be developed and maintained by St. Johns County. As presented in this Master Plan, the 207 Rail Trail will be a transportation/recreation corridor that will be both of immediate and long-term benefit to St. Johns County.

**Scope:** The scope of work for the Concept/Feasibility plan includes two phases:

This Concept/Feasibility plan provides a guideline for the long-range development and implementation of a trail along this 11.5-mile length of ROW along State Road 207 between I-95 and Hastings. The proposed trail will provide a recreational and educational transportation corridor that will serve to enhance this portion of St. Johns County.

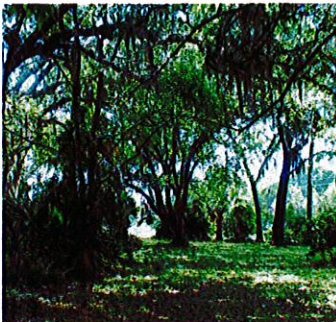
ROW improvements west of Hastings

- SR207 roadway improvements underway west of Hastings. Improvements may affect width of trail ROW.
- ROW near Cracker Branch Creek is overgrown, cannot cross creek, although some structure remains.

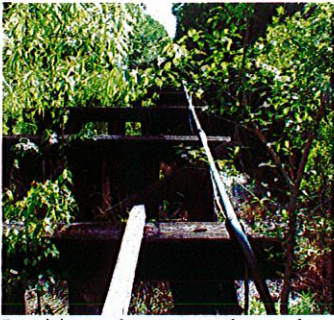
Remaining trestle structure at deep creek

- ROW near Deep Creek is overgrown, cannot cross creek, headwall and supporting structure remains.
- ROW traverses a farm north of Deep Creek. Crops grow up to dirt path in center of ROW.

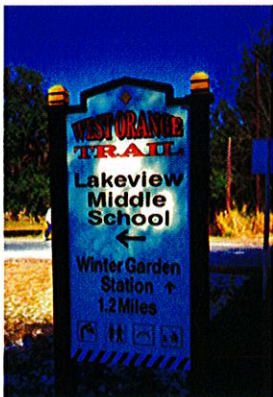
Example of a directional sign.

- Seating- bench style seating, with intermediate arms.
- Bike racks- Tubular steel, loop style, fastened to concrete pads.
- Landscaping- plantings and specialized paving or surfacing, where required.
- Signage:
  - *regulatory*- (safety, rules, regulations)—(crop dusting does occur along the trail, appropriate signage should warn users of the potential occurrence of this activity)
  - *directional*- (mile markers, landmarks, connections)
  - *interpretive*- (educational)
  - *exercise*-(could be incorporated with directional mile markers)

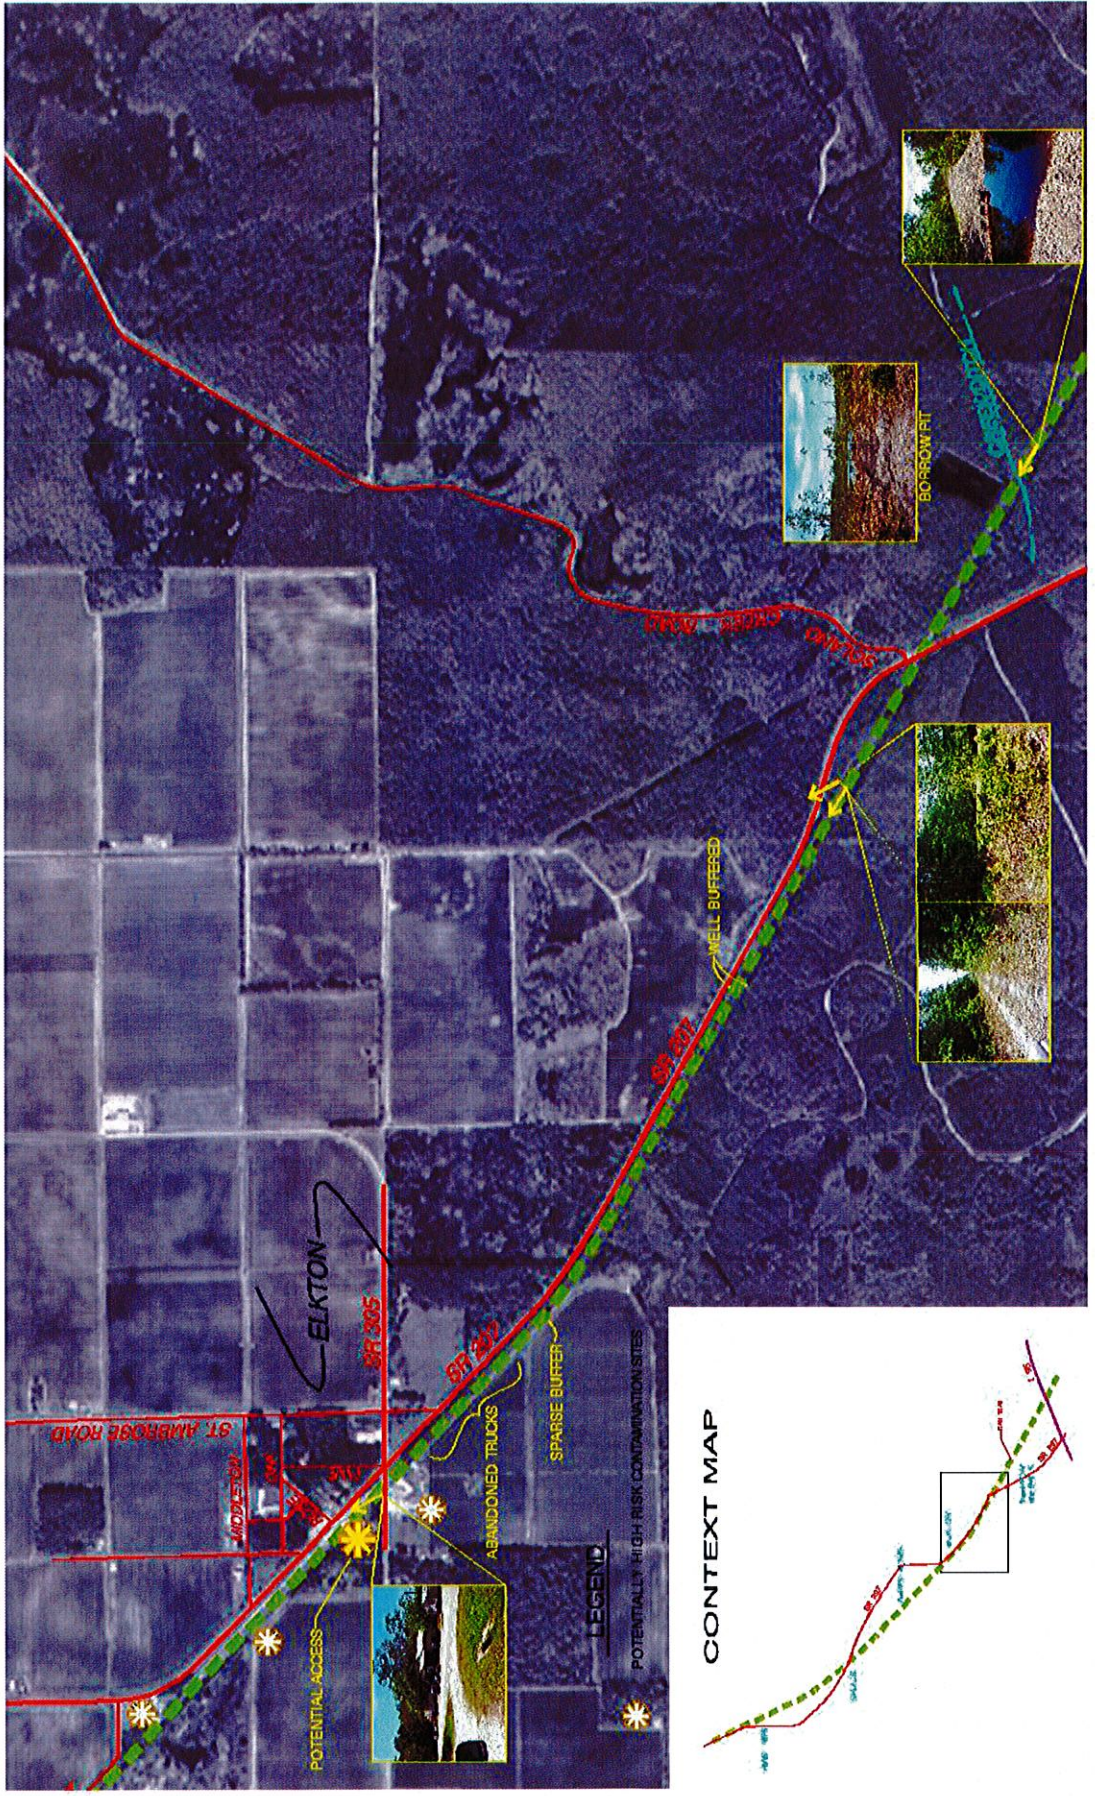
SR 207 RAILS TO TRAILS  
 OPPORTUNITIES/CONSTRAINTS · ELKTON

- The remaining portion of ROW north of Middleton Road is clear of overgrowth.
- There is potential for an access point/intermediate trailhead at the commercial area in Elkton. There is currently a chemical storage area in this commercial area, across the street from the Post Office. This could potentially be an environmental cleanup area.

- Properties immediately north of the commercial area have numerous abandoned vehicles adjacent to the ROW.
- With the exception of some sparse areas, the ROW between SR305 and Solano Creek Road is well buffered.

- North of Solano Creek Road is a borrow pit. This should be explored as a potential recreation area. Just past the borrow pit is a small creek/ditch crossing.

- A potential trailhead has been identified at the southwest quadrant of the intersection of the ROW and Allan Neese Road. The site is approximately 3.5 acres and currently has a grant under review with the Department of Environmental Protection-Florida Greenways and Trails Program. A county landfill located approximately one mile north of the site is nearing closure and could contain recreational elements in the future – potential connection of the two sites should be considered.

- No obstacles to ROW exist at Allan Neese Road.
- The ROW just north of Allan Neese Road to the limit of acquisition has been recently logged and has a sparse buffer.

- The potentially high-risk contamination sites identified in Elkton are Middleton Packers, a farm equipment storage area, and a farm equipment storage/potato packing plant.
