*Strategic Beach Management Plan:*  
*Southwest Gulf Coast Region*

**Office of Resilience and Coastal Protection**  
**Florida Department of Environmental Protection**

**May 2023**

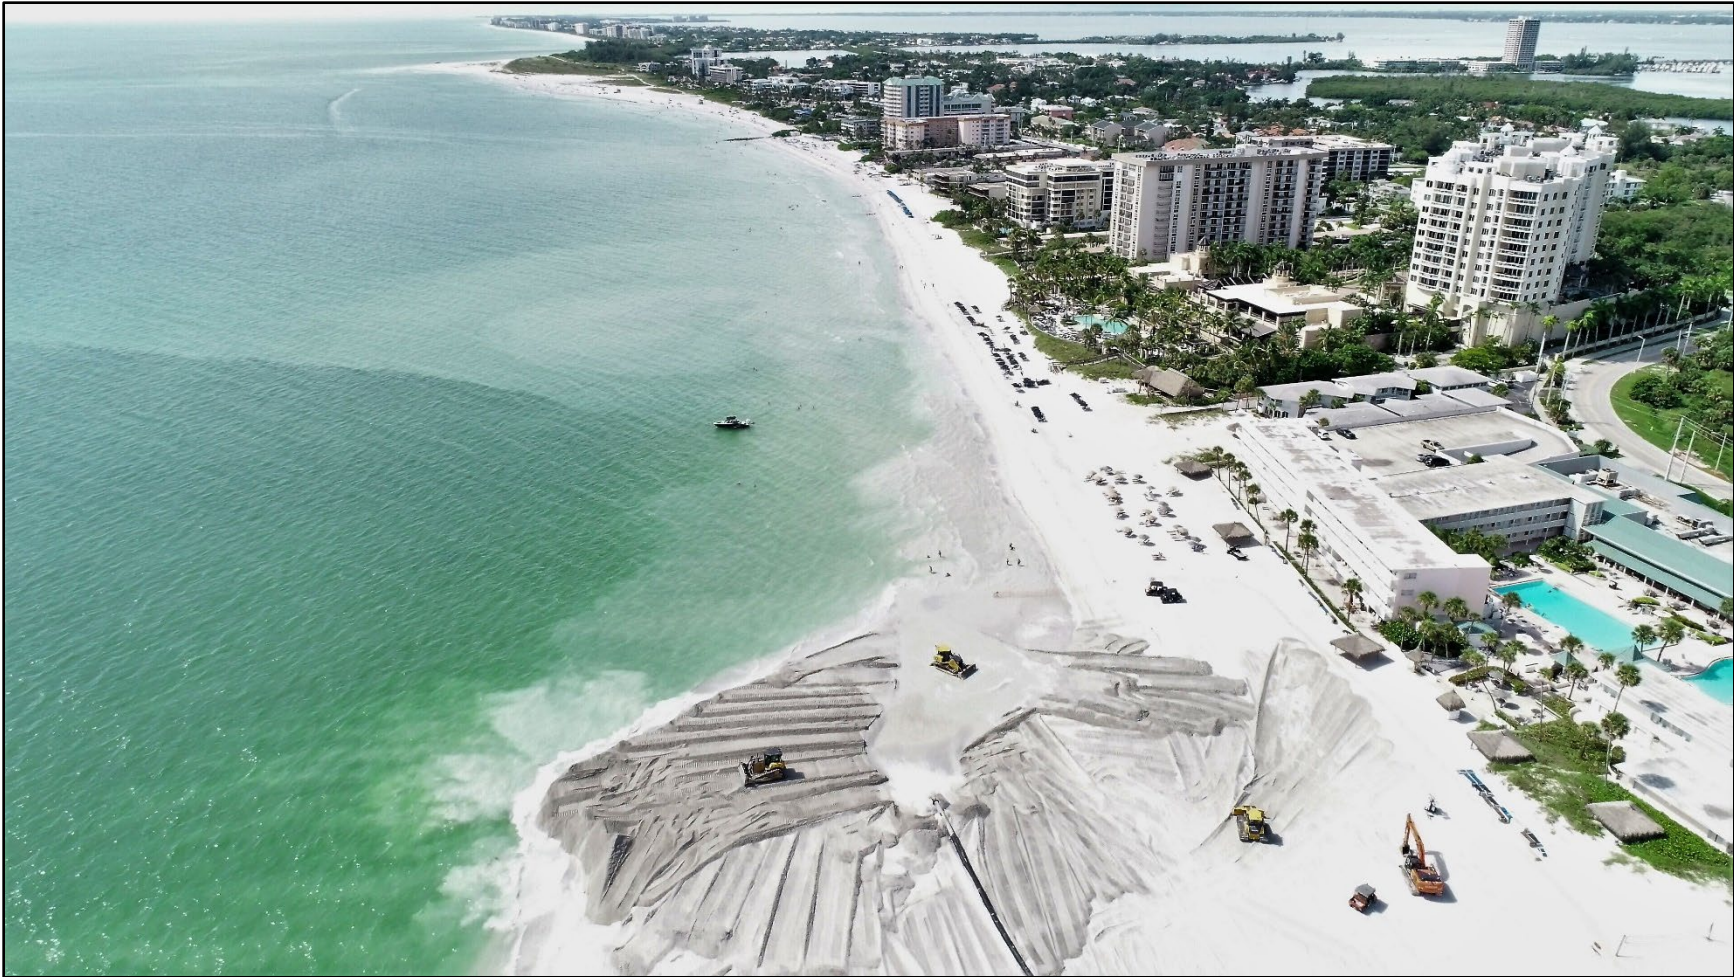
Lido Key Shore Protection Project being constructed in 2020 near R41. Photo courtesy of Camden Mill, P.E., with the City of Sarasota. See additional [construction photos](#) of beach nourishment projects.

In response to the 2004 hurricane season, nourishment was conducted by the City of Sarasota, with construction completed in April 2009 utilizing sand from New Pass. Tropical Storm Debby caused severe erosion along Lido Key's shoreline in 2012, with an initial estimate of sand loss at 130,000 cy. Construction was conducted in early 2015 with placement of approximately 222,800 cy of beach quality sand from the New Pass southern ebb shoal, with placement on Lido Key. In April 2019, the city placed approximately 200,000 cy of sand from New Pass's ebb shoal and channel onto Lido Key Beach between R37 and R43.8. The next nourishment placed approximately 817,880 cy of sandy material in 2020 between R36.5 and R44 from the Big Sarasota Pass channel and ebb shoal. The pay volume was 683,084 cy for the November 2020 project. Two groins were constructed in spring of 2021 with groin # 1 constructed at R42.5 and groin # 2 was constructed at R43.1. The next full beach nourishment is expected in 2030.

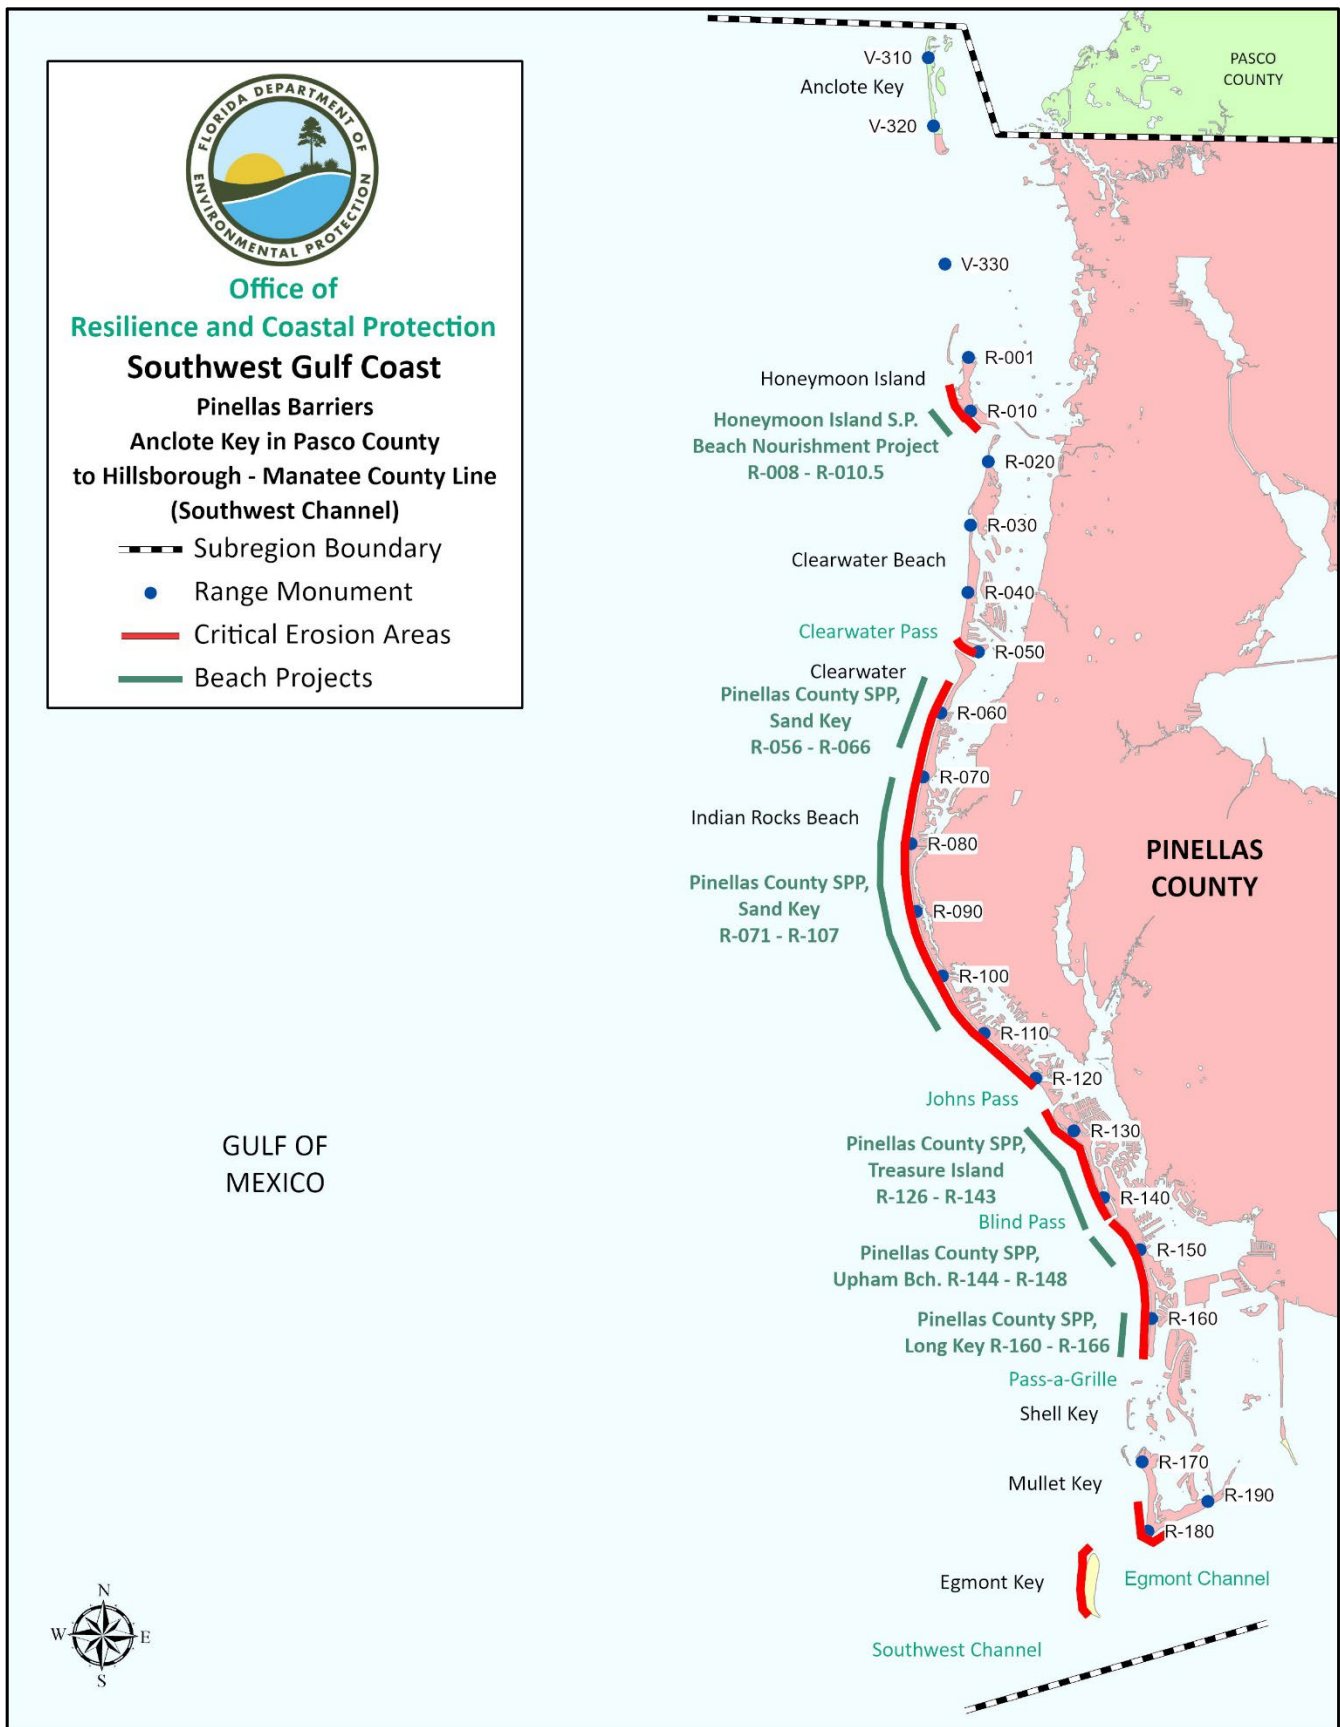
**Figure 1.** Map of Pinellas Barriers subregion of the Southwest region of Florida. View an [interactive map](#) or [COASTS imagery](#).

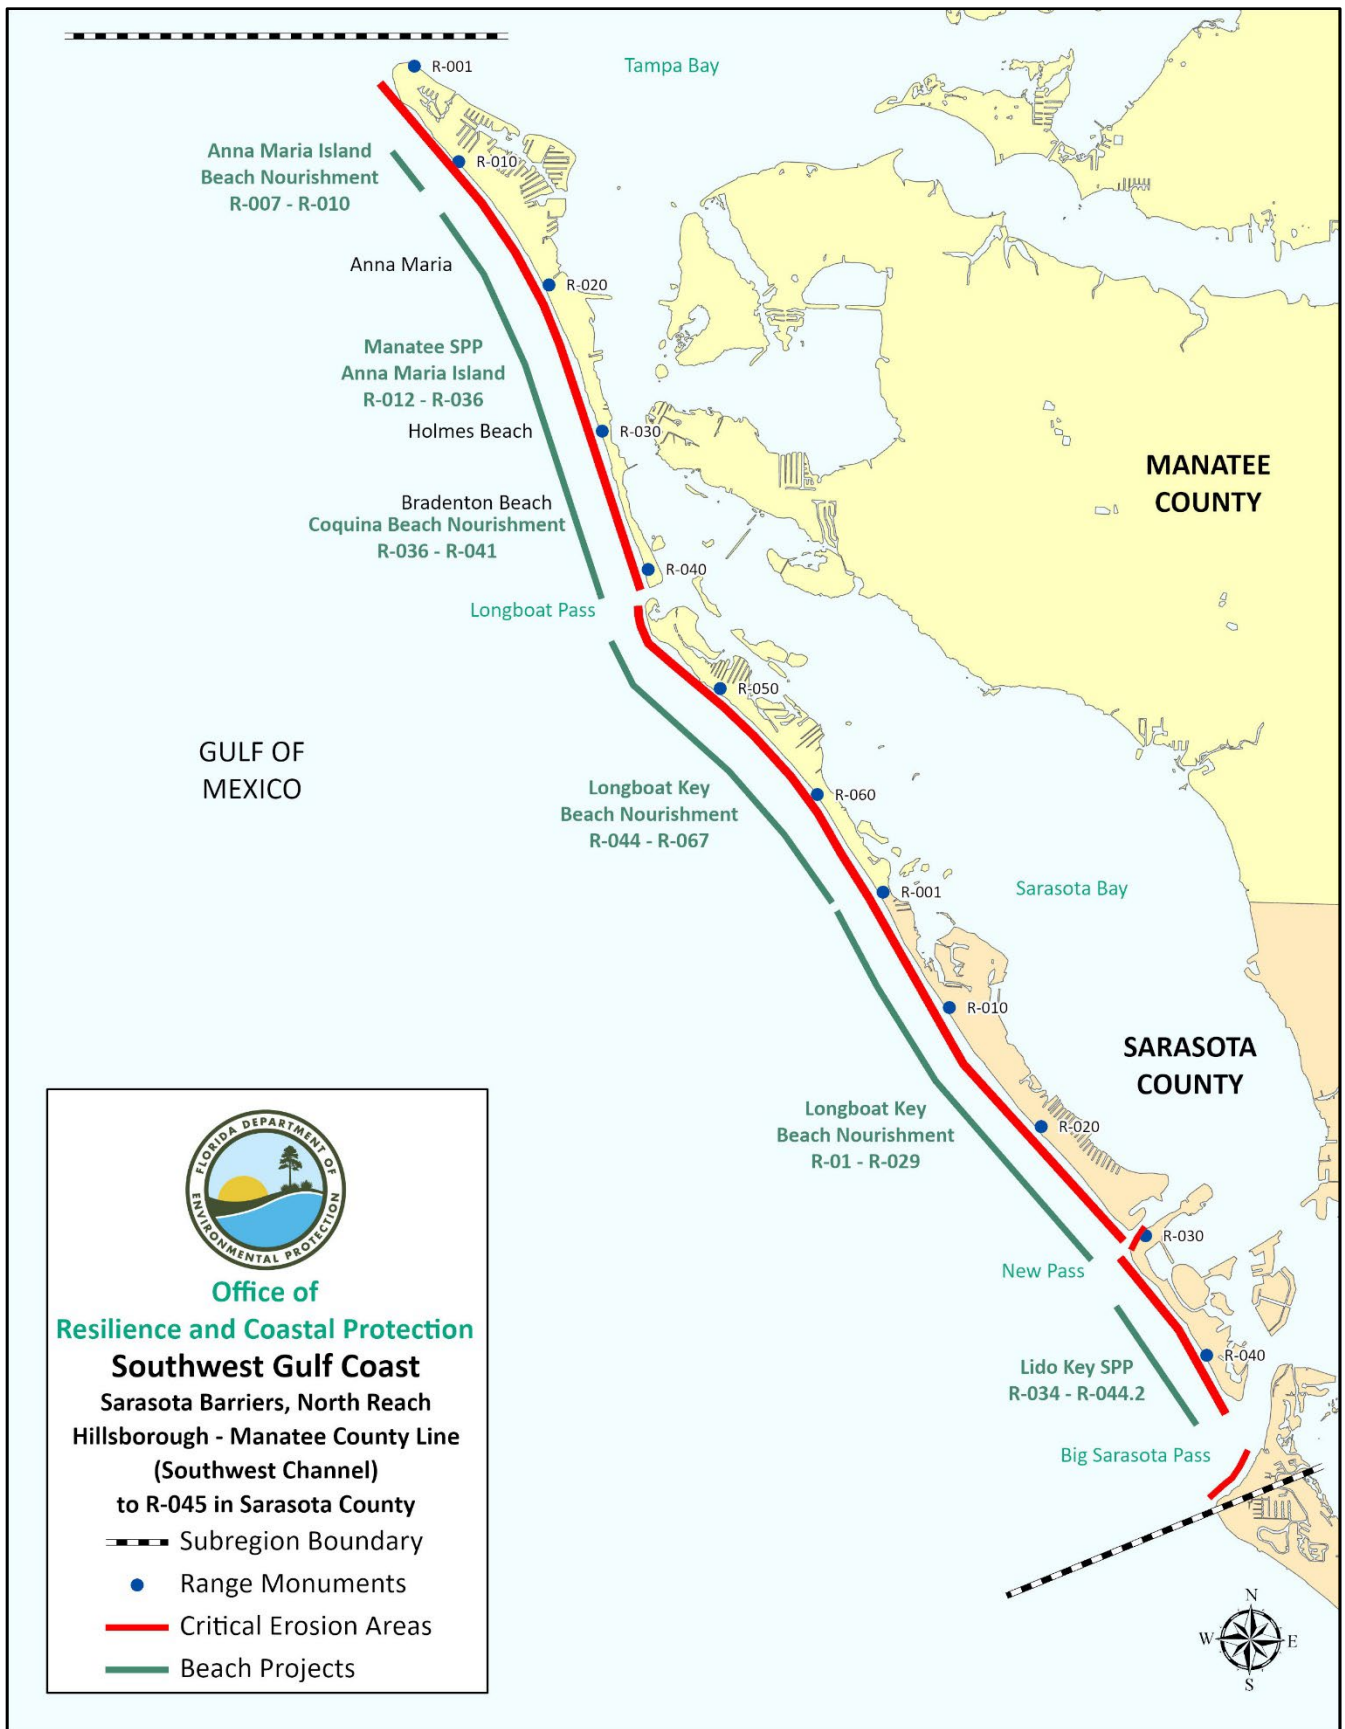
**Figure 2.** Map of Sarasota Barriers North Reach subregion of the Southwest region of Florida. View an [interactive map](#) or [COASTS imagery](#).
