***Strategic Beach Management Plan:
Florida Keys Region***

**Office of Resilience and Coastal Protection
Florida Department of Environmental Protection**

May 2023

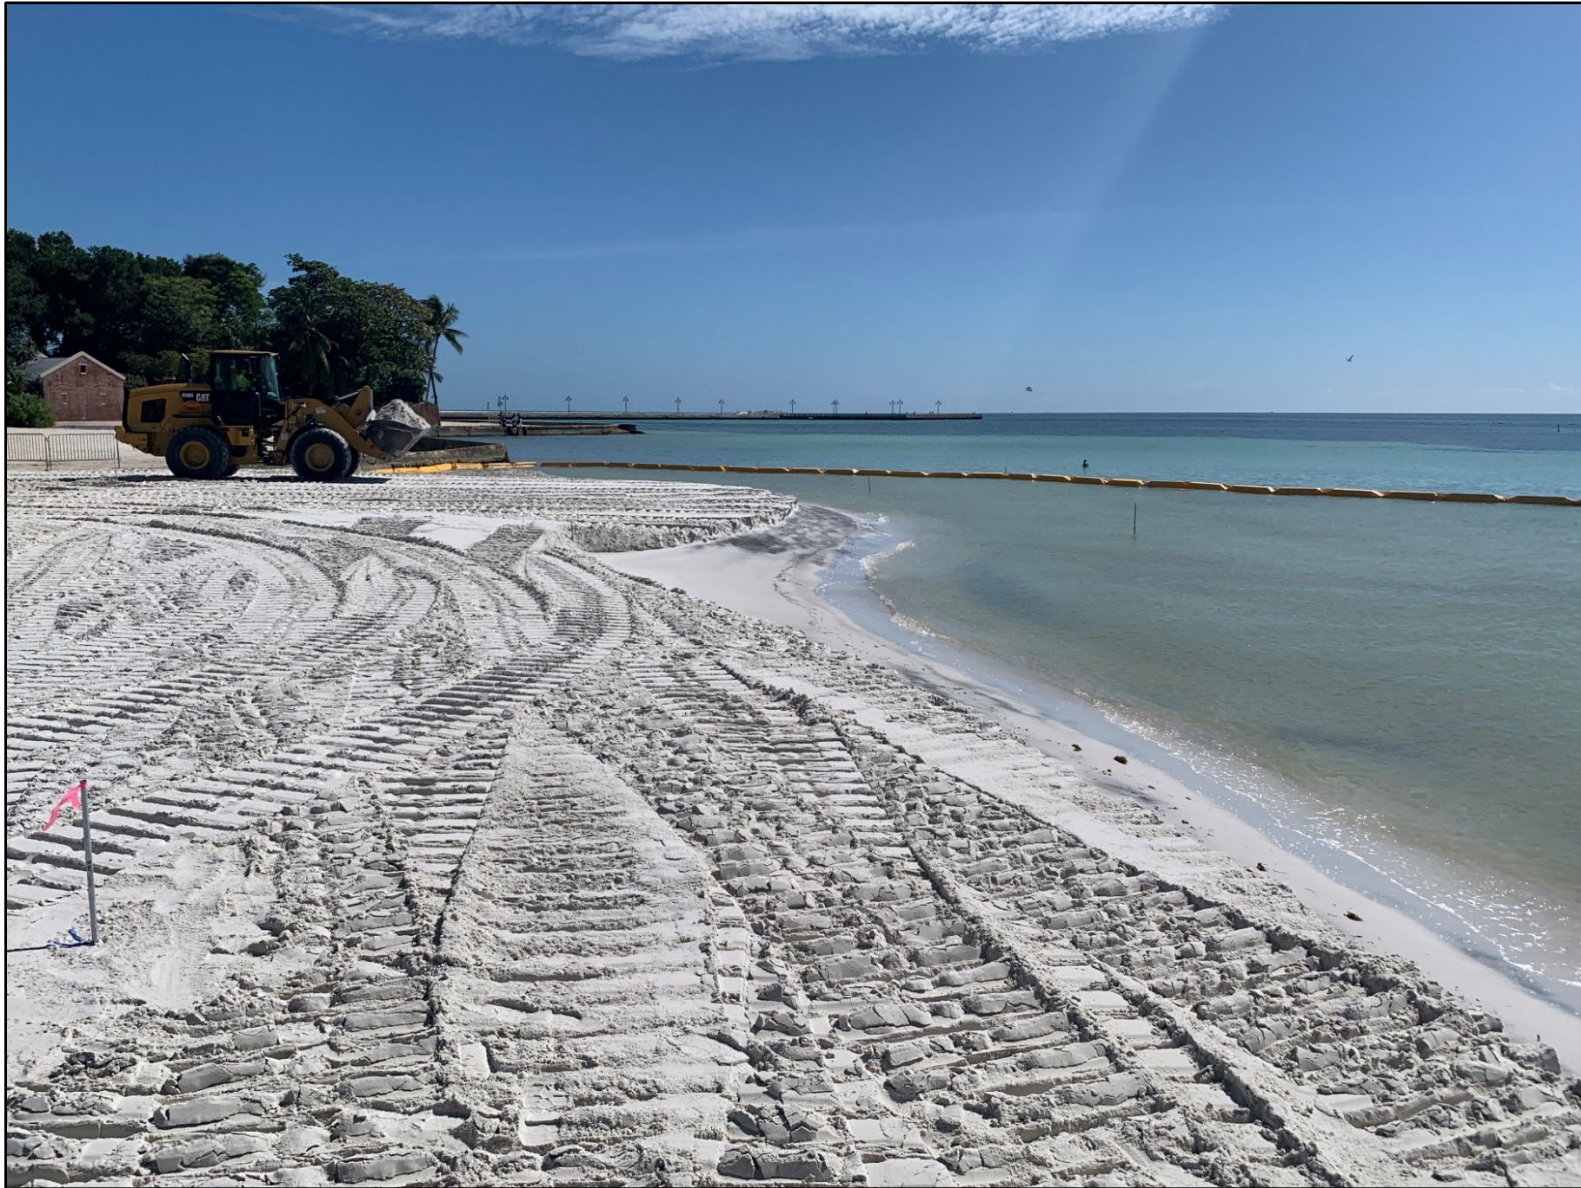
Construction at Higgs Beach in Key West, October 2021. Photo courtesy of Cary Vick, project manager for Monroe County. See additional [construction photos](#) of beach nourishment projects.

Rest Beach was restored in 1995 with the placement of 2,600 cy of sand from an upland mine, removal of invasive exotic plants, construction of a protective berm planted with desired dune vegetation, and public access improvements (Table 3). Rest Beach was nourished with upland sand several times due to

storm activity in 1995, Hurricane Georges (1998), Hurricane Irene (1999), and the 2005 hurricane season. To repair storm damage, the City of Key West conducted emergency nourishment of the berm at Rest Beach in 2009, using 505 cy of upland sand. Storm damage again prompted the city to conduct emergency nourishment of the dune system with the placement of 200 cy of upland sand in early 2012. A permit for the Rest Beach nourishment east of the pier was issued by the department in March 2015; however, the nourishment project has not been constructed to date due to complications with the USACE permitting and regulatory process. The department issued the county a different permit to conduct beach restoration at Higgs Beach in December 2020. The county completed restoration of Higgs beach in December 2021 to the pre-Hurricane Wilma (2005) mean high water line, with the placement of 4,262 cy with sand from an upland mine along 570 feet of shoreline.

| Date | Volume (cy) | Sand Source | Project Location (by V monument) * | Length (mi.) |
|---|---|---|---|---|
| December 2021* | 4,262 | Upland | V413 | 0.11 (Higgs Beach) |

*2021 beach restoration at Higgs Beach. DEP’s [interactive maps](#) have virtual (V) monuments for reference points along the Florida Keys’ shoreline.

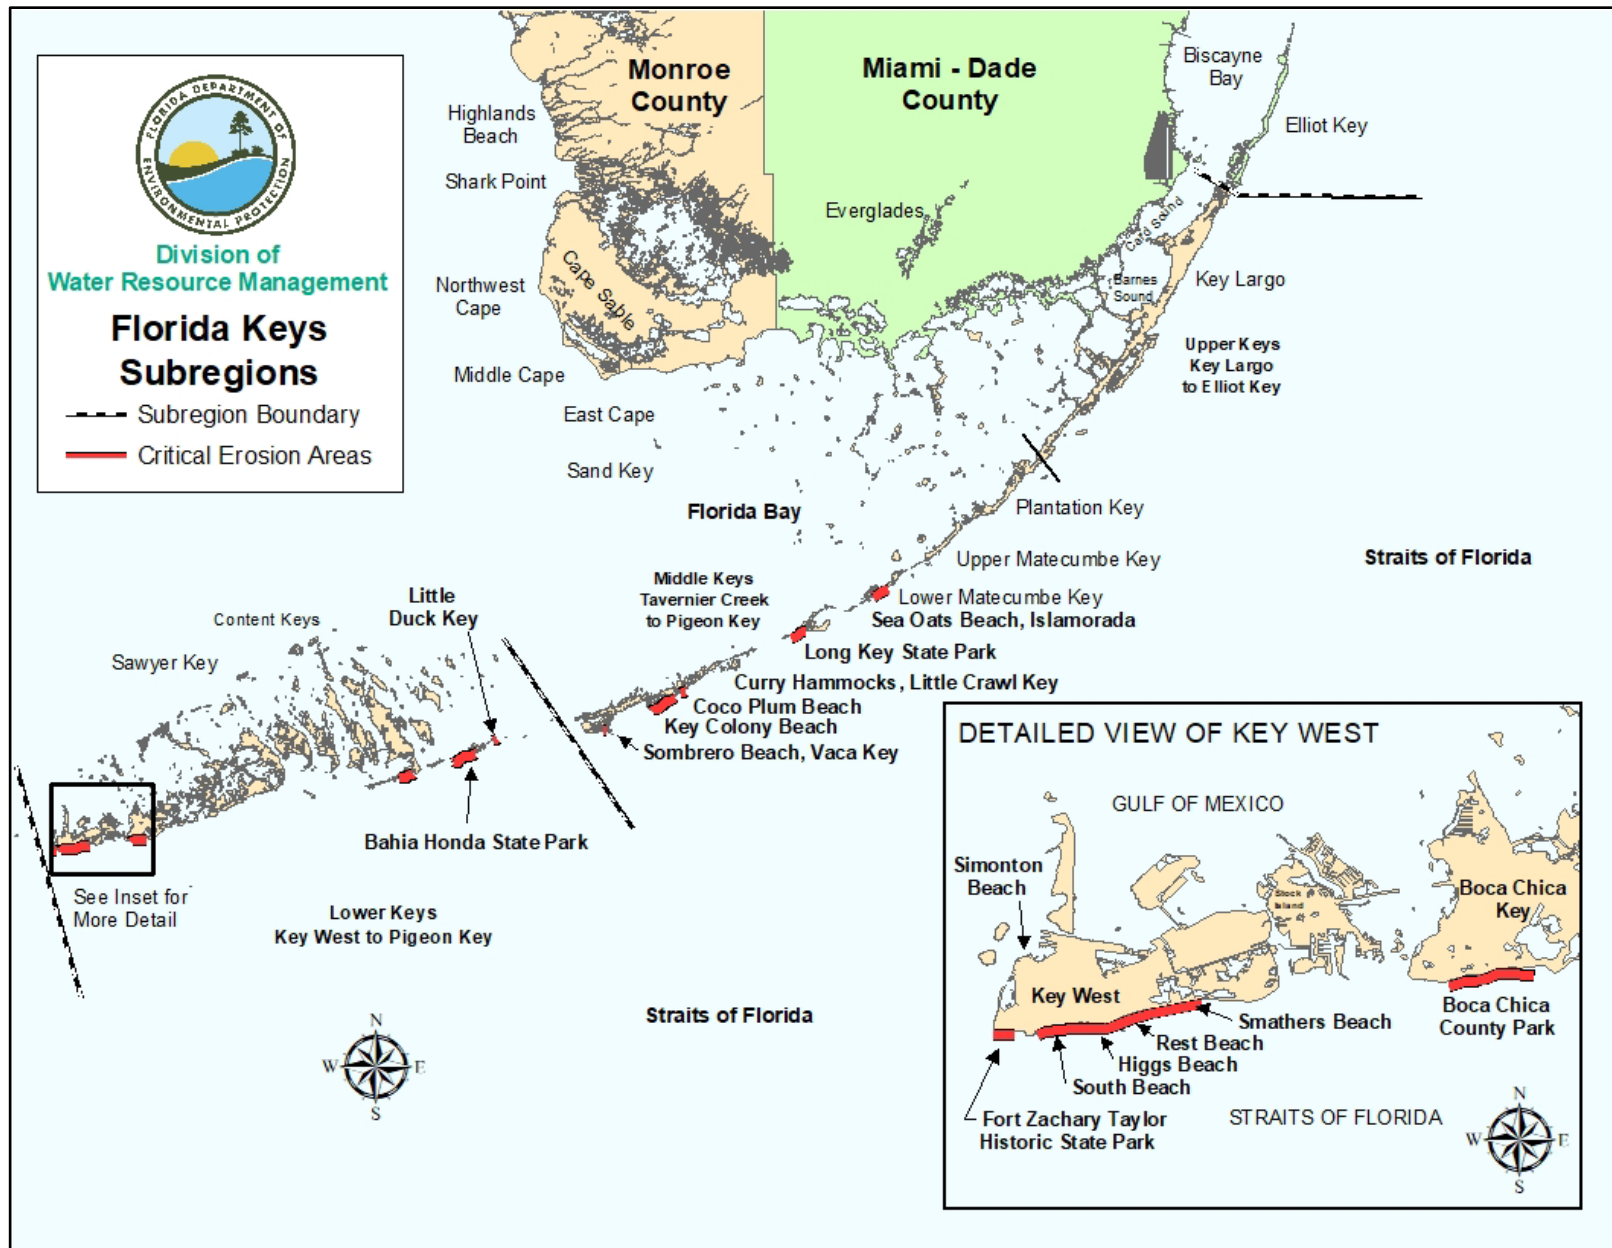
Figure 1. Map of the Florida Keys subregions. View an [interactive map](#) or [COASTS imagery](#).

The **Upper Keys** subregion extends from Soldier Key to Tavernier Creek. No natural beaches exist in the Upper Keys subregion.

The **Middle Keys** subregion extends from Tavernier Creek to Pigeon Key. There are 6.0 miles of critically eroded beaches in this subregion.

The **Lower Keys** subregion extends from Pigeon Key to Key West. There are 7.8 miles of critically eroded beaches in this subregion.

The **Distal Sand Keys** subregion extends west of Key West and includes Woman Key, Boca Grande Key, the Marquesas Keys, and the Tortuga Keys. This subregion has beach erosion conditions that have not been adequately studied for inclusion in this plan.
