**YULEE SUGAR MILL RUINS**  
**HISTORIC STATE PARK**  
Park Chapter

**YULEE SUGAR MILL RUINS HISTORIC STATE PARK**

CITRUS COUNTY, FLORIDA

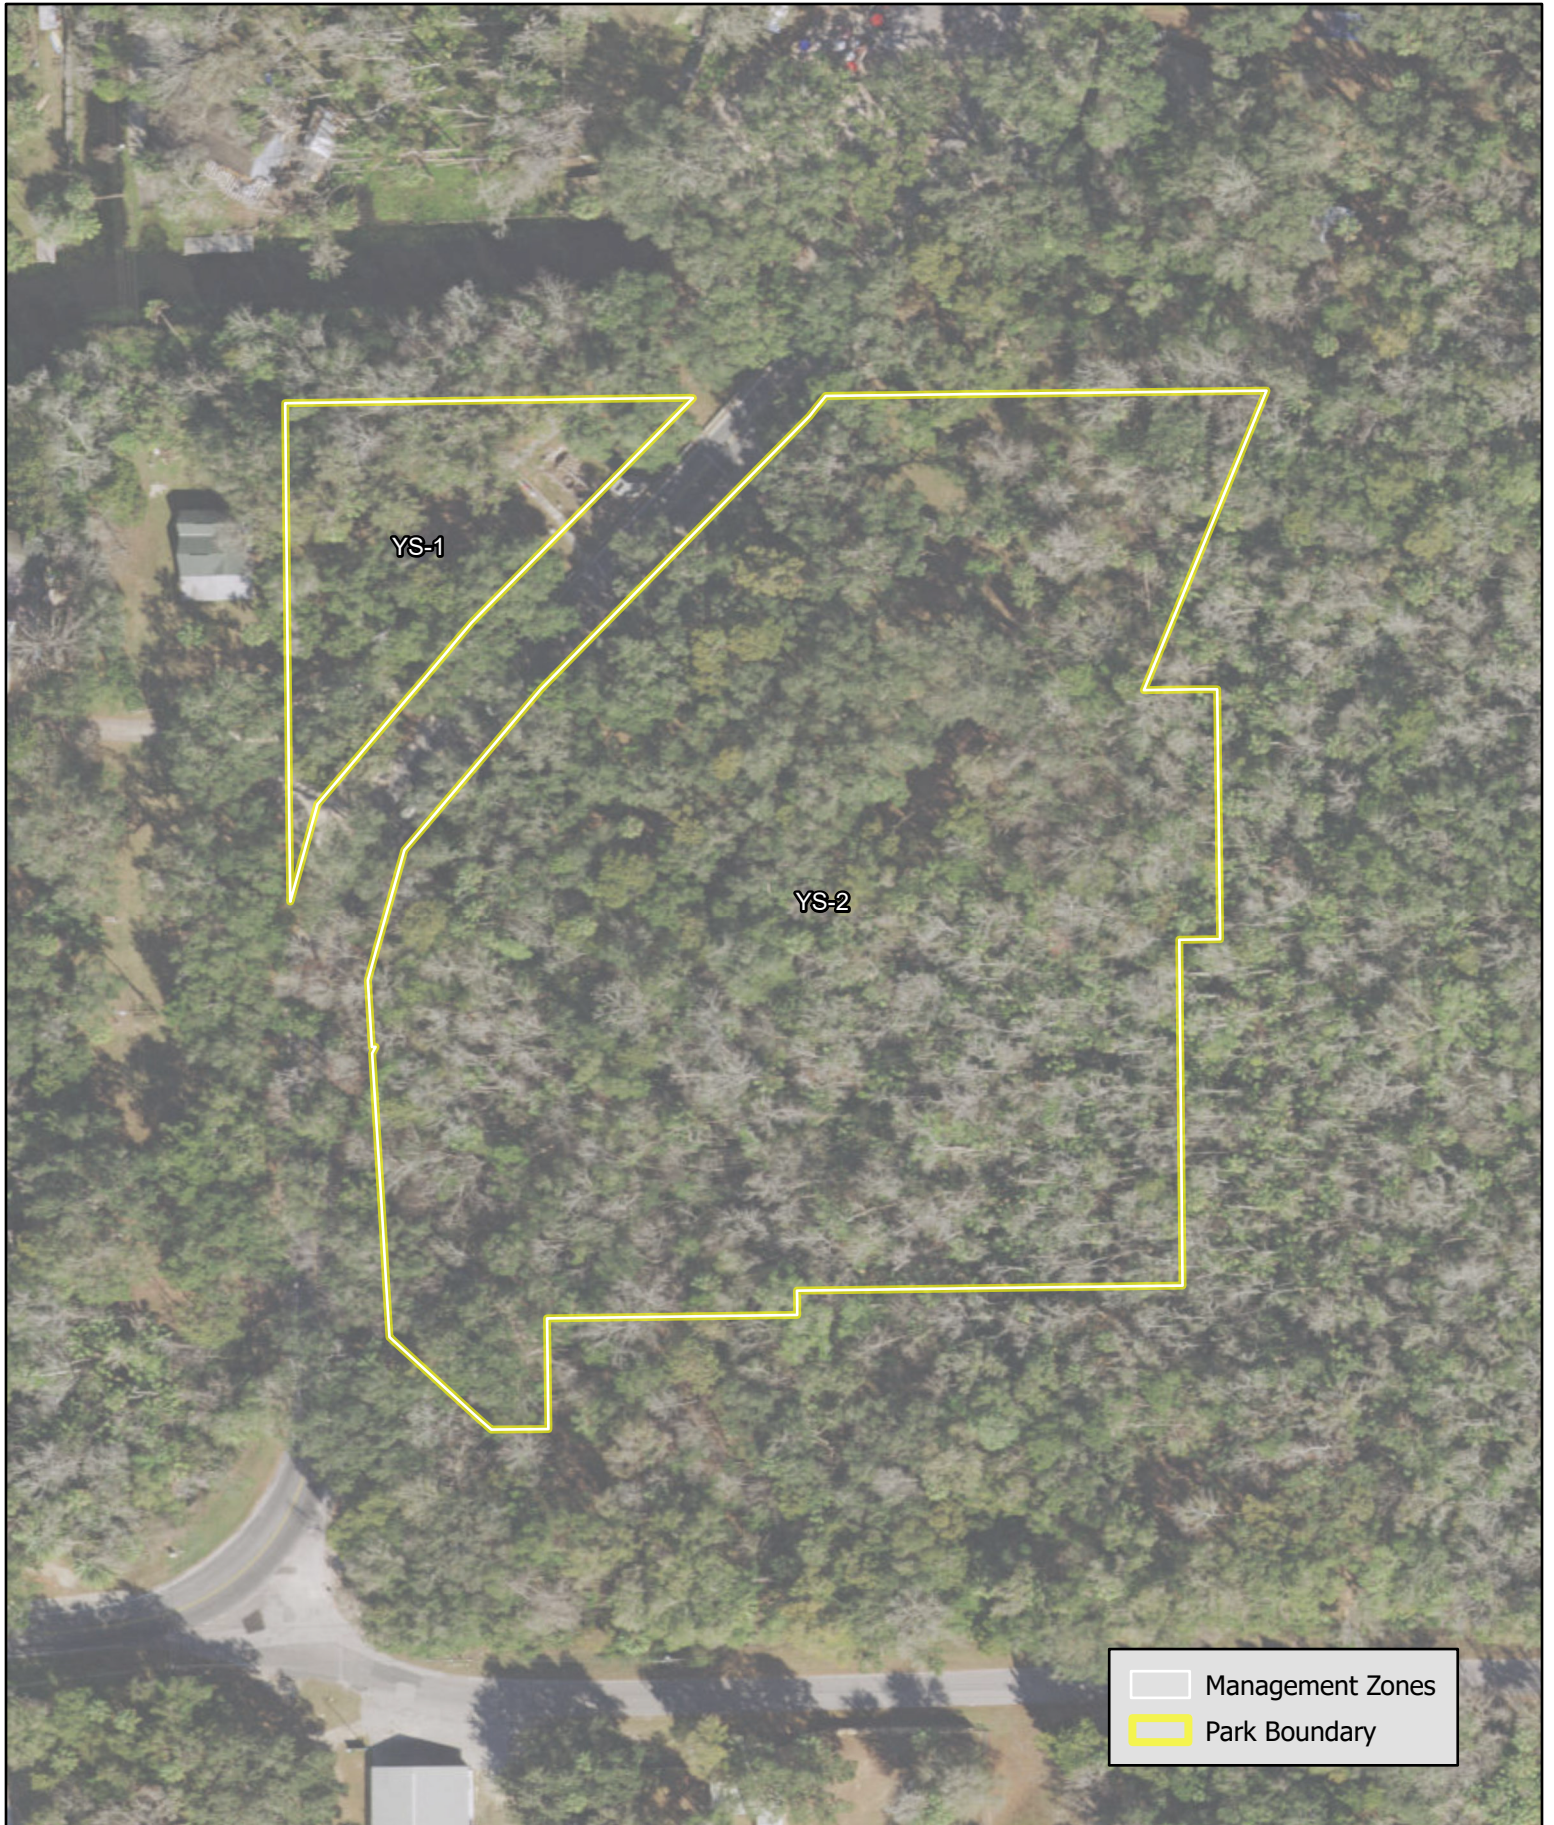
## Management Zones

Zone ID	Acres	Managed with Prescribed Fire	Contains Known Cultural Resources
YS-1	0.54	N	Y
YS-2	4.06	N	N

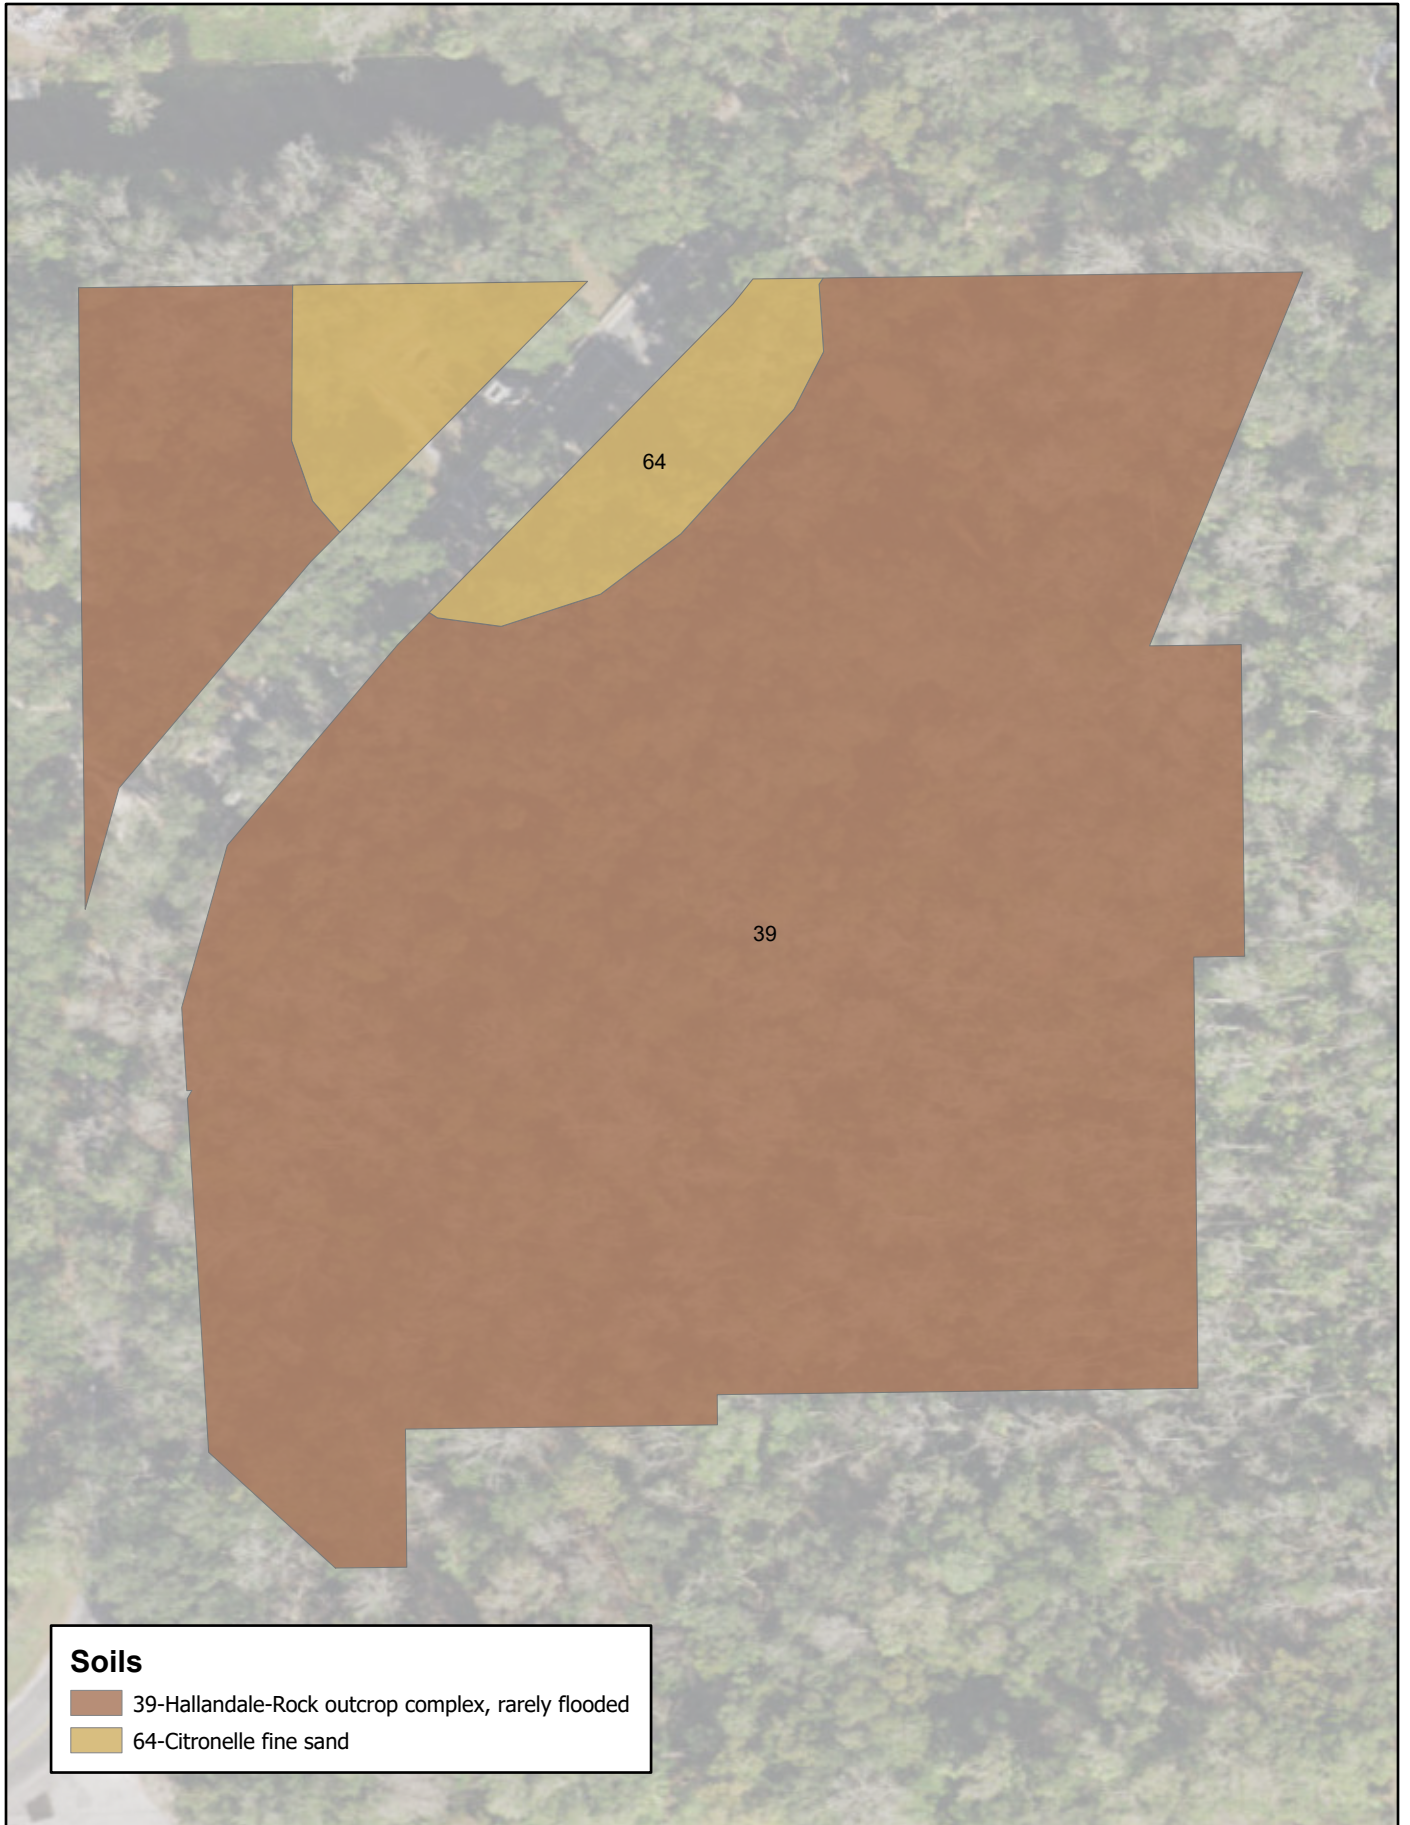
**YULEE SUGAR MILL RUINS HISTORIC STATE PARK**  
**Soils**

According to the Soil Survey of Citrus County (Pilny et al. 1988), Hallandale-Rock Outcrop complex and Citronelle fine sand are the only two soil types found in this small park (see Soils Map). The Hallandale complex consists of a nearly level, poorly drained mineral soil with rock outcrops. A high water table within 10 inches of the surface is characteristic in most years. Citronelle fine sand is a nearly level, somewhat poorly drained soil. It also has a high water table which remains within two to three feet of the surface for up to four months a year. A complete description of these soils is found in the Appendix. Despite the land use history of the area, the soils appear little disturbed except where a county road passes through the park and where an elevated drainfield services the rest room facilities. No significant soil erosion currently occurs in the park. Management activities will follow generally accepted best management practices to prevent soil erosion and conserve soil and water resources on the site.

- 39-Hallandale-Rock outcrop complex, rarely flooded
- 64-Citronelle fine sand

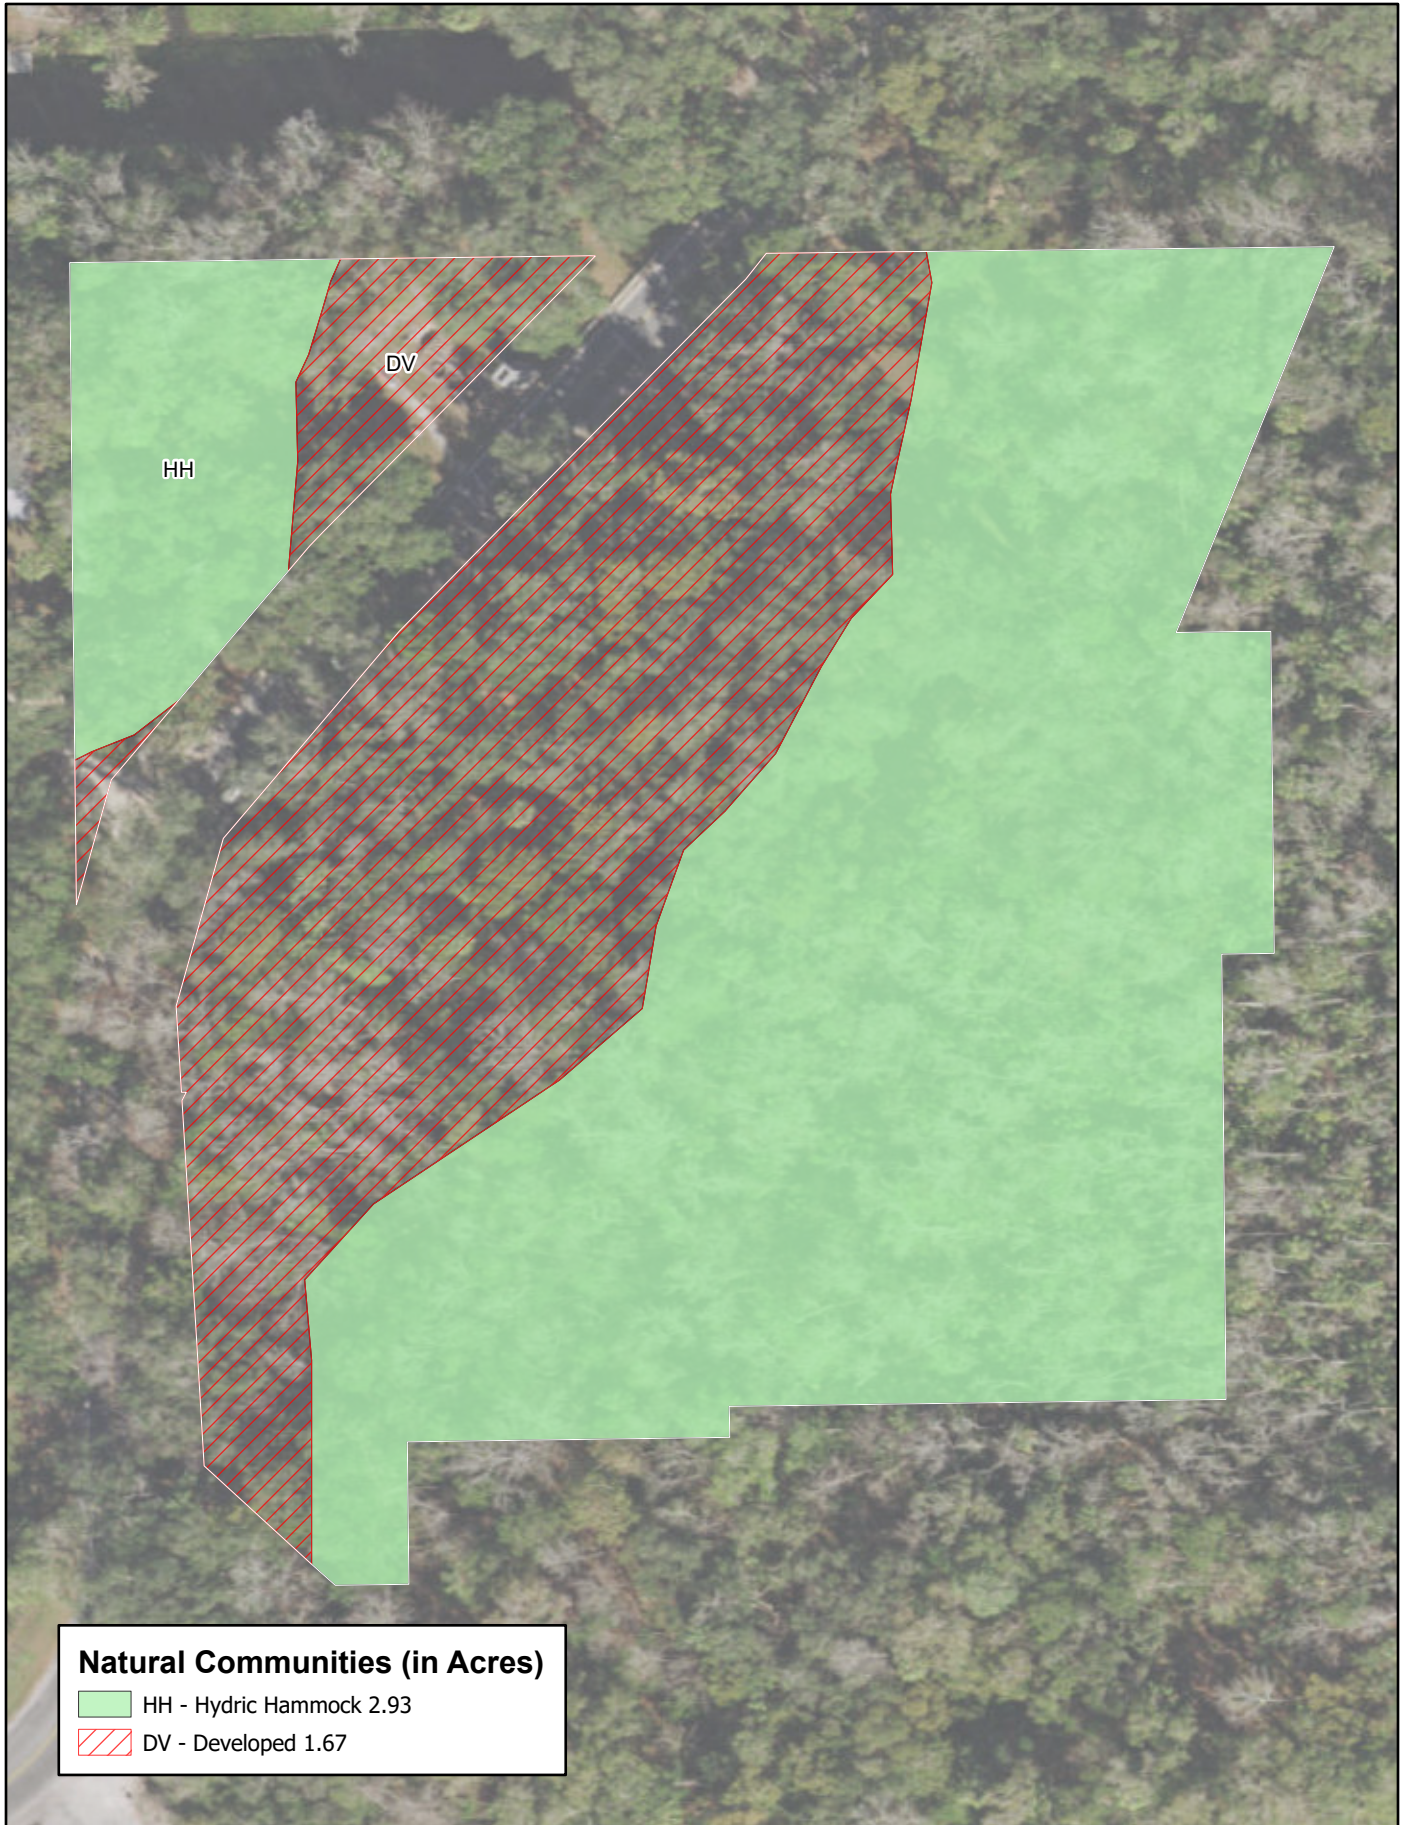
**YULEE SUGAR MILL RUINS HISTORIC STATE PARK**  
**Natural Communities - Existing Conditions**

- HH - Hydric Hammock 2.93
- DV - Developed 1.67

Hydric hammock covers almost two-thirds of the park. Dominant vegetation in the hammock includes cabbage palm, southern red cedar and live oak, with numerous other hardwood species present as well. This community has both the aspect and the composition of relatively undisturbed hydric hammock, some of which still exist in the Homosassa area. The hammock at Yulee Sugar Mill Ruins Historic State Park, however, is not likely an example of a pristine forest, but rather a woodland that has substantially recovered from past disturbances, most of which probably occurred during the period of mill operation. Several wood burning furnaces were features of the mill operations in the mid-1800s, and some of the fuel for the furnaces undoubtedly came from the adjacent hammock. The hydric hammock is generally in good condition. The only active management required for this natural community is to regularly treat any invasive plant species that may be present.

The developed portion of the park contains the sugar mill ruins, which include the standing, limestone masonry remains of the sugar mill complex as well as a representative, yet incomplete, portion of the associated machinery and objects involved in the sugar-making process. The remainder of the developed area consists of a parking lot, picnic area and restrooms. Invasive plants will be controlled as necessary.

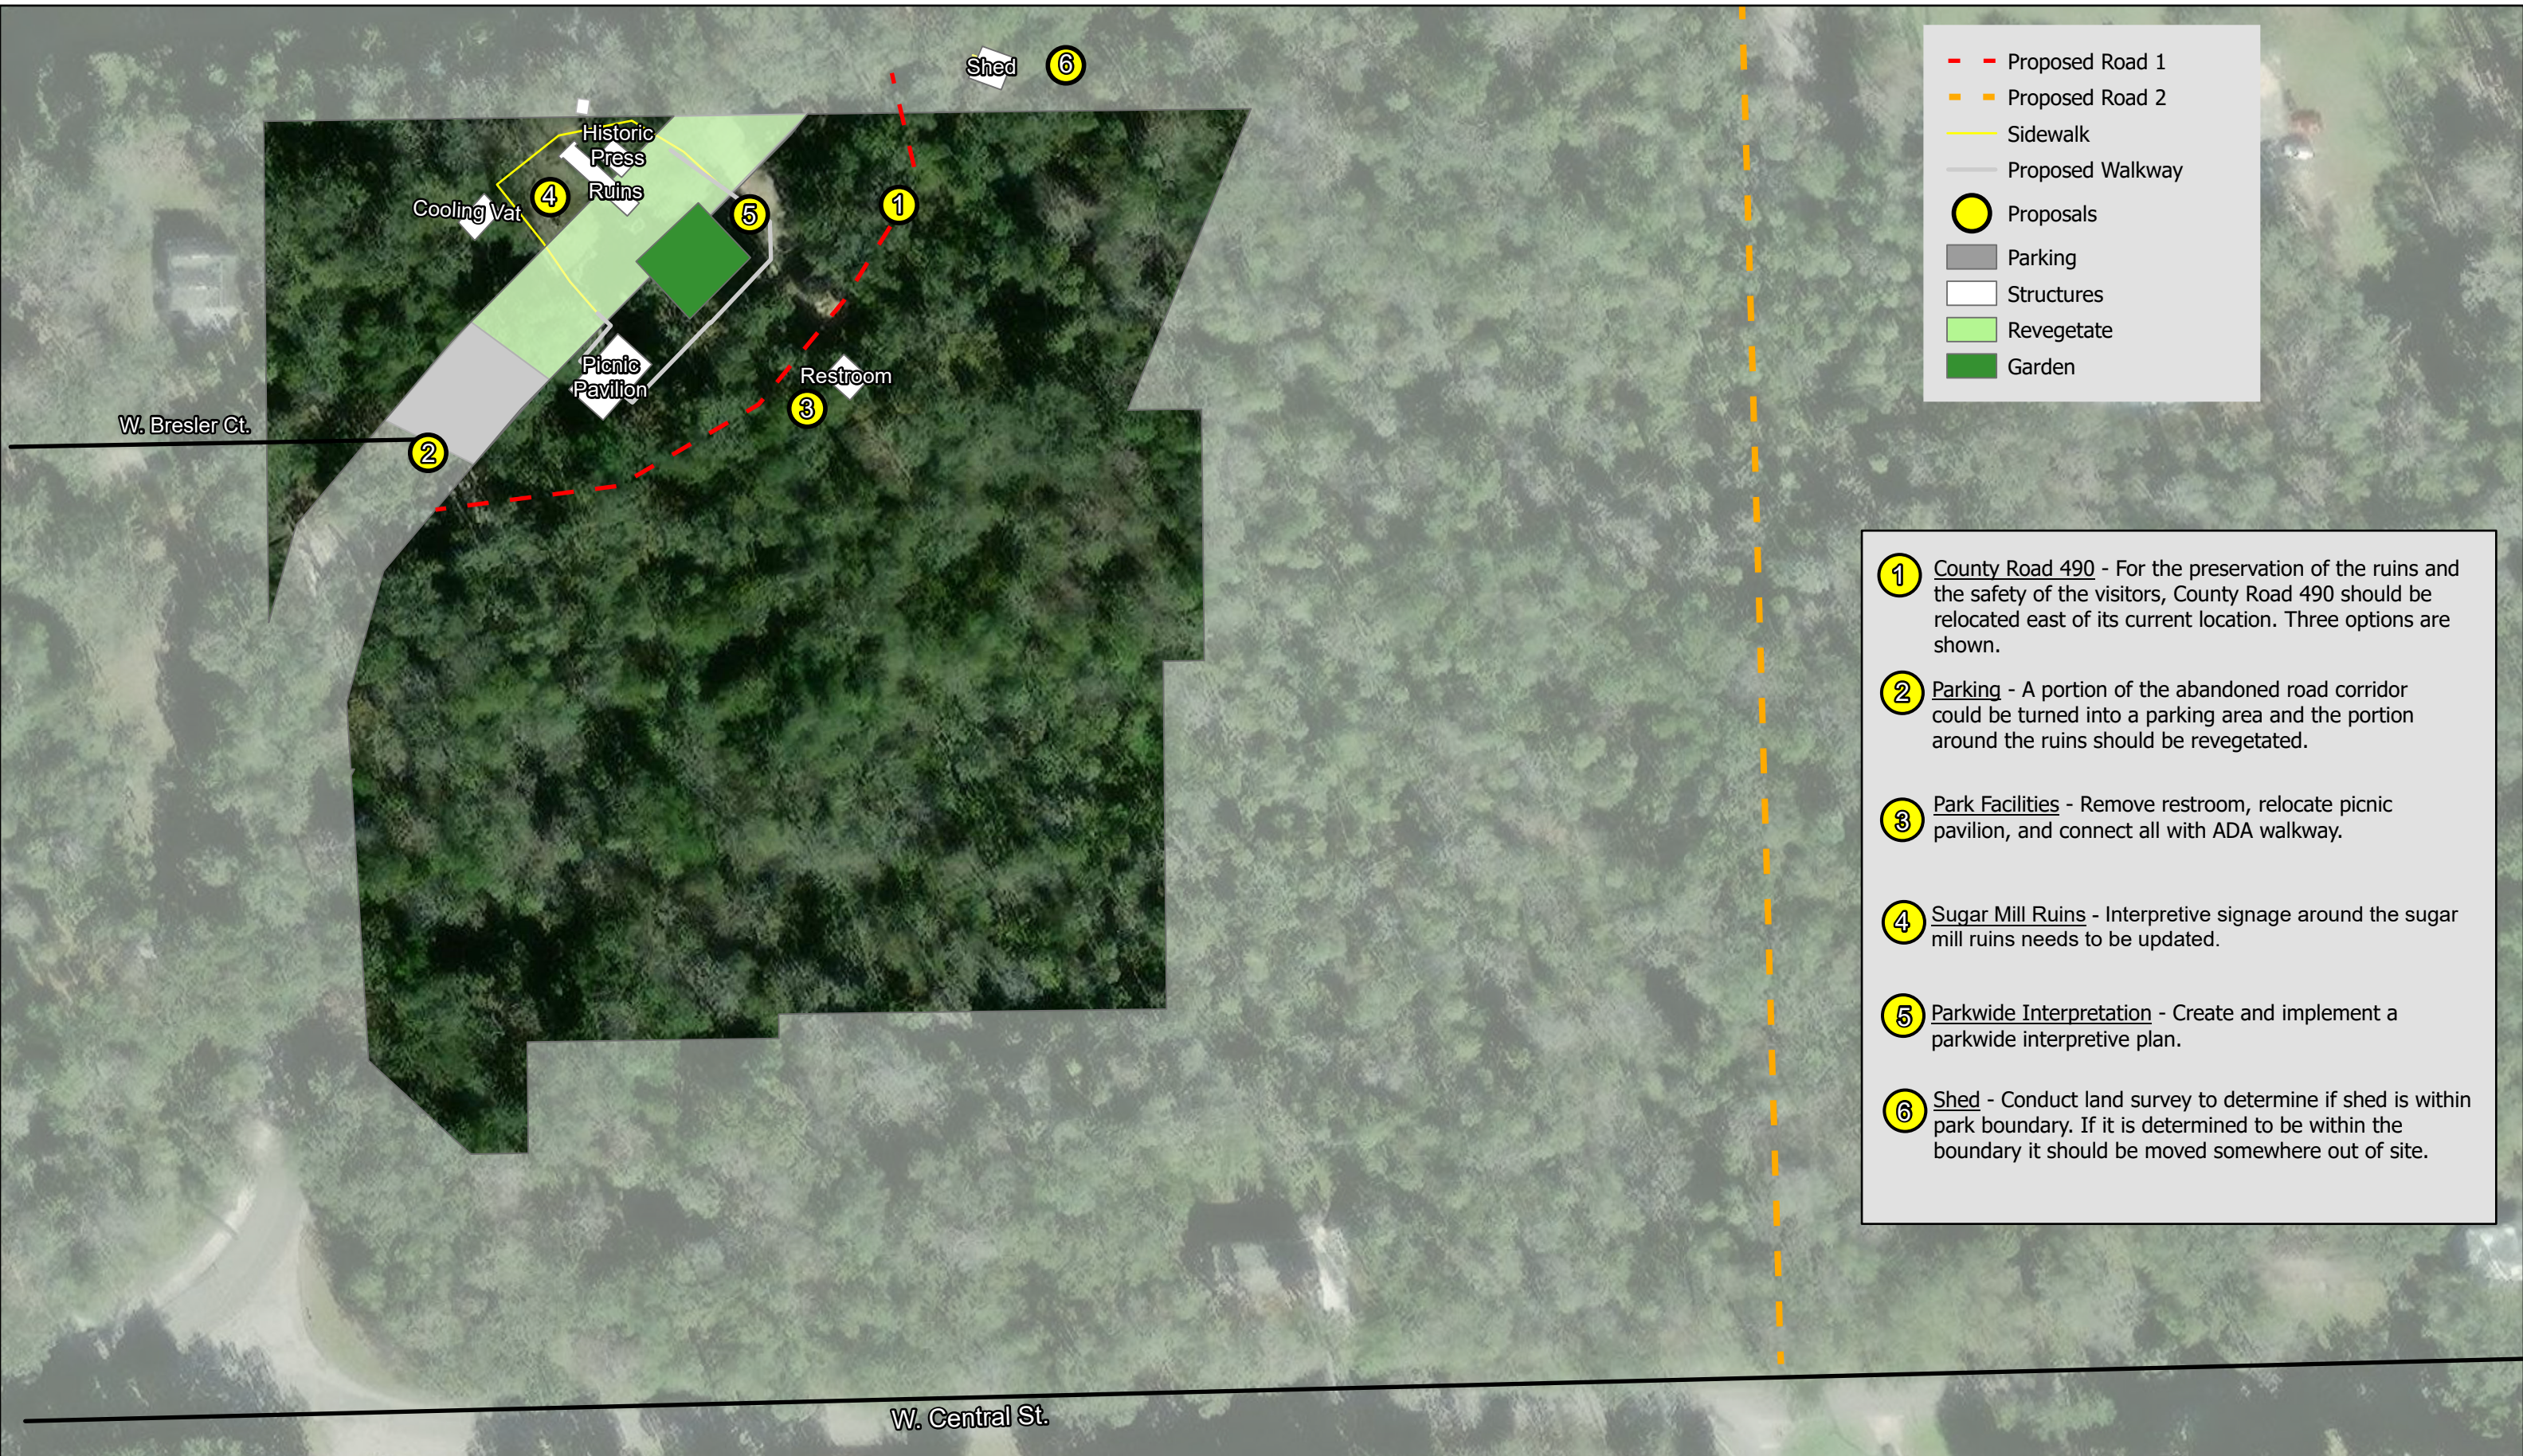
# Yulee Sugar Mill Ruins Historic State Park Conceptual Land Use Plan

- ① **County Road 490** - For the preservation of the ruins and the safety of the visitors, County Road 490 should be relocated east of its current location. Three options are shown.
- ② **Parking** - A portion of the abandoned road corridor could be turned into a parking area and the portion around the ruins should be revegetated.
- ③ **Park Facilities** - Remove restroom, relocate picnic pavilion, and connect all with ADA walkway.
- ④ **Sugar Mill Ruins** - Interpretive signage around the sugar mill ruins needs to be updated.
- ⑤ **Parkwide Interpretation** - Create and implement a parkwide interpretive plan.
- ⑥ **Shed** - Conduct land survey to determine if shed is within park boundary. If it is determined to be within the boundary it should be moved somewhere out of site.

- *Park interior (red line in CLUP)*

- *Platted road right-of-way, eastern edge of potential future park boundary (orange line in CLUP)*
