BASIN MANAGEMENT ACTION PLAN

**for the Implementation of Total Daily Maximum Loads for Fecal
Coliform Adopted by the Florida Department of Environmental
Protection**

Lower St. Johns River Basin Tributaries

December 2009

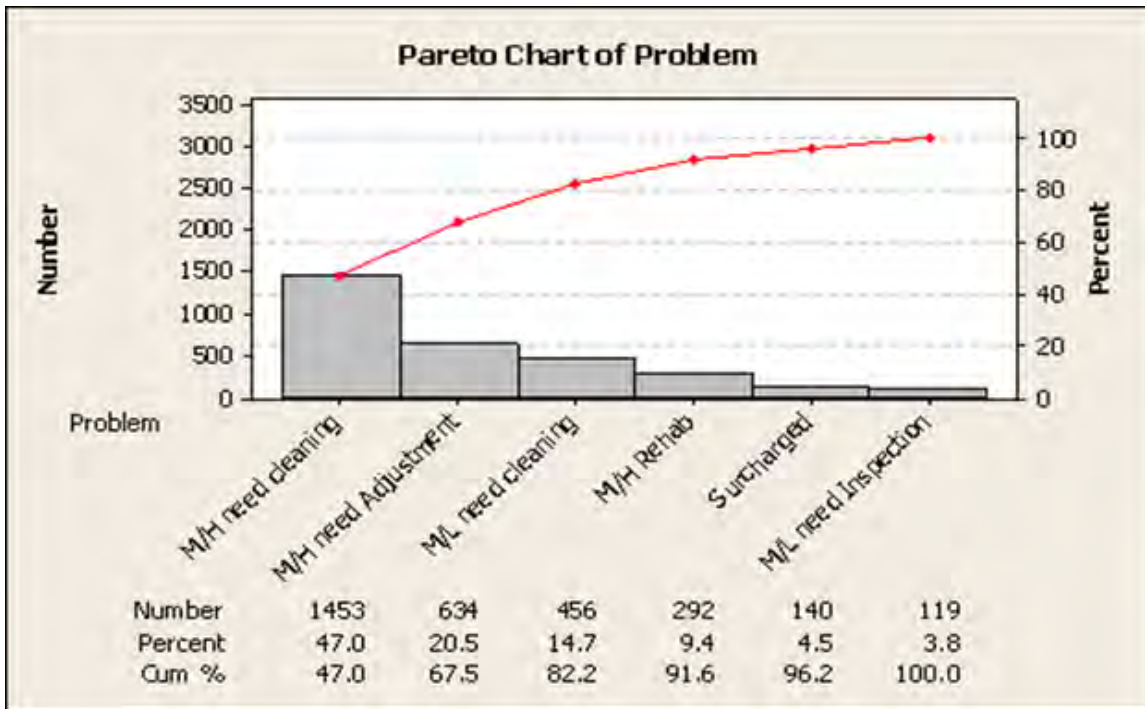
FIGURE E-2. PROBLEMS IDENTIFIED THROUGH THE POP-TOP PROGRAM

JEA implemented the Pop-Top Program in early 2007 to open and inspect all accessible manholes in the service territory (approximately 54,000 manholes), with the objective of preventing future SSOs. Since April 2007, JEA crews have inspected more than 30,000 manholes to detect potential problems in the collection system. Generally, the problems of greatest concern are manifested through surcharged conditions (backups of flow to varying degrees) that typically result from a restriction in flow downstream of the surcharged manhole. In some cases, the discovery of a surcharged condition has resulted in an immediate response to prevent a potential SSO. In many more cases, the pop-top inspections have identified conditions that, if unresolved, could result in an SSO sometime in the future. These lines are placed on a cleaning schedule to avoid the possibility of an eventual SSO. **Figure E-2** shows the problems identified in manholes (M/H) and main lines (M/L) to date as the result of the pop-top inspections, including 140 instances of surcharged lines.

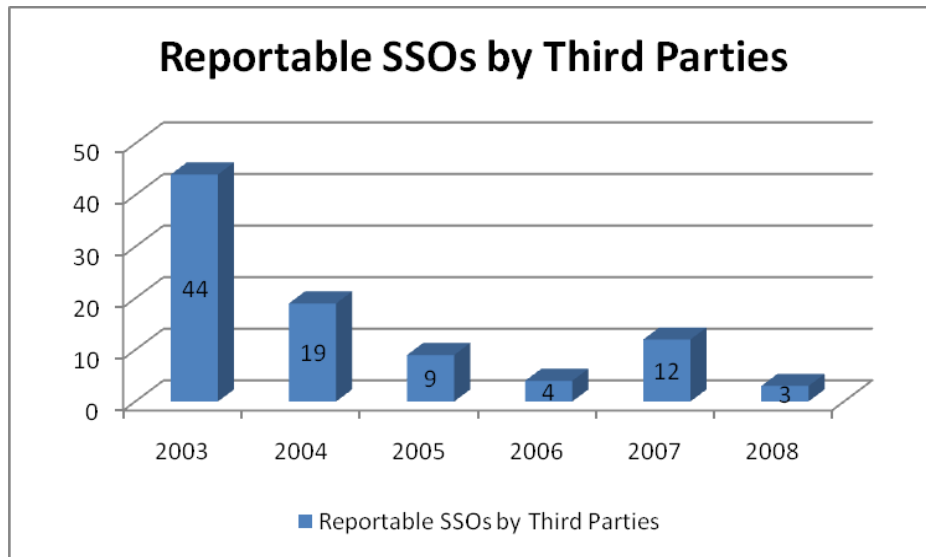
FIGURE E-4. REPORTABLE SSOs BY THIRD PARTIES, 2003–08

In 2003, JEA implemented a program to address SSOs caused by third-party contractors. The program involves an increased emphasis on both education and enforcement of the contractors who routinely perform excavations in the vicinity of JEA infrastructure. The program has been successful in dramatically reducing the SSOs caused by third-party hits on JEA sewage lines, as shown in **Figure E-4**.
