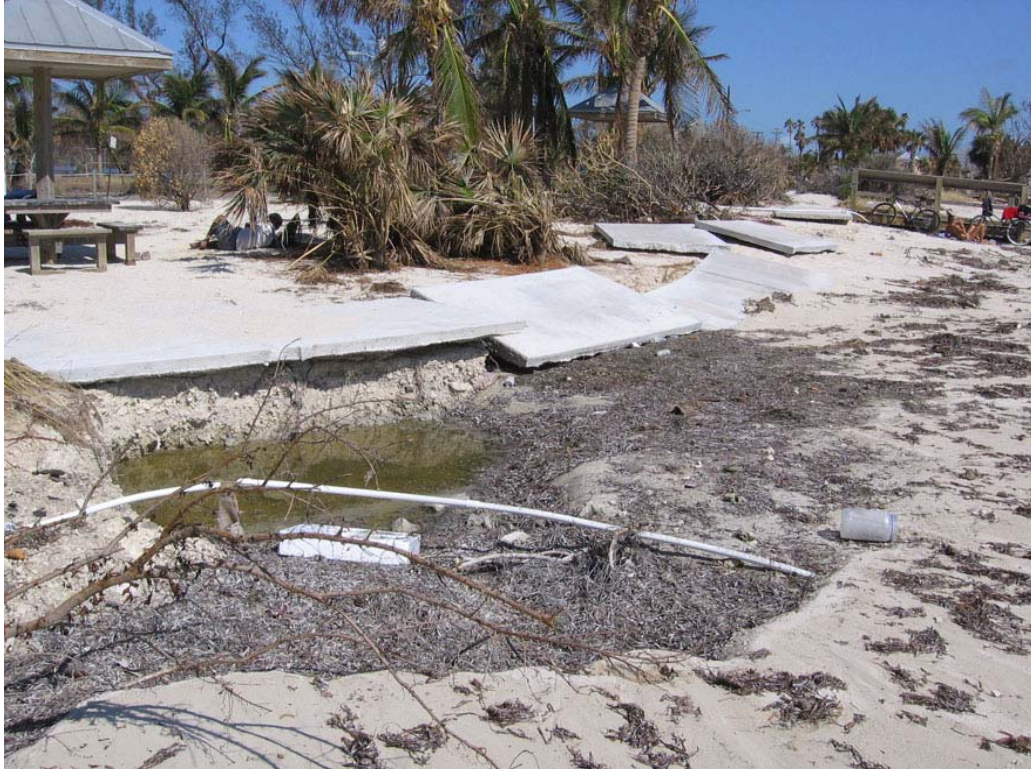
Rest Beach – Wilma inflicted severe erosion, flooding, and overwash, and substantially destroyed the entire park’s recreational infrastructure (Photo 57). Two beach access walkways were destroyed along with a picnic shelter. Approximately 175 feet of concrete sidewalks were also destroyed. East of Rest Beach, 35 feet of concrete block wall was destroyed.

Photo 57. Damage to Rest Beach infrastructure.

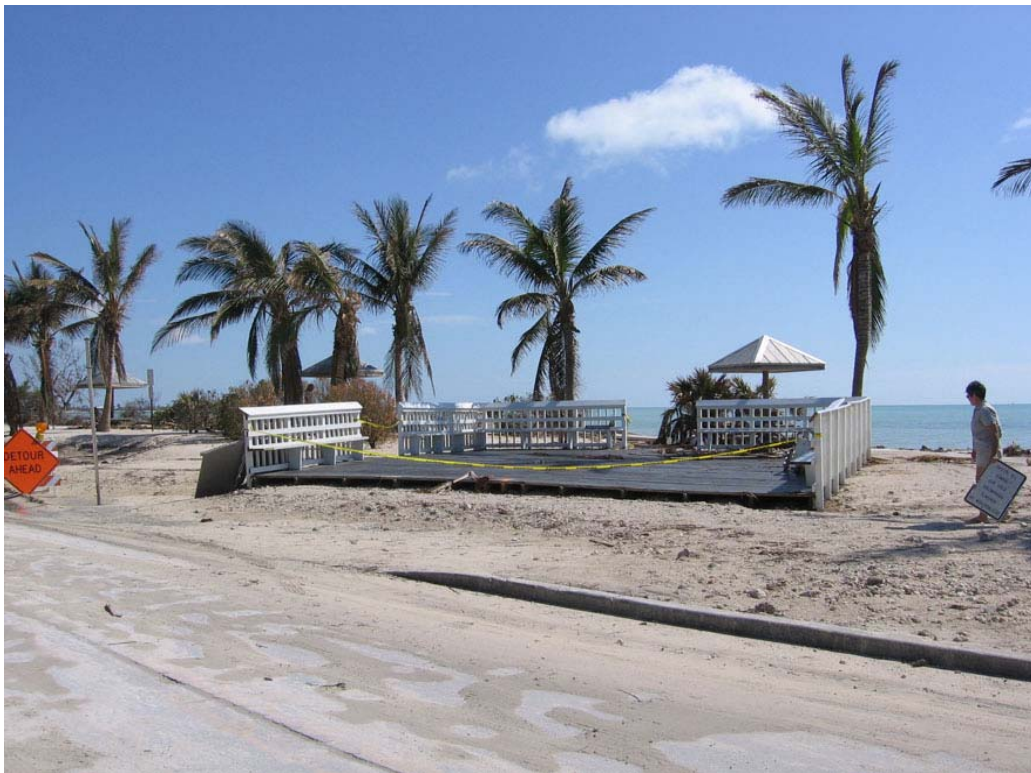
Clarence Higgs Monroe County Beach – The White Street Pier sustained minor damage, losing some of its rails to the storm surge and waves. A county pavilion known as the Yoga by the Sea platform was separated by the storm surge, which floated it northeastward and set it down on the northwest corner of Rest Beach (Photo 58). At the west end of Higgs Beach, a concrete public fishing pier was substantially damaged and lost all its wood deck.

Photo 58. Wilma's storm surge carried the Yoga by the Sea platform from Higgs Beach east to Rest Beach.

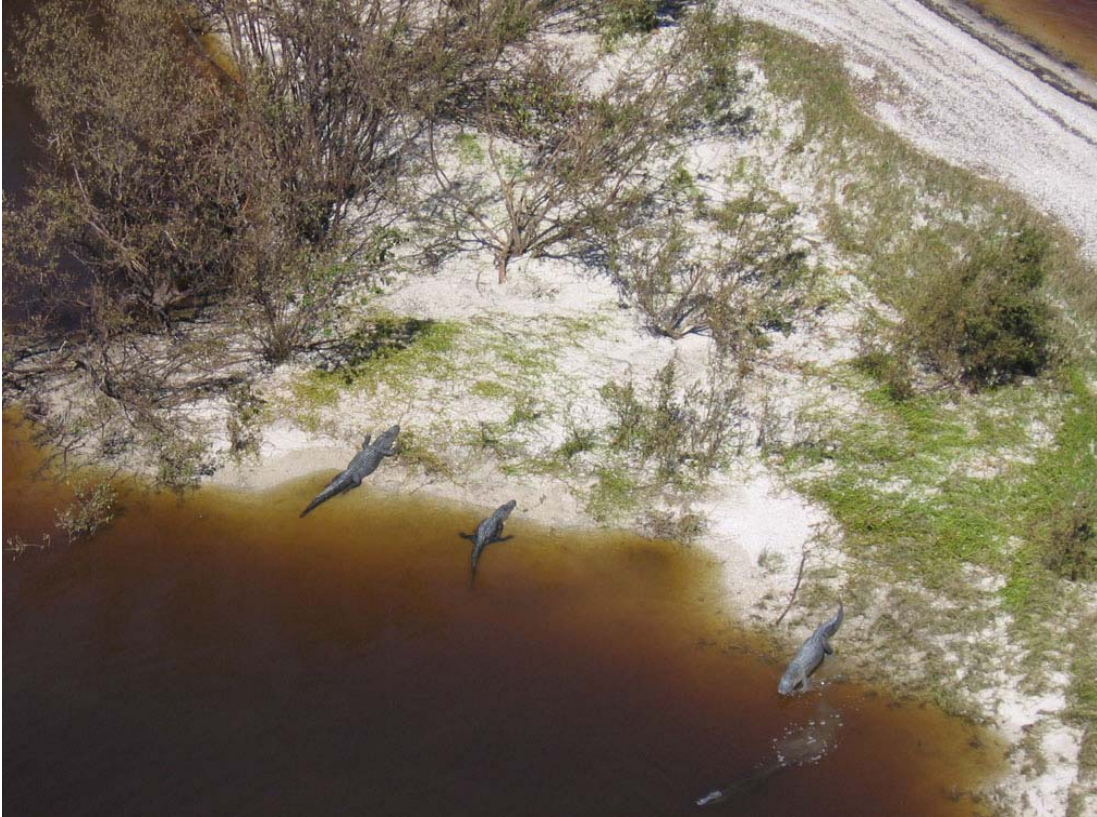
The community and national park facilities sustained major damages due to the winds and storm surge of Hurricane Wilma. Several mobile homes were destroyed and many others sustained major damage. Many single-family dwellings throughout the community sustained major damages due to flooding and winds. Within the park, most of the grade-level buildings were flooded by the storm surge and most buildings sustained major roofing damage. Major structural damage was sustained by many of the grade-level buildings, and understructure damage was sustained by many of the elevated, pile-supported structures. Most of the marina and dock facilities were destroyed or sustained major damage. Throughout the area, trees were uprooted, plants and shrubs were damaged, and wildlife were stressed (Photo 59).

Photo 59. Damaged ecosystem, Everglades National Park (credit: National Park Service).

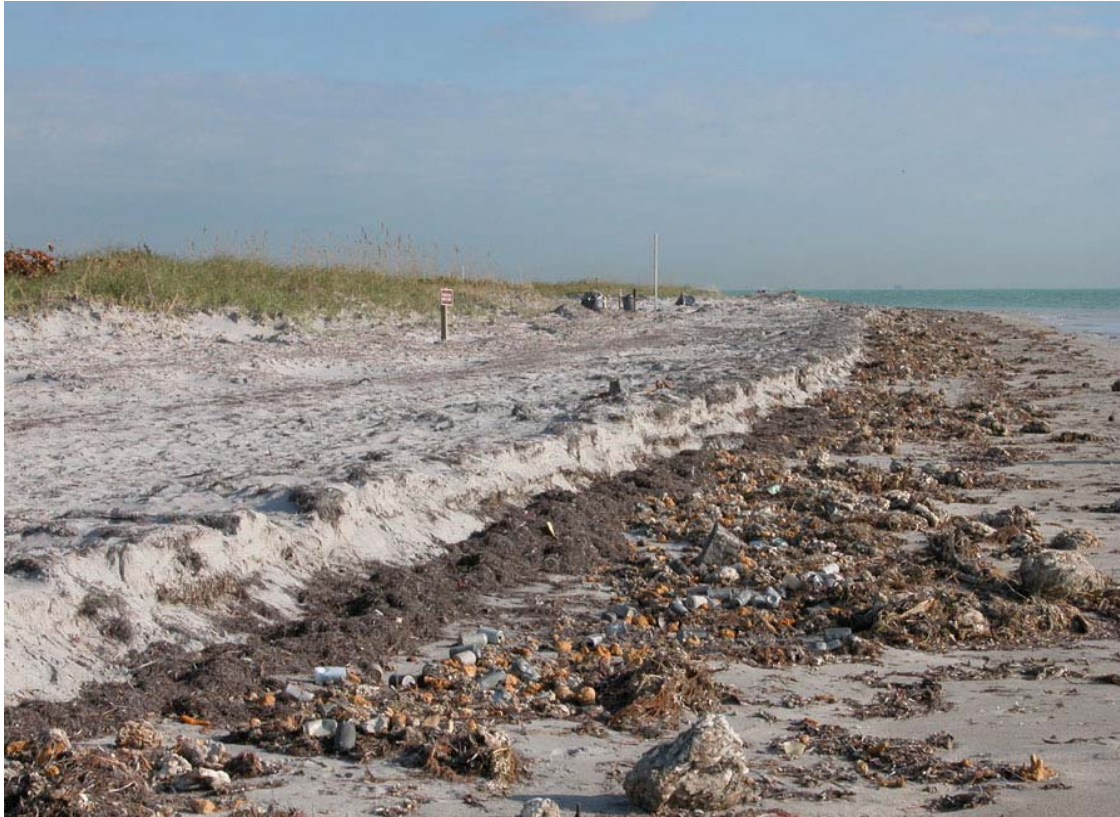
The center of the eye of Hurricane Wilma passed approximately 70 miles north of Dade County on a west to east track. This track placed Dade County within the maximum wind field whereby the majority of the county experienced hurricane force winds. The direction of Wilma's sustained wind in Dade County was primarily from the southwest to west. Due to the predominantly offshore wind, the storm tide along the county's beaches fronting on the Straits of Florida was minimal. Some wave set-up along the west shorelines of the barrier islands did occur. The storm tide at Cape Florida was observed to be about five to six feet. Generally, only minor beach erosion (condition I) was sustained from the Broward-Dade County line south to Government Cut, as well as, along Virginia Key. To the south, along most of Key Biscayne, minor beach erosion (condition I) prevailed; however, at Bill Baggs Cape Florida State Park (R108-R113) erosion conditions transitioned from minor beach erosion (condition I) between R108 and R111.5 to minor beach and dune erosion (condition II) between R111.5 and the terminal groin at the cape near R114. Along this segment, a debris line comprised of old trash and marine invertebrates was deposited (Photo 60).

Photo 60. Minor beach erosion at Bill Baggs Cape Florida State Park (R112).

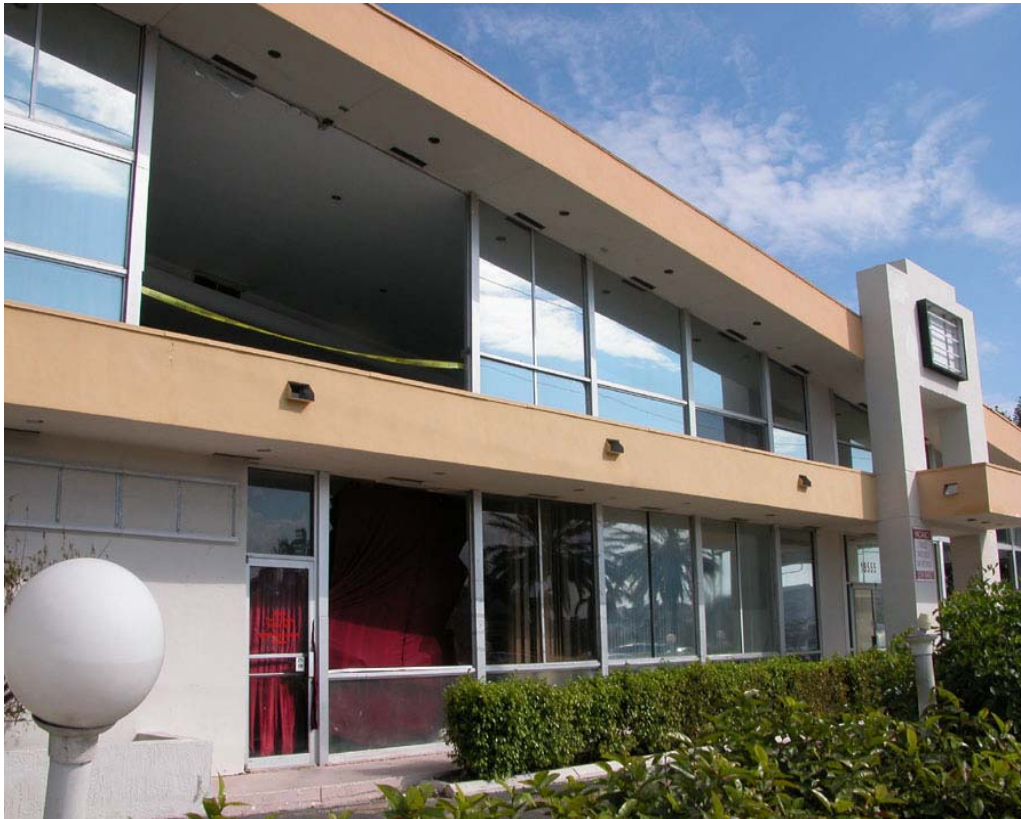
On the barrier islands, there was minor to moderate wind damage to ocean front high-rise condominiums, low-rise motels, commercial buildings, and single-family dwellings (Photo 61). The typical wind damages were broken windows, damaged hurricane shutters, and minor roofing losses. No major structural damage was observed seaward of the Broward County Coastal Construction Control Line or within the Coastal Building Zone. The majority of the damage near the coast occurred north of Bakers Haulover Inlet.

Photo 61. Broken windows, Golden Nugget Motel, Sunny Isles Beach.

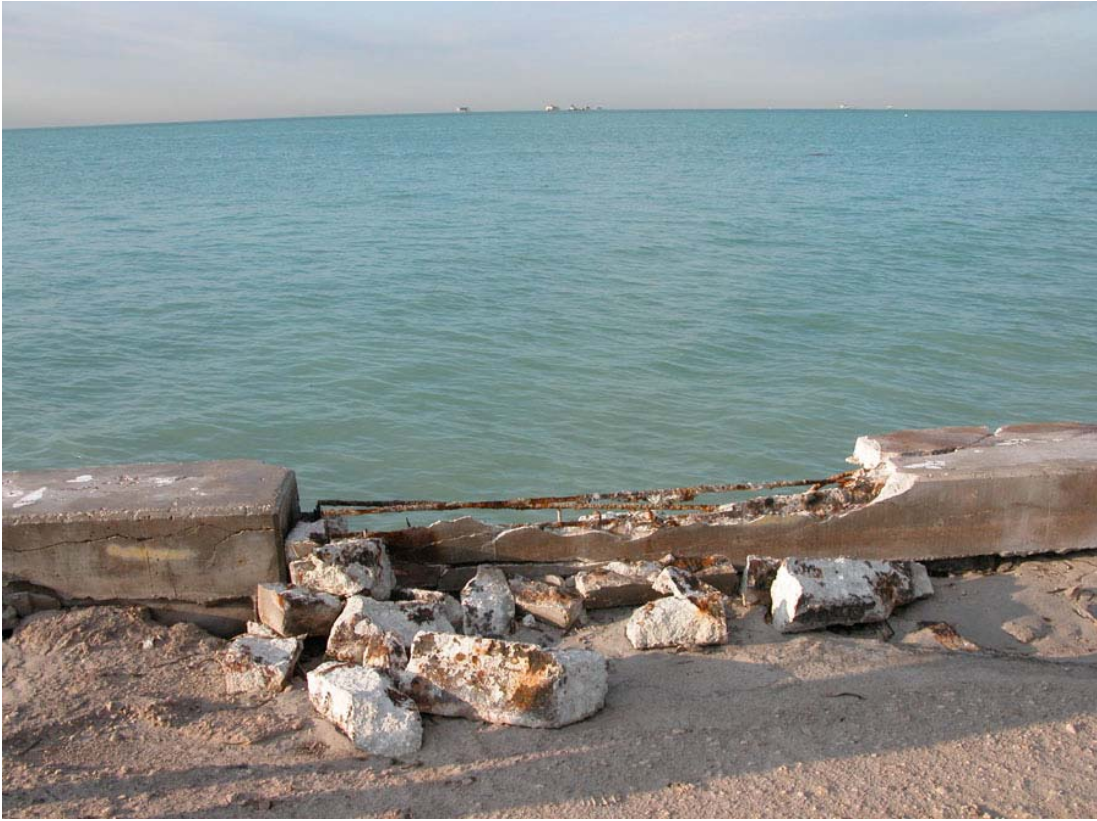
At Cape Florida, a concrete seawall and rock revetment sustained destruction requiring reconstruction. A 72-foot section of the wall was observed to have rotated seaward, and a 12-foot section of the wall lost its concrete cap (Photo 62).

Photo 62. Concrete cap damage, Cape Florida State Park.

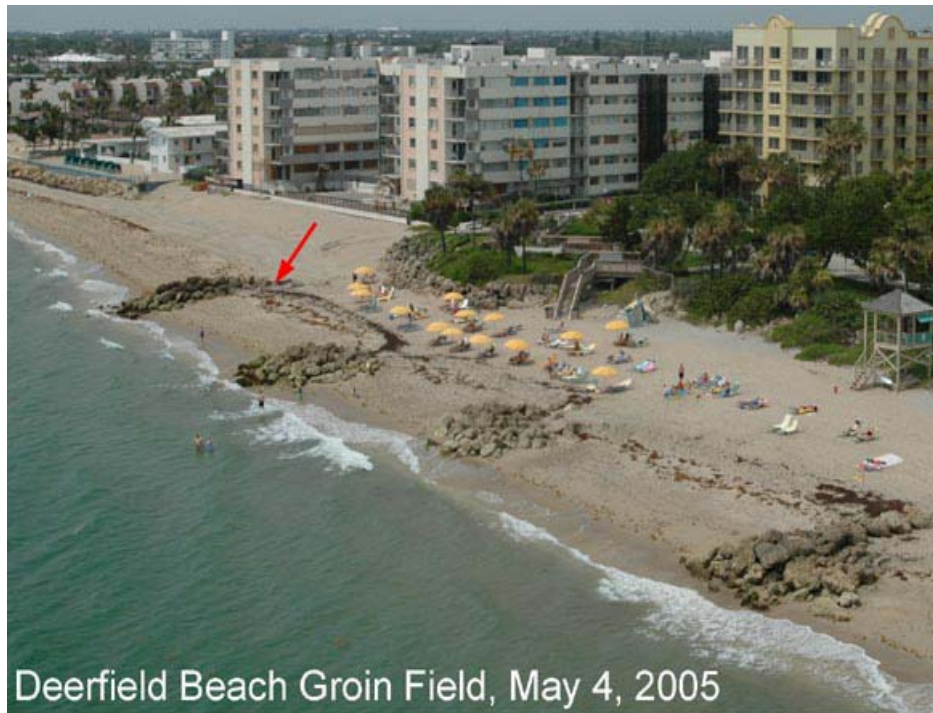
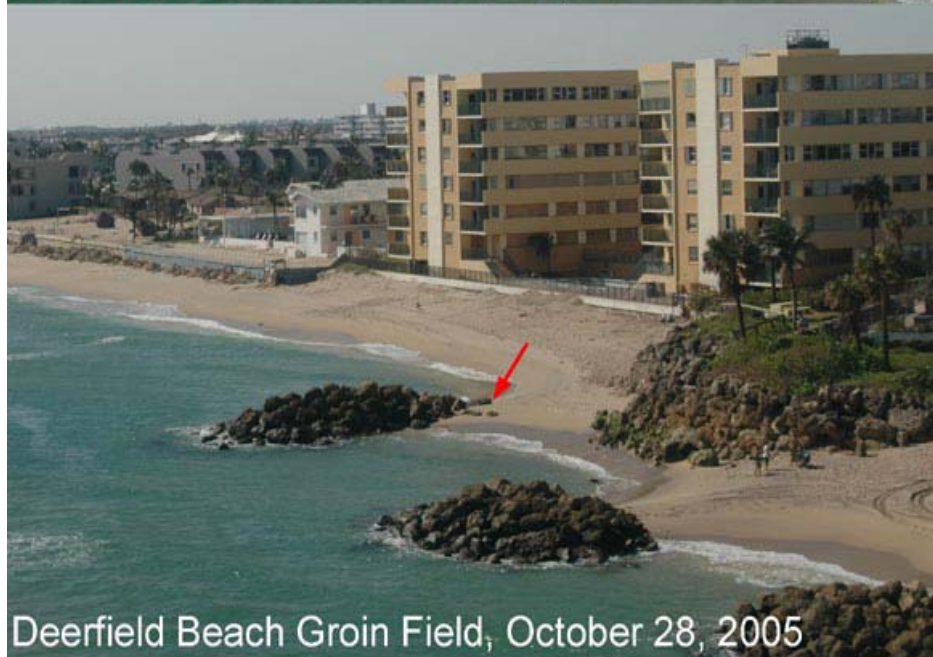
Northern Deerfield Beach (R1-R4.3) sustained minor beach erosion (condition I) and southern Deerfield Beach (R4.3-R6) generally sustained minor beach and dune erosion (condition II). Vertical beach losses were observed to range between two to three feet. At the south end of the Deerfield Beach groin field (R6-R6.8) and along northern Hillsboro Beach (R6.8-R11.6), moderate beach and dune erosion (condition III) was sustained (Photo 63). Vertical beach losses were observed to range between three to six feet. Southern Hillsboro Beach (R11.6-R22) sustained minor beach erosion (condition I). North of Hillsboro Inlet (R22-R24), accretion of the beach was observed.

Photo 63. Moderate erosion at Deerfield Beach (R6.8).

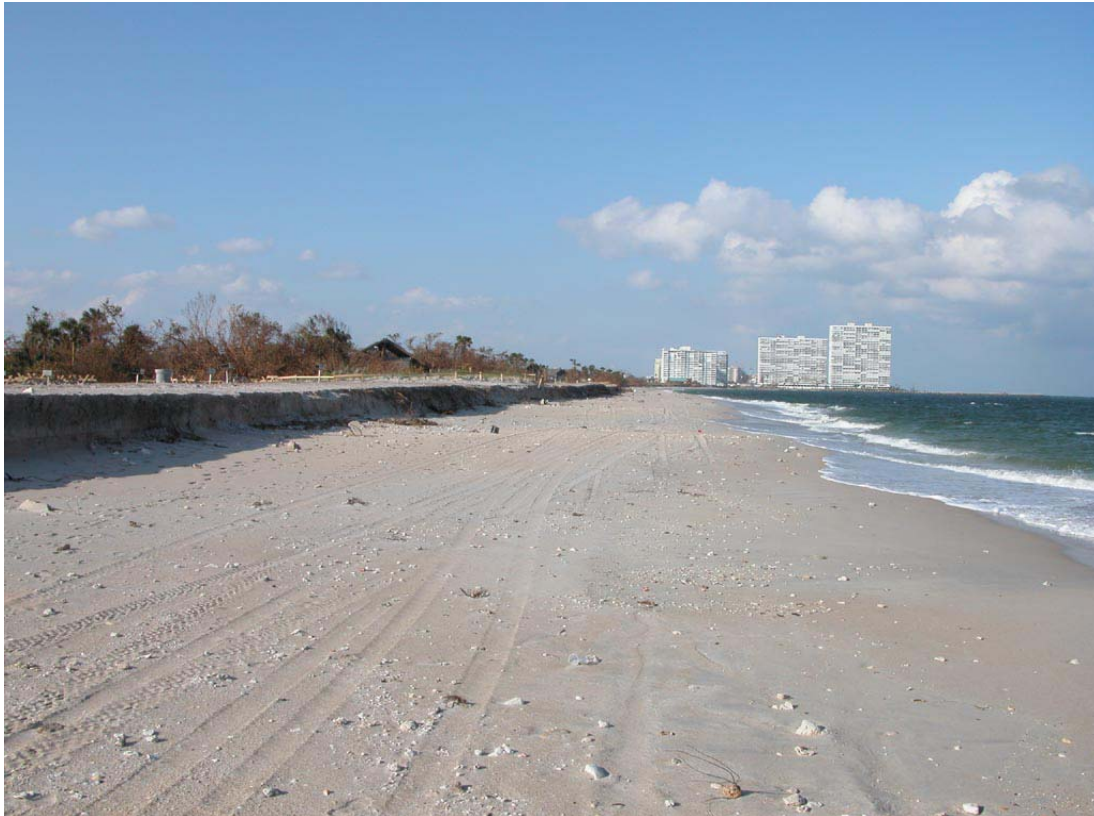
South of Port Everglades Entrance, conditions within John U. Lloyd State Park (R86-R98) varied between minor beach erosion (condition I) and minor beach and dune erosion (condition II) (Photo 64). Also within the park, small segments of moderate beach and dune erosion (condition III) were sustained near R90 and R96. To the south, Dania, Hollywood, and Hallandale generally sustained minor beach erosion (condition I); however, small segments of beach accretion were observed.

Photo 64. Moderate beach erosion at John U Lloyd State Park (R88).

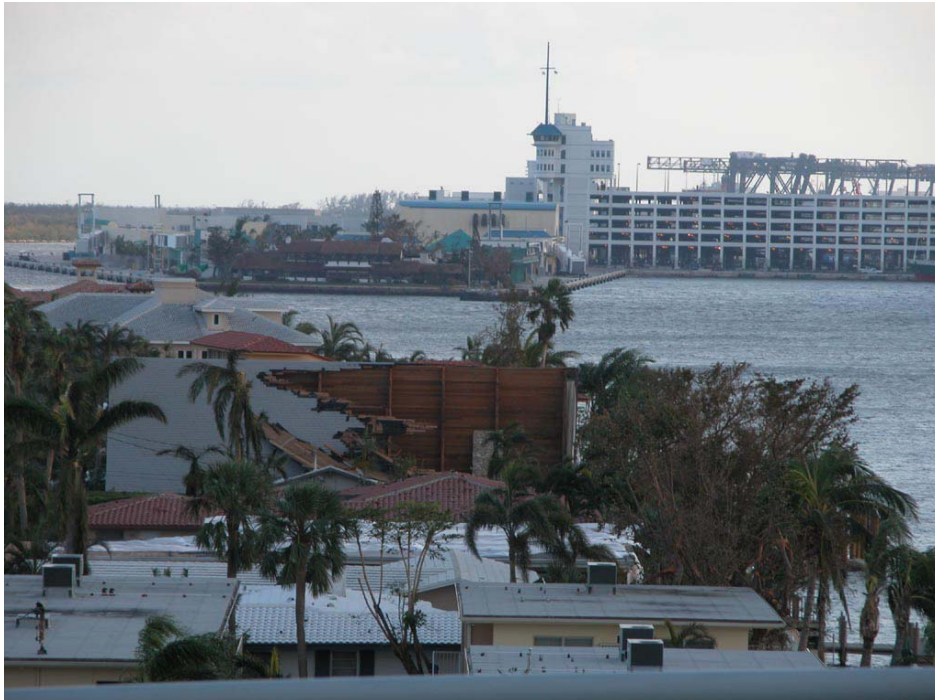
Atlantic Intracoastal Waterway sustained major roof damage (Photo 65). Many boats, docks, and bulkheads were damaged. Dry storage marinas sustained major damage (Photo 66).

Photo 65. Major roofing damage. Fort Lauderdale.

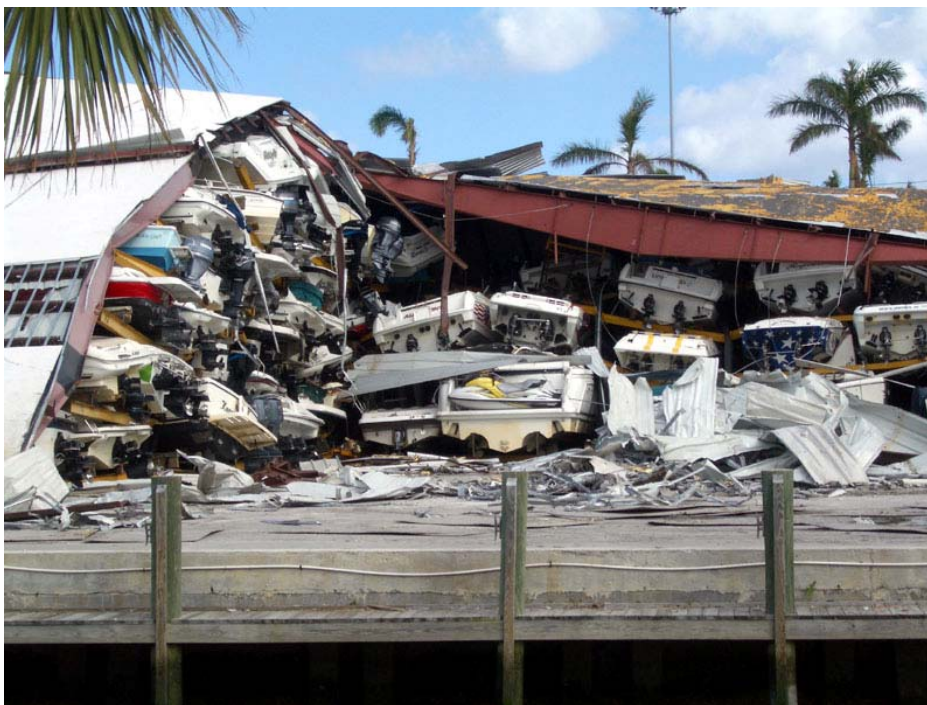
Photo 66. Destroyed dry storage marina (Marina One, Deerfield Beach).

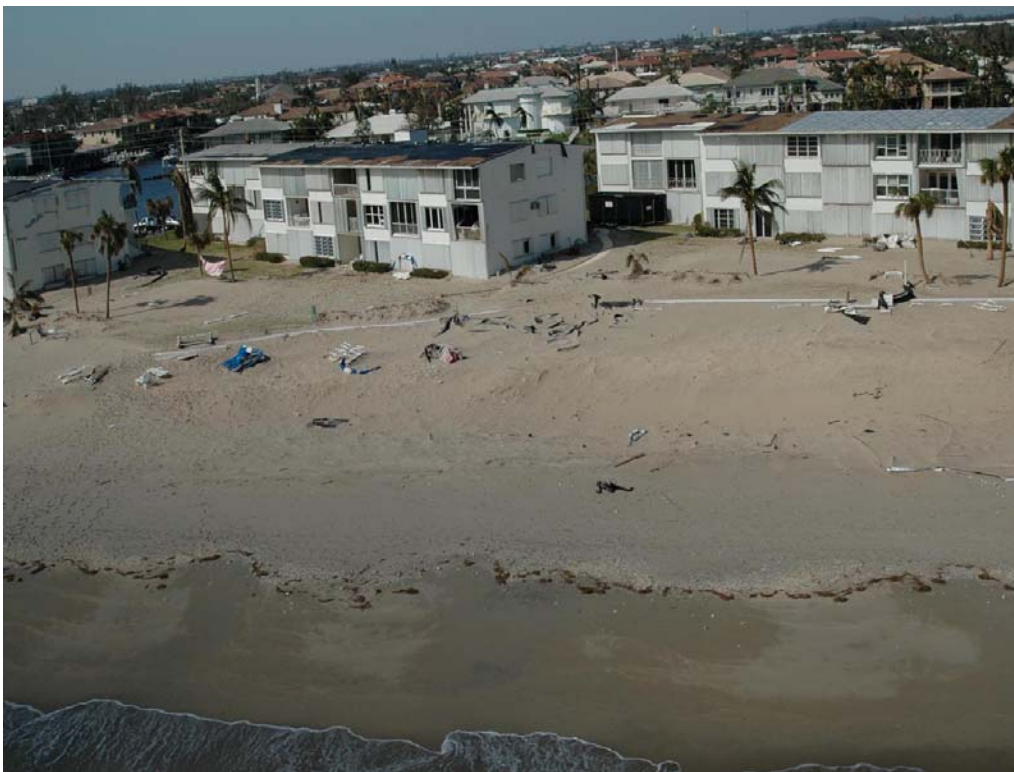
Along the ocean front of Deerfield Beach, 15 major structures sustained major roofing damage, including seven multifamily dwellings (condominiums) and six single-family dwellings. One unit of a condominium was also severely damaged by a storm-related propane gas explosion. Further inland in Deerfield Beach, numerous retirement communities of manufactured homes sustained major damages. In Hillsboro Beach, only one multifamily dwelling sustained complete roof failure, but many others sustained major damage to roof sheathing/cladding (Photo 67).

Photo 67. Damaged multifamily dwellings, Hillsboro Beach (R16.7)

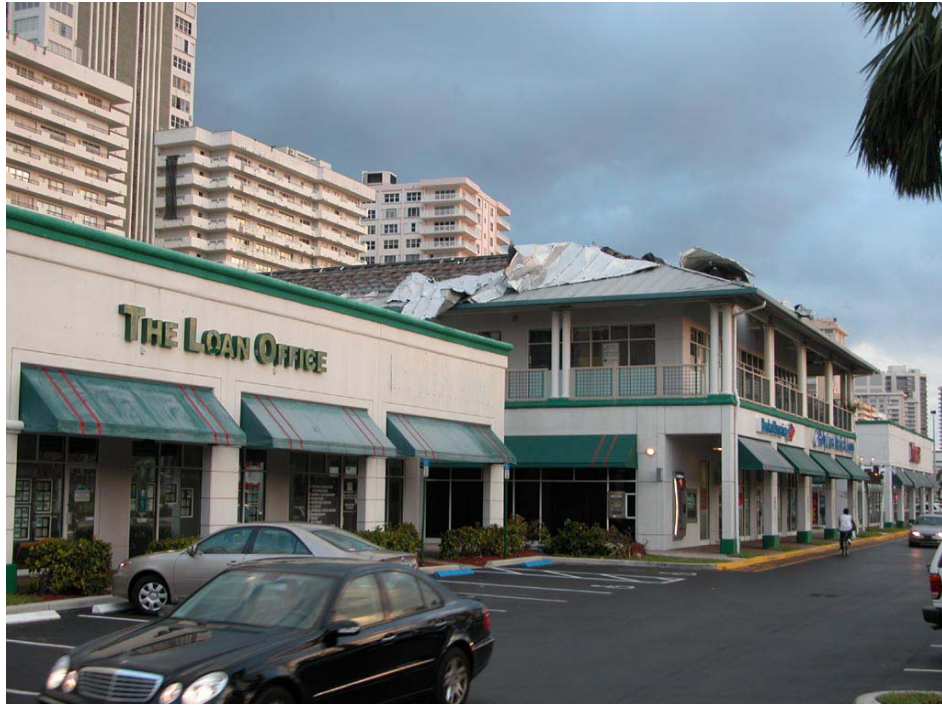
Along the coastal communities between Hillsboro Inlet (R25) and Port Everglades Entrance (R84.7), widespread wind damage to roofing and siding was sustained. High-rise condominiums along the ocean front sustained significant interior losses due to damaged sliding glass doors, windows, and siding. The Pompano Beach Fishing Pier, previously damaged by the waves of Hurricane Frances in 2004, sustained additional wind damage. A construction crane in Fort Lauderdale Beach experienced high fatigue stresses that weaken the structure's support brackets. Commercial buildings along State Road A1A within the Coastal Building Zone sustained major roofing damage (Photo 68). In Lauderdale-by-the-Sea, a beach motel (R49.3) sustained major roof damage (Photo

Photo 68. Major roofing damage to commercial building, Ft. Lauderdale (R55.6).

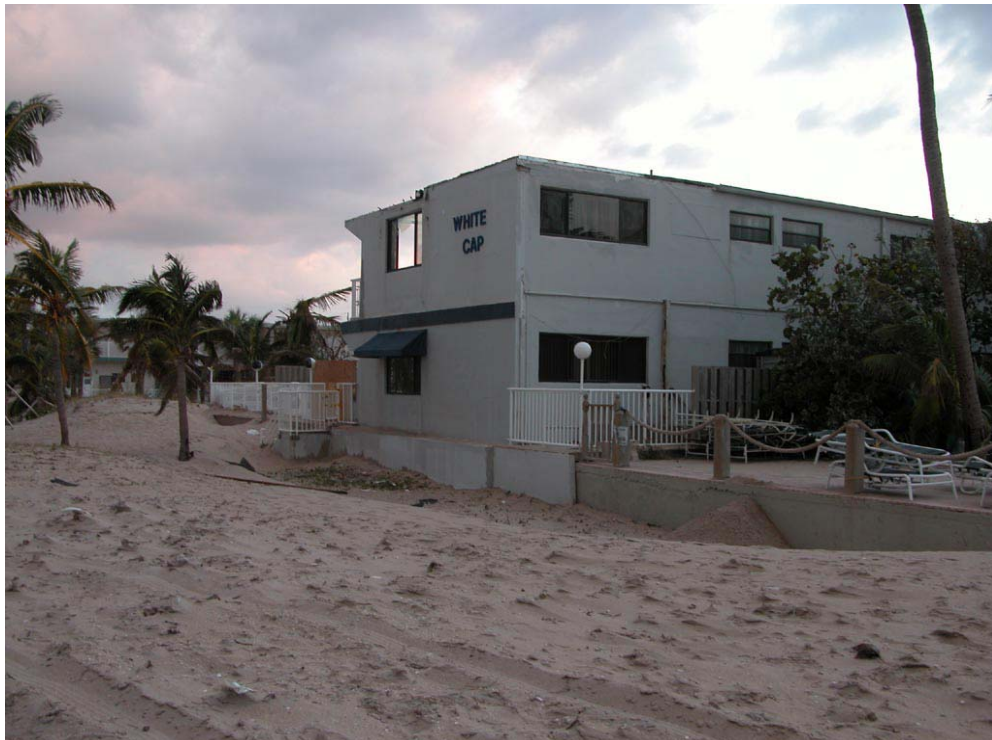
Photo 69. Roof destroyed at beach side hotel, Lauderdale-by-the-Sea (R49.3).

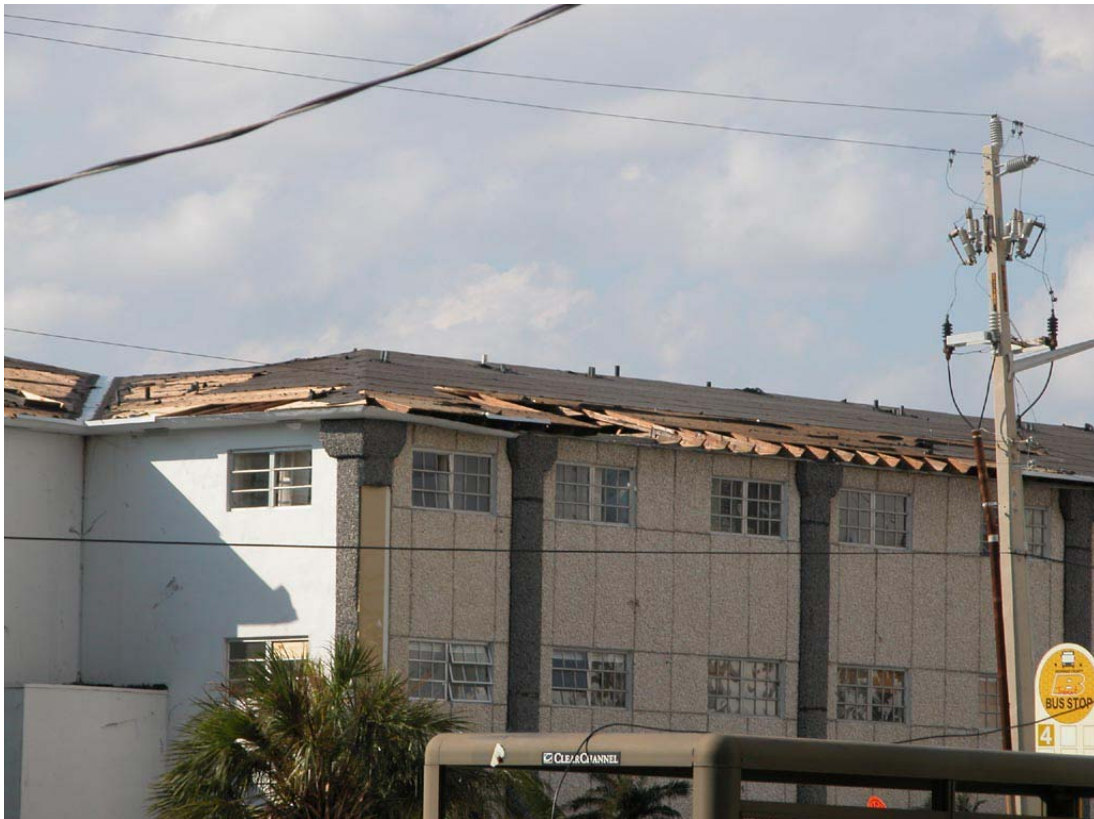
At John U. Lloyd State Park, the park manager's living quarters were damaged. Along the ocean front of Dania, Hollywood, and Hallandale, many multifamily dwellings (condominiums and hotels) sustained minor to major roofing damage. Most of the high-rise hotels and condominiums seaward of the Broward County Coastal Construction Control Line sustained cladding and window damage on their south and west sides. In Hollywood, a condominium (R119.8) sustained major roof damage (Photo 70). In Hallandale a construction crane was toppled and strewn along A1A.

Photo 70. Major roofing damage, Hollywood (R119.8).

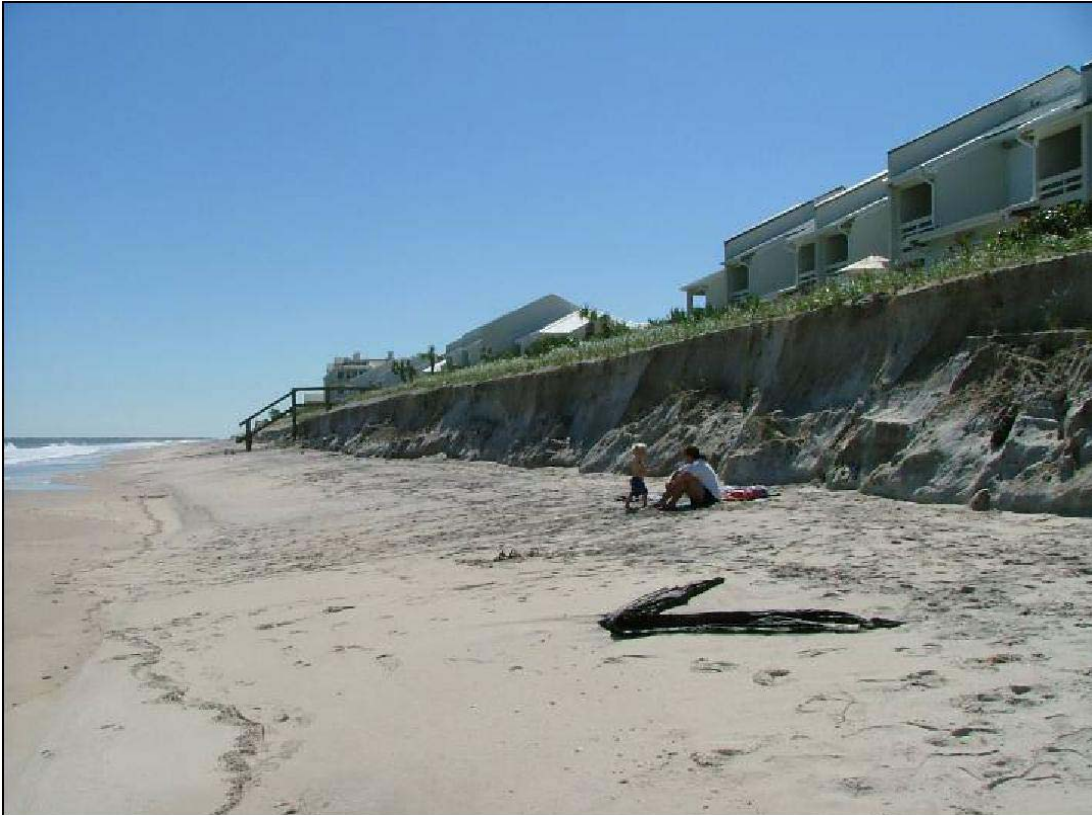
Most of the county sustained minor beach and dune erosion (condition II). No overwash occurred within the county, and the most significant dune recession was observed adjacent to vertical seawalls. The most severe erosion conditions were observed in the Town of Indian River Shores between R46 and R55, where moderate beach and dune erosion (condition III) was sustained (Photos 71 and 72). The critically eroded south county beaches between R101 and R107 sustained minor beach and dune erosion (condition II) (Photo 73).

Photo 71. Erosion of dune restoration project, R47.4, Indian River County.

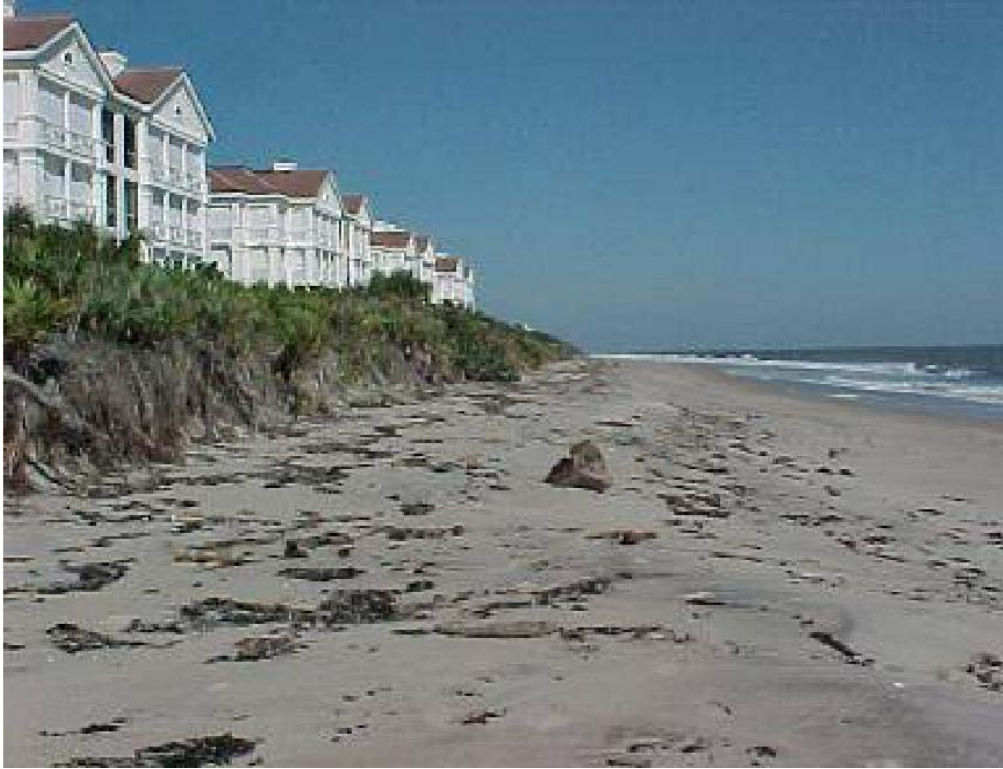
Photo 72. Moderate beach and dune erosion, Indian River County (R51).

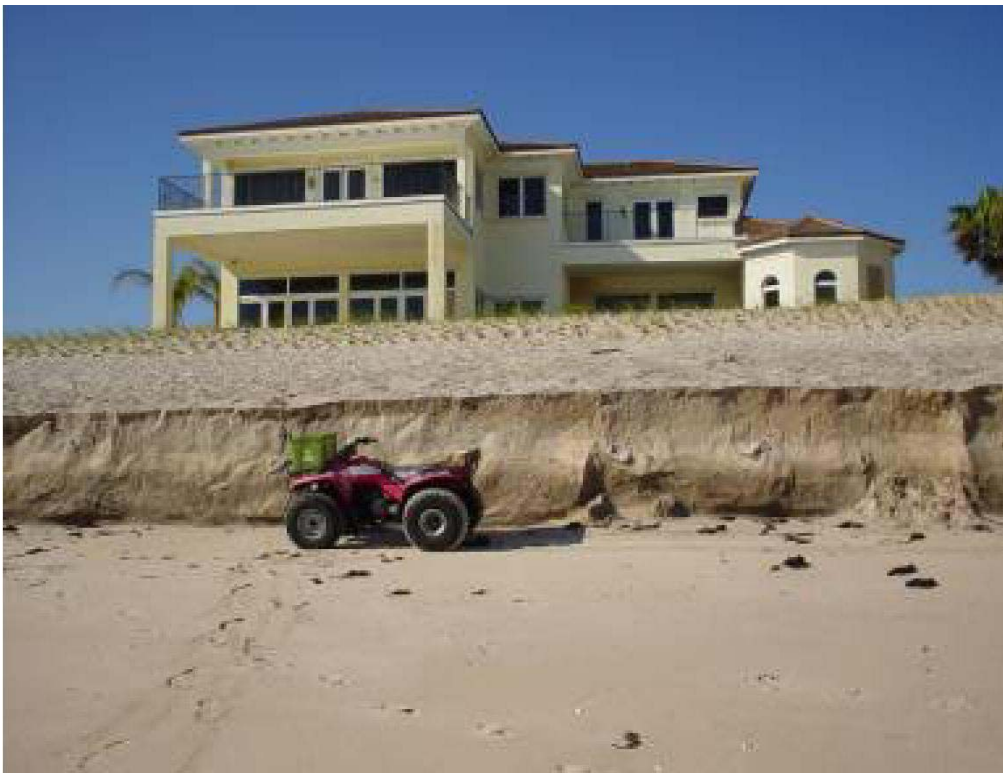
Photo 73. Erosion of dune restoration project, south Vero Beach (R102.5).

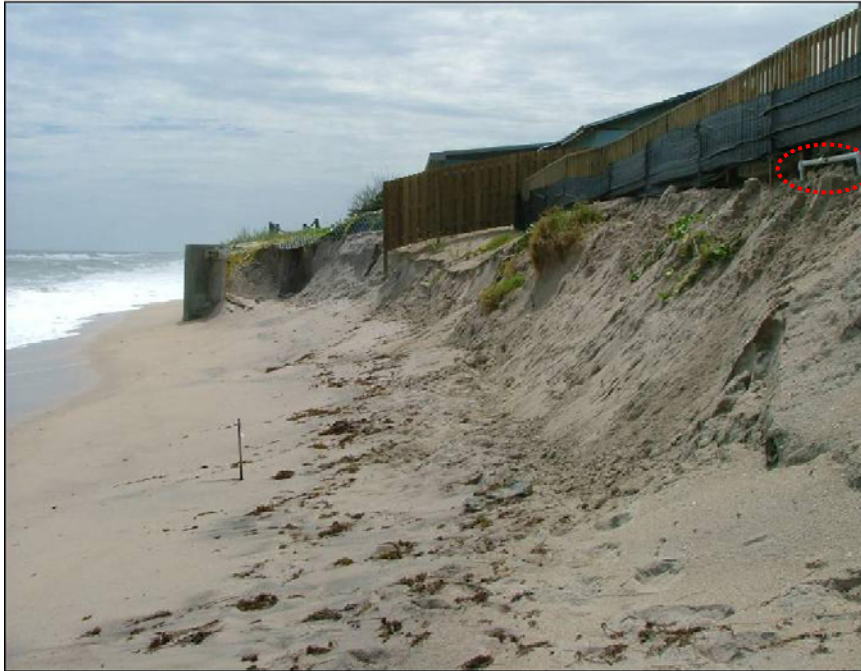
Throughout Brevard County, minor beach erosion (condition I) was sustained. One exception was observed in the critically eroded south county area near R158.5. In early September 2005, when Hurricane Ophelia passed 70 miles offshore of Brevard County, there was significant erosion at this location where dune restoration had been conducted following the 2004 storms (Photo 74). Additional moderate beach and dune erosion (condition III) from Hurricane Wilma's offshore passage, has now undermined a swimming pool and threatened a neighboring single-family dwelling (Photo 75).

Photo 74. Erosion of dune restoration project by Hurricane Ophelia, Brevard County (R158.5).

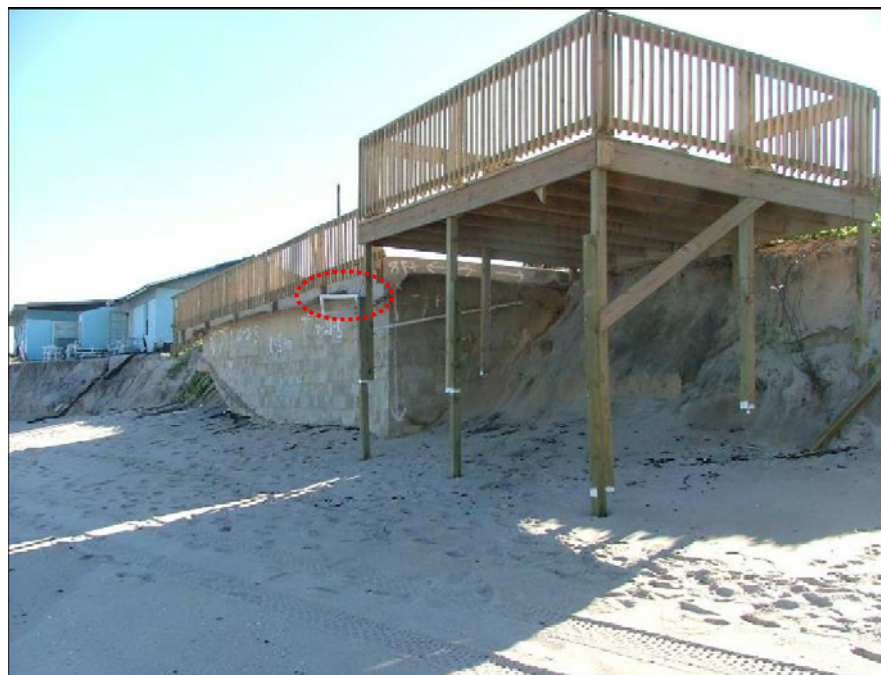
Photo 75. Pool undermined and dwelling threatened by Wilma, Brevard County (R158.5).

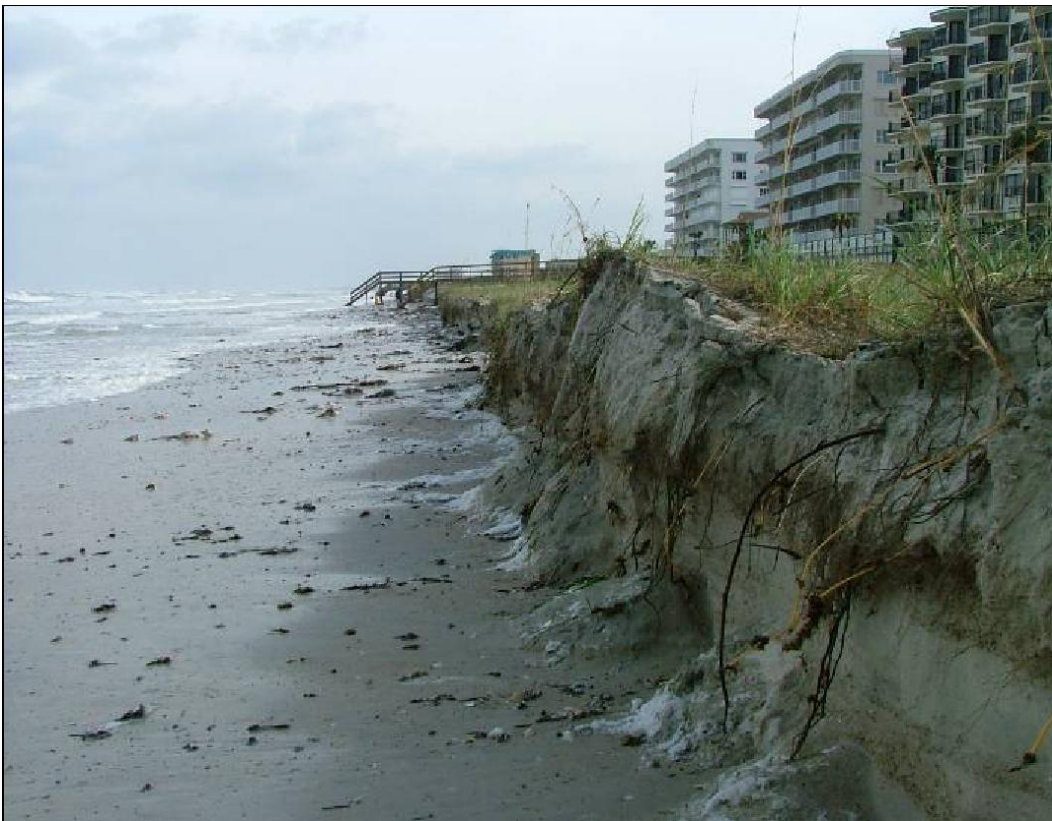
The beaches and dunes of Volusia County were severely eroded in 2004 by the impacts of Hurricanes Charley, Frances, and Jeanne, and a December northeaster. In early September 2005, Hurricane Ophelia passed offshore and caused additional beach erosion throughout the county. Hurricane Wilma's offshore passage inflicted additional erosion to these vulnerable beaches. Along most of northern Volusia County (R1-R115) only minor beach erosion (condition I) was sustained. South of the Port Orange Causeway along the south end of Daytona Beach Shores, Wilbur by the Sea, and the Town of Ponce Inlet (R115-R145), minor to moderate beach and dune erosion (condition II-III) was sustained. The dune erosion escarpment varied from two to six feet in this area (Photo 76). The area immediately north of Ponce de Leon Inlet (R145-R148) sustained only minor beach erosion (condition I).

Photo 76. Dune erosion escarpment, Town of Ponce Inlet (R139).
