Hurricane Irma
Post-Storm Beach Conditions and
Coastal Impact in Florida

Division of Water Resource Management
Florida Department of Environmental Protection

April 2018

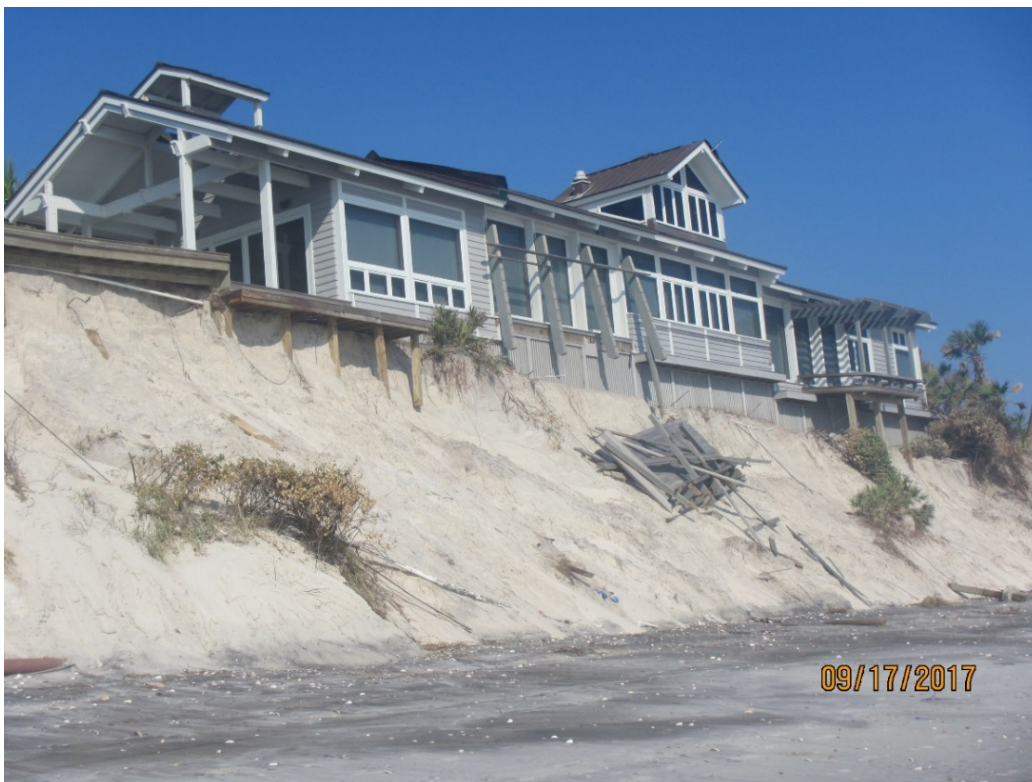
Irma’s impact along the northern coast of St. John’s County (R1-R118) north of St. Augustine Inlet was particularly severe, resulting in 115 buildings being left in imminent danger of incurring damage from another major storm (see Figure 9 and Figure 10). Example profiles of the major beach and dune erosion are shown in Figure 11 at R28 in Ponte Vedra and in Figure 12 at R94 in South Ponte Vedra adjacent to three destroyed single-family dwellings. South of St. Augustine Inlet, major beach and dune erosion (condition IV) was sustained along Anastasia Island State Park (R123-R140). Along the developed segment of Anastasia Island (R140-R193), including St. Augustine Beach, Crescent Beach and Matanzas Shores, the island sustained moderate to major beach and dune erosion (condition III to IV). Major beach and dune erosion is shown in Figure 13 at R142 in St. Augustine Beach adjacent the St. Augustine Beach

Figure 10. Major dune erosion threatening structure at R27.6, Ponte Vedra.

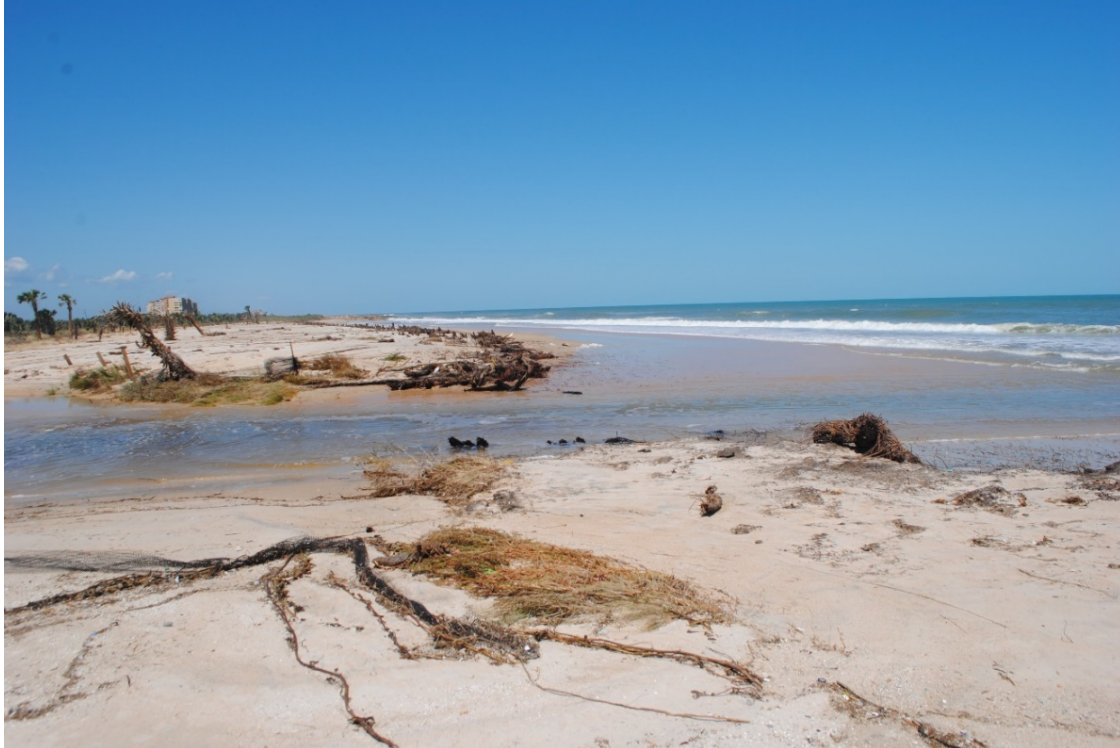
Figure 21. Dune breach by storm surge of Irma, Washington Oaks State Park, R14.5.

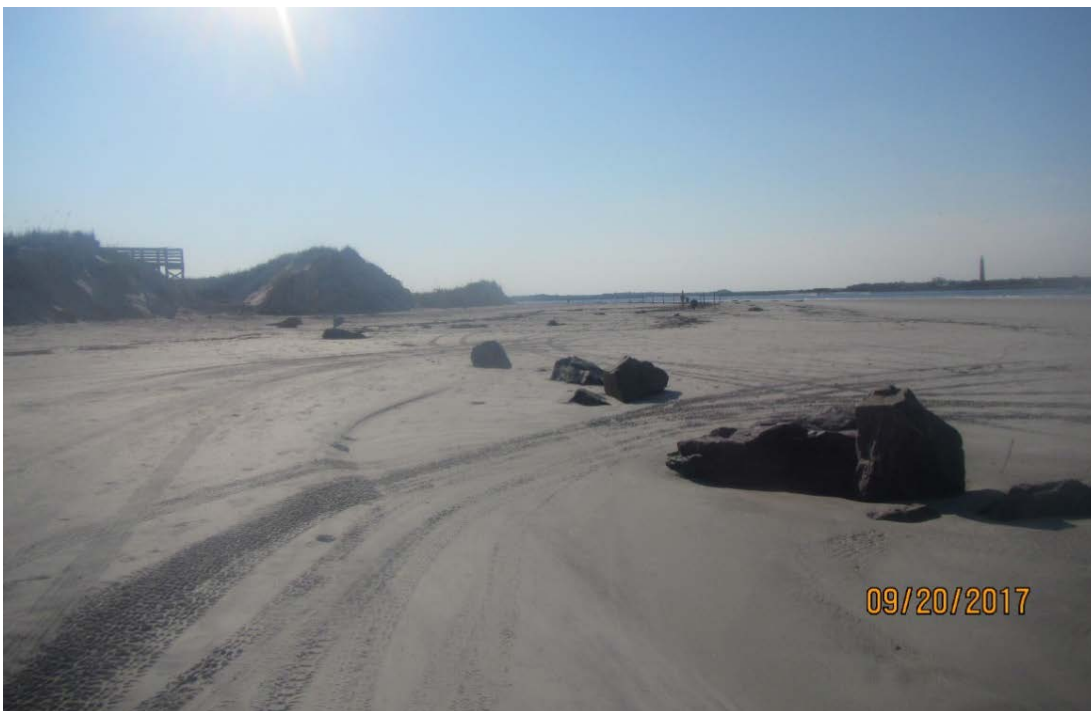
Figure 26. South jetty breach and overwash into Ponce de Leon Inlet (looking northwest), R149.

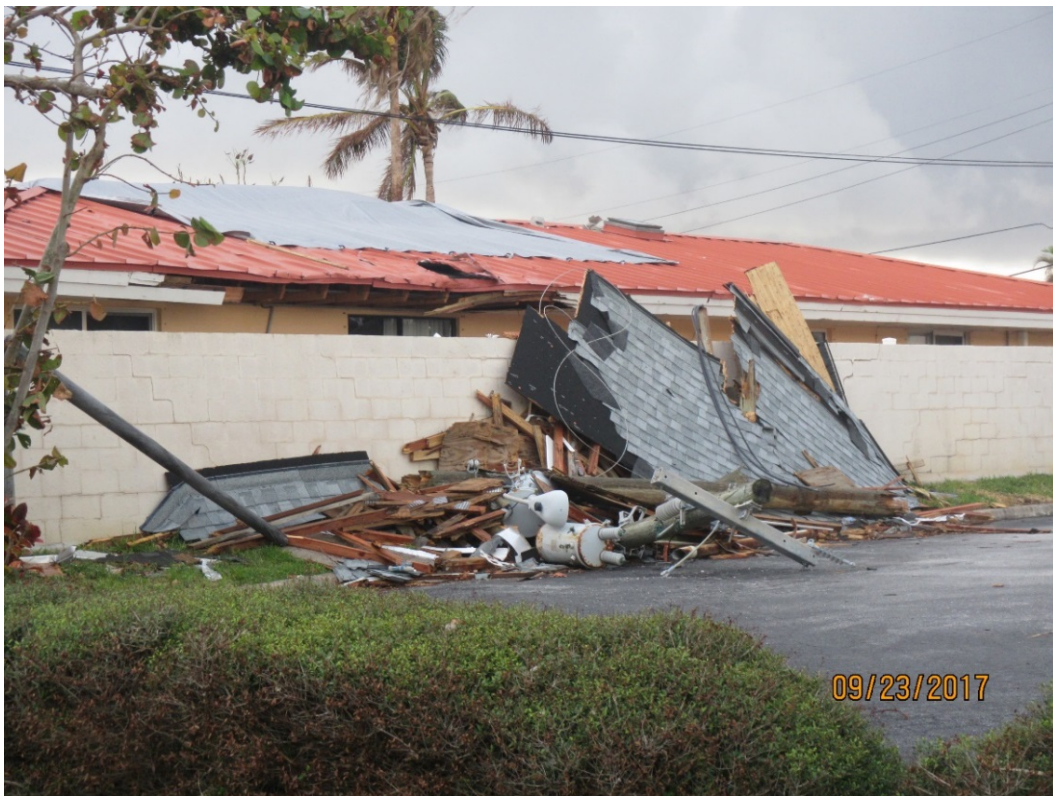
Figure 33. Condominium roof section blown across State Road A1A onto single-family dwelling by tornado at R122, Indialantic.

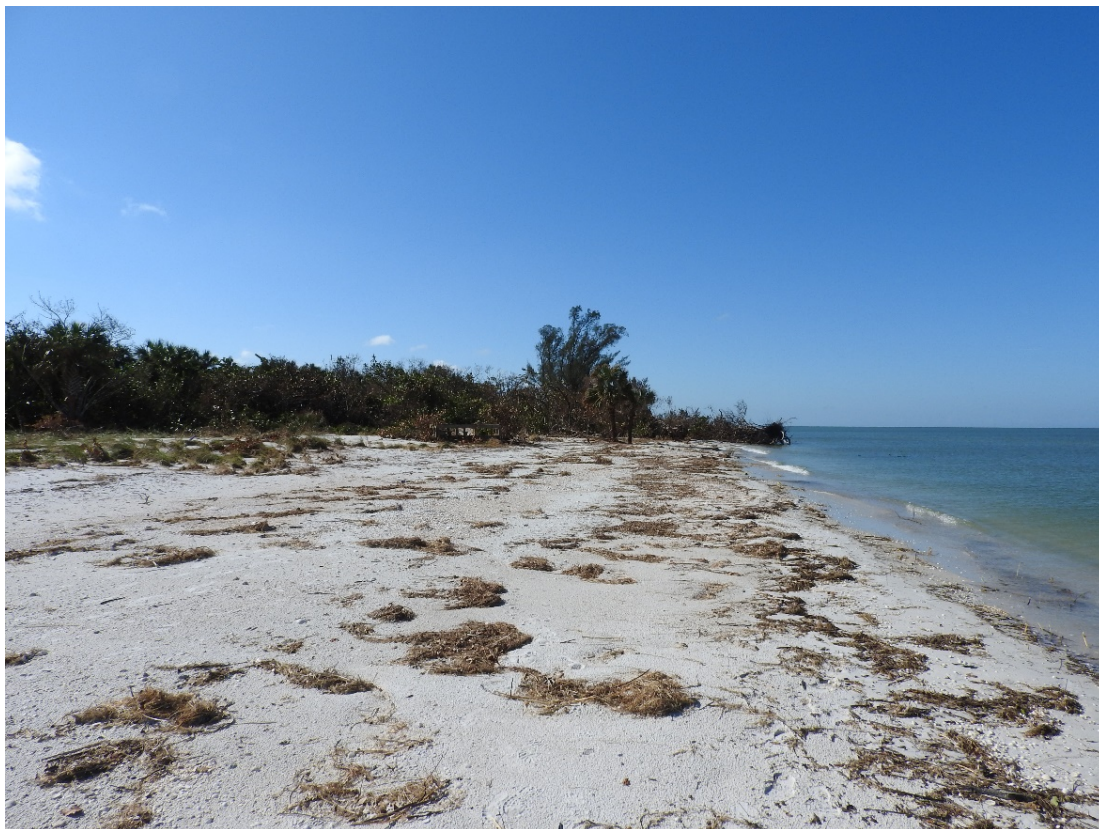
Figure 39. Major beach and dune erosion near R17 south of Wiggins Pass looking south.

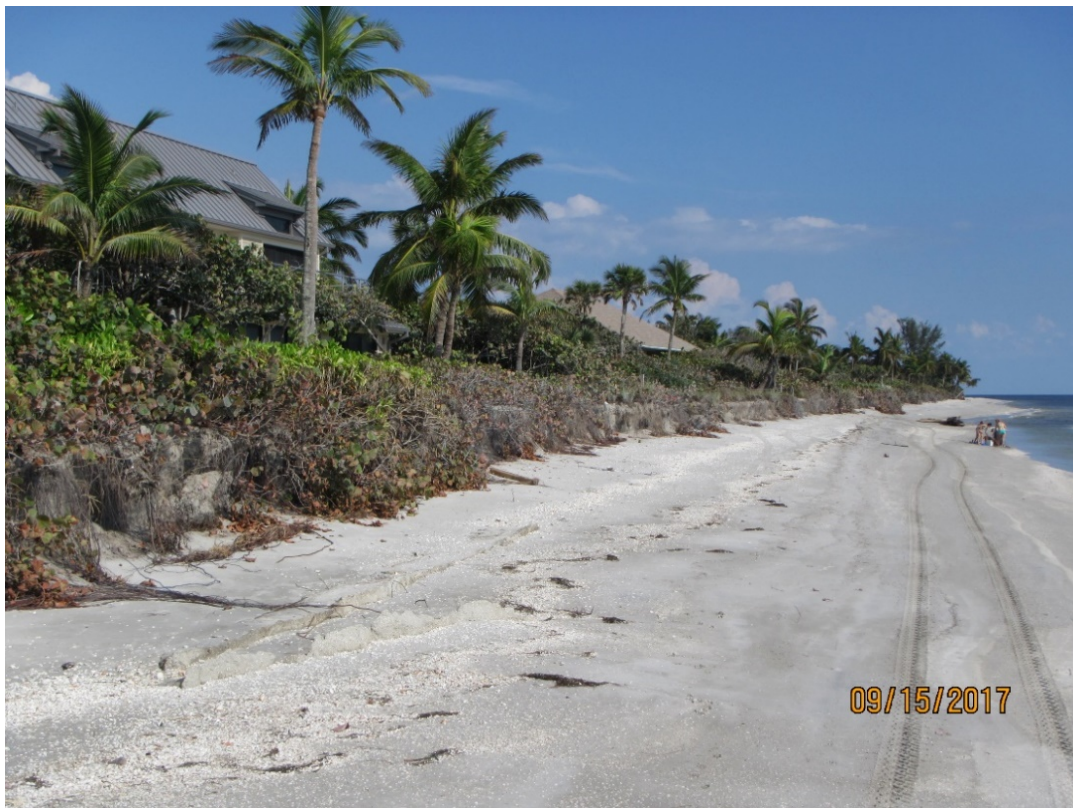
Figure 46. Erosion at the southern end of Sanibel Island near R131.

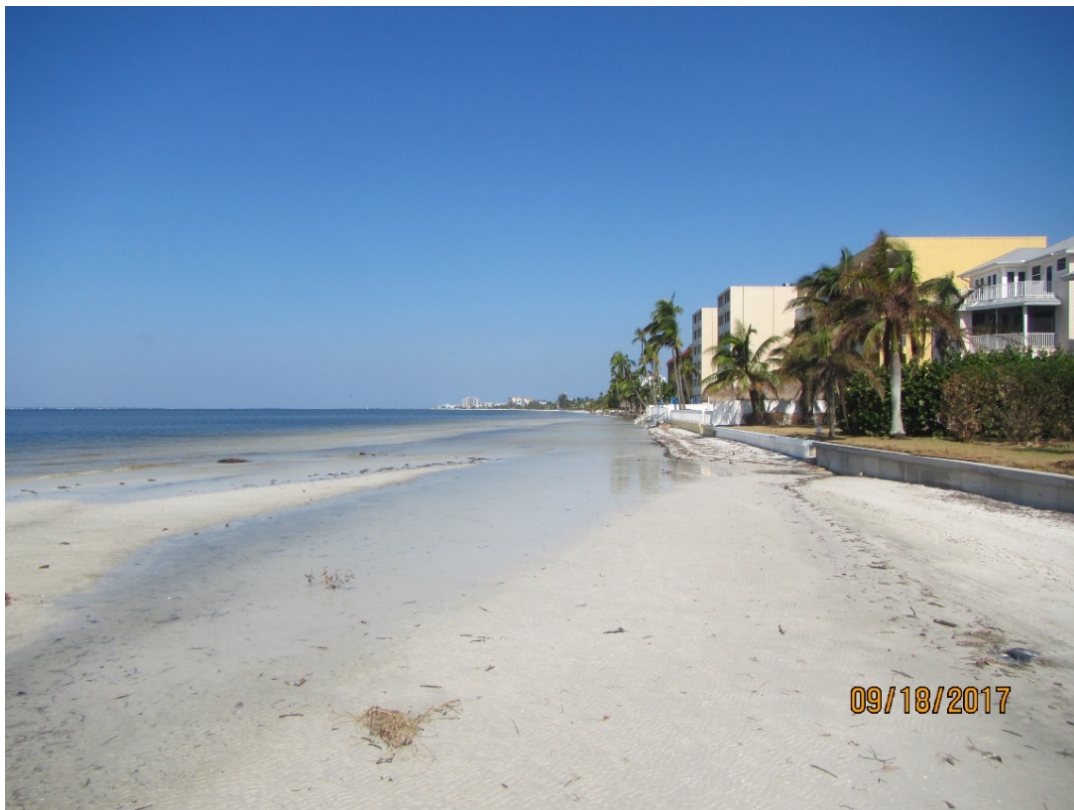
Figure 47. Erosion at Fort Myers Beach near R194.

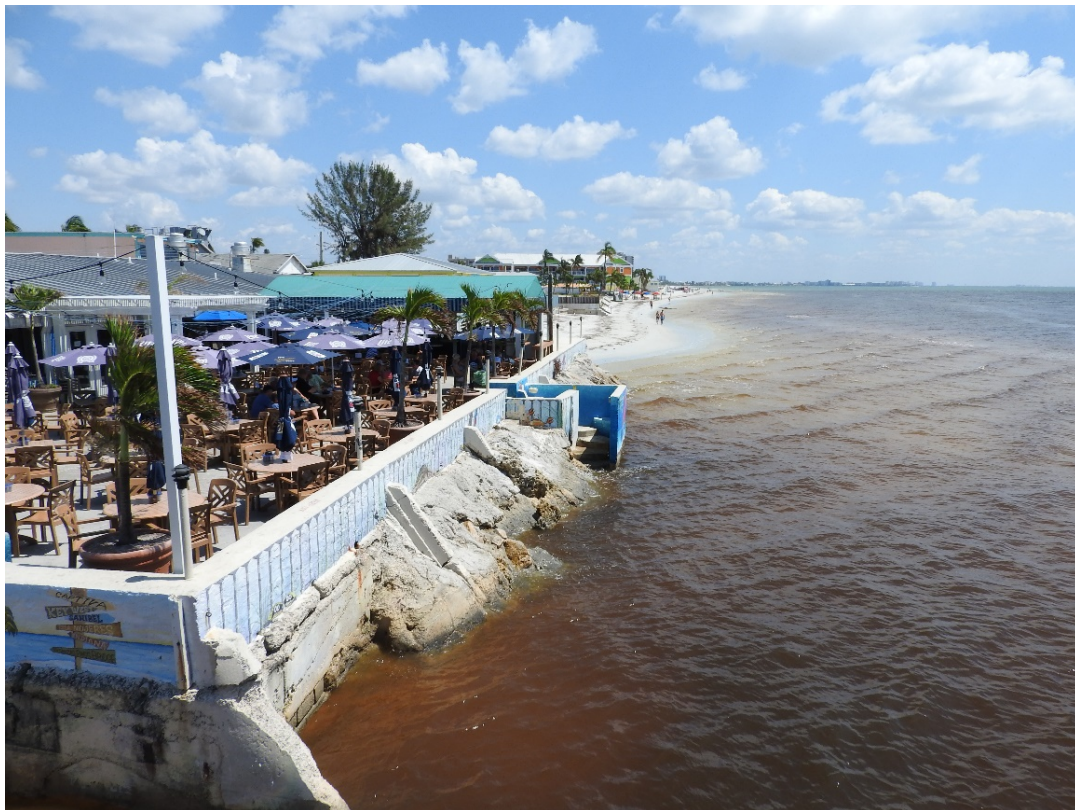
Figure 48. Erosion south of the Fort Myers Beach Pier near R180.

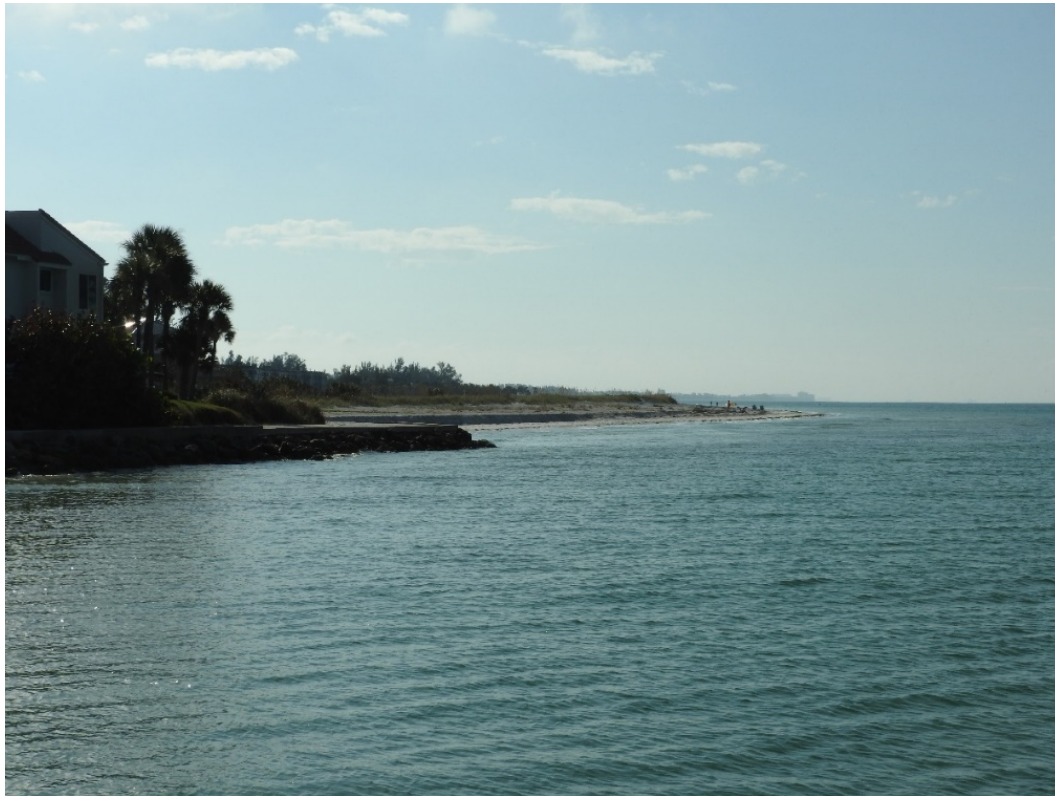
Figure 59. The northern end of Longboat Key had severe erosion between R43 and R45.

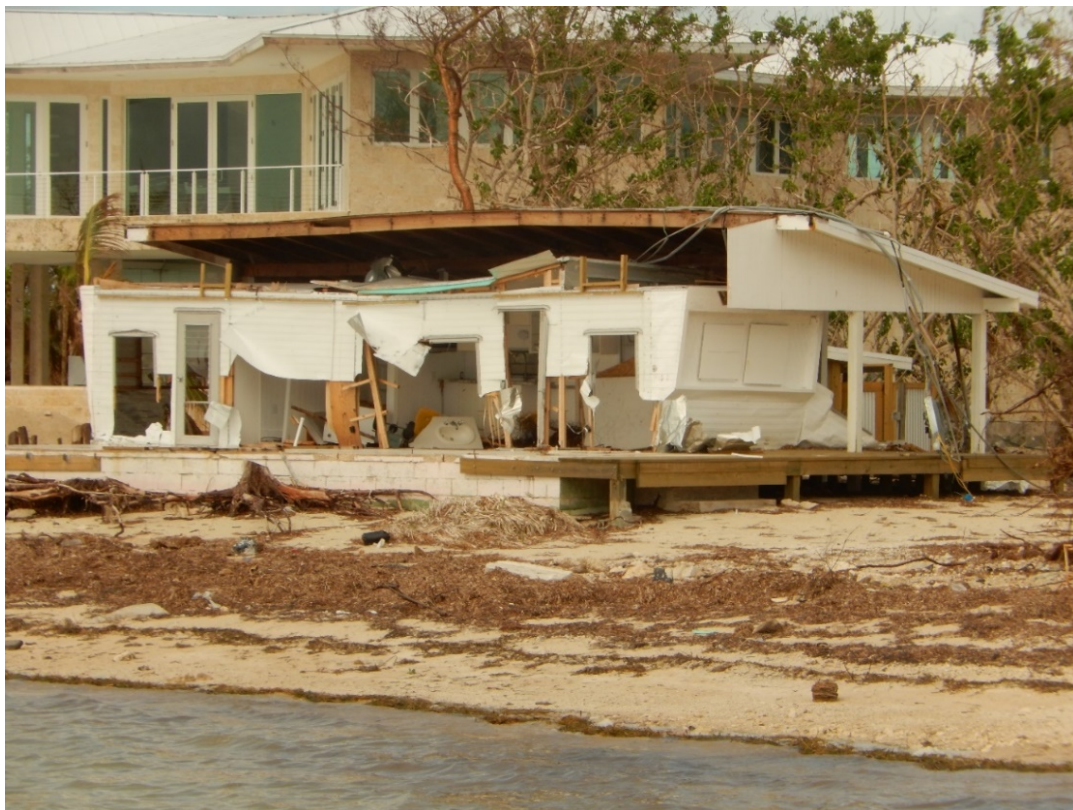
Figure 65. Single-family dwelling destroyed on Grassy Key.

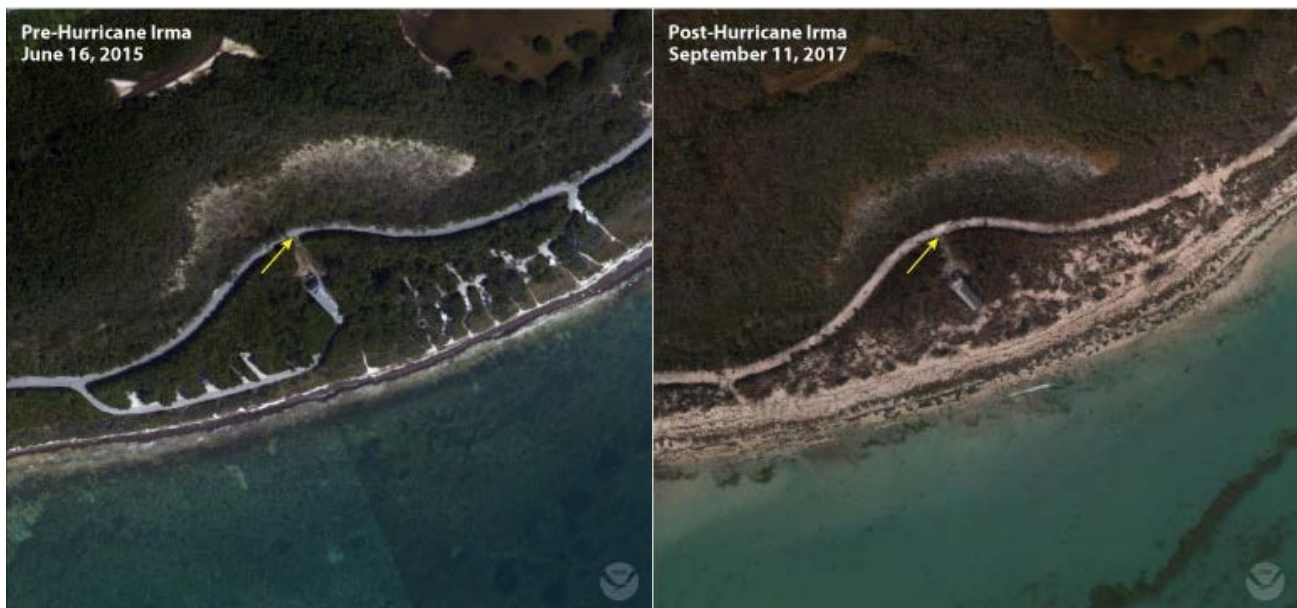
The eastern 7,400 feet of beach on Bahia Honda Key, known as Sandspur Beach, is a fine-grained carbonate beach that averages 60 feet in width, fronting prominent vegetated barrier dunes. Except for periodic hurricane impacts, most of this stretch of beach has been stable. Hurricane Irma inflicted major beach and dune erosion (condition IV) along Sandspur Beach and substantially destroyed the park's infrastructure. Comparing pre- and post-Irma NOAA aerial photography, as much as approximately -75 feet of shoreline recession was observed within Sandspur Beach, particularly between the campsites and the day-use parking lots (Figure 84). About 1,000 feet of road and all the campsites were destroyed or severely damaged (Figure 85). In the high use public beach access area, two 500-foot-long asphalt parking lots were destroyed, and approximately 1,500 feet of park road was damaged (Figure 86). Three beach pavilions, a large bathhouse, and seven beach access walkways were also destroyed adjacent to the parking lots (Figure 87, Figure 88 and Figure 89). In addition, at the far eastern end of Bahia Honda Key, a state park maintenance building was destroyed. Along with the beach erosion and damage to park structures and infrastructure, Irma caused extensive damage to native vegetation across the island.

Figure 84. Comparative NOAA aerial photos of the Bahia Honda State Park campgrounds adjacent to Sandspur Beach (Source: National Assessment of Coastal Change Hazards, St. Petersburg Coastal and Marine Science Center, USGS).

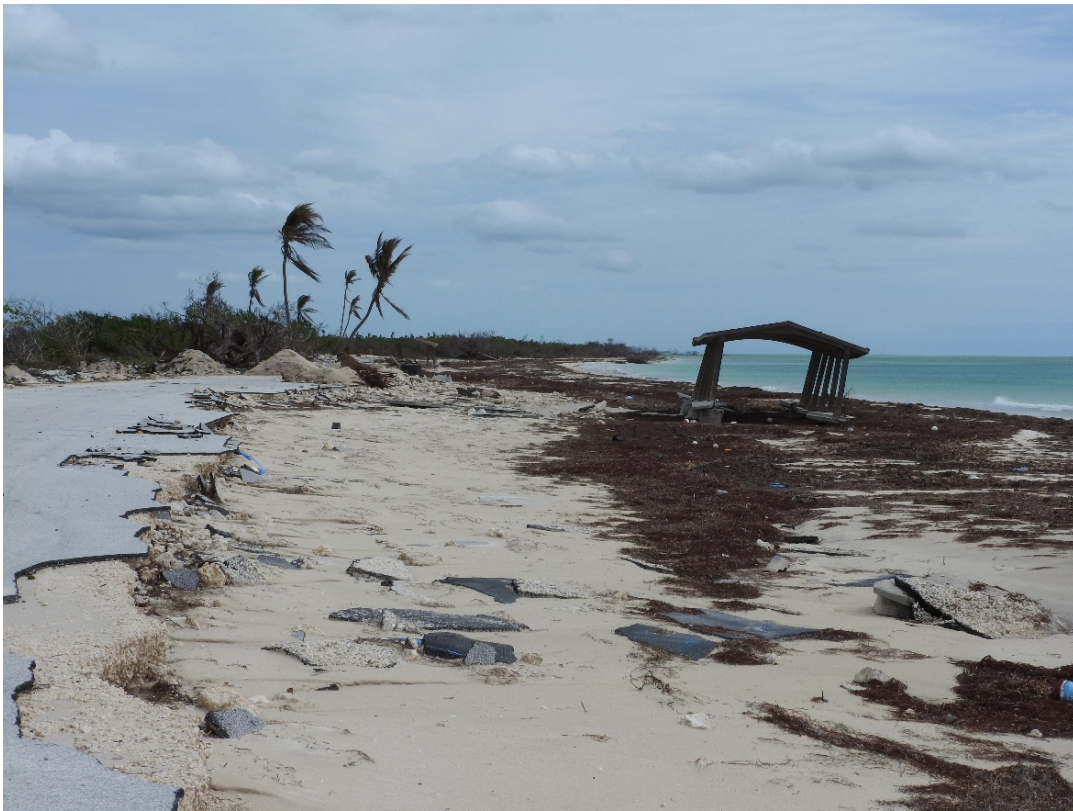
Figure 86. Sandspur Beach parking lot destroyed.

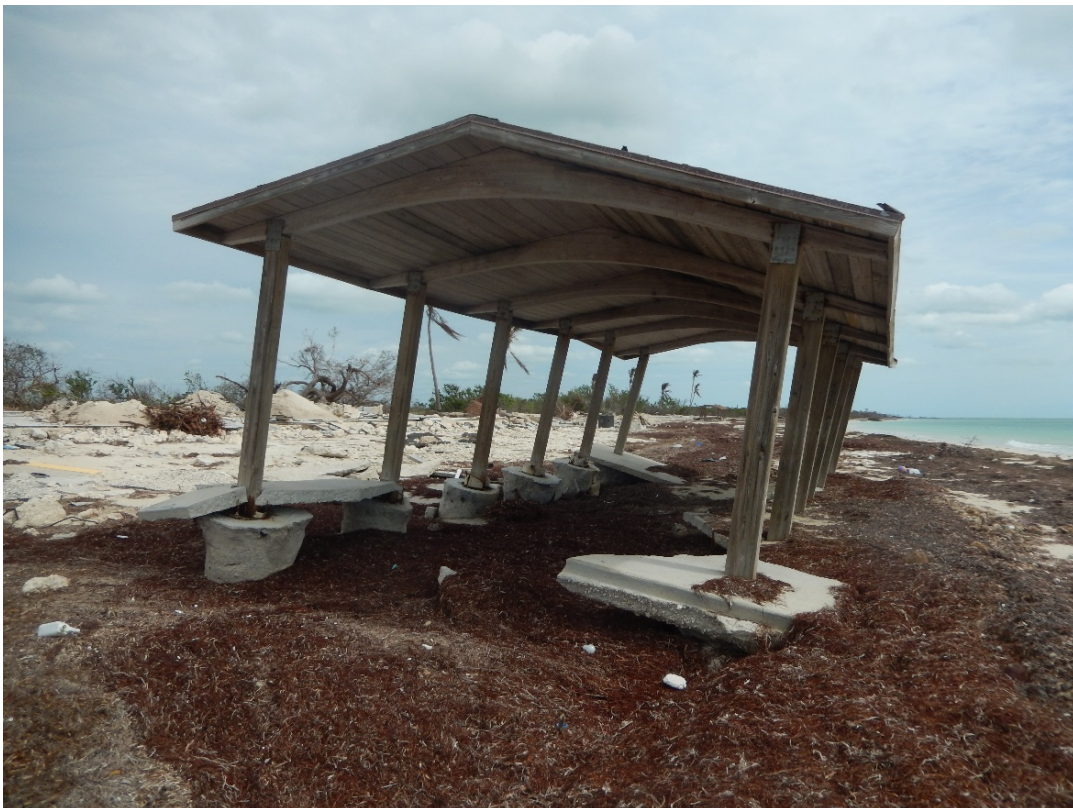
Figure 87. Middle beach pavilion and parking lot destroyed, Sandspur Beach.

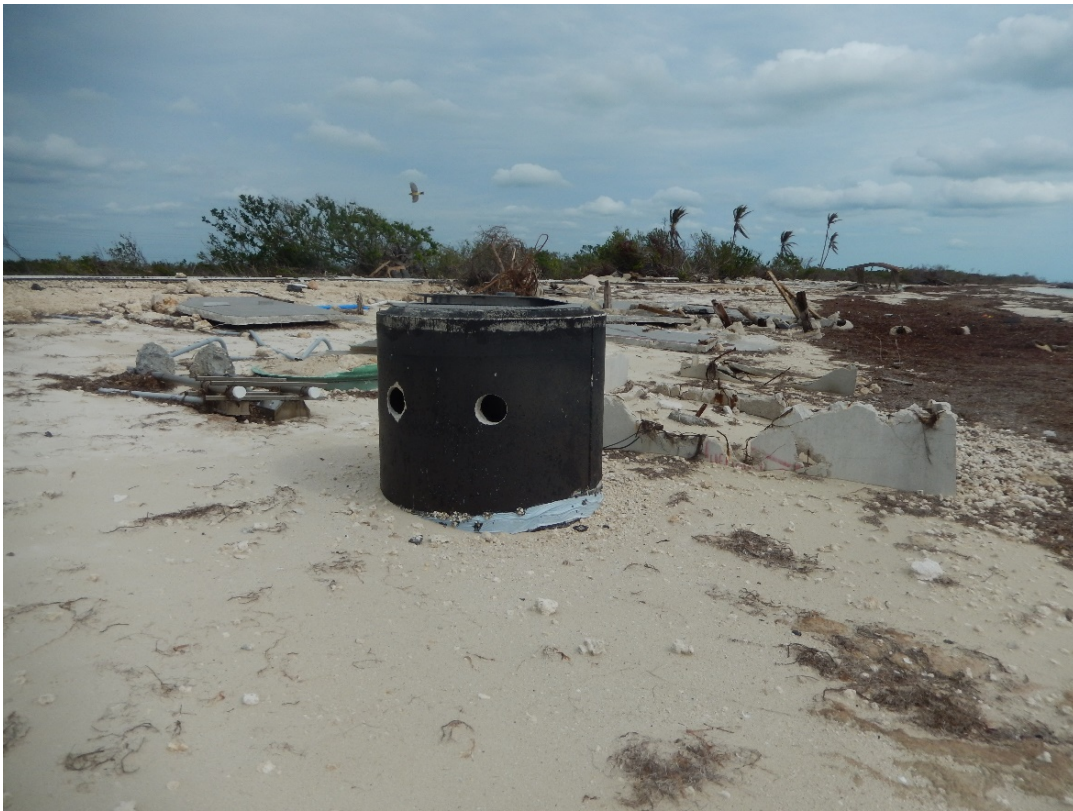
Figure 88. Bathhouse structure totally destroyed, Sandspur Beach.

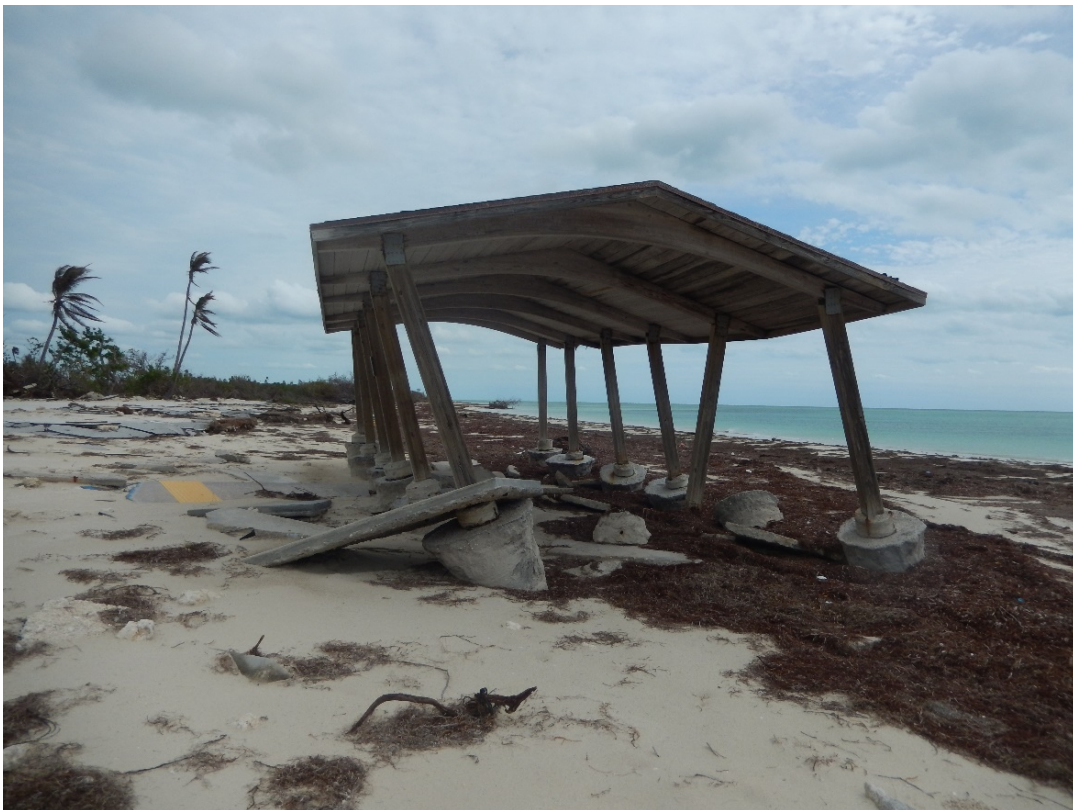
Figure 89. Eastern pavilion structure and parking lot destroyed, Sandspur Beach.

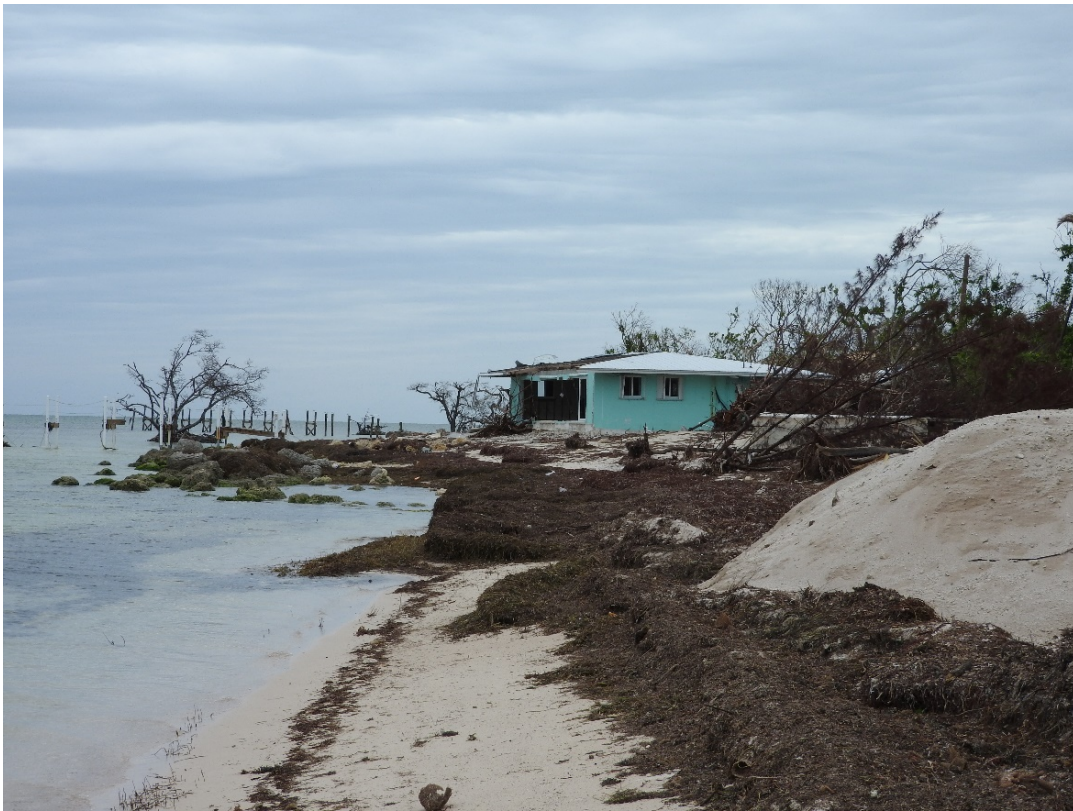
Figure 92. Dwelling and dock destroyed, Long Beach, Big Pine Key.

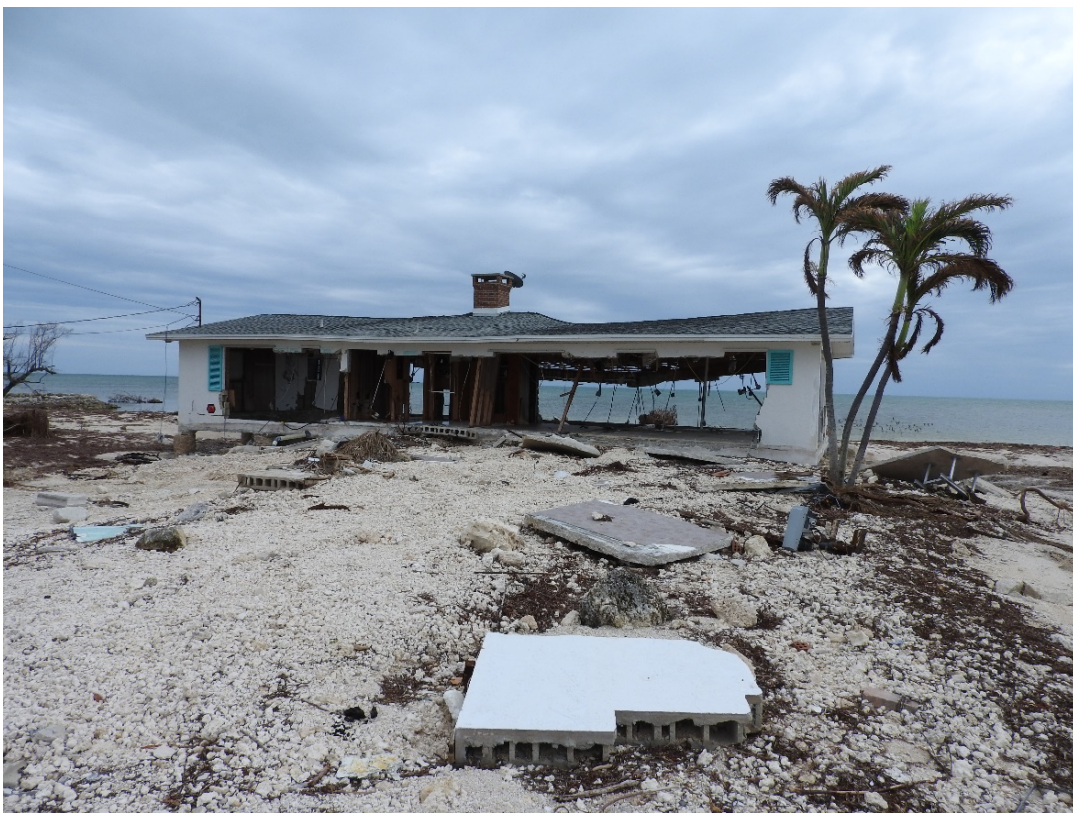
Figure 93. Single-family dwelling destroyed, Long Beach, Big Pine Key.
