HURRICANE DENNIS

SUPPLEMENTAL DAMAGE ASSESSMENT REPORT

Impact of Hurricane Dennis on Dog Island And Discussion of Post-Storm Recovery Responses

***Ralph R. Clark
Florida Department of Environmental Protection
Division of Water Resource Management
Bureau of Beaches and Coastal Systems
August 2005***

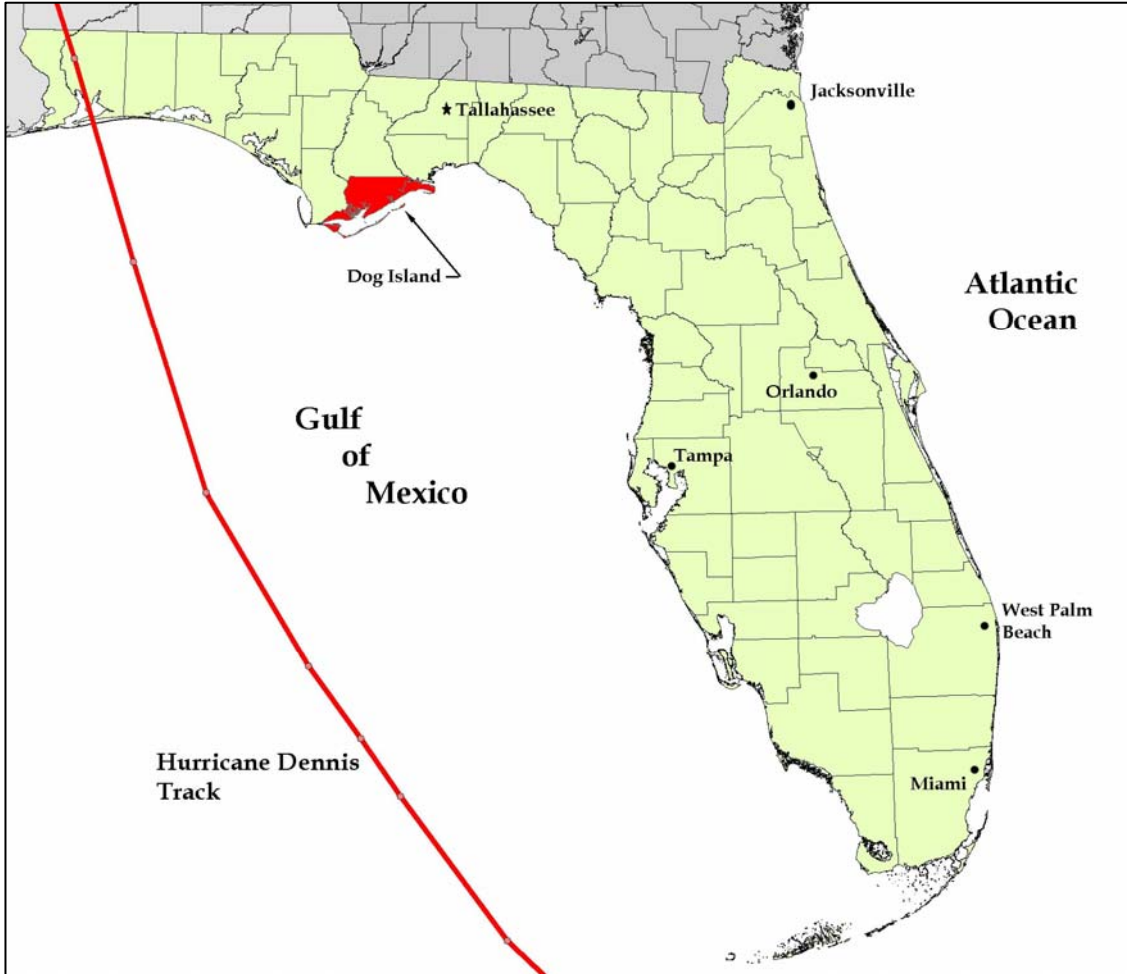
Figure 1. Hurricane Dennis Track Map.

On Sunday afternoon, July 10, 2005, Hurricane Dennis made landfall on the northwest coast of Florida with the eye crossing Santa Rosa Island near Big Sabine Point (Figure 1). Dog Island in Franklin County, Florida, lies between 184 and 190 miles east of the point of landfall of the eye of Hurricane Dennis (Figure 1). Dennis made landfall as a category three hurricane on the Saffir-Simpson hurricane intensity scale having winds of 115 to 120 mph near its eye.
