*Hurricane Michael Post-Storm  
Beach Conditions and Coastal Impact Report*

**Division of Water Resource Management  
Florida Department of Environmental Protection**

**January 2019  
(Revised April 2019)**

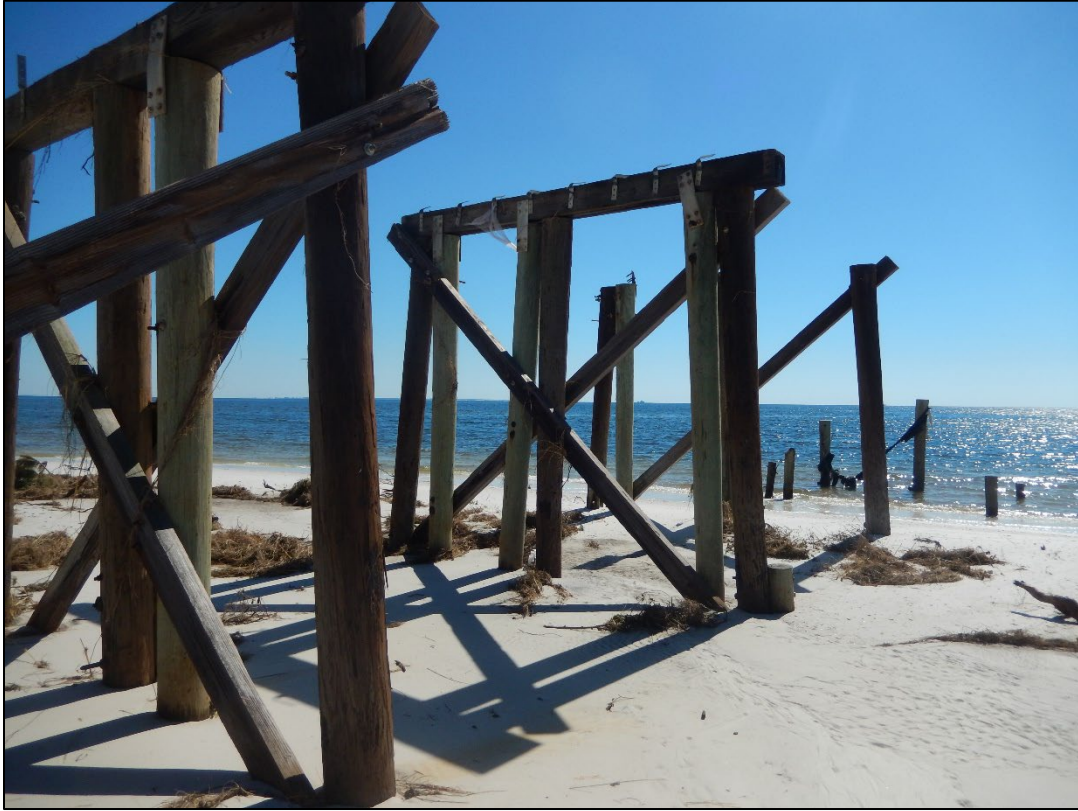
**Figure 30.** Mexico Beach pier destroyed near R129.

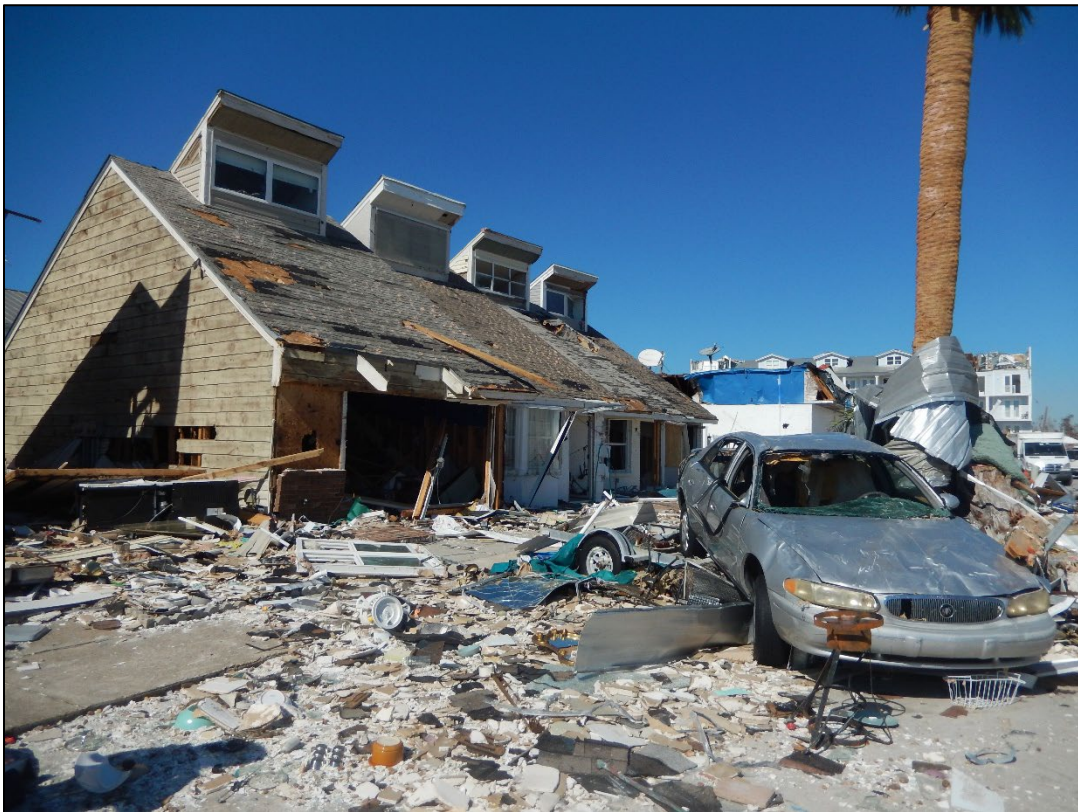
**Figure 31.** Multifamily dwelling destroyed near R129, Mexico Beach.

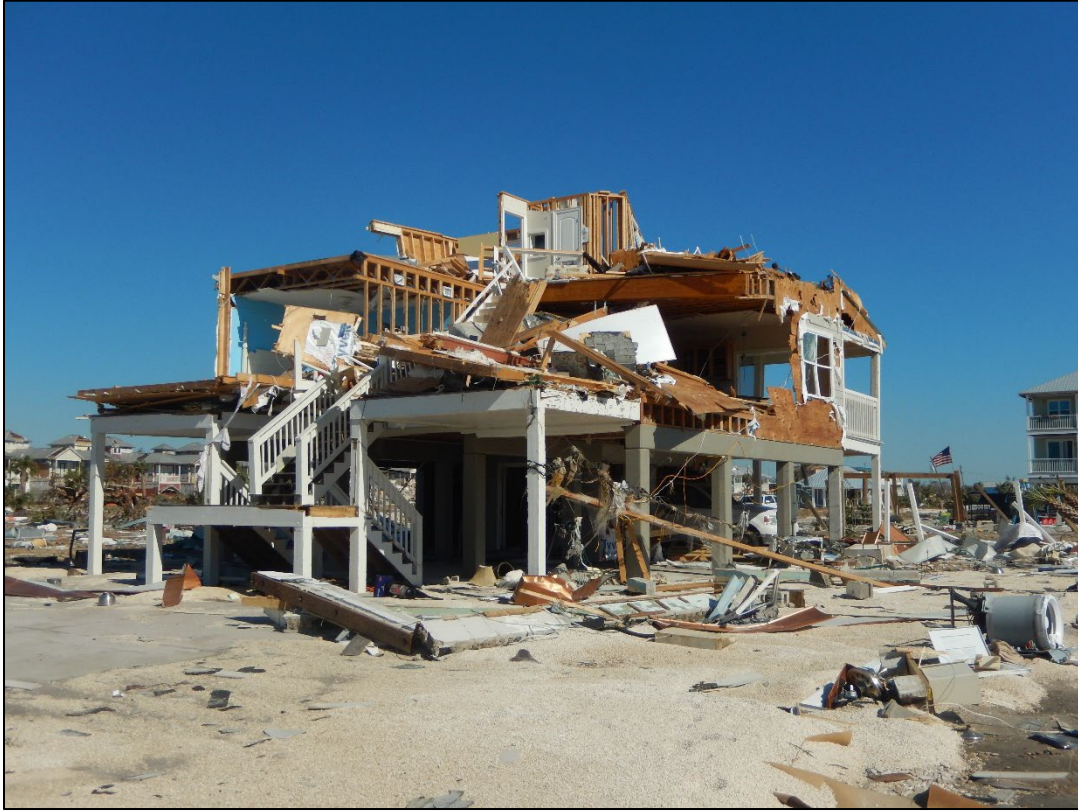
**Figure 32.** *Pile-supported dwelling destroyed near R129, Mexico Beach.*

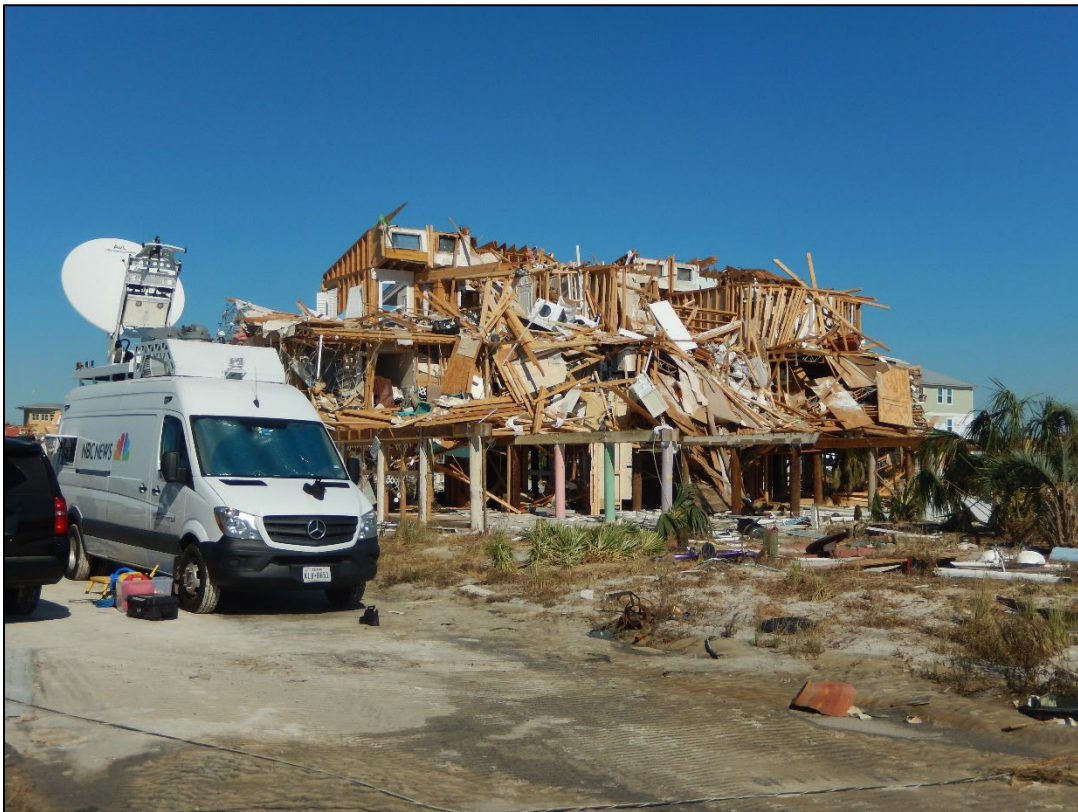
**Figure 33.** *Pile-supported multifamily dwelling destroyed near R129, Mexico Beach.*

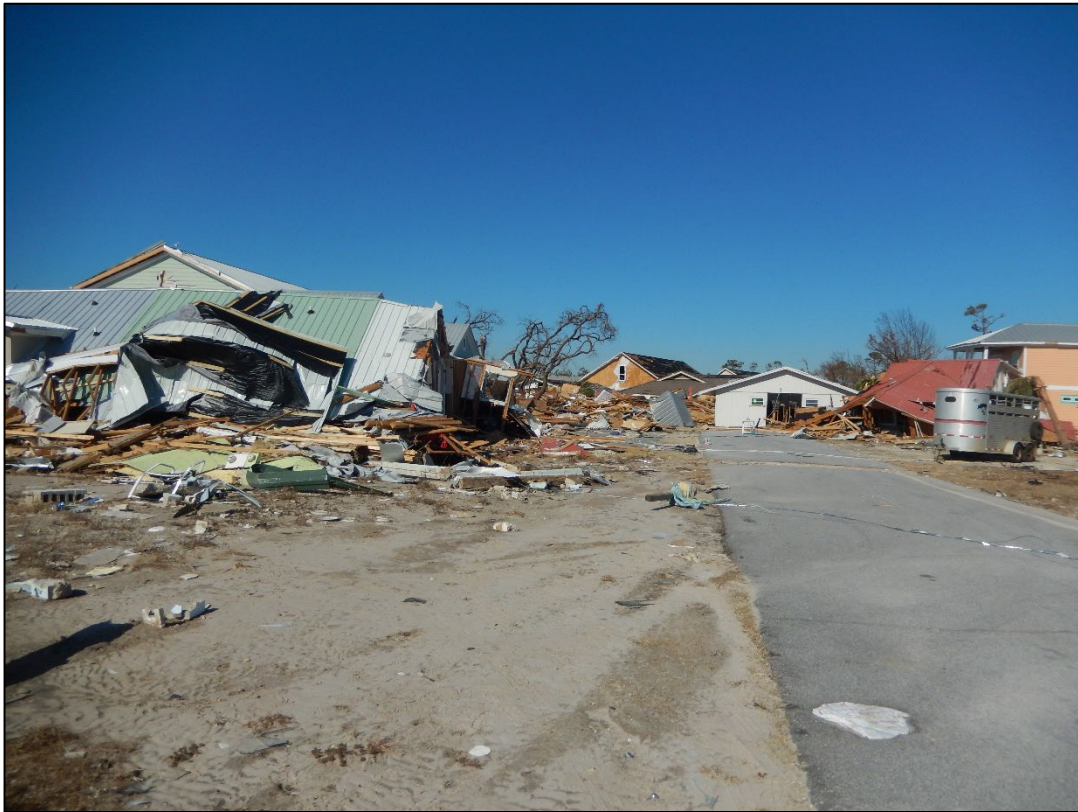
**Figure 34.** Buildings transported several hundred feet landward by the flood across U.S. 98 and deposited on 15<sup>th</sup> Street, R130, Mexico Beach.

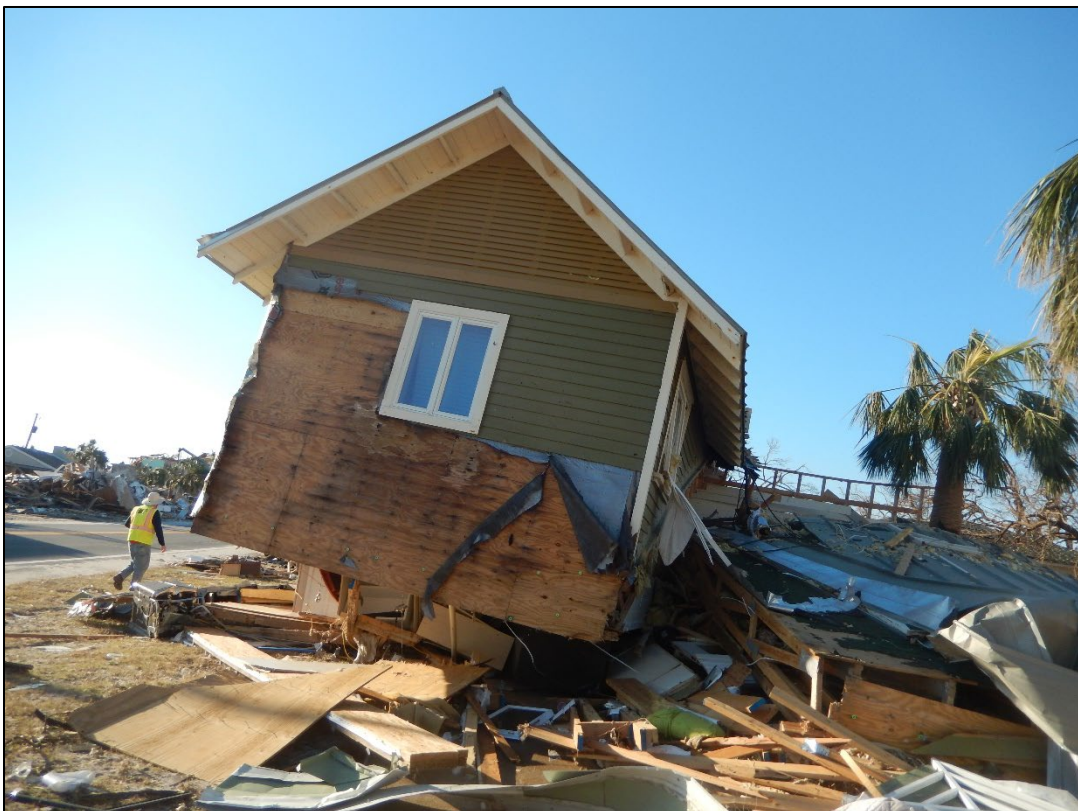
**Figure 35.** Beach dwelling transported across U.S. 98 by the storm surge, Mexico Beach.

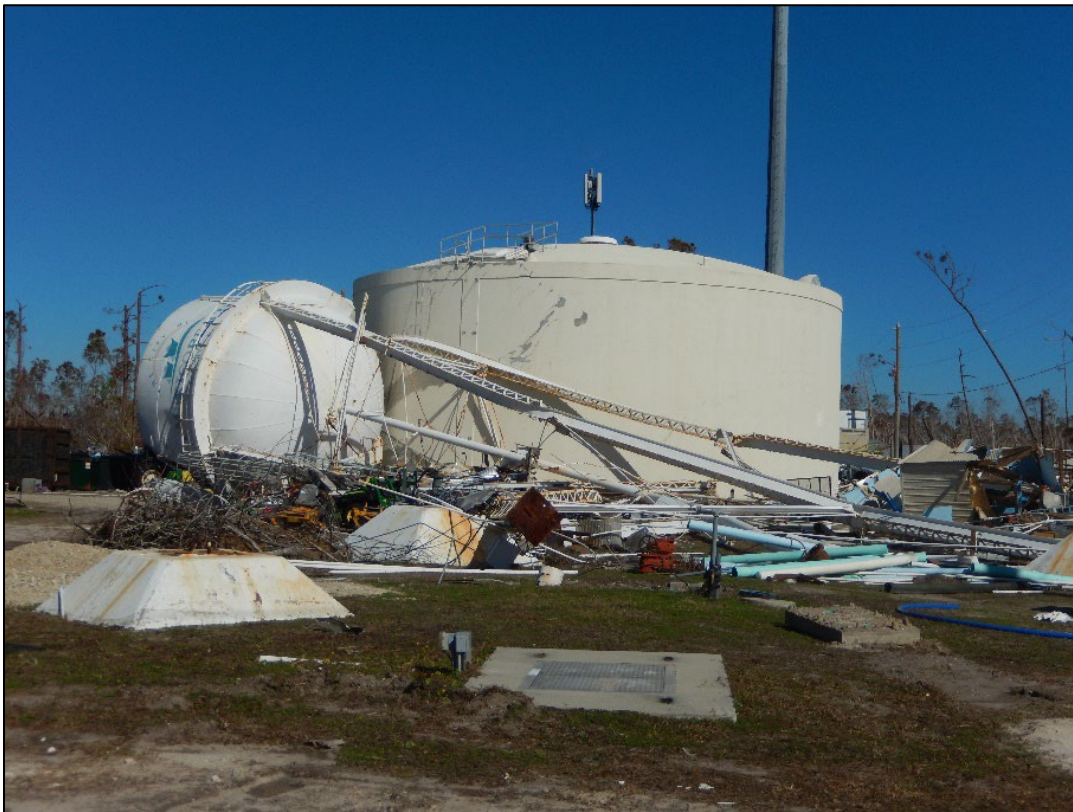
**Figure 37.** City water tower collapsed under high winds near R134, Mexico Beach.

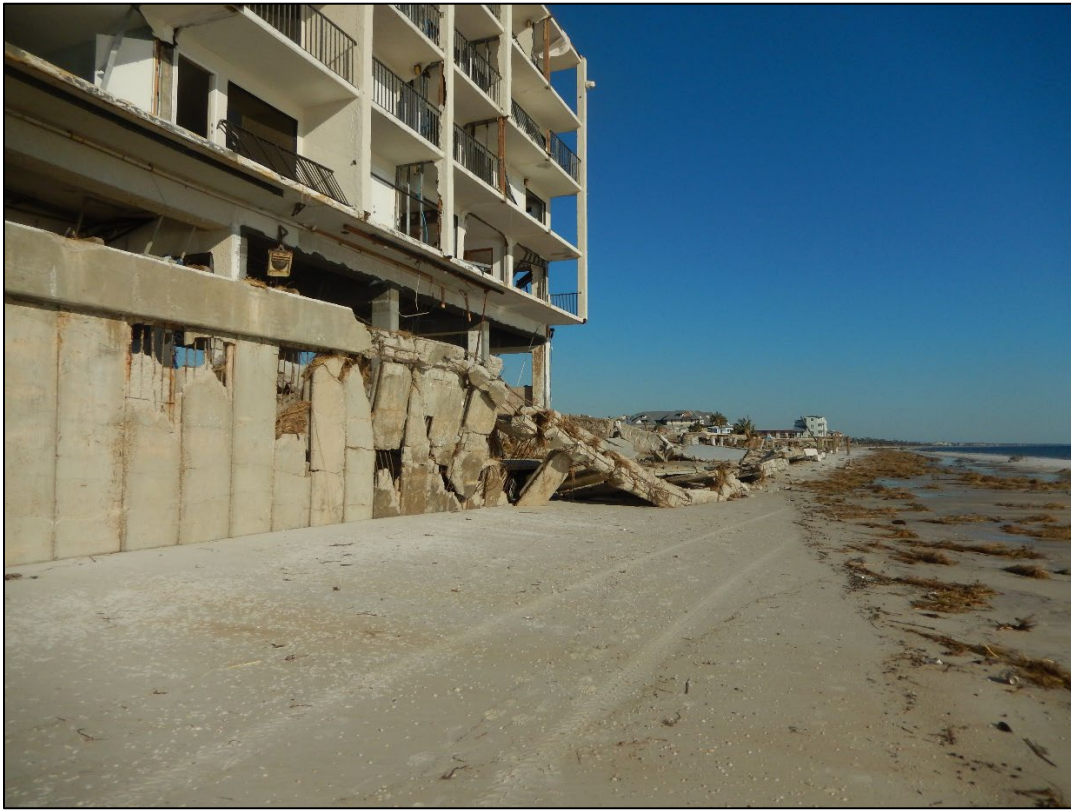
**Figure 38.** Over 700 feet of reinforced concrete seawall destroyed at R135, Mexico Beach.

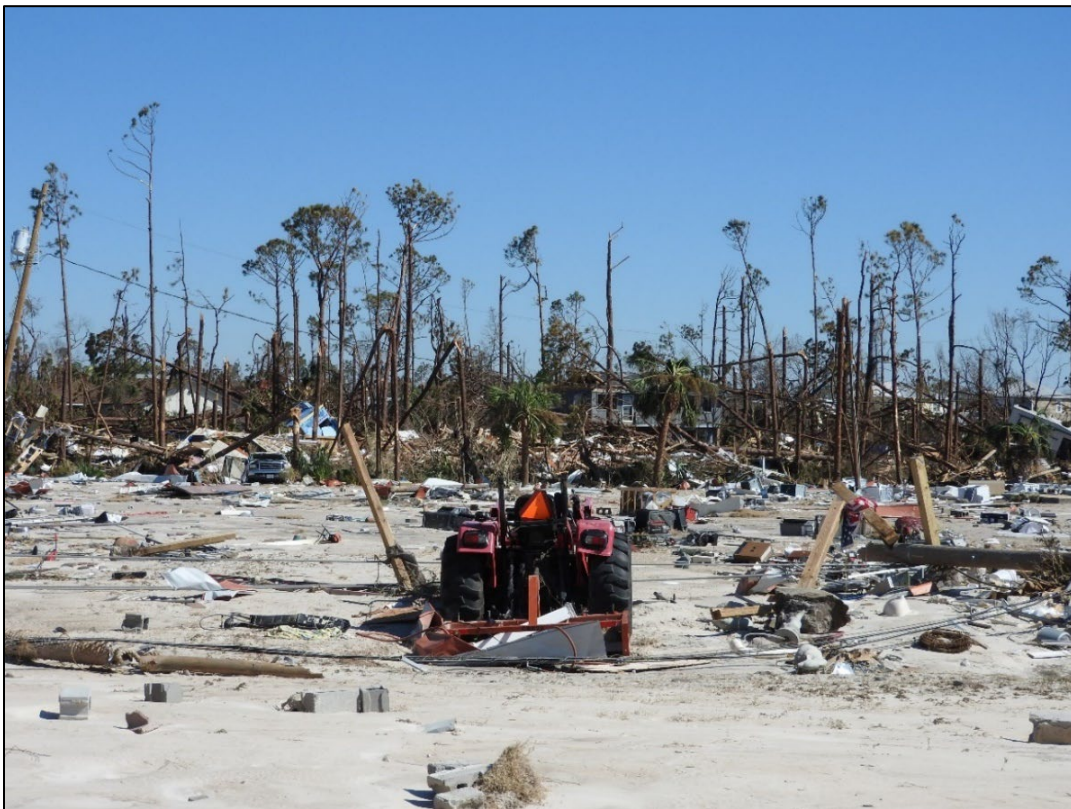
**Figure 39.** Storm surge transported debris and sand overwash across U.S. 98 near R135, Mexico Beach.

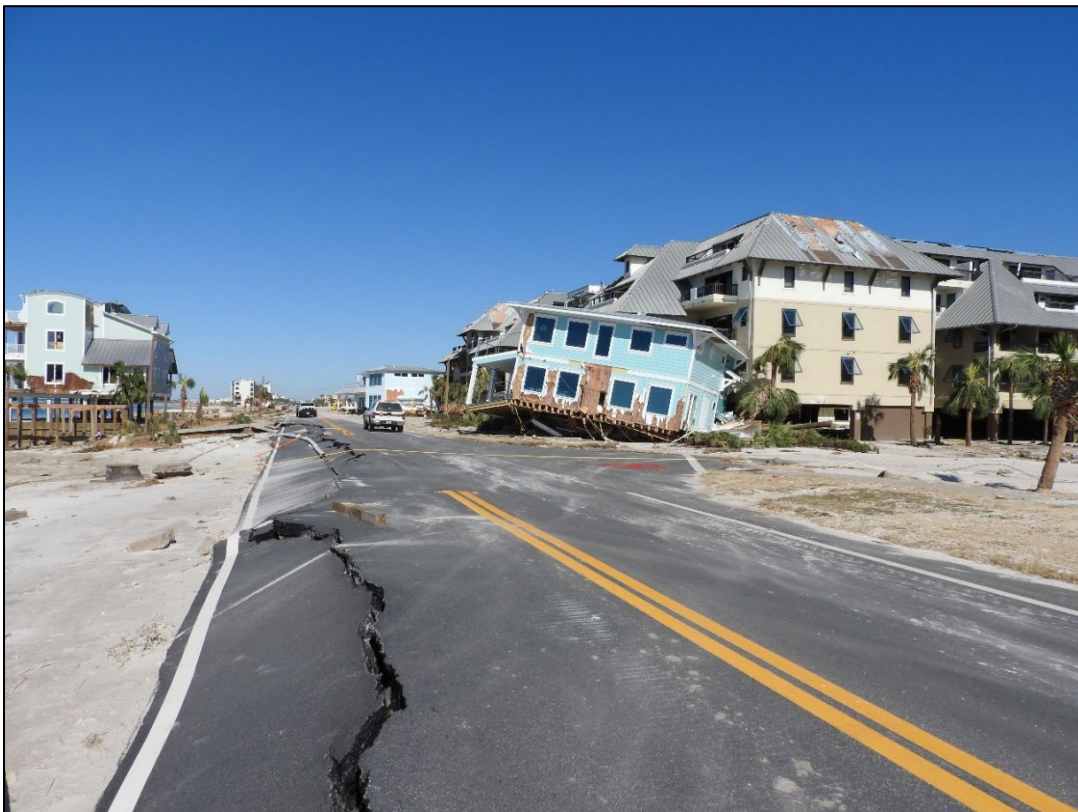
**Figure 41.** Dwelling transported across U.S. 98 by the storm surge near R136, Mexico Beach.

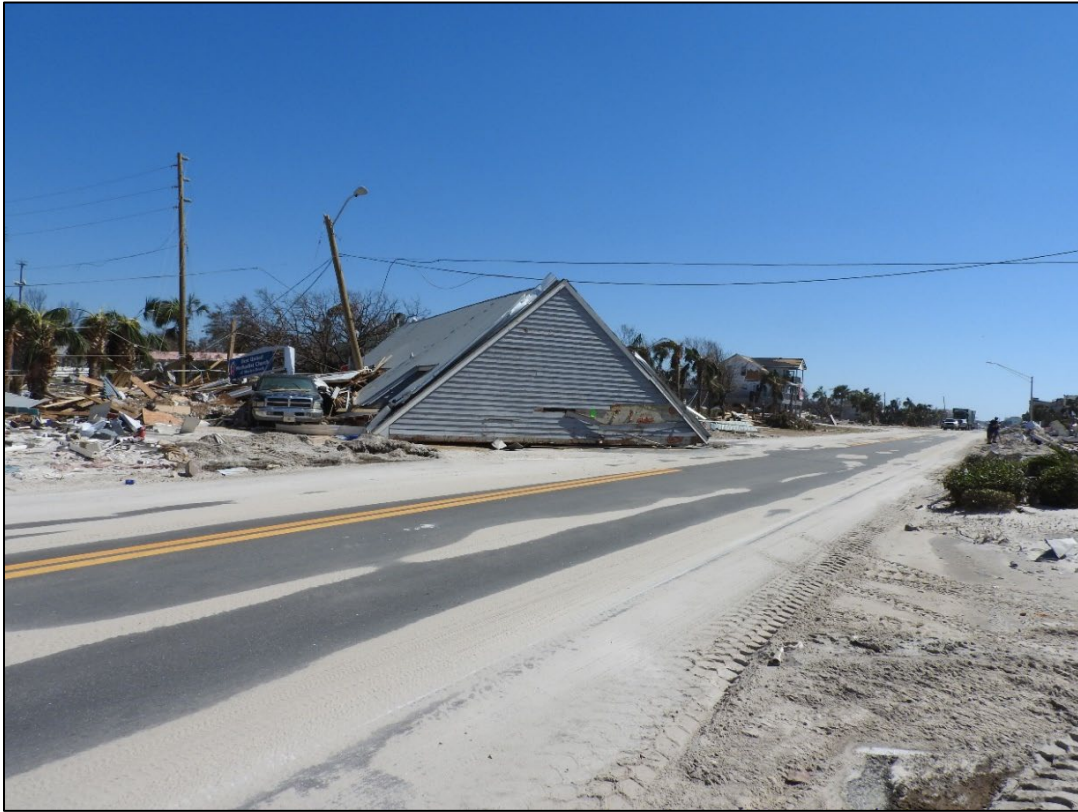
**Figure 42.** Roof of dwelling transported across U.S. 98 by the storm surge near R138, Mexico Beach.

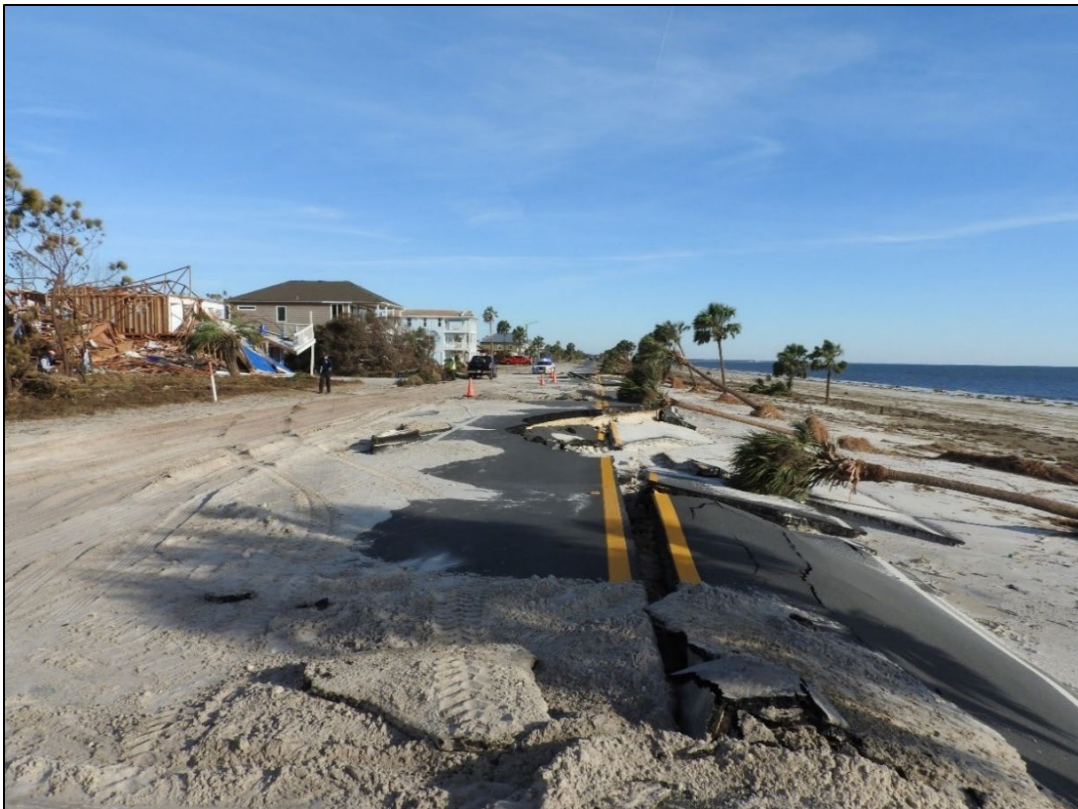
**Figure 43.** Segment of U.S. 98 destroyed near R139, Mexico Beach.

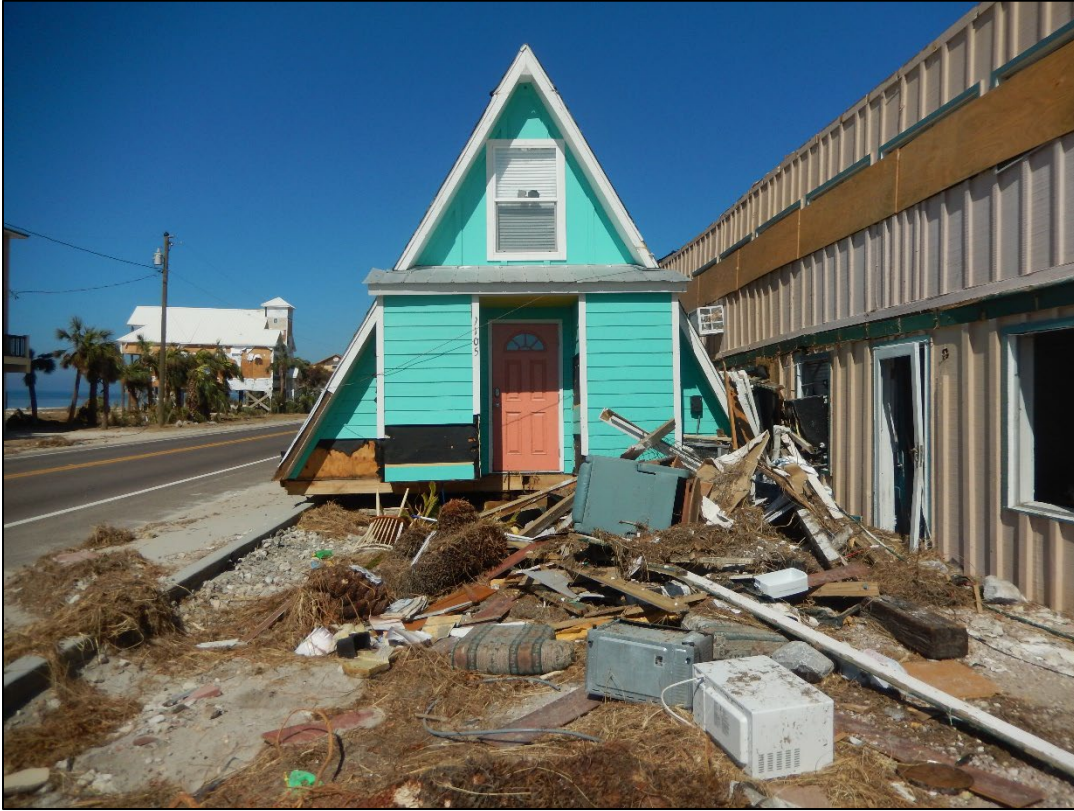
*Figure 56. Dwelling transported across U.S. 98 by the storm surge near R2, Beacon Hill.*

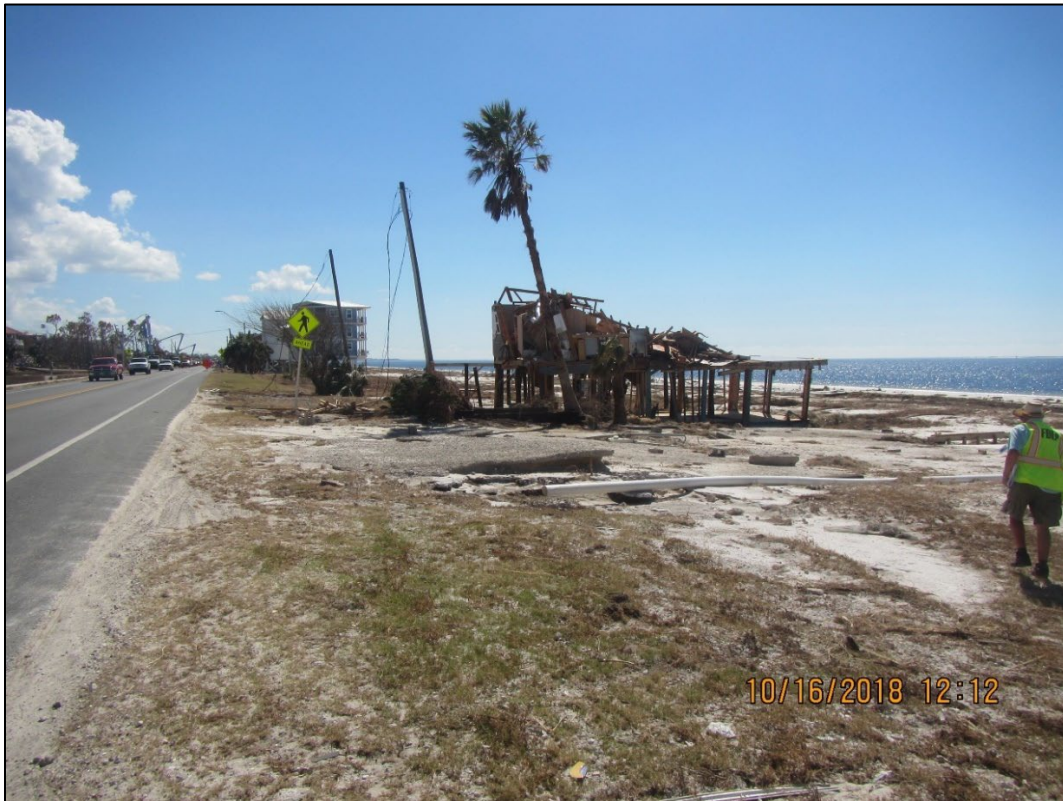
**Figure 58.** Dwellings destroyed along U.S. 98 near R3.5, Beacon Hill.

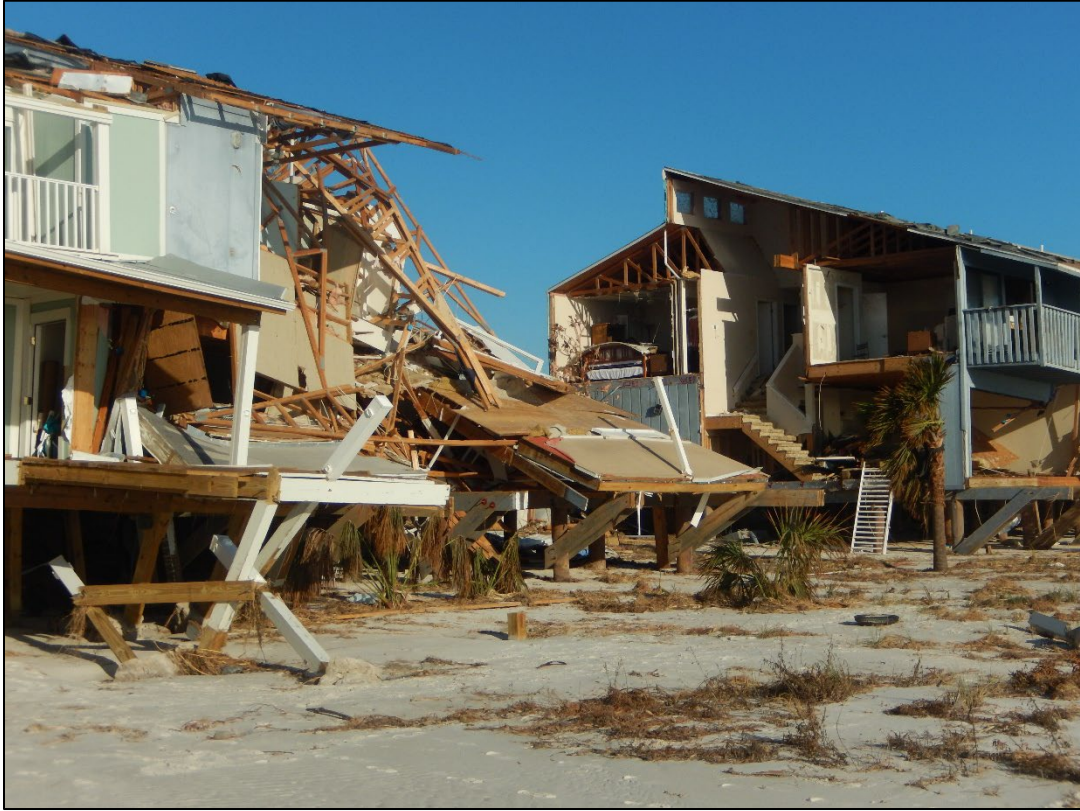
*Figure 61. Townhouses destroyed near R7, Beacon Hill.*

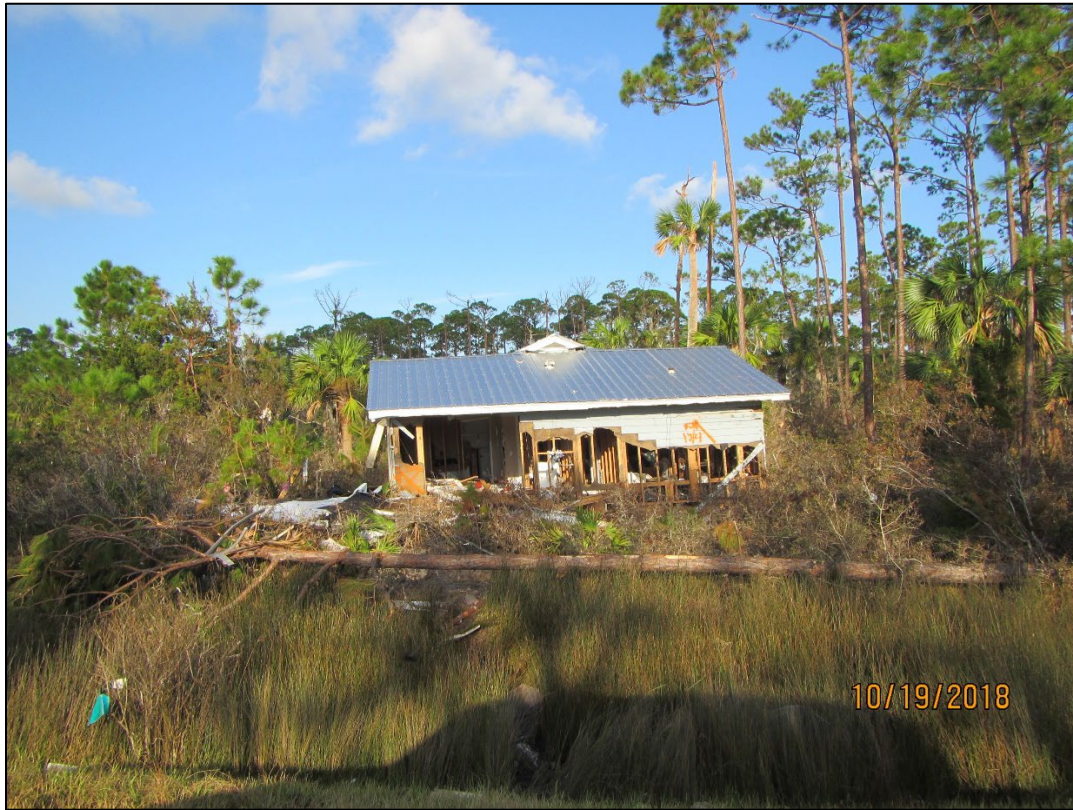
**Figure 67.** Destroyed dwelling transported across S.R.30A by the storm surge, St. Joseph Bay.

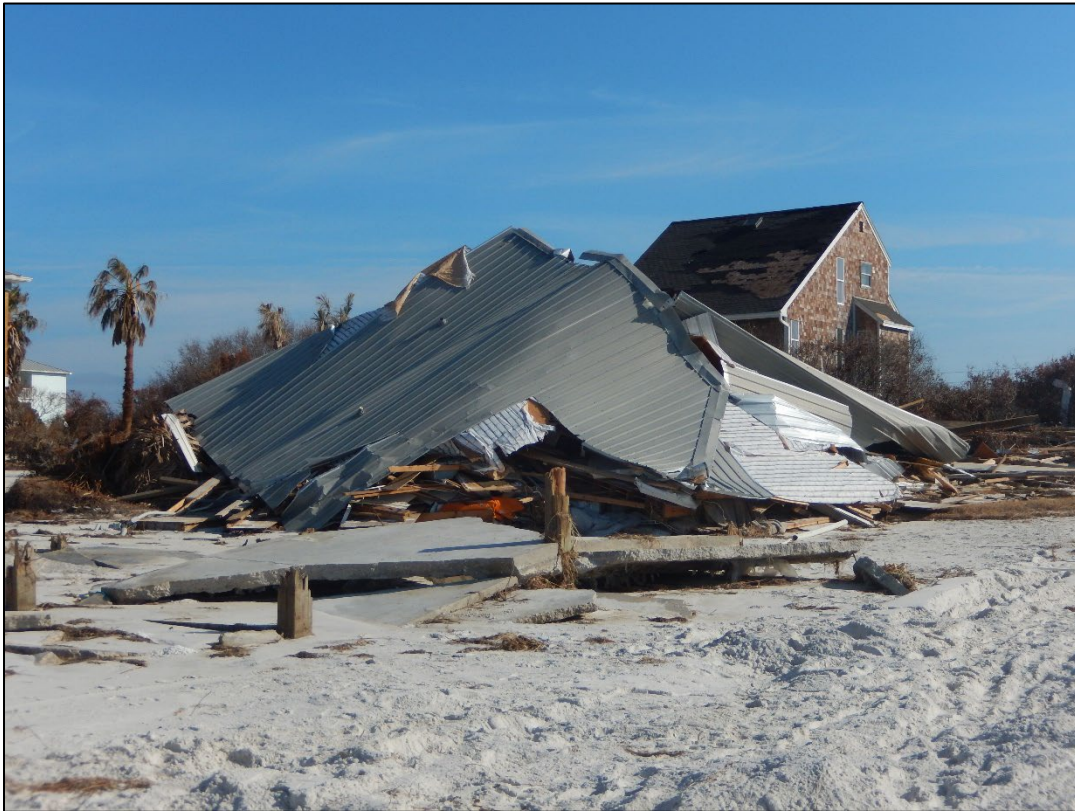
*Figure 71. Dwelling destroyed near R99.5, St. Joseph Peninsula.*

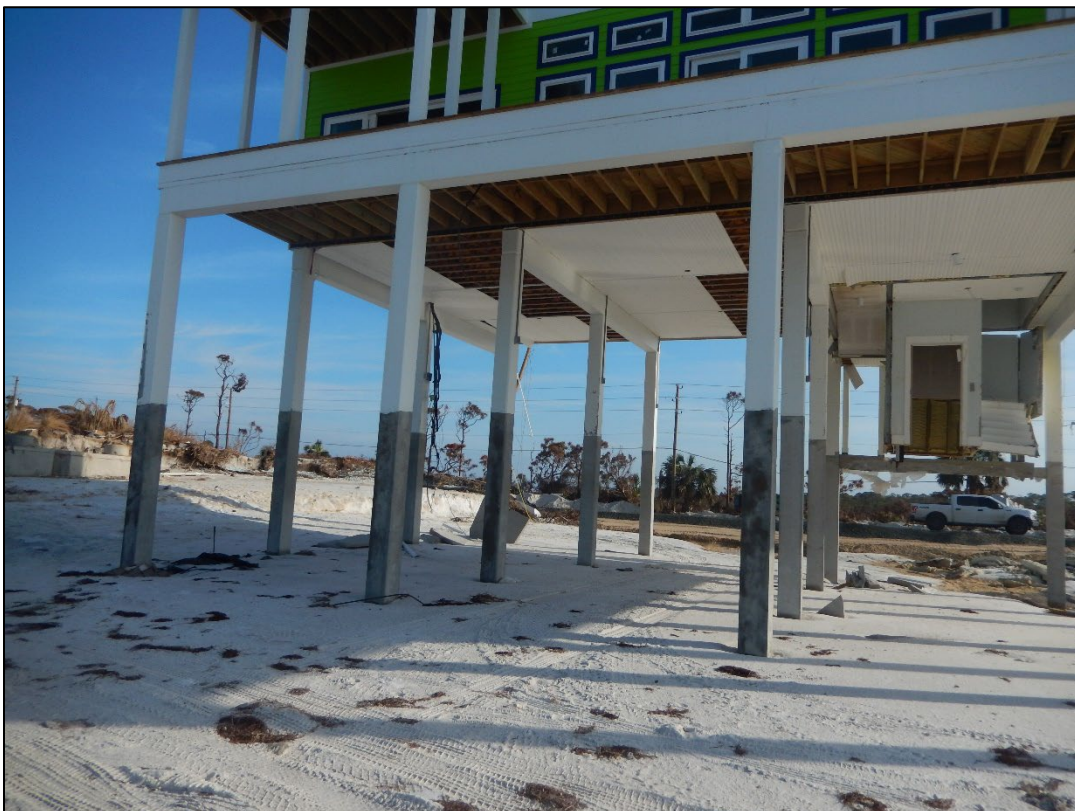
*Figure 72. Over six feet of vertical loss of grade beneath structure near R104.*

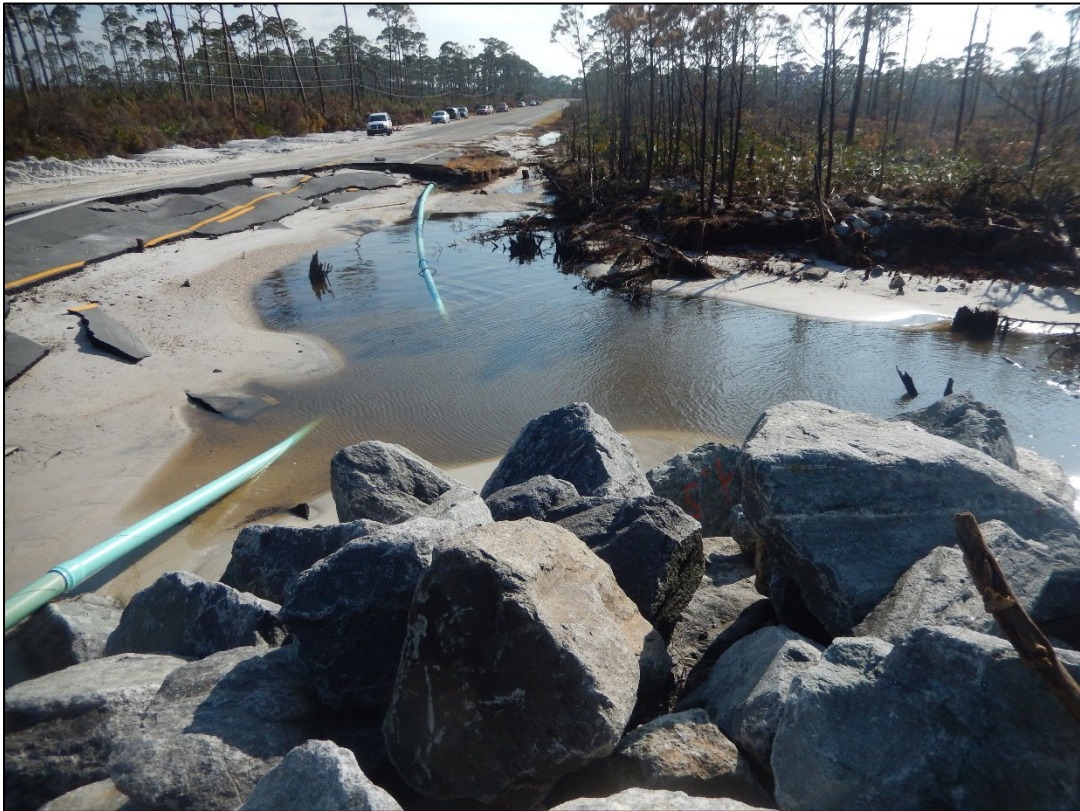
**Figure 75.** County Road 30E destroyed south of the Stump Hole boulder mound, R107.

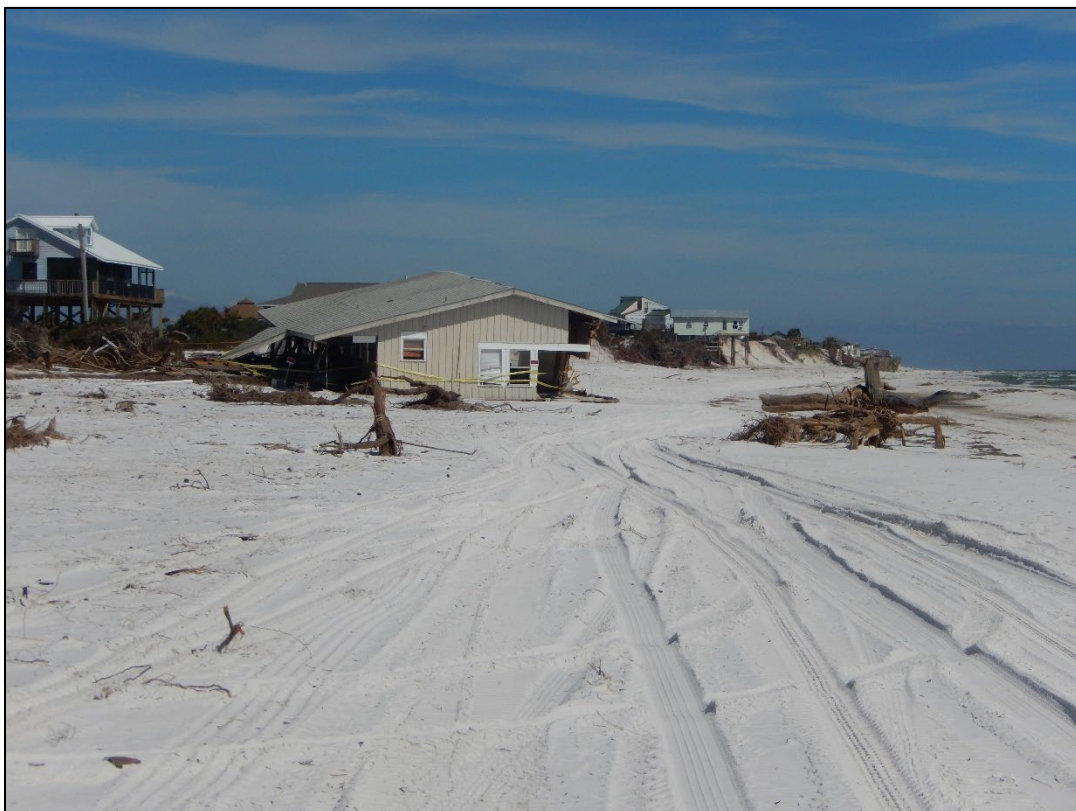
**Figure 94.** Dwelling destroyed near R174, Dog Island.

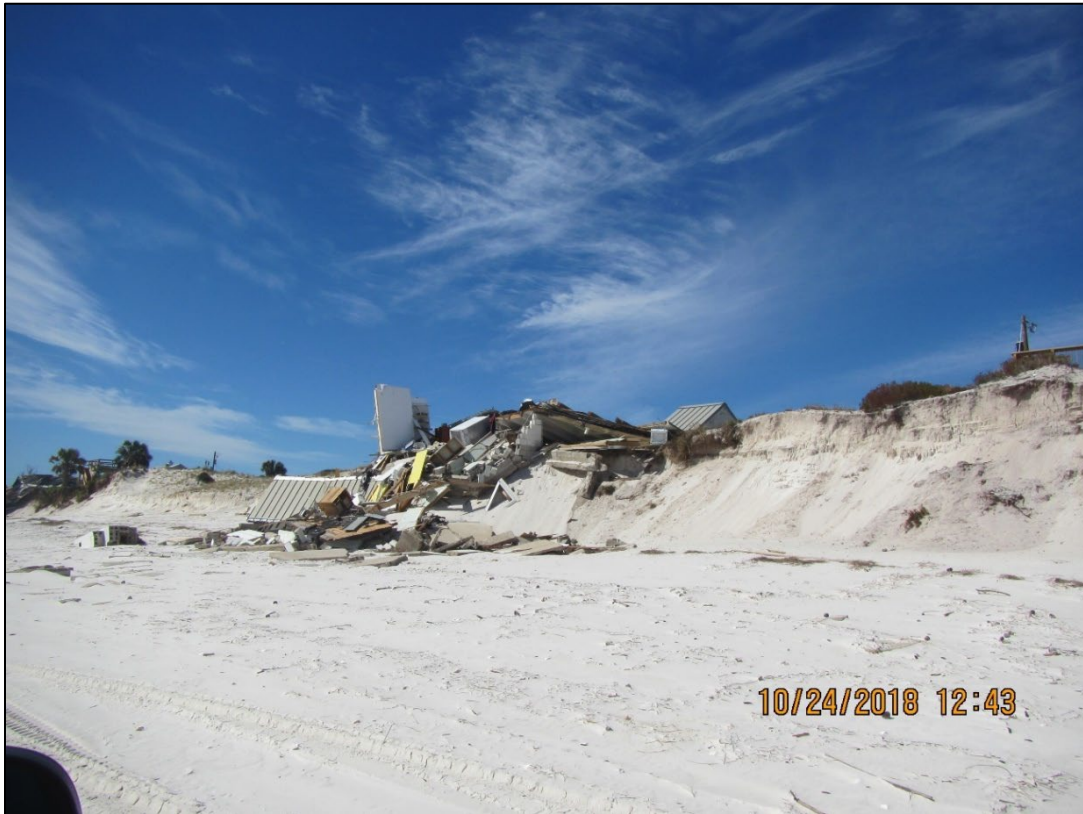
*Figure 95. Dwelling destroyed near R176, Dog Island.*

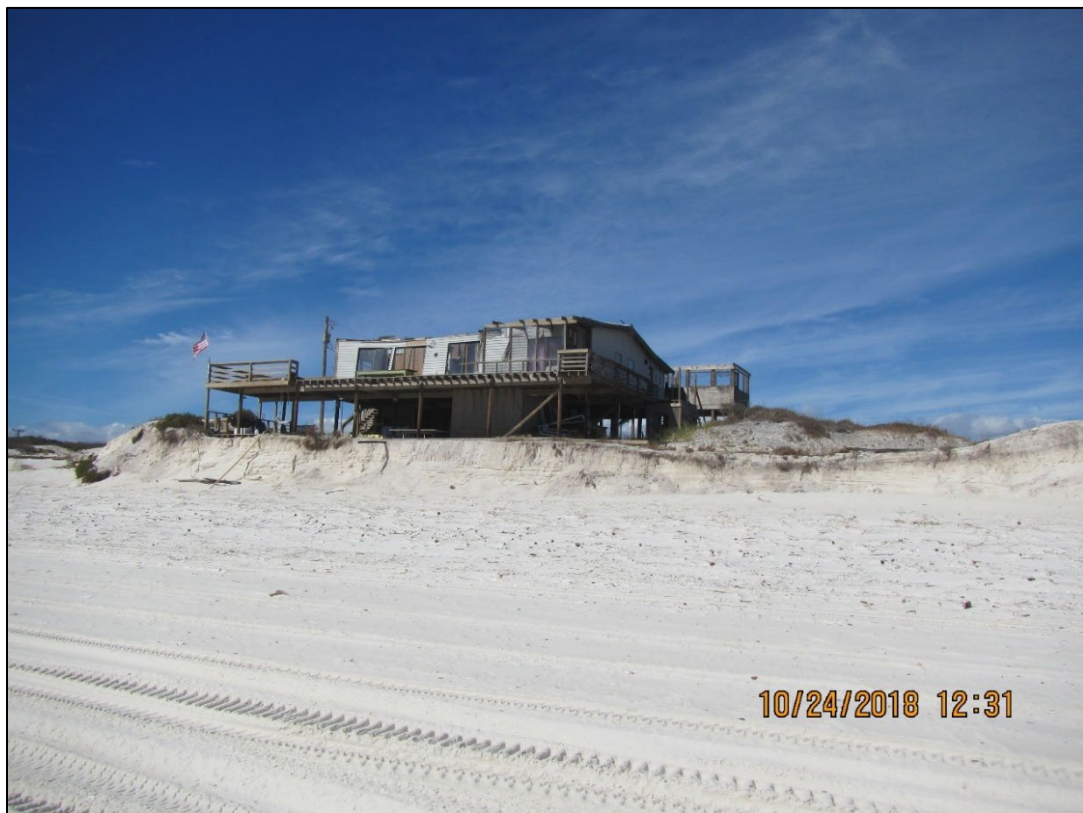
*Figure 96. Dwelling destroyed near R178, Dog Island.*

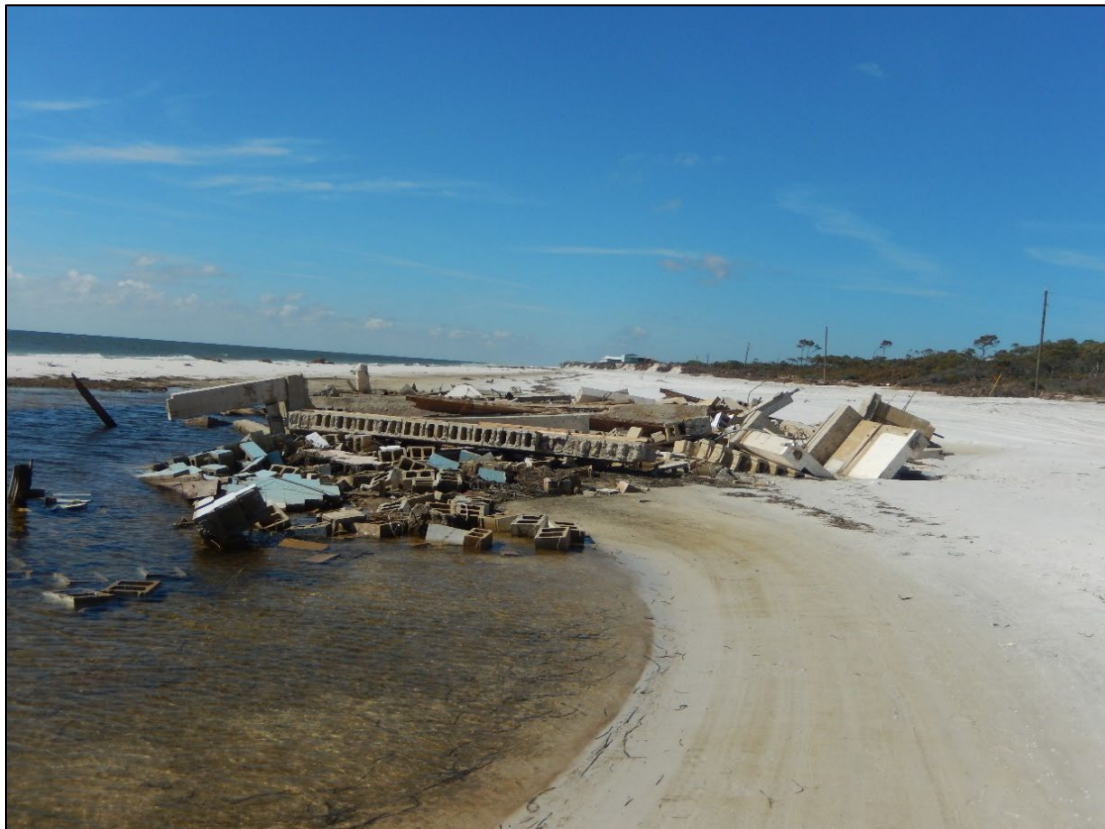
**Figure 98.** Pelican Inn destroyed near R183, Dog Island.

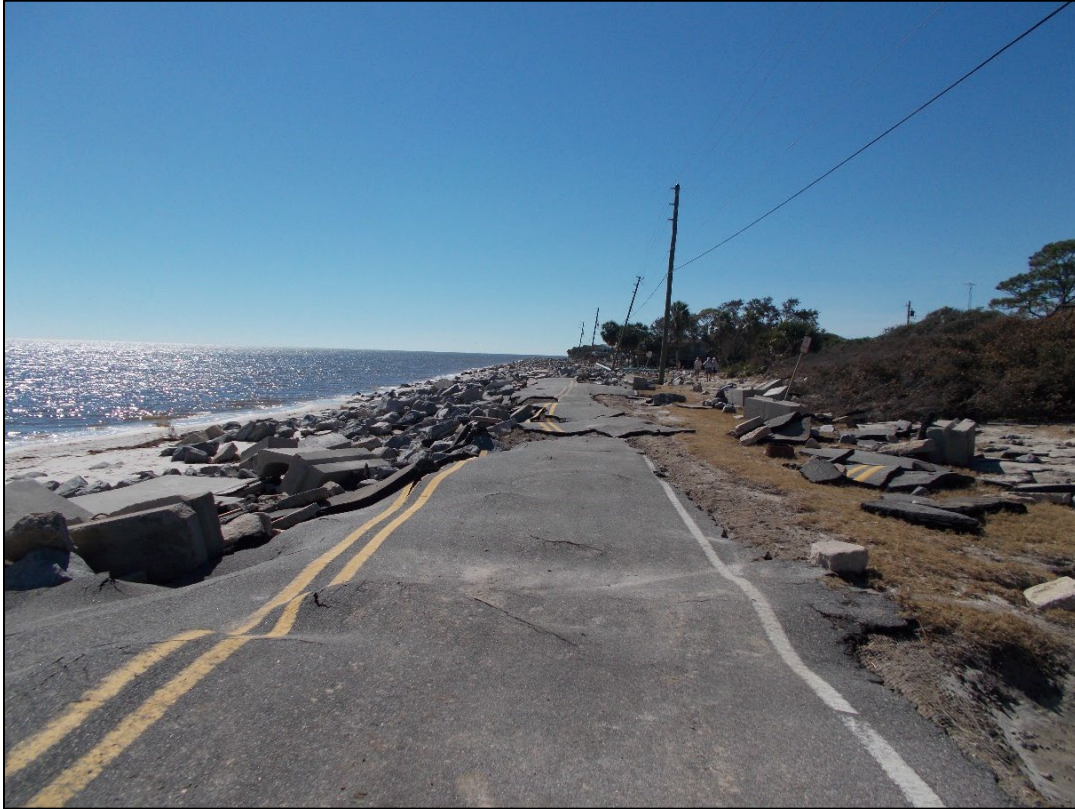
**Figure 99.** 3,000 feet of road and revetment destroyed between R211-R214, Southwest Cape.

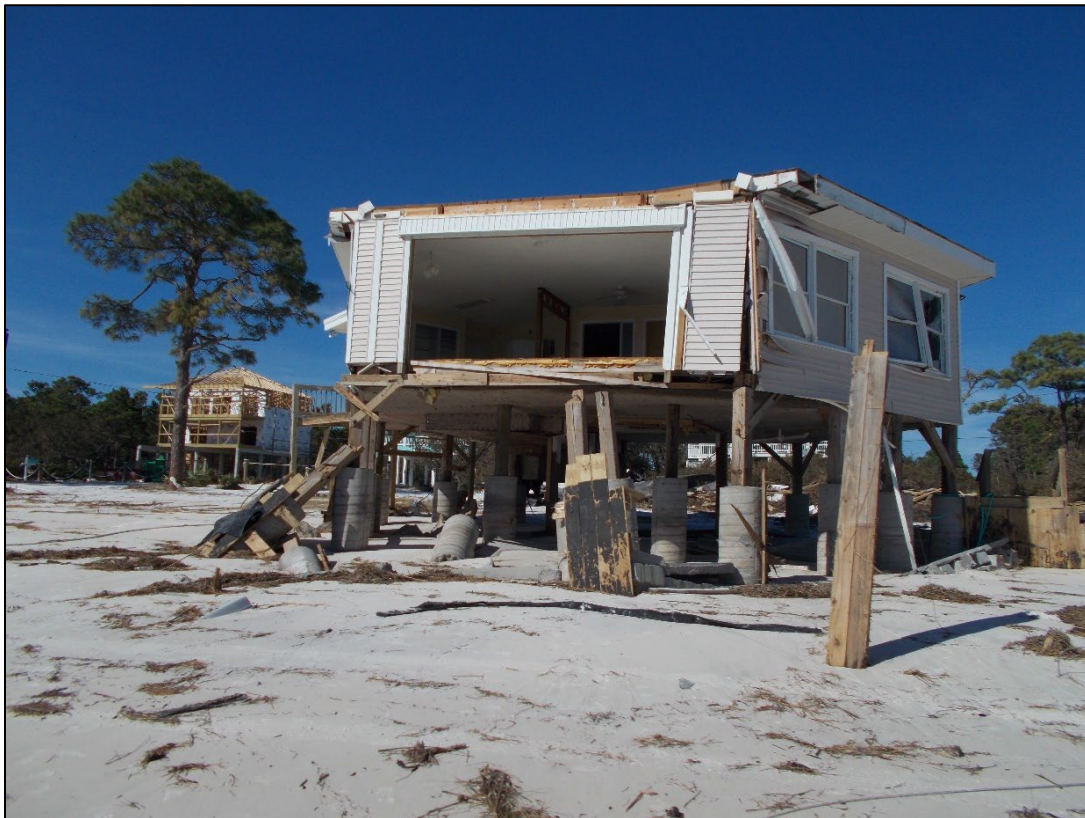
**Figure 100.** Dwelling destroyed near R210, Southwest Cape.

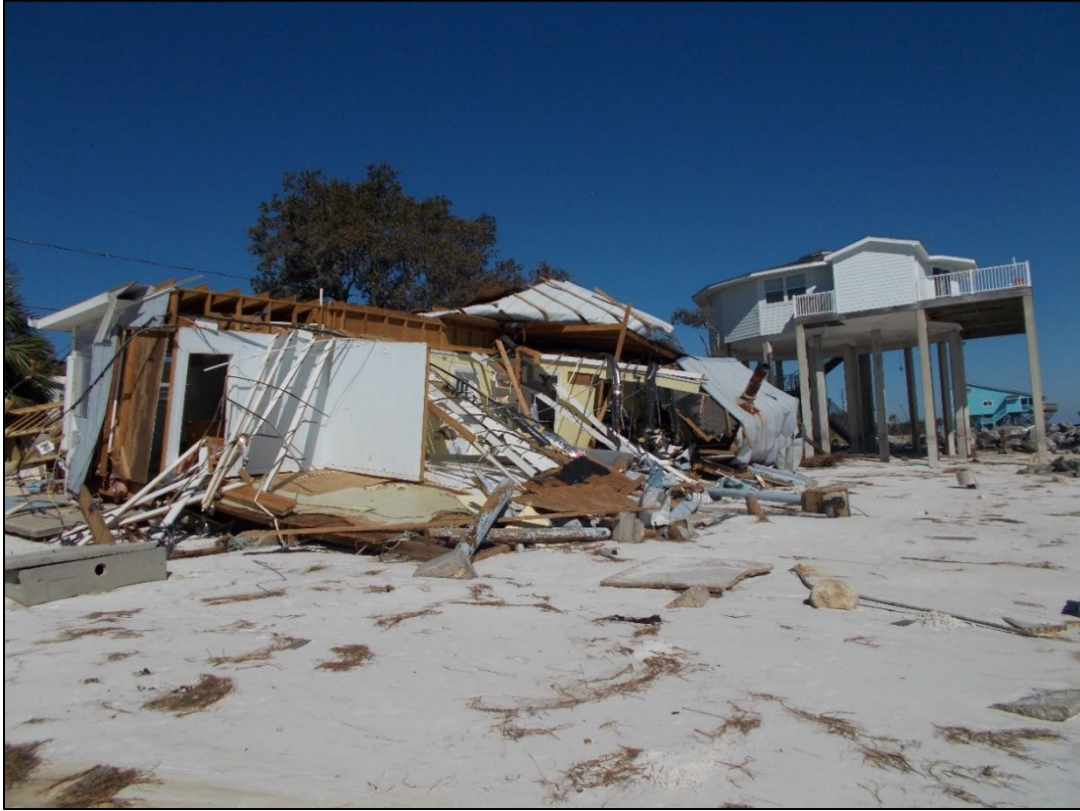
*Figure 101. Dwelling destroyed near R211, Southwest Cape.*
