Environmental Concerns With Reuse and Disposal of Chromated Copper Arsenate (CCA) Treated Wood

New CCA Research Sponsored by the Florida Center For Solid and Hazardous Waste Management

Helena Solo-Gabriele, Ph.D., P.E., University of
Miami, Coral Gables, Florida

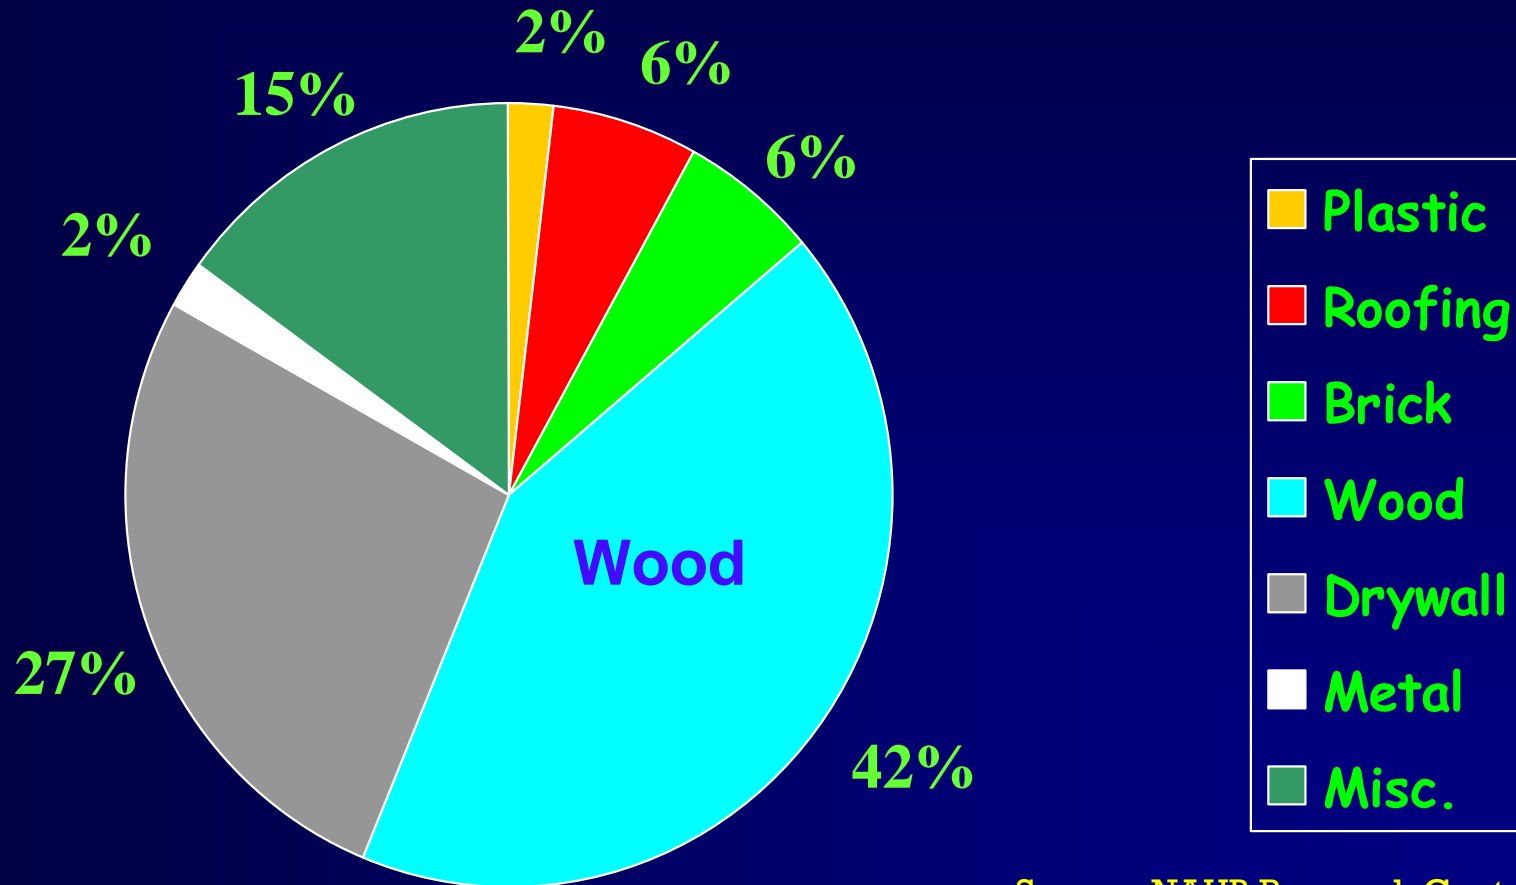
Wood is One of the Largest Components of C&D Debris

Source: NAHB Research Center
Average of 4 Sites

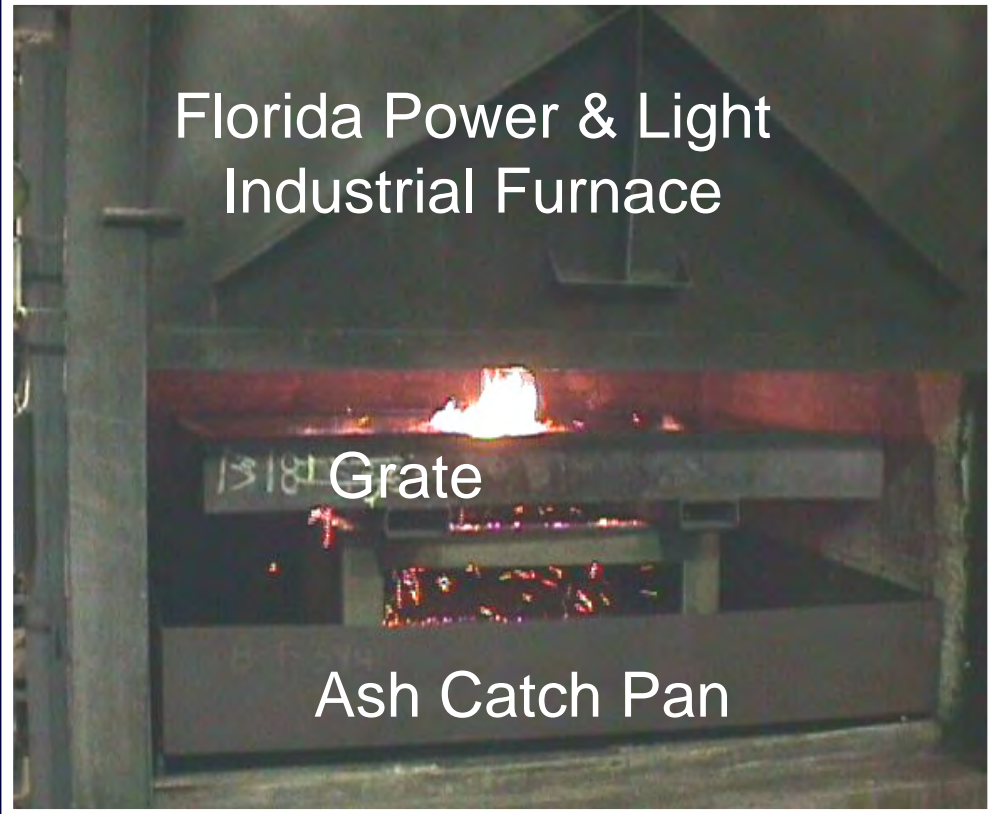
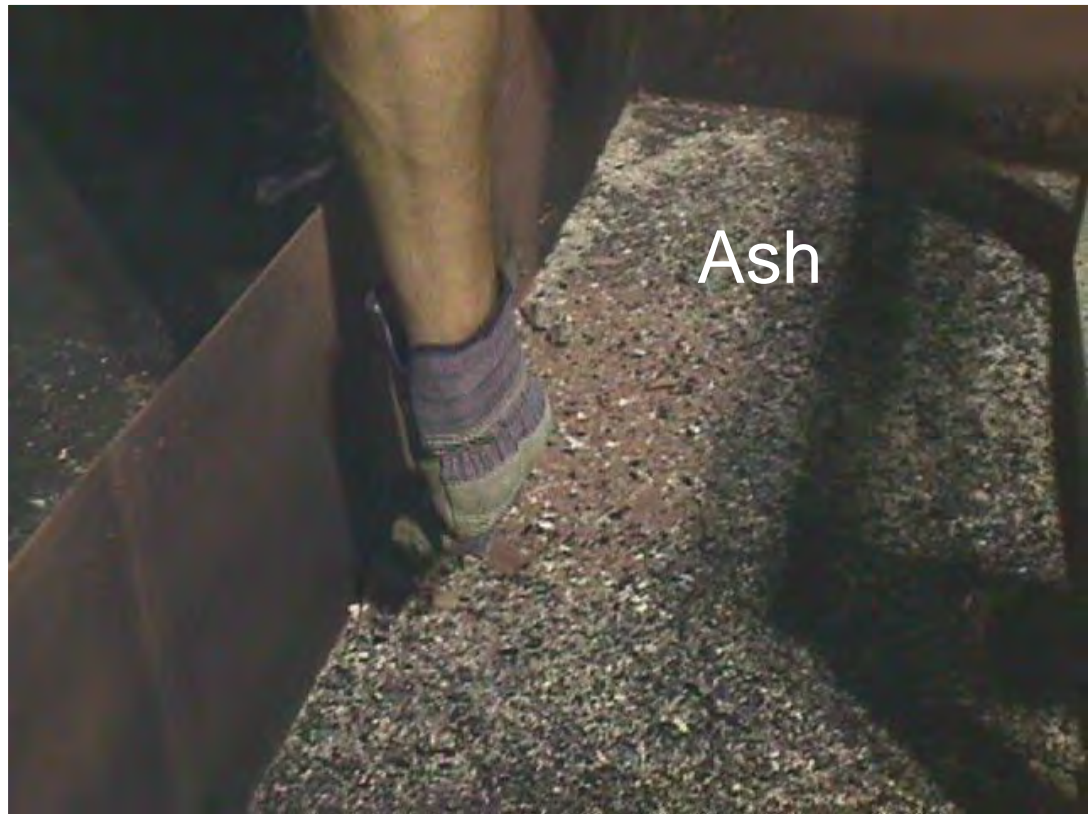
Sample Ashing

- Ash could not be obtained from the wood-burning facilities.
- Ash was produced in an industrial furnace.
- Specific wood streams were combusted.
- Ash was chemically analyzed to assess management options.

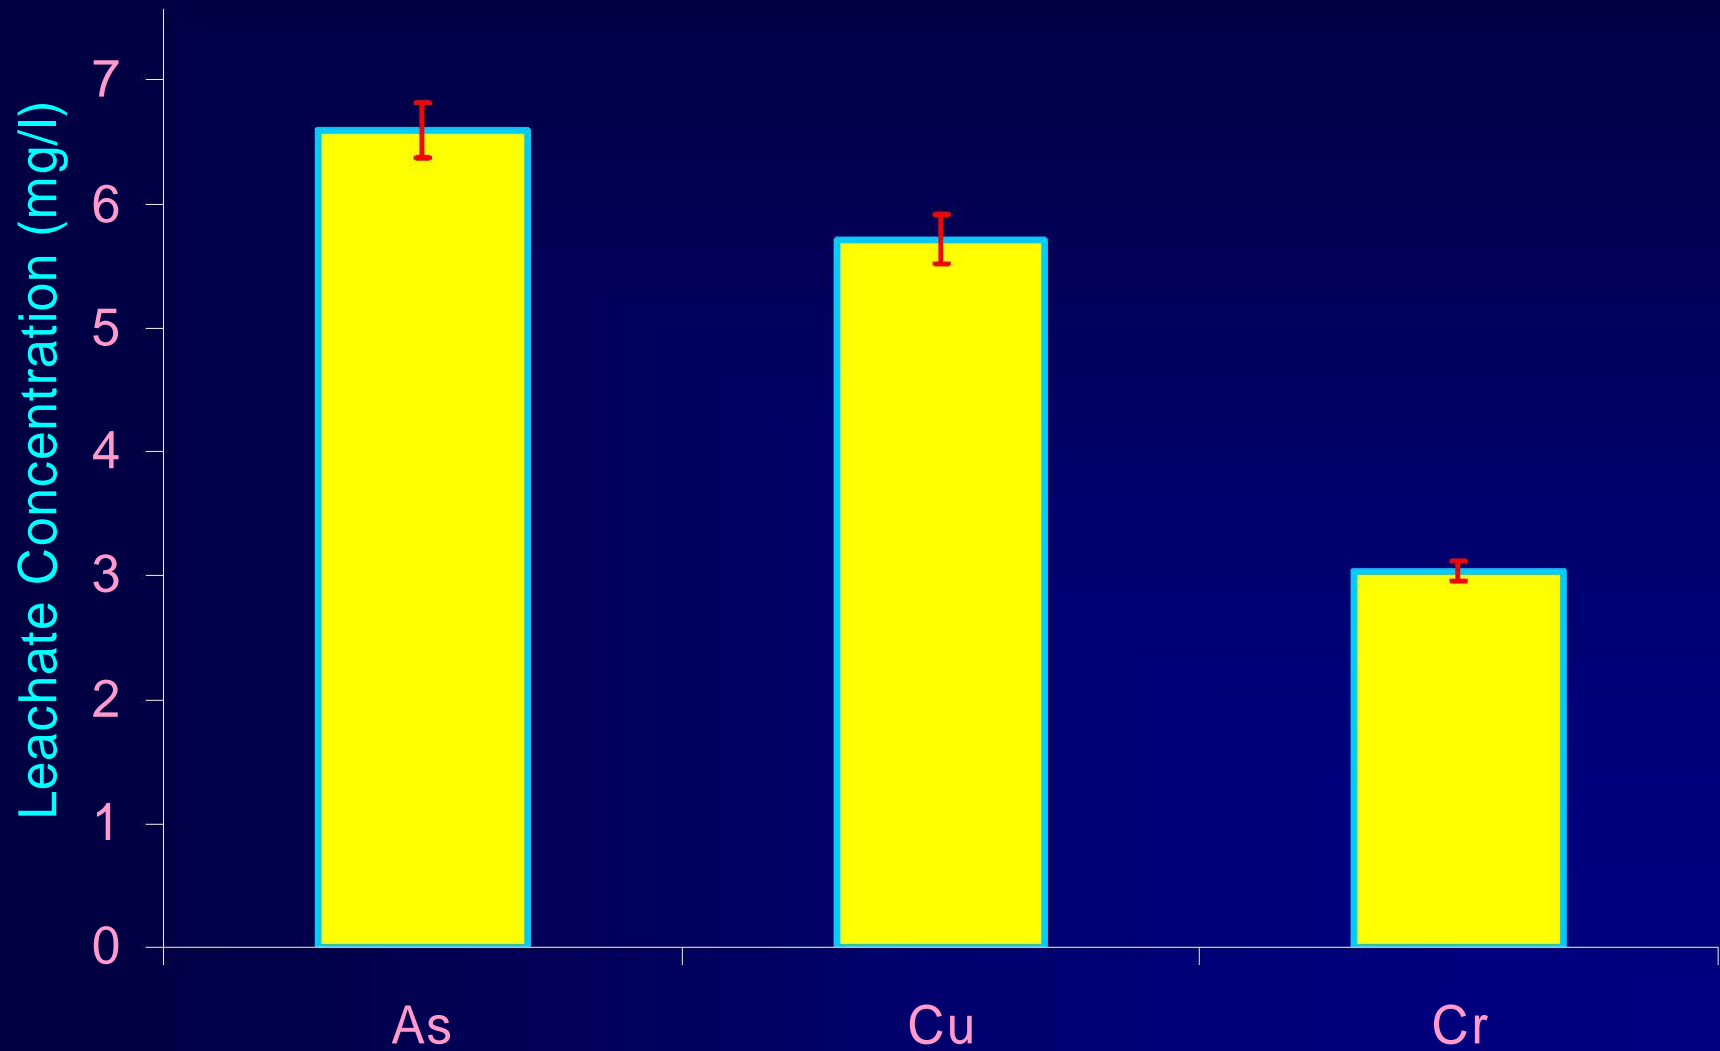
TCLP Results on 0.25 pcf CCA (Type C) Sawdust

- 0.25 pcf, Type C Dimensional Lumber.
- Size-reduced to consistency of sawdust.

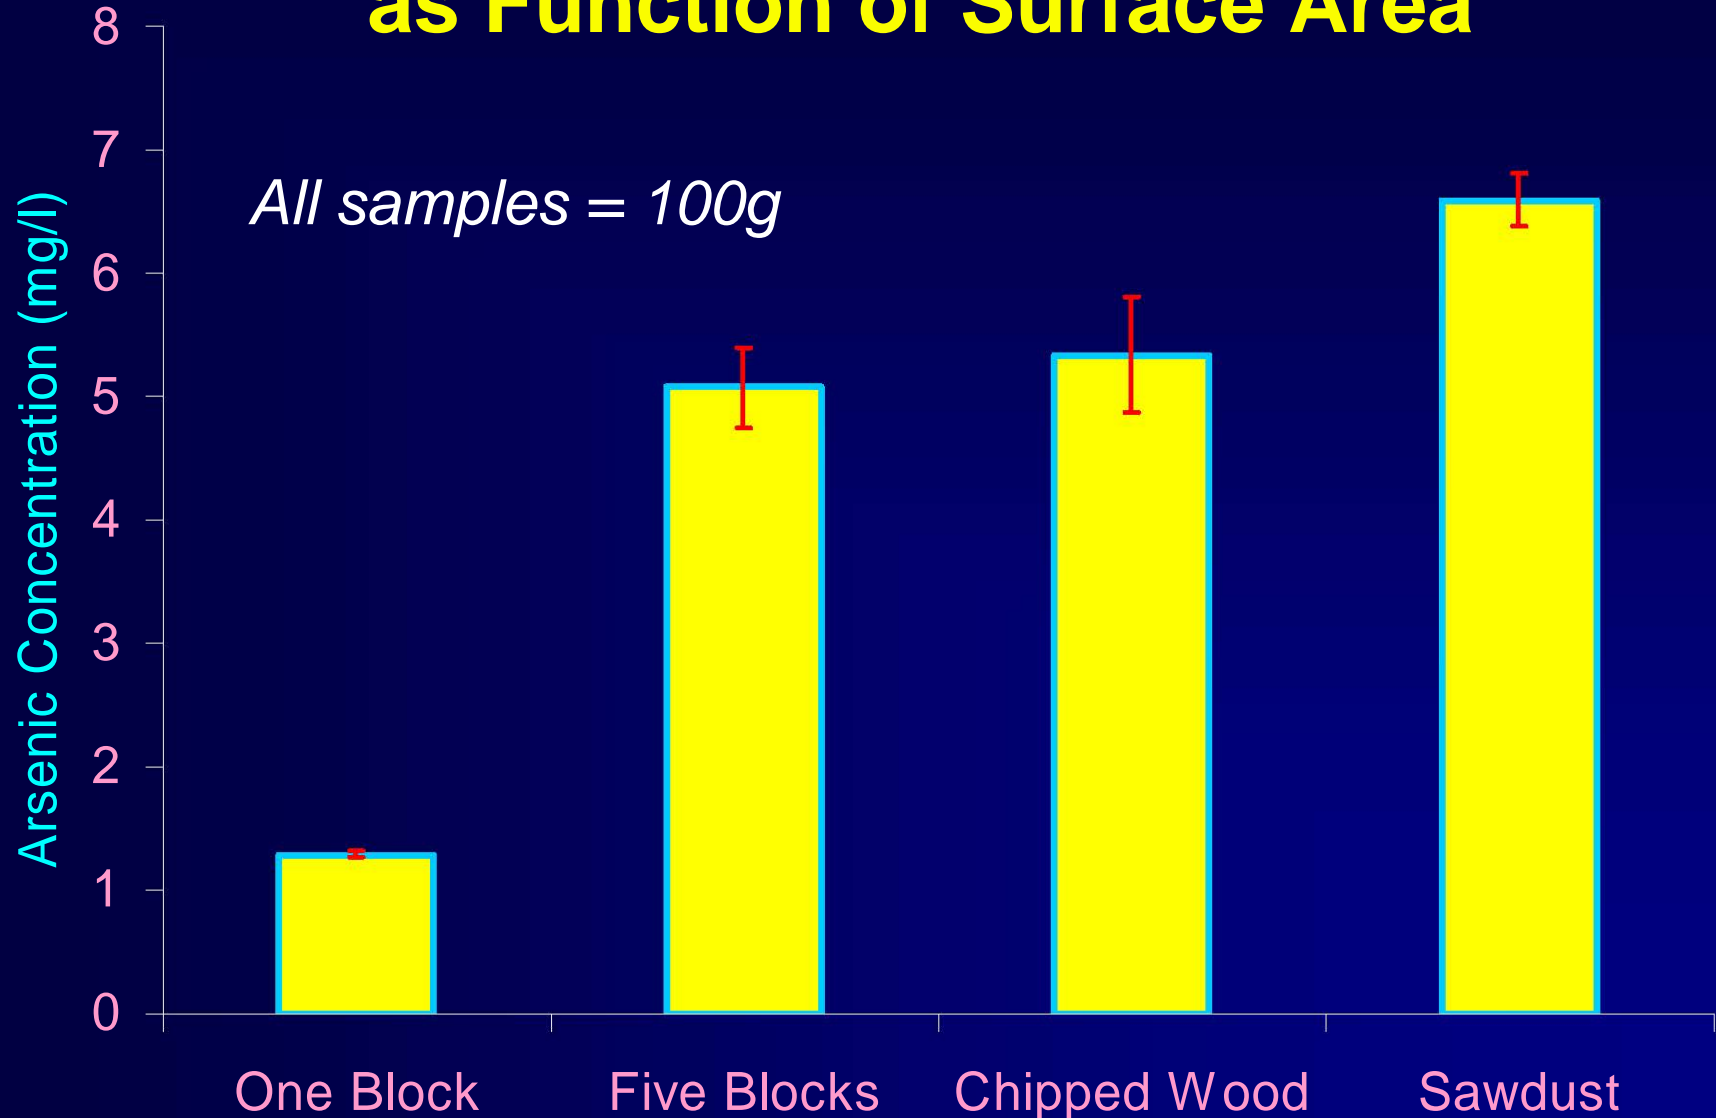
As TCLP Results 0.25 pcf CCA (Type C) as Function of Surface Area

- The smaller the size, the greater the surface area available for leaching.
- Same wood sample was tested at different sizes.

- Tests were only for one wood sample, and thus can not be used to draw conclusions for all similar wood products (more testing will be conducted).
- Results fall within the range of previously reported data.
- Results indicate that CCA-treated wood of this nature should not be disposed in unlined landfills.

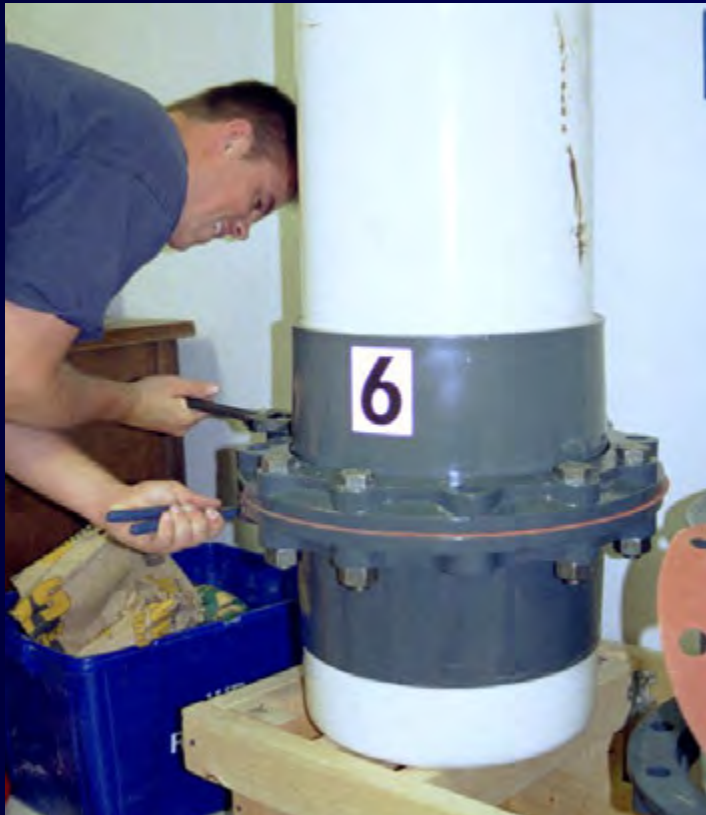
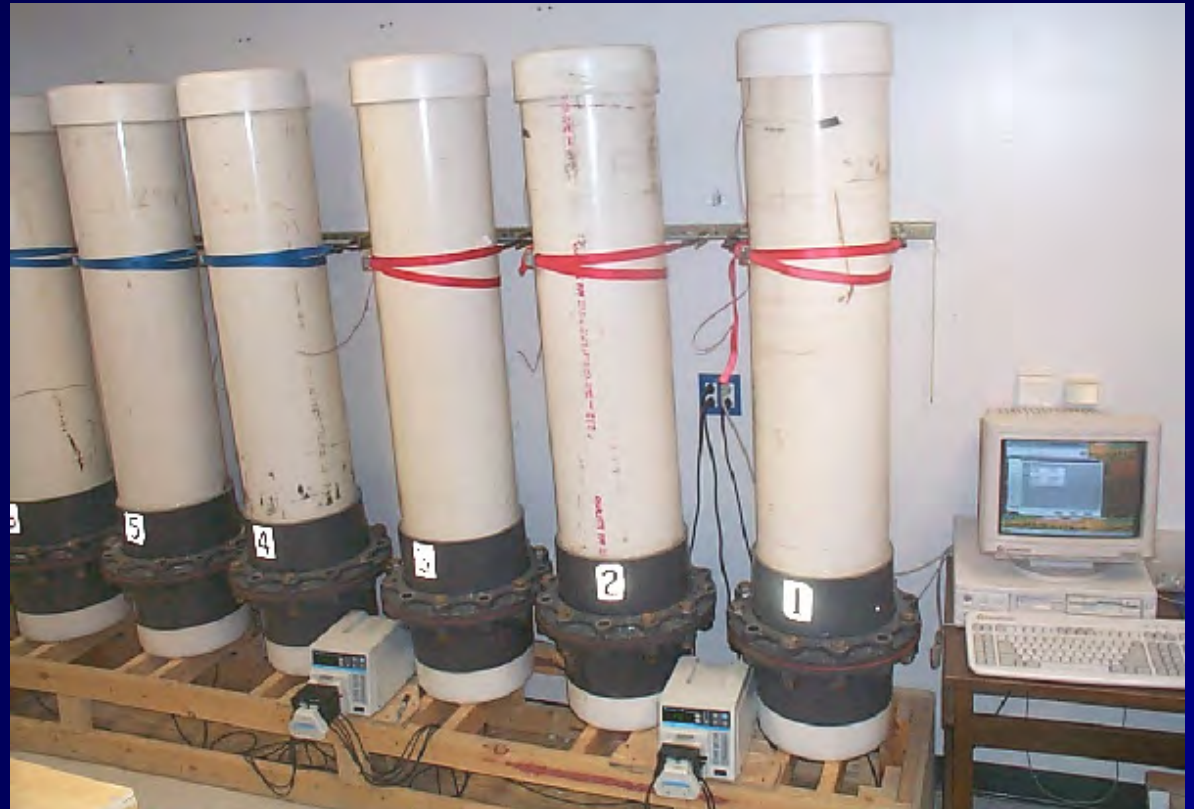
Laboratory Leaching Columns

- As part of ongoing work characterizing C&D waste leachate, C&D landfills have been simulated in the lab.
- While laboratory testing can never fully duplicate actual landfill conditions, such testing can provide very valuable information.
- The most recent round of laboratory tests included CCA wood as part of the waste stream.

- Leachate that resulted from rainfall infiltrating through the waste was collected and analyzed.
- Arsenic, Copper, and Chromium were included as part of the analysis.

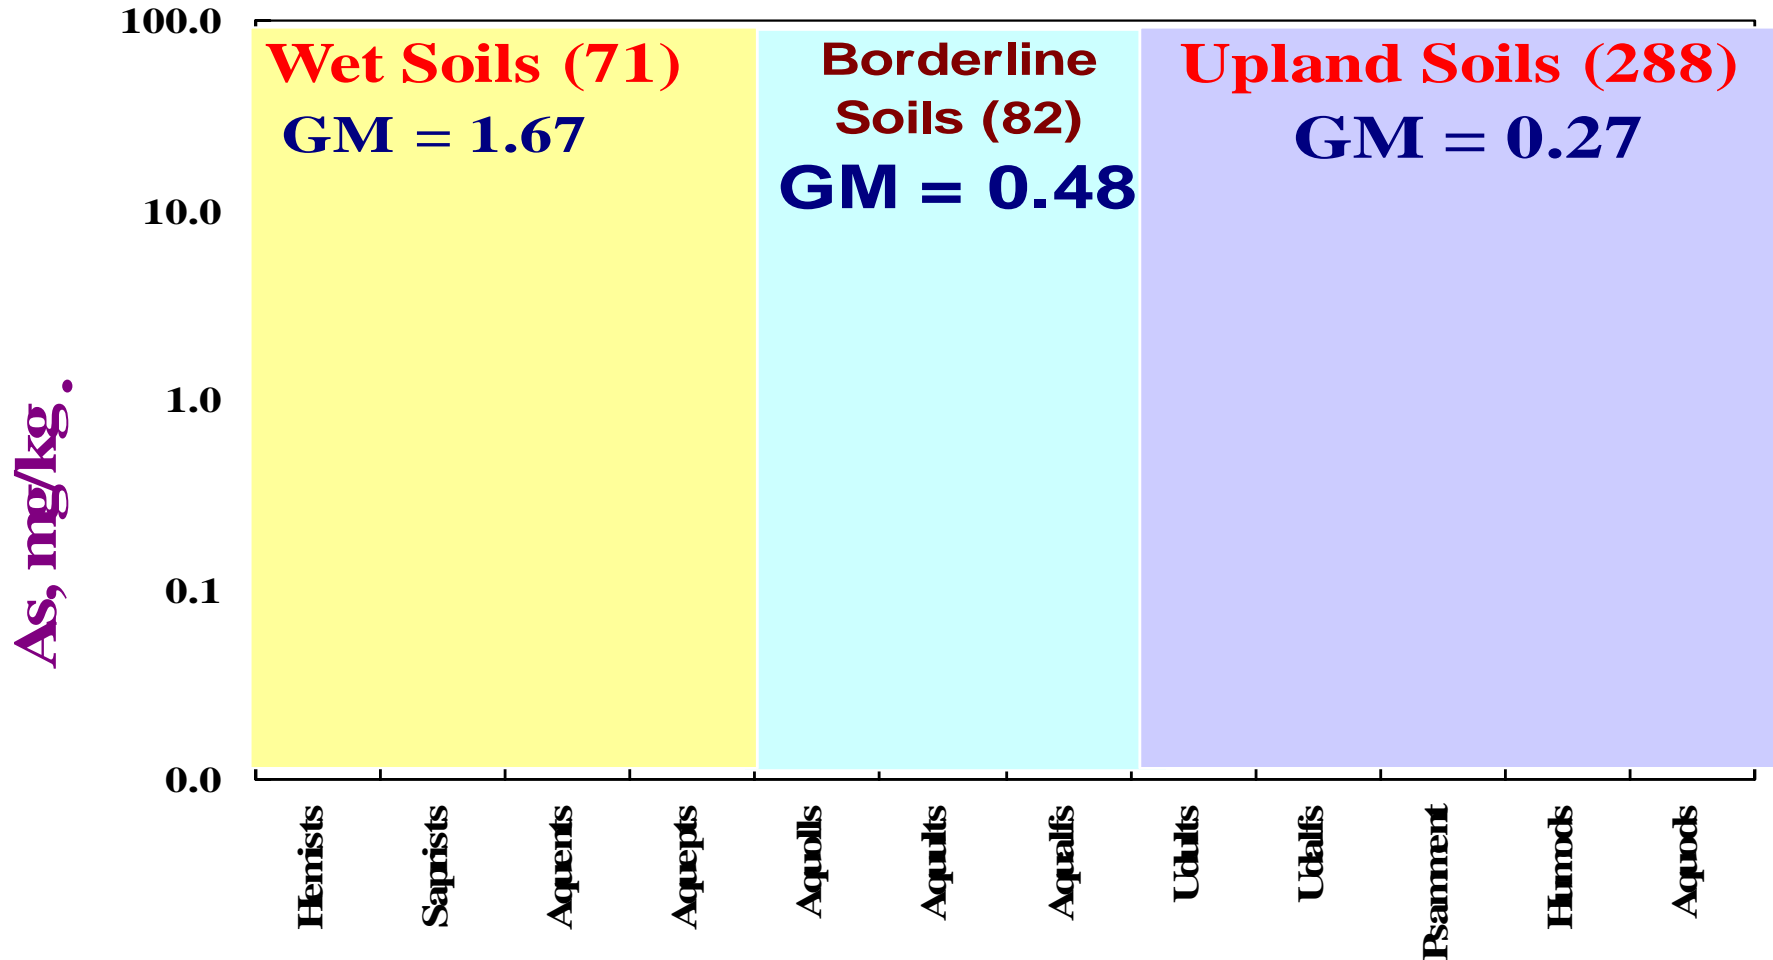
Arsenic Concentrations (ppm) in Wet, Borderline and Dry soils

Arsenic concentrations in soils

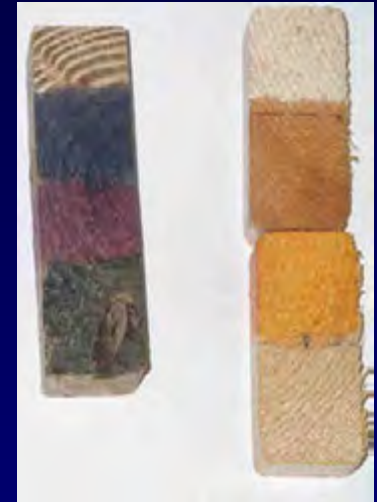
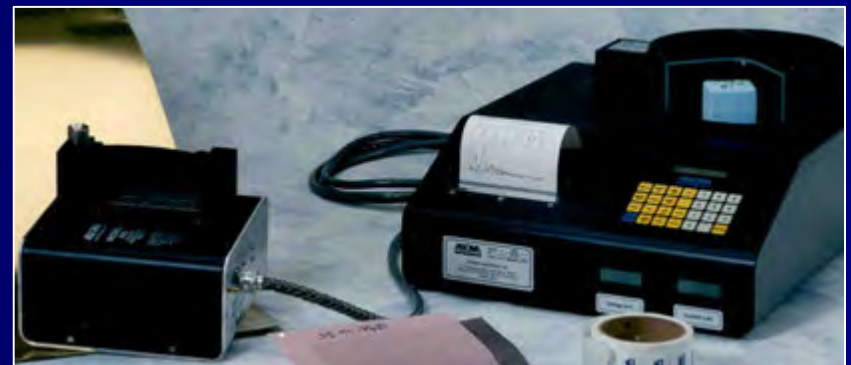
Treated Untreated

Identifying CCA-Treated Wood in Mixed Wood Streams

- Chemical Stains Very Promising
Advantage: Low Capital Cost
Disadvantage: Labor Intensive
