Dagny Johnson Key Largo Hammock Botanical State Park

Approved Unit Management Plan

**STATE OF FLORIDA
DEPARTMENT OF ENVIRONMENTAL PROTECTION**

**Division of Recreation and Parks
April 2019**

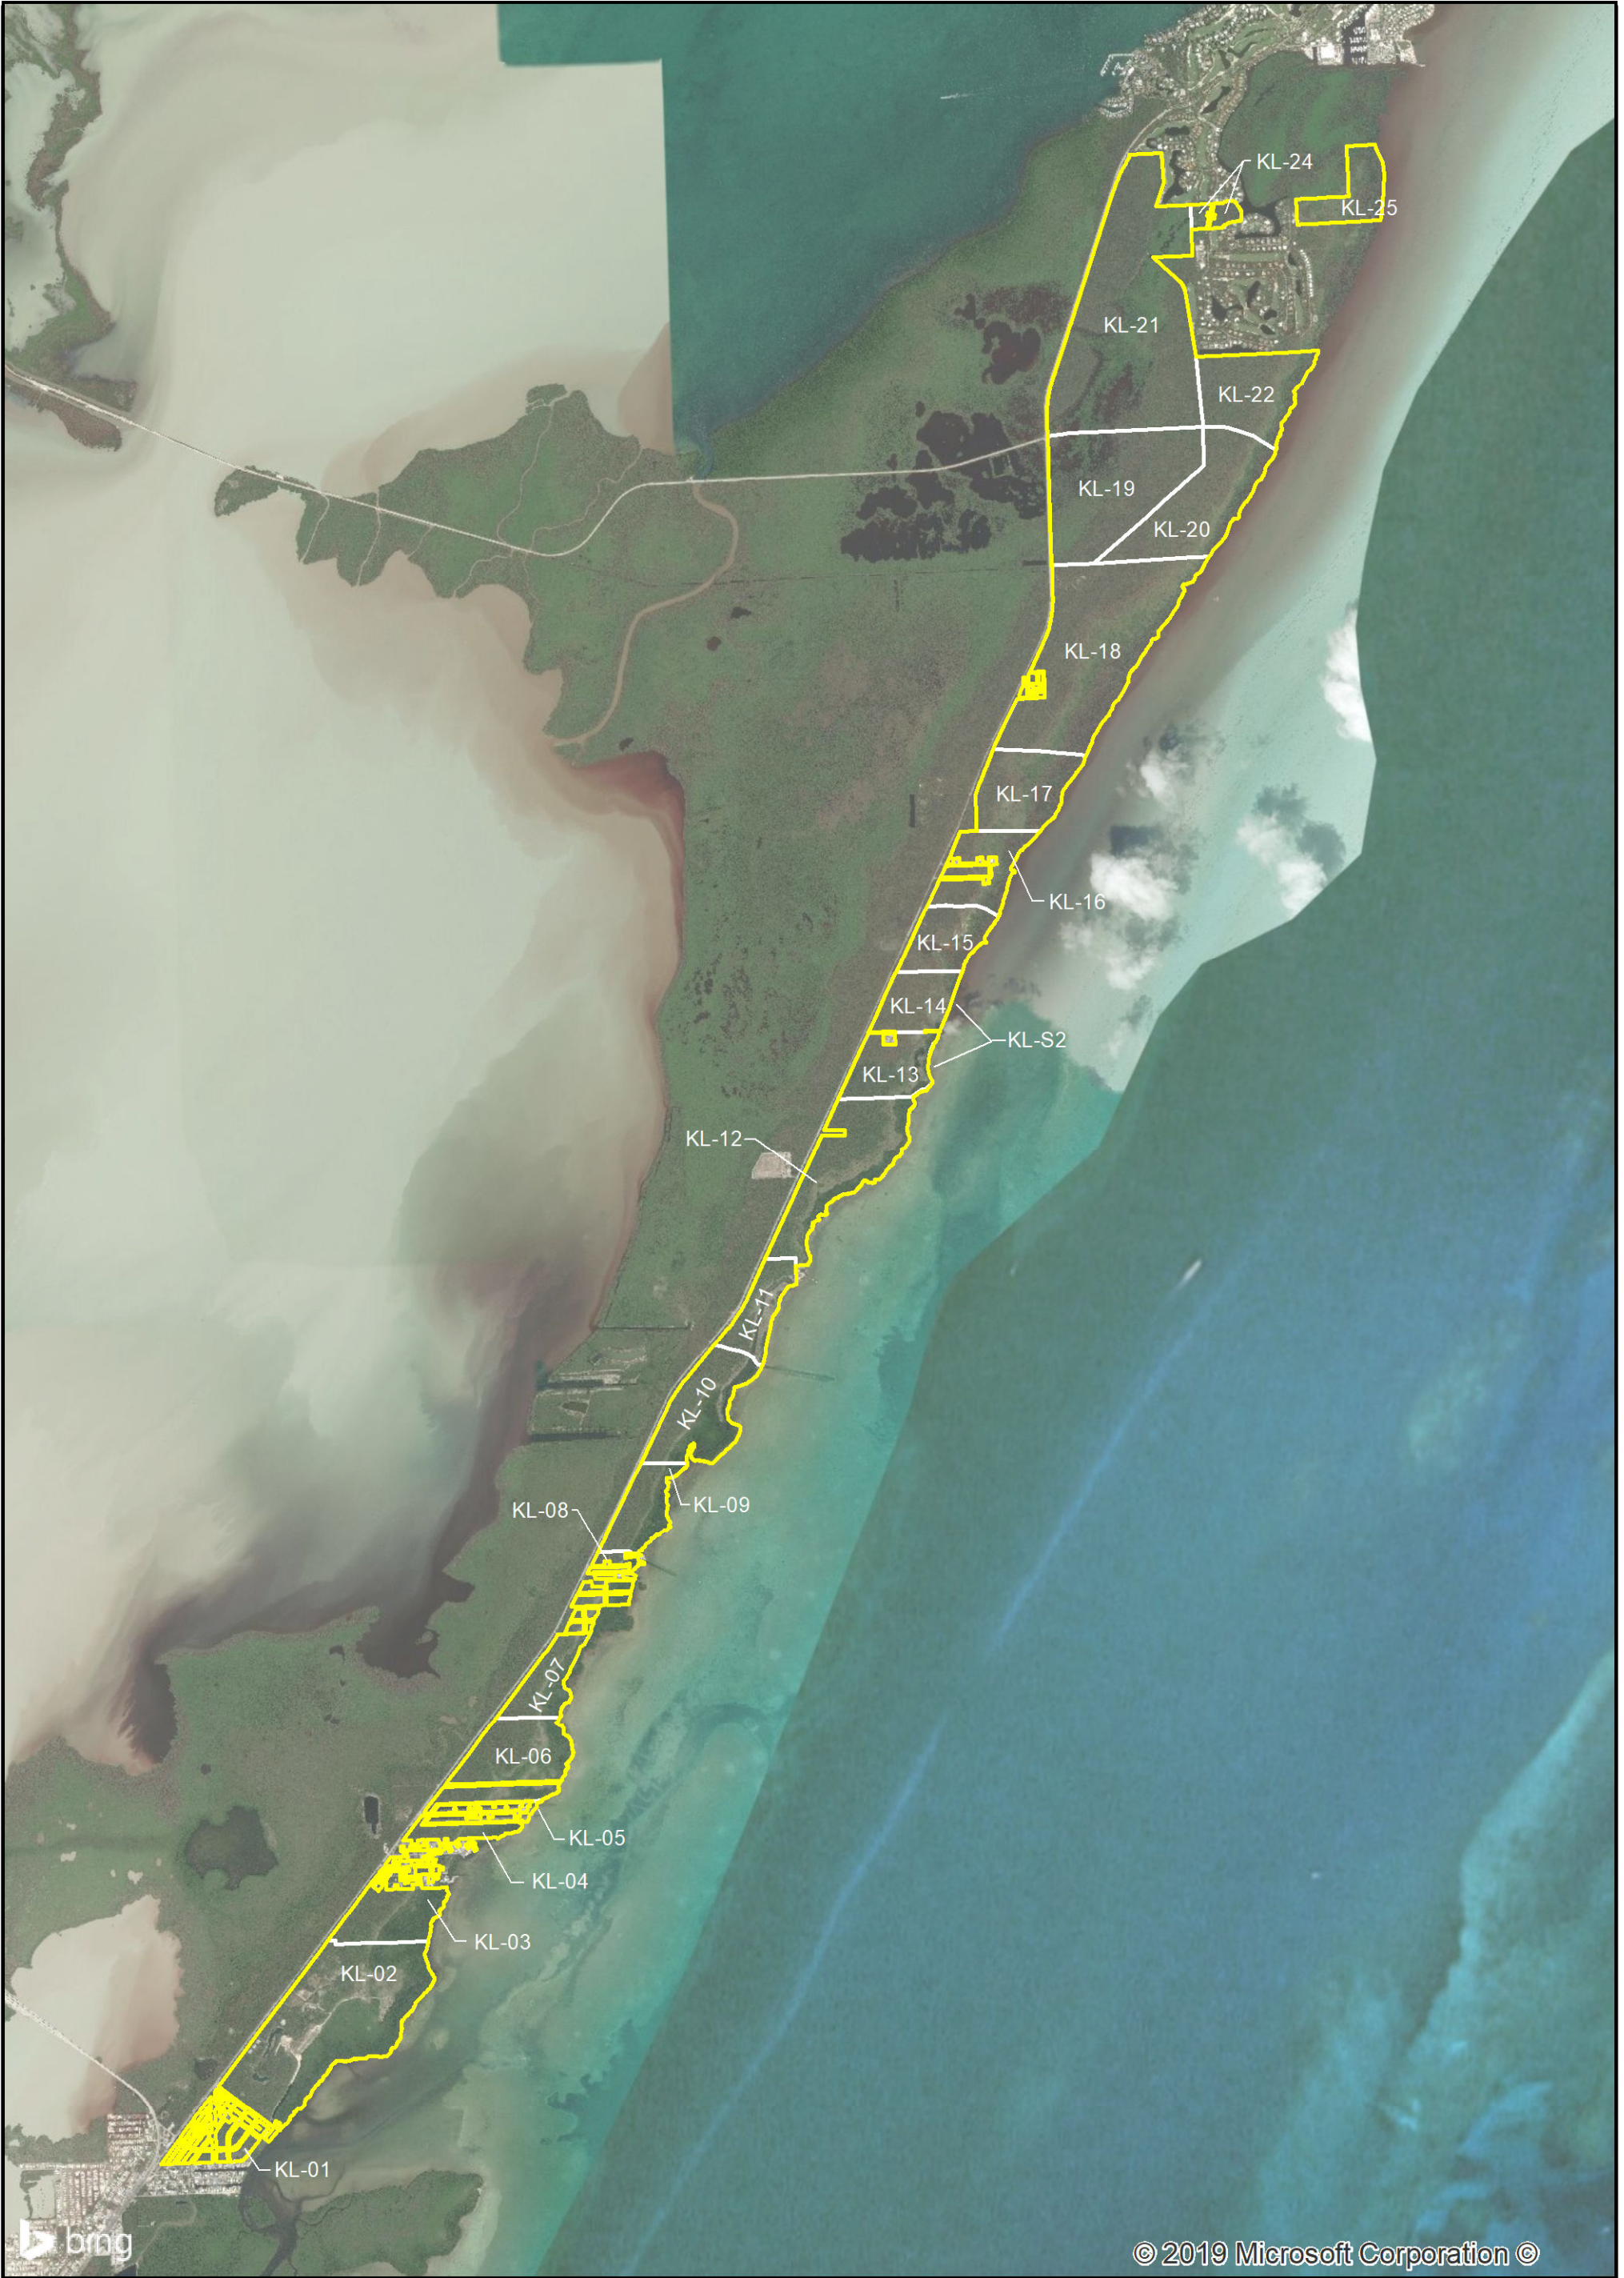
MANAGEMENT ZONE MAP

The entire park is divided into management zones that delineate areas on the ground that are used to reference management activities (see Management Zones Map). The shape and size of each zone may be based on natural community type, burn zone, and the location of existing roads and natural fire breaks. It is important to note that all burn zones are management zones; however, not all management zones include fire-dependent natural communities. Table 1 reflects the management zones with the acres of each zone.

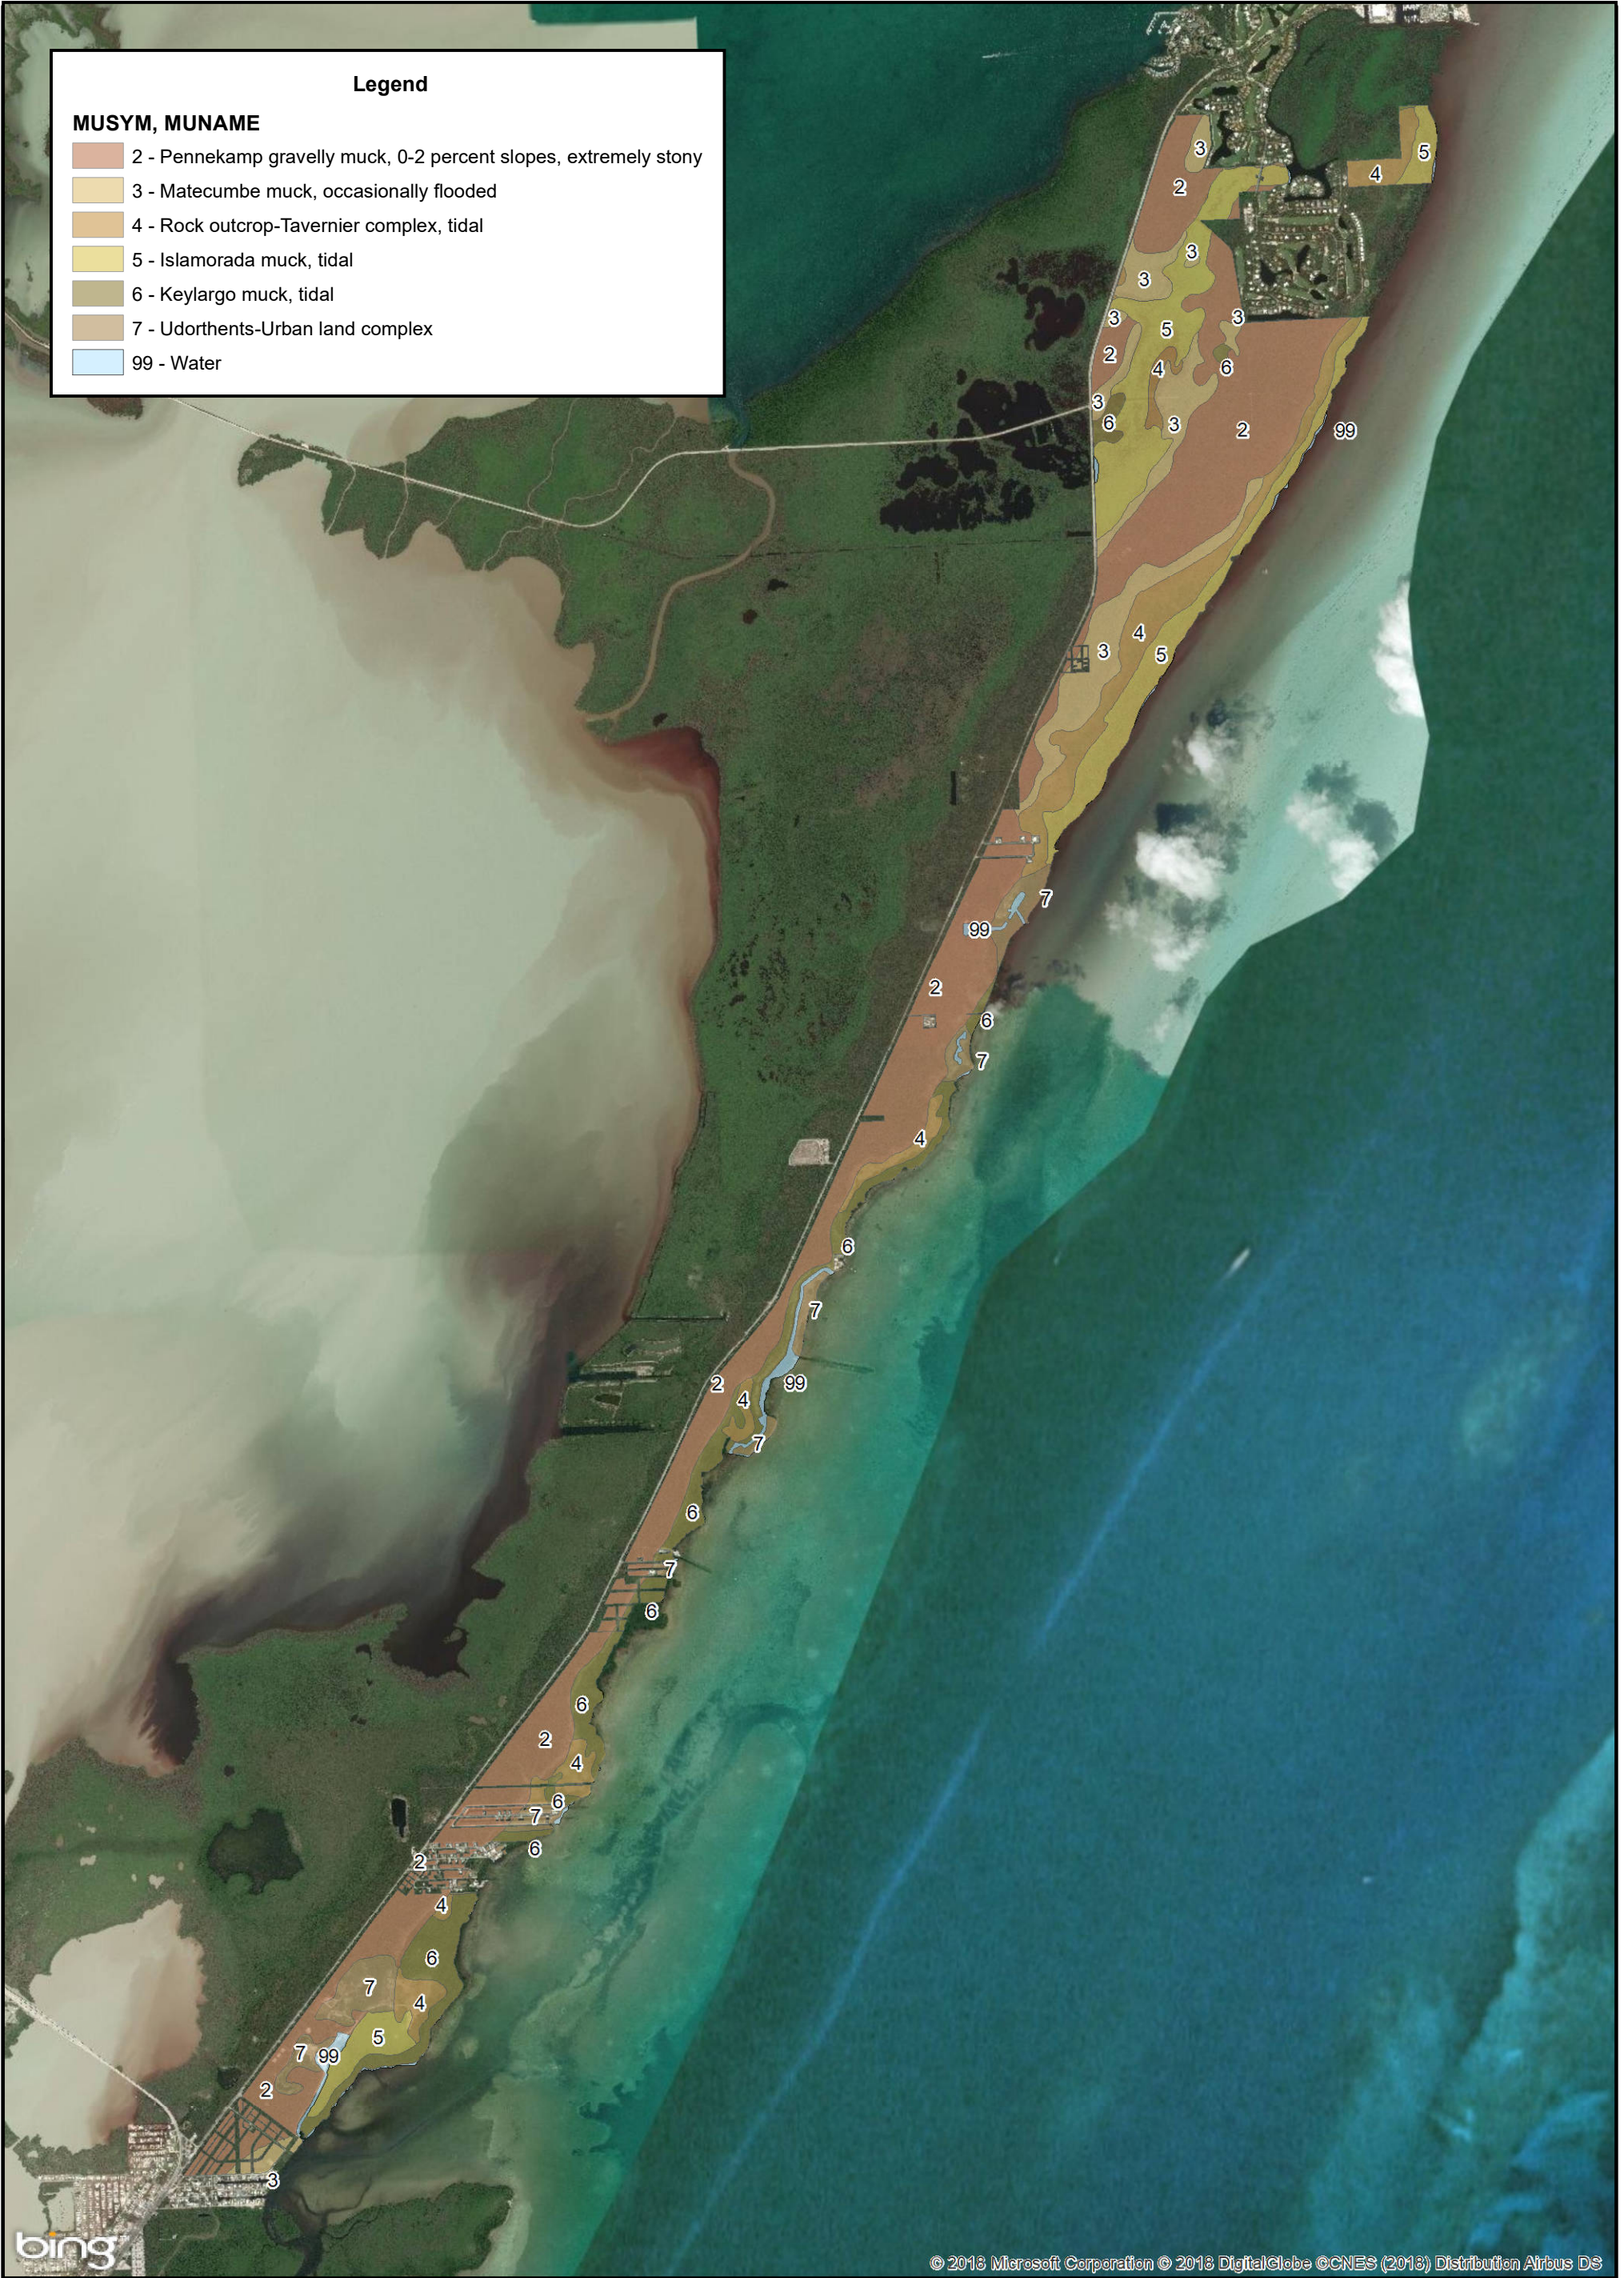
MUSYM, MUNAME

- 2 - Pennekamp gravelly muck, 0-2 percent slopes, extremely stony
- 3 - Matecumbe muck, occasionally flooded
- 4 - Rock outcrop-Tavernier complex, tidal
- 5 - Islamorada muck, tidal
- 6 - Keylargo muck, tidal
- 7 - Udorthents-Urban land complex
- 99 - Water

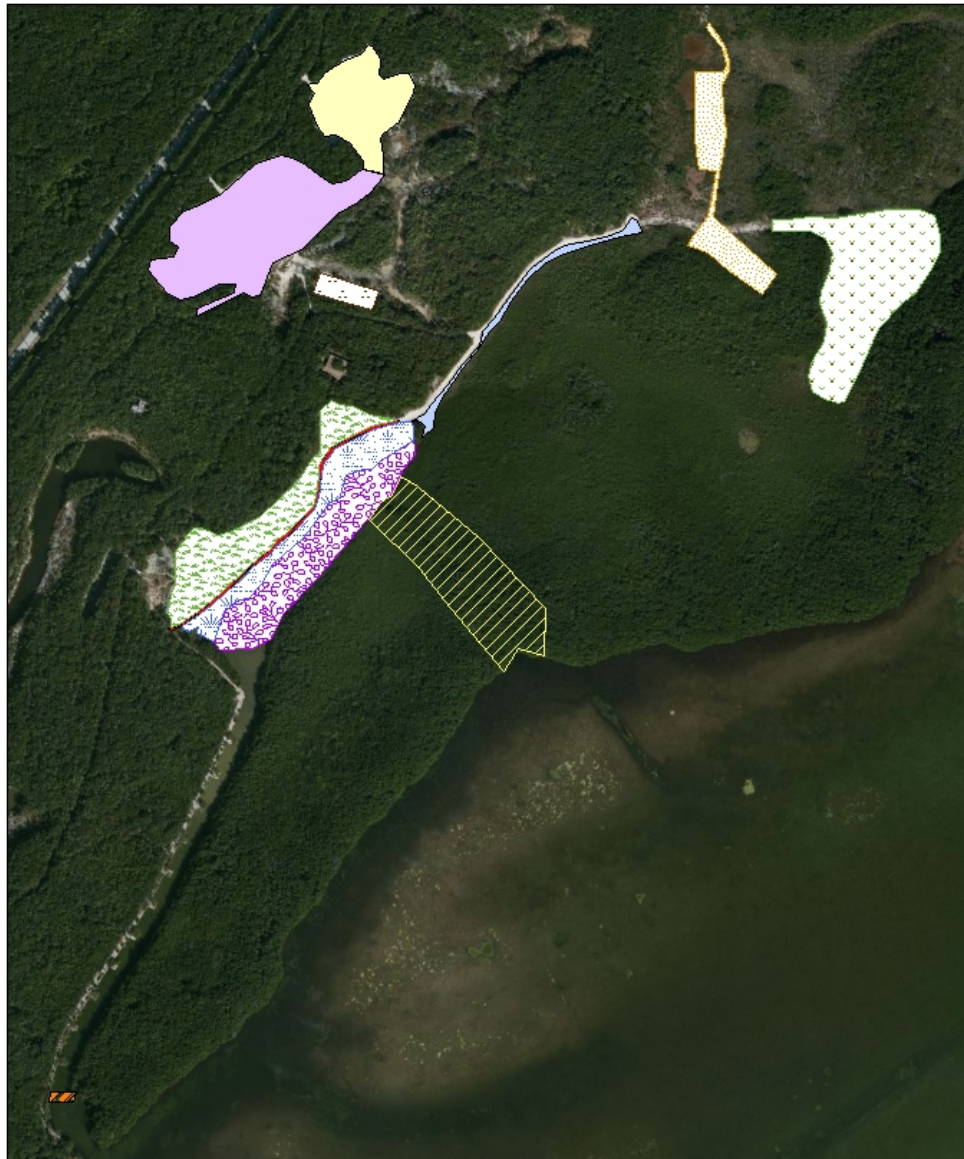
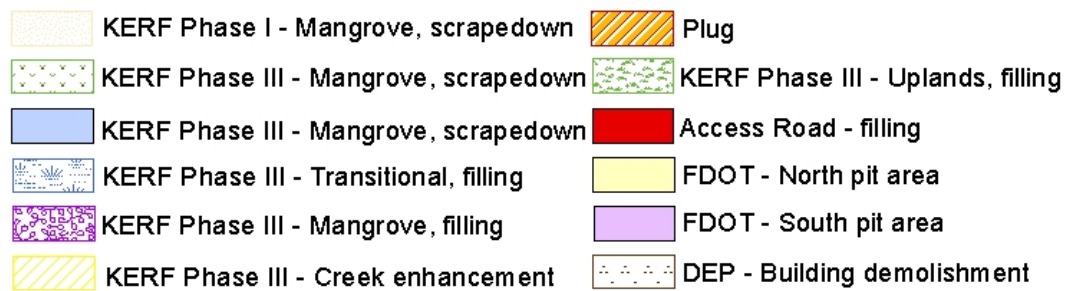
Figure 1: Restoration efforts by area

A current phase of restoration is slated to begin in March 2016. This phase will see the removal of the remaining buildings/structures and fill associated with the initial development. Most of the old roads in the area will also be removed, except for the section located in the current day-use section which will be minimized to twelve feet. The areas will be graded down to match surrounding natural elevations. (Figure 2) All acceptable materials which are produced in the course of demolition will be used to fill in the remaining open marina basin and

Port Bougainville Past Restoration Overview

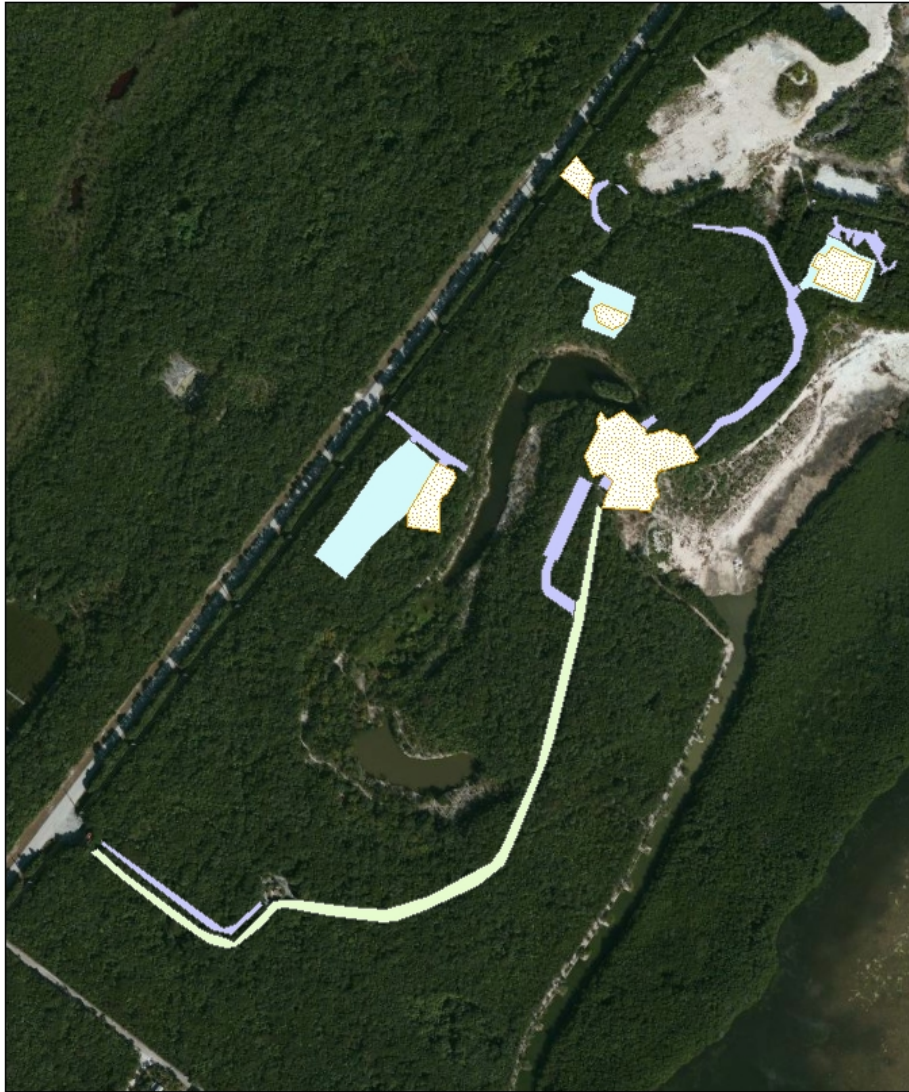
The Carysfort Marina property was acquired in 1993 by the State of Florida. In the 1980's the site had been partially developed with the intent on creating a multi-family residential facility with marina, but prior to acquisition the property was only actively serving as a marina and campground.

Port Bougainville Current Restoration

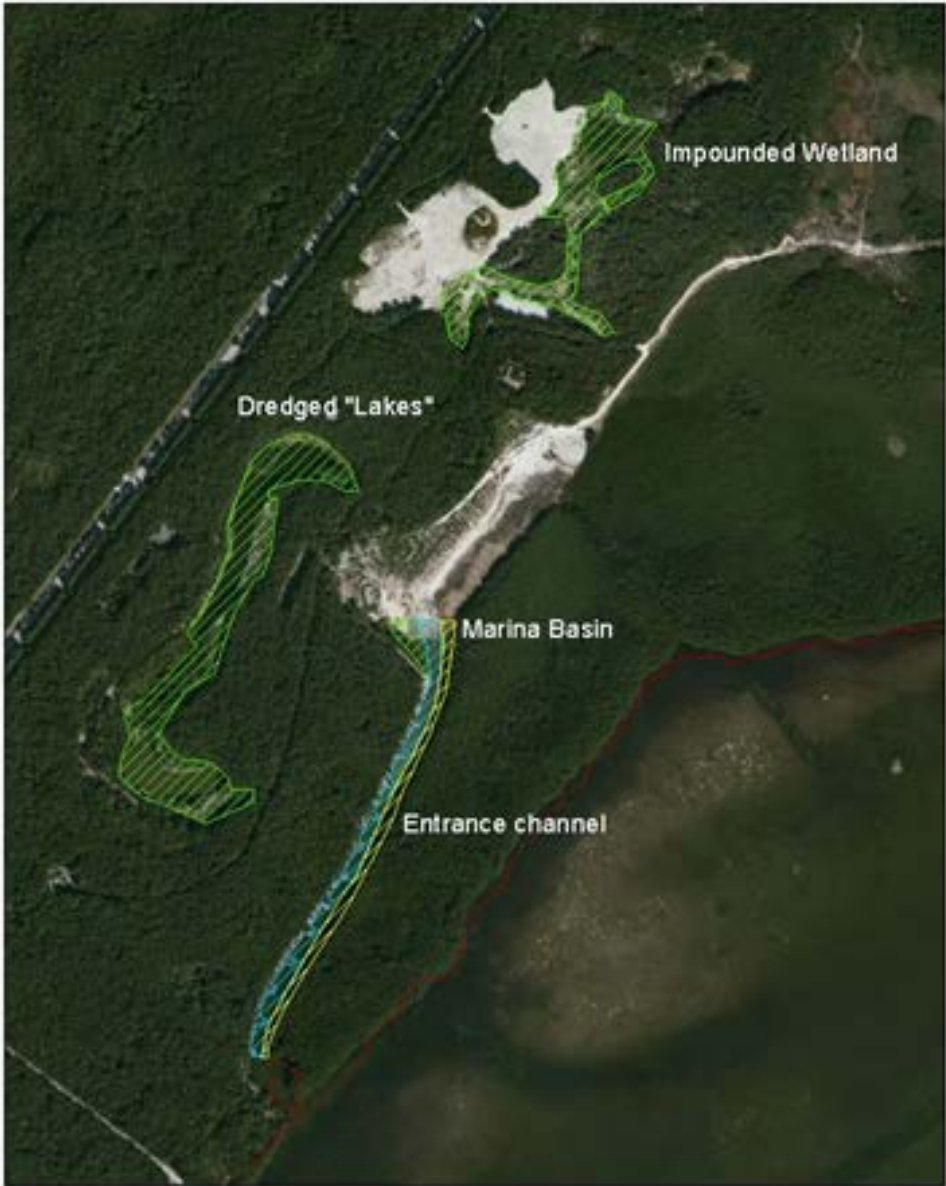
Figure 3: Remaining restoration locations.

Port Bougainville Restoration Remaining

- Remaining upland restoration: approx. 10.66 acres
- Remaining transitional wetland restoration: approx. 1.72 acres
- Remaining mangrove restoration: approx. 1.14 acres

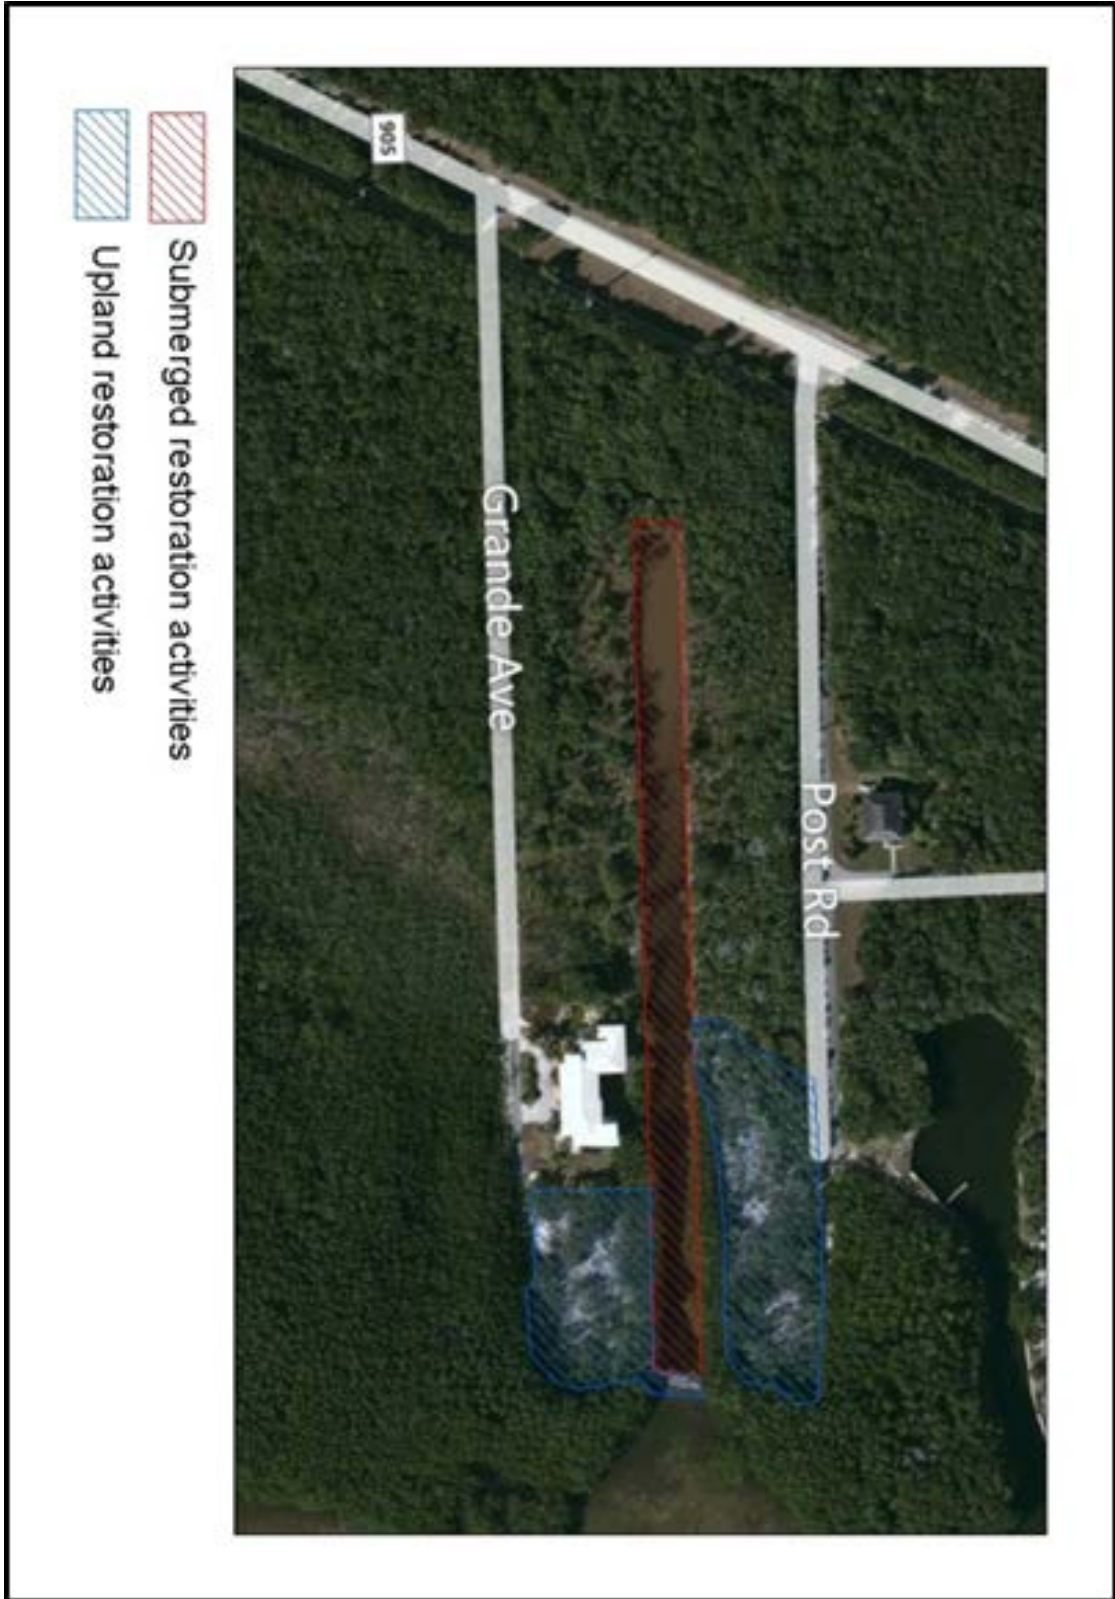
Figure 4: JHT Subdivision needed restoration locations.

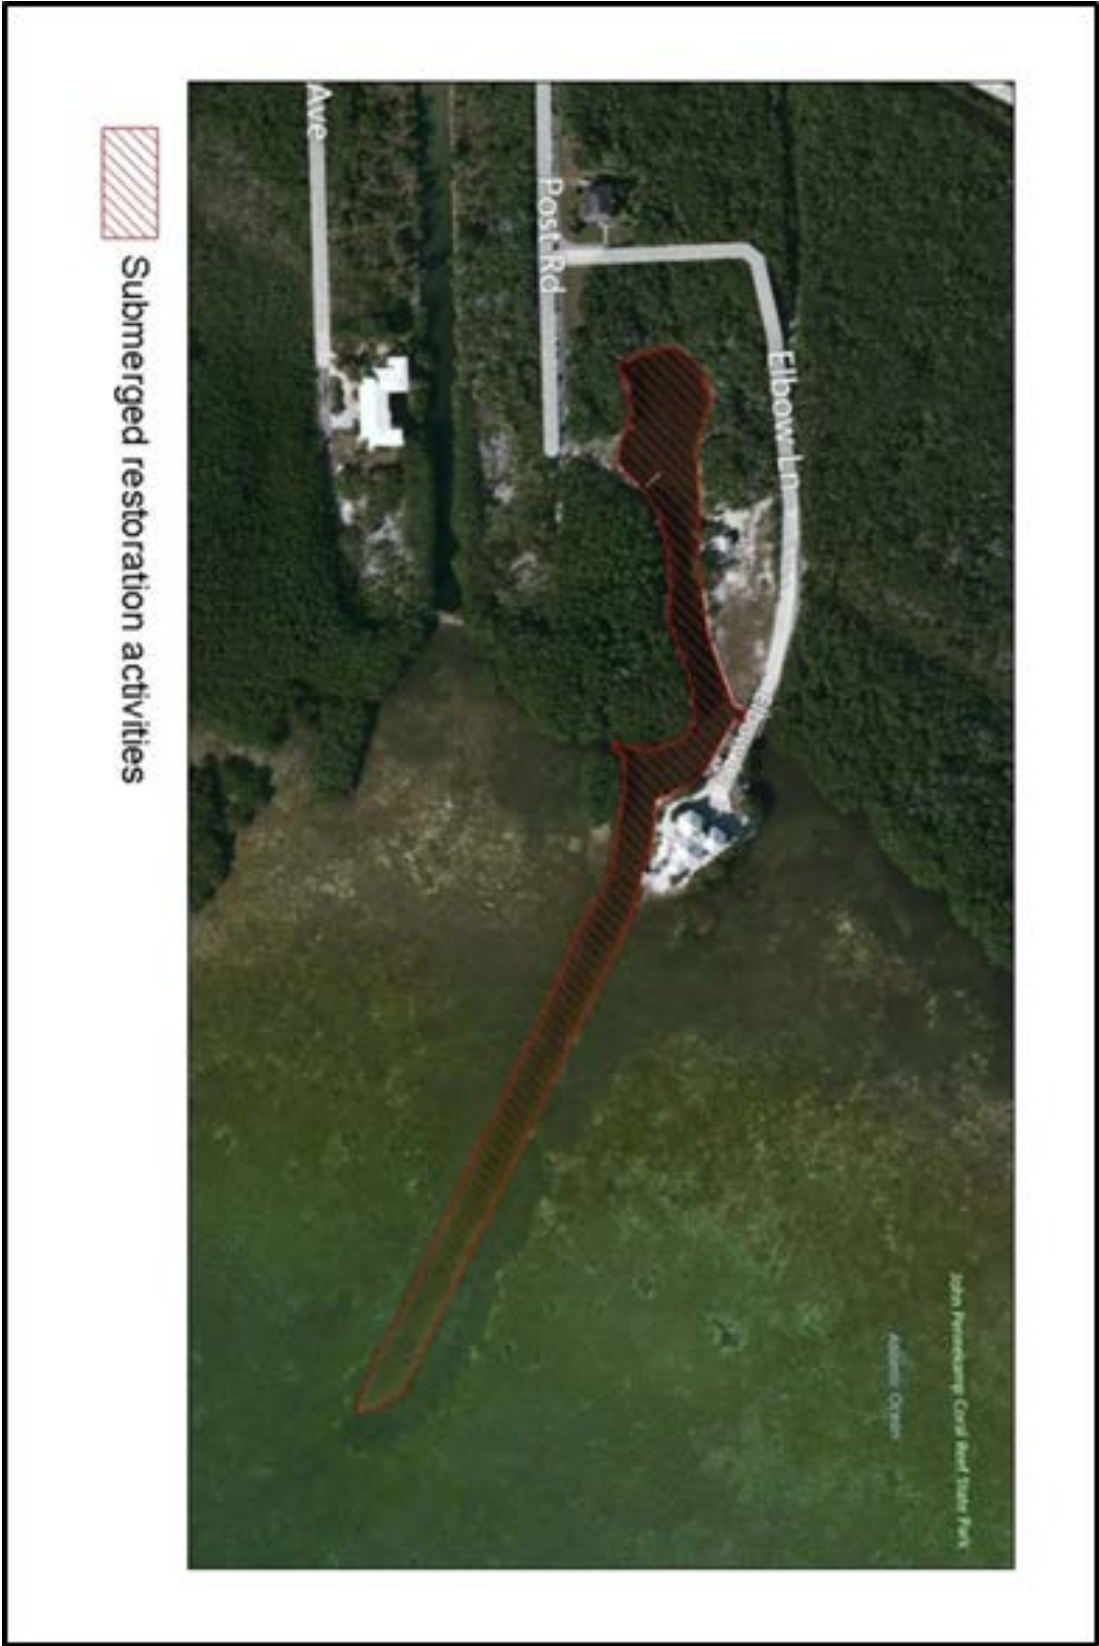
Figure 5: Elbow Light Club needed restoration locations.

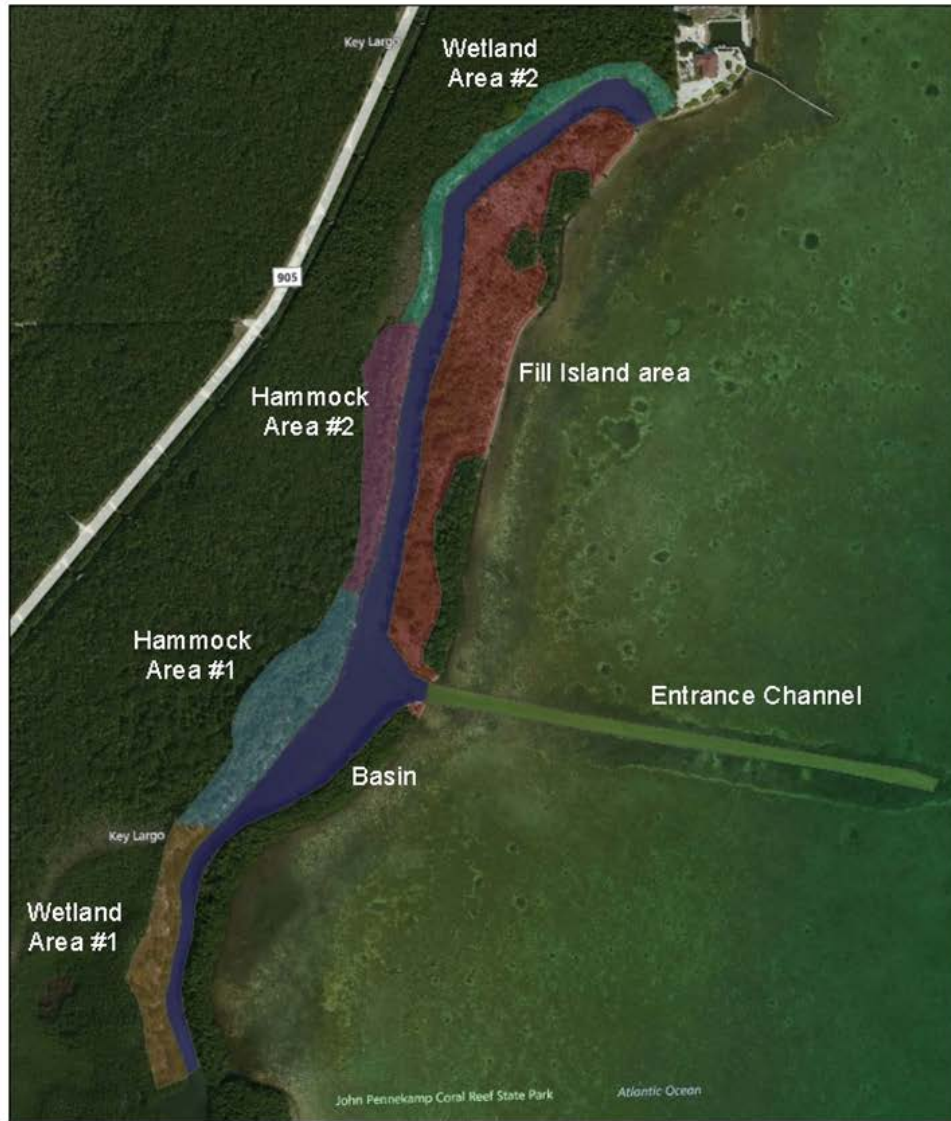
Ocean Forest Estates - Needed Restoration

Hammock Area #1	3.2 acres	67,200 cu yds
Hammock Area #2	2.0 acres	64,320 cu yds
Wetland Area #1	1.8 acres	17,280 cu yds
Wetland Area #2	2.5 acres	19,200 cu yds
Fill Island	9.9 acres	182,400 cu yds

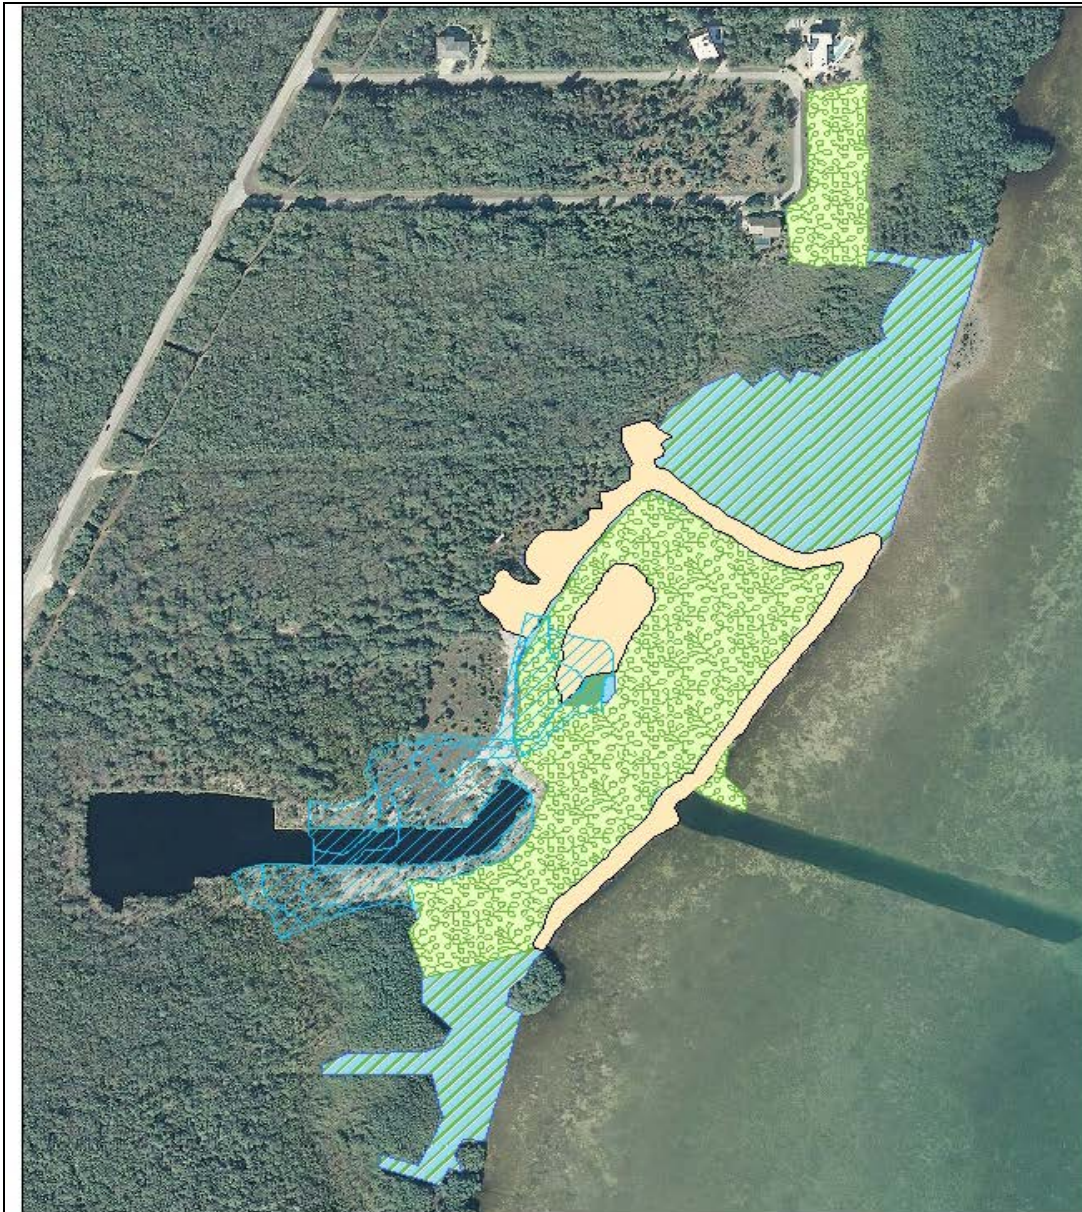
Carysfort Marina Restoration: 32.08 Acres of Wetland Restoration

Figure 7: Overview of restoration activities at Carysfort Marina.

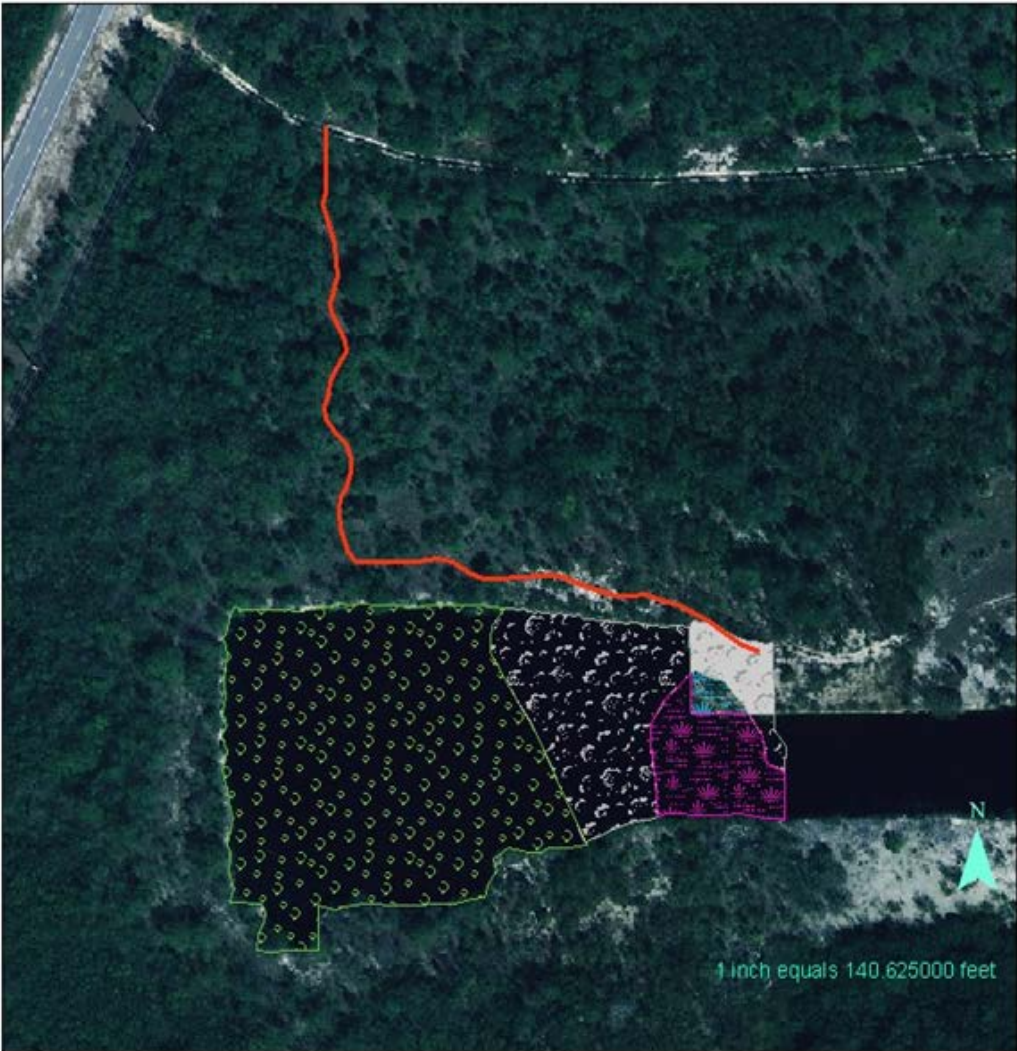
Caryfort Marina Restoration, Work Remaining

Remaining Restoration:
1.02 acres of wetland restoration
1.96 acres of hammock restoration

Figure 8: Remaining restoration needs at Carysfort Marina.

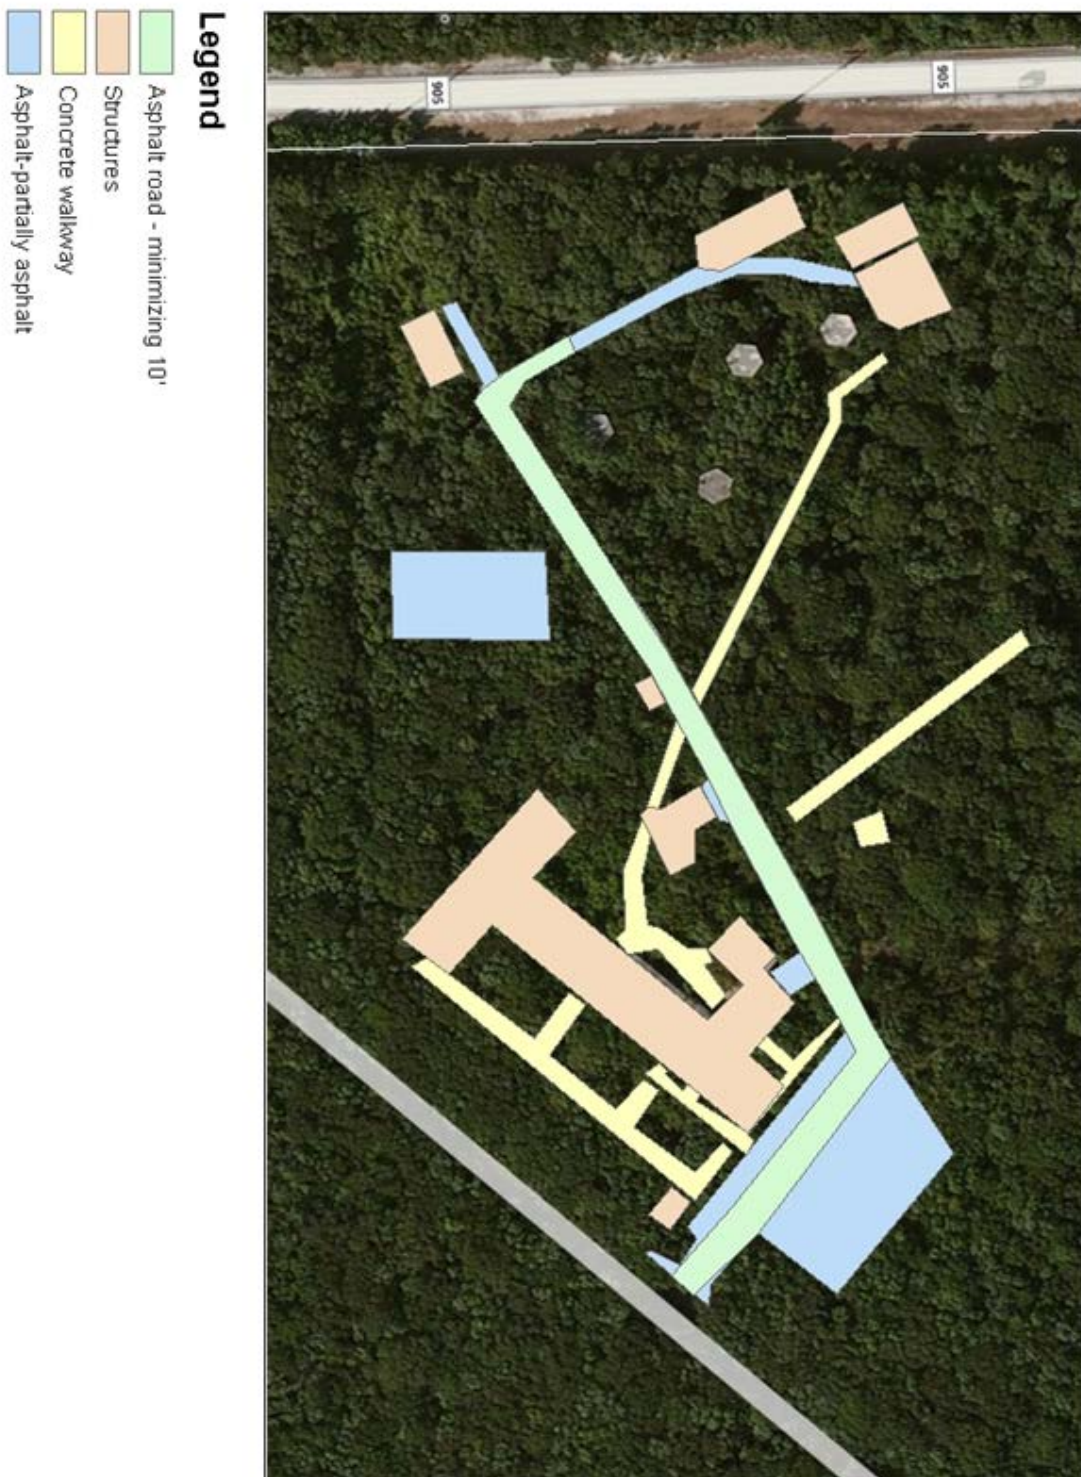
Figure 9: Currently identified restoration activities at the Nike Radar Site.

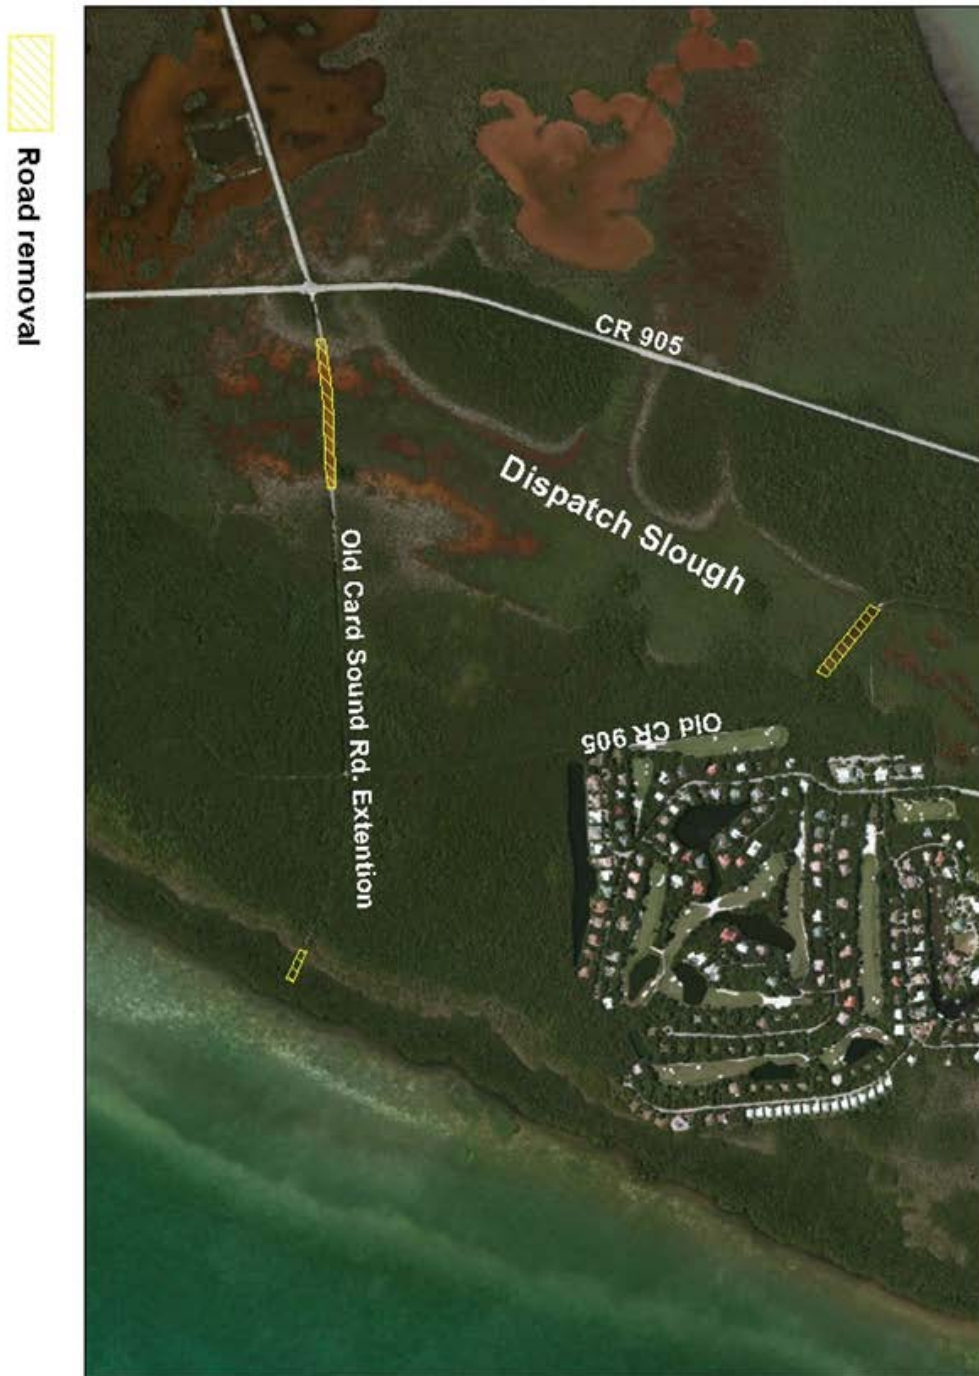
Figure 10: Dispatch Slough project locations.
