## **Critically Eroded Beaches in Florida**

**Office of Resilience and Coastal Protection  
Florida Department of Environmental Protection  
August 2024**

## August 2024

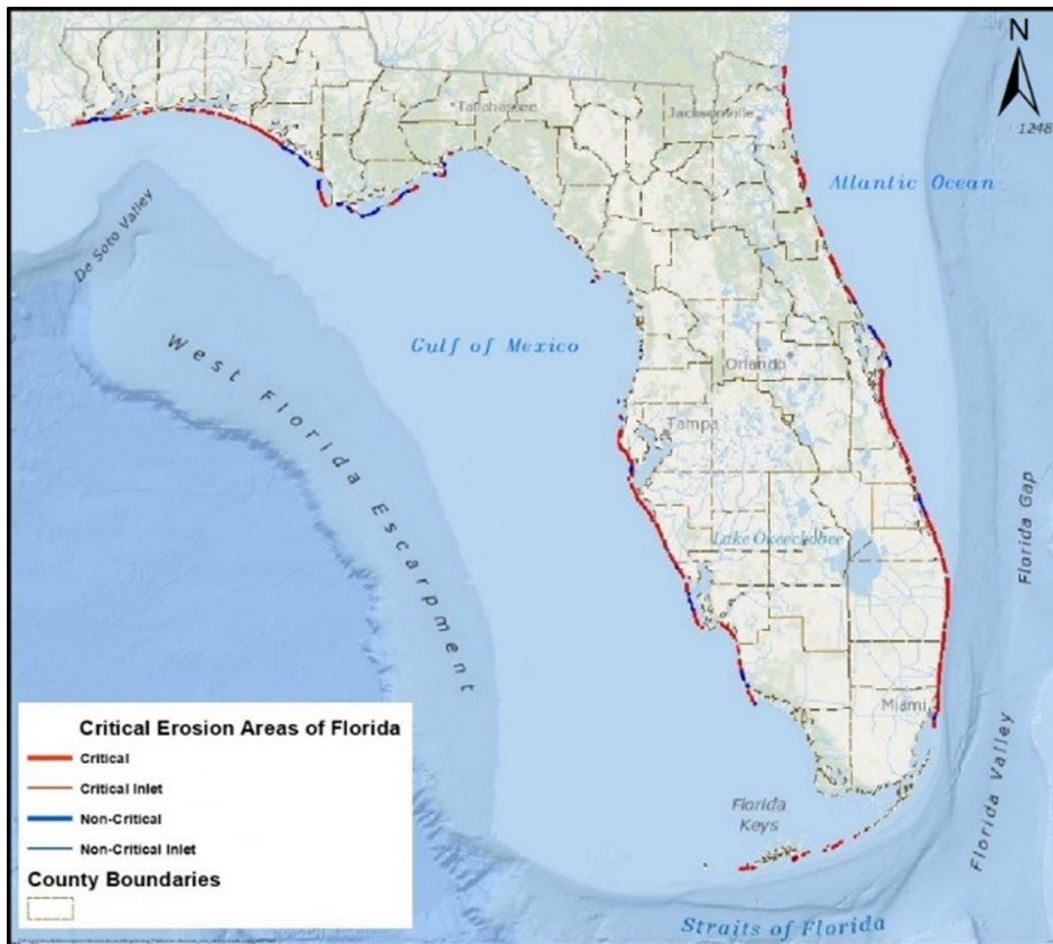
**Figure 1.** Statewide areas of critically and non-critically eroded shoreline [Graphic from [ROSSI](#) database]. View an [interactive map](#) with aerial imagery showing R monuments and the critical erosion areas.

No changes were made in the updated Critically Eroded Beaches Report of 2022. Due to erosion caused by Hurricanes Ian and Nicole (2022), additional critical erosion areas were added to the 2023 critical erosion report in St. Johns County (0.8 mile), Volusia County (5.0 miles) and Lee County (0.4 mile). Both Volusia County (0.9 mile) and St. Johns County (7.6 miles) had non-critical erosion segments added into the 2023 report. Due to eastward erosion progression along St. George Island (0.6 mile) in Franklin County and new information on critical wildlife habitat being threatened (0.2 mile) along Gomez Key in Levy County, two erosion segments have been added into the 2024 report. One segment (0.2) in Pasco County was delisted in 2024 at Hudson Beach due to coastal armoring of the beach. The 2024 list includes 432.8 miles of critically eroded beach, 9.1 miles of critically eroded inlet shoreline, 96.5 miles of non-critically eroded beach and 3.2 miles of non-critically eroded inlet shoreline statewide, as shown in Figure 1.
