**Figure 24**  
**Summary of Analytical Results in Sediment and Surface Water**  
**Indian River State College**  
**4600 Kirby Loop Road**  
**Fort Pierce, St. Lucie County, Florida**

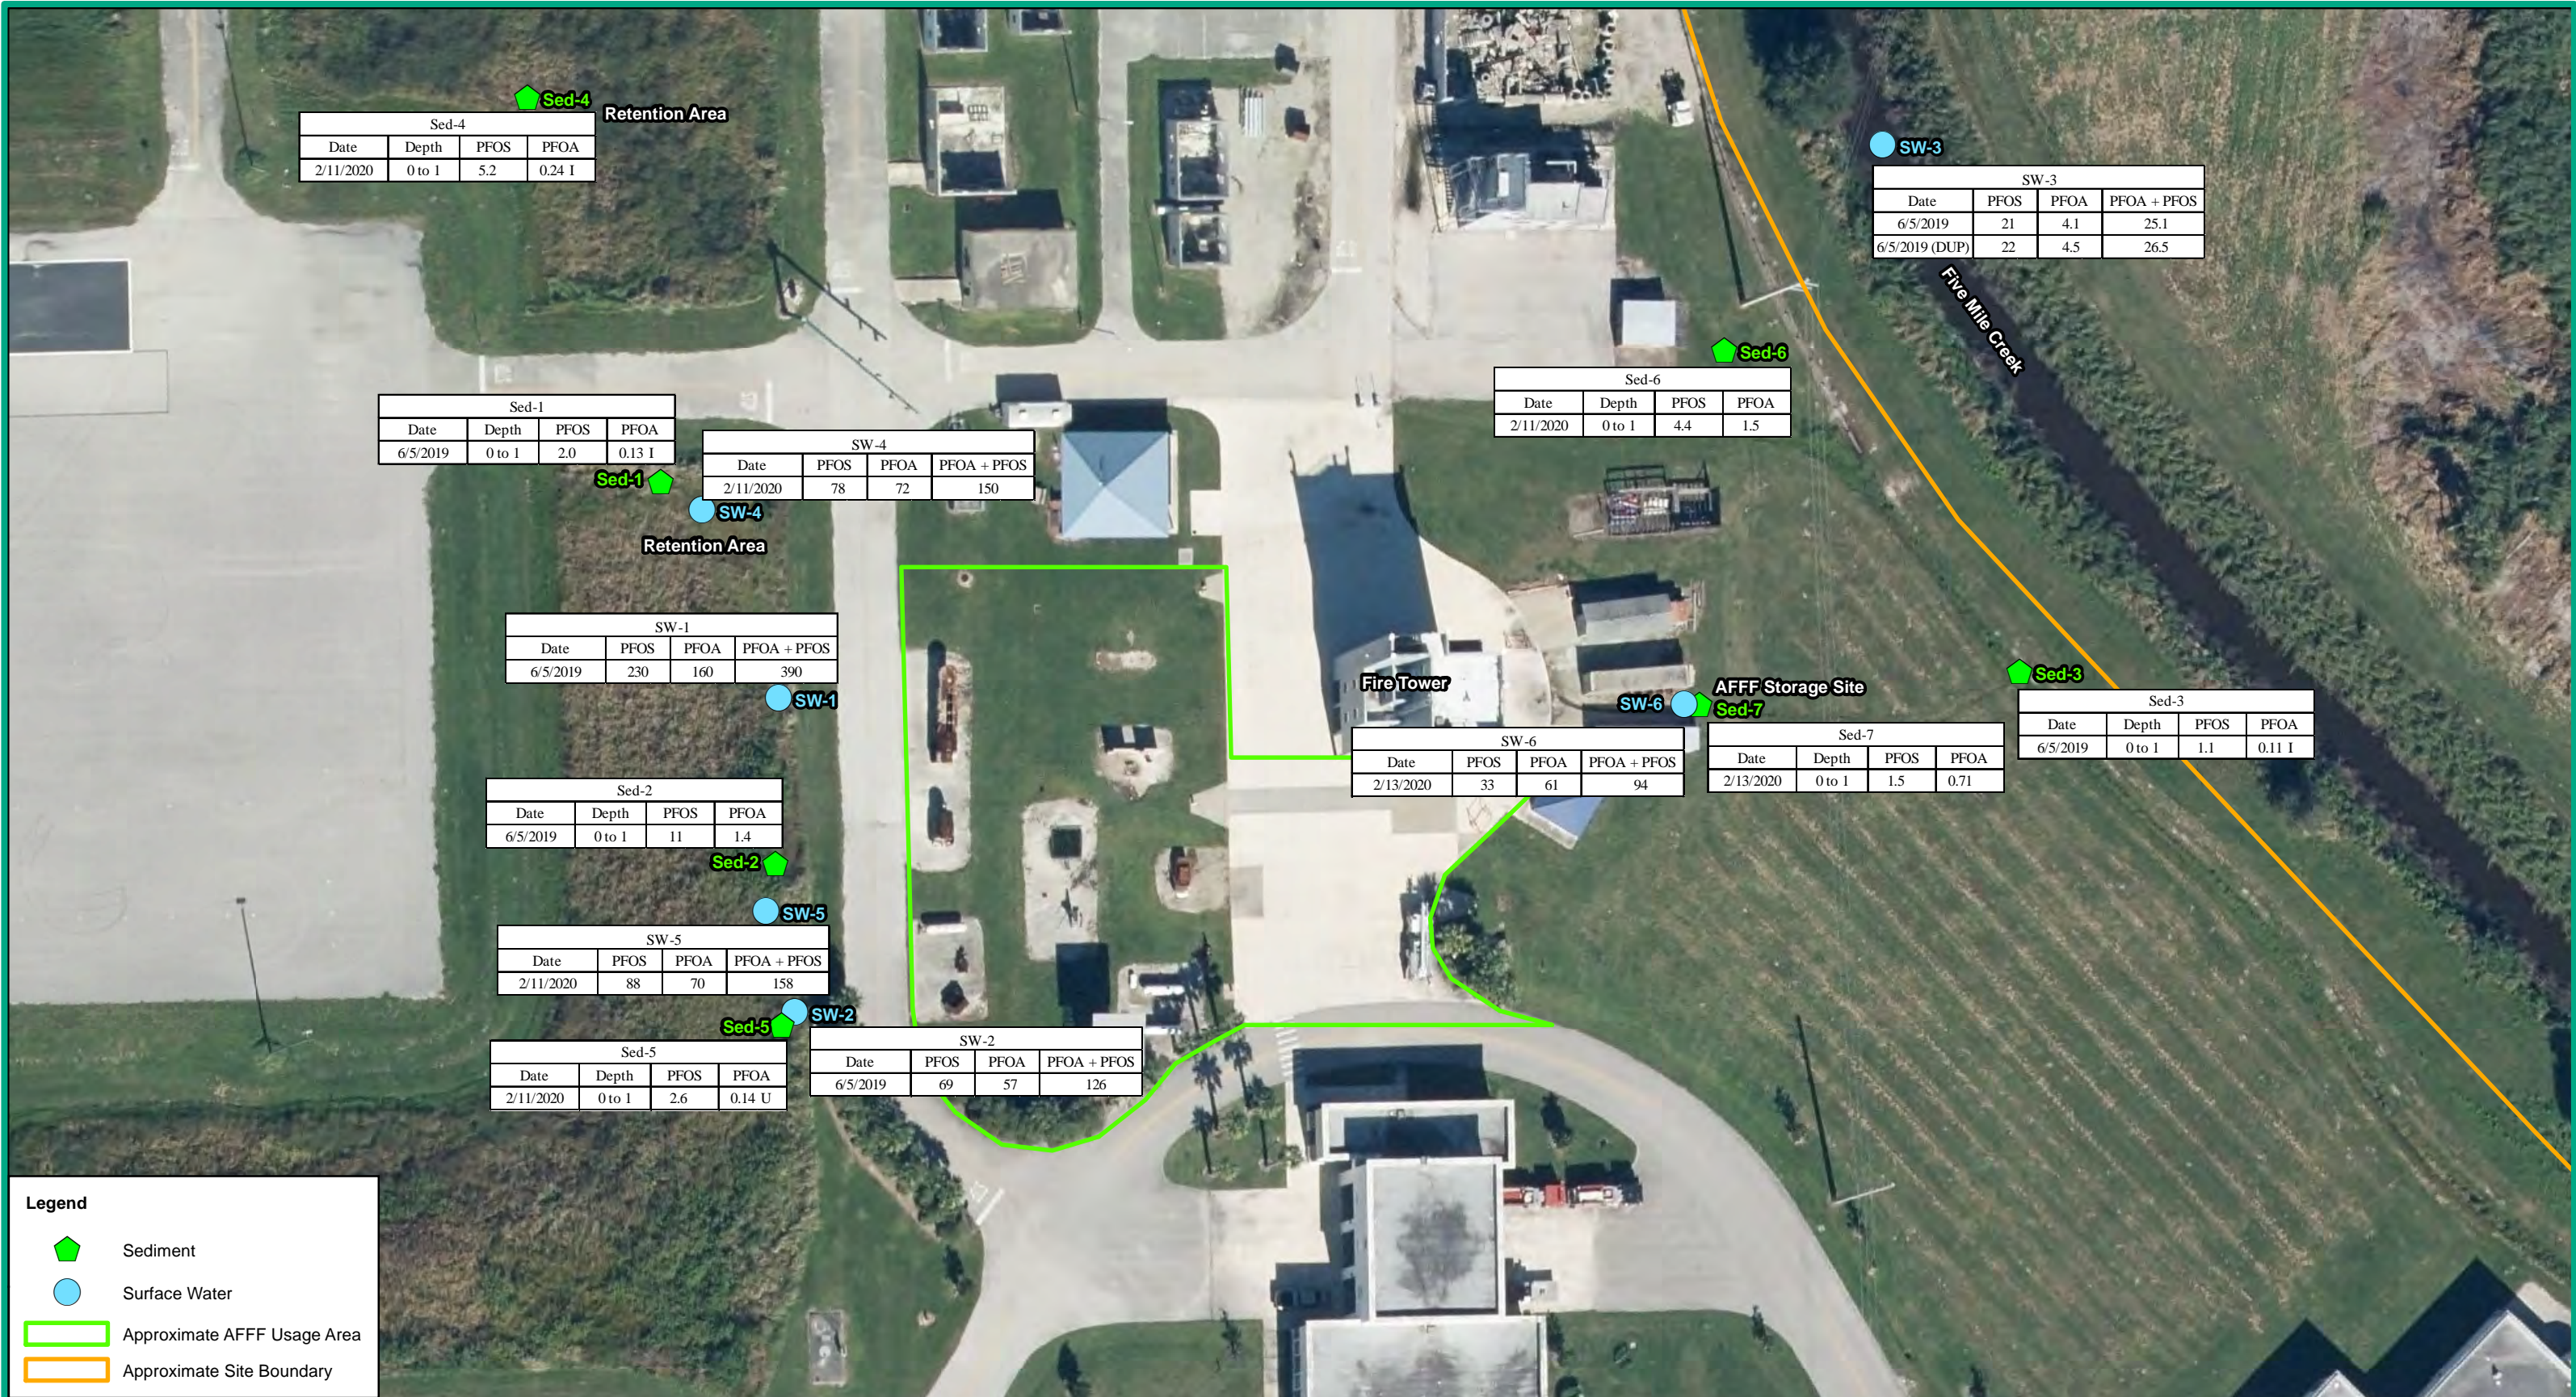
1. Surface water results are provided in nanograms per liter (ng/L). Sediment results are provided in micrograms per kilogram (µg/Kg).
2. Depth is provided in feet below land surface (ft BLS).
