RE: John D. MacArthur Beach State Park – Lease No. 3205

**State of Florida Department of Environmental Protection
John D. MacArthur Beach State Park
Unit Management Plan
Division of Recreation and Parks
August 2020**

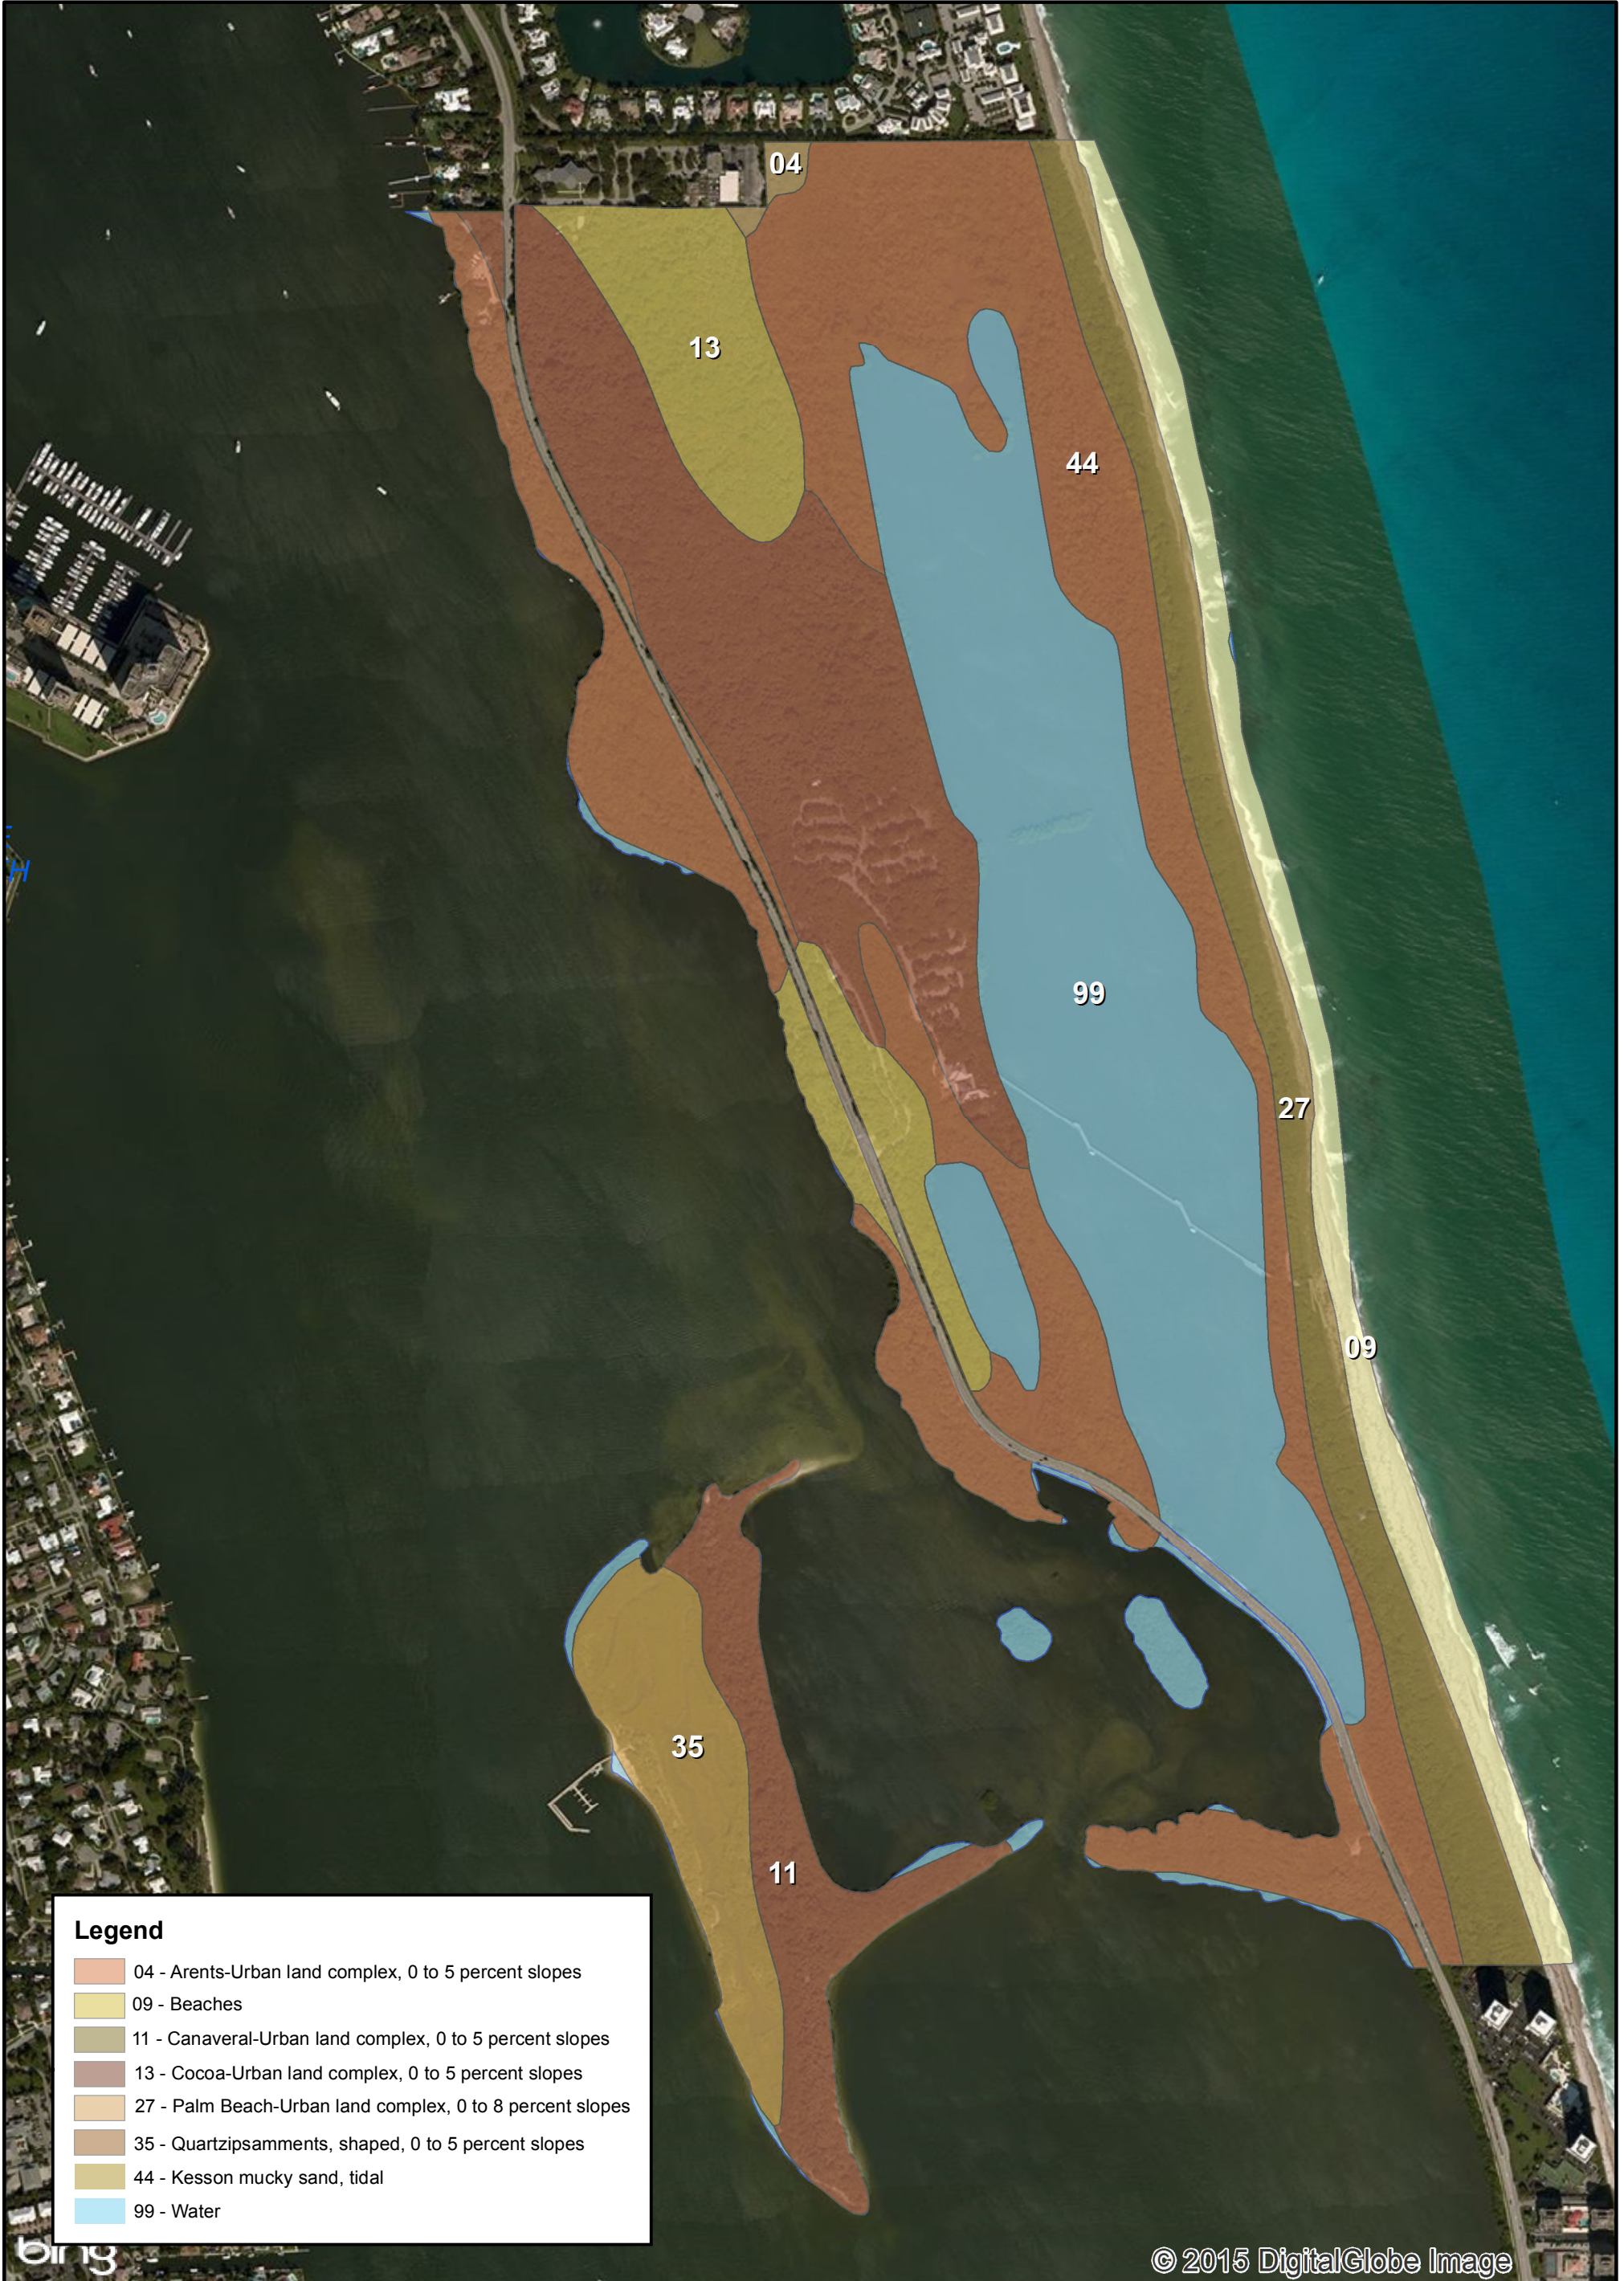
Legend

- 04 - Arents-Urban land complex, 0 to 5 percent slopes
- 09 - Beaches
- 11 - Canaveral-Urban land complex, 0 to 5 percent slopes
- 13 - Cocoa-Urban land complex, 0 to 5 percent slopes
- 27 - Palm Beach-Urban land complex, 0 to 8 percent slopes
- 35 - Quartzipsamments, shaped, 0 to 5 percent slopes
- 44 - Kesson mucky sand, tidal
- 99 - Water

Kesson mucky sand, tidal, is the predominant soil type found in the park consisting of 125.1 acres or 23.5 percent of the total soil composition for the park. The park contains 26.5 percent of the total of this soil type for all of Palm Beach County. Formerly mapped as tidal swamp, this soil is found along the shoreline of the Lake Worth Lagoon, the Lake Worth Cove and the mangrove areas of the park. It is subject to tidal flooding creating a high salinity environment and is often exposed during periods of low tide.

Canaveral-Urban land complex is the second most abundant soil type comprising 90.9 acres or 17.1 percent of the total soil composition for the park. Sand is the dominant component of this soil and is found throughout the typical profile. Because the freshwater lens is found close to the surface, this soil type is able to support a more diverse plant community and is usually found in association with the maritime hammock.

Cocoa-Urban land complex is found in association with upland coastal ridges at the park. This soil type is similar to Canaveral and Palm Beach soils where sand is the dominant component. This soil type is found in a small segment of maritime hammock in the northern section of the park and a small area along the southern boundary. The Cocoa-Urban land complex comprises 33.2 acres or 6.2 percent of the total soil composition for the park.

Palm Beach-Urban land complex is found in the upper beaches and dunes of the park where drainage is excessive, and the available water capacity is very low. The Palm Beach-Urban land complex comprises 32.9 acres or 6.2 percent of the total soil composition for the park.

Arents-Urban land complex is the smallest soil component within the park consisting of 1.4 acres or 0.3 percent of the total soil composition. It is located on the northern boundary and is associated with an unimproved road used by park staff for beach access.
