John's Pass Inlet Management Plan
Division of Water Resource Management
Florida Department of Environmental Protection
January 2018

Final Order Adopting John's Pass - Inlet Management Plan

John's Pass in Pinellas County, Florida.

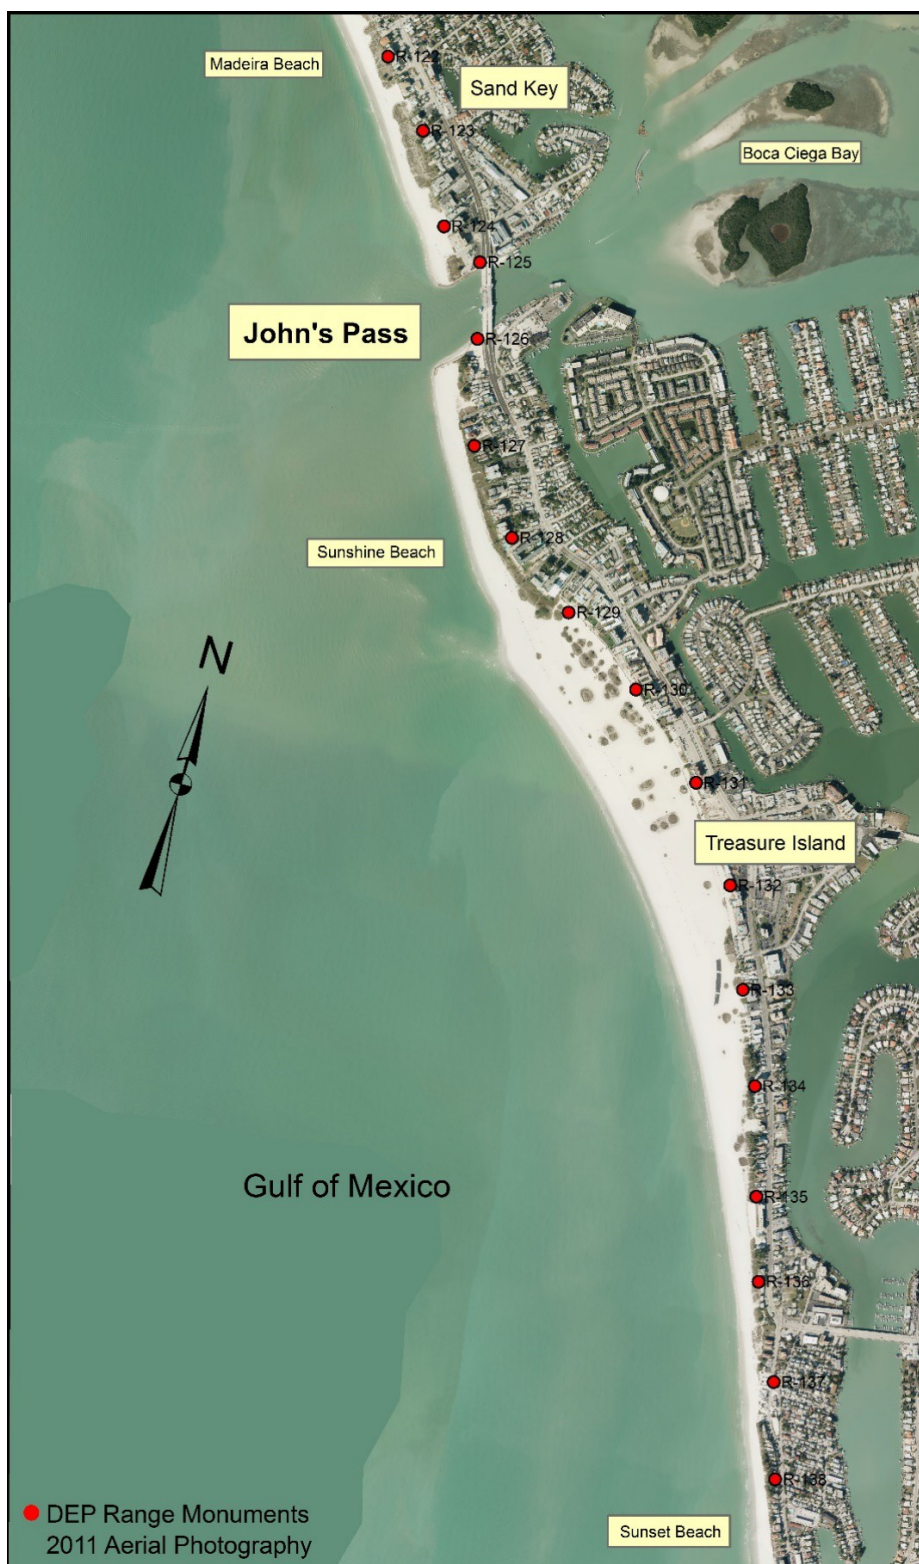
Figure 1. John's Pass in Pinellas County, FL.
Photo courtesy of the Southwest Florida Water Management District (SWFWMD).

John's Pass is located in Pinellas County on the southwest Gulf of Mexico coast of Florida, separating the barrier islands of Sand Key to the north and Treasure Island to the south (*Figure 1*).

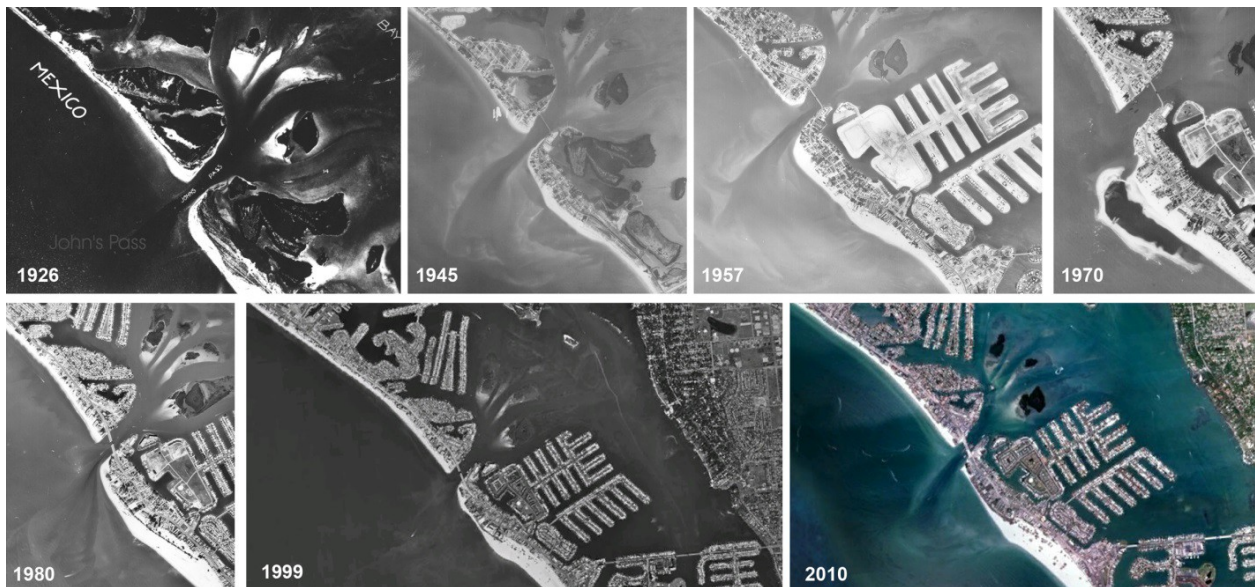
Figure 2. Historical aerial photos of John's Pass from 1926 to 2010. Various sources: U.S. Department of Commerce; Florida Department of Transportation; USF-CRL.

In 1960, 94,000 cubic yards of sand were dredged from John's Pass, and placed 2,000 feet offshore on the inlet's ebb shoal to the south of the inlet channel. In 1960, the University of Florida, Coastal and Oceanographic Engineering Laboratory studied erosion at Madeira Beach to the north of John's Pass, and recommended that a jetty be constructed north of the inlet. In 1961, a 460-foot curved jetty was constructed on the north side of John's Pass, and 30,000 cubic yards of sand dredged from John's Pass were placed on Madeira Beach to the north of the inlet. Placement of material over the John's Pass ebb shoal was conducted in 1960, and led to the formation of O'Brian's lagoon when the berm emerged and migrated shoreward attaching to Treasure Island. This resulted in the widening of Sunshine Beach. Note the emerged shoal developed from ebb shoal dredge disposal shown in the 1970 photo from *Figure 2*.

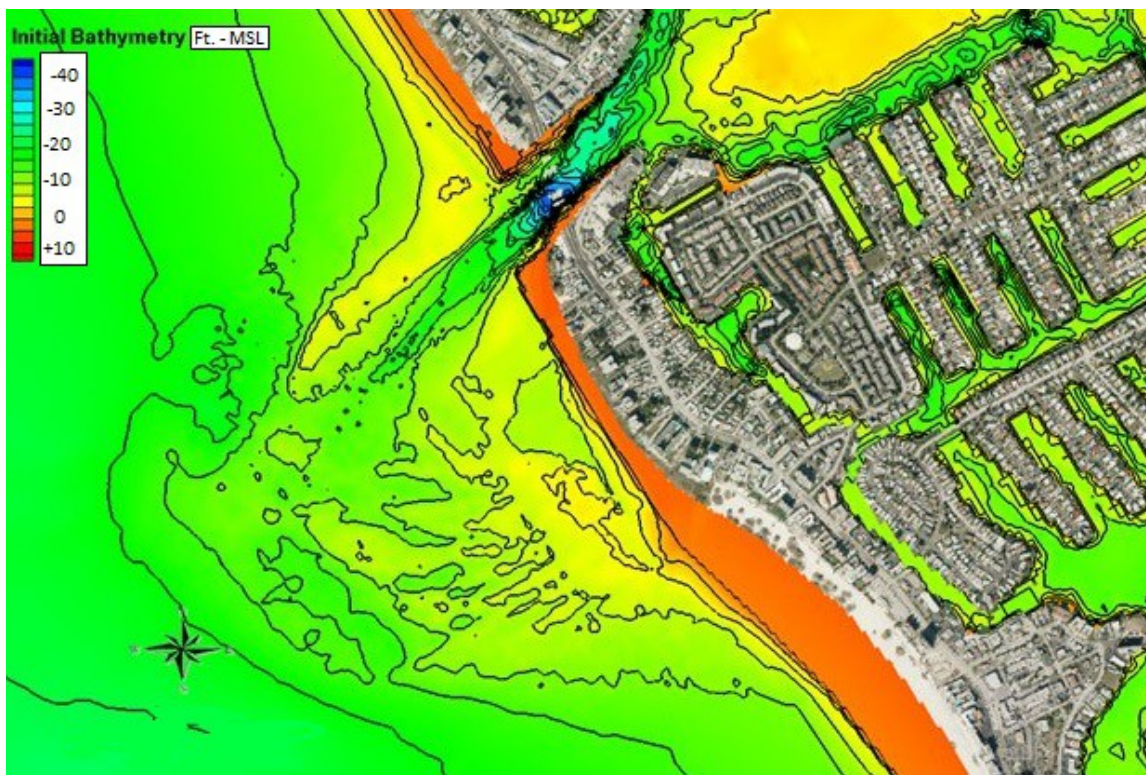
Figure 4. Initial bathymetry illustrating the present conditions at John's Pass (Wang et al., 2016).

Alternative 1 provides baseline conditions for comparison with the various management alternatives, as shown in *Figure 4*. Alternative 1 is the baseline simulation based on the detailed bathymetry surveyed in 2014, which includes the partially filled dredge pits at both John's Pass excavated in 2010, as well as the newly constructed beach fill (in 2014) at Sunshine Beach and Sunset Beach at the two ends of Treasure Island. Based on time-series bathymetry surveys, the channel excavation pit from the 2010 dredging project at John's Pass received roughly 28,800 cubic yards per year of sand. The offshore dredge pit received about 3,500 cubic yards per year of sand over the budget period from October 2010 to June 2014. However, the infilling rate in the John's Pass channel pit was 50,200 cubic yards per year during the first year and was about 21,600 cubic yards per year during the following years. Considering the time-varying infilling rate, the 152,000-cubic-yard dredge pit would take 5.7 years to fill. This suggests a dredging cycle of six years.

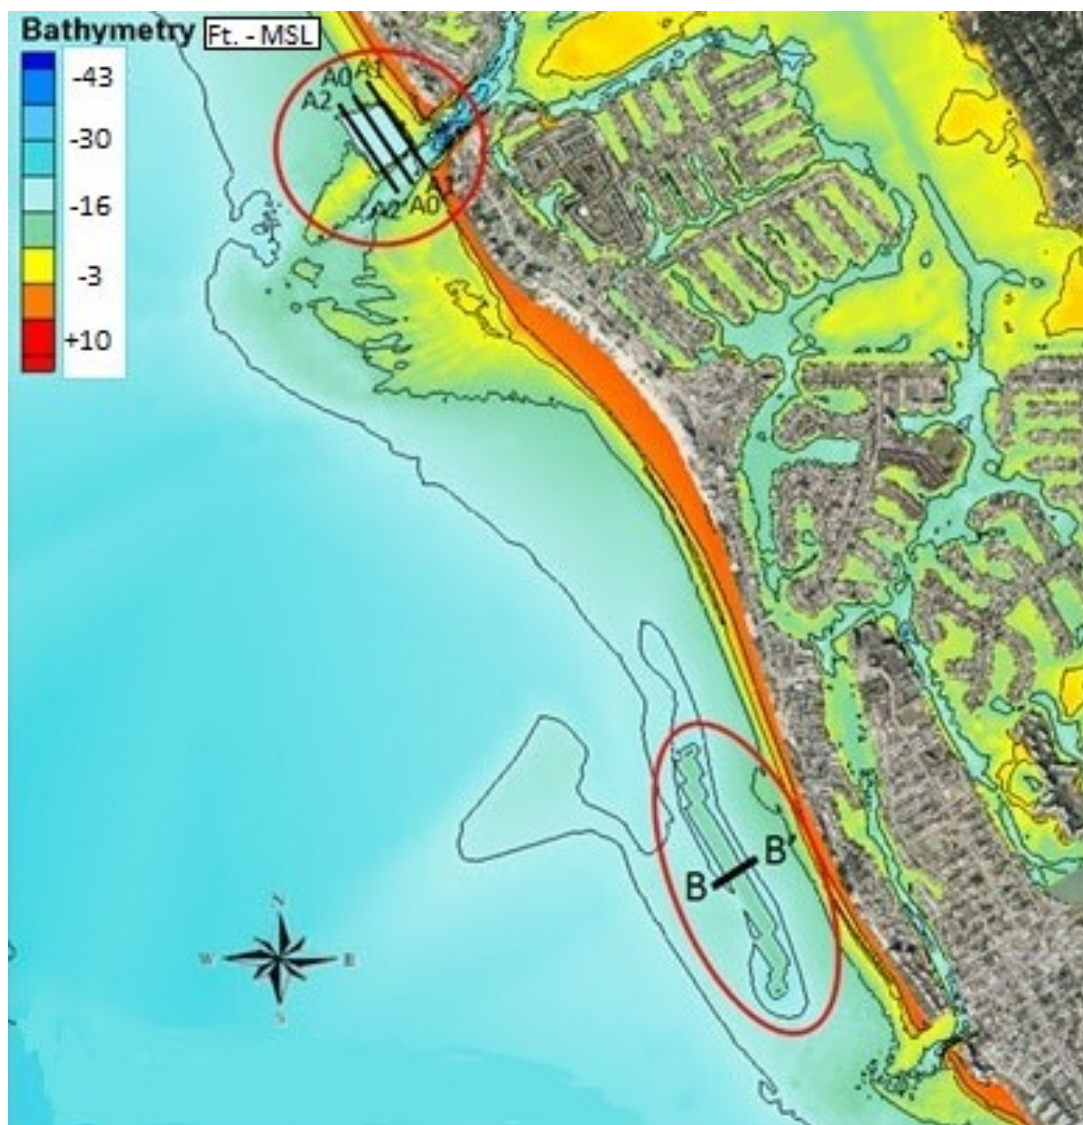
Figure 5. Bathymetry for the Alternative 2 model run. A dredge pit (A-A') is excavated at the channel margin linear bar just north of the John's Pass navigation channel. The sand is placed in an old dredge pit (B-B') seaward of Sunset Beach (Wang et al., 2016).

The nearshore area of the northern half of the John's Pass ebb shoal has a large quantity of beach quality sand. Alternative 2 analyzed the potential for filling the old dredge pit offshore (B-B') of Sunset Beach to mitigate the local erosion problem in that vicinity. Overall, the CMS model predicted that the Alternative 2 proposed excavation (A-A' in Figure 5) would have a significant negative influence on the beach processes directly north of the inlet. The influence along Sunshine Beach to the south was not considered significant. The excavation would also have a significant influence on tidal flow patterns through the main channel between the barrier islands, as well as the northern portion of the ebb shoal. Filling the old dredge pit offshore of Sunset Beach did not significantly affect beach processes at either Sunset Beach or Upham Beach, north and south of Blind Pass, and therefore the hypothesized beneficial effects were not observed in the model. Because Alternative 2 was shown to cause negative effects to the beach and coastal processes north of John's Pass, and was not shown to benefit the beach conditions at Sunset Beach, Alternative 2 is not recommended as a management strategy.

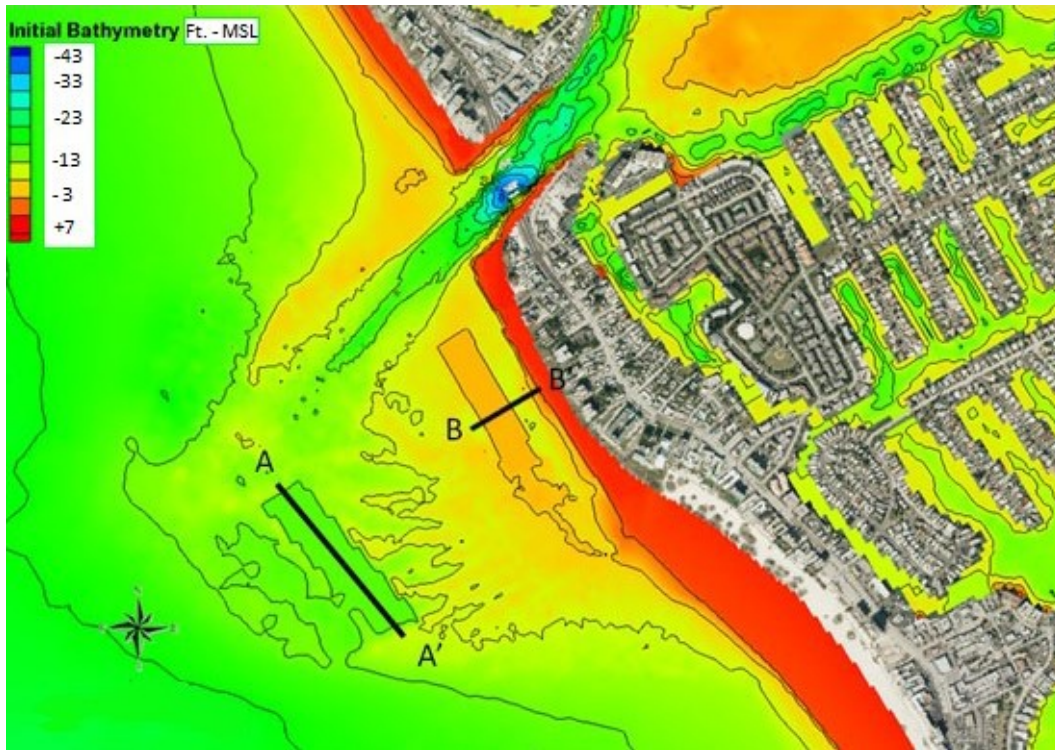
Figure 6. Alternative 3 showing the dredge pit (A-A') and the berm nourishment (B-B') (Wang et al., 2016).

The seaward fringe of the John's Pass ebb shoal has relatively finer sediment. A potential application of the sediment for nearshore nourishment is investigated in Alternative 3, and involves dredging a borrow pit along the south lobe of the ebb shoal immediately landward of the 2010 borrow area (A-A') and placing a submerged nearshore berm (B-B') along Sunshine Beach (Figure 6). The CMS model predicted slow filling of the dredge area and landward migration of the nearshore berm that would eventually attach to and widen the beach. Alternative 3 had considerable localized effects on wave

conditions. Westerly approaching waves were shown to be reduced over the dredge pit and over the distal portion of the main channel, while the nearshore berm functioned as a submerged breakwater and significantly reduced the wave heights landward of the nearshore berm. The Alternative 3 ebb shoal dredge area showed potential for direct beach placement or nearshore placement, as an additional sediment source beyond dredging the channel. However, the ebb shoal dredge pit was shown to take 10 to 20 years to re-fill, and therefore, its use would be limited.

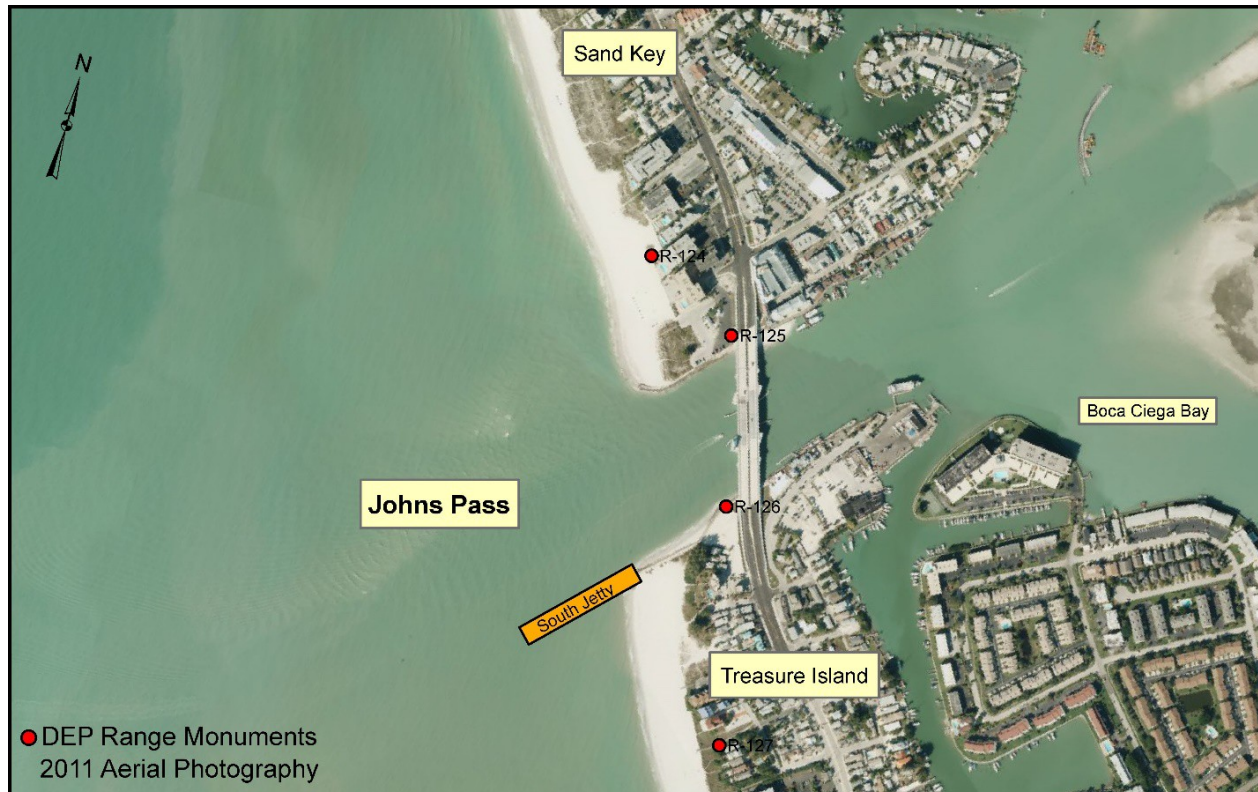
Figure 8. Alternative 5 illustrating an extension of the south jetty (Wang et al., 2016). The 2011 aerial photo is courtesy of the SWFWMD.

Alternative 5 investigates the potential of extending the south jetty 230 feet, and does not involve any dredging or fill placement (*Figure 8*). Alternative 5 was determined to have minimal influence on the hydrodynamics and morphodynamics of the inlet and adjacent beaches. Because Alternative 5 was determined to have minimal influence in stabilizing Sunshine Beach, the south jetty extension is not recommended as an inlet management option. Its cost cannot be justified by its minimal benefits.

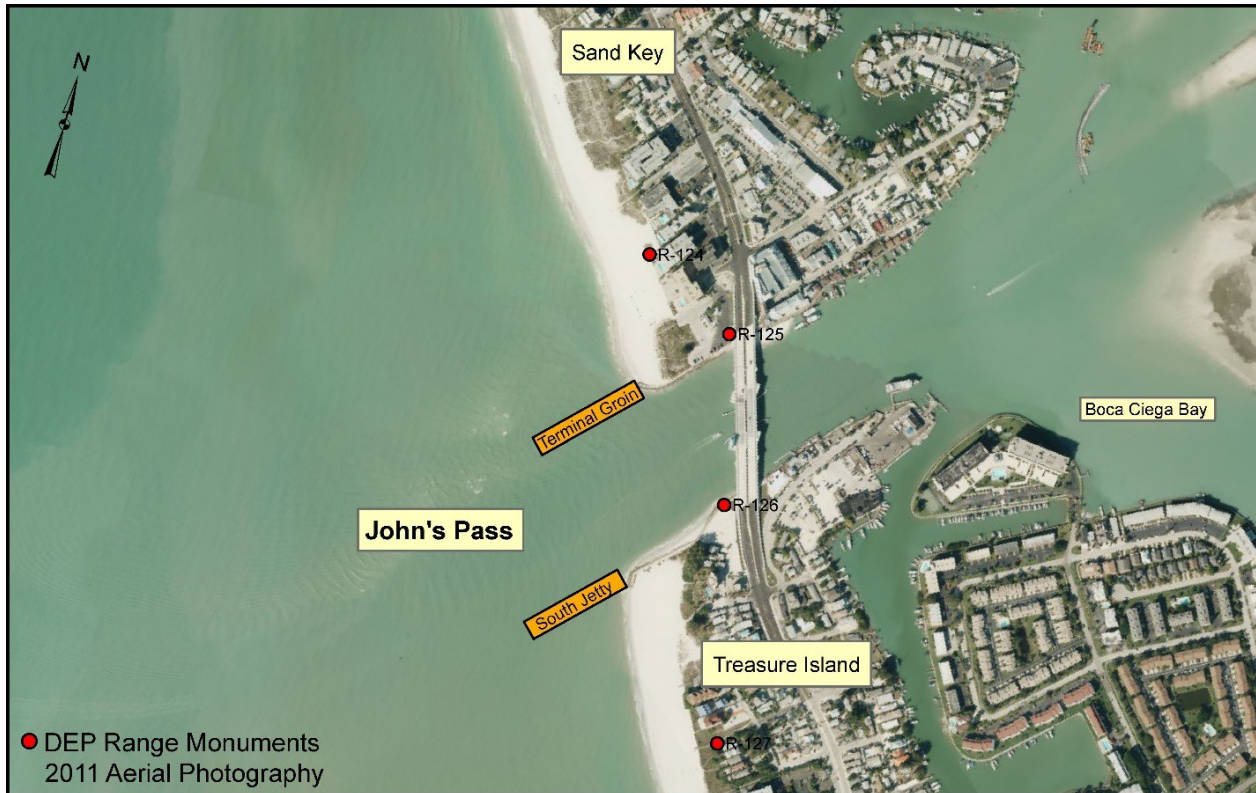
Figure 9. Extension of both jetties in Alternative 6 (Wang et al., 2016). The 2011 aerial photo is courtesy of the SWFWMD.

Alternative 6 investigates a structural option to include lengthening both the north and south jetties by 230 feet, and like Alternative 5, does not involve any dredging or fill placement (*Figure 9*). The model predicted modest accretion of the beaches immediately adjacent to John's Pass, due to the impoundment of sand by the extended jetties. The extended jetties had little influence on the wave field of John's Pass, but they had a significant influence on the flow field seaward of the jetties. The jetty extensions create a longer channel for ebb flow, which results in an ebb jet that extends farther seaward. The enhanced ebb flow jet may have a temporary influence on sand bypassing around the ebb shoal.

With the impoundment of sand at Sunshine Beach, there are potential negative impacts on beaches farther to the south of the inlet. Alternative 6 is not recommended because the benefits do not appear to justify the high cost of jetty construction, and because of the uncertainties associated with the beaches down-drift of the impoundment fillet.

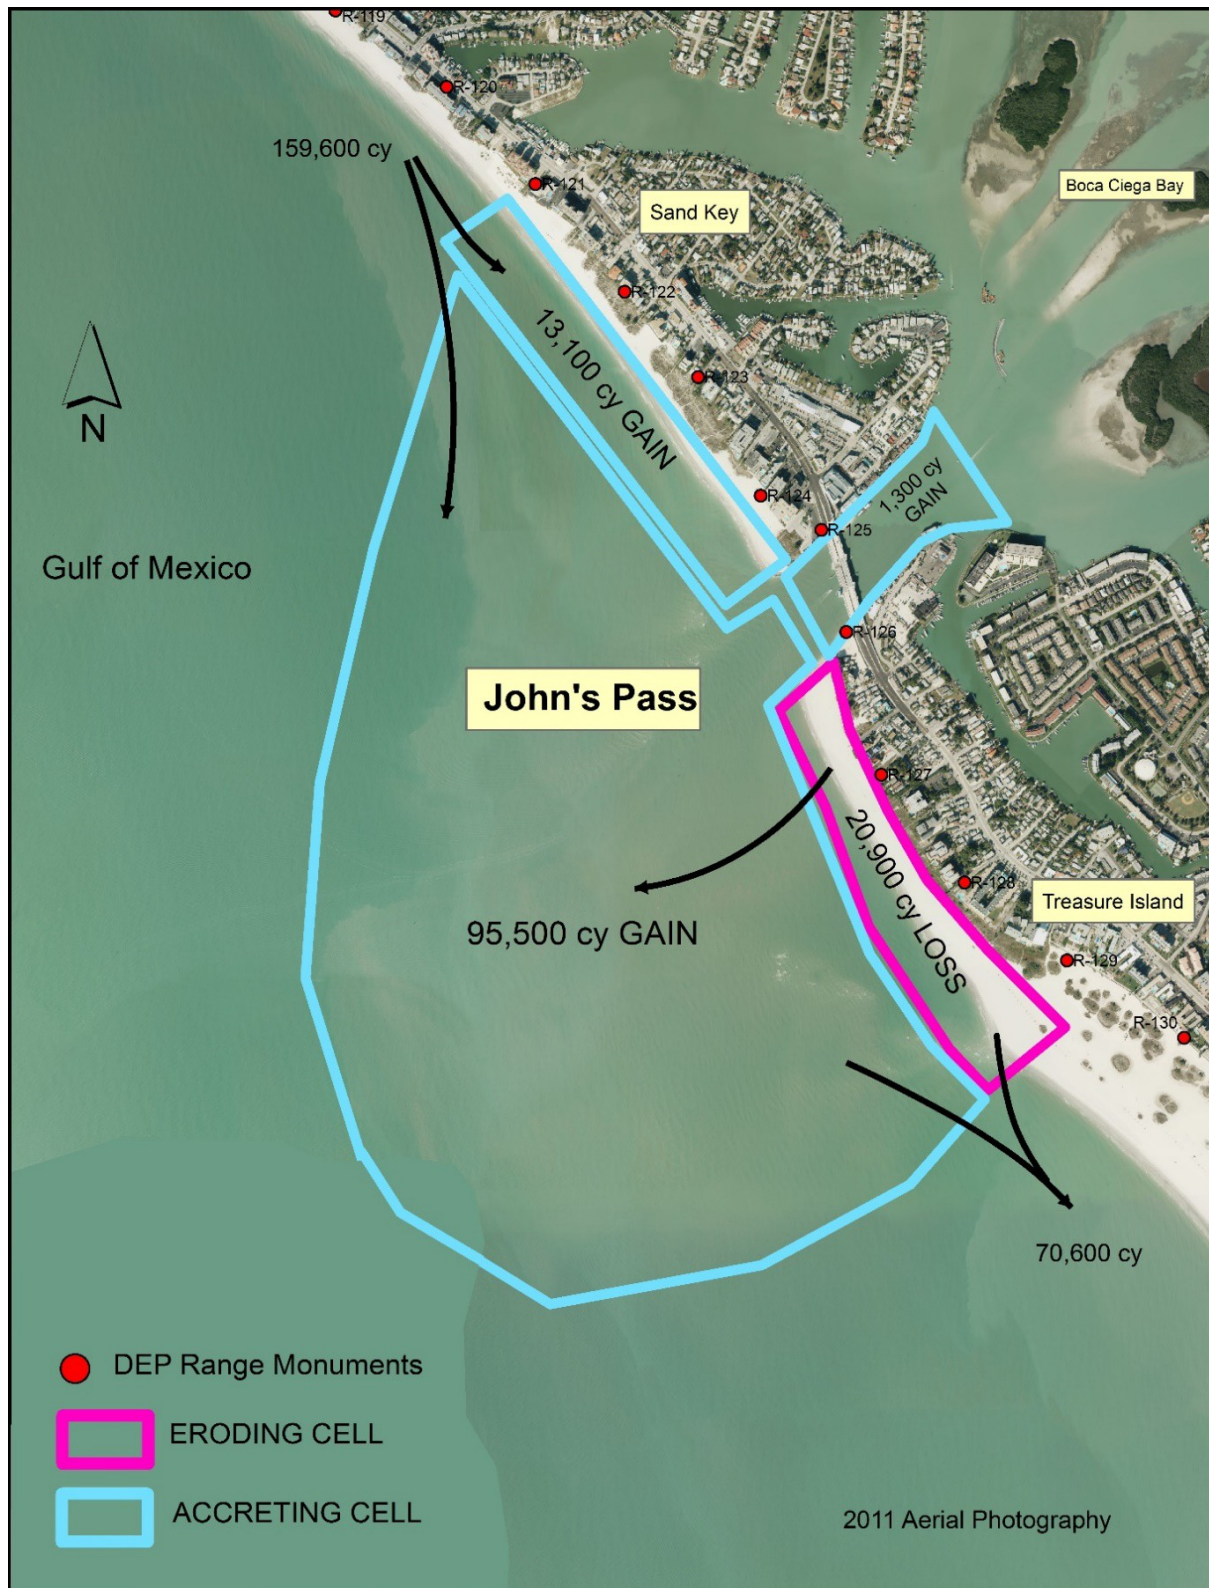
Figure 12. Annualized sediment budget at John's Pass determined based on field data collected from October 2010 to June 2014 (Wang et al., 2016). The 2011 aerial photo is courtesy of the SWFWMD.

Therefore, this updated sediment budget is influenced by the artificial sand supply from the 2010 Treasure Island and Long Key beach nourishments and the 2012 Sand Key nourishment. Since the beaches in the study area are nourished regularly and the budget period incorporates a large portion of a beach nourishment cycle, this updated sediment budget should represent a typical situation inclusive of artificial sand supplies from beach nourishments. For this sediment budget, the coast directly affected by John's Pass has been divided into the beach and inlet cells as shown in *Figure 12*.

Beach erosion and accretion have been measured by comparing the surveys of October 2010 and June 2014, which has yielded the volume losses and gains for each of the beach and inlet cells. North of these cells, the input longshore transport quantity was based on the sum of the erosion along Sand Key south of R60. R60 has been determined to be a point of divergence in longshore transport, causing a drift divide where to the north of R60, sediment moves northward toward Clearwater Pass, and to the south of R60, sediment moves southward toward John's Pass. Over the period of measurement, Sand Key experienced a loss of 159,600 cubic yards per year, which would be the longshore transport to the north cell for the John's Pass sediment budget.

To the north of John's Pass, Madeira Beach between R121 and R125 gained an annualized 13,100 cubic yards per year of sediment between October 2010 and June 2014. During the same period, to the south of John's Pass, Sunshine Beach between R126 and R129 lost an annualized -20,900 cubic yards per year of sediment. These losses were offset by gains within the John's Pass system, including the channel and the ebb shoal. Specifically, the John's Pass channel from the entrance at the inlet jetties, extending into the inlet interior, saw an annualized gain during the same period of 1,300 cubic yards per year of sediment. Outside the entrance to John's Pass, i.e., the ebb shoal, there was an annualized gain for the same period of 95,500 cubic yards per year.

Combining the John's Pass channel and ebb shoal gains equals 96,800 cubic yards per year, which is over four times the 20,900 cubic yards per year needed to offset the losses to Sunshine Beach south of John's Pass. The southern half of Treasure Island between R135 and R143 is eroding. Between October 2010 and June 2014, this southern segment of Treasure Island lost an annualized -64,100 cubic yards. The John's Pass channel and ebb shoal annualized gain of 96,800 cubic yards per year exceeds the losses at both the north and south ends of Treasure Island, which is approximately -85,000 cubic yards per year. This suggests there is sufficient sand accumulating within the John's Pass system to balance the erosion losses at not only Sunshine Beach immediately south of John's Pass, but also along the southern half of Treasure Island between R135 and R143 and north of Blind Pass.
