Hurricane Irma
Post-Storm Beach Conditions and
Coastal Impact in Florida

Division of Water Resource Management
Florida Department of Environmental Protection

April 2018

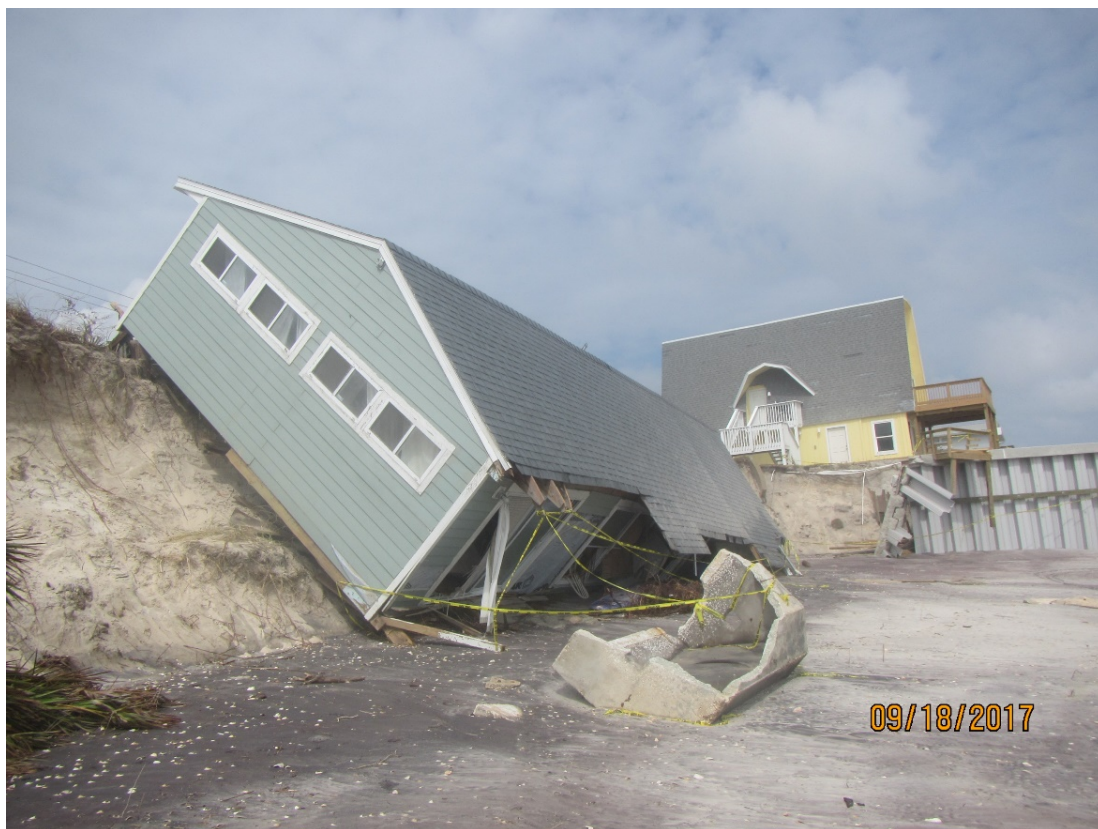
Figure 15. Single-family dwelling destroyed at R110, Vilano Beach.

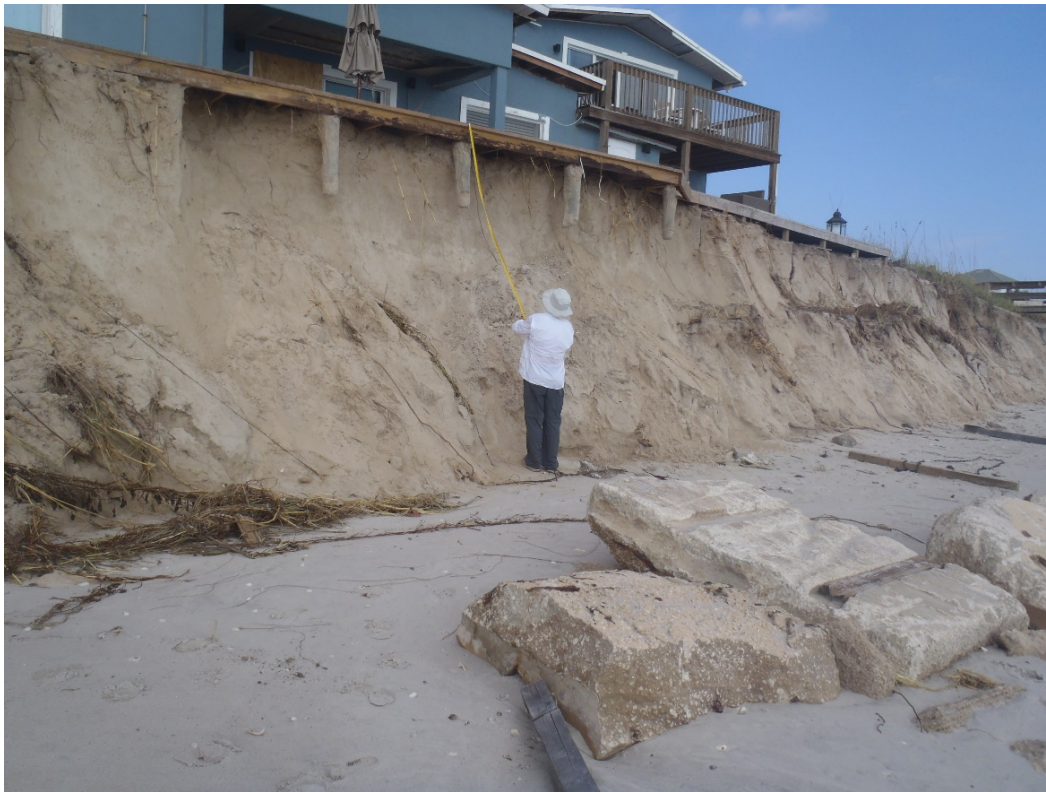
Figure 31. Major dune erosion at Shell Street, Indian Harbour Beach, R97.

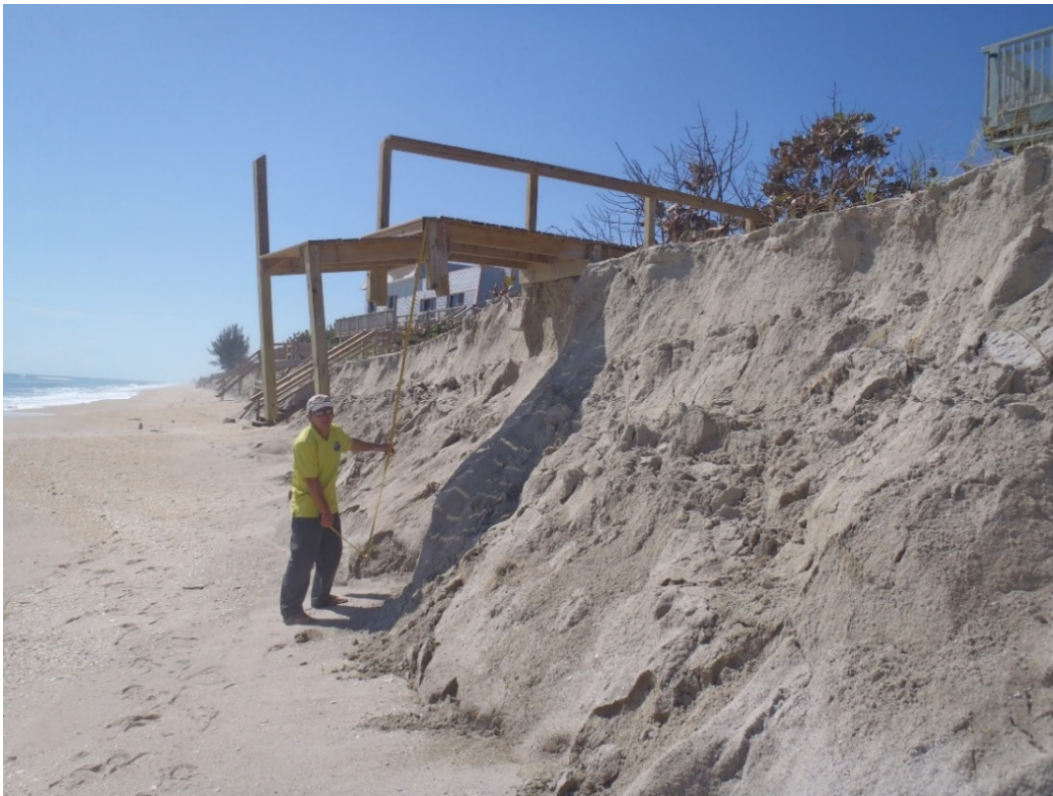
Figure 32. Major dune erosion near R196, south Brevard County.

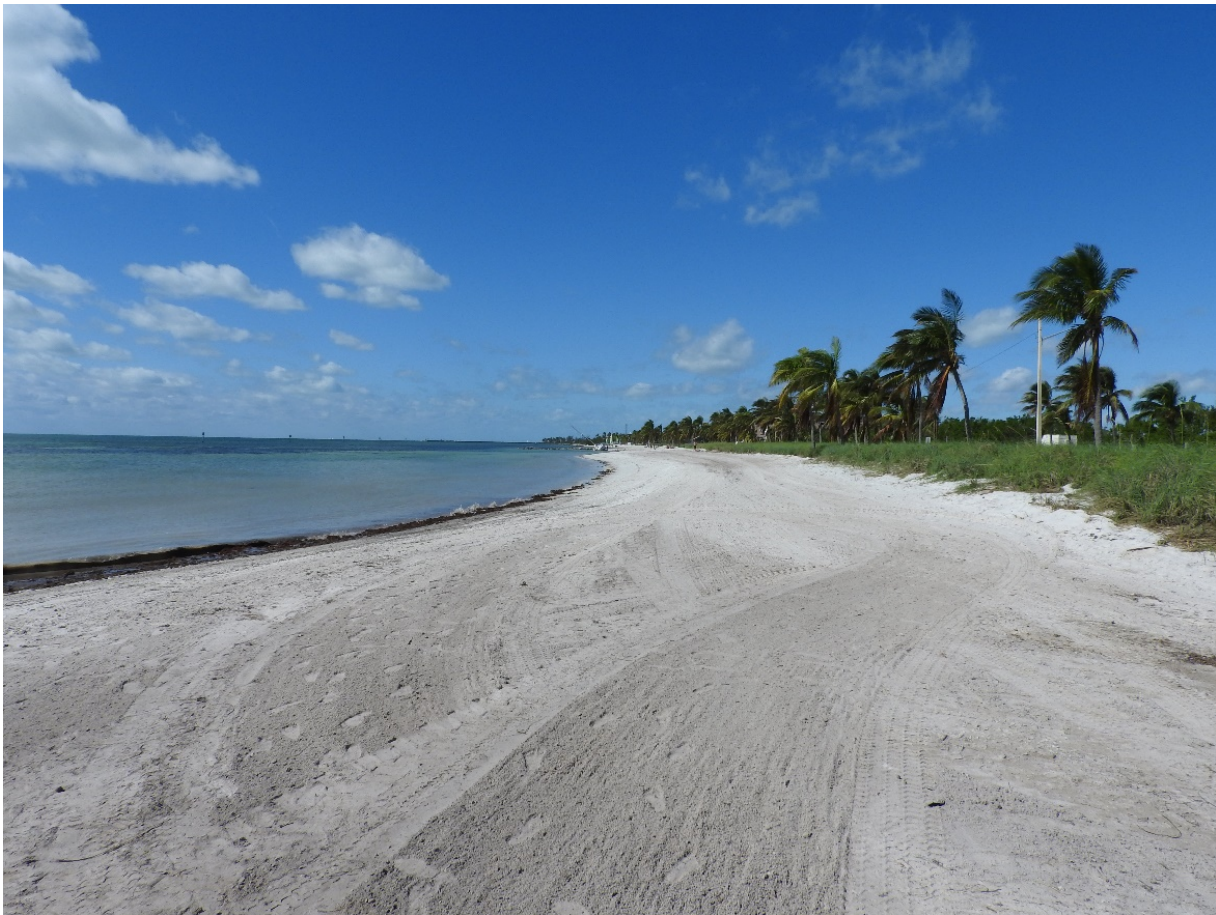
Figure 96. *George Smathers Beach, Key West.*

To the west is the 3,300-foot segment of shoreline named George Smathers Beach, which was originally restored in 1960 and included the construction of four boulder mound limerock groins (200 to 300 feet long) and beach restoration with 30,000 cubic yards of crushed limerock fine-grained sediment. George Smathers Beach was subject to erosion from several storms, and was first nourished with oolitic aragonite material from the Bahamas in 1989 and again with quartz sand trucked in from South Florida in 2000. Minor beach erosion (condition I) was sustained during Hurricane Irma (Figure 96). Surveys by the City of Key West measured a sand volume loss of -1,630 cubic yards (Atkins, 2017).

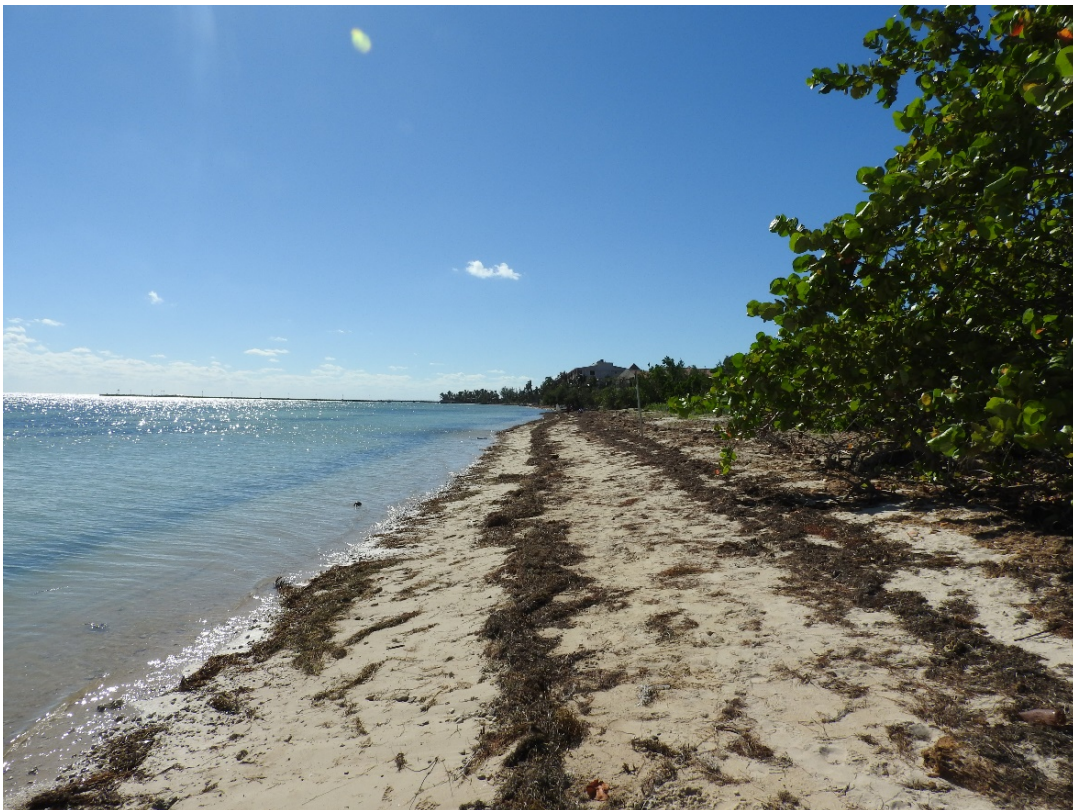
Figure 98. *Berg and Kitsos Beach, Key West.*

rock revetment, which sustained minor damage (level II damage). To the west is a city park along Berg and Kitsos Beach, which experienced minor beach and dune erosion (condition II) to one of the last segments of natural beach on Key West (Figure 98). West of Berg and Kitsos Beach are private properties with seawalls and little to no beach remaining. To the west of these private properties is a 660-foot city park called Rest Beach. A wide beach prior to the hurricane of 1944, Rest Beach was adversely affected by the White Street Pier construction in the mid-1960s. Rest Beach sustained minor beach and dune erosion (condition II) during Hurricane Irma (Figure 99). Sidewalks and beach access walkways were destroyed.

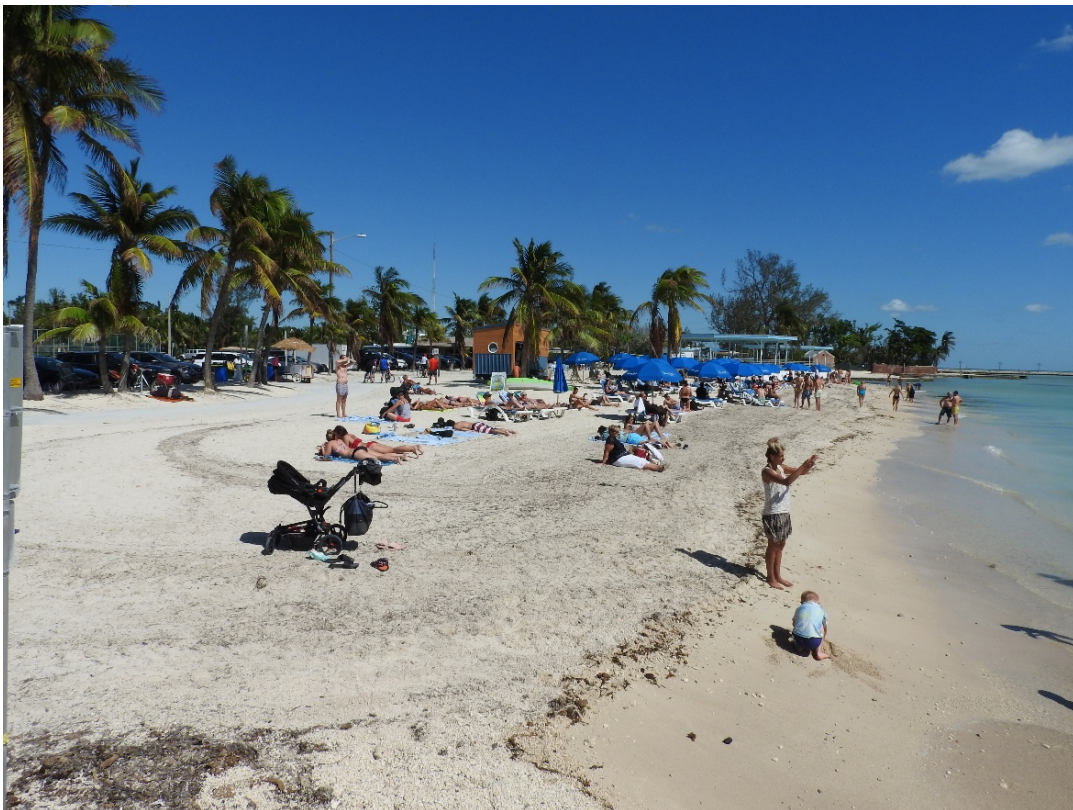
Figure 100. Clarence Higgs Beach, Key West.

West of Rest Beach and the White Street Pier is a 1,250-foot segment of Monroe County park known as the Clarence S. Higgs Memorial Beach. Although the gardens within West Martello Tower sustained wind damage, the seawall and revetment along the tower and the eastern segment of Higgs Beach sustained no discernable damage. The unarmored western segment of Higgs Beach experienced minor erosion and needs additional sand (Figure 100).

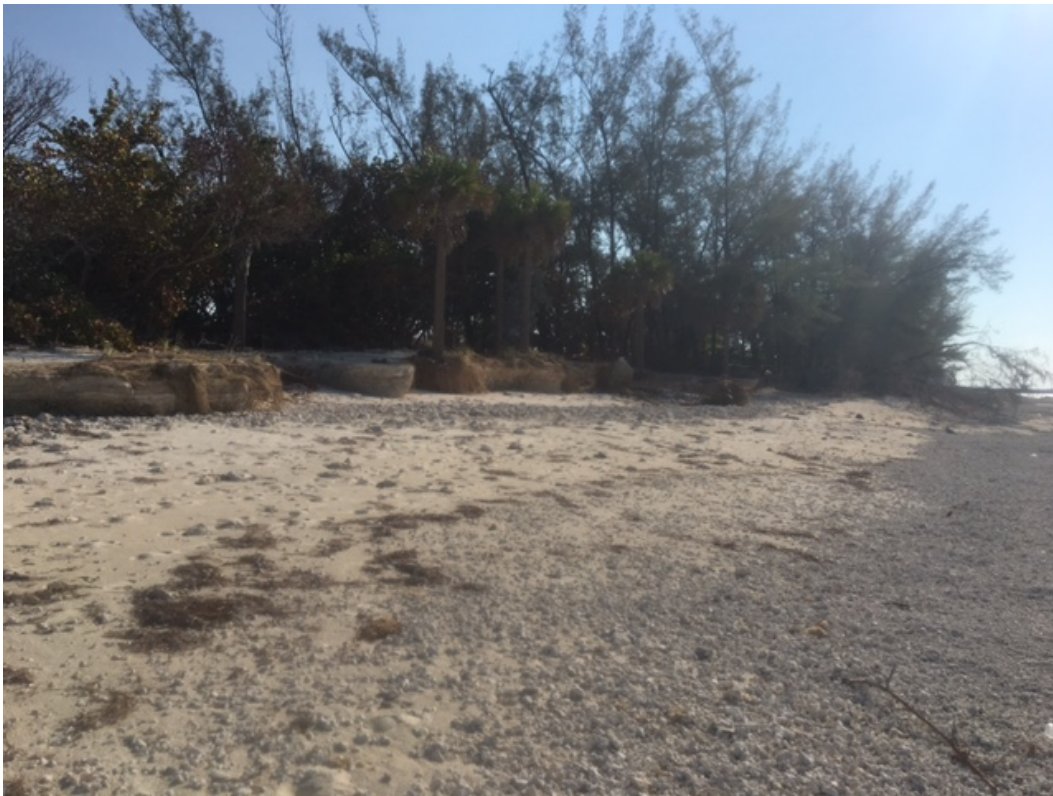
On the southwestern tip of Key West is an area that was built by dredge spoil from the ship channel dredging project of the 1950s. The fill site surrounds the 150-year old Fort Zachary Taylor and includes a 1,500-foot recreational beach within the Zachary Taylor State Park. This beach sustained minor beach and dune erosion (condition II) (Figure 101). In addition, two of the four nearshore boulder mound breakwaters appear to have sustained minor damage (level II damage) (Figure 102). On the northwestern shoreline of Key West at the northern end of Simonton Street is another street-end pocket beach that sustained minor beach erosion (condition I).

Figure 101. *Minor beach and dune erosion, Fort Zachary Taylor State Park.*
