*Hurricane Michael Post-Storm  
Beach Conditions and Coastal Impact Report*

**Division of Water Resource Management  
Florida Department of Environmental Protection**

**January 2019  
(Revised April 2019)**

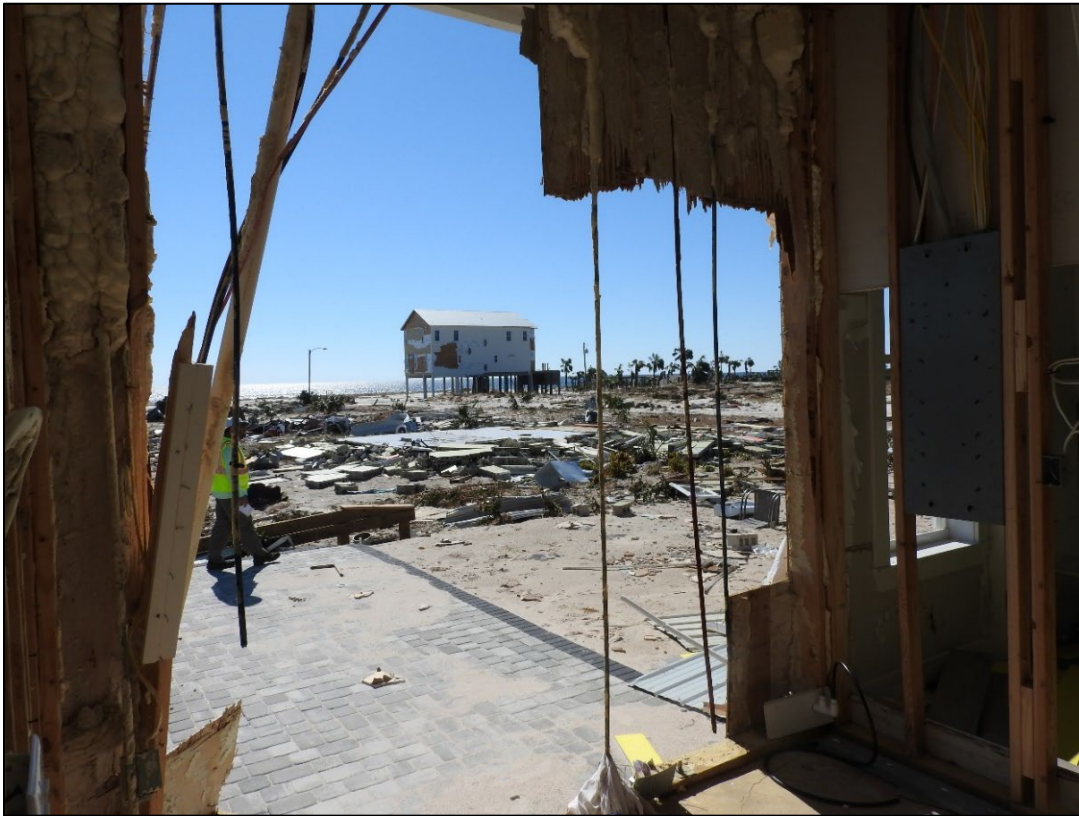
**Figure 36.** Dwellings destroyed by storm surge near R132, Mexico Beach.

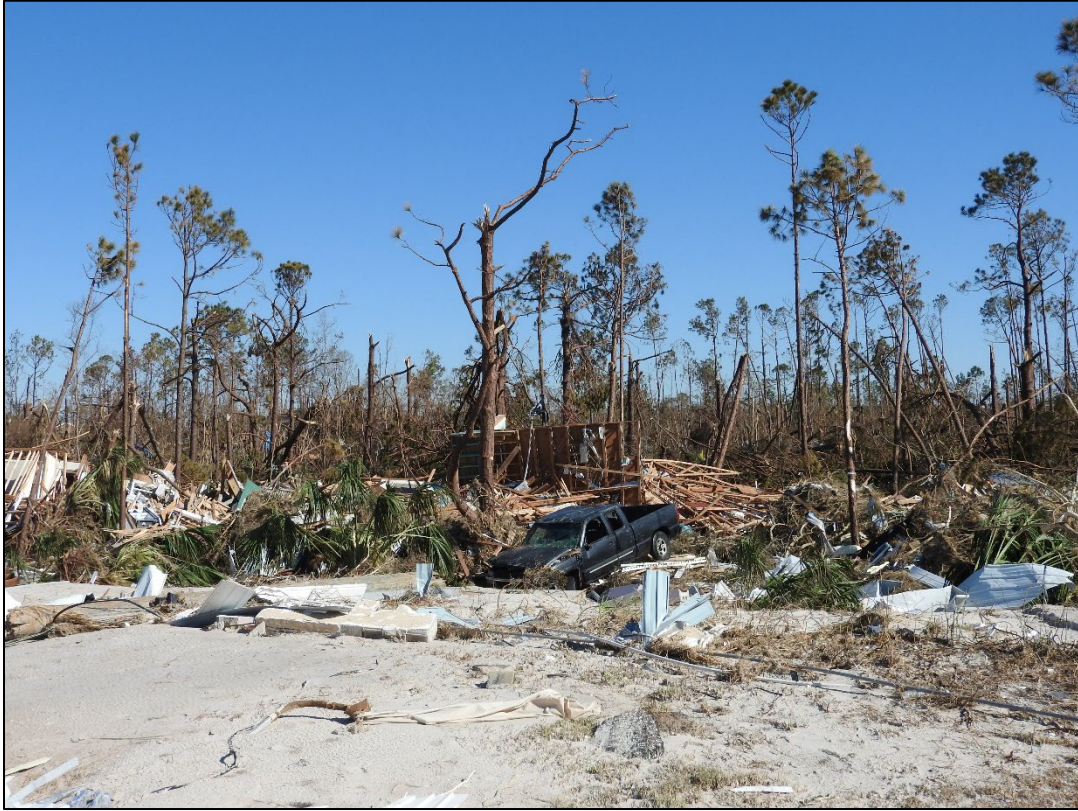
**Figure 40.** Debris transported by the storm surge inland near R136, Mexico Beach.

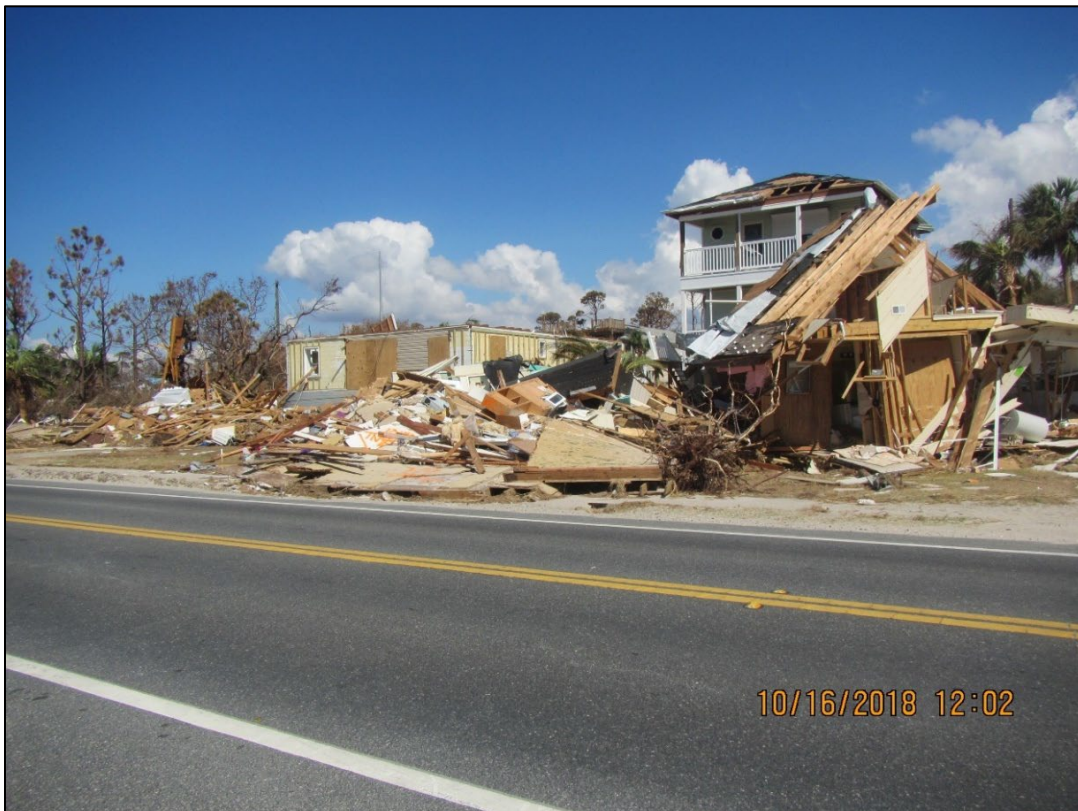
*Figure 57. Dwellings along U.S. 98 destroyed near R3, Beacon Hill.*

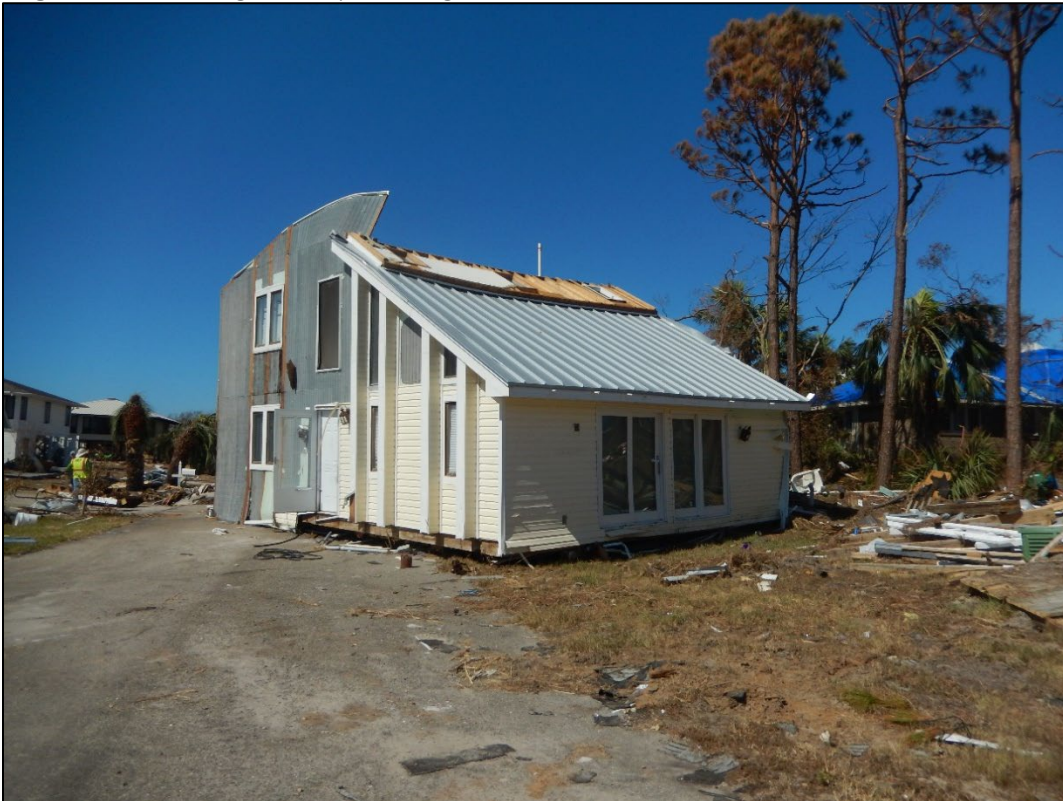
**Figure 59.** Dwelling transported by storm surge onto Trade Winds Dr. near R6, Beacon Hill.

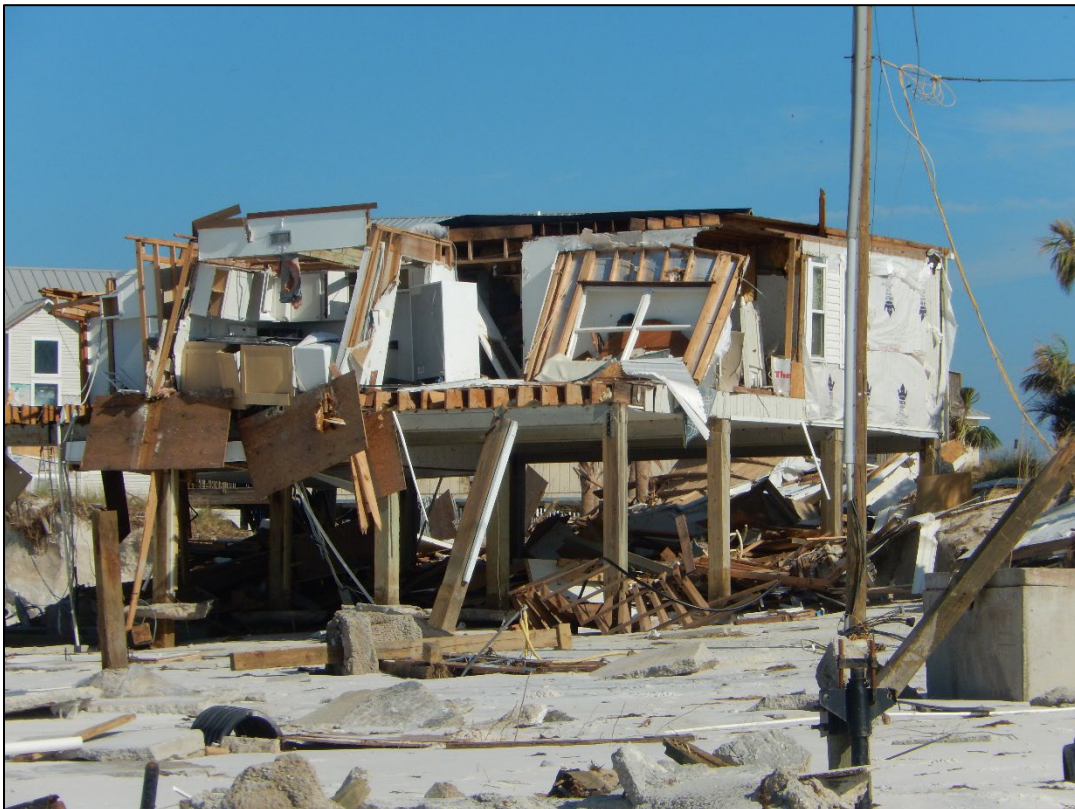
**Figure 70.** *Pile-supported dwelling destroyed near R97.5, St. Joseph Peninsula.*

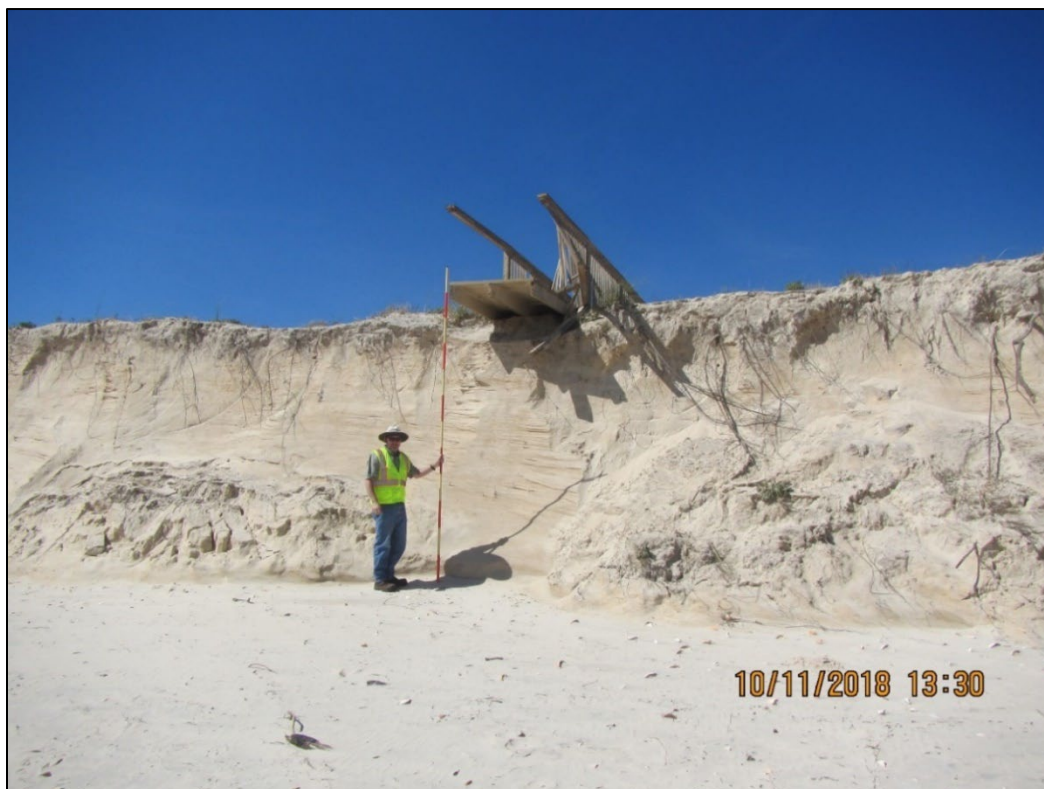
Along St. Vincent Island, Little St. George Island, and St. George Island, major beach and dune erosion (Condition IV) was sustained. Severe dune erosion was sustained at Bob Sikes Cut at R52 (**Figure 83**). Along St. George Island Plantation (R52-R73), the dunes retreated as much as 50 feet (**Figure 84**).

**Figure 84.** Major dune erosion at R72, St. George Island.

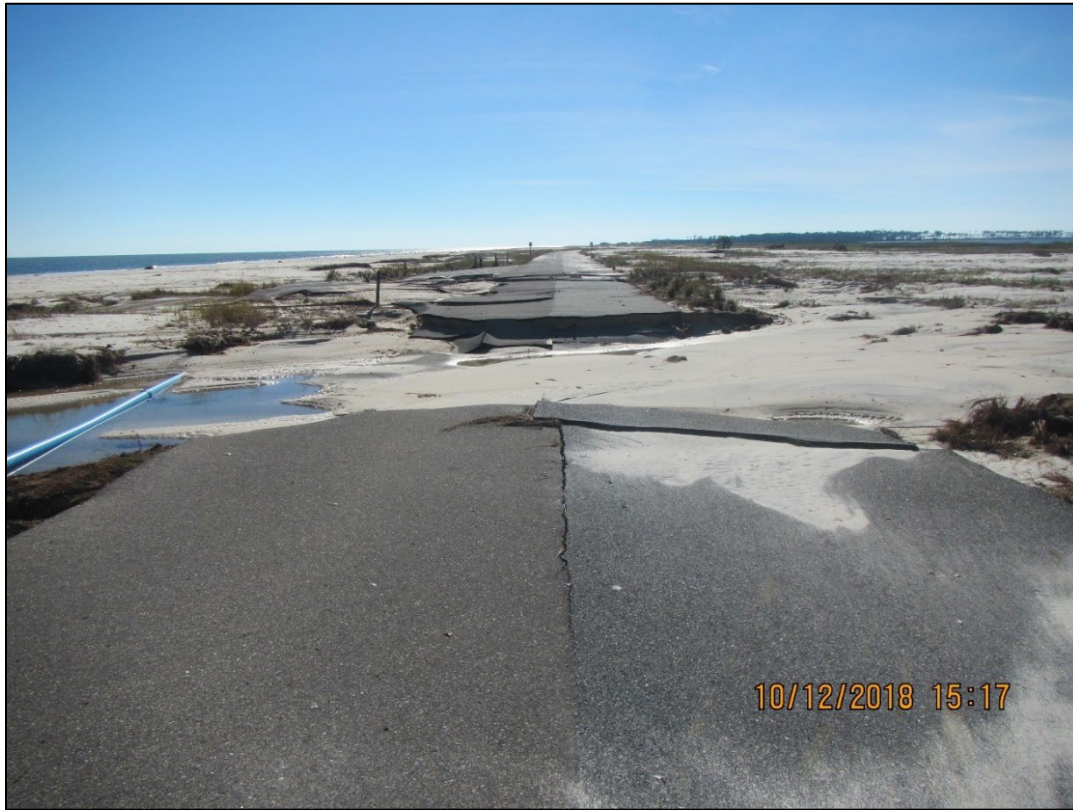
**Figure 91.** Dunes leveled and park road destroyed at R114, St. George Island.
